SURVEYDATE 11/13/2025

ORGANIZATION RAMSEY HISTORIC CONSULTANTS

SURVEYAREA NAPERVILLE SURVEY UPDATE

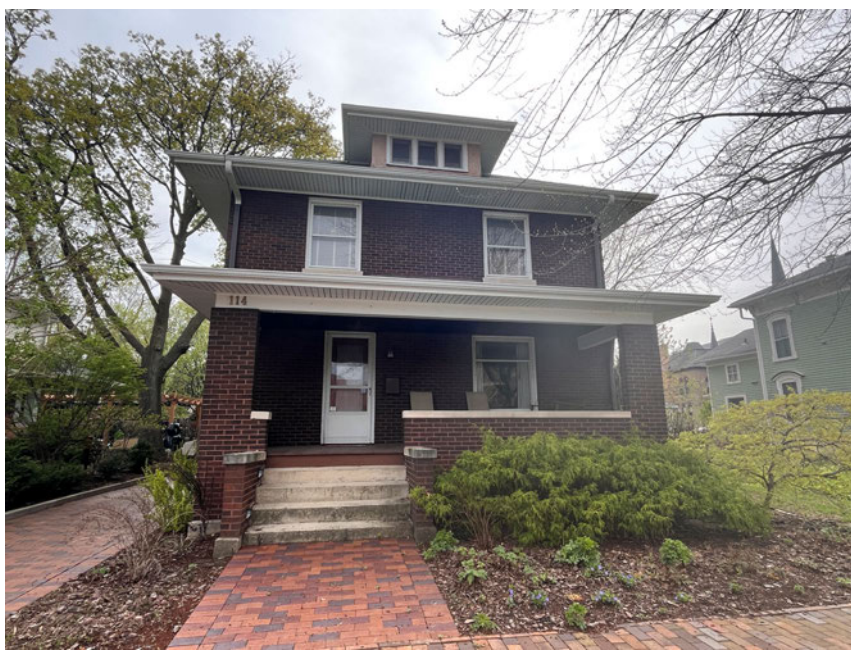
Aluminum siding installed under eaves

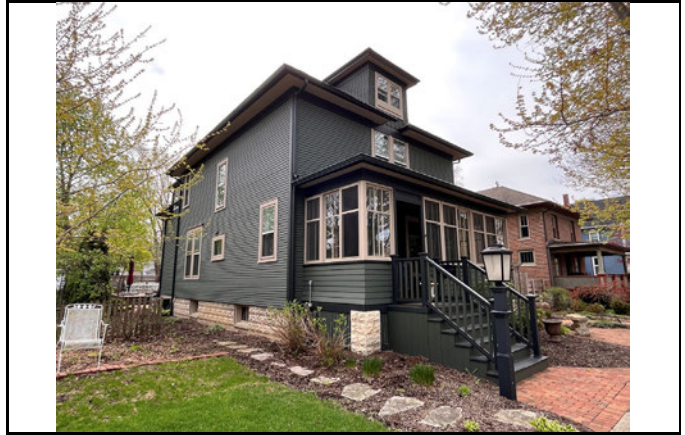
Two windows in front dormer replaced with 1/1 windows in downsized openings.

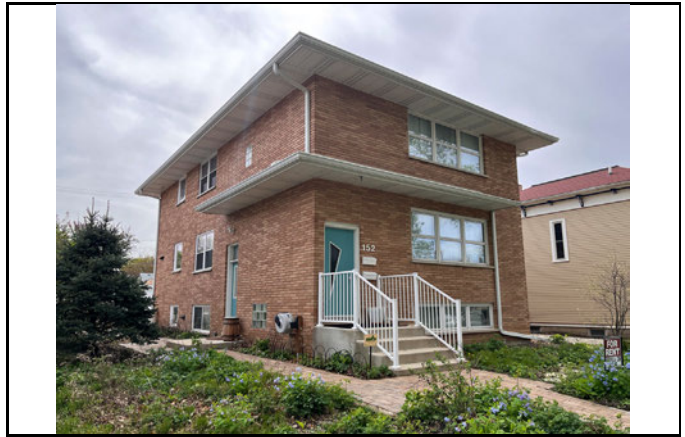
Metal railing at front steps; replacement front door (historically compatible).

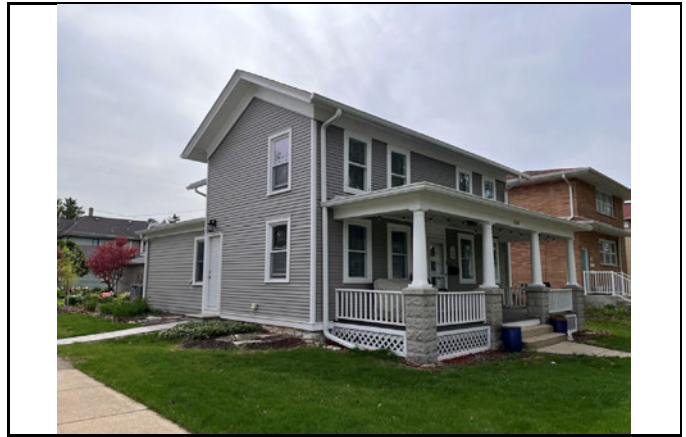
Replacement windows on street-facing north elevation (historically compatible); replacement door and stoop at north entrance.

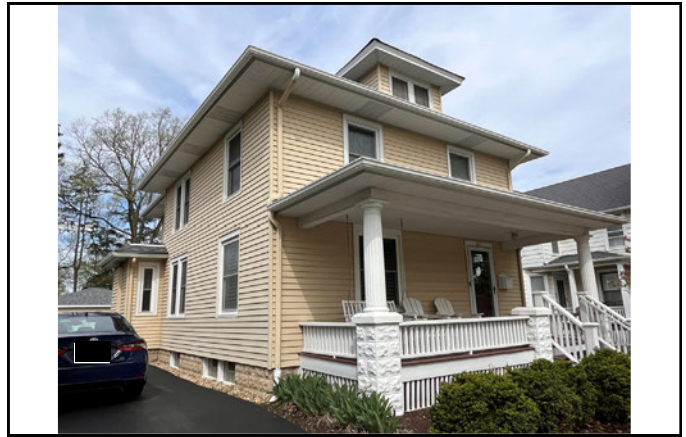
2nd-story replacement windows in original openings; railing replacement at porch steps

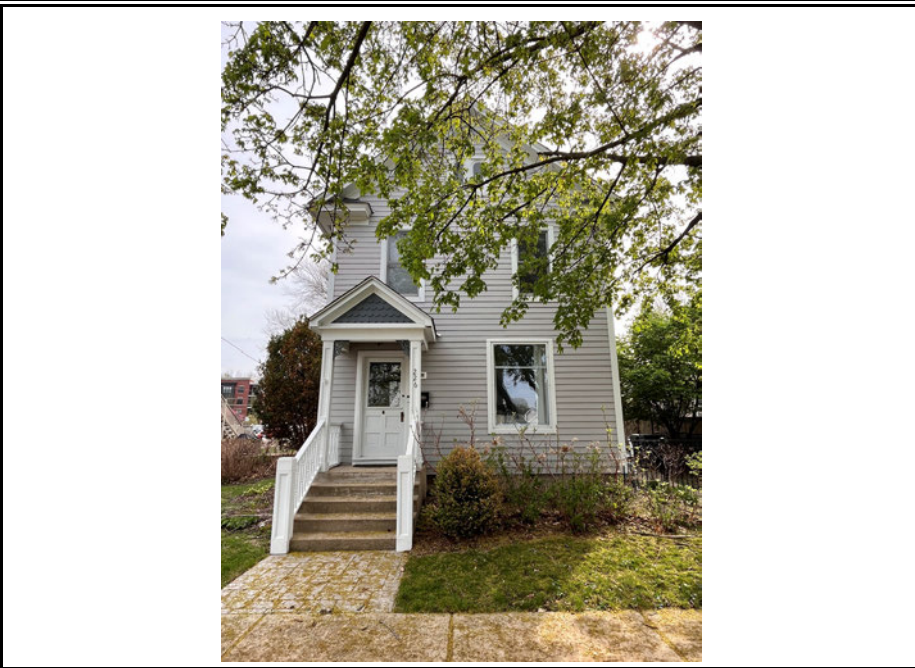
COA Compliance Notes Board width of replacement siding does not match historic wood siding.
