| <b>STREET #</b> | 105 |
| <b>STREET</b> | ELLSWORTH |

| <b>PREPARER</b> | Lara Ramsey | <b>SURVEYDATE</b> |
| <b>PREPARER ORGANIZATION</b> | RAMSEY HISTORIC CONSULTANTS | <b>SURVEYAREA</b> |

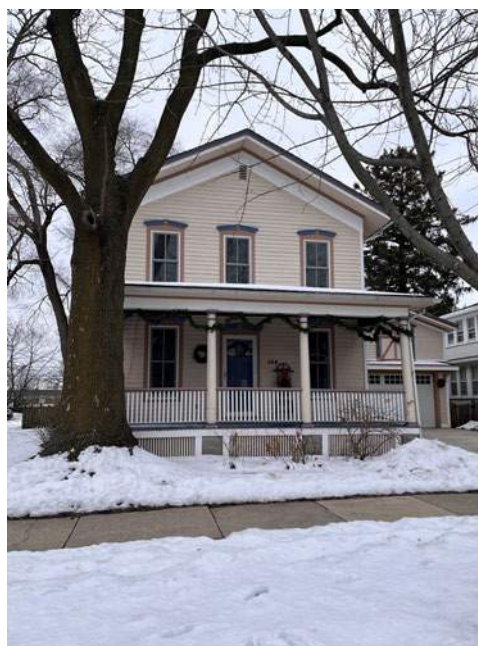
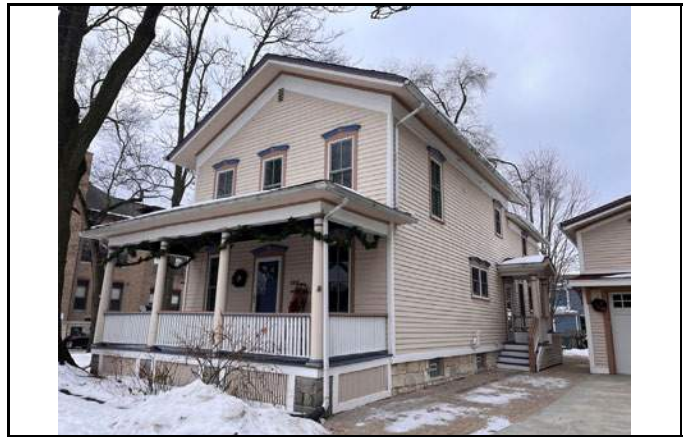
| <b>CONDITION</b> | good | <b>REASON for SIGNIFICANCE</b> | Fine, simple iteration combination of the Italianate and Greek Revival styles within the district. |
| <b>INTEGRITY</b> | minor alterations and addition(s) | | |

| <b>ALTERATIONS</b> | Replacement front door (not historic); front porch add./replacement S. porch (historic--c. 1905); S side door, surround, & canopy/stoop (not historic); glass block in basement windows (not historic). Post-2007 -- 2/2 double-hung Aluminum replacement windows throughout; non-historic north entrance porch replaced with historically compatible entry porch; new detached garage. |

☒ **ELIGIBLE WORK COMPLETED WITHOUT COA?**

2/2 double-hung Aluminum replacement windows throughout

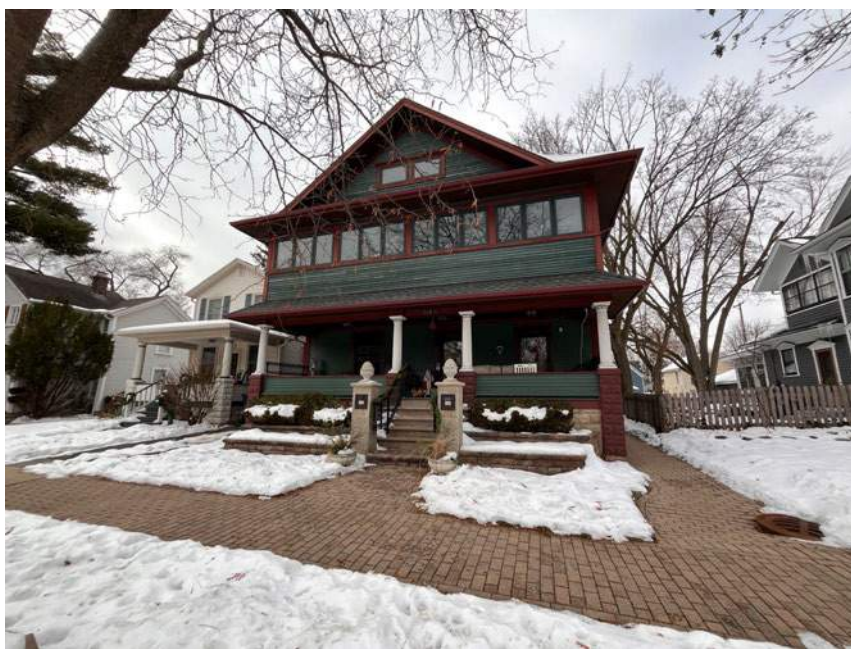
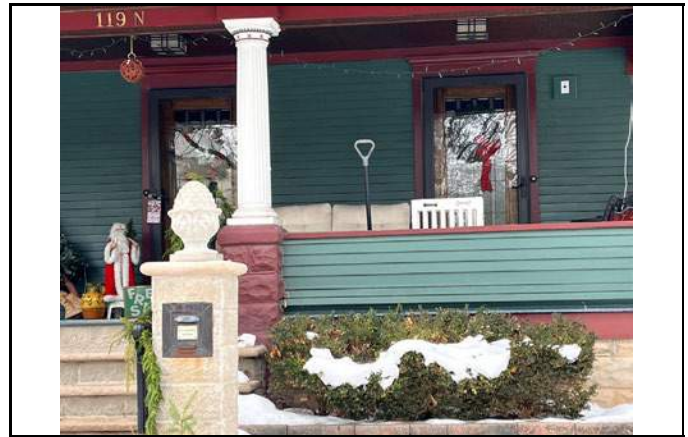
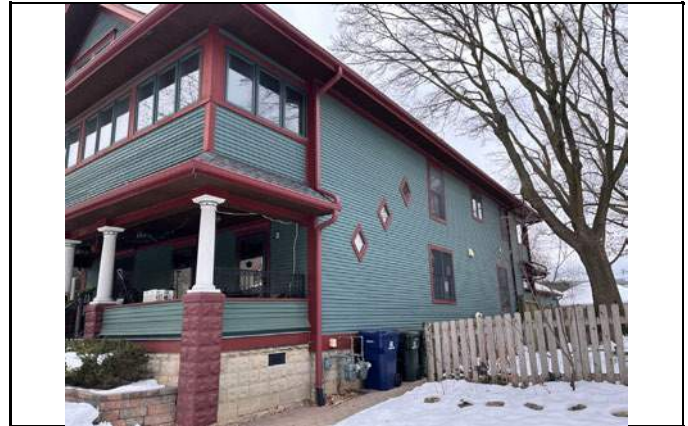
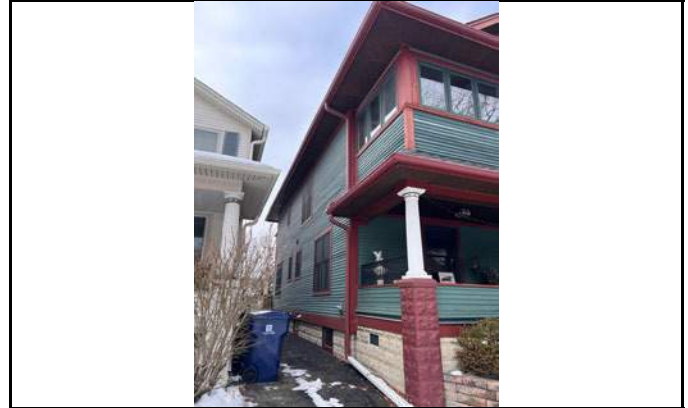
| CONDITION | excellent | REASON for SIGNIFICANCE | Unusual combination of the Craftsman and Prairie styles in the historic district, with distinctive 2nd story sun porch. |

| ALTERATIONS | Post-2007 -- house appeared to be vacant/under renovation during 2007 survey. Post-2007 alterations include 2nd story rear addition; 1/1 aluminum replacement windows on front and side elevations, some in altered openings; aluminum single-light replacement windows in 2nd story sun porch; replacement front doors at center and north end entries under front porch; north end enclosure of front porch evident in 2007 survey removed; cast-stone steps to front porch flanked by brick planters; wrought iron railings added above north and south knee walls at front porch. |

☒ ELIGIBLE WORK COMPLETED WITHOUT COA?

NOTES ON WORK: All work listed in alterations with the exception of the replacement front door in north end entry under porch

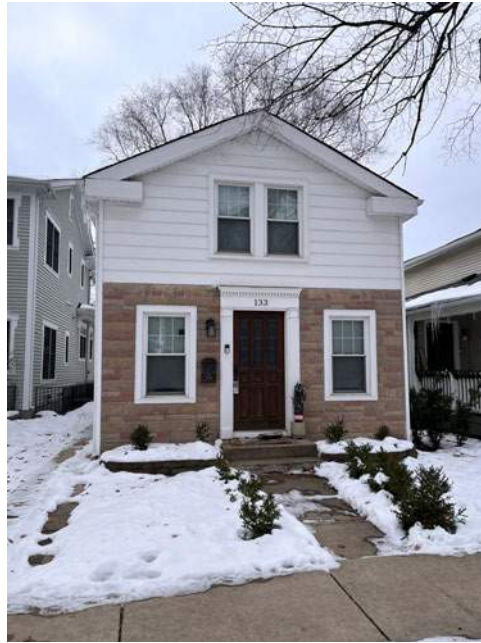
| CONDITION | good/fair | REASON for SIGNIFICANCE | |

| ALTERATIONS | Aluminum siding (not historic); stone veneer on 1st story façade (not historic); 1 story rear addition. Post-2007 -- 6/1 vinyl replacement windows in existing openings; replacement front door; aluminum siding around first story windows at west end of south elevation replaced. | | |

6/1 vinyl replacement windows in existing openings; replacement front door; aluminum siding around first story windows at west end of south elevation replaced.

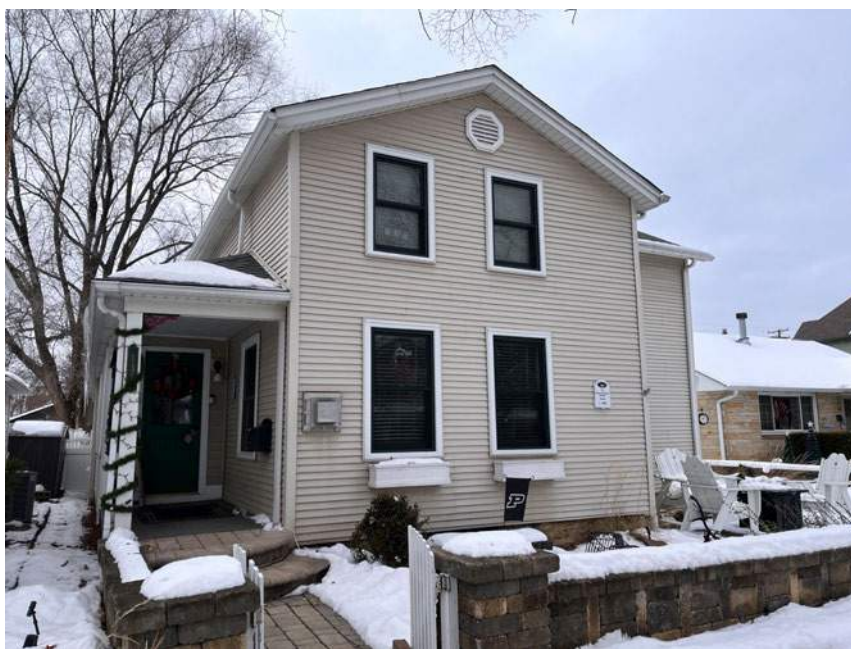
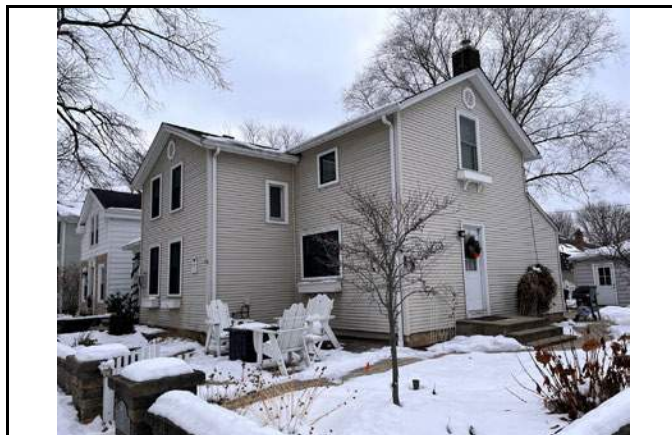
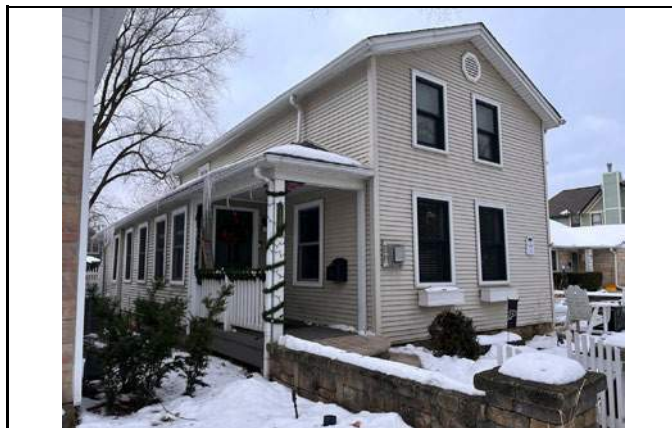
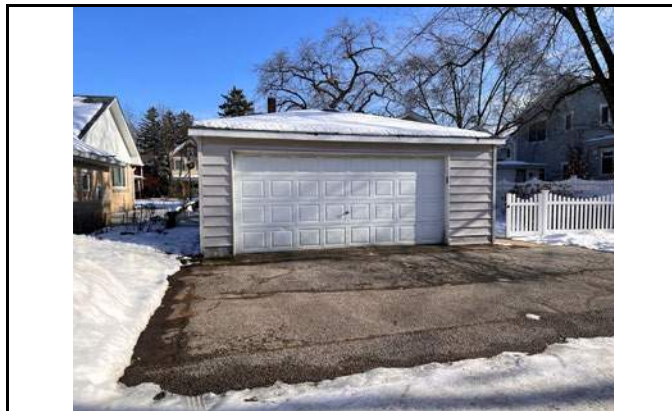
CATEGORY building HISTORIC FUNCTION Domestic - single dwelling  
CONDITION good REASON for SIGNIFICANCE  
INTEGRITY major alterations and/or addition(s)  
SECONDARY STRUCTURE Detached garage

According to Sanborn Maps, house was originally a one-story structure that has been altered and added to over the years: 1 story south side addition is historic, but south porch appears to have been altered (replacement posts, railing, and steps, Aluminum under eaves); second story addition to original house is historic; first story on north addition was added sometime between 1926 and 1949, with 2<sup>nd</sup> story added after; aluminum siding; replacement windows in altered openings (not historic--house originally had a full porch and entry on front façade); multiple rear additions; stone steps to north side entry and stone patio at front of house (not historic)

Windows on front façade appear to be newer 1/1 aluminum replacement windows; porch railing replaced.

| <b>COA COMPLIANCE NOTES:</b> | Porch structure does not appear to have been replaced, but porch railing is replacement. |

☒ **ELIGIBLE WORK COMPLETED WITHOUT COA?**

| <b>NOTES ON WORK:</b> | Replacement windows on front façade. |

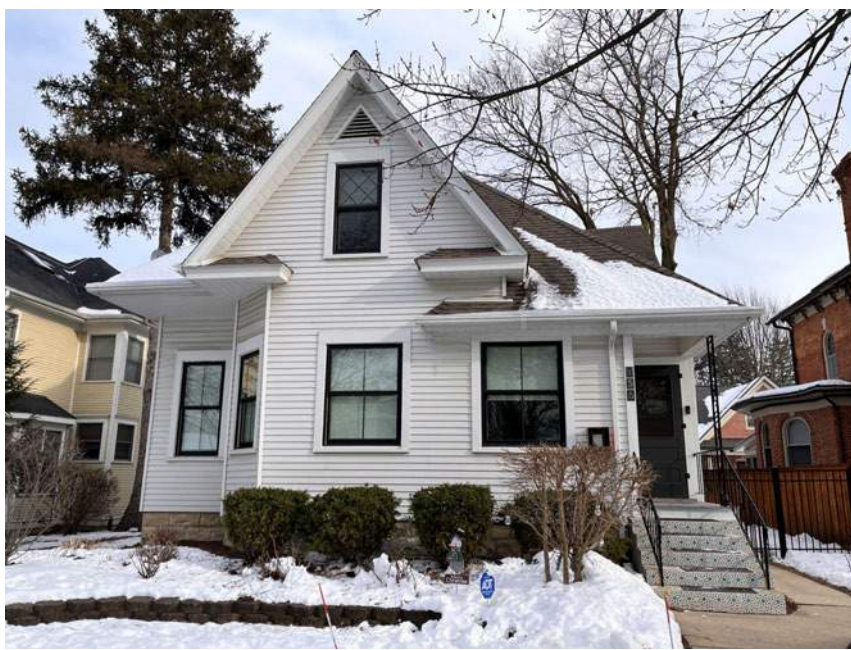
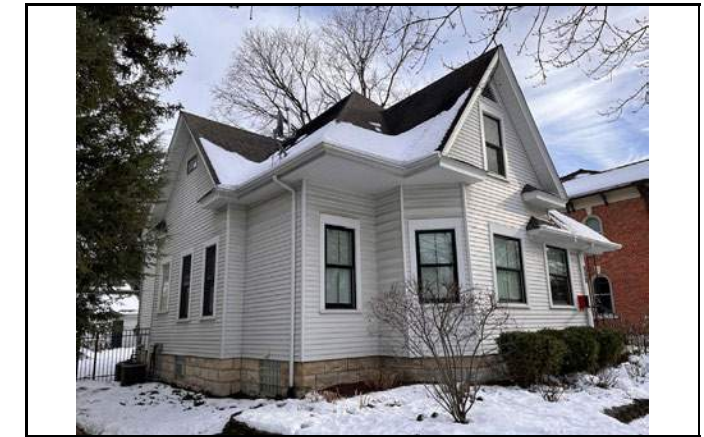
| CONDITION | good | REASON for SIGNIFICANCE | Good local example of early 20th century Queen Anne. |

| ALTERATIONS | Aluminum siding (not historic); porch has been downsized (see Sanborn maps), with replacement wrought iron supports/railings and concrete steps (not historic); rear porch addition; 2nd story rear addition; glass block in basement windows. Post-2007 -- 2/2 replacement windows on first story; replacement diamond/1 windows under front and south gables; replacement window in downsized opening under north gable; tilework on risers at front porch steps. |

**COA COMPLIANCE NOTES:** 2007 survey photos show 1/1 double-hung windows on front and side elevations -- replacement windows are 2/2.

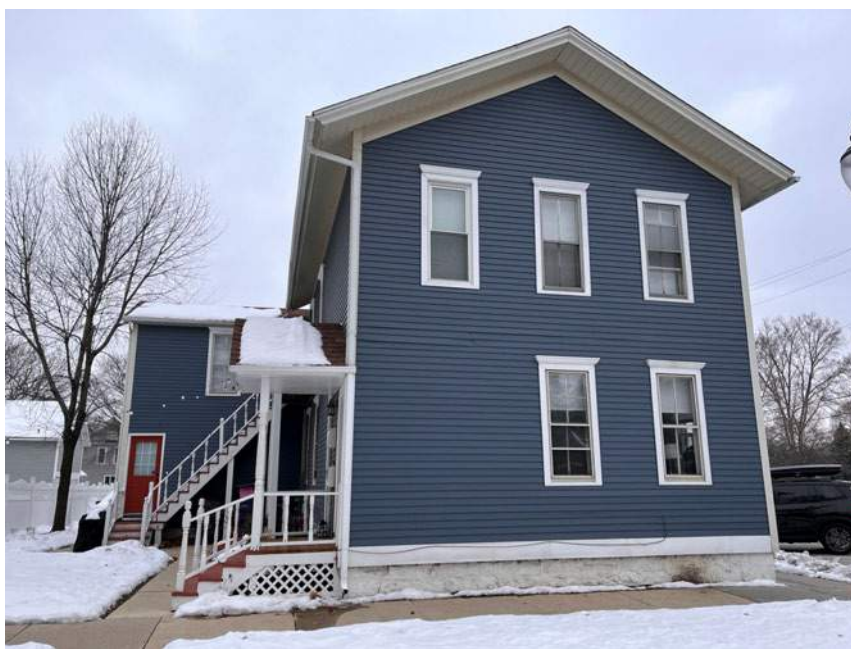
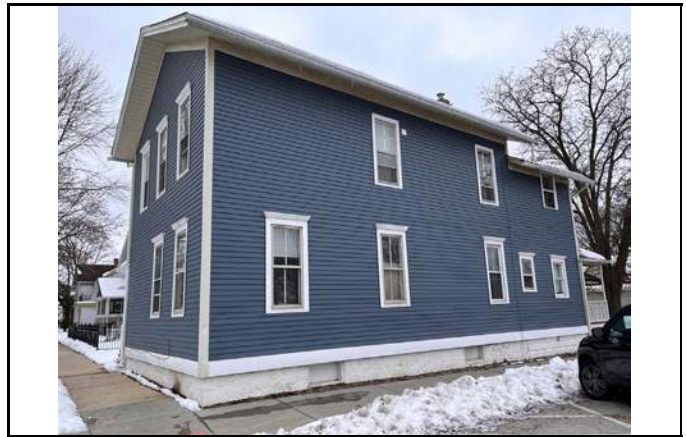
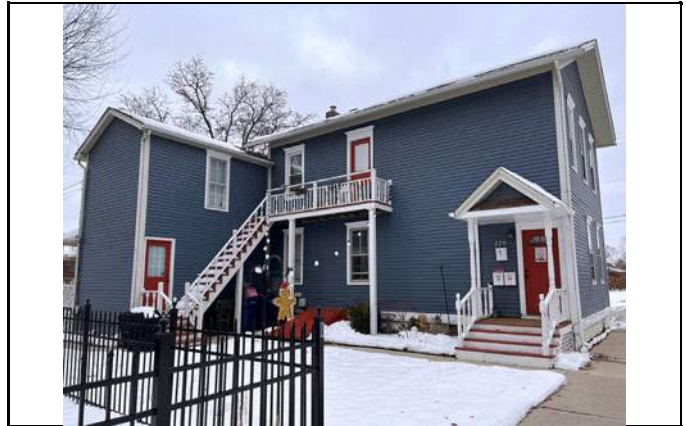
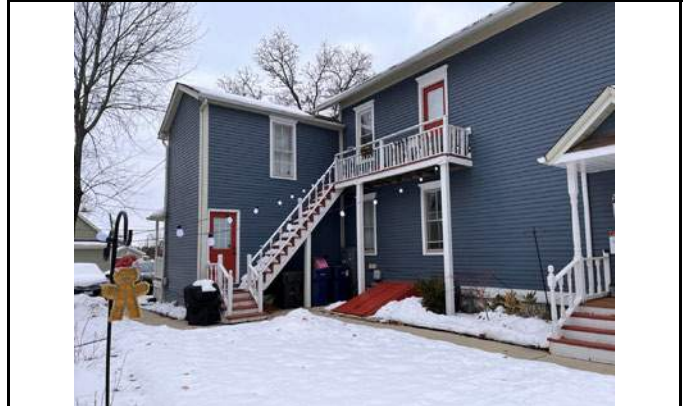
### ☒ **ELIGIBLE WORK COMPLETED WITHOUT COA?**

**NOTES ON WORK:** 1/1 vinyl replacement windows in select openings on front façade and north elevation; non-historic fixed shutters removed.
