| STREET # | 5 |
| STREET | COLUMBIA |
| PIN | 0818403007 |

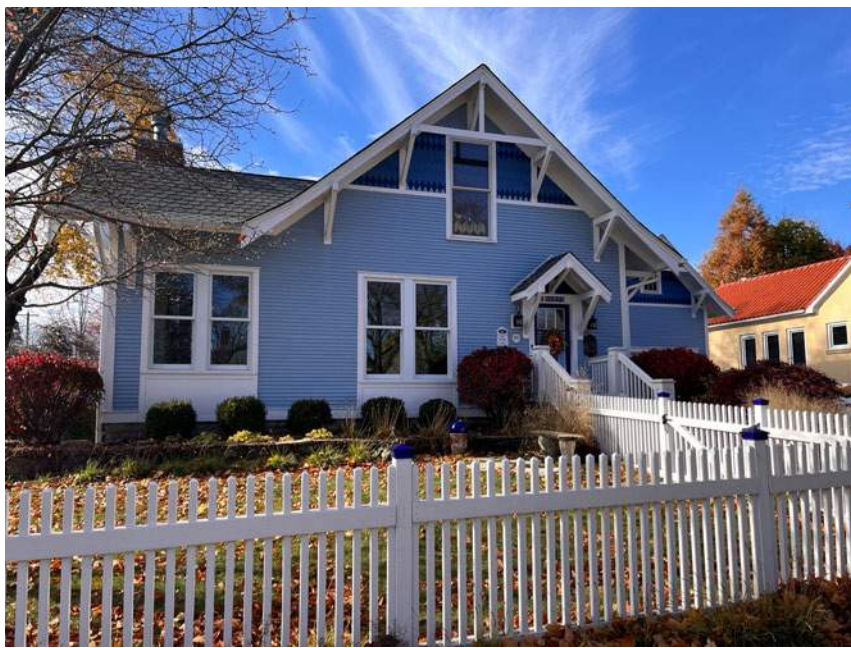
| CONDITION | excellent | REASON for SIGNIFICANCE | |
| INTEGRITY | major alterations and/or addition(s) | | |

| ALTERATIONS | House recently renovated (received Illinois property tax assessment freeze)--large 1.5 story rear addition; replacement siding and shingles; replacement knee brackets and bracing; replacement windows in original openings (window under front gable was probably added when the attic was built out, before the latest renovation); replacement front stoop and entry canopy; north dormer addition. Post -2007 -- no changes. |

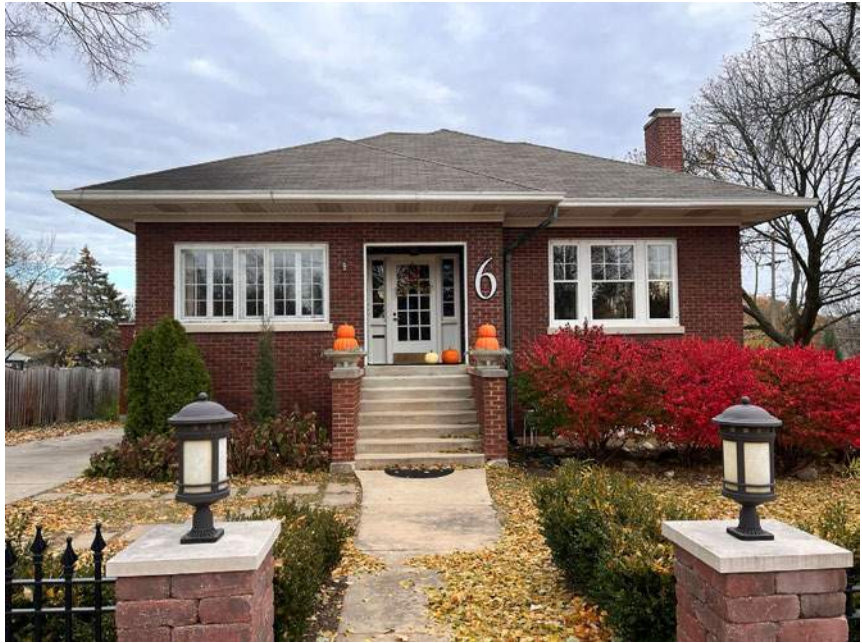
| <b>CONDITION</b> | good | <b>REASON for SIGNIFICANCE</b> | Excellent example of a 1920s brick bungalow. If not for changes to front entrance and addition of porte cochere, this house would be rated significant. |

| <b>ALTERATIONS</b> | Jalousie windows in south dormer (not historic); Aluminum under eaves. Post-2007 -- porte cochere with hipped roof and square brick supports attached to north elevation (required removal of existing hipped roof canopy over north side secondary entrance); replacement French door and sidelights recessed within existing opening at front entrance; 3/1 wood window on 2nd story of south elevation replaced with new 3/1 window in downsized opening; new hipped roof canopy over rear ground-level entrance. | | |

| COA COMPLIANCE NOTES: | Work approved in COA #22-252 appears to have not been undertaken. Window replacement in south dormer (approved, COA #16-4092) also not undertaken. | | |

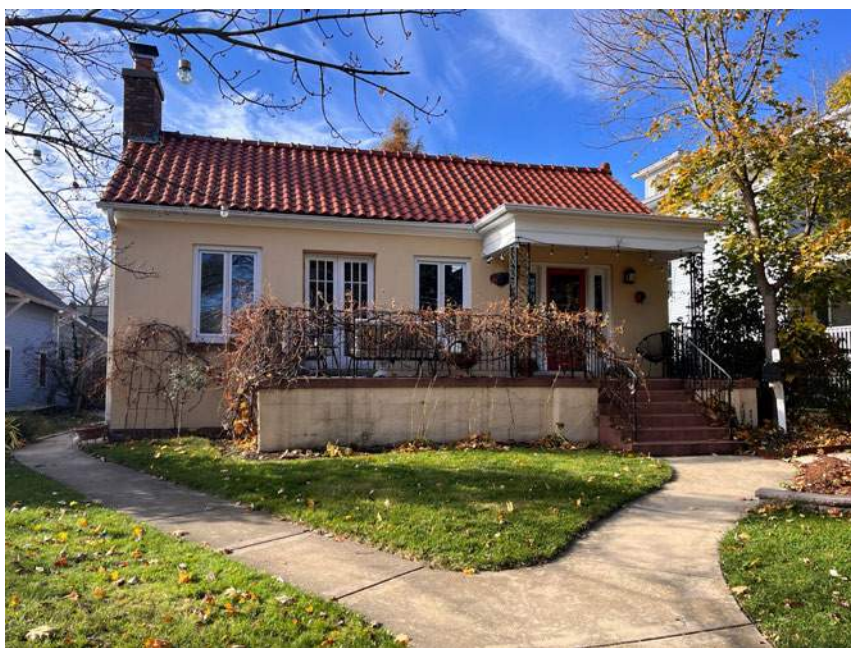
| CONDITION | excellent | REASON for SIGNIFICANCE | |

| ALTERATIONS | Replacement windows in original openings; raised terrace addition south of front porch; wrought iron railing on porch. Post-2007 -- no changes to principal structure. Folding doors replaced with overhead door on detached garage. |

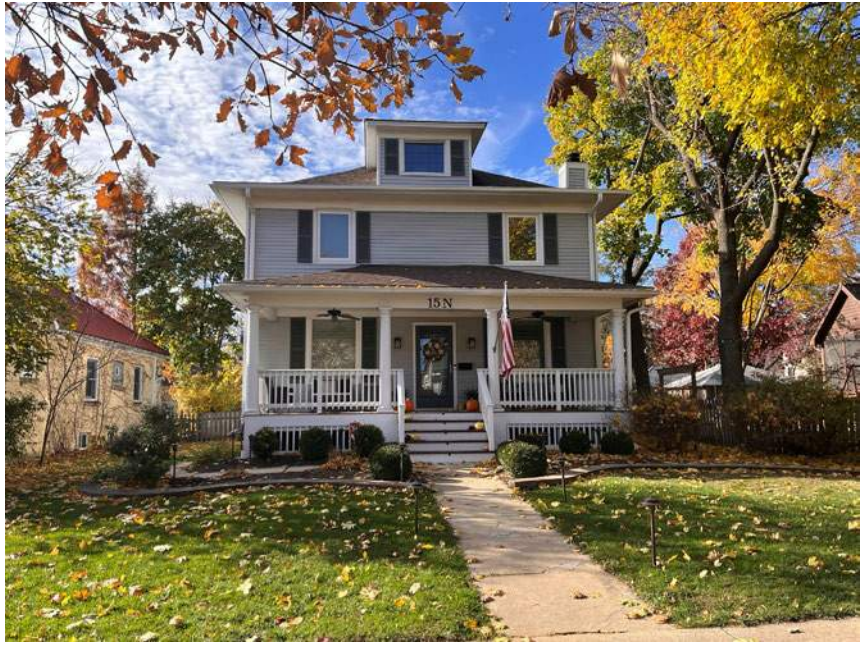
| CONDITION | excellent | REASON for SIGNIFICANCE | |

| ALTERATIONS | Replacement 1/1 double hung windows in original openings on 2nd story and side elevations (not historic); Aluminum siding; 1 story rear addition; rear enclosed porch addition; fixed shutters; wrought iron railings at steps. Post-2007 -- All windows on front façade replaced with single-light Aluminum windows (not historically compatible configuration); replacement Aluminum siding; solid knee walls on porch replaced with painted wood railings (COA approved). | | |

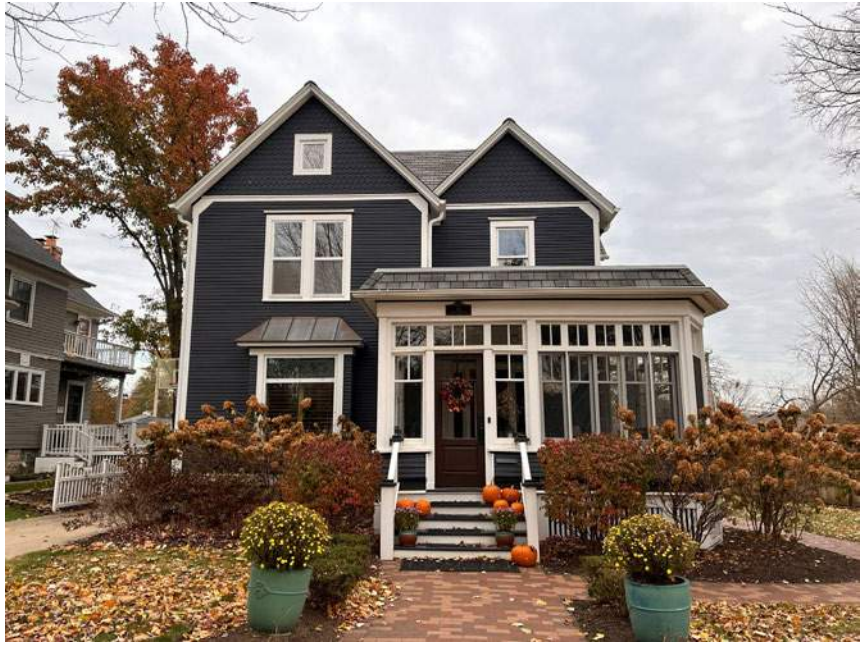
| CONDITION | excellent | REASON for SIGNIFICANCE | Good example of the style, with historic alterations. |

| ALTERATIONS | Replacement windows in original openings (historic); front porch addition (c. 1920--enclosed after 1954) ; 2 story rear addition; rear deck addition (not historic). Post-2007 -- non-historic awnings over 2nd-story windows on front façade (present during 2007 survey) removed. | | |

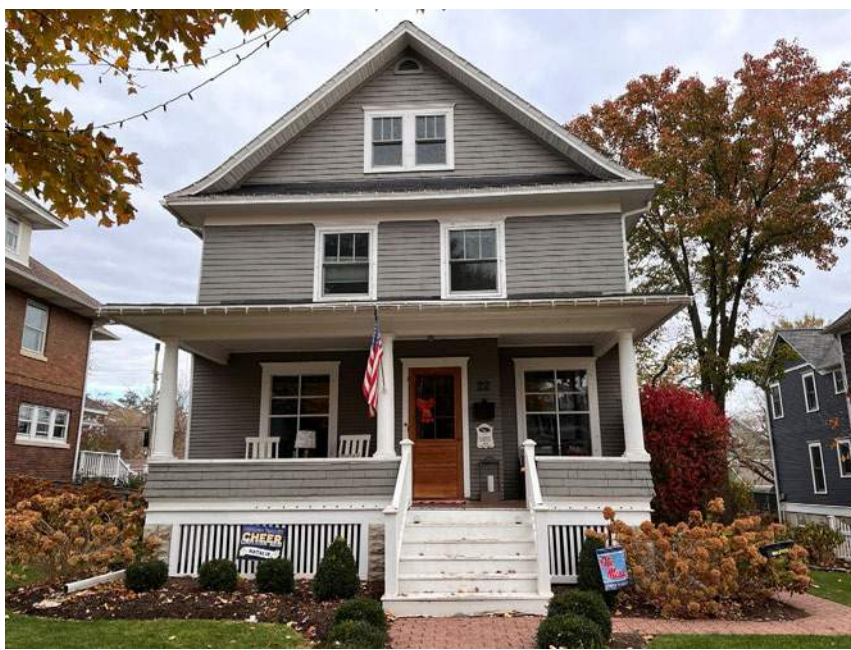
| CONDITION | excellent | REASON for SIGNIFICANCE | Handsome Queen Anne-Free Classic residence with flared, pent gable roof and full width front porch. |

| ALTERATIONS | Front entry bay is a possible addition (historic); 2 story rear addition (1994); replacement windows in dormers and under front gable (not historic, pre-2007); rear/south porch and deck addition (not historic); fixed shutters (not historic). Post-2007 -- Aluminum replacement windows throughout (COA approved); new wood railing at steps to south/rear deck. | | |

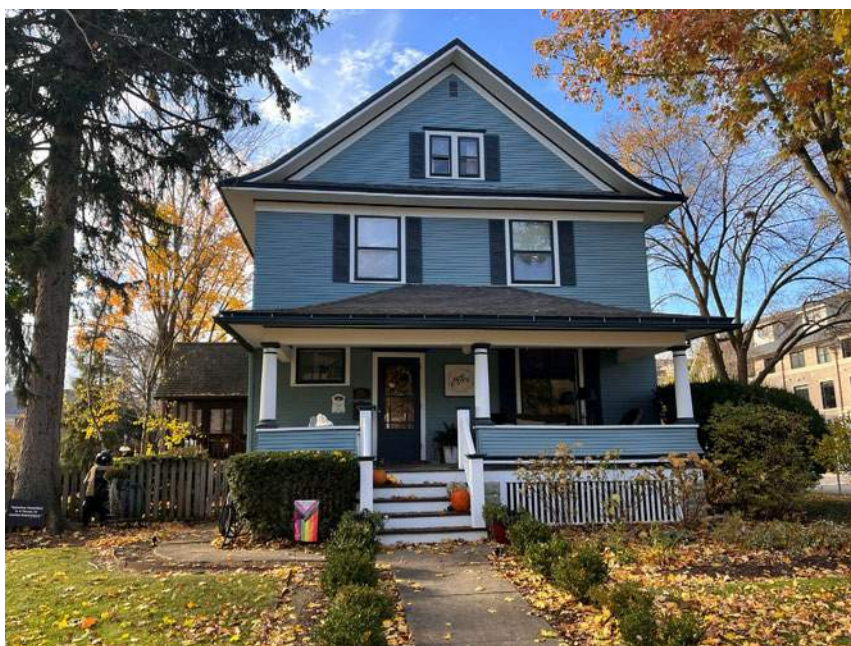
| CONDITION | excellent | REASON for SIGNIFICANCE | Fine example of early 20th-century Queen Anne-Free Classic, with flared, pent gable roof and hipped porch with classical columns. |

| ALTERATIONS | Replacement railings at steps (not historic); two story rear addition; 1 story south/rear addition (not historic). Post-2007 -- square oriel bay addition on first story of south elevation. |

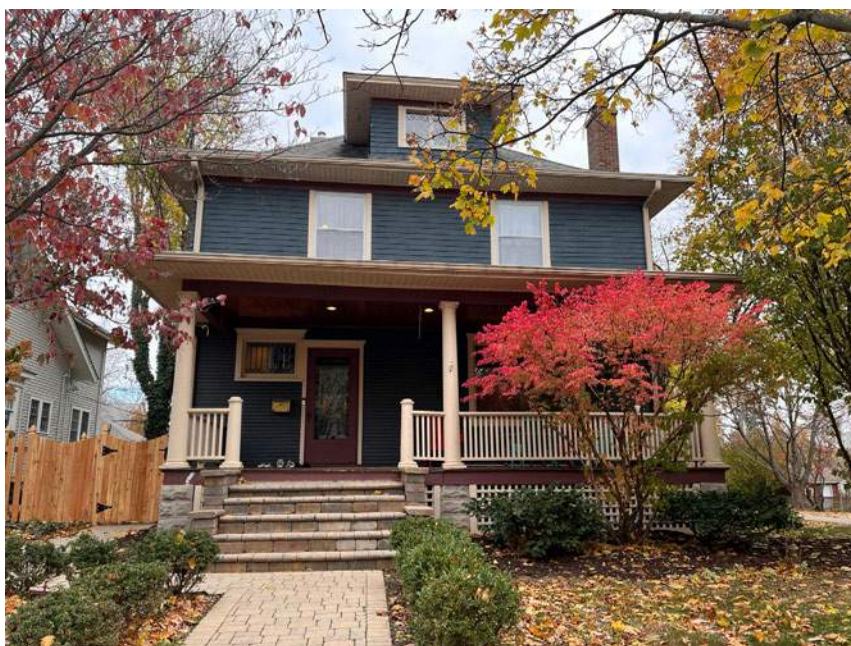
| <b>CONDITION</b> | excellent | <b>REASON for SIGNIFICANCE</b> | One of several intact, early 20th-century examples of the style along Columbia Avenue, with an appropriately-placed rear addition. |

| <b>ALTERATIONS</b> | Replacement front steps (not historic); large 2 story rear addition, with 2nd south bay and rear porch (not historic). Post-2007 -- no changes. | | |

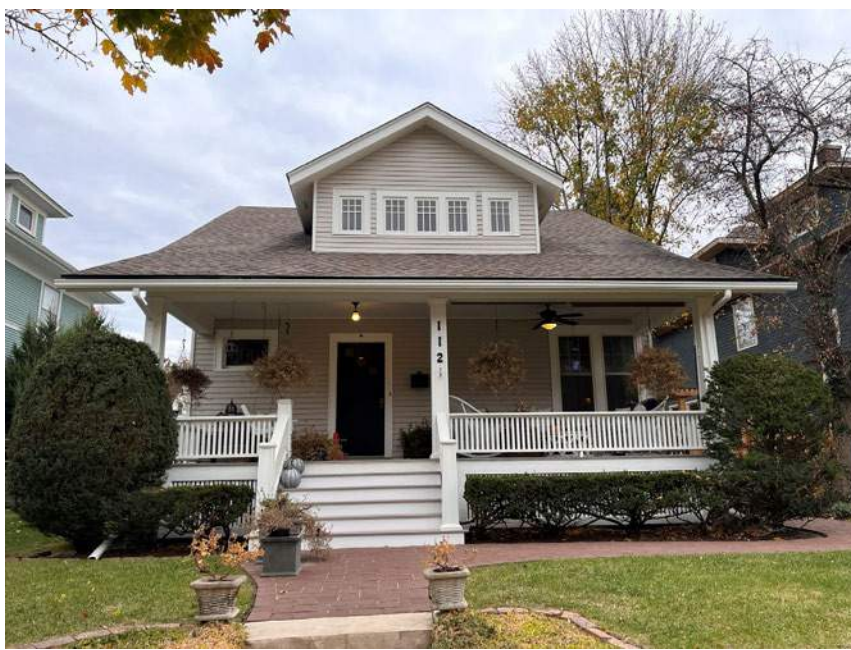
| <b>CONDITION</b> | excellent | <b>REASON for SIGNIFICANCE</b> | Notable example of the Bungalow type, with few alterations. |

| <b>ALTERATIONS</b> | 2 story rear addition (not historic); replacement windows in original openings on 2nd story (not historic). Post-2007 -- Aluminum double-hung replacement windows on first story on side elevations. |

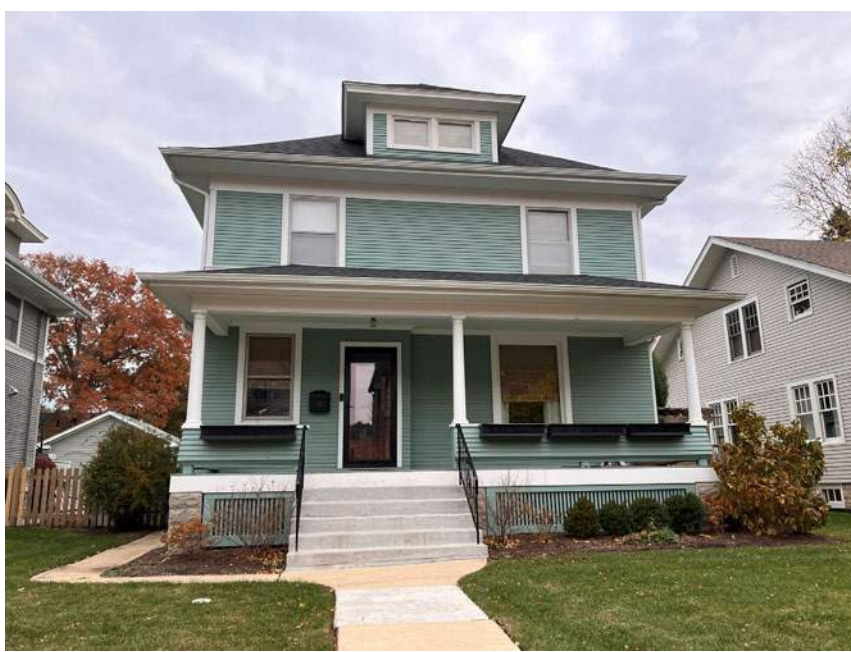
| <b>CONDITION</b> | excellent | <b>REASON for SIGNIFICANCE</b> | Handsome example of American Foursquare type, with few alterations. |

| <b>ALTERATIONS</b> | Replacement front steps (not historic); 1 story rear addition. Post-2007 -- no changes. | | |

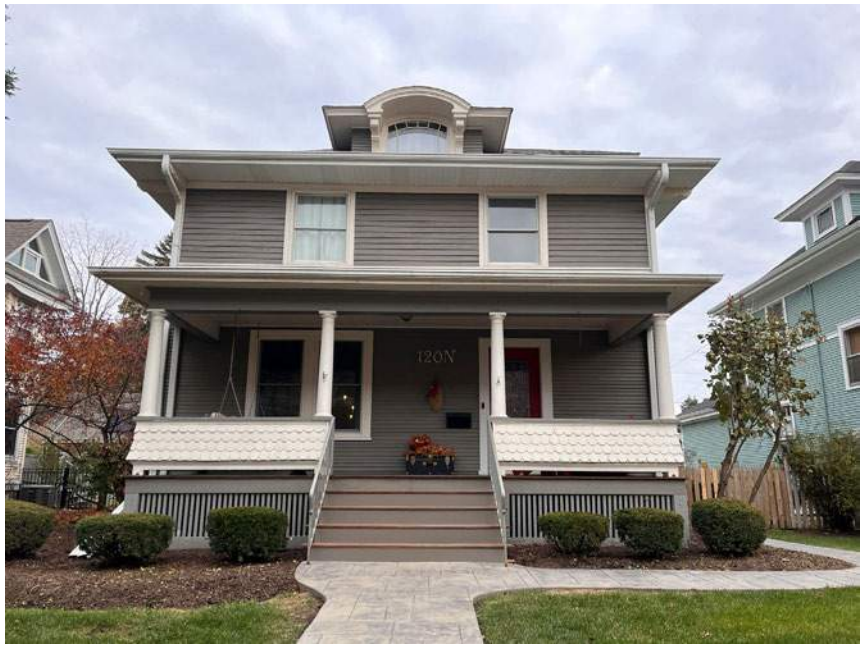
| CONDITION | good | REASON for SIGNIFICANCE | Fine, well-preserved example of American Foursquare, with distinctive Palladian front dormer. |

| ALTERATIONS | Post-2007 -- Aluminum replacement windows in original openings; south dormer addition. | | |

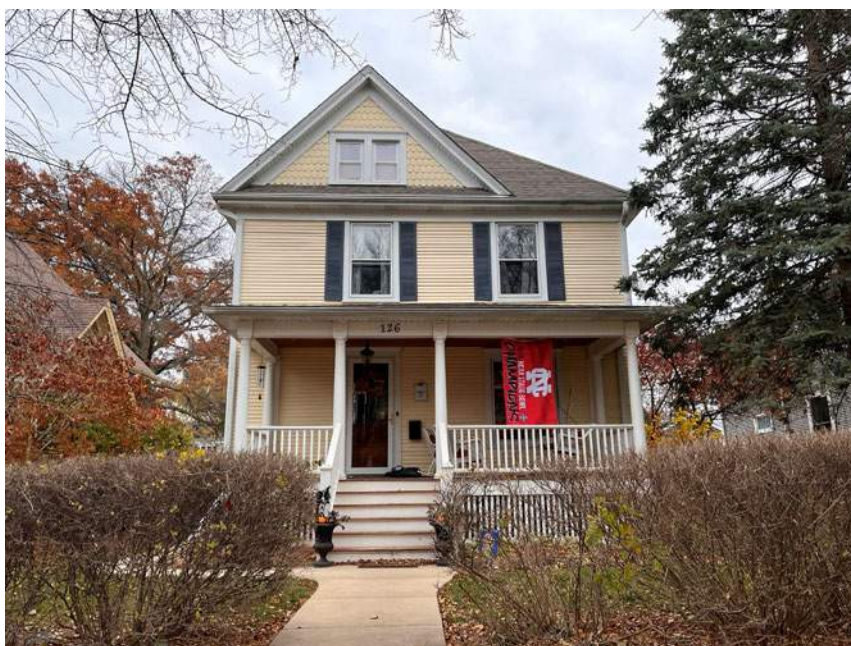
| CONDITION | excellent | REASON for SIGNIFICANCE | |

| ALTERATIONS | Gabled dormer additions (front and north--not historic); gable over south bay filled with windows (not historic); fixed shutters at 2nd story of front façade (not historic); 1 story rear addition (not historic); vinyl under eaves. Post-2007 -- replacement front porch. | | |

| <b>COA COMPLIANCE NOTES:</b> | Fascia board on replacement porch features square blocks above columns that were not present on previous porch. |

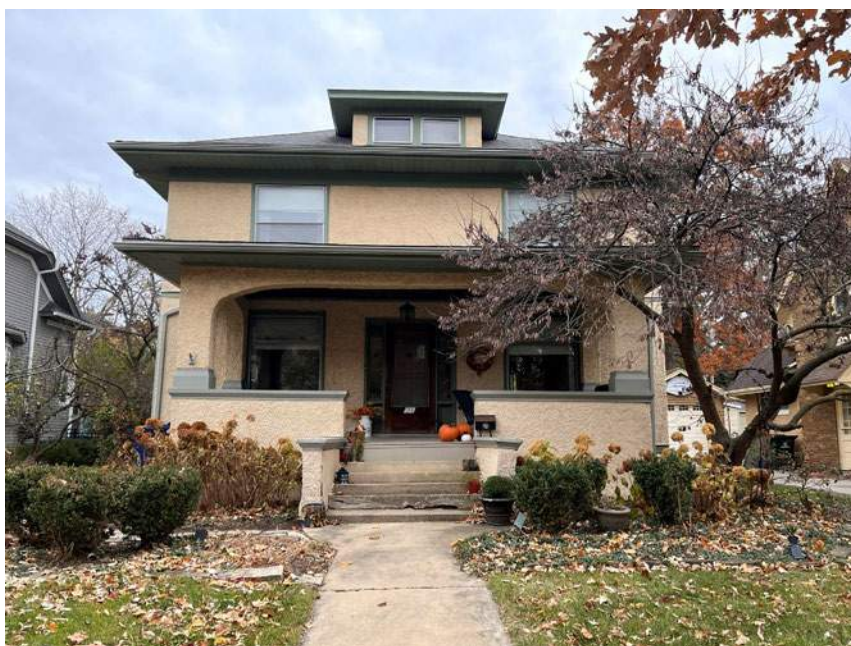
| CONDITION | good | REASON for SIGNIFICANCE | Excellent stucco example of the American Foursquare type with Prairie detailing |

| ALTERATIONS | Glass block replacement windows on 2nd story of north elevation. Post-2007 - no changes. | | |

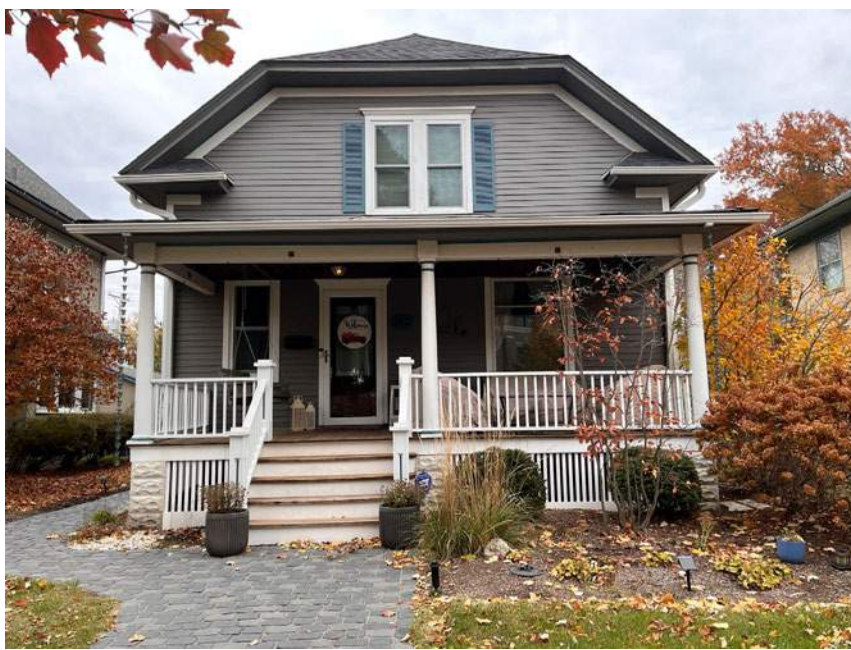
| <b>CONDITION</b> | good | <b>REASON for SIGNIFICANCE</b> | |

| <b>ALTERATIONS</b> | Post-2007 -- Aluminum siding replaced with fiber-cement board siding; solid knee walls on porch replaced with wood railings; replacement siding; Aluminum replacement windows in original openings. |

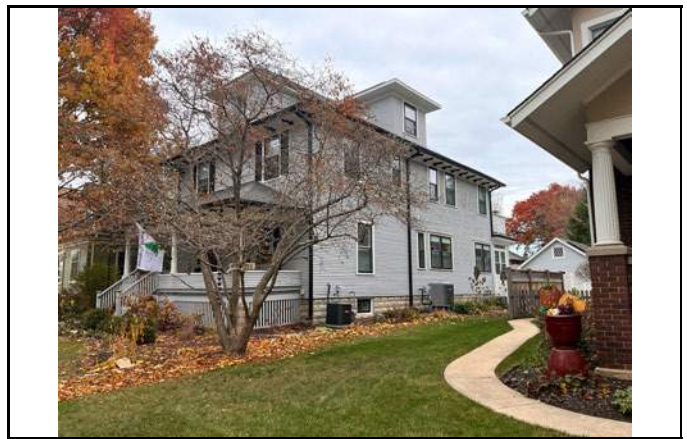
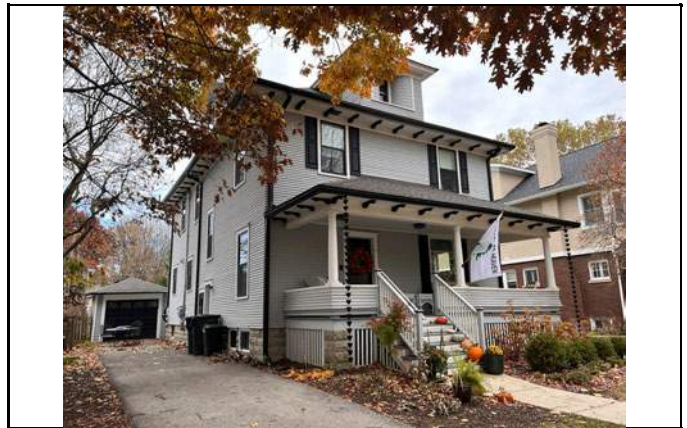
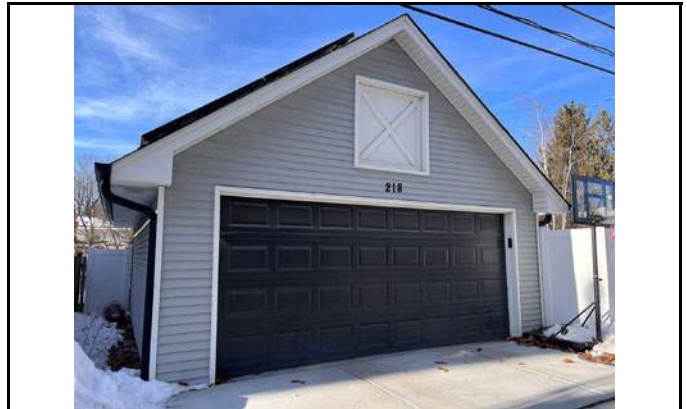
| NOTES ON WORK: | Replacement windows in altered openings on north and south elevations (pre-2018); rear porch addition (pre-2018). |

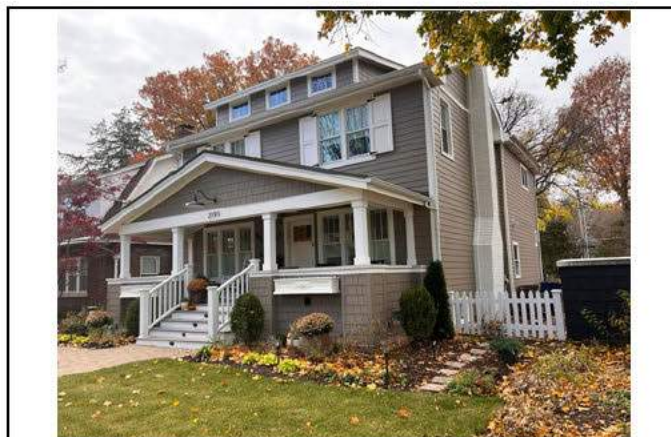
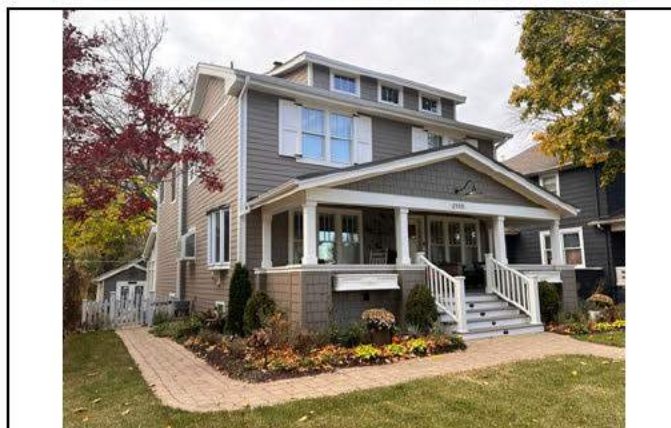
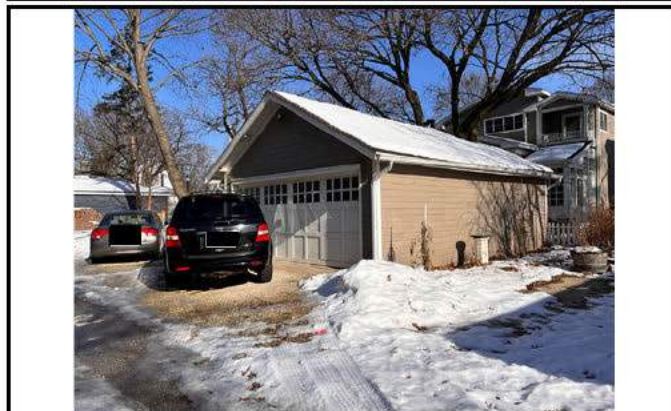
| NOTES ON WORK: | Aluminum replacement windows on 2nd story of front façade. |

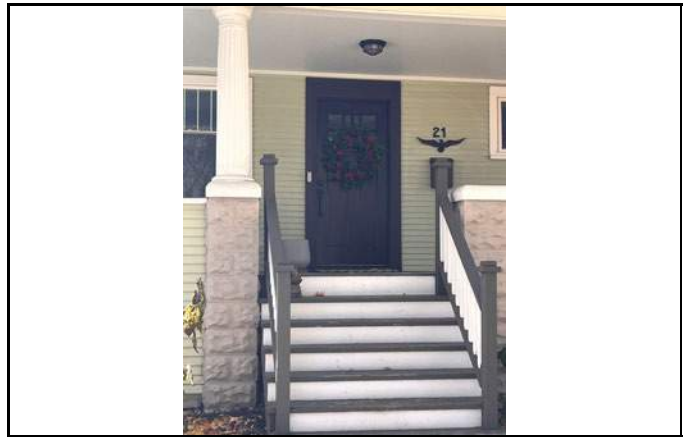
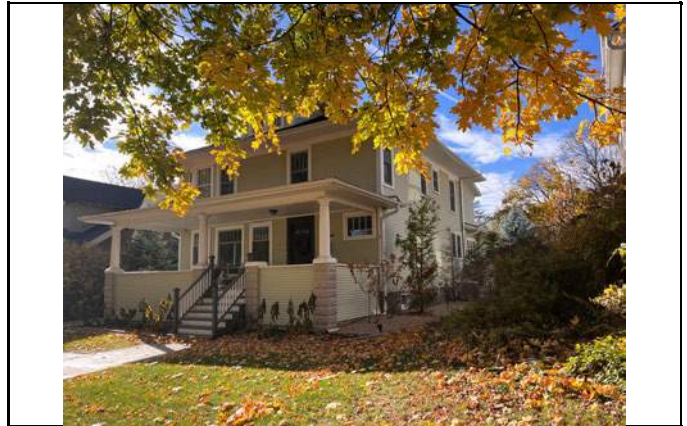
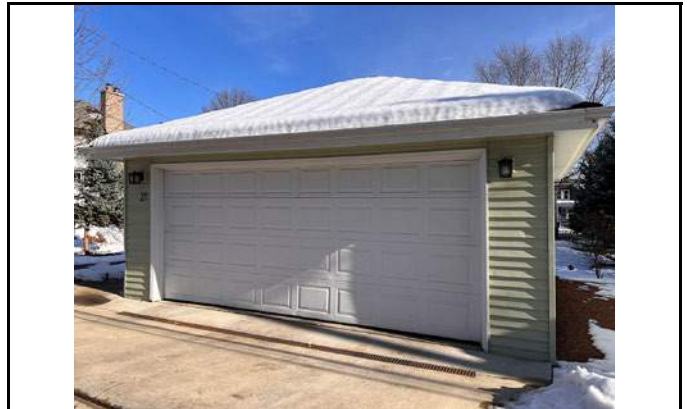
| NOTES ON WORK: | Replacement front door; replacement railings at porch steps. |
