CITY OF NAPERVILLE

**BID NUMBER: REQ-22-114 WORK
ORDER #4**

ENGINEERING SERVICES FOR CENTRAL ELEVATED WATER TANK RELOCATION

On July 23, 2021, Dixon Engineering Inc. performed a preliminary maintenance inspection on the 500,000 gallon radial arm (Central Tank) elevated water storage tank owned by the City of Naperville, Illinois. Purposes of the inspection were to evaluate the interior and exterior coating's performance and life expectancy, assess the condition of metal surfaces and appurtenances, review safety and health aspects, and make budgetary recommendations for continued maintenance of the tank. All recommendations with budgeting estimates for repairs are incorporated in this report.

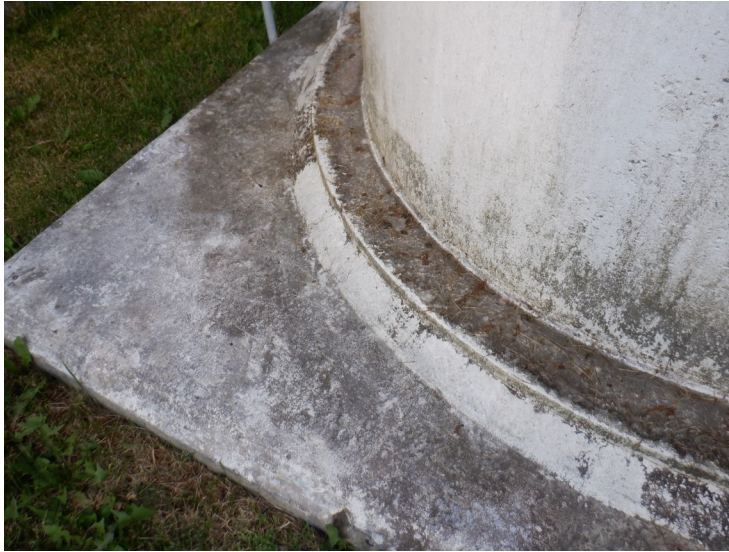
1) The exposed riser foundation is in good condition overall. The coating is in poor condition.

Recoat the exposed concrete with an epoxy coating system to help prevent deterioration. The cost would be incidental to exterior painting.

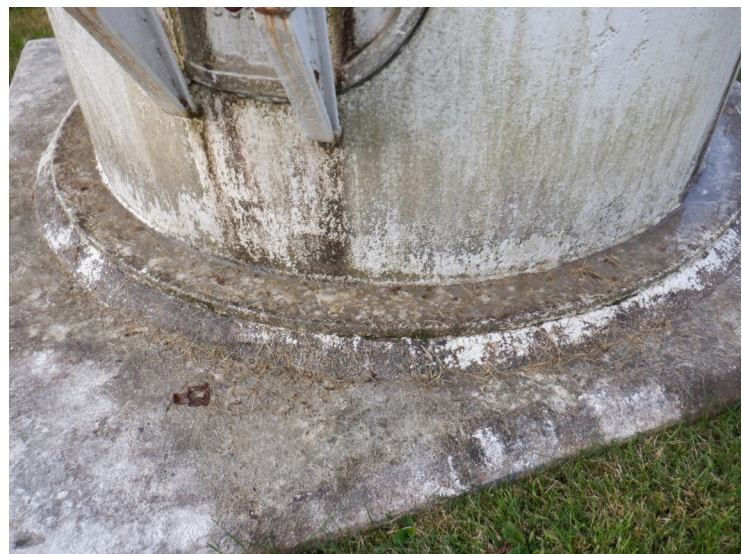
2) Same.

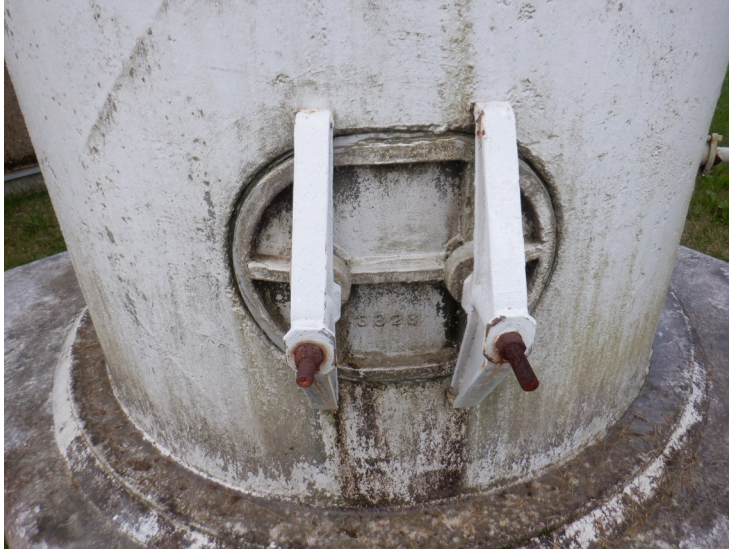
4) The elliptical riser manway is in good condition.

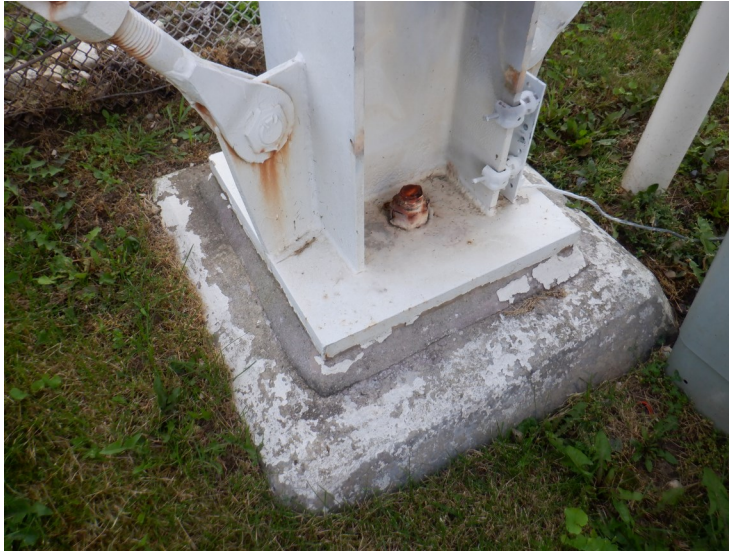
10) Typical leg foundation that is in good condition. The coating is in poor condition overall.

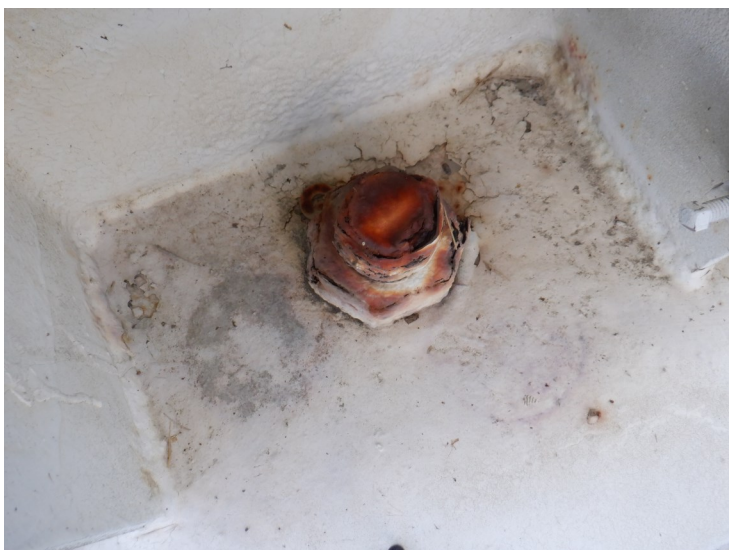
12) Anchor bolt with minor steel loss from corrosion.

Replaced the deteriorated anchor bolt nuts. The cost would be incidental to the next paint project.

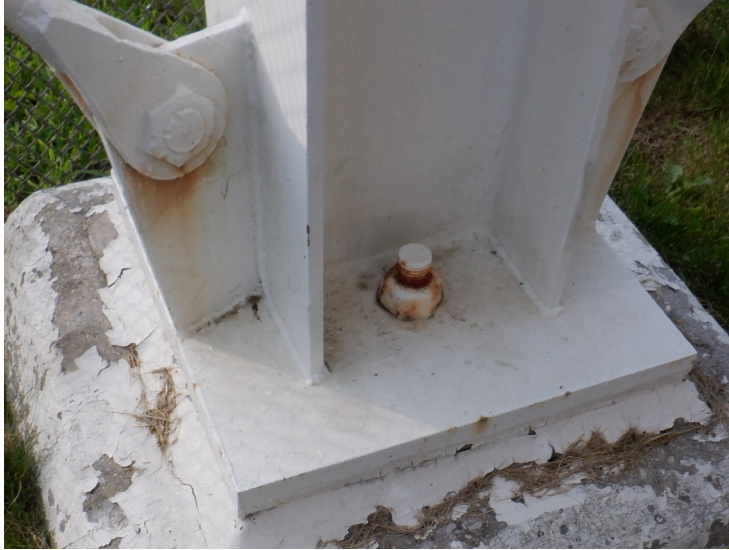
13) Same.

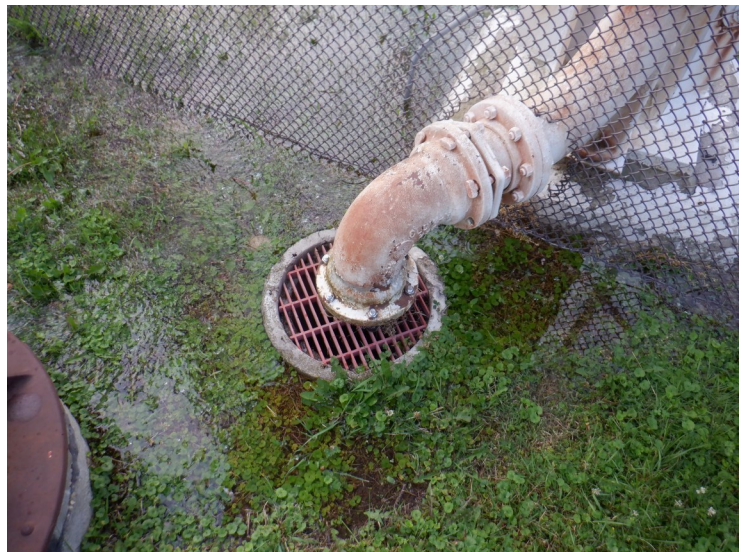
The overflow pipe exits the upper sidewall, extends along the sidewall, through the balcony, and down along a leg to ground. The discharge end of the overflow pipe is screened. The screen is in fair condition. The pipe discharges to a catch basin with a drain. The air gap does not meet the required 12-24 inches. The discharge area is in fair condition.

14) The overflow pipe discharges to a catch basin.

Modify the overflow pipe discharge so the air gap is between 12 and 24 inches to bring it into compliance with current Illinois EPA requirements. Install a flap gate or duck bill check valve at the new discharge. The flap gate would allow water to discharge even if the screen becomes covered with debris or frosted over. The flap gate is designed to stay closed to prevent rodents or birds from entering the pipe. The duck bill check valve would allow water out but prevent debris from clogging the discharge. The estimated cost is \$4,000.

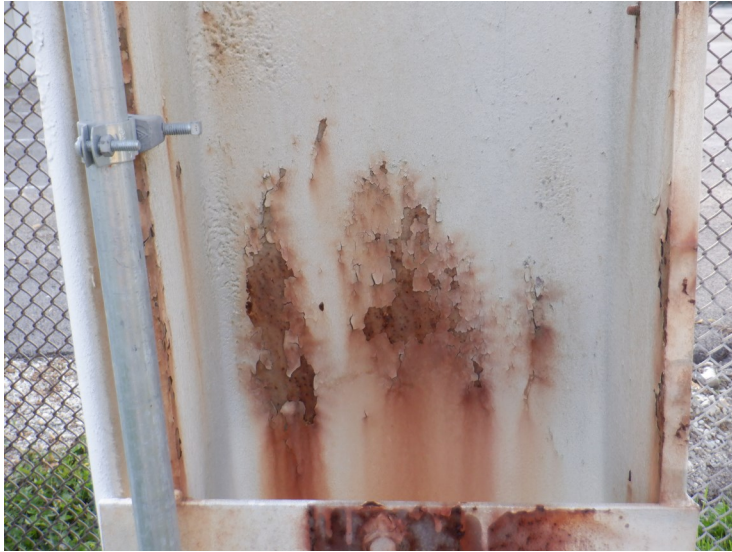
16) Coating failures with rust undercutting on a leg.

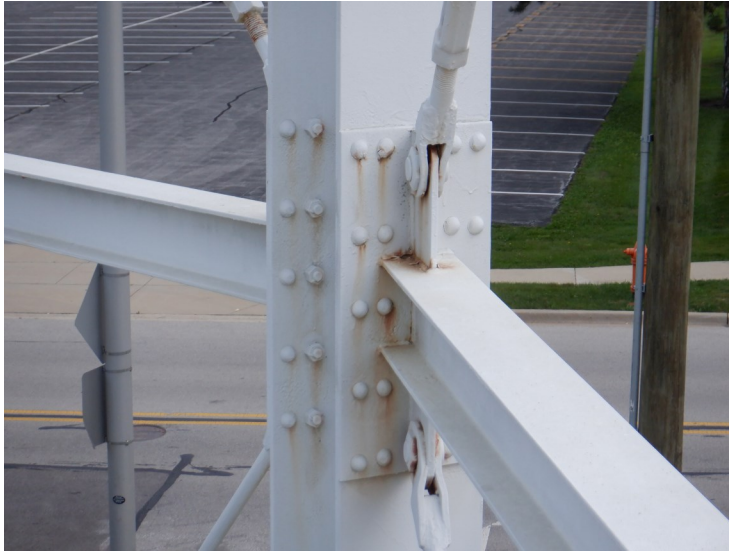
22) Spot coating failures and rust bleedthrough at a strut and leg connection.

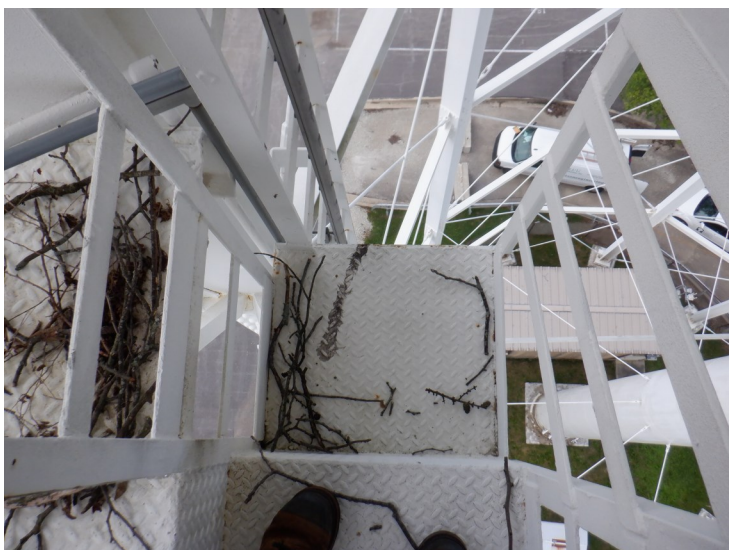
24) The step-off platform under the bowl is in good condition. There are remains of a hawk nest on the platform.

Install a handrail where one is missing at the step-off platform under the bowl. The estimated cost is \$2,000.

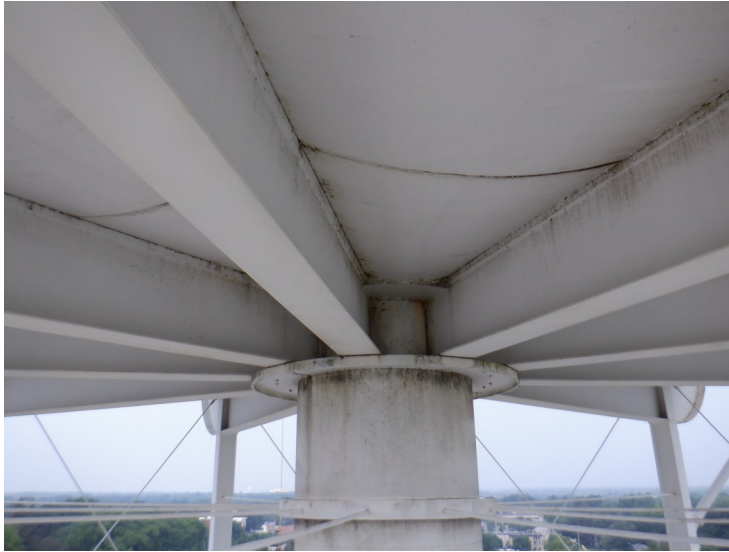
The bowl coating is in fair condition with several failures. Primary methods of deterioration are spot failures to the substrate with rust undercutting. The bowl is covered with light to moderate mildew growth.

25) The bowl coating is in fair condition overall. There is mildew growth on the bowl.

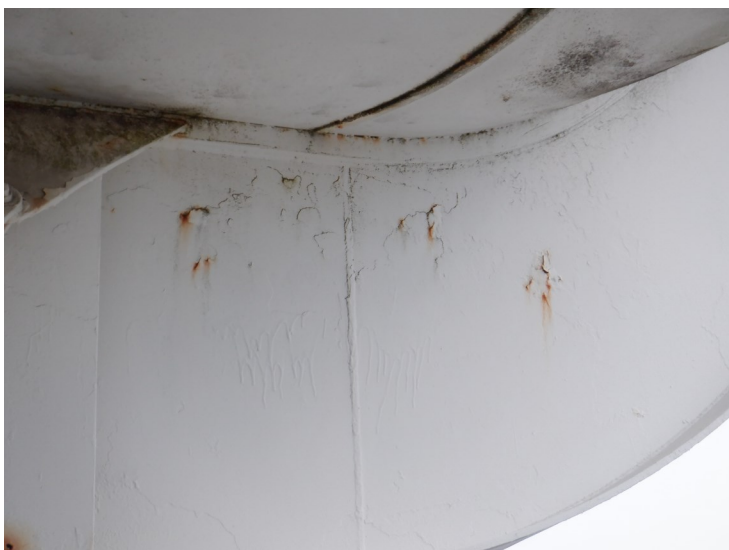
27) Spot coating failures on the radial arm bowl stiffeners.

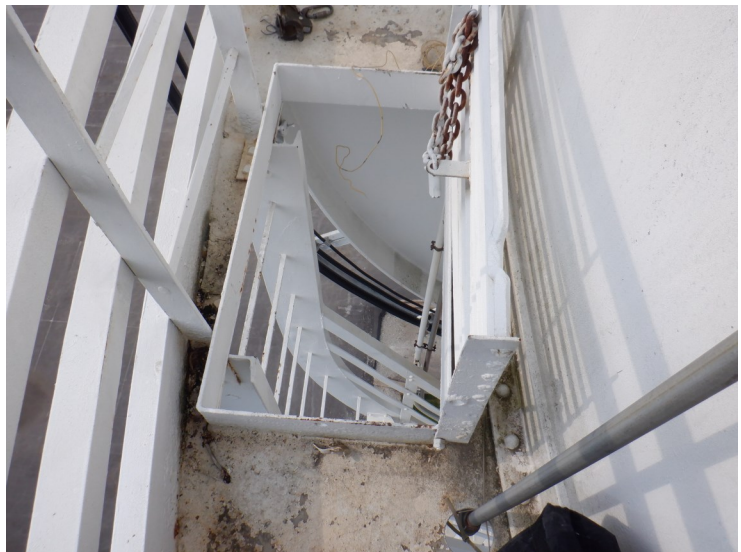
Coating on the top of the balcony is in poor condition with numerous failures. Primary methods of deterioration are spot failures to the substrate with rust undercutting, rust bleedthrough, delaminated topcoat, and erosion.

30) The balcony is in good condition. The coating is in poor condition.

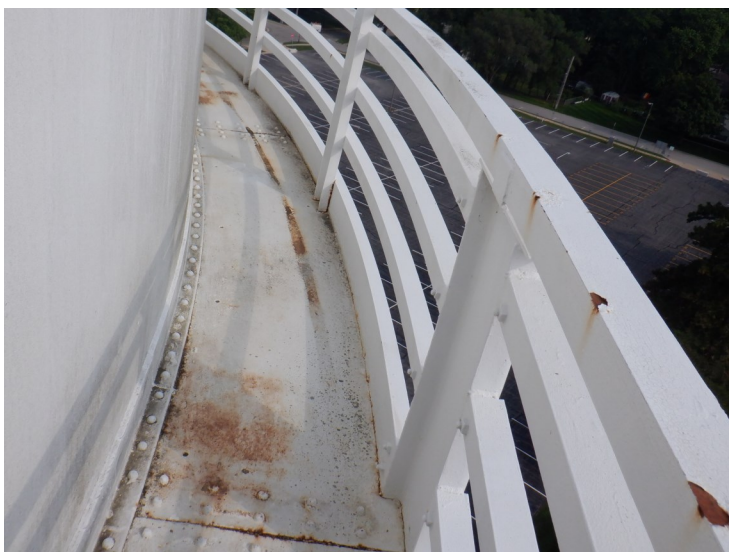
33) Spot coating failures on the handrail.

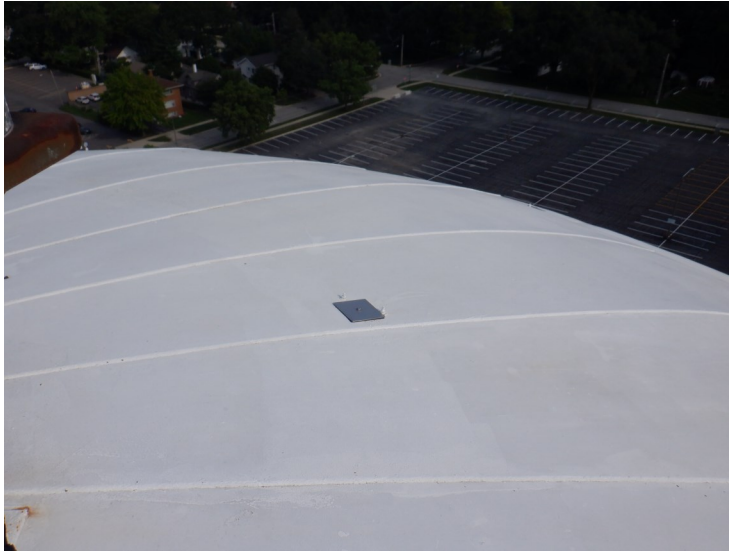
The roof coating is in poor condition with numerous failures. Primary methods of deterioration are spot failures to the substrate with rust undercutting, delaminated topcoat, erosion, and micro-cracking.

46) The roof coating is in poor condition overall.

Remove the existing coating by dry abrasive blast cleaning the steel to a commercial (SSPC-SP6) condition and apply a urethane system. All blast work would be performed inside a dust tight containment system using negative air pressure.

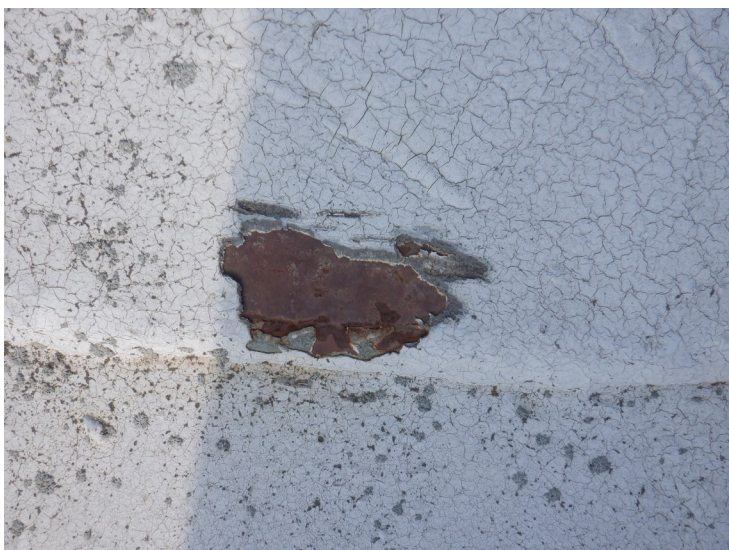
47) Micro-cracking on the exterior roof.

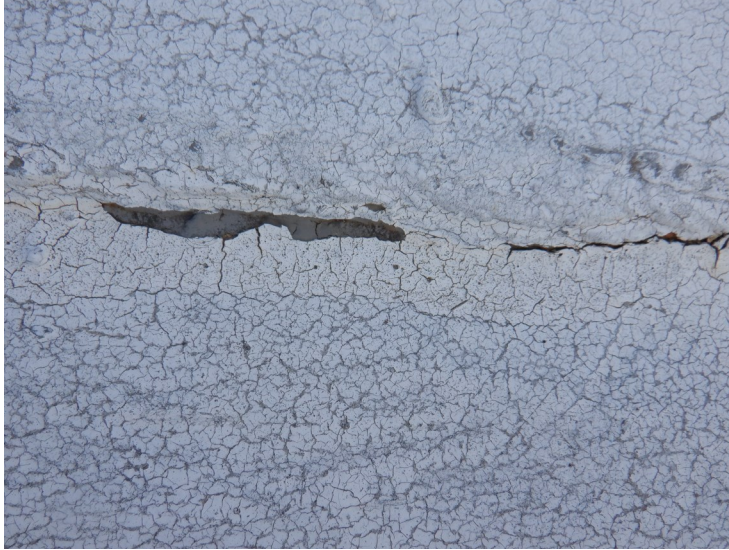
48) Spot coating failure on the roof.

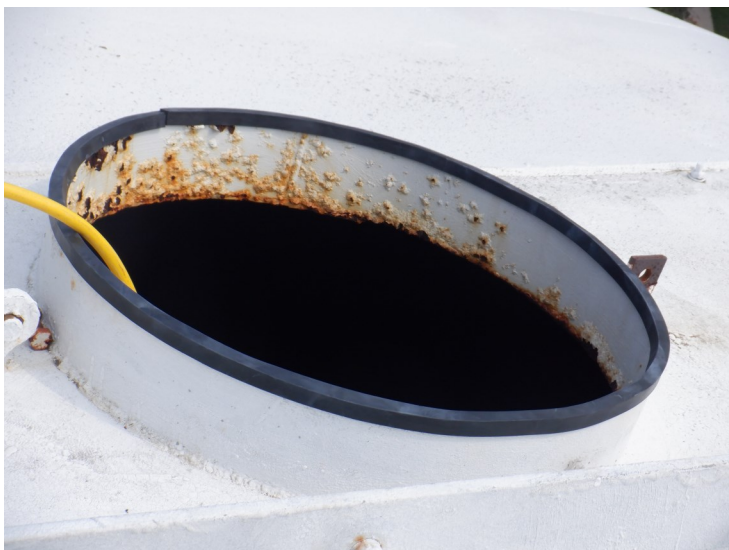
There is a 24 inch diameter roof hatch to the wet interior that is in good condition. The hinged cover is in good condition. There is no handhold next to the hatch to aid the climber while entering and exiting the opening. The hatch was secured with a bolt. The hatch neck curb height meets the minimum height requirement of 4 inches. The hatch cover lip meets the minimum height requirement of 2 inches. A gasket was installed on the roof hatch curb by the inspection crew

50) The wet interior roof hatch is in good condition. There are spot coating failures on the cover.

Replace the wet interior roof access hatch with a new 30 inch hatch. Average rescue baskets will not pass through the existing hatch. The estimated cost is \$4,000.

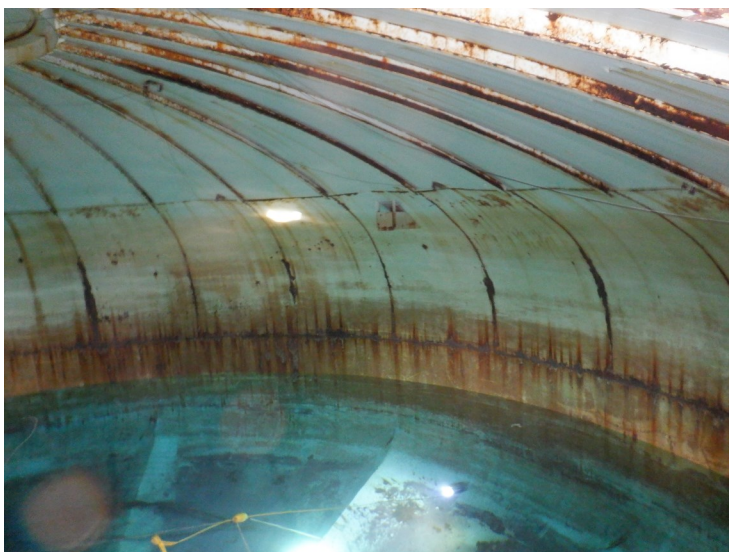
The roof coating is in poor condition with numerous failures. Primary methods of deterioration are spot failures to the substrate with rust undercutting. There are coating failures throughout the roof and roof stiffeners. Corrosion on the roof stiffeners is typical but should be corrected before structural loss of steel occurs.

52) The wet interior roof coating is in poor condition overall.

Apply a three-coat epoxy system to the prepared surfaces. Epoxy coating systems are recommended in most applications because they have good adhesion and abrasion resistant qualities. The estimated cost is \$210,000.

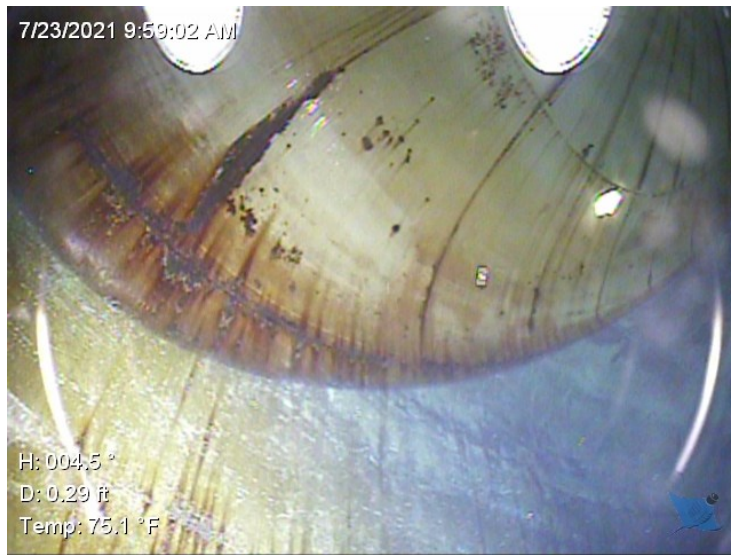
54) Same.

Monitor the corrosion on the edges of the stiffeners. Repaint the roof before metal loss becomes significant.

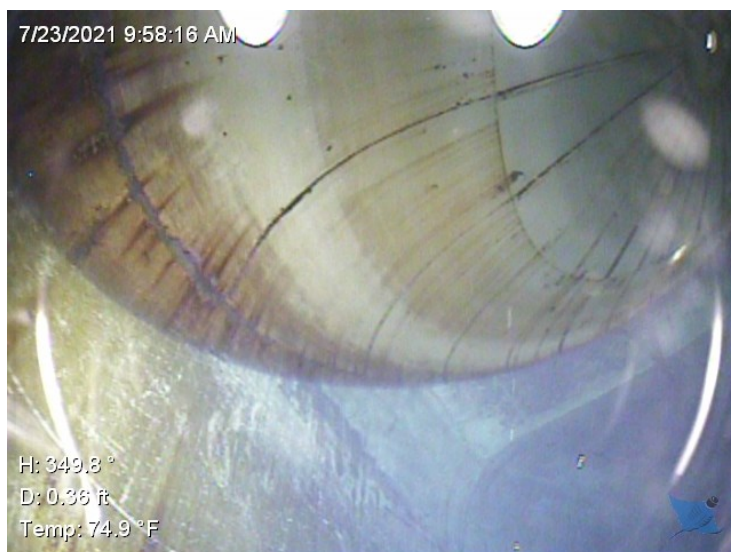
The sidewall coating is in poor condition with numerous failures. Primary method of deterioration is spot failures to the substrate.

55) Spot coating failures on the wet interior sidewall.

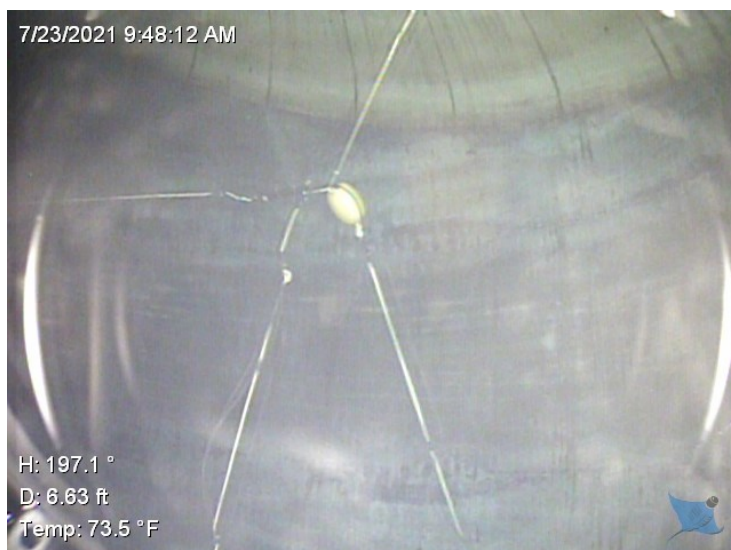
58) Spot coating failures on the sidewall below the water line.

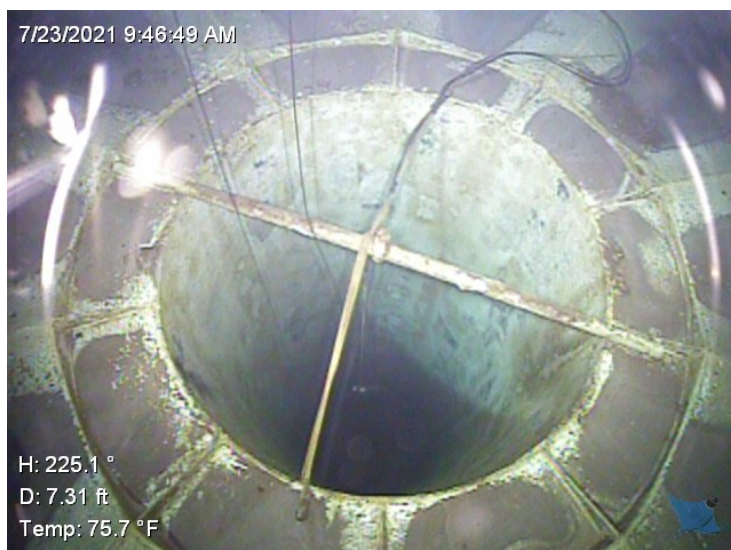
There was a painter's railing located at the upper sidewall. The stiffener is in poor condition and is lying on the tank bottom.

64) The painter's railing has broken from the sidewall and is lying on the bowl.

Remove the damaged painter's railing from the tank bottom. The cost would be incidental to wet interior repainting.
