CITY OF NAPERVILLE

**BID NUMBER: REQ-22-114 WORK
ORDER #4**

**ENGINEERING SERVICES FOR
CENTRAL ELEVATED WATER
TANK RELOCATION**

APPENDIX B – CENTRAL ELEVATED WATER TANK INSPECTION REPORT 10

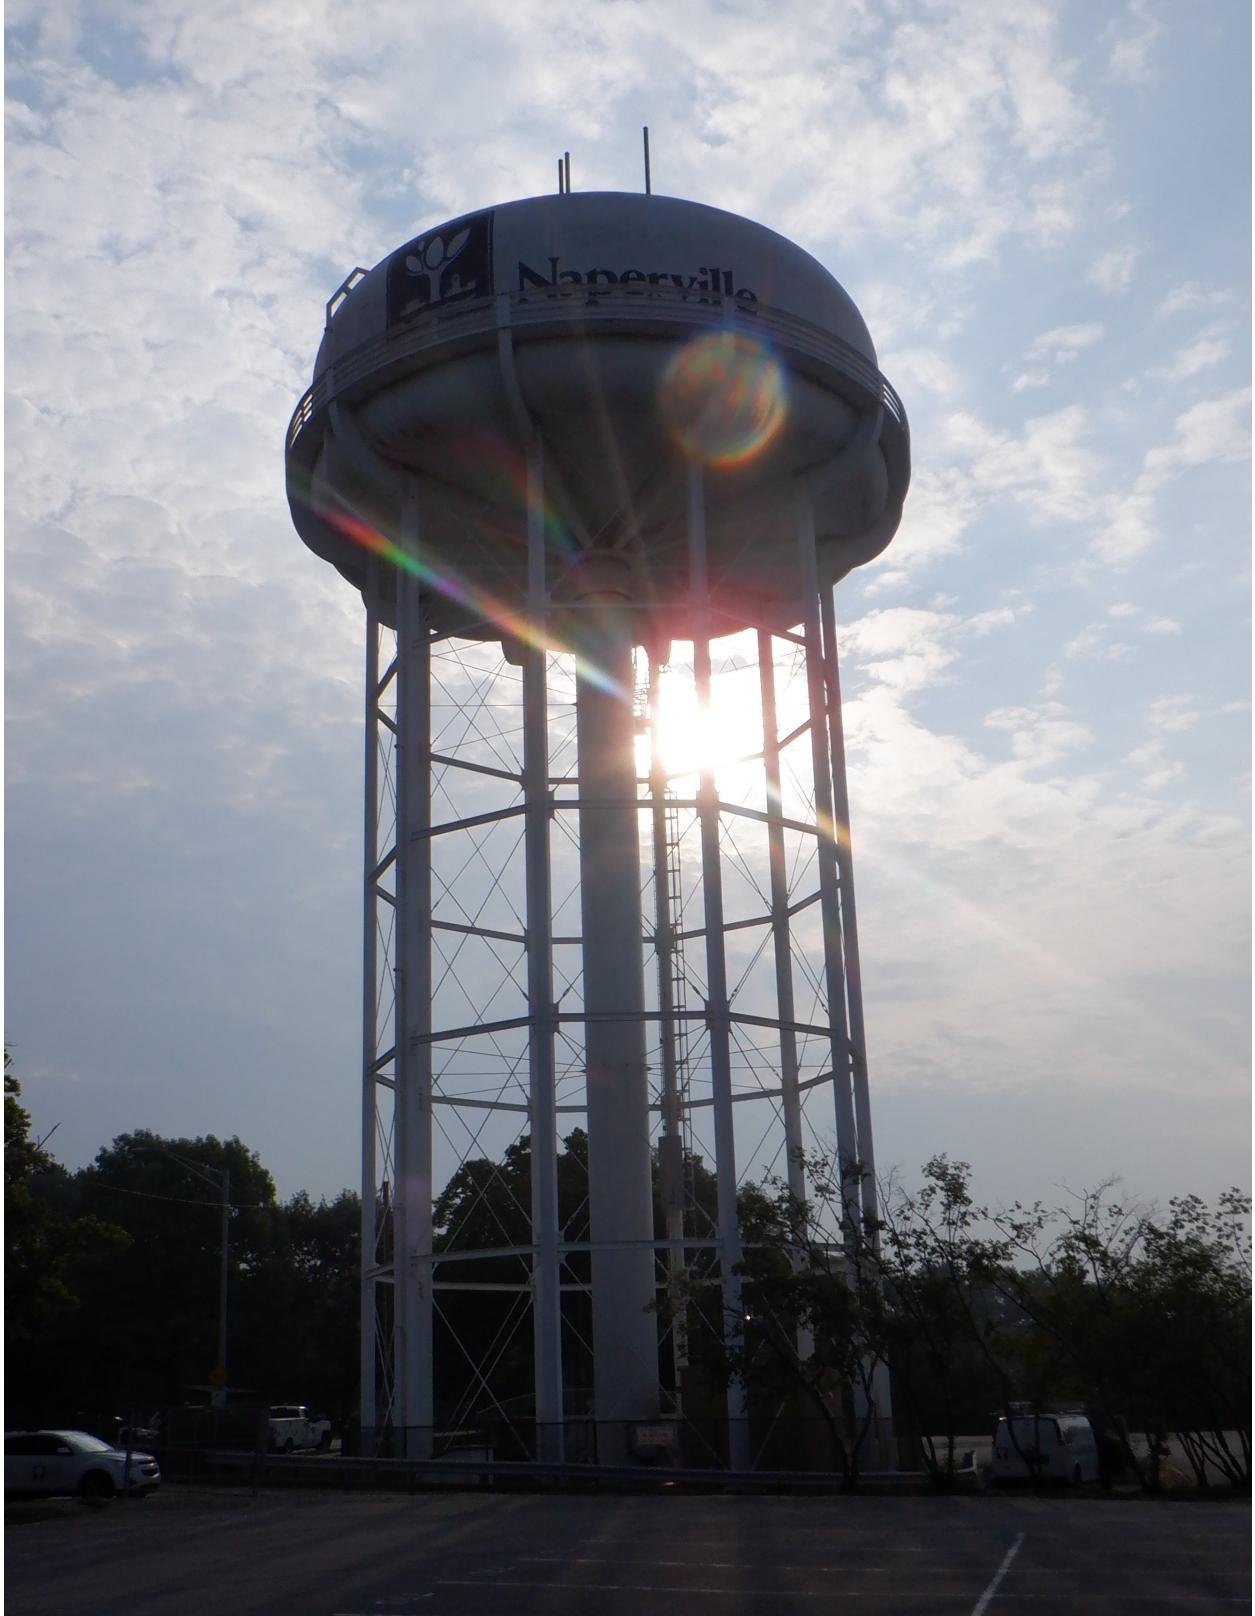
500,000 gallon radial arm (Central Tank) located in Naperville, Illinois.

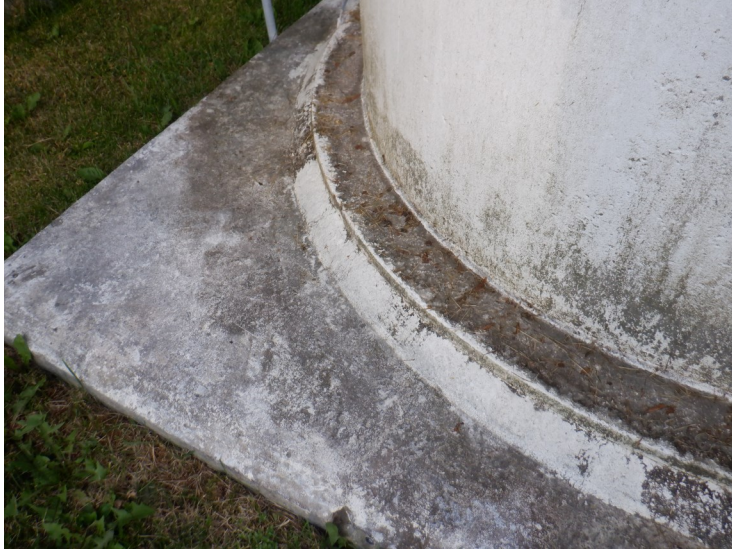
1) The exposed riser foundation is in good condition overall. The coating is in poor condition.

Recoat the exposed concrete with an epoxy coating system to help prevent deterioration. The cost would be incidental to exterior painting.

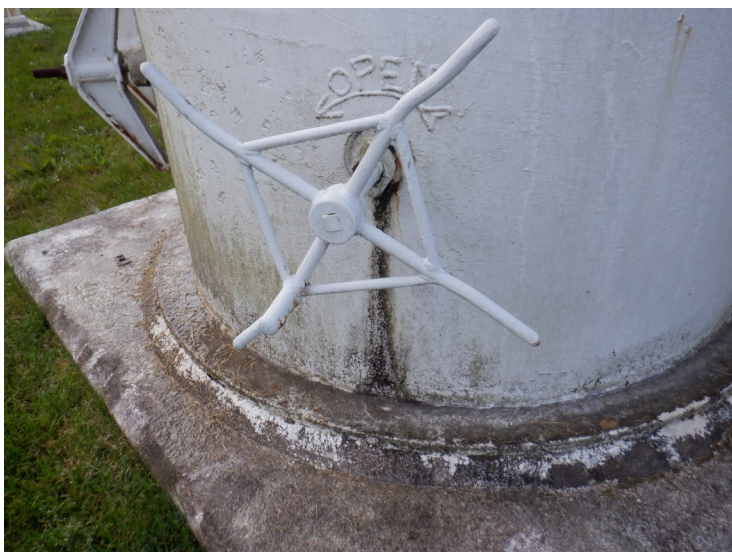
3) The riser drain valve is not functional.

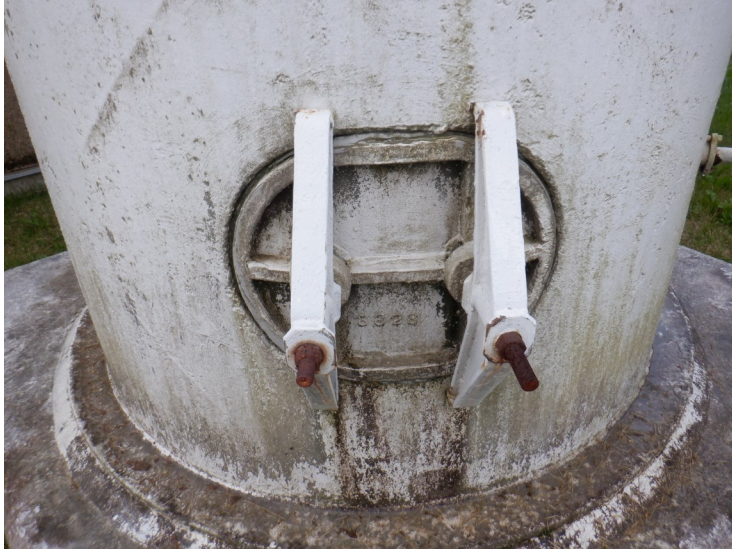
4) The elliptical riser manway is in good condition.

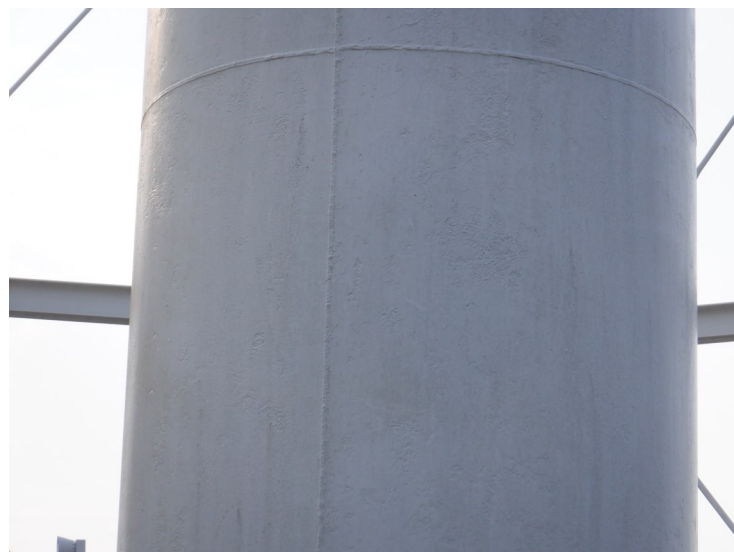
6) The riser coating is in fair condition overall.

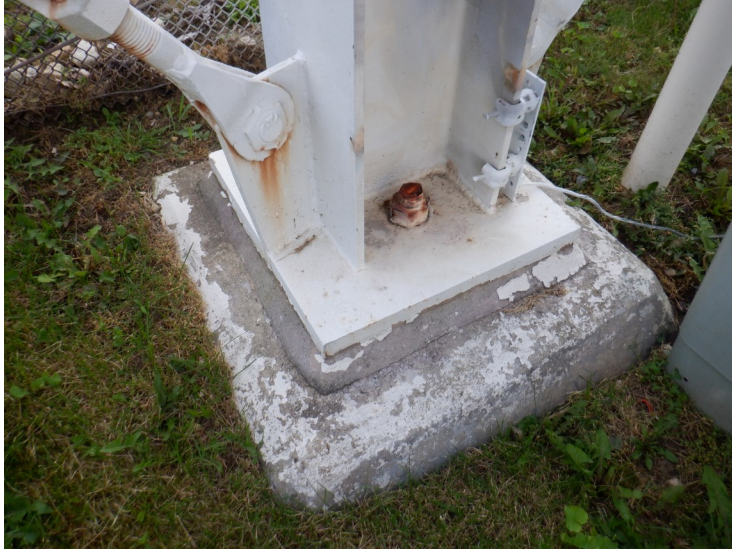
10) Typical leg foundation that is in good condition. The coating is in poor condition overall.

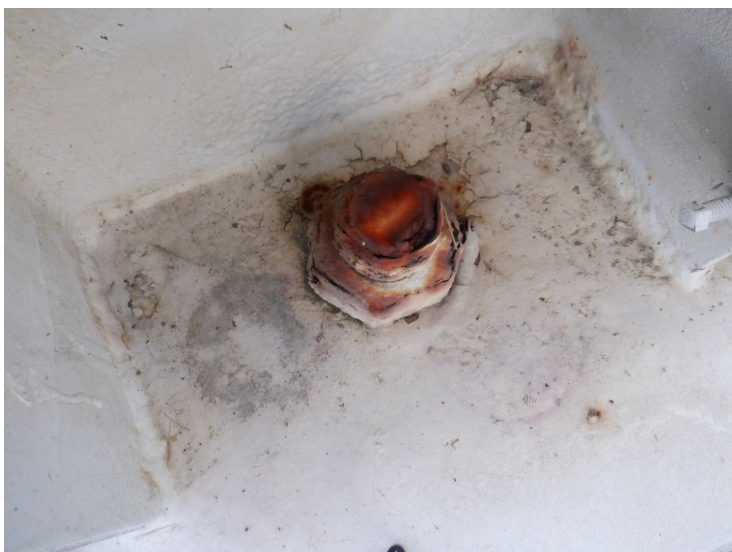
12) Anchor bolt with minor steel loss from corrosion.

Replaced the deteriorated anchor bolt nuts. The cost would be incidental to the next paint project.

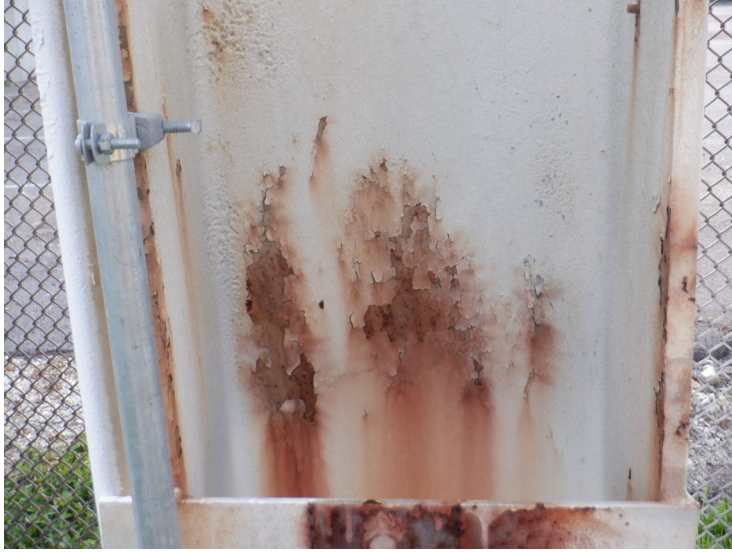
The riser and leg coating is in fair condition with numerous failures. Primary methods of deterioration are spot failures to the substrate with rust undercutting, rust bleedthrough, and micro-cracking.

16) Coating failures with rust undercutting on a leg.

Remove the existing coating by dry abrasive blast cleaning the steel to a commercial (SSPC-SP6) condition and apply a urethane system. All blast work would be performed inside a dust tight containment system using negative air pressure.

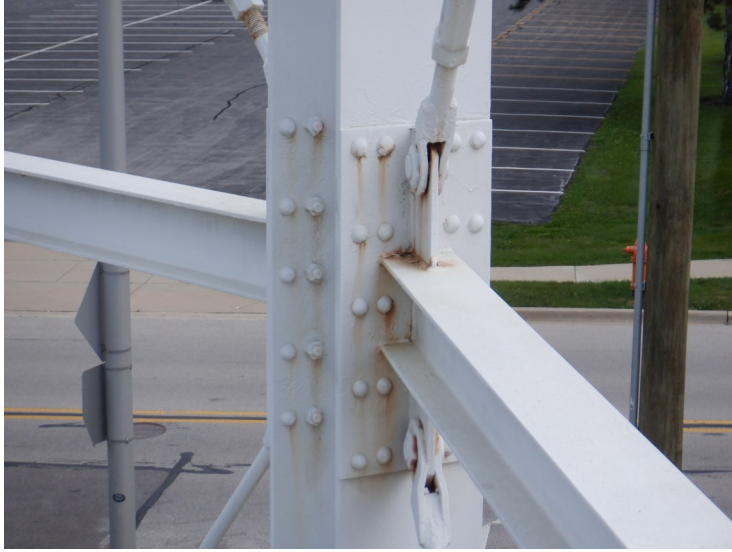
22) Spot coating failures and rust bleedthrough at a strut and leg connection.

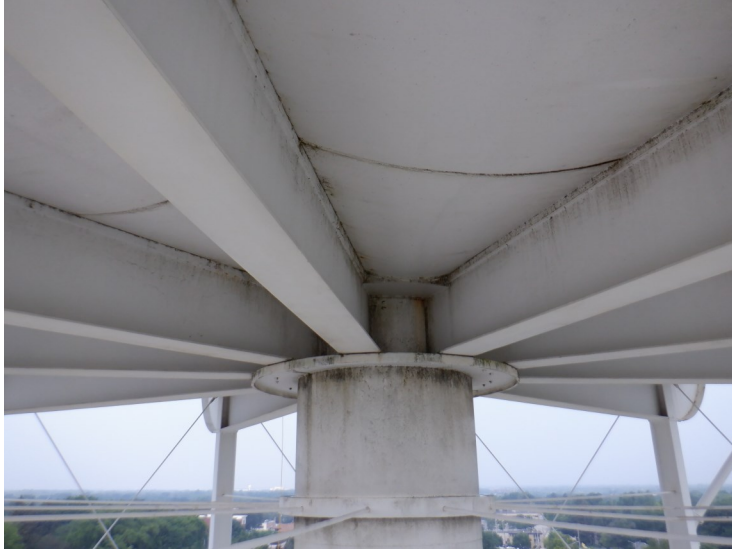
The bowl coating is in fair condition with several failures. Primary methods of deterioration are spot failures to the substrate with rust undercutting. The bowl is covered with light to moderate mildew growth.

25) The bowl coating is in fair condition overall. There is mildew growth on the bowl.

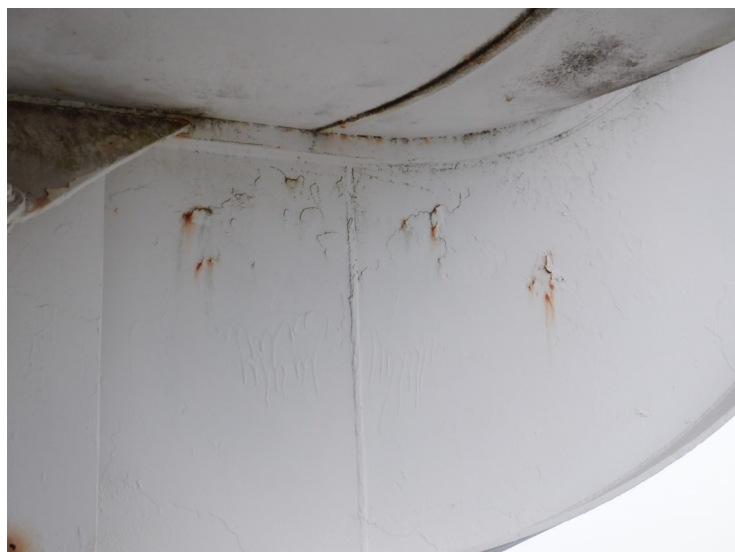
27) Spot coating failures on the radial arm bowl stiffeners.

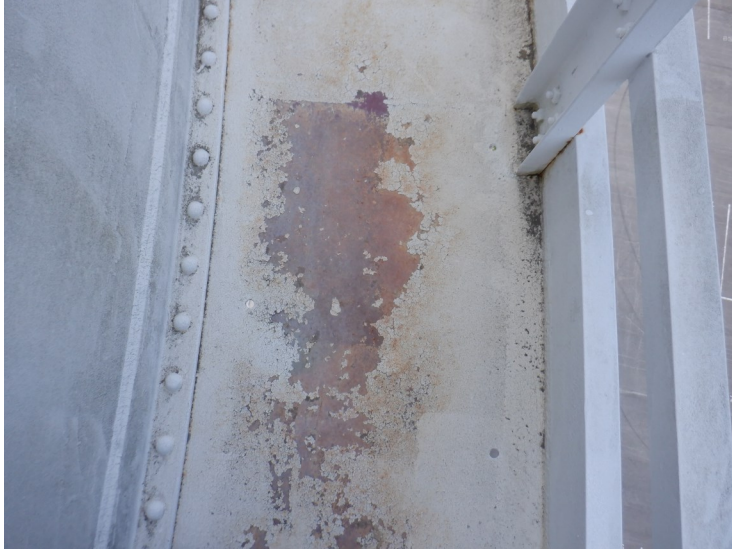
Coating on the top of the balcony is in poor condition with numerous failures. Primary methods of deterioration are spot failures to the substrate with rust undercutting, rust bleedthrough, delaminated topcoat, and erosion.

30) The balcony is in good condition. The coating is in poor condition.

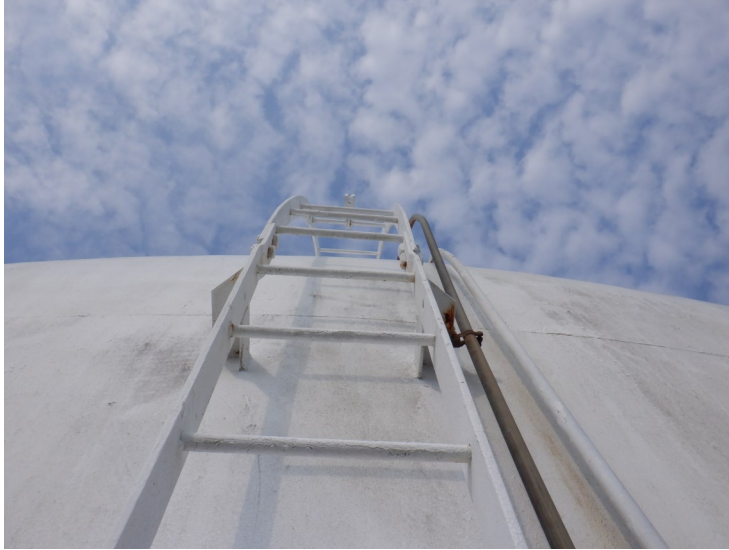
There is a fixed sidewall/roof ladder that follows the curve of the roof to the center near the vent. The ladder is in good condition. The ladder meets OSHA size requirements. The ladder is not equipped with a fall prevention device.

37) The sidewall ladder is in good condition. The ladder is not equipped with a fall prevention device.

Replace the roof and sidewall ladder with a vertical sidewall ladder that runs up to a step-off platform. The platform would have a handrail that would extend around the roof hatch. The step-off platform and railing will provide a safer working area at the roof hatch. The estimated cost is \$15,000.

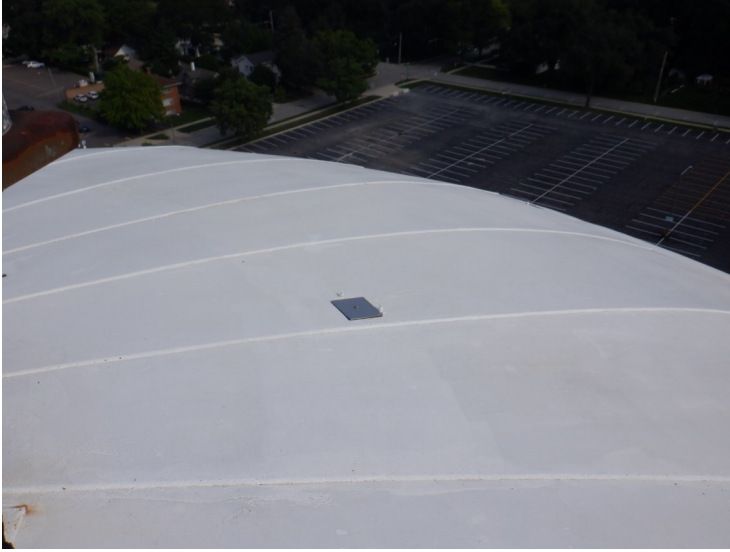
The roof coating is in poor condition with numerous failures. Primary methods of deterioration are spot failures to the substrate with rust undercutting, delaminated topcoat, erosion, and micro-cracking.

46) The roof coating is in poor condition overall.

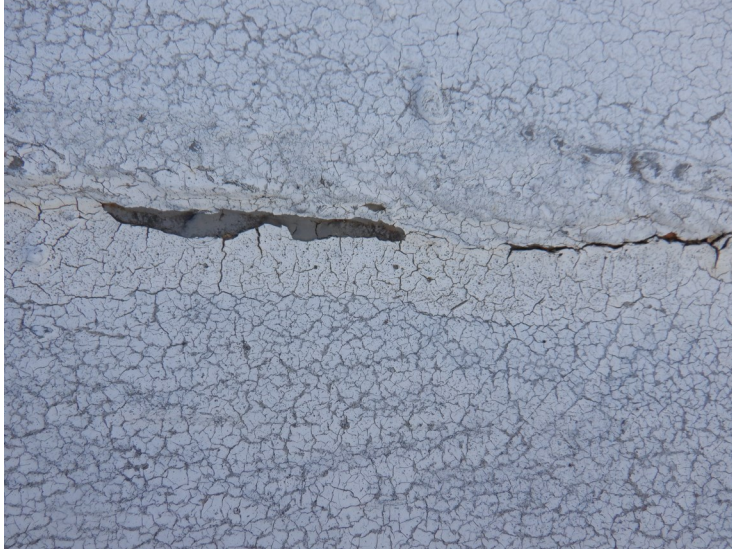
48) Spot coating failure on the roof.

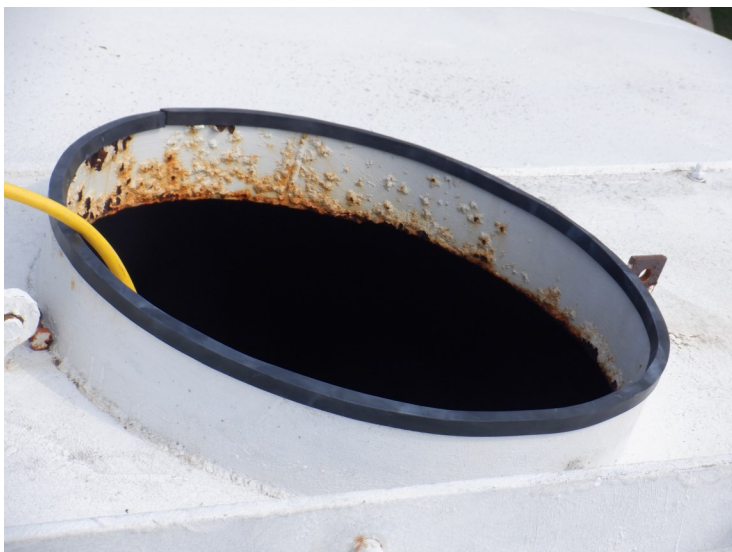
There is a 24 inch diameter roof hatch to the wet interior that is in good condition. The hinged cover is in good condition. There is no handhold next to the hatch to aid the climber while entering and exiting the opening. The hatch was secured with a bolt. The hatch neck curb height meets the minimum height requirement of 4 inches. The hatch cover lip meets the minimum height requirement of 2 inches. A gasket was installed on the roof hatch curb by the inspection crew

50) The wet interior roof hatch is in good condition. There are spot coating failures on the cover.

Replace the wet interior roof access hatch with a new 30 inch hatch. Average rescue baskets will not pass through the existing hatch. The estimated cost is \$4,000.

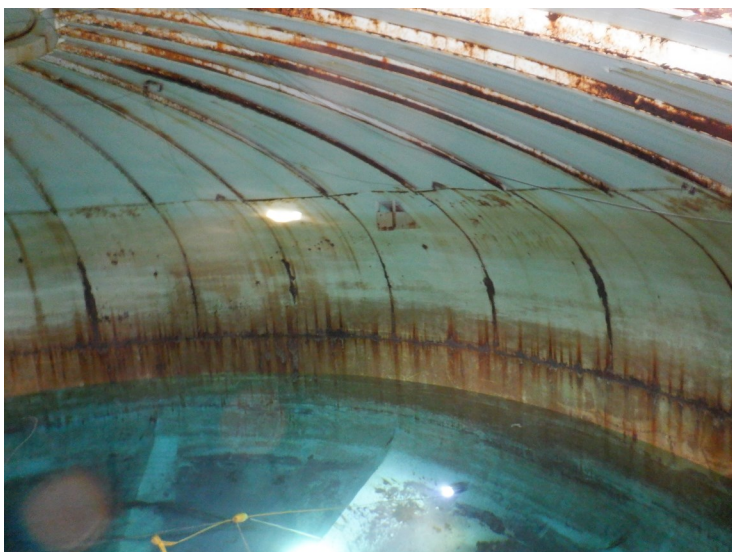
The roof coating is in poor condition with numerous failures. Primary methods of deterioration are spot failures to the substrate with rust undercutting. There are coating failures throughout the roof and roof stiffeners. Corrosion on the roof stiffeners is typical but should be corrected before structural loss of steel occurs.

52) The wet interior roof coating is in poor condition overall.

Budget to repaint the wet interior in one to two years. Abrasive blast clean the entire wet interior to a near-white metal (SSPC-SP10) condition. Wet interior coating systems must be approved for potable water storage tanks contingent upon meeting requirements of NSF/ANSI 61.

Apply a three-coat epoxy system to the prepared surfaces. Epoxy coating systems are recommended in most applications because they have good adhesion and abrasion resistant qualities. The estimated cost is \$210,000.

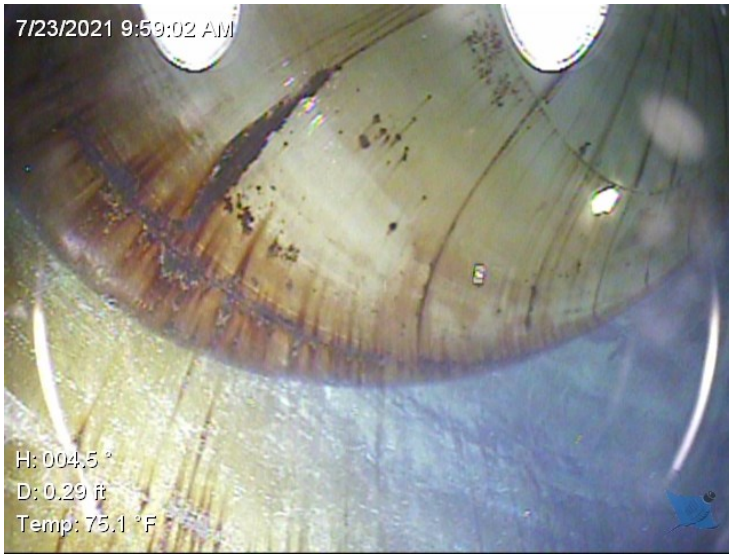
53) Coating failures on the roof stiffeners.

Monitor the corrosion on the edges of the stiffeners. Repaint the roof before metal loss becomes significant.

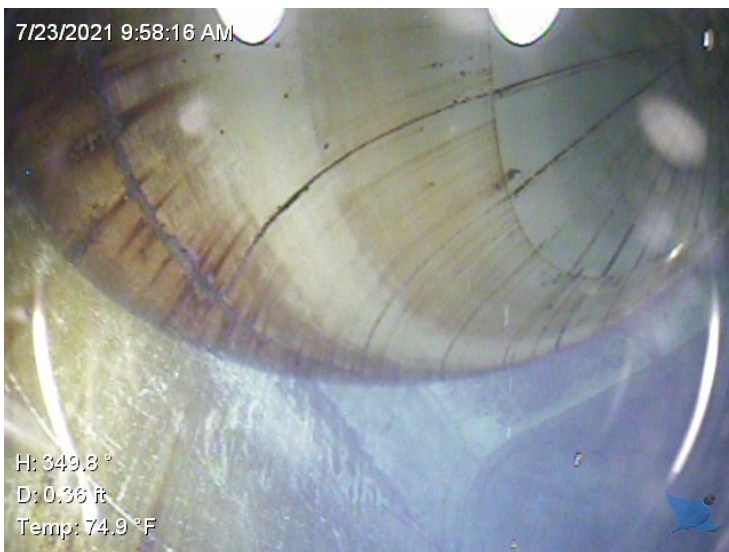
The sidewall coating is in poor condition with numerous failures. Primary method of deterioration is spot failures to the substrate.

55) Spot coating failures on the wet interior sidewall.

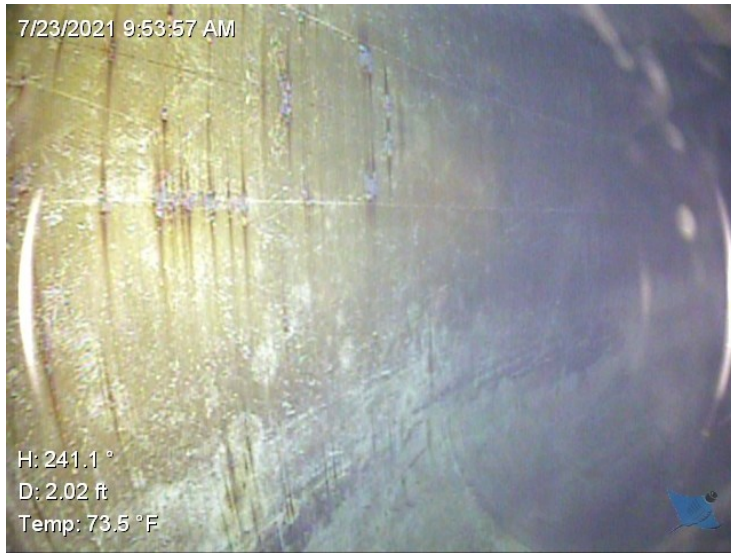
58) Spot coating failures on the sidewall below the water line.

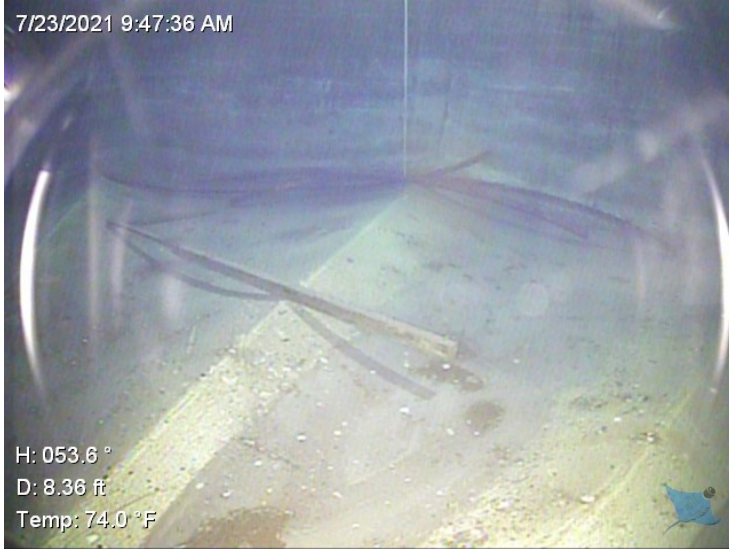
There was a painter's railing located at the upper sidewall. The stiffener is in poor condition and is lying on the tank bottom.

64) The painter's railing has broken from the sidewall and is lying on the bowl.

Remove the damaged painter's railing from the tank bottom. The cost would be incidental to wet interior repainting.

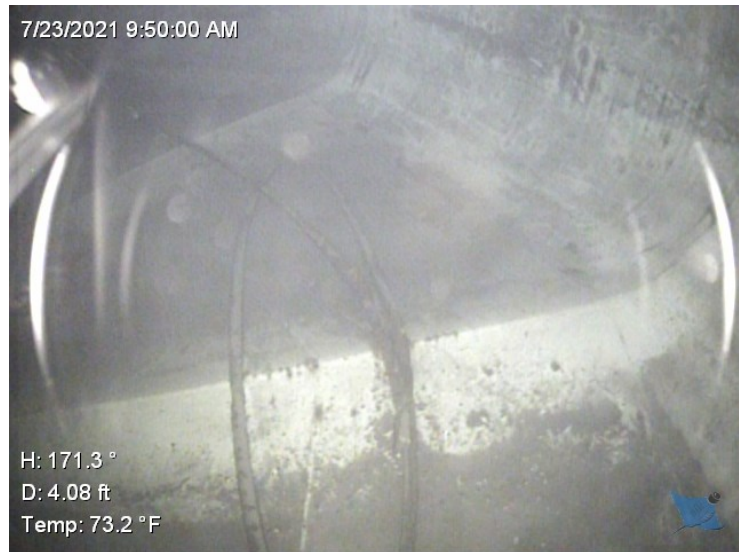
66) There is no safety grate over or around handrail the riser.
