PREPARER ORGANIZATION RAMSEY HISTORIC CONSULTANTS

NAPERVILLE HISTORIC DISTRICT

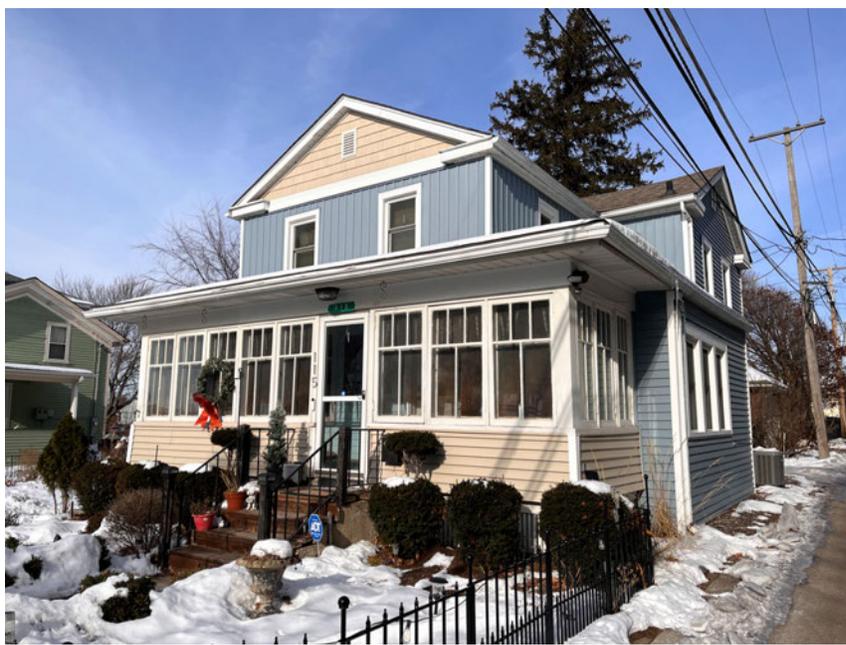
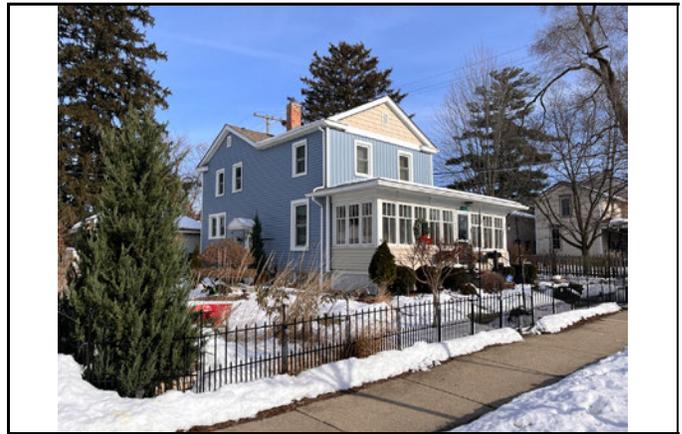
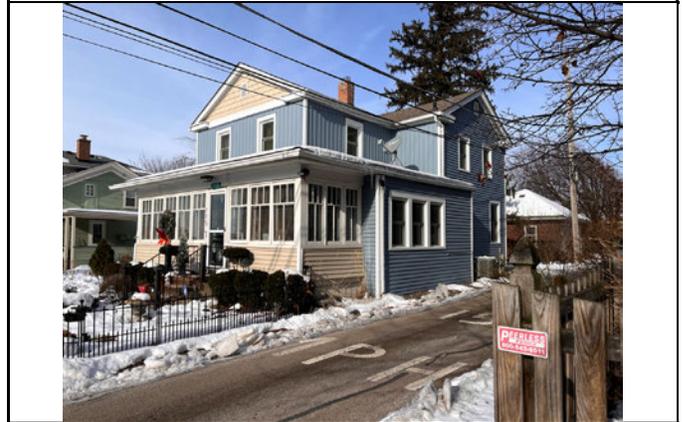
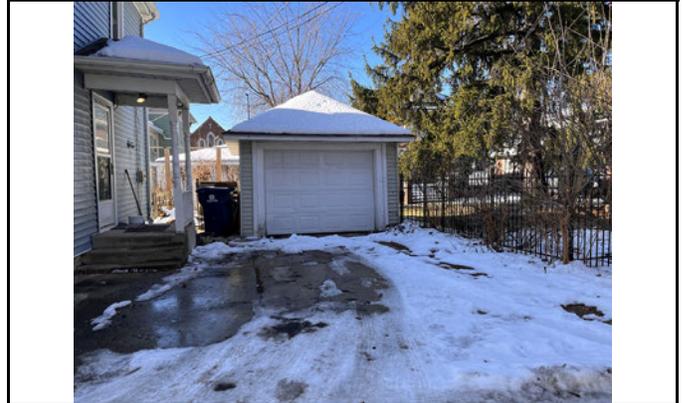
HISTORIC INFO According to owner of Bungalow on Center Street, this house was moved from the site of his house to Franklin when his house was built in the 1920s.

NOTES ON WORK: Replacement siding and trim; 1/1 replacement windows in original openings.

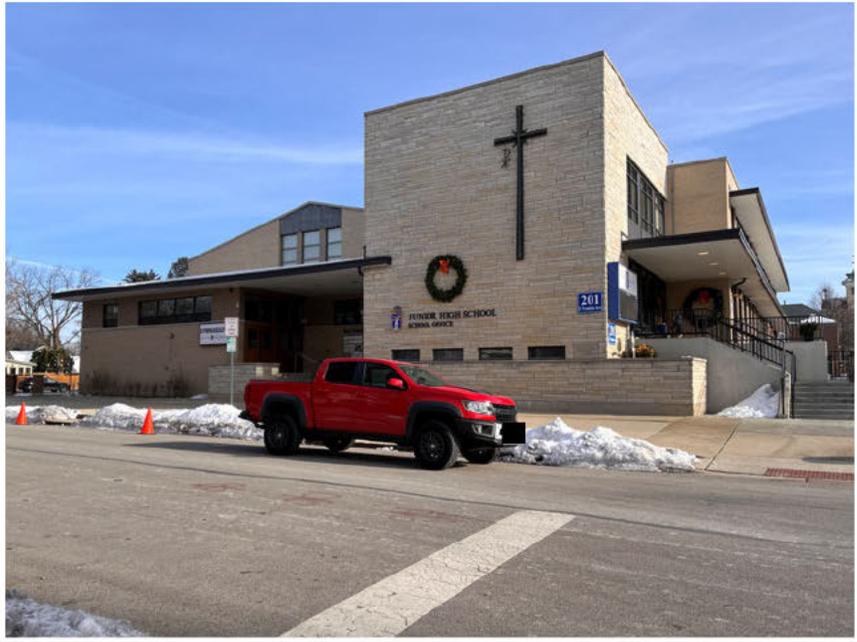
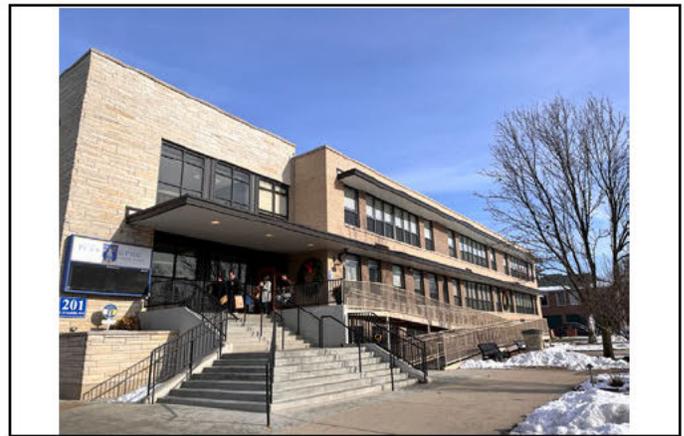
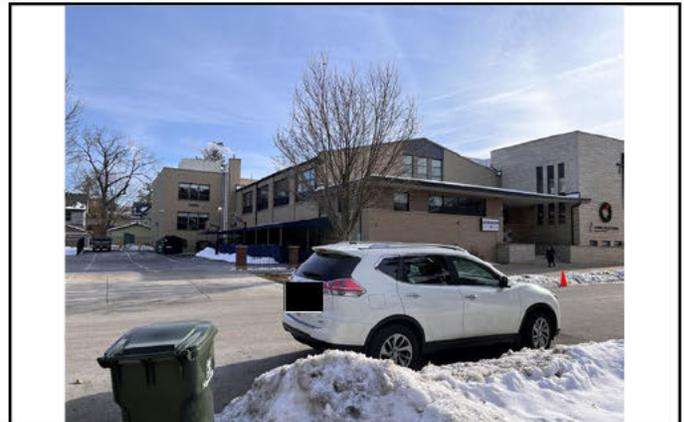
ALTERATIONS Multi-light steel windows on south elevation east of main entrance replaced with 1/1 double-hung Aluminum windows; Post-2007 -- new steps at southwest entrance; metal wheelchair ramp along south elevation; windows and doors at main entrance replaced with new Aluminum windows that match the original configuration

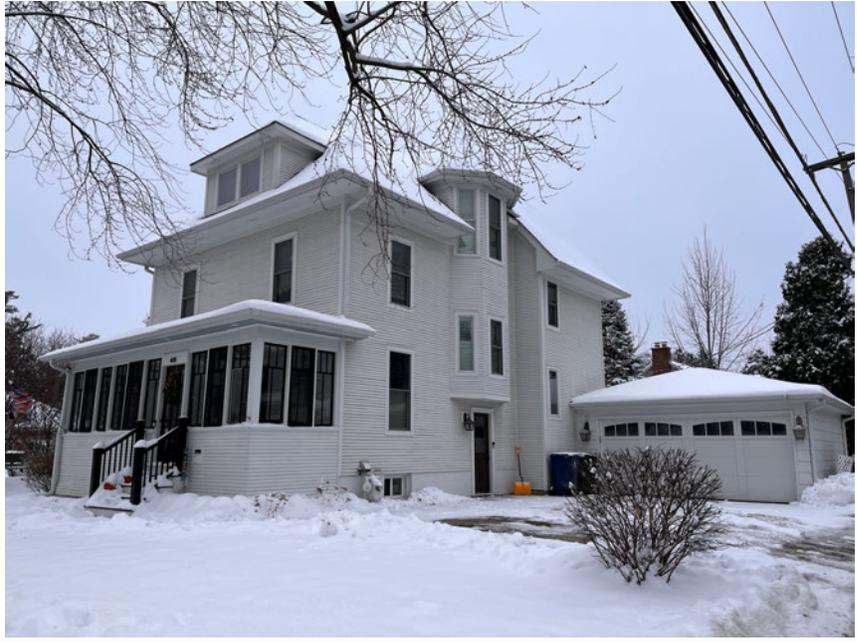
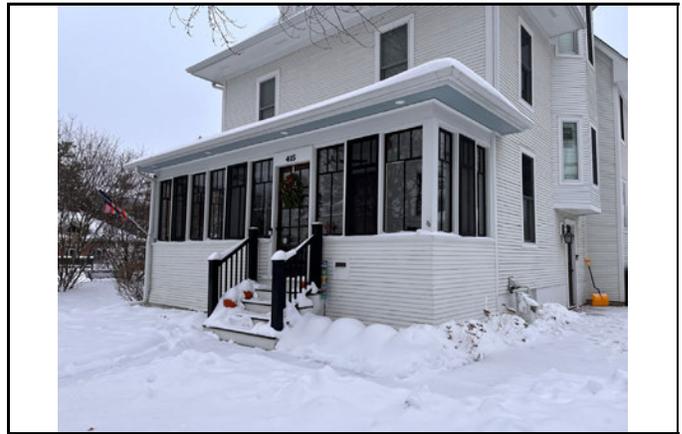
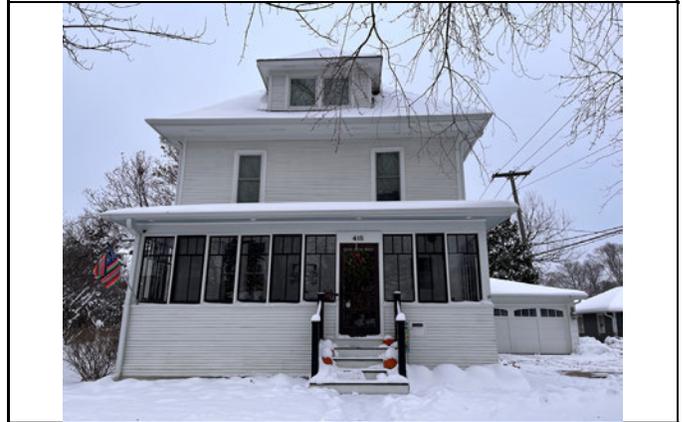
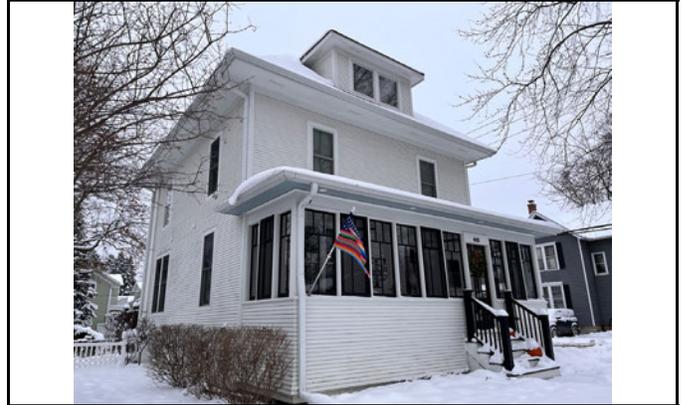
SIGNIFICANT FEATURES Rectangular massing and wood exterior siding; full-width front porch with shallow hipped roof; historic 1/1 wood windows on front elevation above porch and at first and second stories of west elevation at original structure; some historic windows also remain on east elevation; 5-light windows at porch enclosure

ALTERATIONS Replacement front door and steps (not historic); one-story rear addition/connector addition to rear garage (not historic). Post-2007 -- roof rebuilt with steeper pitch and taller front and side dormers; one story east addition at garage; 2nd-story addition over existing northeast addition between house and garage; oriel bay on east elevation extended up to create a two-story bay that pierces the roofline; some 1/1 Aluminum replacement windows in original and altered openings; replacement porch door and replacement door in ground-level east entrance; rear deck.

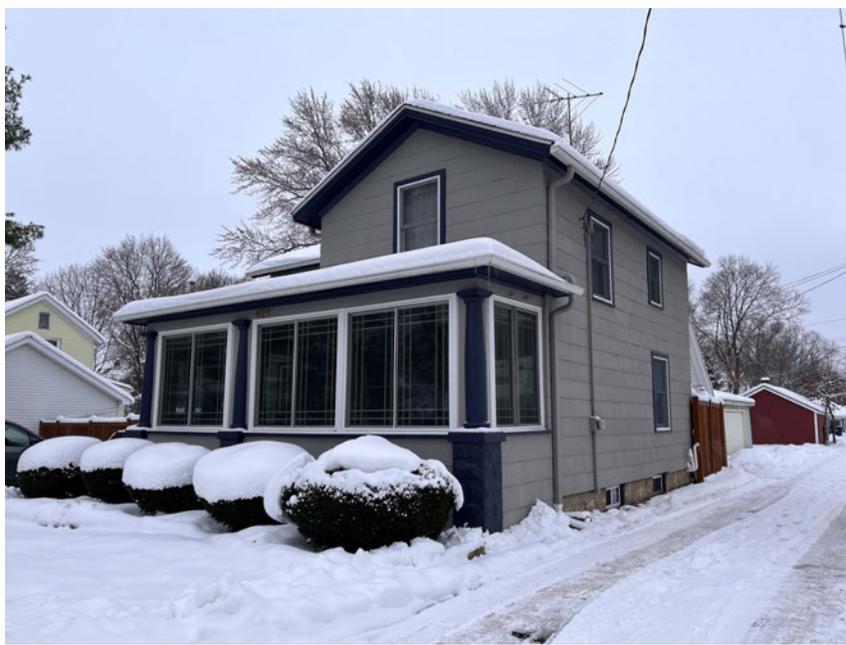
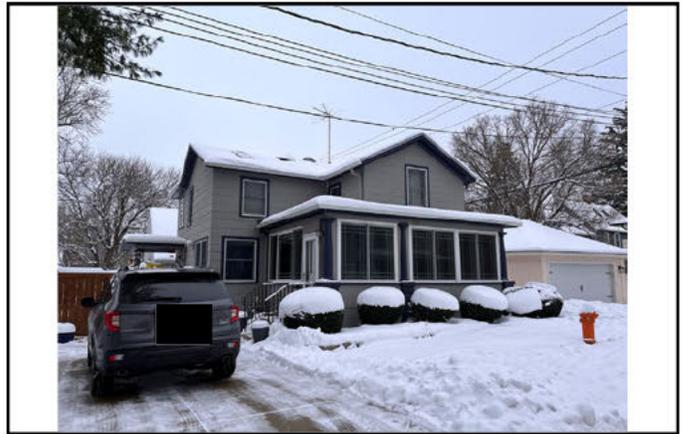
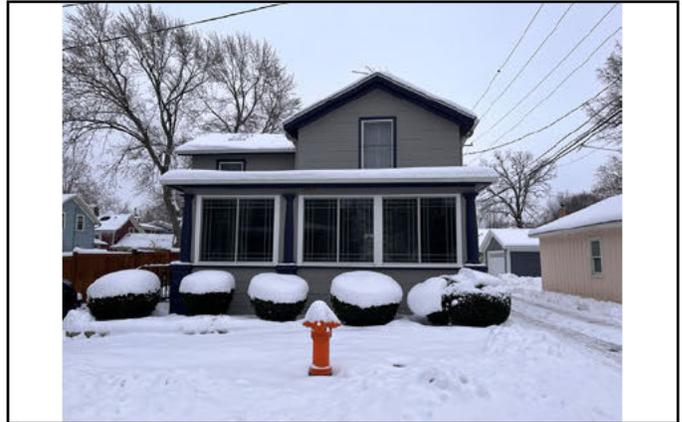
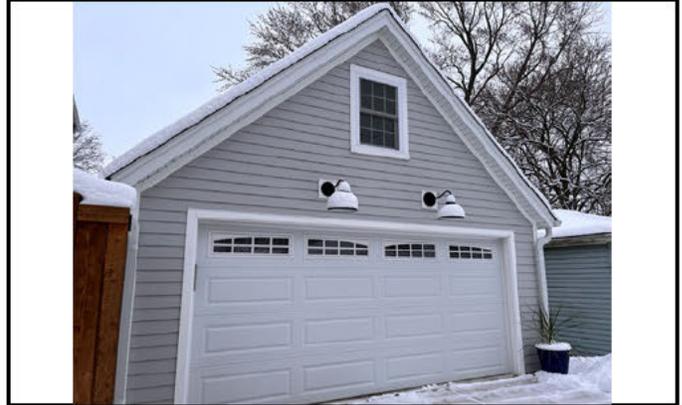
ALTERATIONS Replacement siding (1950s); front porch extended (c. 1915); 1/1 aluminum or vinyl replacement windows throughout, and in altered opening on wing; 2 story rear addition (post-1954); east side entry porch (post-1954); skylights. Post-2007 -- paired nine-light wood casement windows in porch replaced with aluminum/vinyl multi-light fixed windows; repainted.

NOTES ON WORK: paired nine-light wood casement windows in porch replaced with aluminum/vinyl multi-light fixed windows.

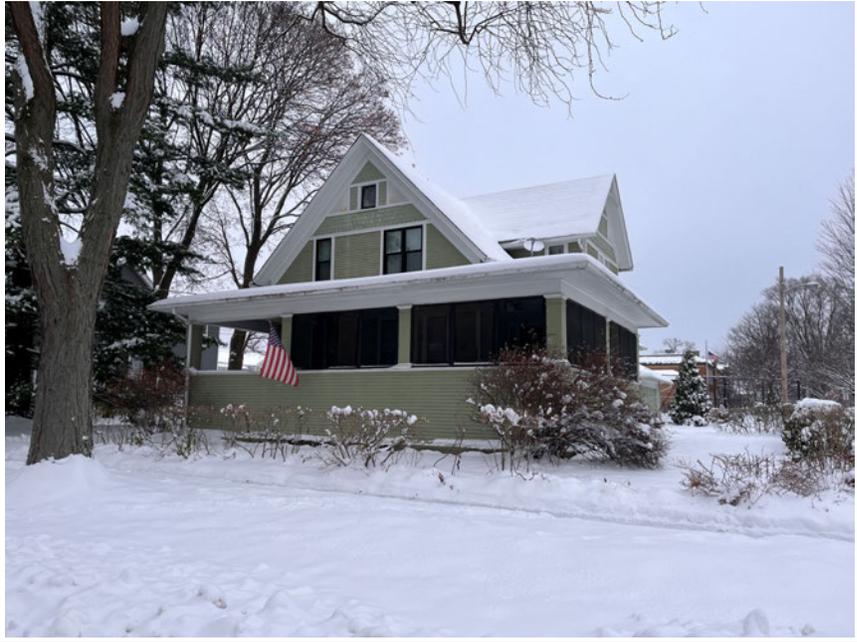
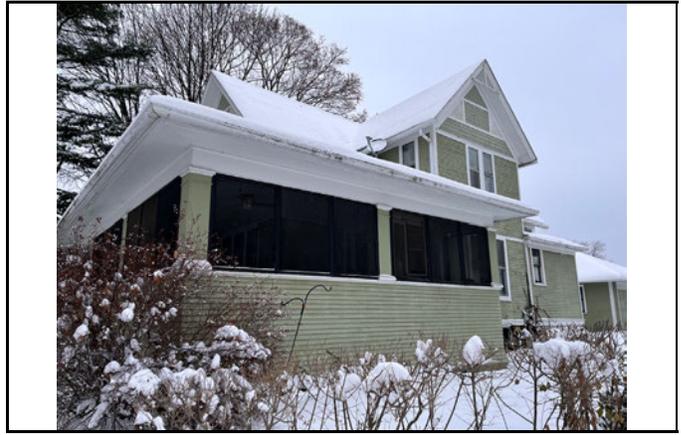
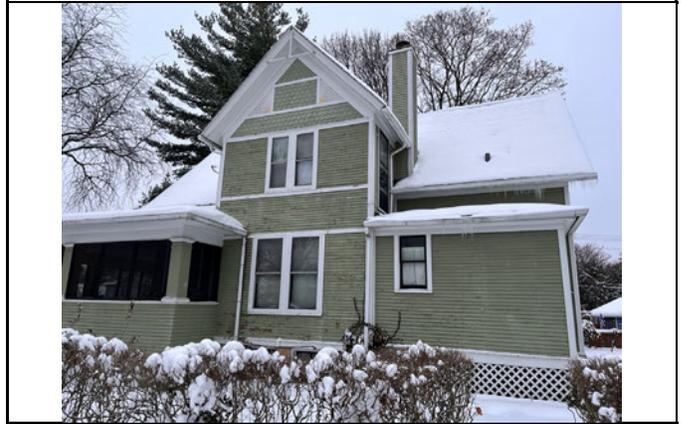
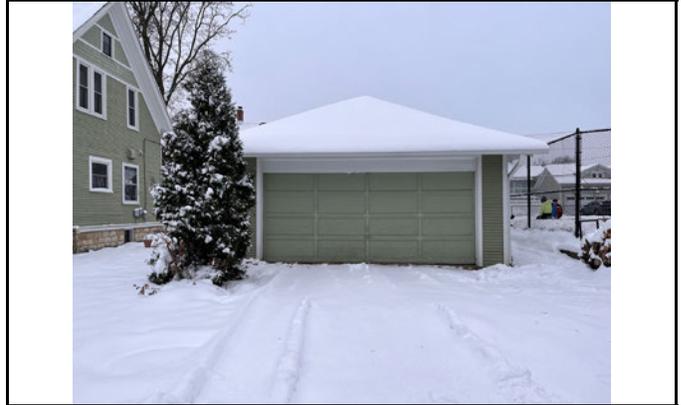
NOTES ON WORK: Southwest porch structure appears to have been repaired/rebuilt.
