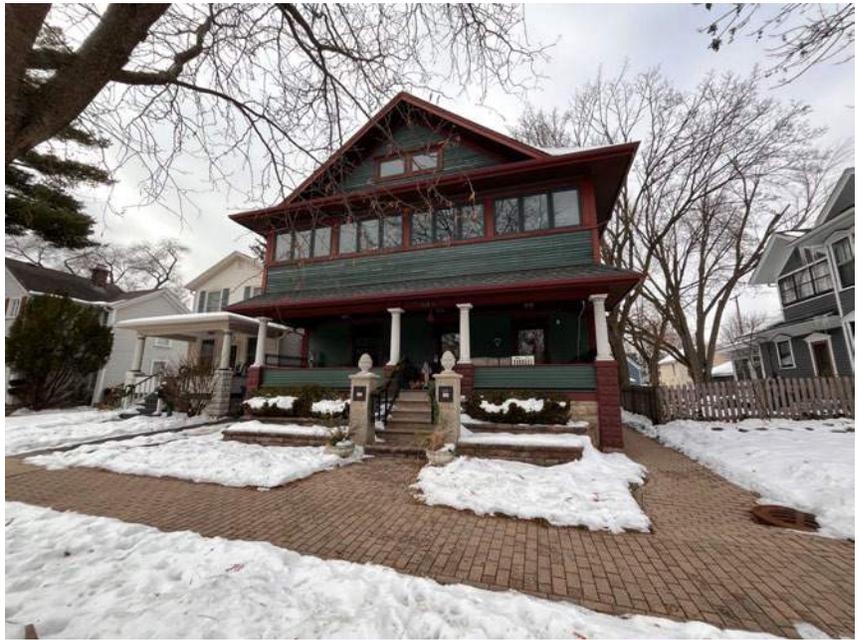
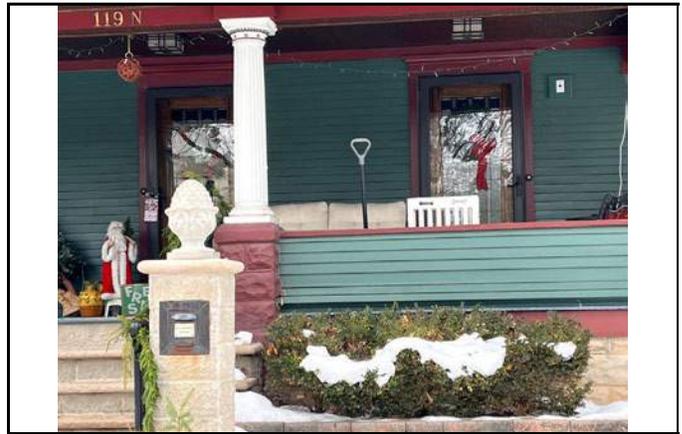
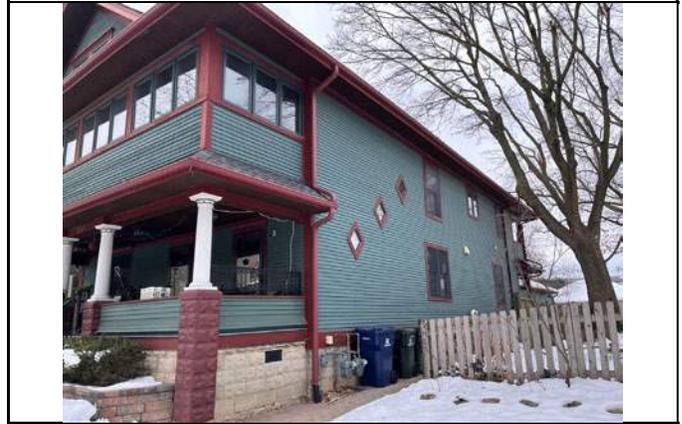
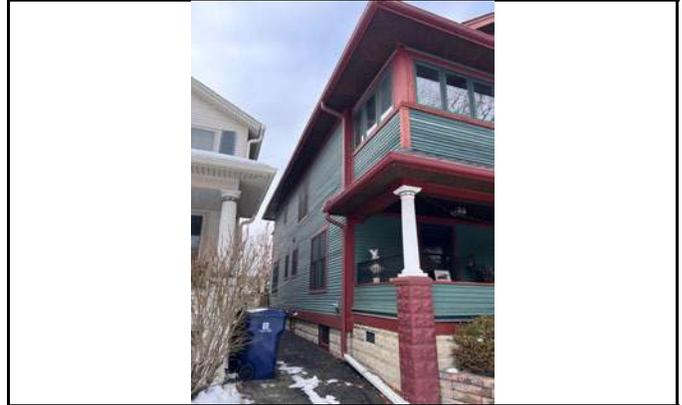
**COA DECISION** COA #18-3335 - Replacing door with window and in-kind replacement matching existing window (approved 8/22/2018); COA #19-1196 - remove window replace with door - door existed prior to 2018 (approved 4/26/2019)

**NOTES ON WORK:** All work listed in alterations with the exception of the replacement front door in north end entry under porch

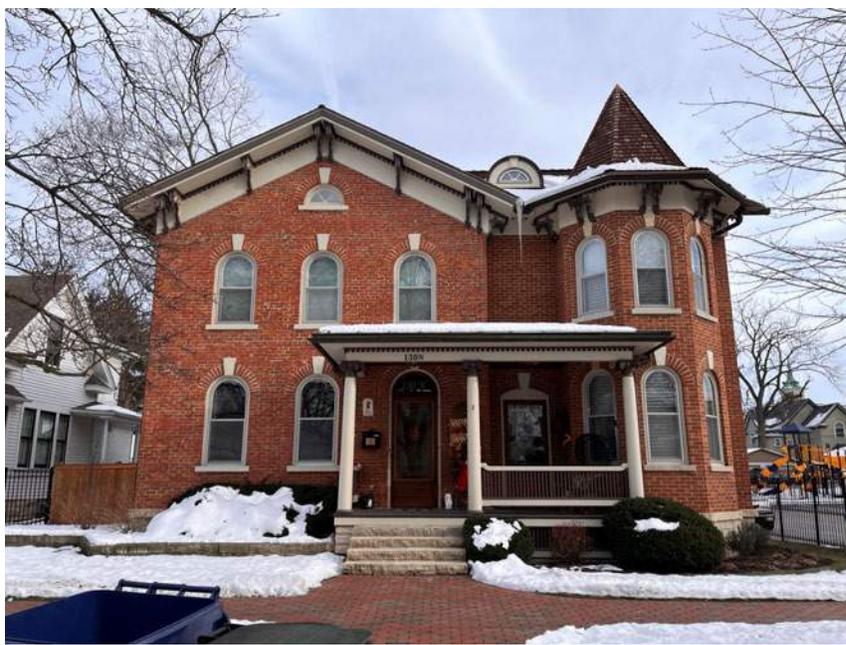
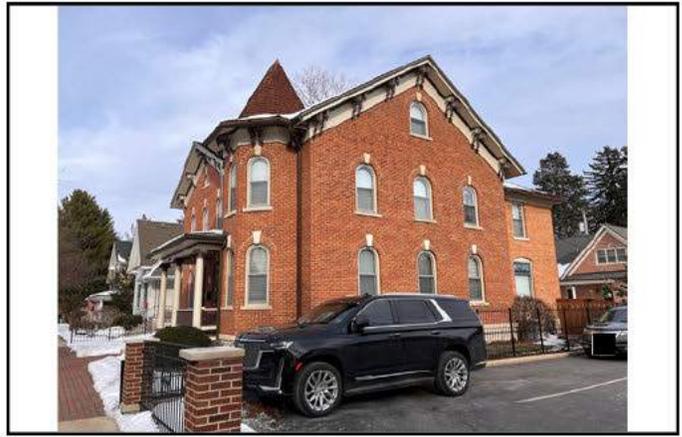
**SIGNIFICANT FEATURES** Front gable portion is original house (windows on first story appear historic); round arch window openings w/ center keystones; half round window under gable; round arch front entry; historic two-story south/rear addition constructed in 1903 (addition originally featured a second west-facing porch)

**ALTERATIONS** Paired brackets & dentils appear to be later (may be restoration); replacement windows on 2nd story or original structure (not historic); replacement door & transom (not historic); large 2 story S. side addition w/ corner tower (not historic--1990s); replacement porch (not historic-1990s); 1 story north bay addition (not historic); segmental arch window on 2nd story north elevation (not historic); chimney (not historic); rear screened porch addition (not historic). Post-2007 -- no changes.

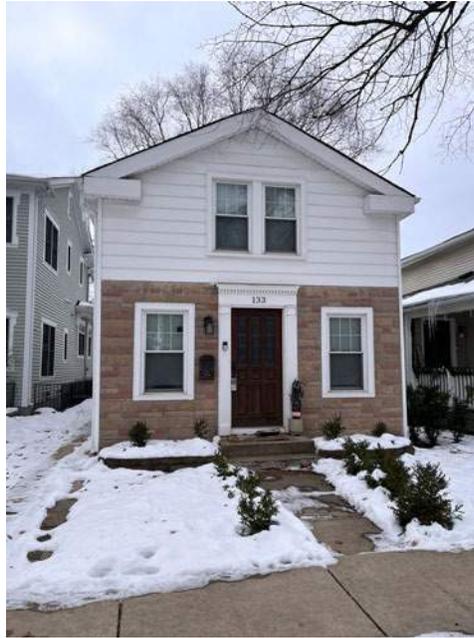
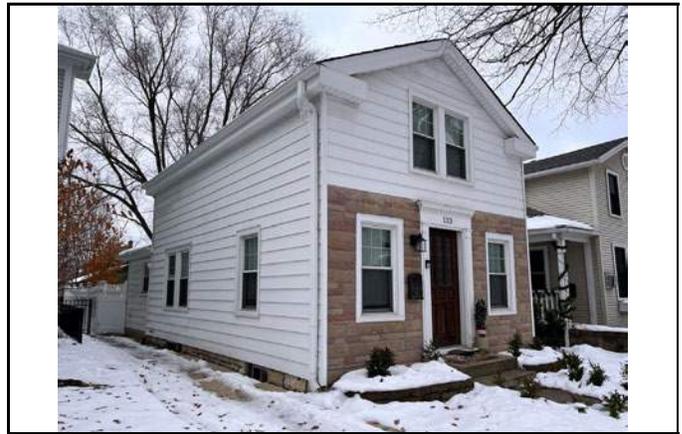
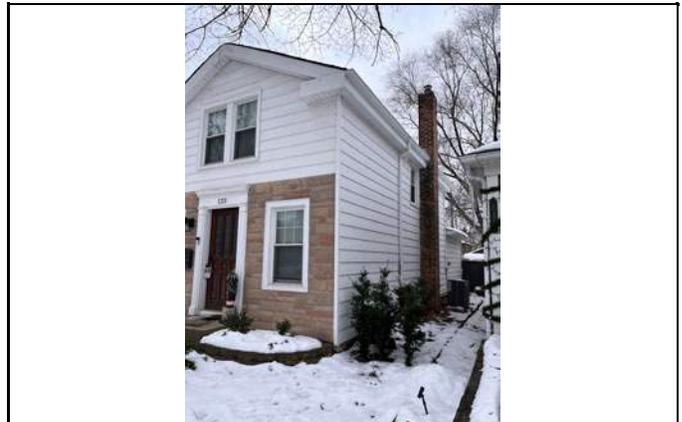
**NOTES ON WORK:** 6/1 vinyl replacement windows in existing openings; replacement front door; aluminum siding around first story windows at west end of south elevation replaced.

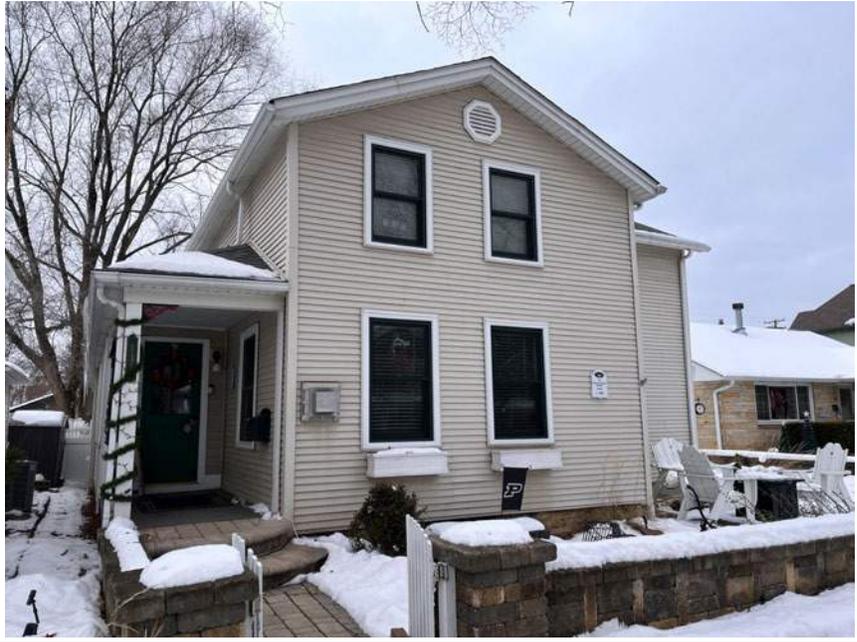
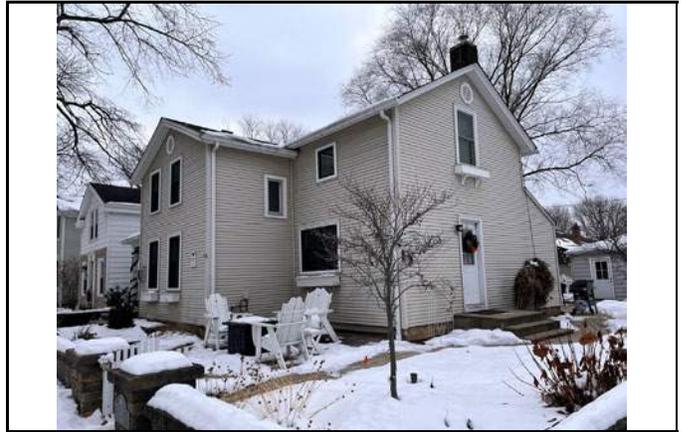
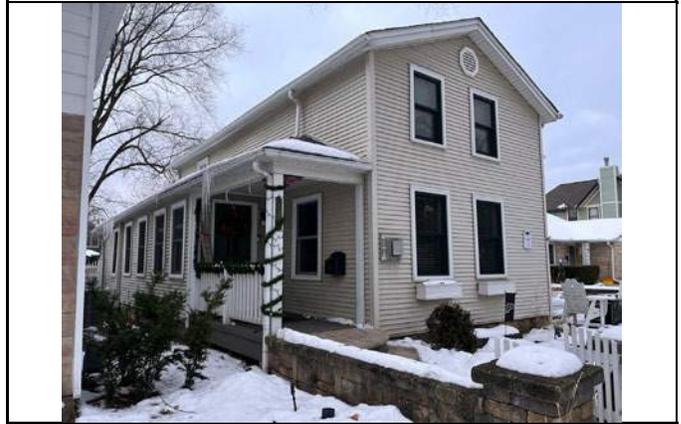
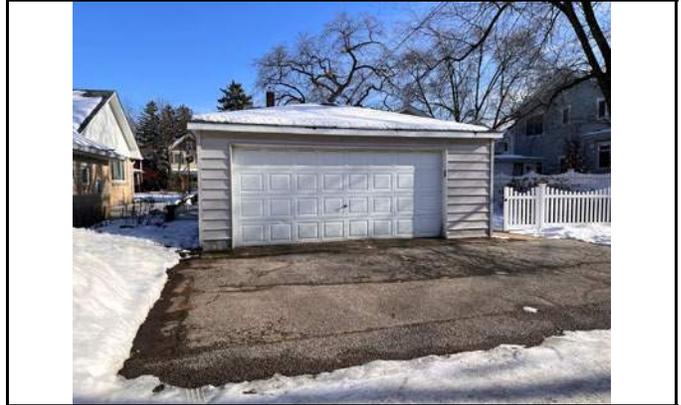
According to Sanborn Maps, house was originally a one-story structure that has been altered and added to over the years: 1 story south side addition is historic, but south porch appears to have been altered (replacement posts, railing, and steps, Aluminum under eaves); second story addition to original house is historic; first story on north addition was added sometime between 1926 and 1949, with 2<sup>nd</sup> story added after; aluminum siding; replacement windows in altered openings (not historic--house originally had a full porch and entry on front façade); multiple rear additions; stone steps to north side entry and stone patio at front of house (not historic)

Windows on front façade appear to be newer 1/1 aluminum replacement windows; porch railing replaced.

**COA COMPLIANCE NOTES:** Porch structure does not appear to have been replaced, but porch railing is replacement.

**NOTES ON WORK:** Replacement windows on front façade.

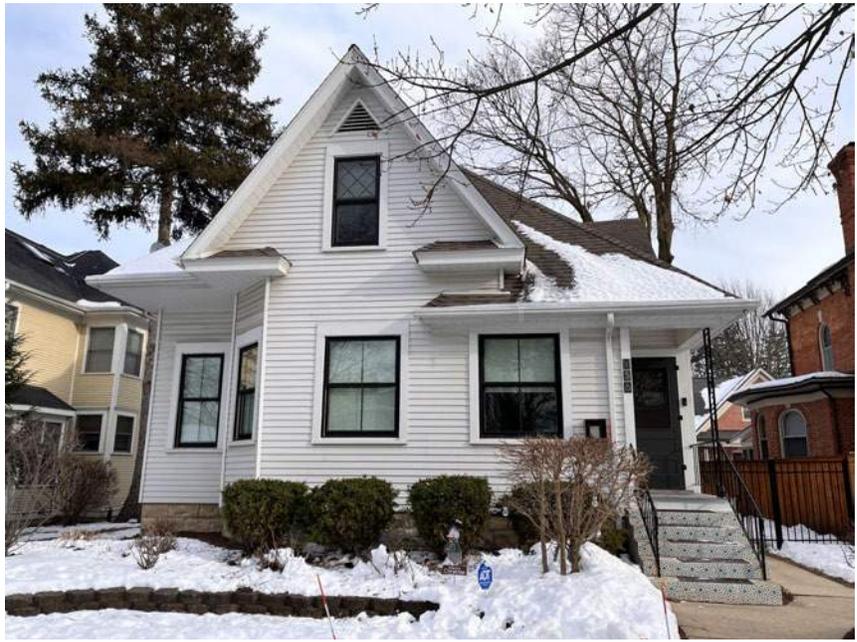
**COA COMPLIANCE NOTES:** 2007 survey photos show 1/1 double-hung windows on front and side elevations -- replacement windows are 2/2.

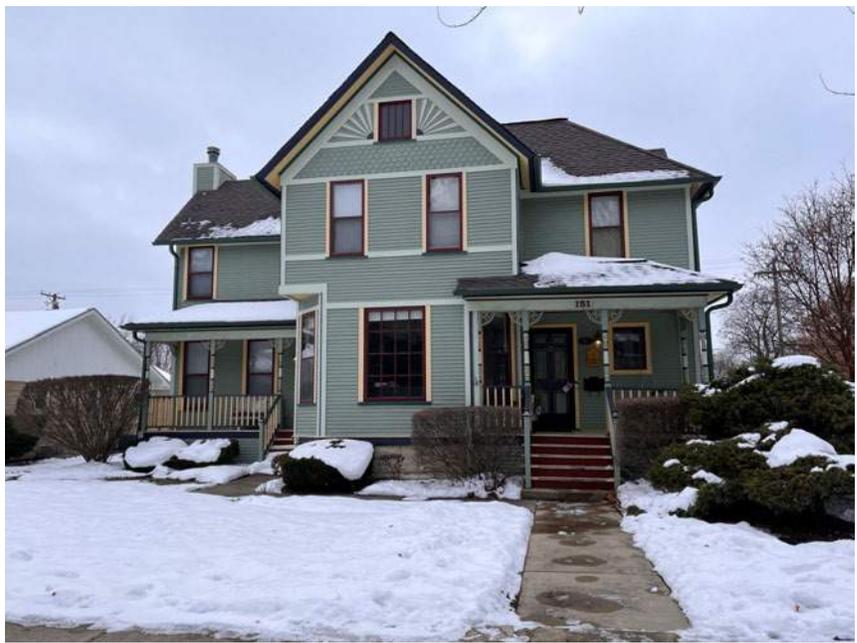
Recent renovation. Appropriate restoration work includes: replacement siding; replacement porch spindles and supports; replacement 1/1 windows; multi-light replacement windows on front bay; north entry porch; 1 story rear addition. Inappropriate alterations include glass block basement windows and a large 2-story addition to the south, including entry and porch, which is difficult to distinguish from the original massing of the home.

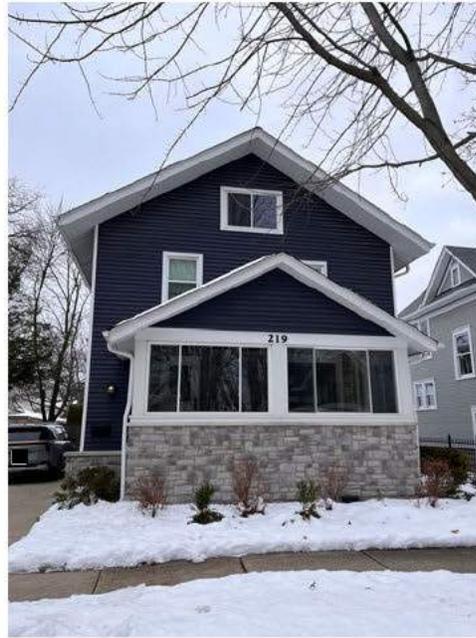
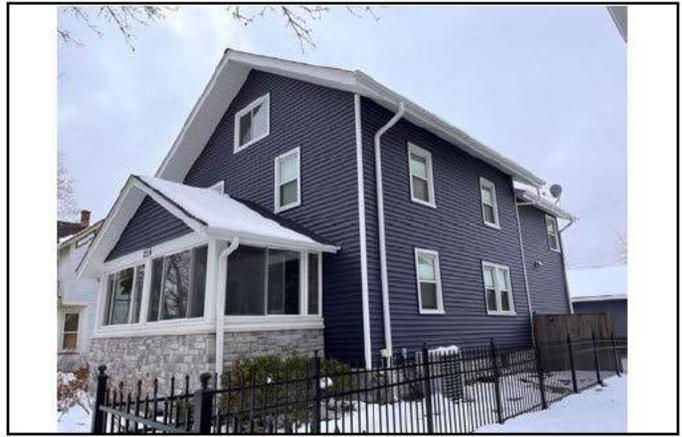
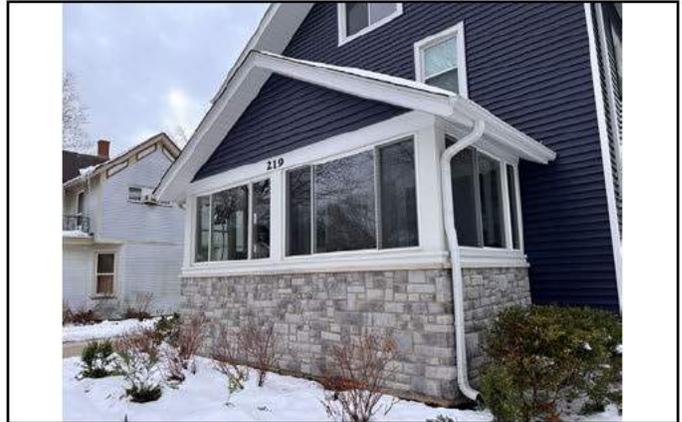
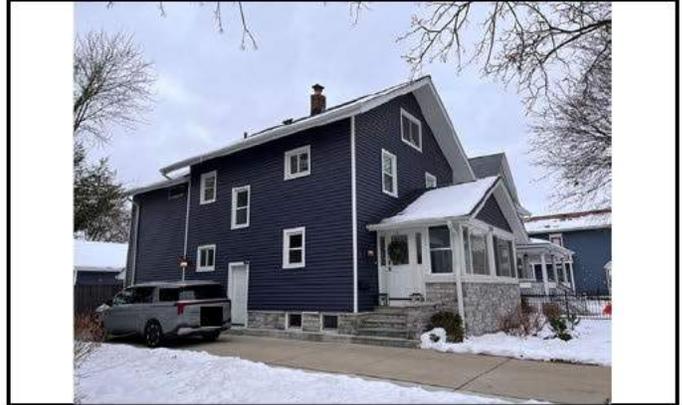
**NOTES ON WORK:** Replacement windows throughout; south side entry porch removed; replacement door in ground-level south-side entry.

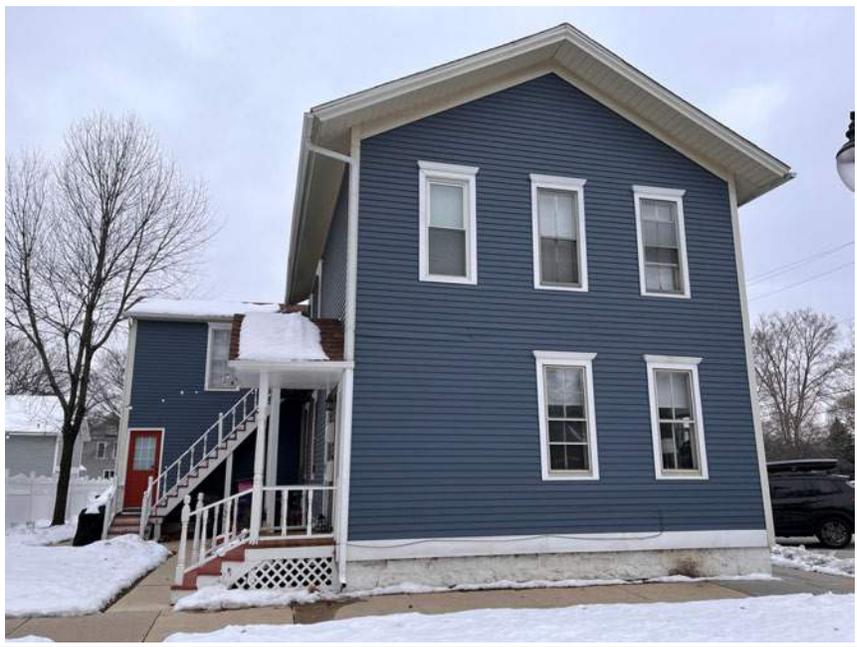
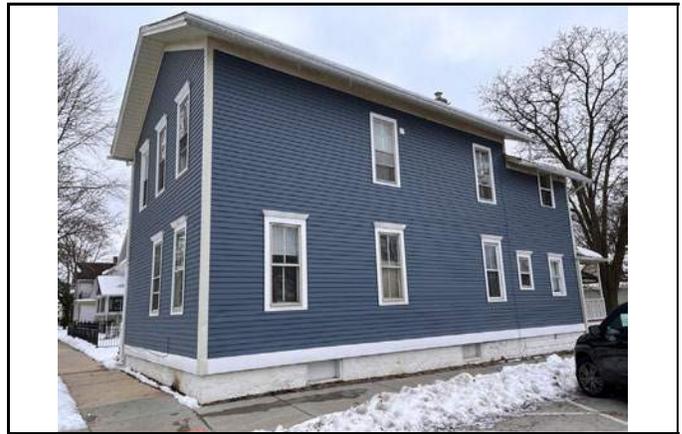
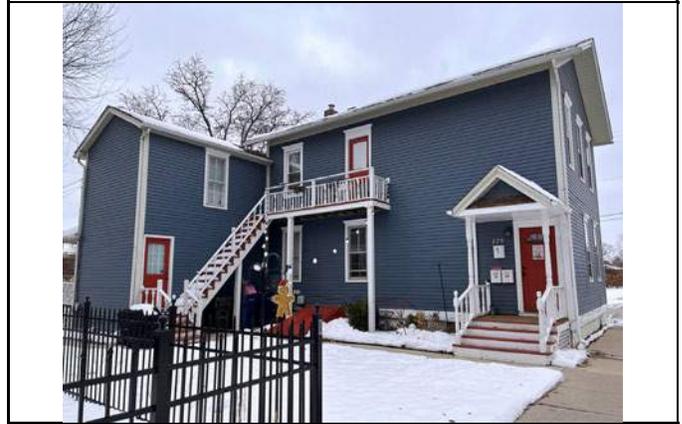
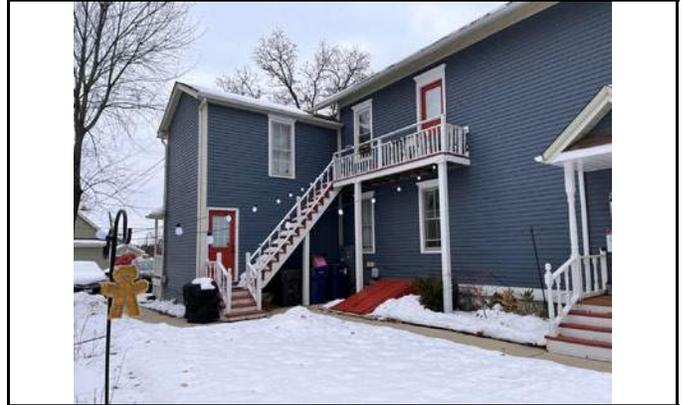
**NOTES ON WORK:** 1/1 vinyl replacement windows in select openings on front façade and north elevation; non-historic fixed shutters removed.

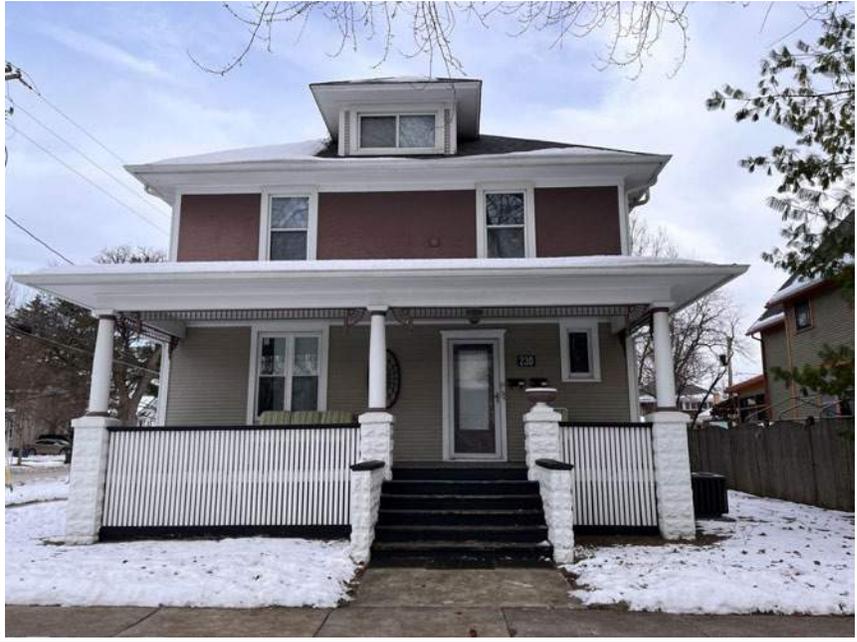
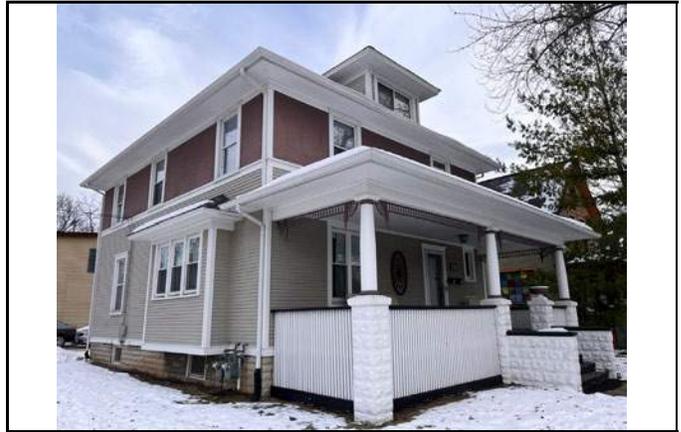
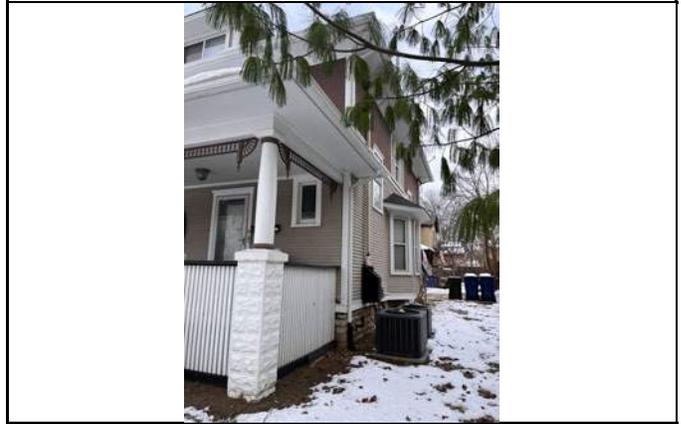
**NOTES ON WORK:** single window at north end of front façade under porch replaced with paired Aluminum/vinyl 1/1 double-hung windows.

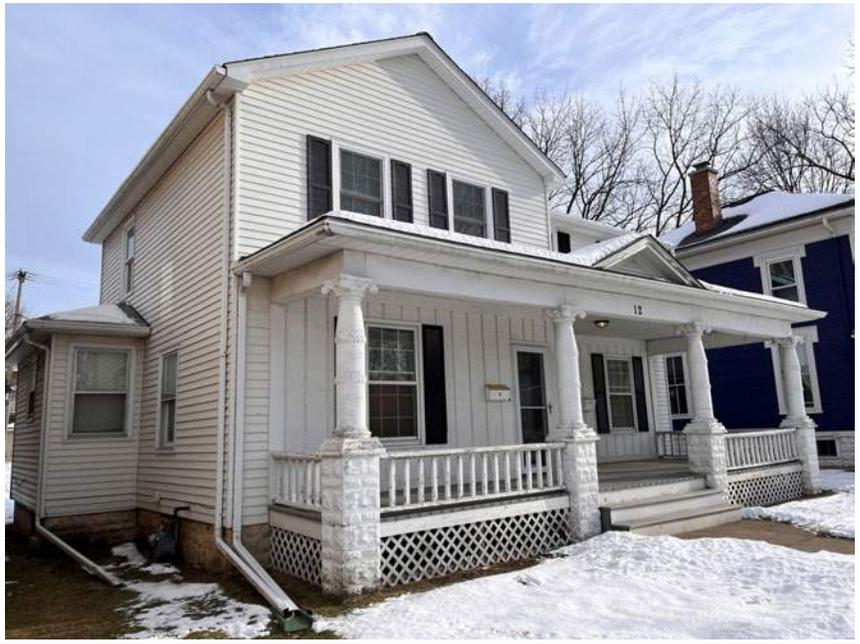
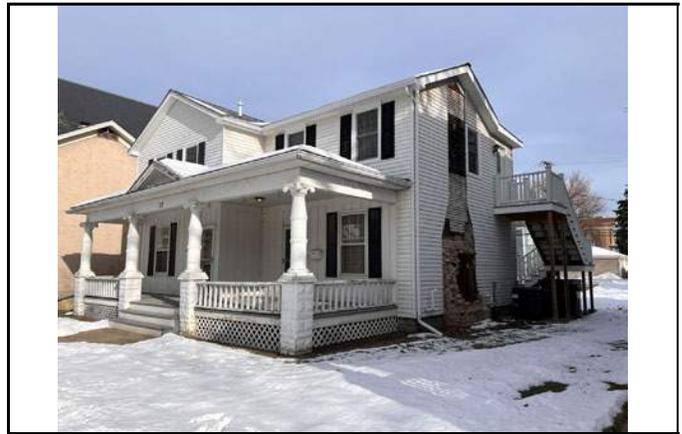
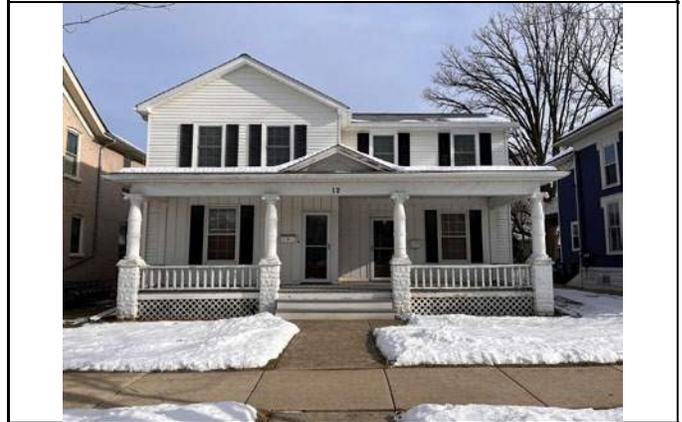
**NOTES ON WORK:** Aluminum/vinyl replacement windows on 2nd story; chimney on south elevation demolished.

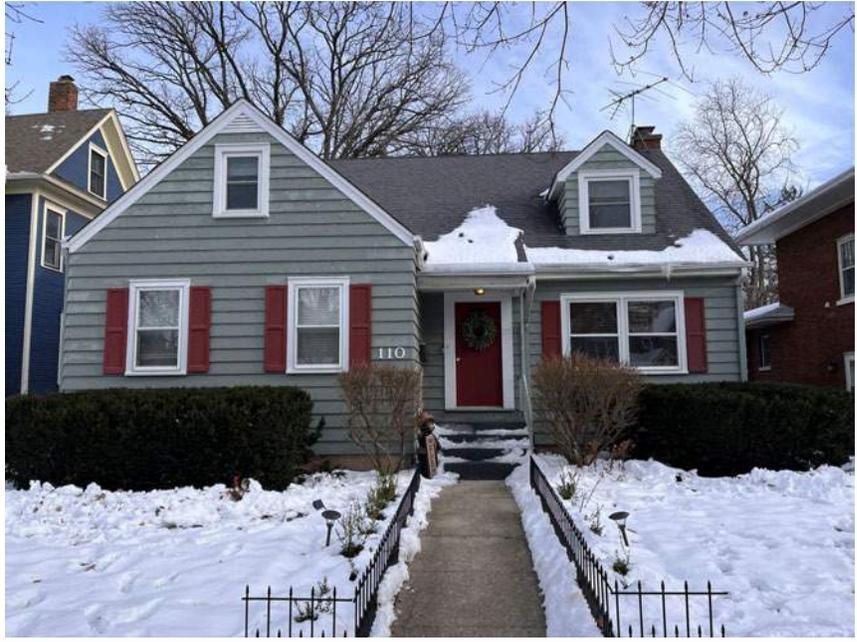
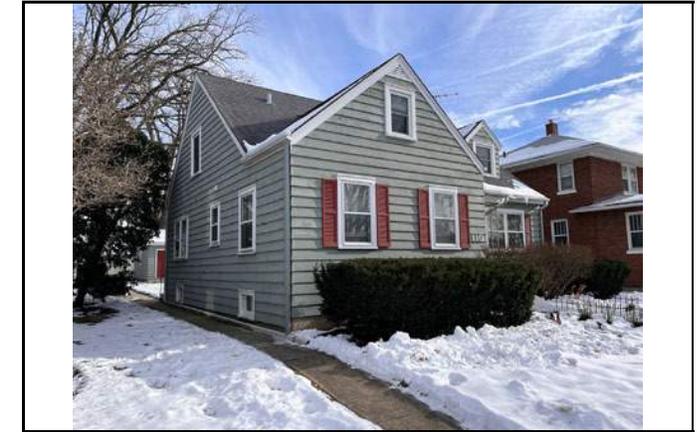
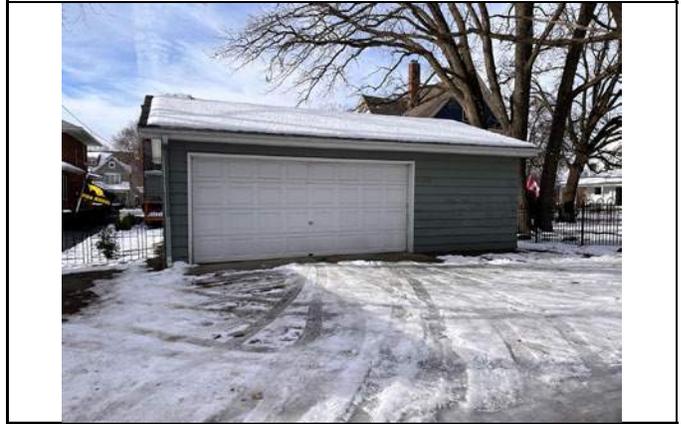
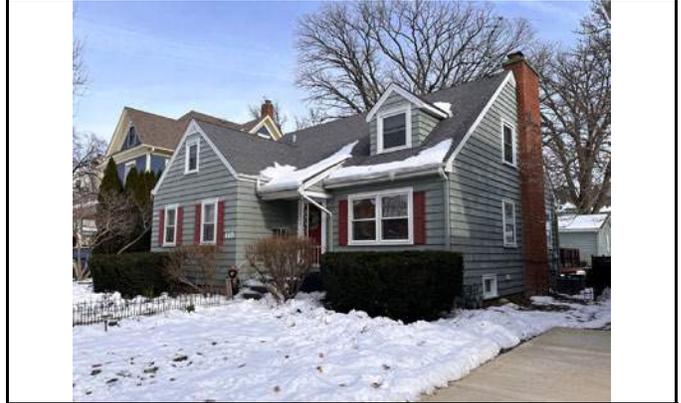
**NOTES ON WORK:** 1/1 replacement windows on attic level and in front dormer.
