ADDENDUM NO. 1 (DRAFT)
Naperville Riverwalk
Moser Tower Structural Assessment
November 2019

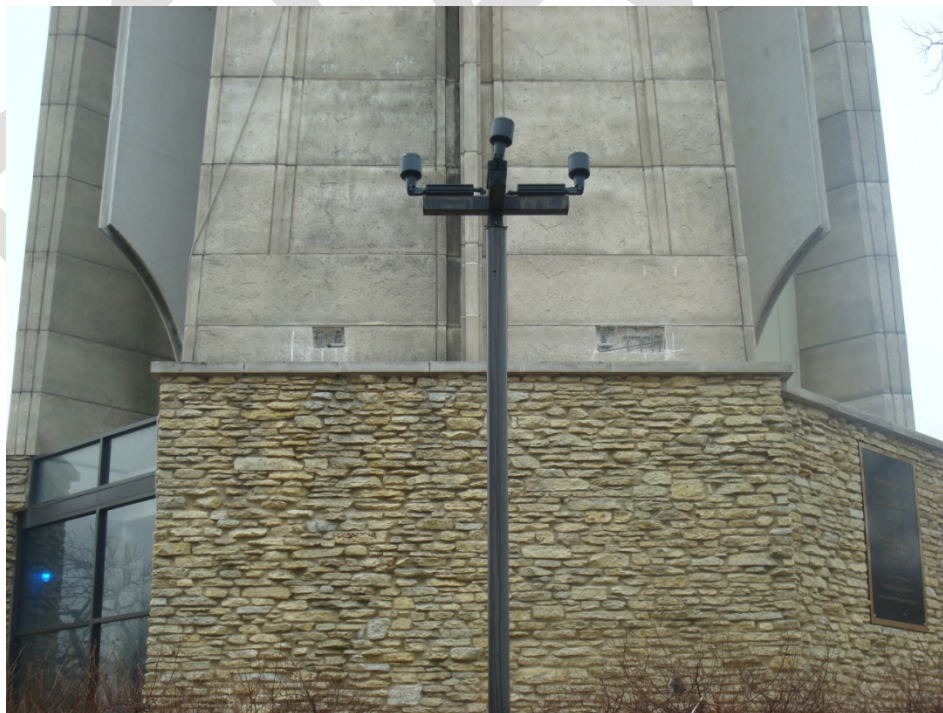
Photograph #1: Areas of exposed post-tensioned rods at NW corner.

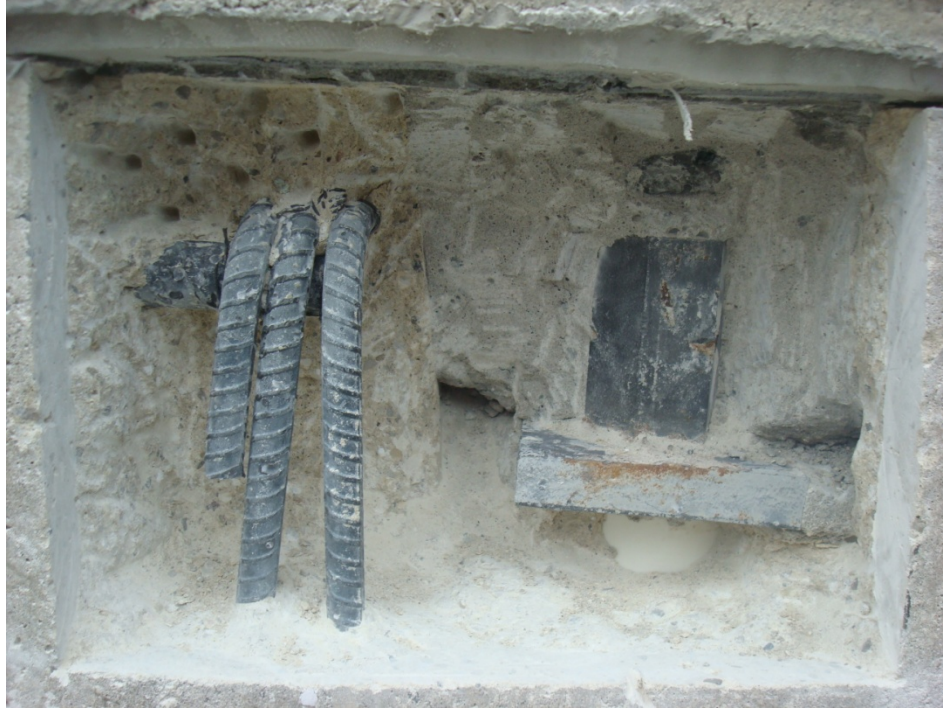
Photograph #2: Exposed end of PT rod and reinforcement bars at left opening

As can be clearly seen in Photographs #2, #3, and #4, the post-tensioned rod, reaction plate, and adjacent reinforcement bars are in good condition. There is no sign of corrosion that would cause deterioration of the rods, plates, or bars. These removals also confirmed that the rods have been encased in grouted sleeves, as called out on the precast shop drawings, providing additional protection to these rods from corrosion due to water infiltration.

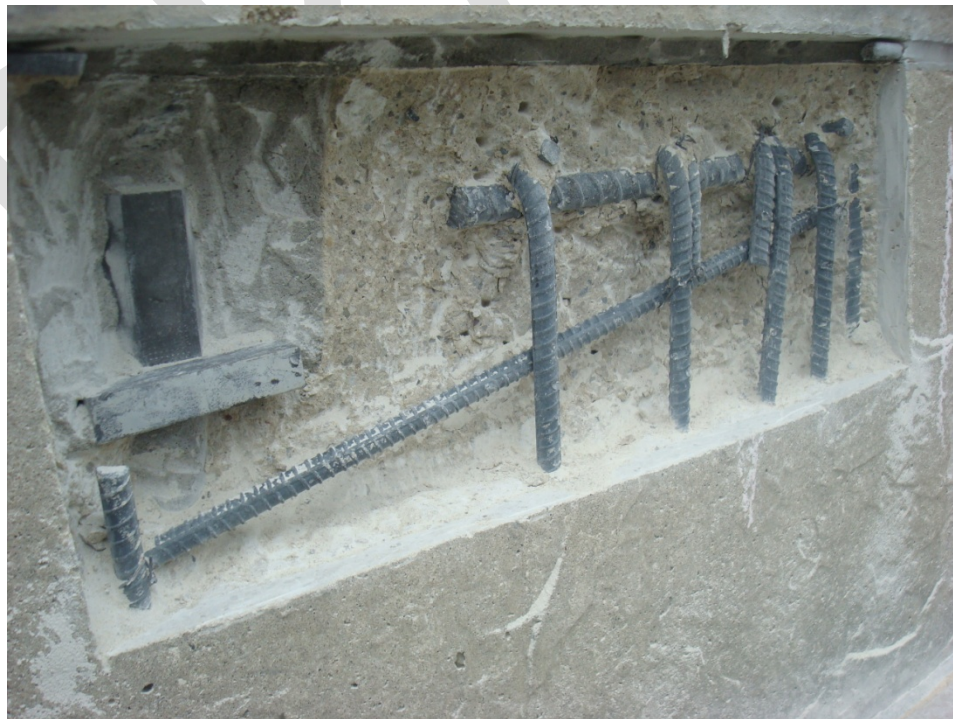
Photograph #3: Exposed end of PT rod and reinforcement bars at right opening

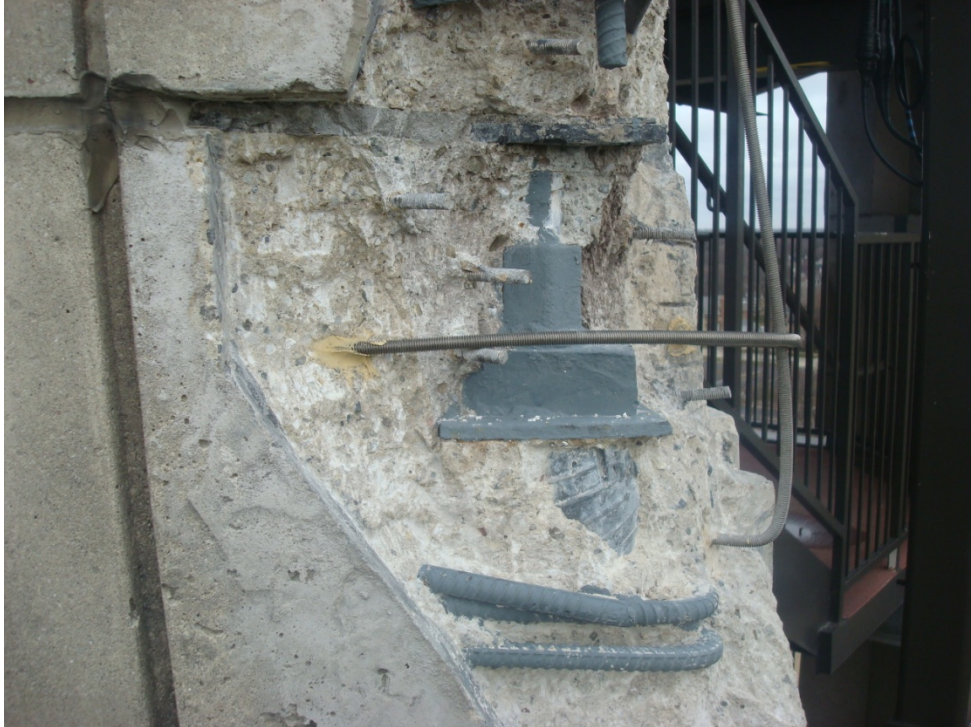
Additionally, one area of spalled and cracked concrete was identified and removed by the Contractor at an upper level of the tower exterior on the northeast elevation, exposing the condition of the exposed post-tensioned rod and reinforcement in this area.

Photograph #4: Exposed end of PT rod and reinforcement bars at right opening

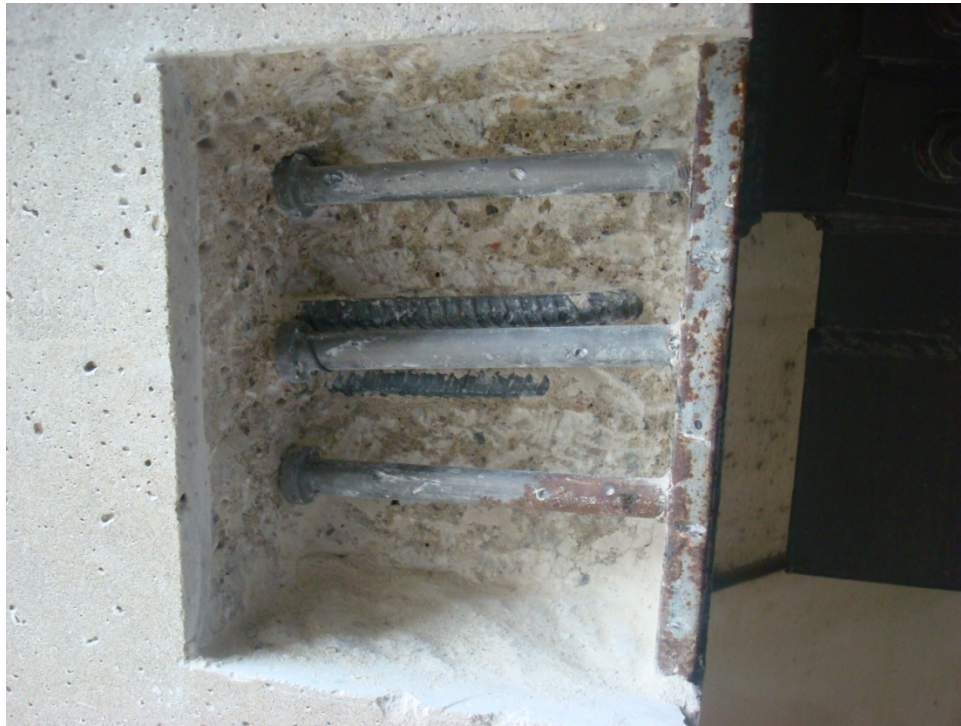
Photograph #5: Exposed connection plate and embedded studs at northeast side of Elev. 52.5.

On the right side of Photograph #5 is the steel plate where steel framing connects to the concrete pillars. The condition of the connection is critical to structural stability. The three rods depicted horizontally in Photograph #5 are automatically welded steel studs connected to the steel plate. The studs create shear and bond capacity to the concrete, transferring the vertical and horizontal loads from the steel framing into the concrete pillars. These components were substantially found in good condition.

As can be clearly seen in Photographs #5, #6, and #7, the embedded parts of these connections that are exposed are in good condition. There is evidence of minor surface corrosion on a portion of the embedded steel studs, along with the backside and edges of the plate, but no evidence of significant deterioration of these members. These removals confirm that the installation conforms to the girder support detail C4 shown on C1.1 of the Charles Vincent George drawings.

2. **Clean, Paint, and Flash Embedded Steel Connections:** The polygonal ring to concrete connections are critical to the structural stability of the tower and must be maintained in good condition. Steel corrosion must be abated by cleaning and painting areas of exposed surface corrosion, and installing flashing around these connections to prevent future corrosion from occurring on the exposed and/or embedded steel. Additional reinforcement may be included in some areas. Rust staining as a product of moisture trapped between steel surfaces or between steel and concrete surfaces will lead to corroded metal expansion, cracking of concrete in contact with steel, and eventual loss of structural connection. These conditions are most serious, require repair, and will require periodic inspection and future repairs.

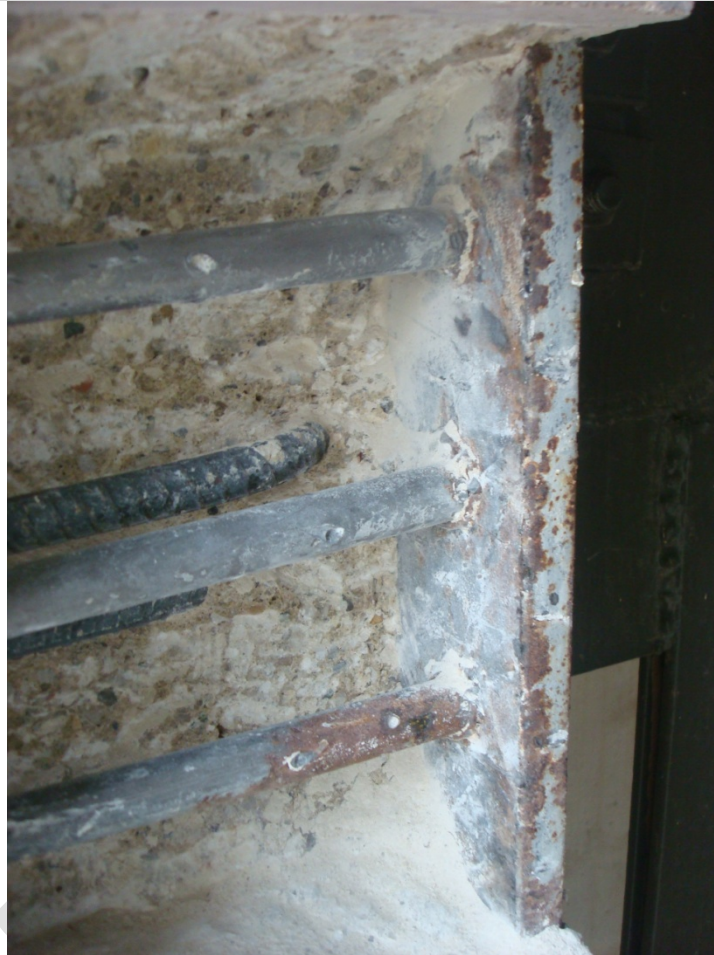
Photograph #6: Backside of connection plate and embedded studs at northeast side of Elev. 52.5.

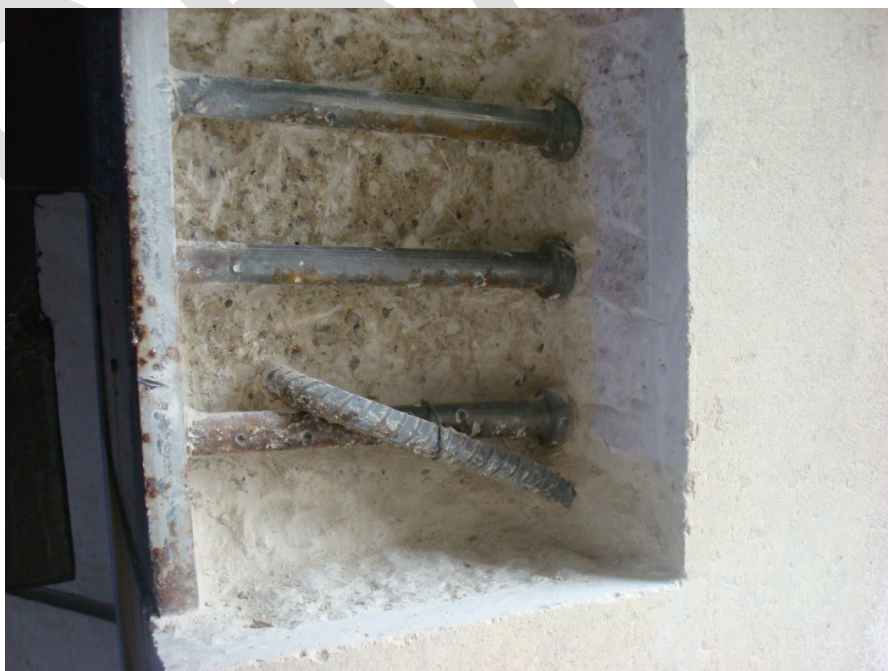
Photograph #7: Exposed connection plate and embedded studs at northwest side of Elev. 52.5.

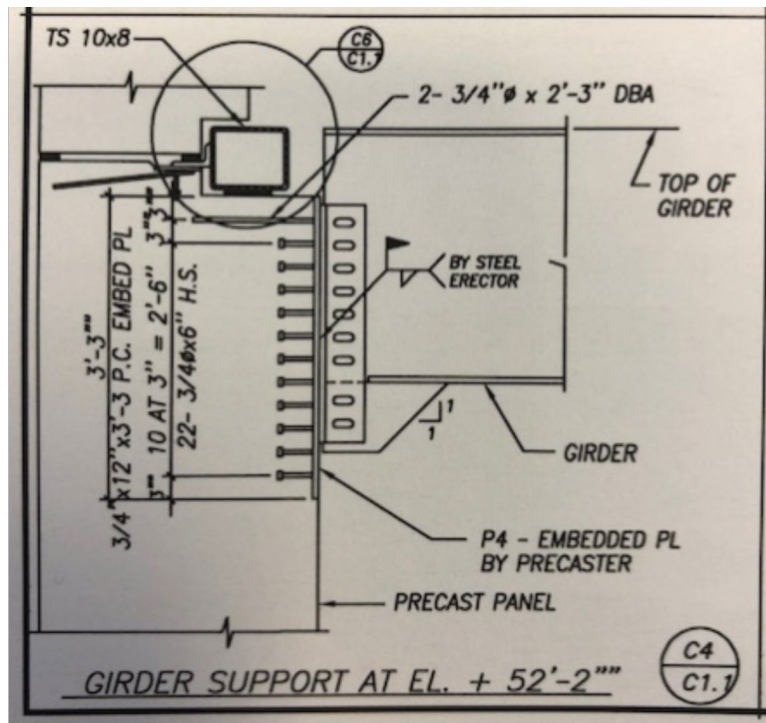
Weather intrusion through concrete cracks and spalled aggregates propagate corrosion on the backside of the connection plate, resulting in corrosion product flow down the face of the concrete. These plates are anchored to the concrete with steel studs, subject to corrosion deterioration. **The weather intrusion and corrosion propagation in these connections must be abated.**
