## Craftstone Architects, Inc.

14150 S Route 30, Suite 201  
Plainfield, Illinois 60544

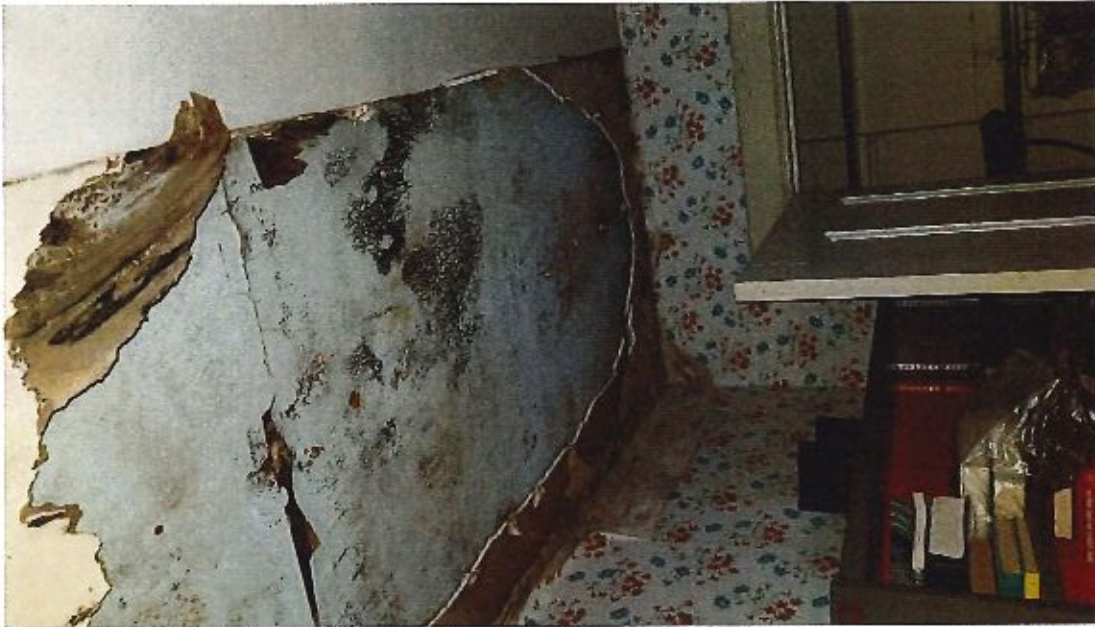
*Image 7 - 2<sup>nd</sup> floor southeast bedroom with ceiling falling in and showing signs of mold due to water damage*

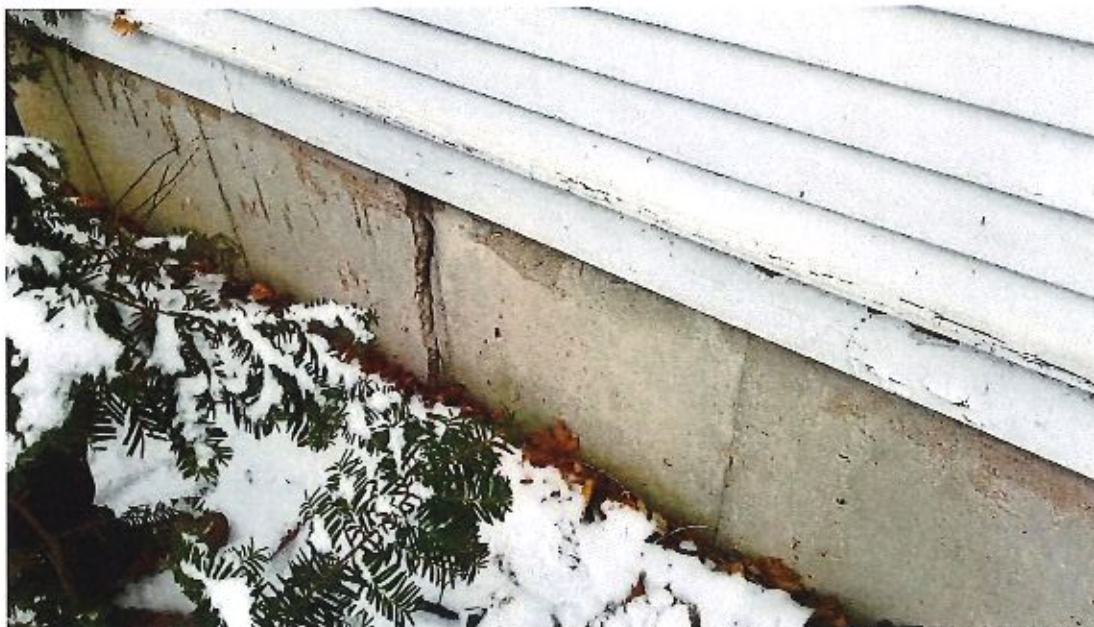
*Image 10 – Concrete foundation with significant crack with separation in foundation.*

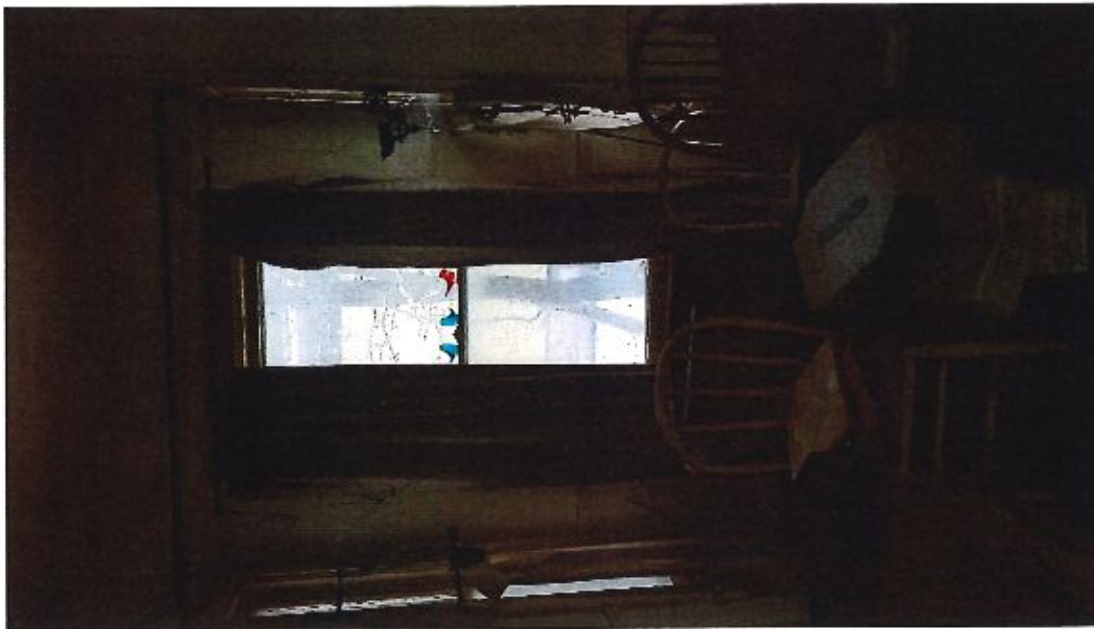
*Image 11 – Bay bump out at dining room from inside with floor, walls and ceiling dropping at outside wall.*

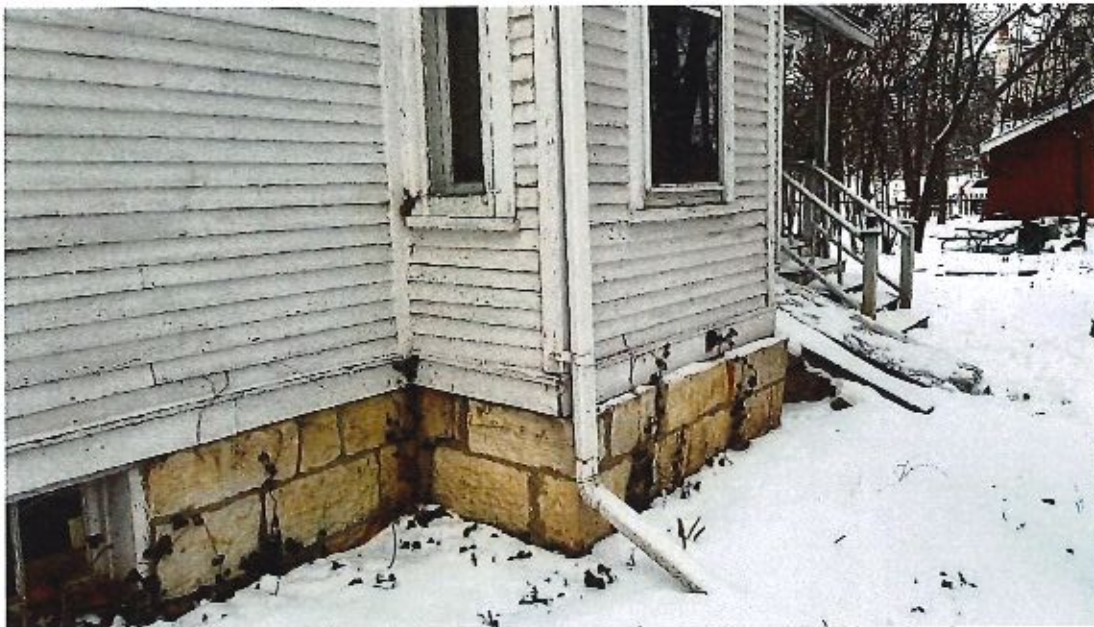
*Image 12 – Bay bump out at dining room with dropped floor, walls & ceiling. Foundation cracked and pulled away from main foundation.*

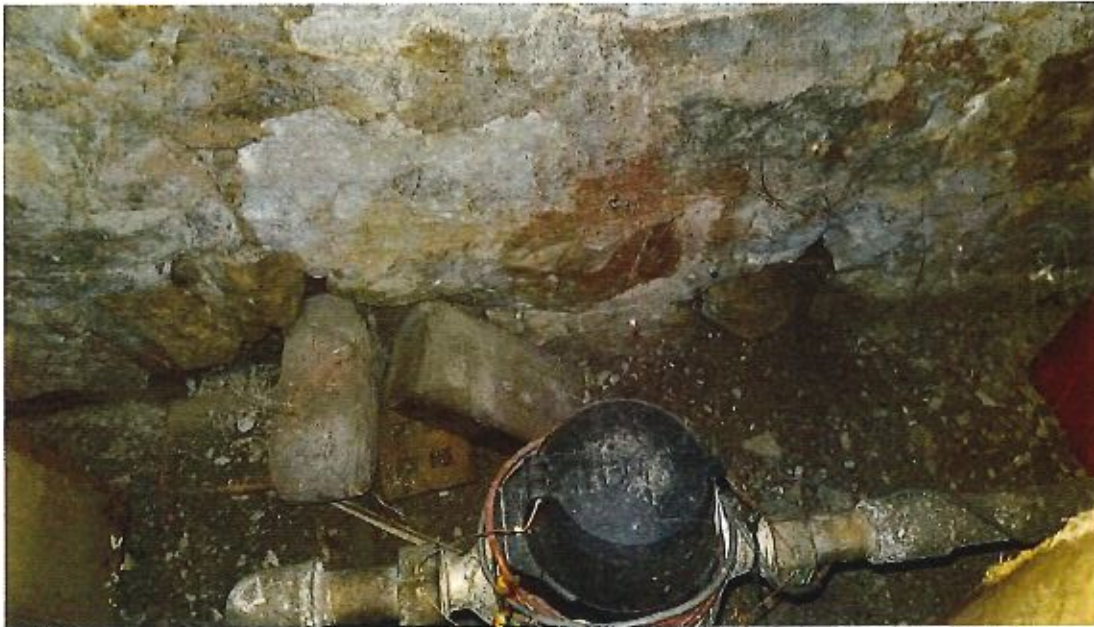
*Image 13 – water meeting with copper connections to lead water piping. Also, bottom of wall where bricks and stones located have holes where water and debris is filtering into basement.*

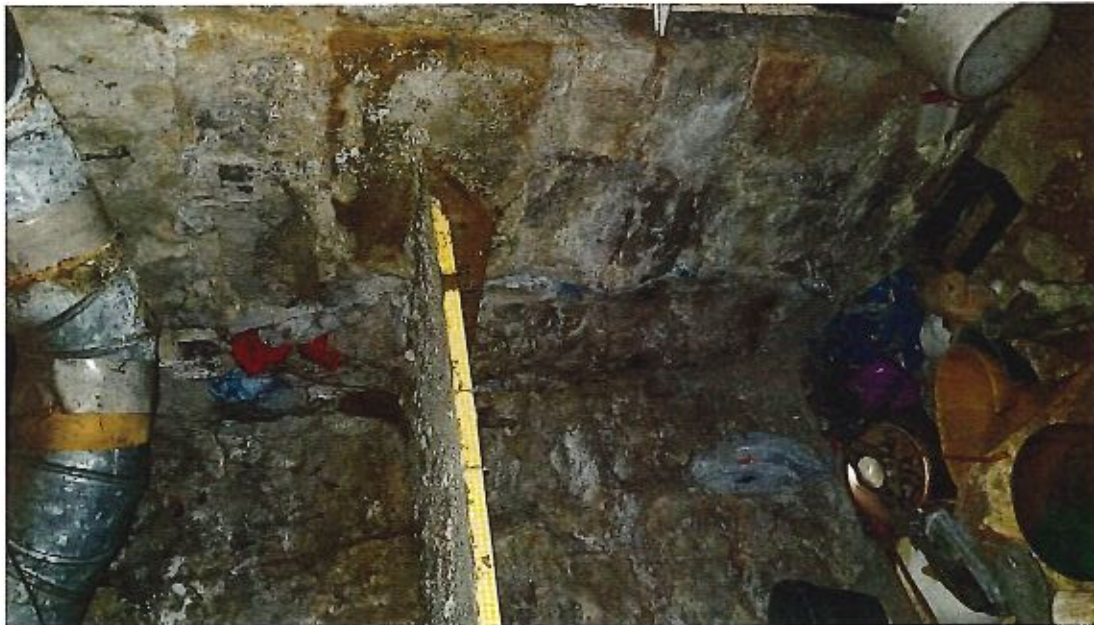
*Image 14 – Ductwork is corroding and stone foundation has signs of patching large cracks with plastic bags shoved in cracks and towards bottom one of the cracks appears to be filled with silicone caulk.*

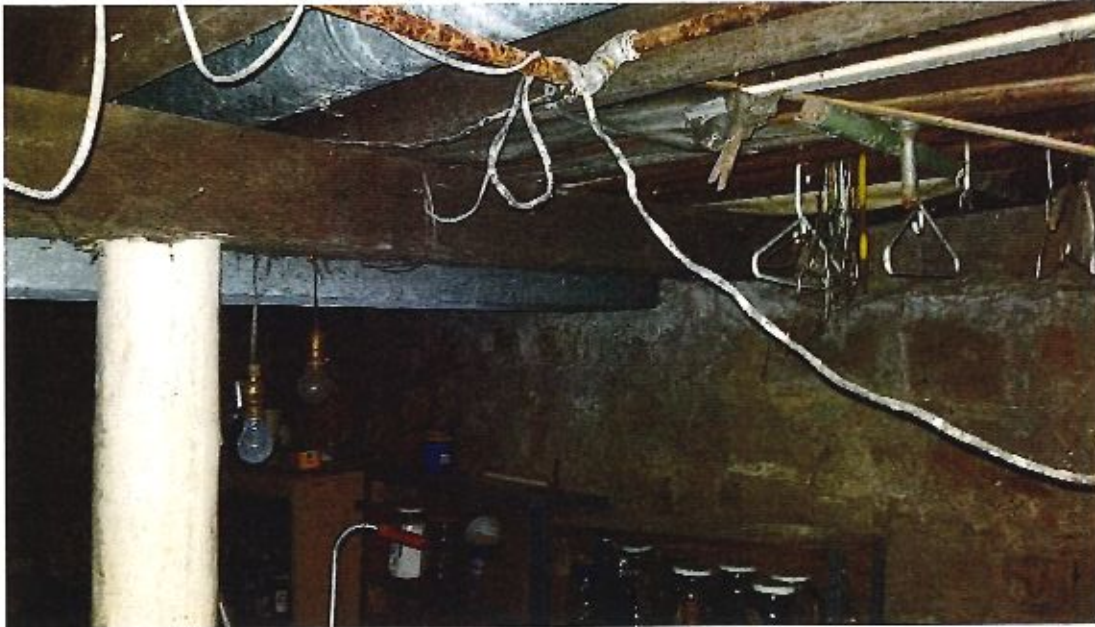
Image 15 – Undersized basement wood beam with lights hanging from ceiling with rope cord

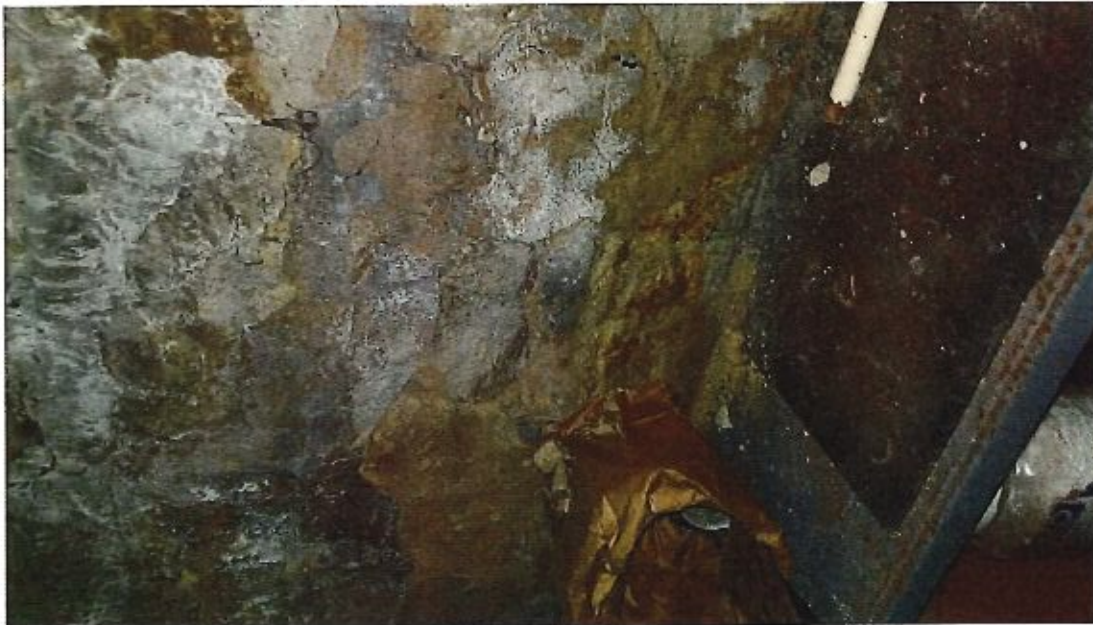
Image 16 – Stone foundation joints patched and if rubbed with finger, is rubs off as can be seen with sand sitting on wood ledge.

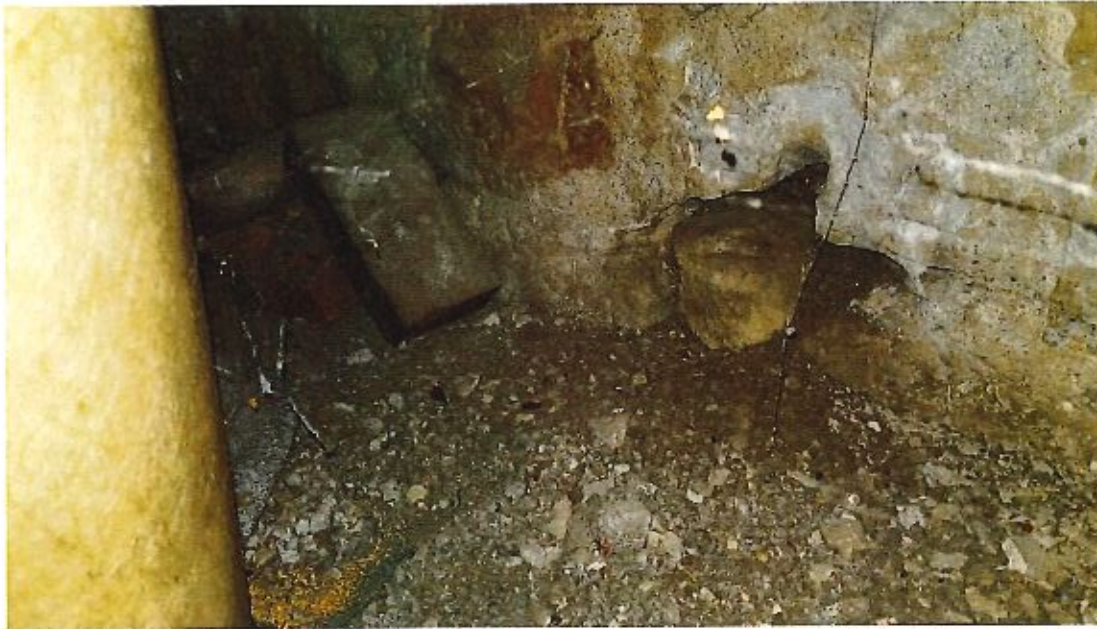
*Image 17 – Stone foundation wall plugged with stone and brick with signs of water and sediment entering basement from outside.*

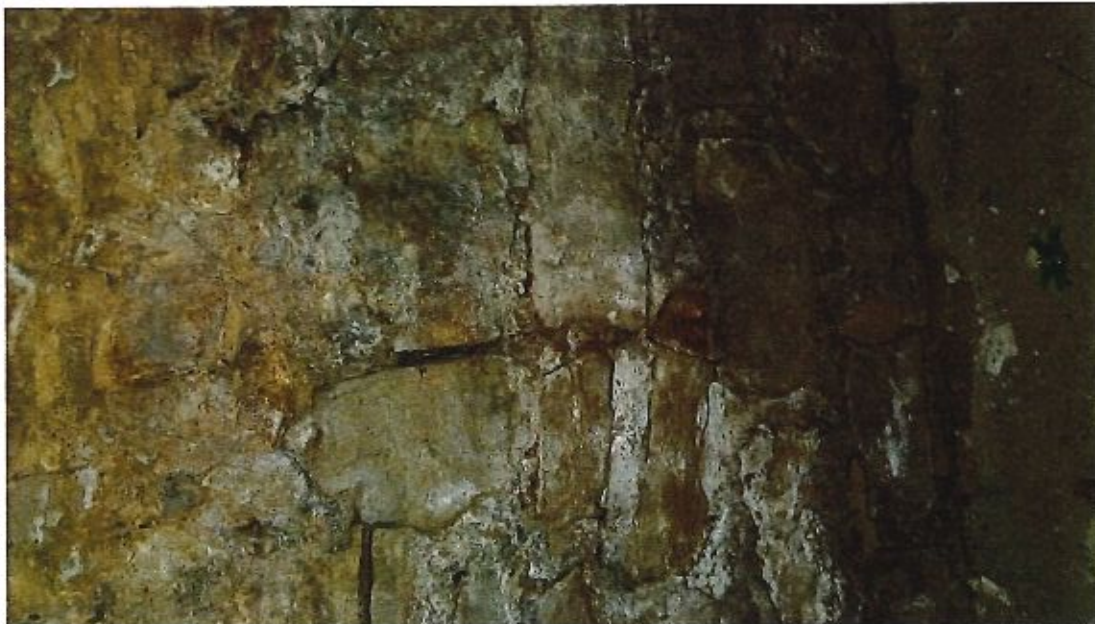
*Image 18 – Stone foundation cracks with signs of seepage.*

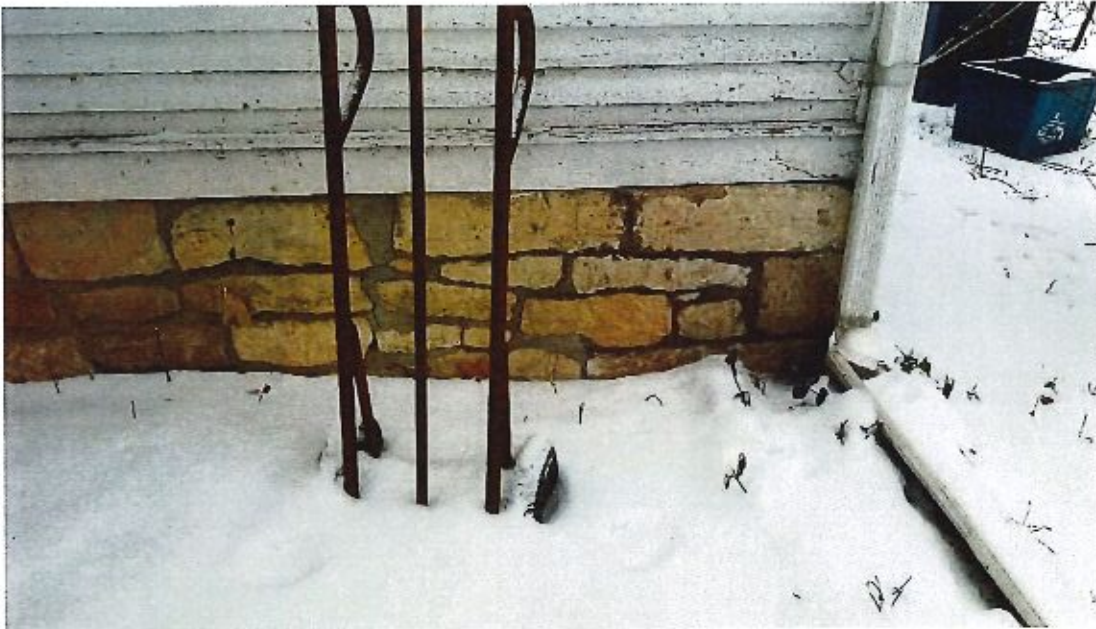
Image 19 – Stone foundation with signs of patching

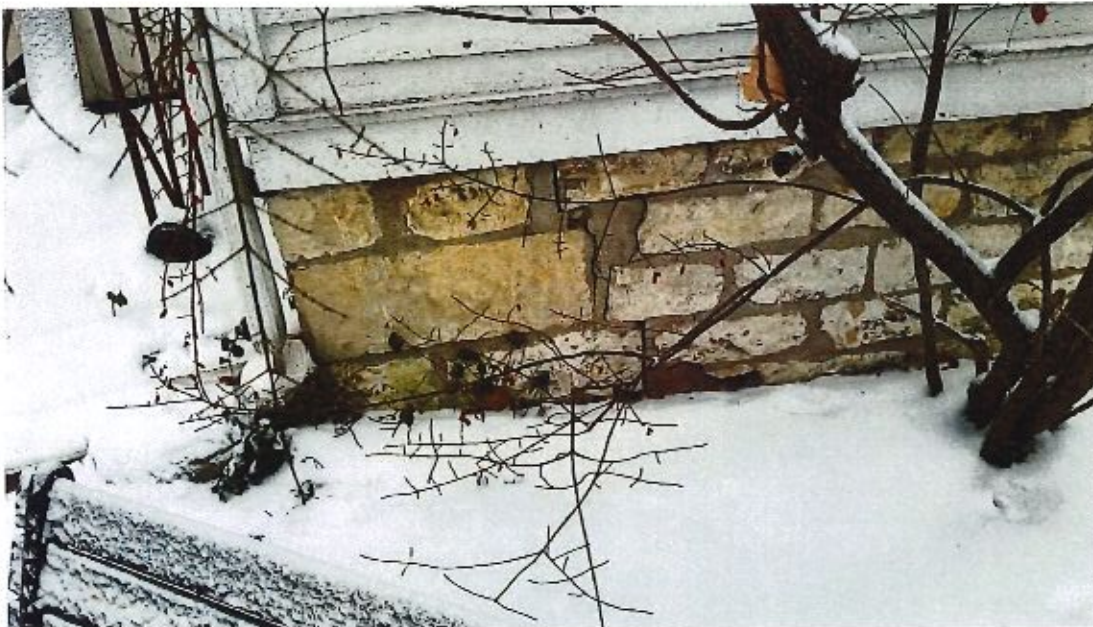
Image 20 – Stone foundation with signs of patching

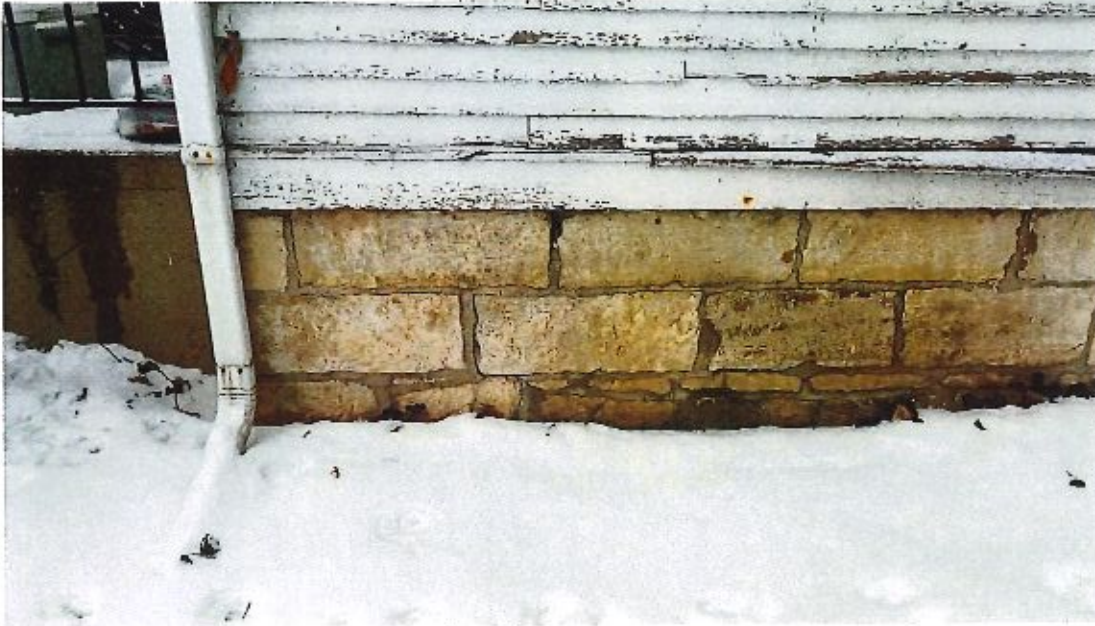
*Image 21 - Stone foundation with signs of patching*

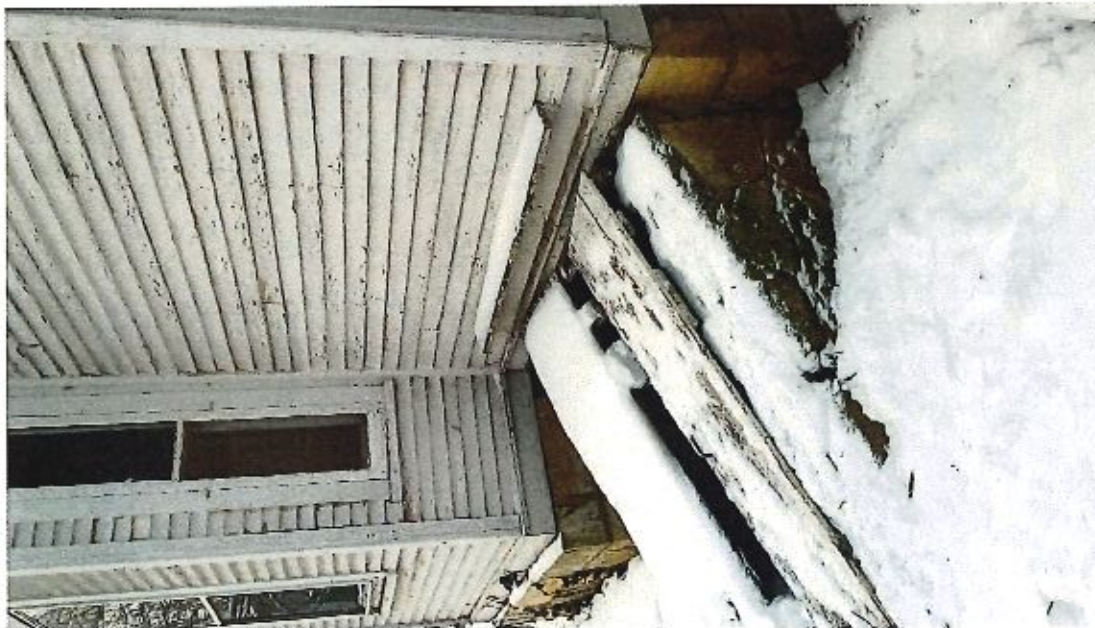
*Image 22 - Stone foundation at exterior basement access pulling away and failing.*

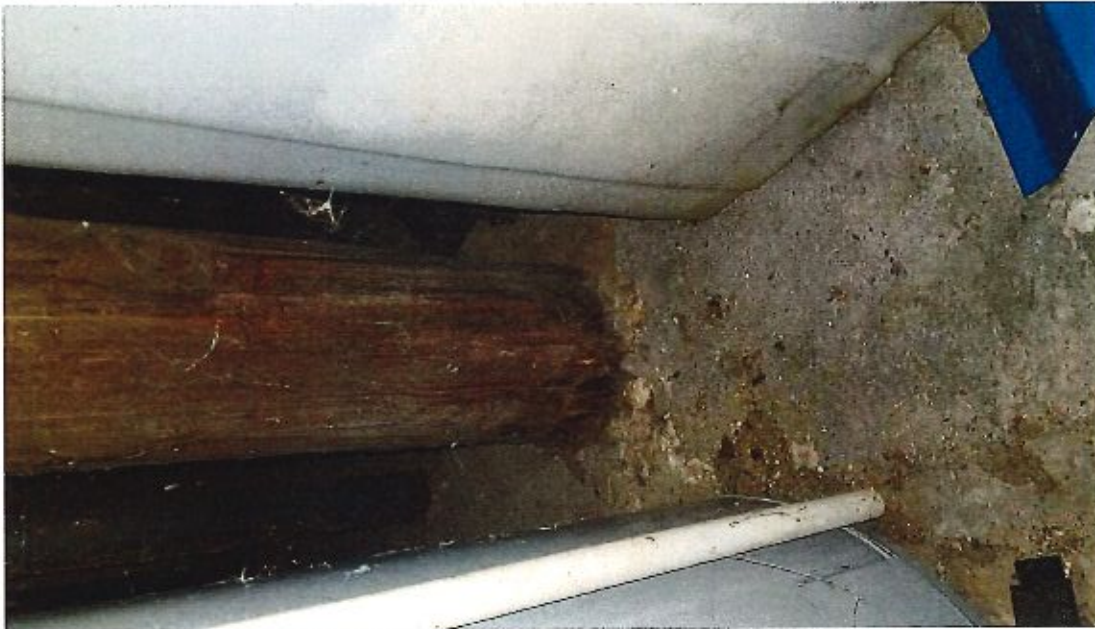
Image 23 – Rotting wood post in basement supporting middle beam

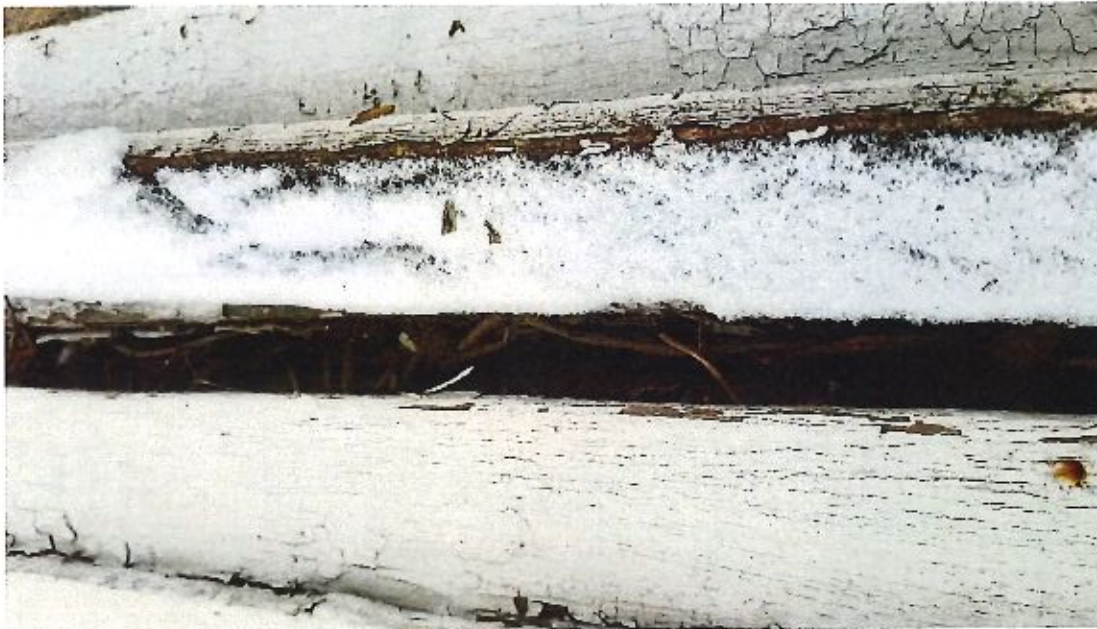
*Image 25 – Plant material found under siding and in wall on south side exterior wall*

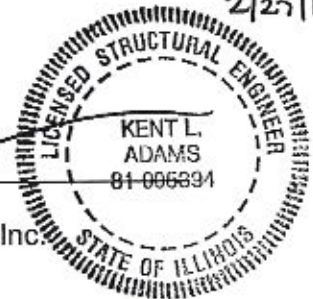
License Exp. 11/30/20

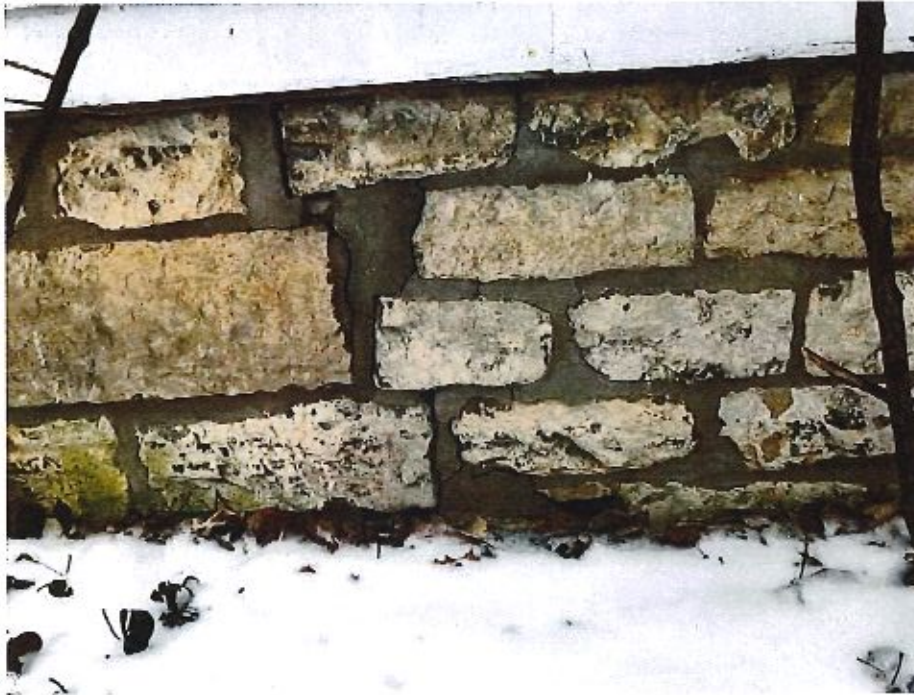
Image 2 – Separation of concrete for the addition and original stone foundation

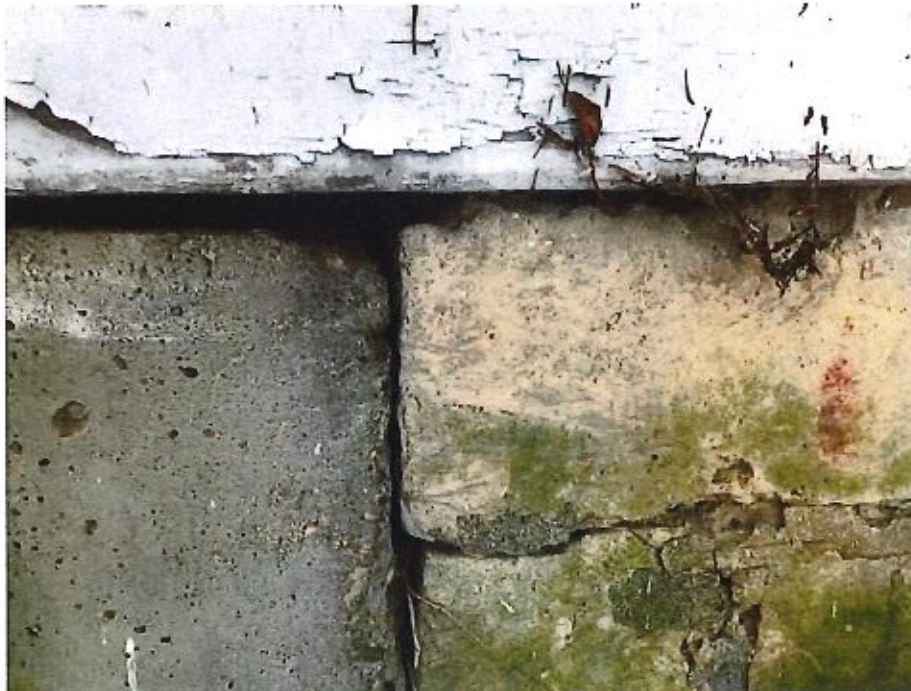
Image 3 – Separation of foundation and wood floor structure

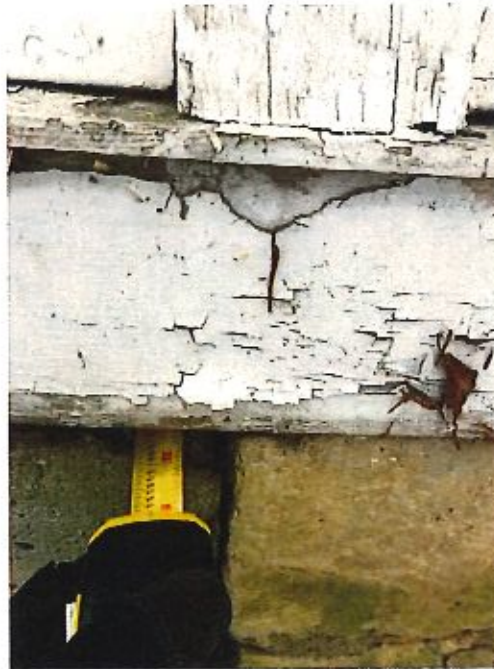
Image 4 – Crack in north foundation wall

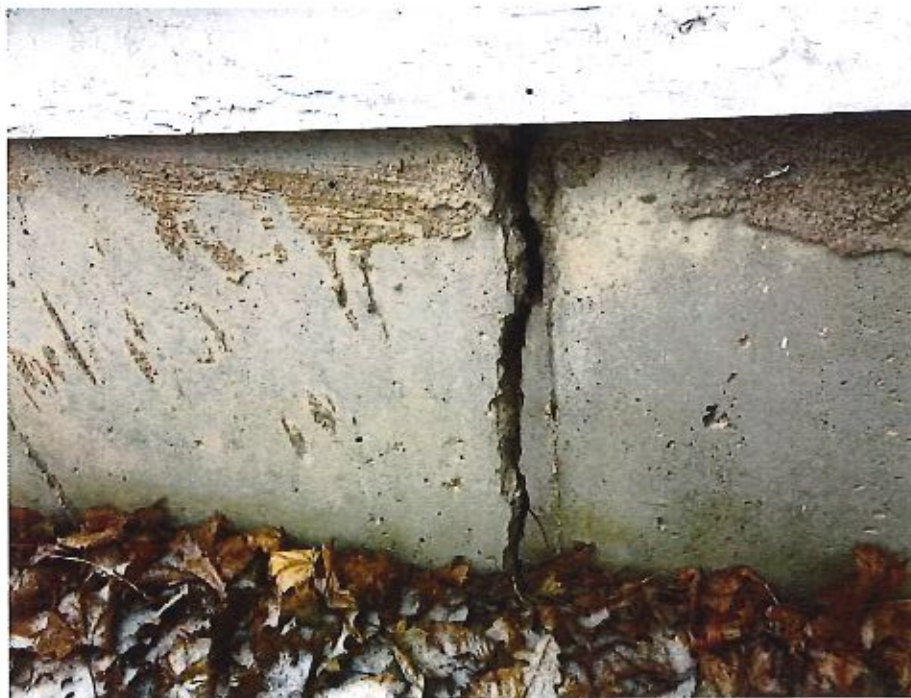
Image 5 – Basement column

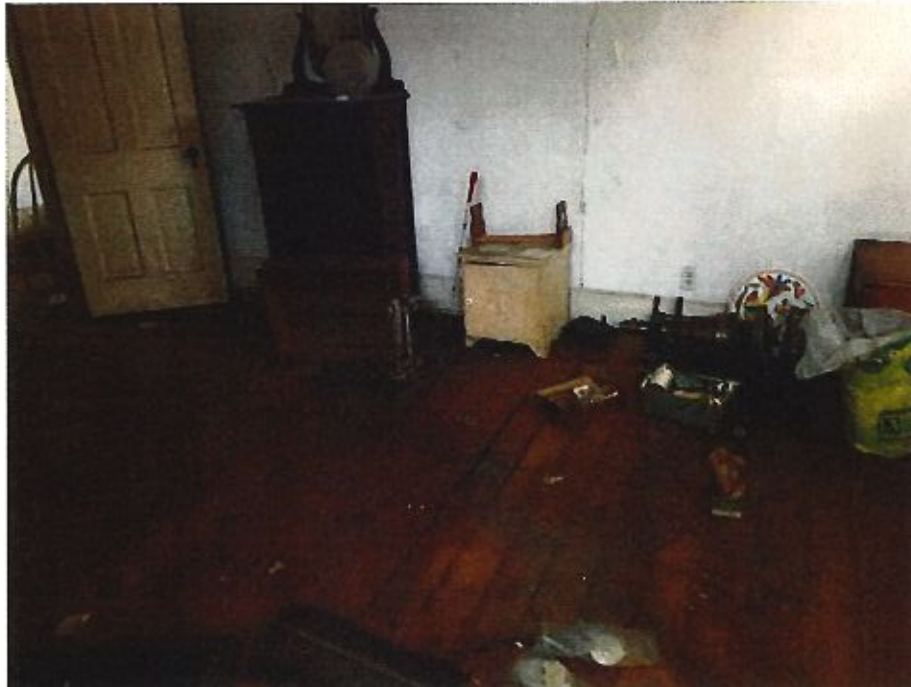
Image 9 – Leaning foundation and exterior wall

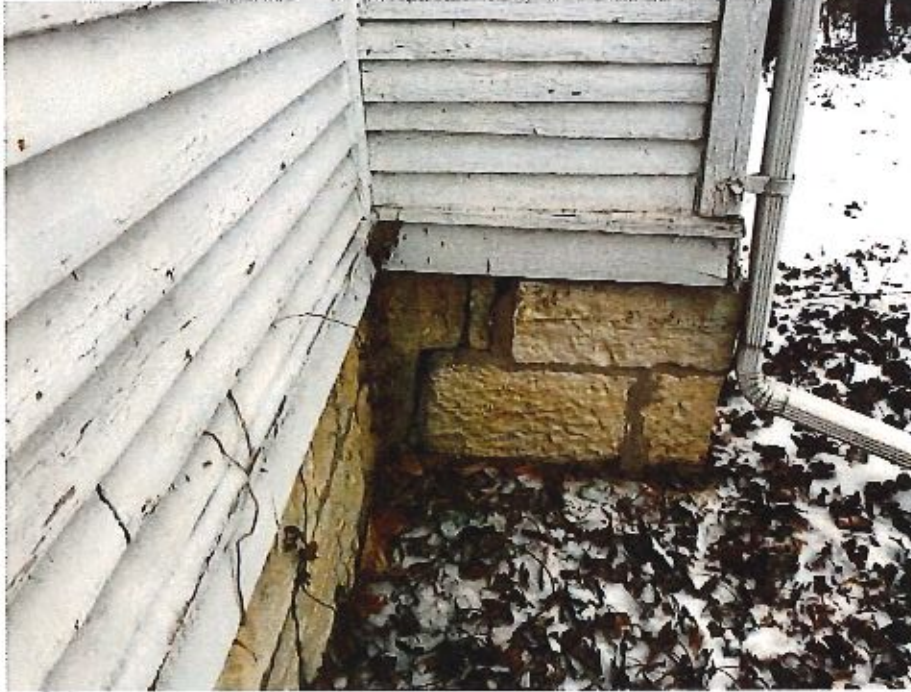
Image 10 – Leaning wall at stair

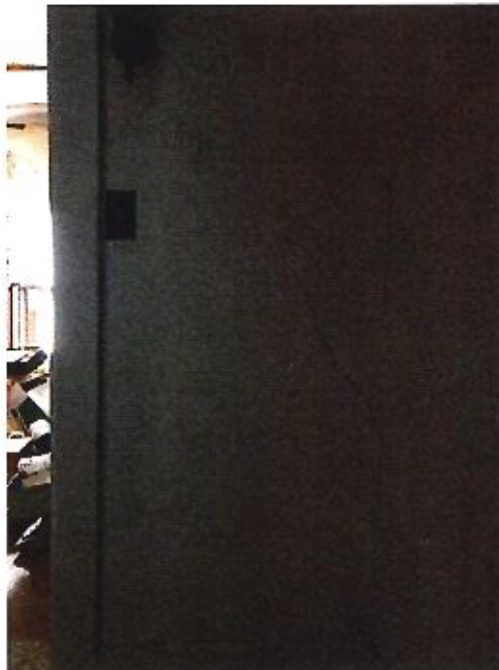
Image 11 – Water damage on second floor ceiling
