Craftstone Architects, Inc.

14150 S Route 30, Suite 201
Plainfield, Illinois 60544

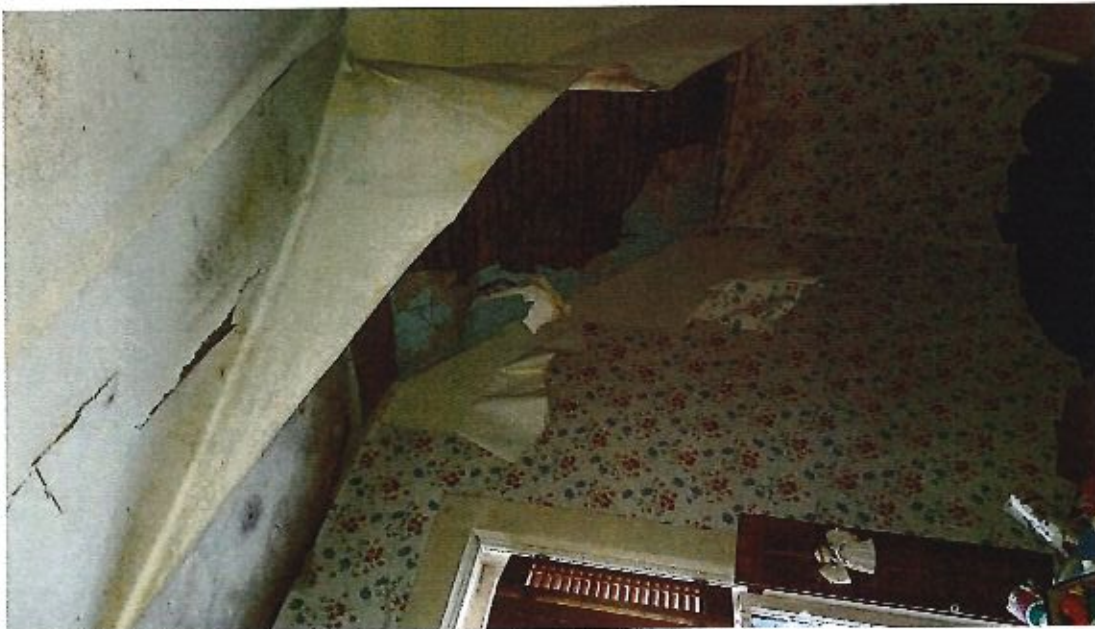
Image 6 – 2nd floor southeast bedroom with ceiling falling in and showing signs of mold due to water damage

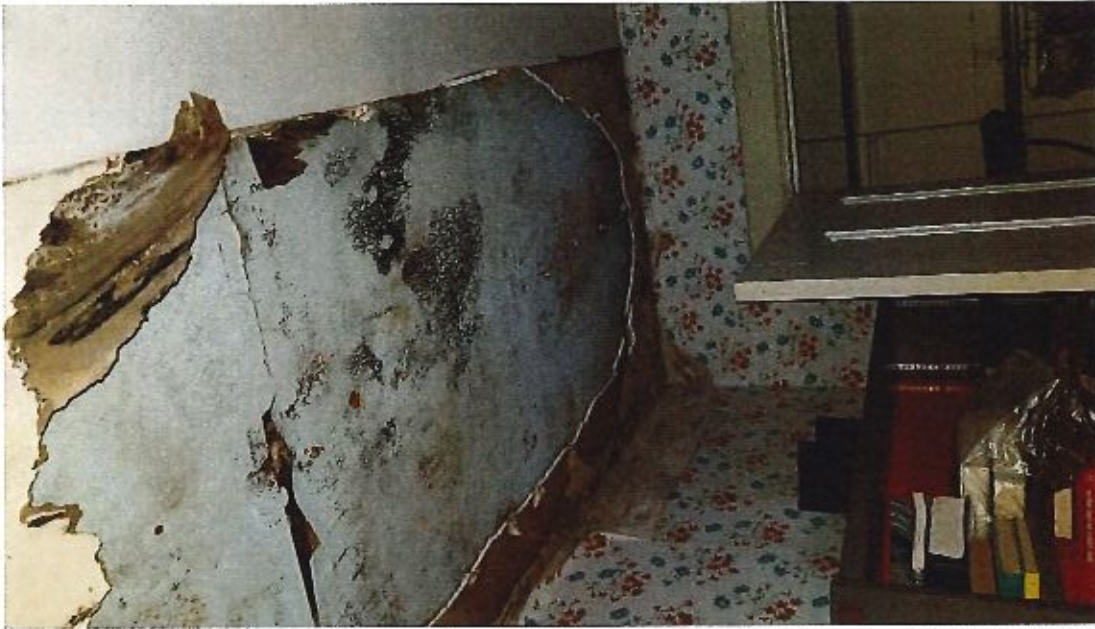
Image 7 - 2nd floor southeast bedroom with ceiling falling in and showing signs of mold due to water damage

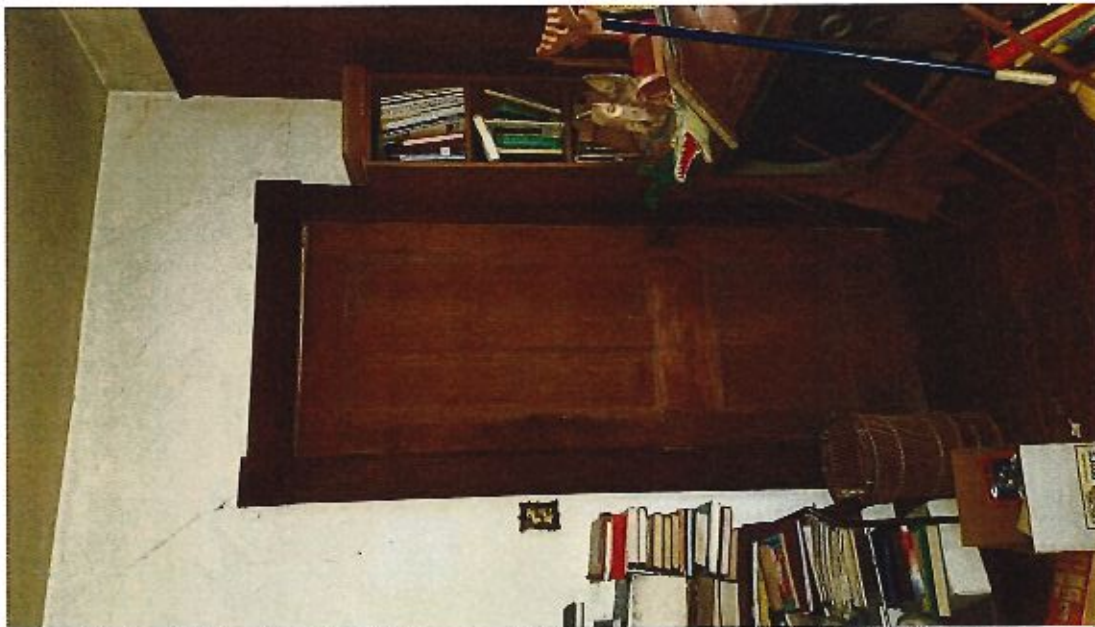
Image 8 - Door to foyer from front living room that is no longer square in jamb and stuck closed

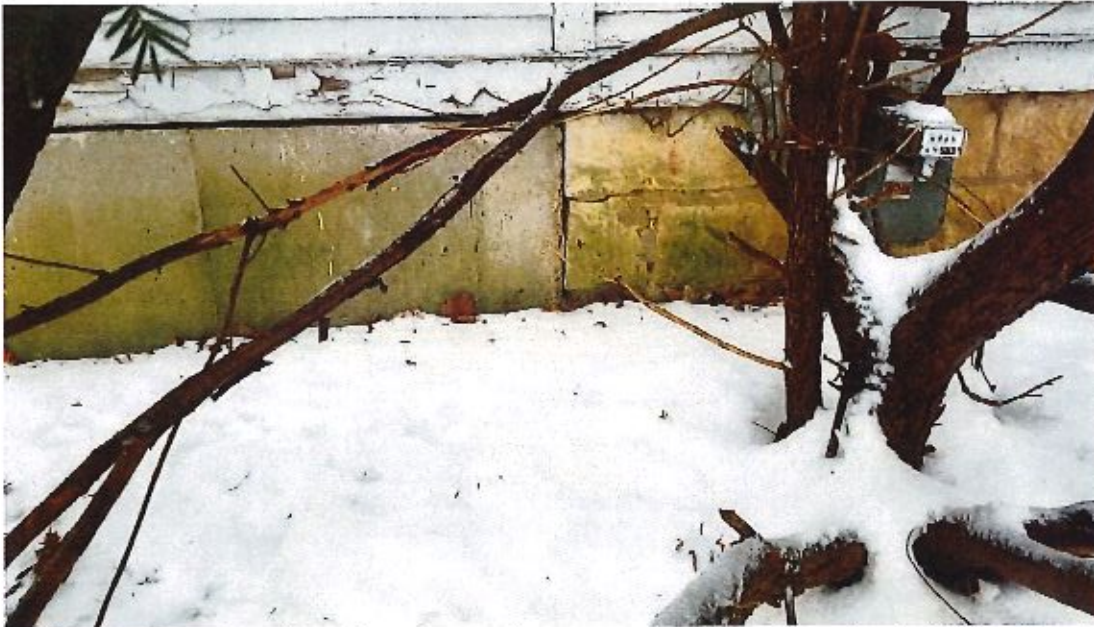
Image 9 – Concrete foundation dropped or settling at stone foundation. Stone foundation has signs of cracking also.

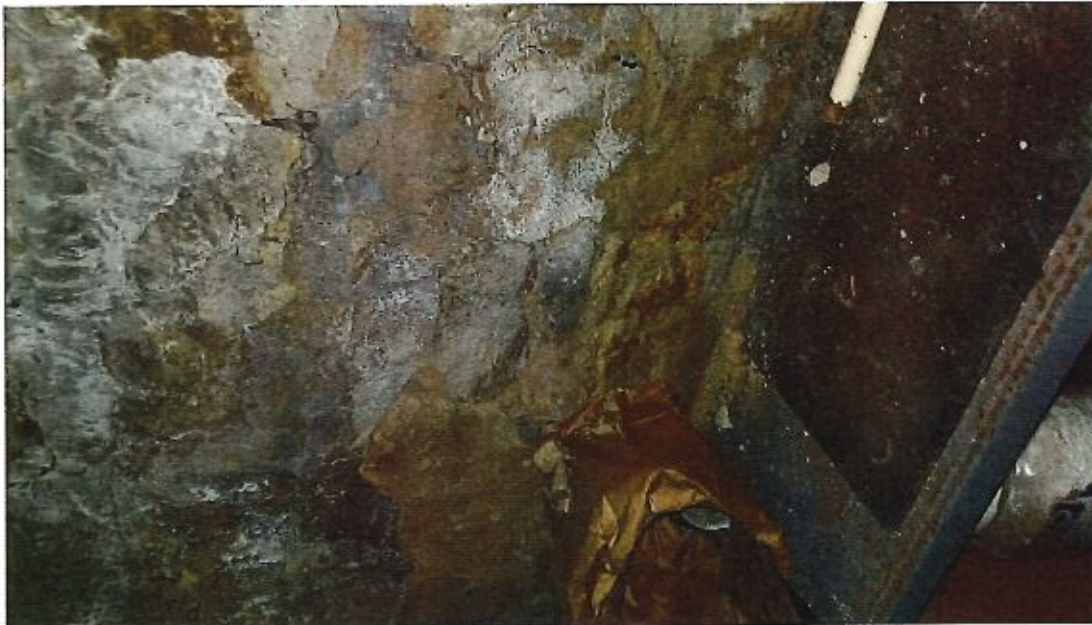
Image 16 – Stone foundation joints patched and if rubbed with finger, is rubs off as can be seen with sand sitting on wood ledge.

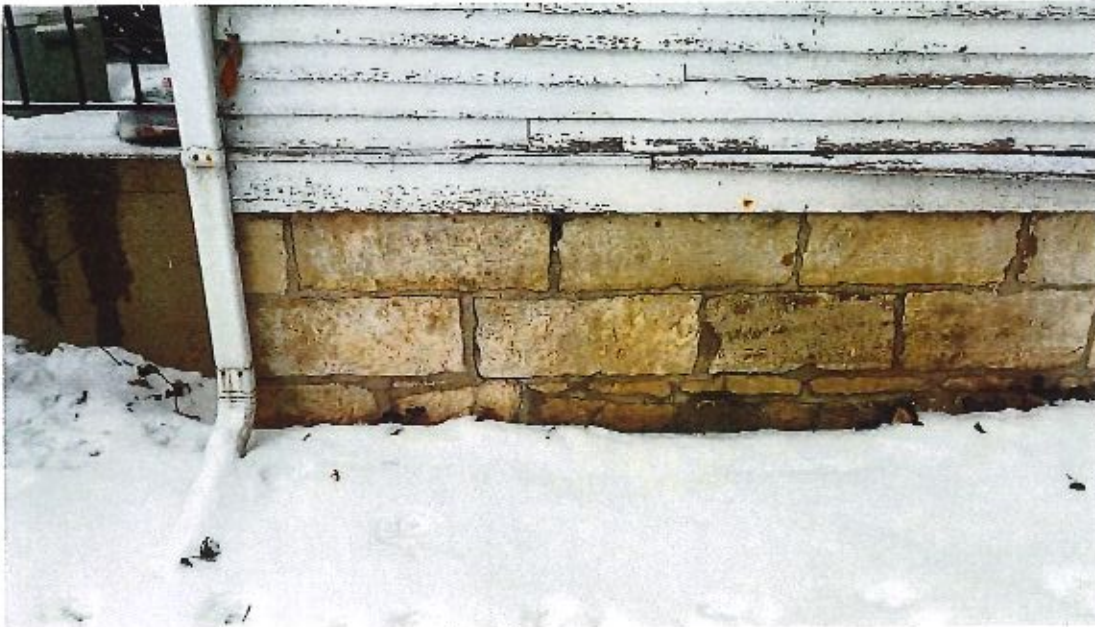
Image 21 - Stone foundation with signs of patching

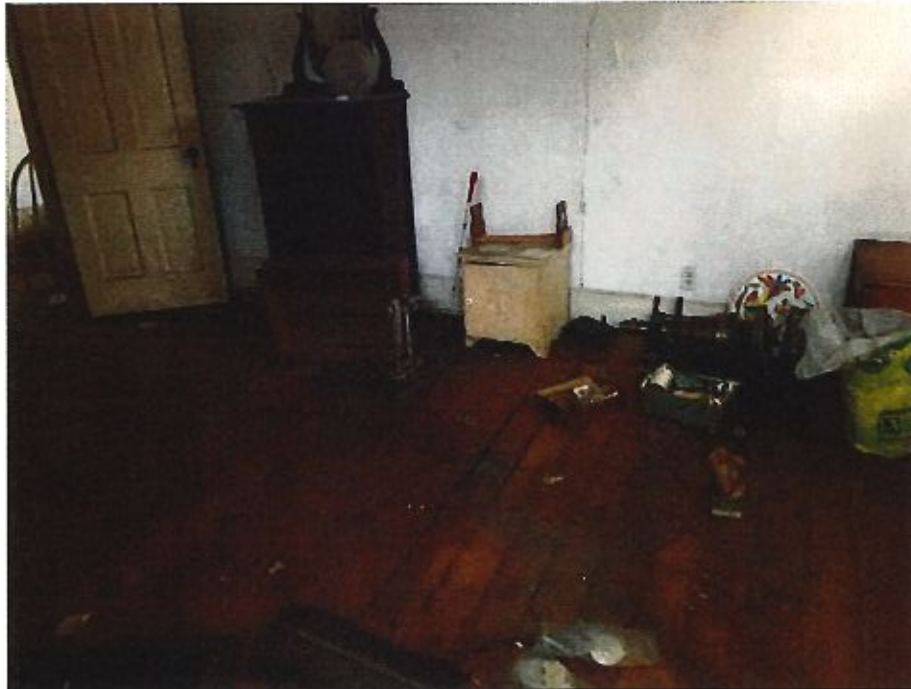
Image 9 – Leaning foundation and exterior wall

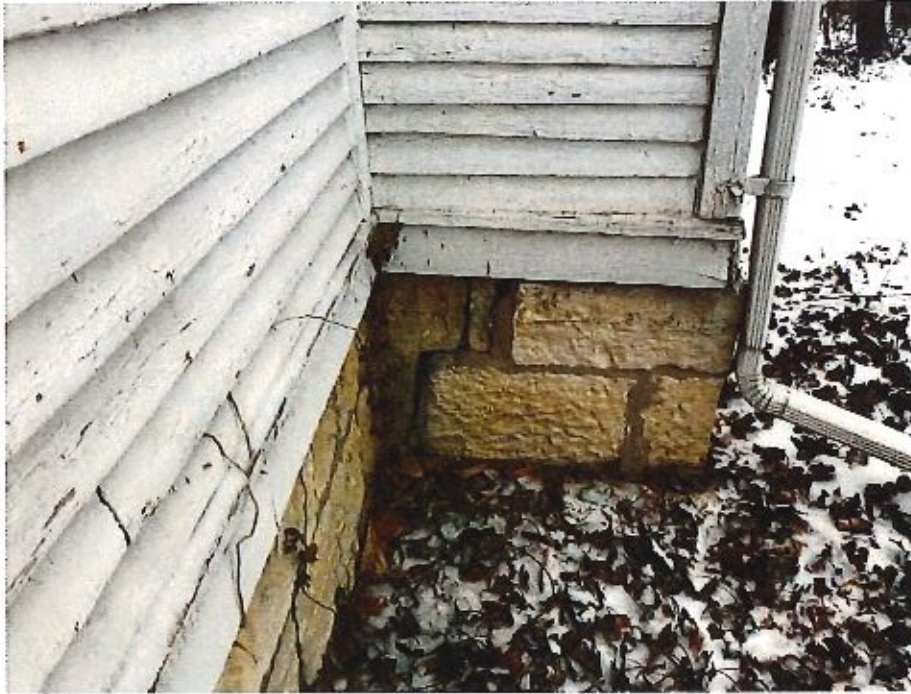
Image 10 – Leaning wall at stair
