HISTORIC NAME First Congregational Church of Naperville (1906 Building)

SURVEYAREA NAPERVILLE SURVEY UPDATE

City of NAPERVILLE
2025 HISTORIC RESOURCES SURVEY UPDATE
CONTINUATION SHEET

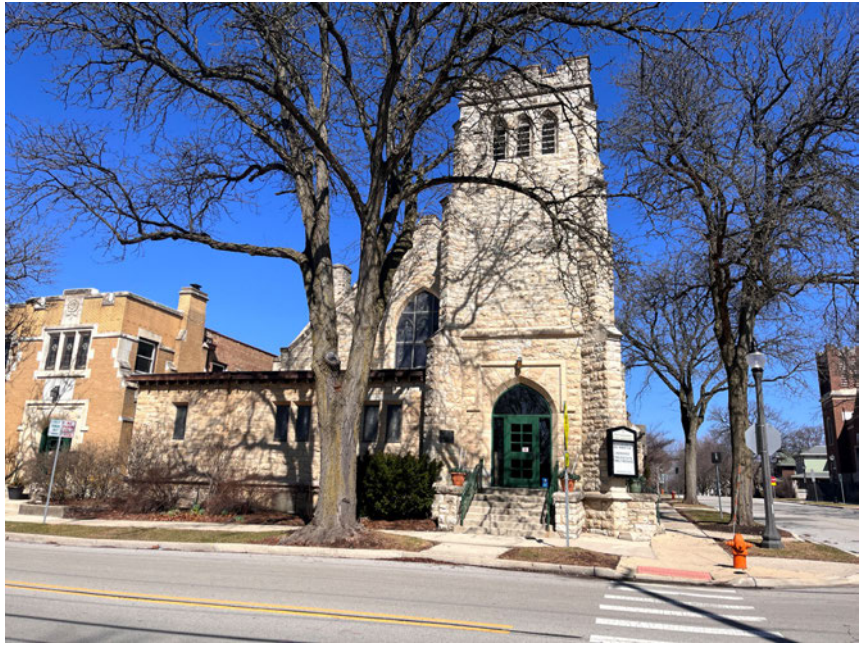
SIGNIFICANT FEATURES 1906 Building -- rough-face stone exterior; parapeted front gable main roof; prominent southeast corner entrance/bell tower with buttressed corners, pointed-arch louvered openings at belfry, and crenelated parapet; pointed-arch entrance openings on south and east walls of tower framed with limestone label molds; one-story wing extending from west wall of bell tower; projecting bay on east elevation with parapeted gable and buttressed corners; gable-roof entrance porch to original Sunday school wing at north end of east elevation

ALTERATIONS Alterations to 1906 building -- replacement entrance doors at bell tower; handrails at entrance steps; slate roof replaced with asphalt shingle; western entrance removed to accommodate 1930 parish hall addition. Two-story Late Gothic Revival west parish hall addition (1930, not included in landmark ordinance); one-story Neo-Gothic Revival west addition (1979, not included in landmark ordinance)

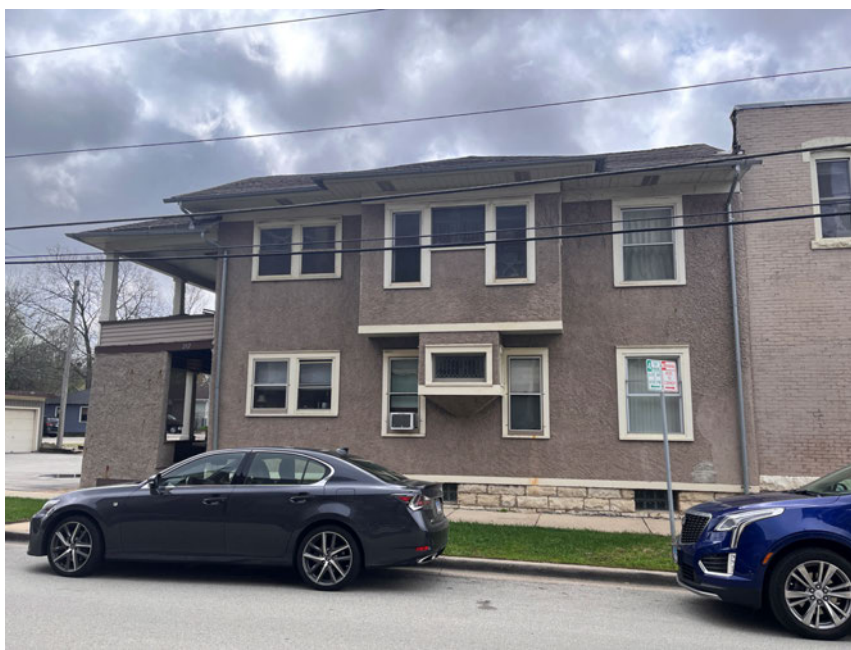
SIGNIFICANT FEATURES Sanborn maps indicate that the building was either remodeled from or built on the foundation of an early addition to building at 4-6 S. Ellsworth. The original building was a one-story frame structure (c. 1895); the second story was built between 1898 and 1909. The exterior was clad in stucco between 1909 and 1921, and the second-story projecting window bay was likely added at that time. Significant historic features include the hipped roof with overhanging eaves and second-story square projecting window bay on north elevation

ALTERATIONS 1/1 replacement windows in original openings (wood and vinyl); glass block replacement windows in basement; east 2-story porch addition (c. 1950). Post-2007 - no changes.

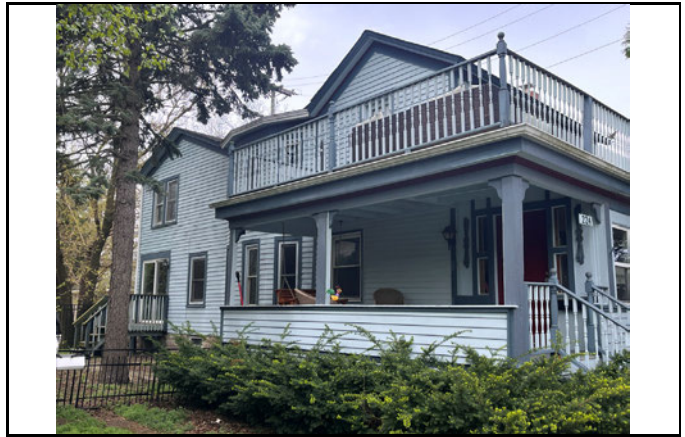
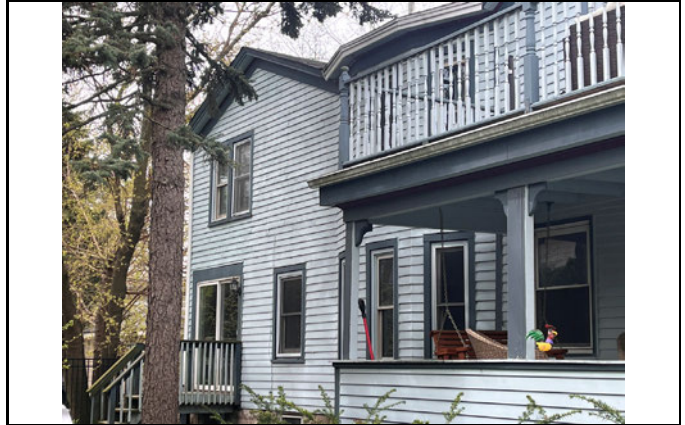
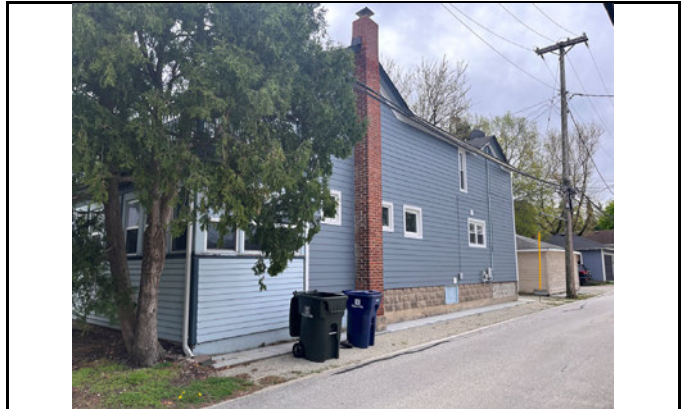
HISTORIC NAME	
COMMON NAME	
ARCHITECT	
BUILDER	
ARCHITECT SOURCE	
HISTORIC INFO	
PERMITS	
LANDSCAPE	Midblock on south side of residential street; front sidewalk; west alley; similar setbacks; mature trees
COA DATES	
COA DECISION	
COA Compliance Notes	
COA Work Not Completed	
Work Not Requiring COA	Replacement siding and windows along alley elevation

Historic 5-light wood storms in enclosed section of porch replaced with 1/1 aluminum or vinyl windows.

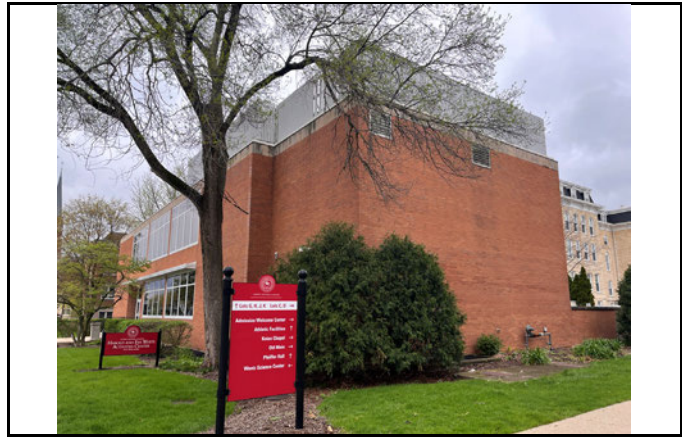
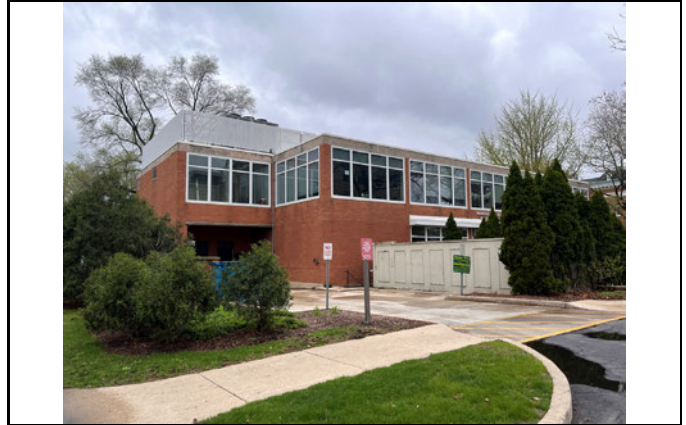
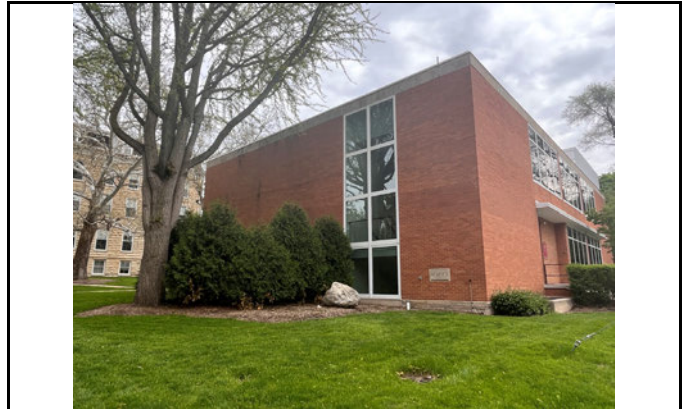
HISTORIC NAME	
COMMON NAME	White, Harold and Eva Activities Center
ARCHITECT	
BUILDER	
ARCHITECT SOURCE	
HISTORIC INFO	
PERMITS	
LANDSCAPE	Northwest corner of Loomis and Benton; front and east sidewalks; rear parking lot; similar setbacks; mature trees
COA DATES	3/26/2019
COA DECISION	COA #19-731 - In-kind window replacement (approved 4/1/2019). City records show that the application was withdrawn due to inactivity, but windows have been replaced.
COA Compliance Notes	Configuration of replacement windows required for COA not indicated in COA approval or file. Configuration of replacement windows installed varies from original multi-light windows.
COA Work Not Completed	
Work Not Requiring COA

New doors and transom in downsized opening at south entrance

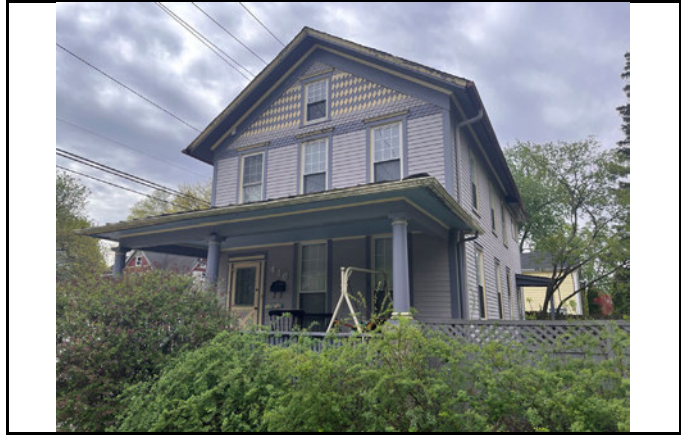
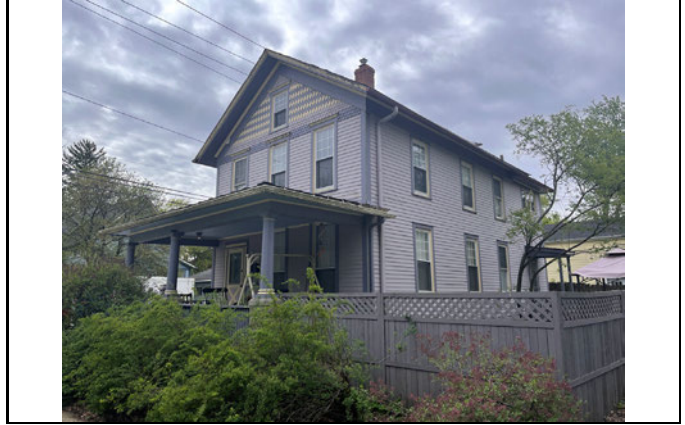
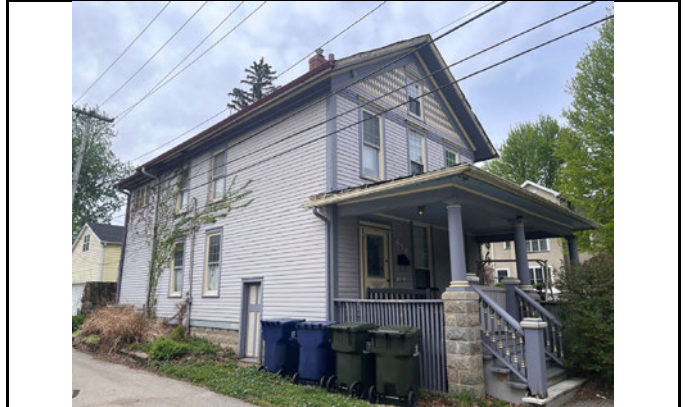
HISTORIC NAME	
COMMON NAME	
ARCHITECT	
BUILDER	
ARCHITECT SOURCE	
HISTORIC INFO	
PERMITS	House first appears on 1921 Sanborn Map (not shown on 1909 map).
LANDSCAPE	Midblock on south side of residential street; front sidewalk; east alley; west side driveway; similar setbacks; mature trees; rear/west fence
COA DATES	
COA DECISION	
COA Compliance Notes	
COA Work Not Completed	
Work Not Requiring COA	Replacement windows on on secondary (alley and west) elevations.

9/1 Aluminum/vinyl replacement windows on front façade.

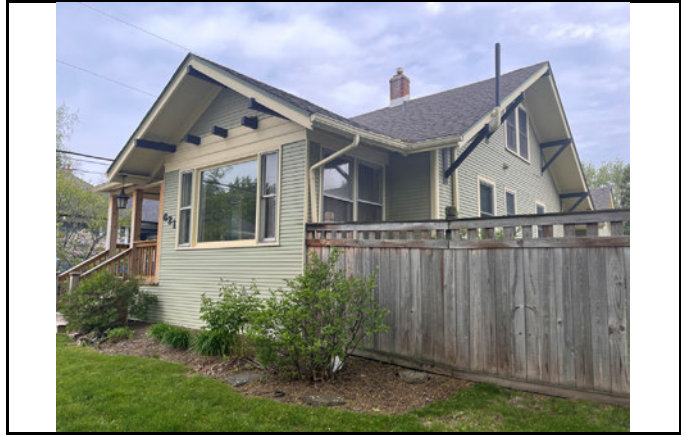
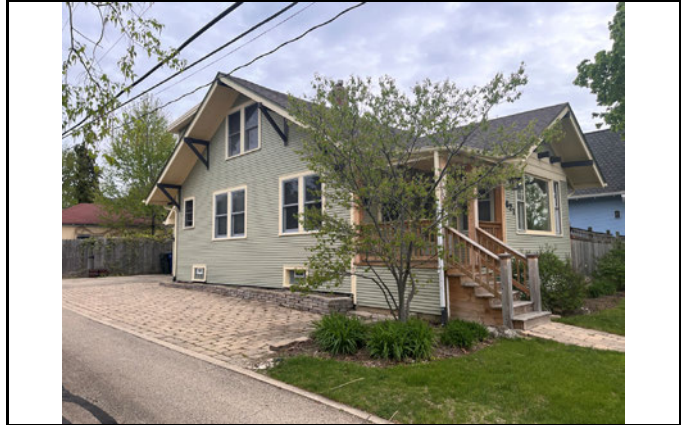
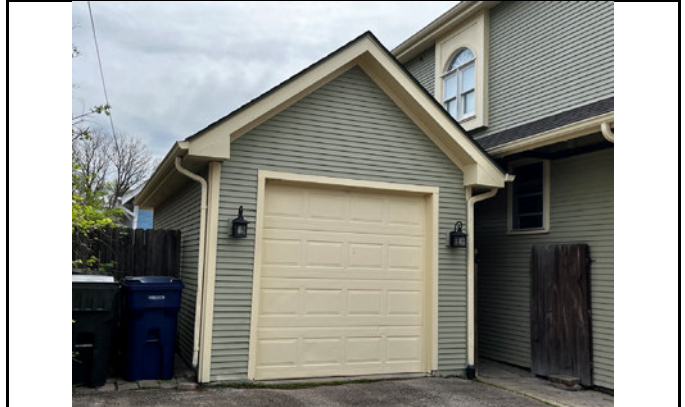
Work Not Requiring COA Exterior repainting

Replacement porch decking, posts, railings, and front steps
