ORGANIZATION RAMSEY HISTORIC CONSULTANTS

SURVEYAREA NAPERVILLE SURVEY UPDATE

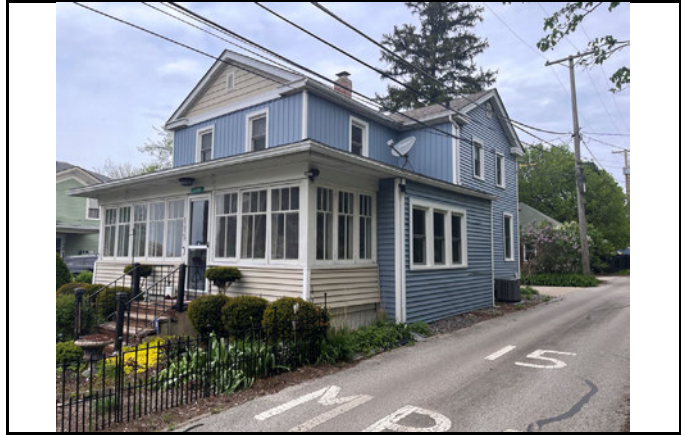
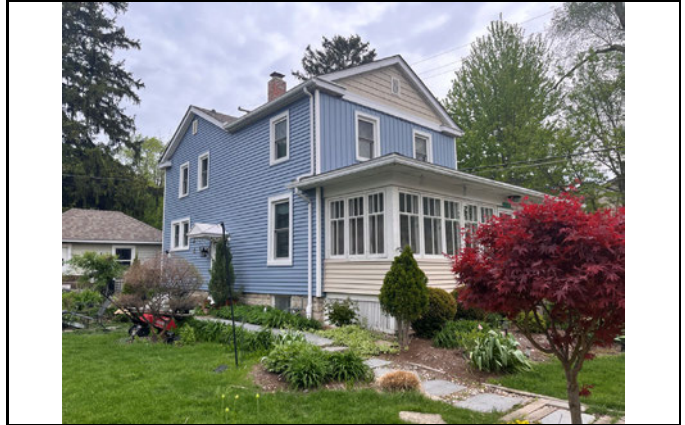
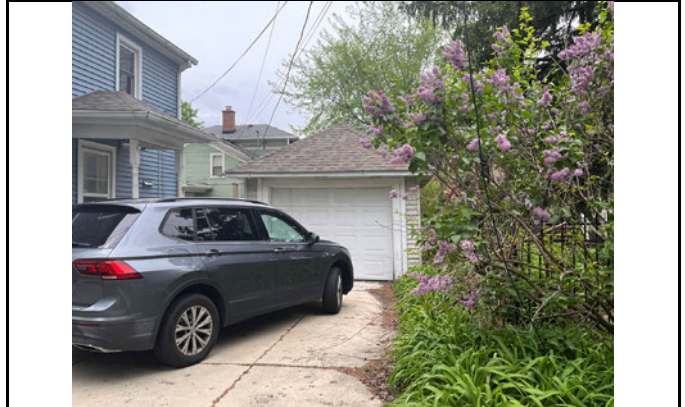
Work Not Requiring COA Replacement siding and windows on east and west secondary elevations.

Vertical replacement siding and replacement windows in original openings on front façade

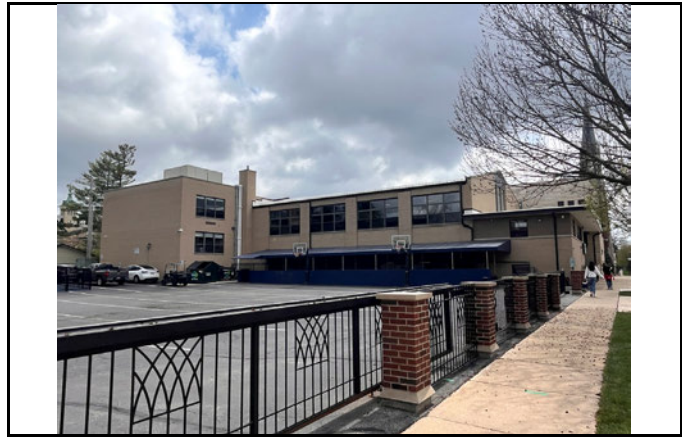
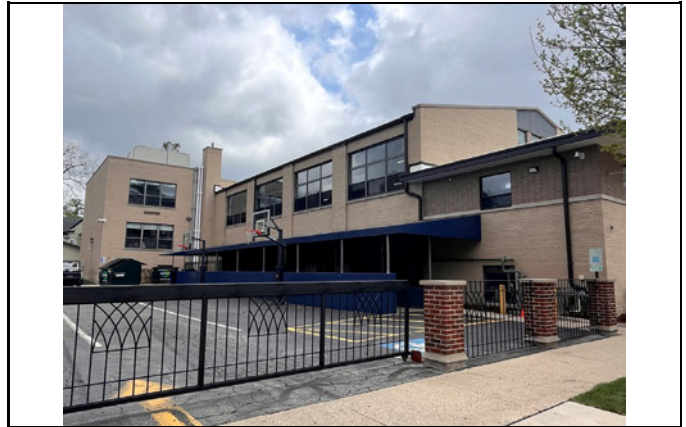
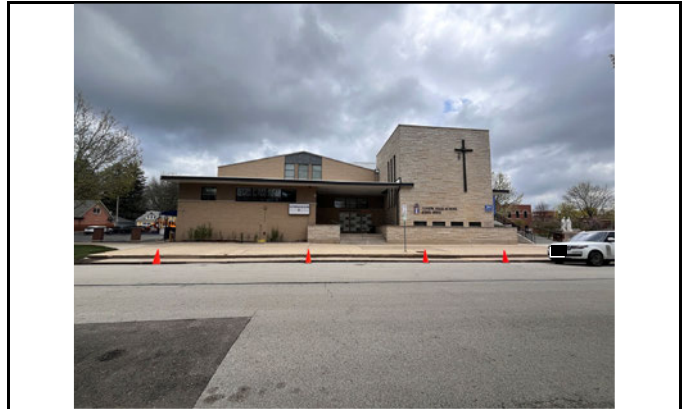
ALTERATIONS Multi-light steel windows on south elevation east of main entrance replaced with 1/1 double-hung Aluminum windows; Post-2007 -- wheelchair ramp along south elevation. New steps at southwest entrance; windows and doors at main entrance replaced with new Aluminum windows that match the original configuration

Wheelchair ramp along south elevation. New steps at southwest entrance

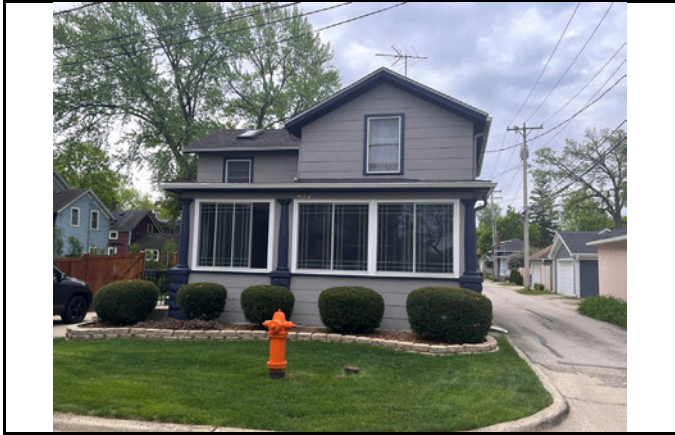
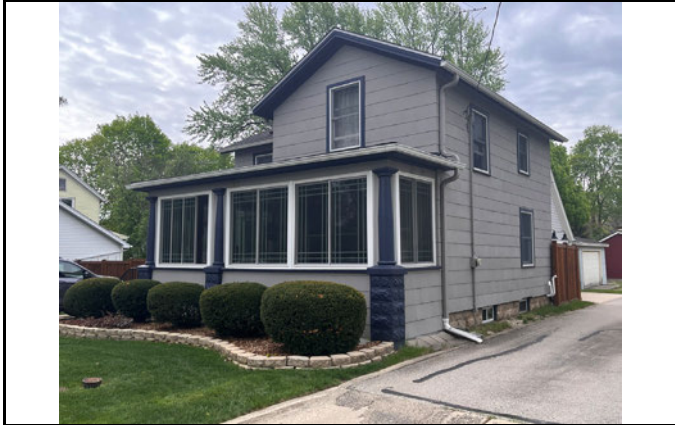
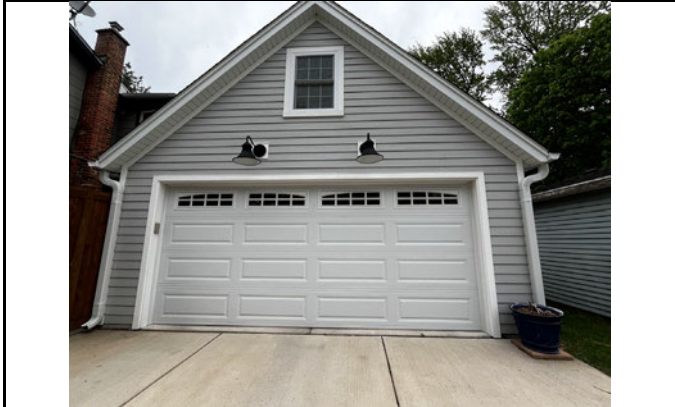
ALTERATIONS Replacement siding (1950s); front porch extended (c. 1915); 1/1 aluminum or vinyl replacement windows throughout, and in altered opening on wing; 2 story rear addition (post-1954); east side entry porch (post-1954); skylights. Post-2007 -- paired nine-light wood casement windows in porch replaced with aluminum/vinyl multi-light fixed windows; repainted.

Paired nine-light wood casement windows in porch replaced with aluminum/vinyl multi-light fixed windows.
