PREPARER	Lara Ramsey	SURVEYDATE	12/4/2025
ORGANIZATION	RAMSEY HISTORIC CONSULTANTS	SURVEYAREA	NAPERVILLE SURVEY UPDATE

ILLINOIS URBAN ARCHITECTURAL AND HISTORICAL SURVEY CONTINUATION SHEET

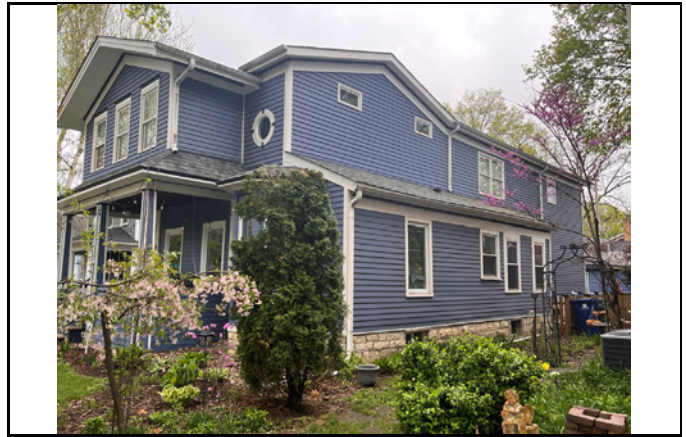
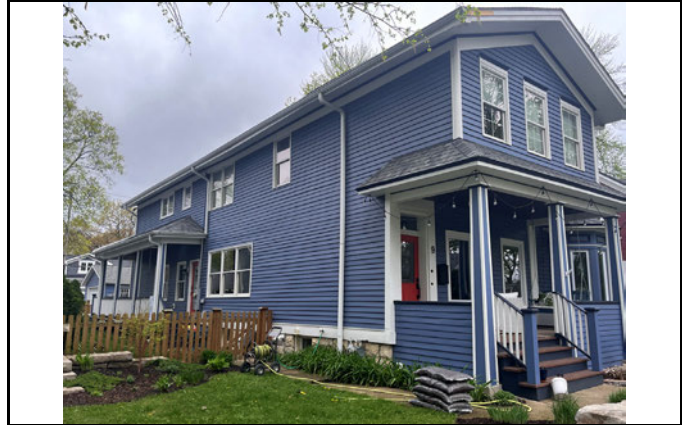
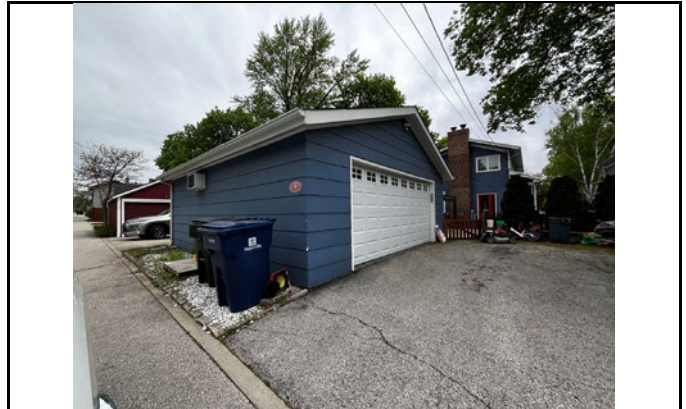
French doors under porch north of main entrance replaced with single-light windows in downsized openings; 1/1 double-hung windows in polygonal first-story window bay replaced with single-light windows; replacement front door; replacement railings at front

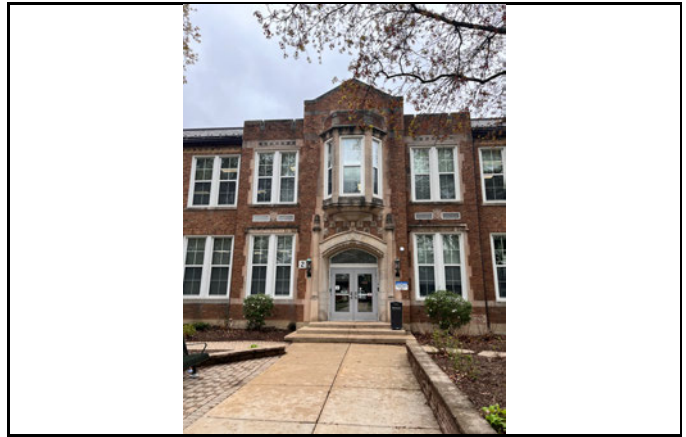
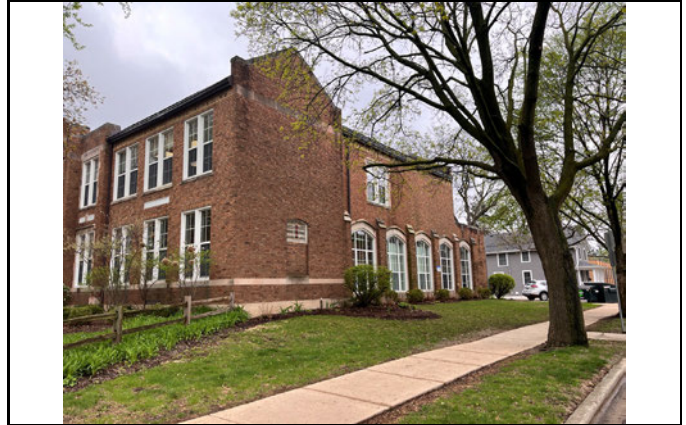
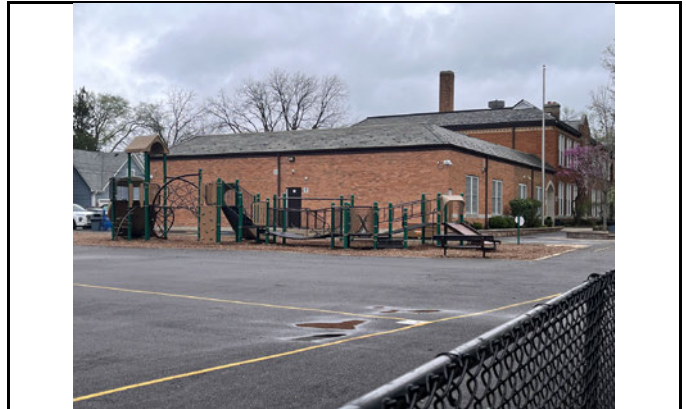
Replacement multi-light windows in arched openings at first story of north elevation.

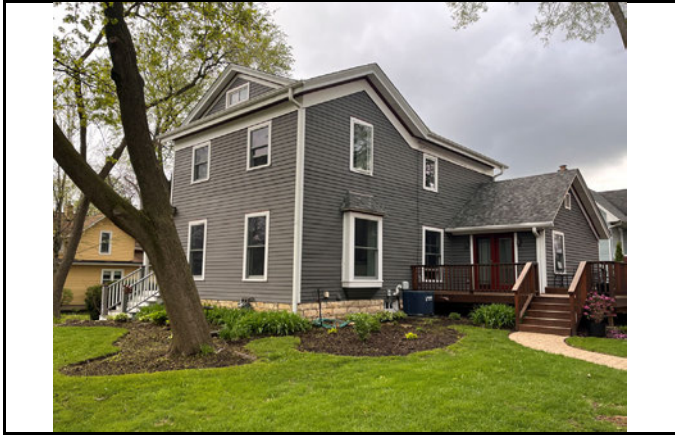
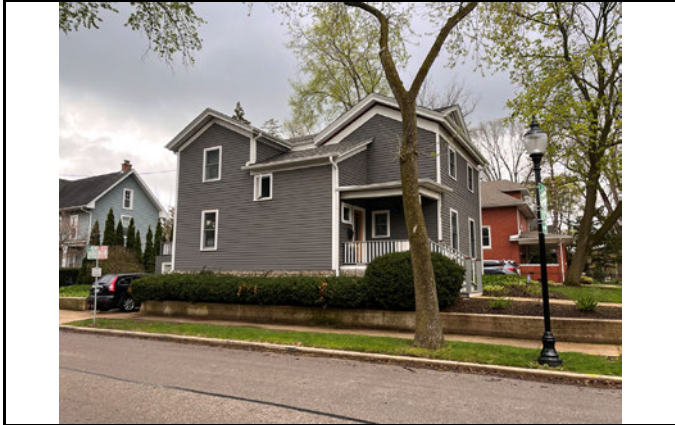
Work Completed Without COA Replacement windows on primary west and north elevations; replacement railings at entry porch; replacement front door.

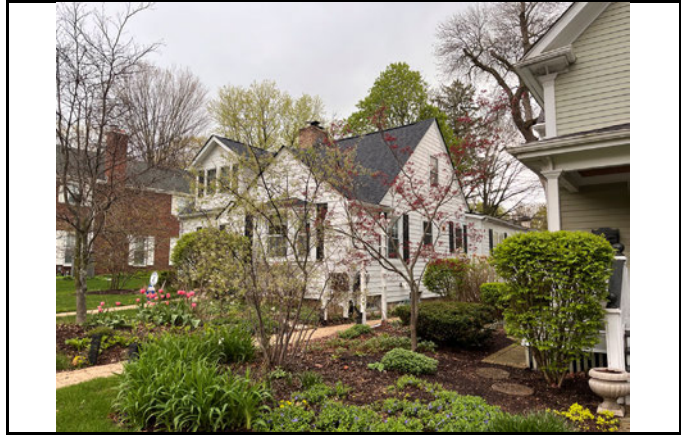
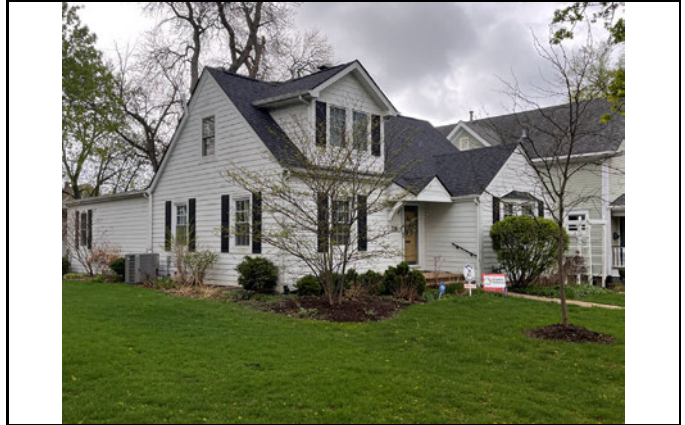
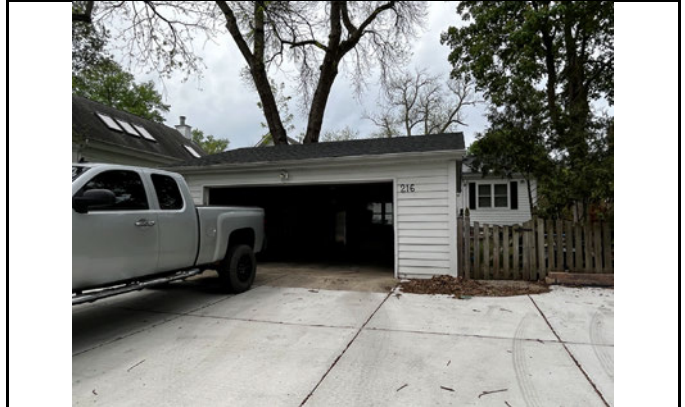
Replacement siding on front façade; 6/6 and 4/4 double-hung replacement windows on front façade; replacement entry steps; shed-roof entry canopy replaced with gabled canopy

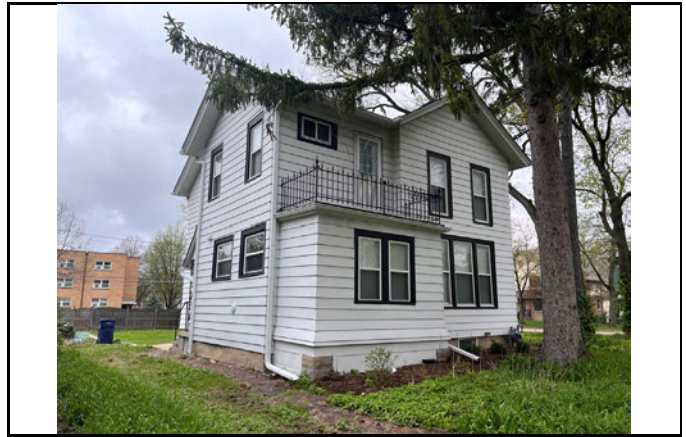
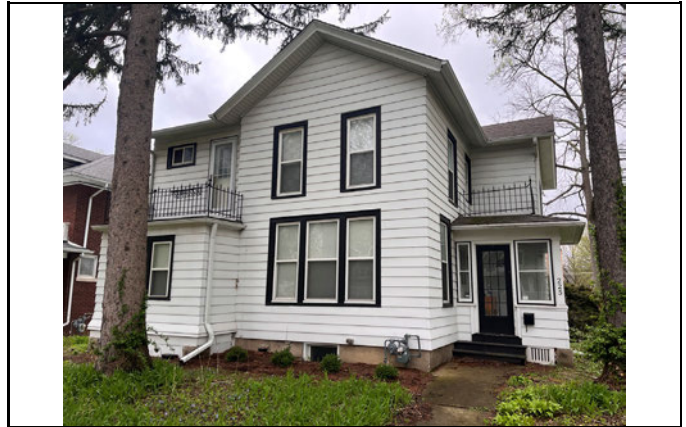
Work Completed Without COA	1/1 double-hung Aluminum replacement windows on primary east and north elevations
-----------------------------------	---

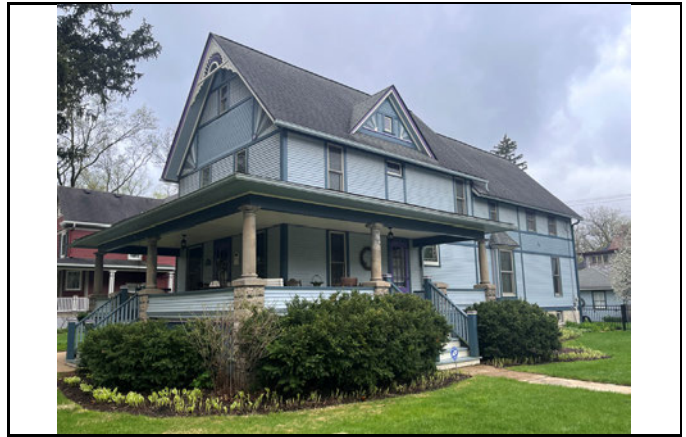
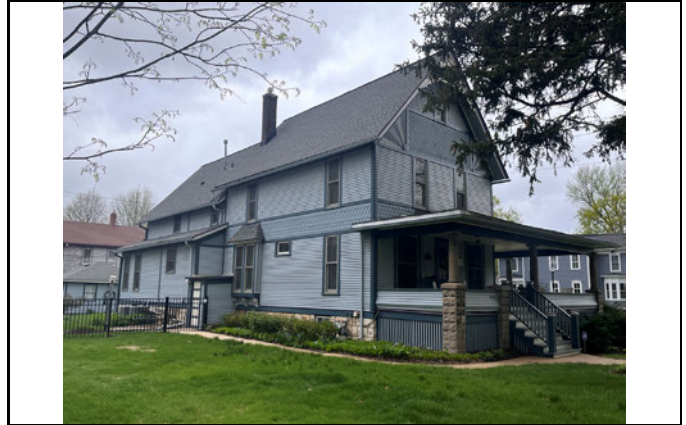
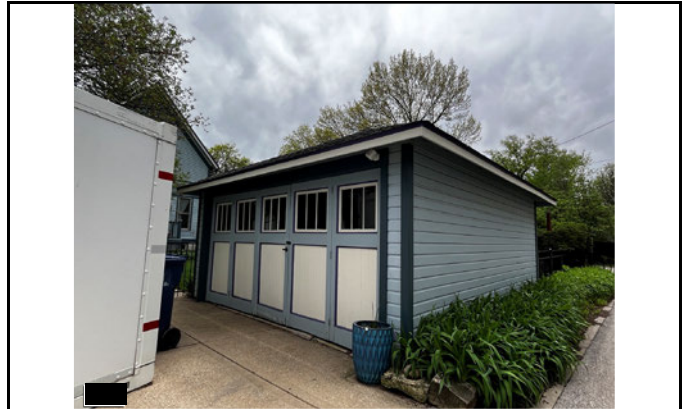
Most 1/1 windows on primary east and north elevations appear to be replacement windows (compatible type and configuration). Railings added to front porch steps.

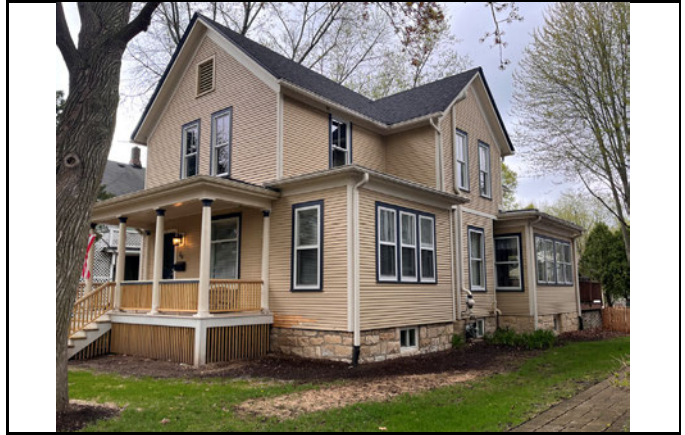
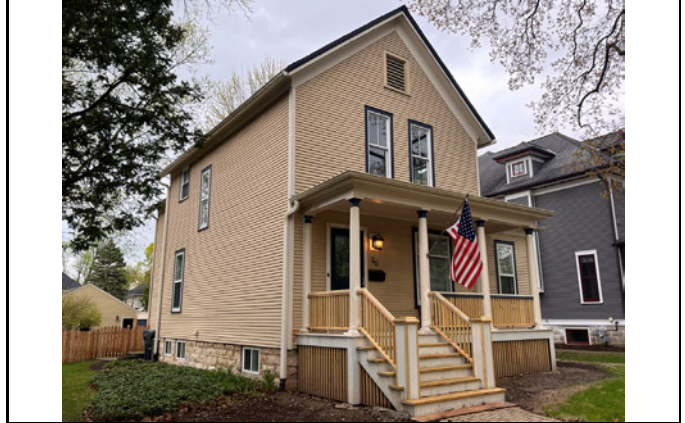
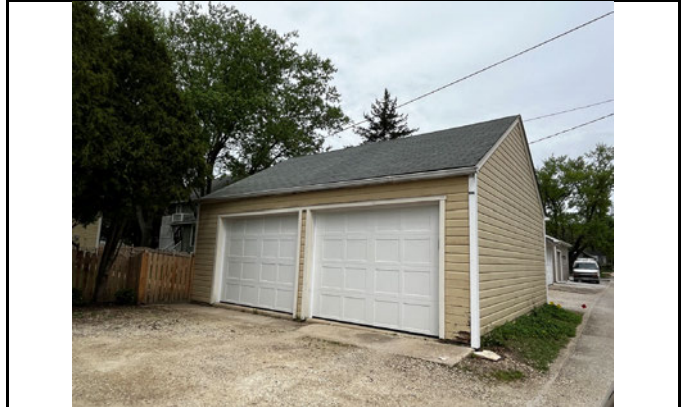
Work Completed Without COA	Porch steps and railing replaced
----------------------------	----------------------------------

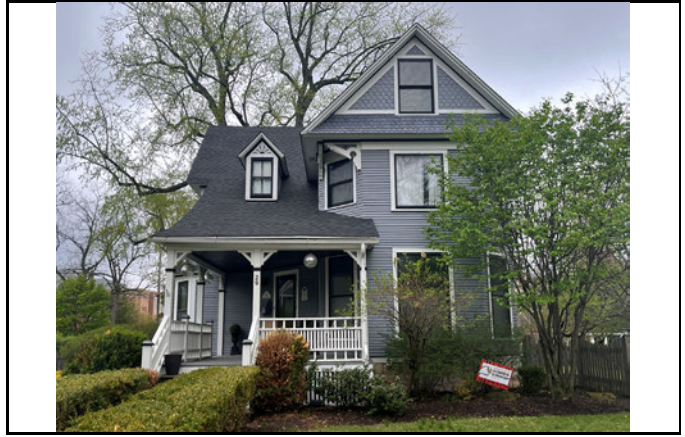
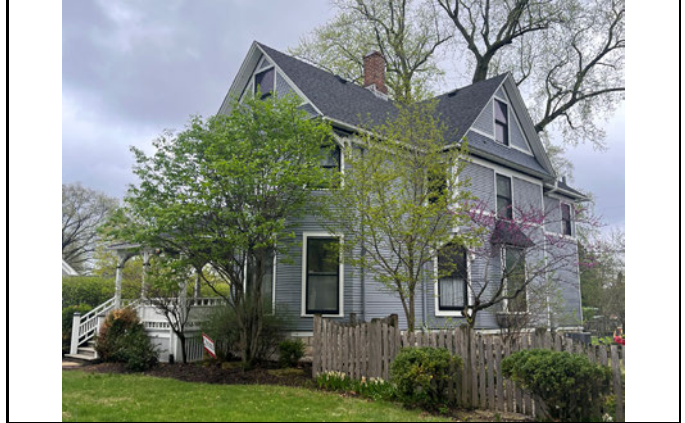
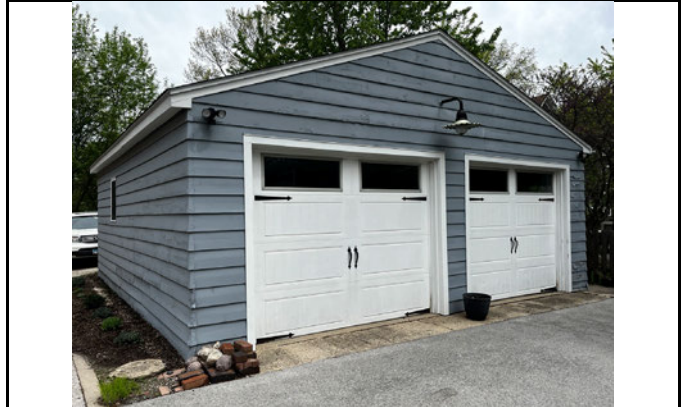
Replacement windows under front gable in enlarged opening.

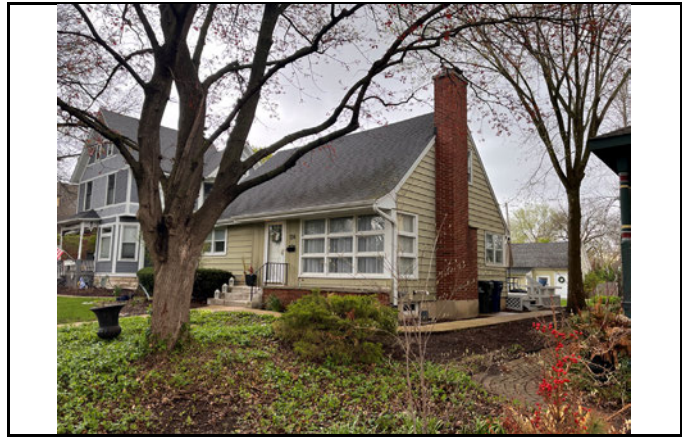
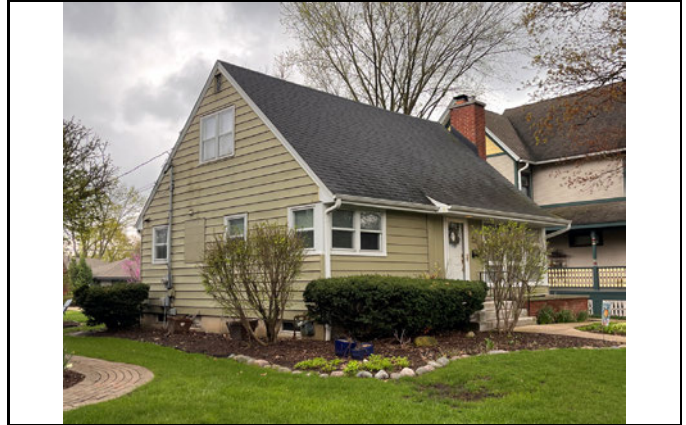
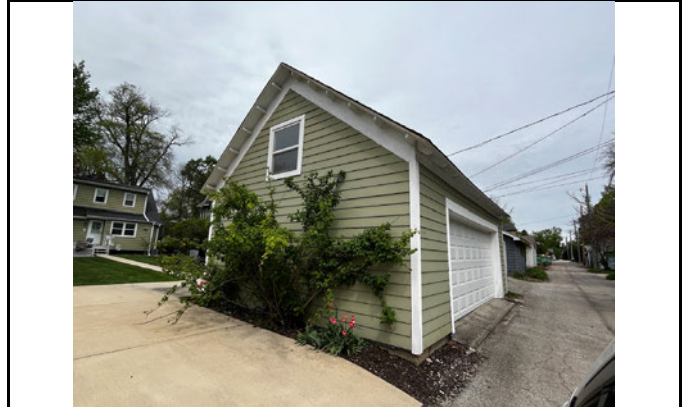
Work Completed Without COA	Replacement front door.

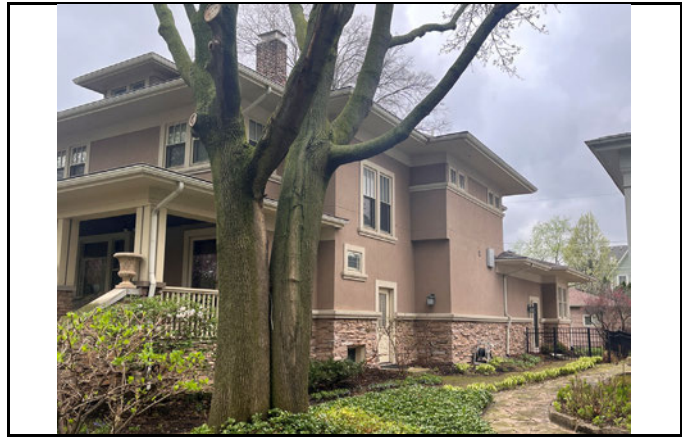
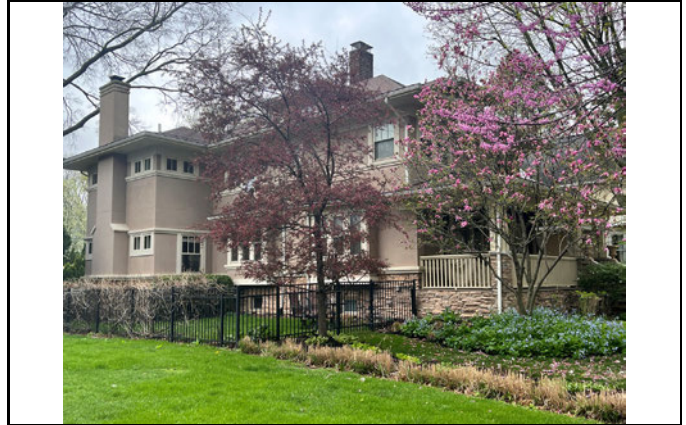
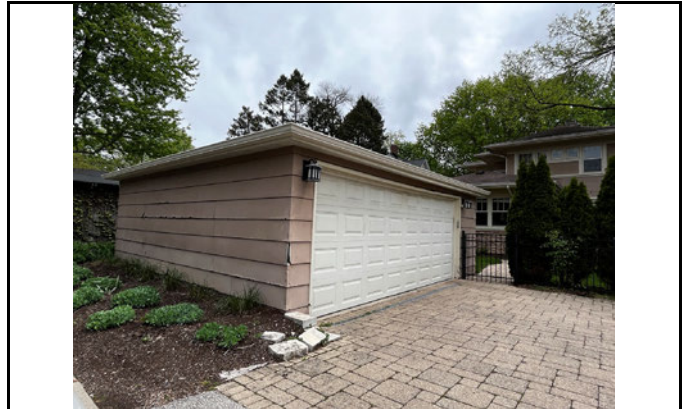
Work Completed Without COA	3/1 replacement windows on front façade

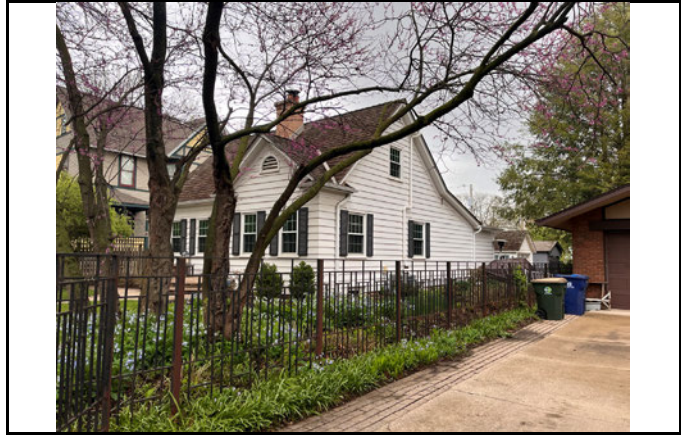
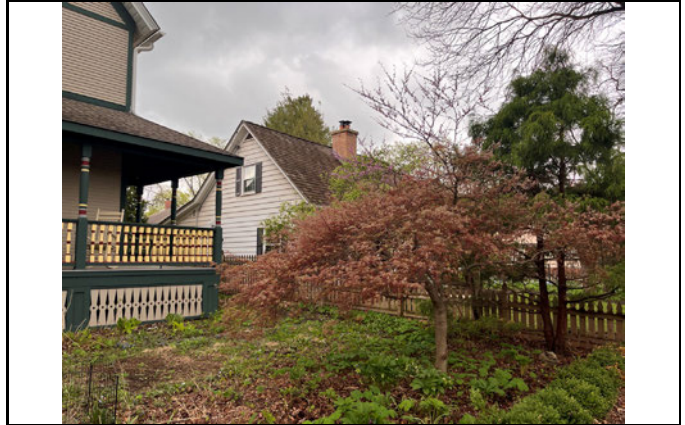
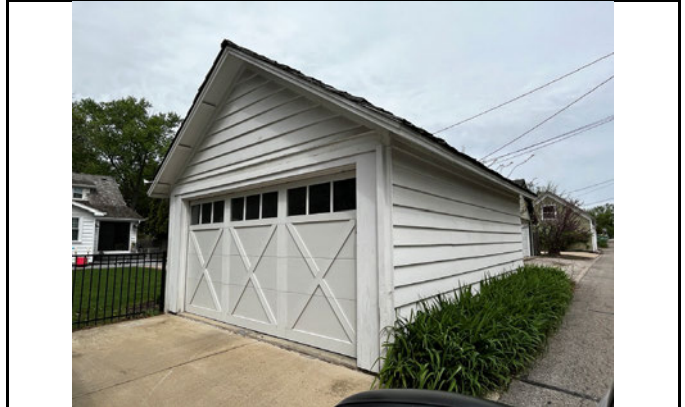
COA Compliance Notes Asphalt shingle siding replaced with cedar shingle.

Work Completed Without COA Replacement windows on front façade; replacement front door.
