## OLD NICHOLS LIBRARY Limited Condition Assessment

110 South Washington Street  
Naperville, Illinois

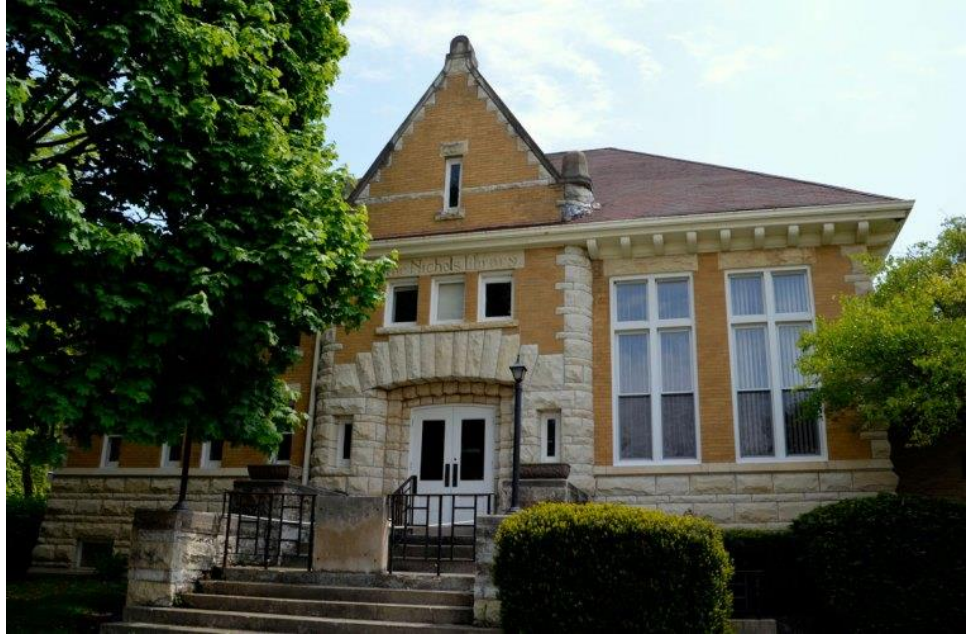
**Final Report**  
August 8, 2017

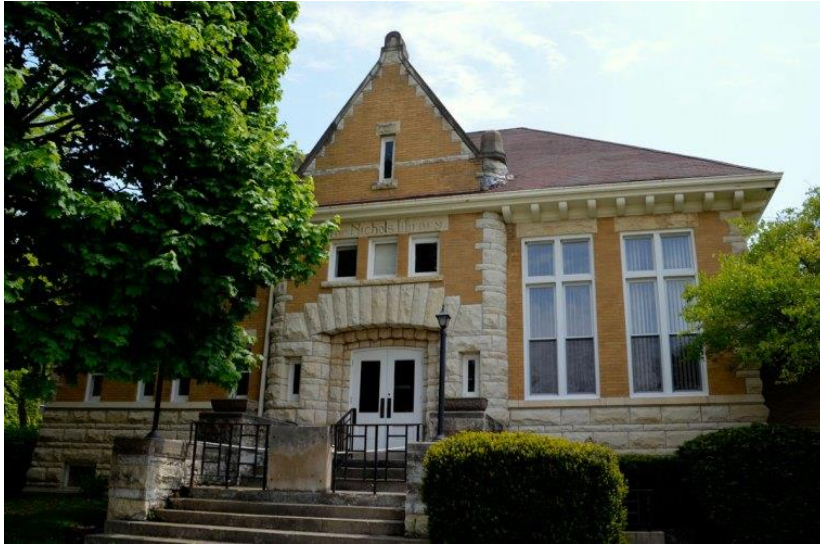
*Figure 1. Over all view of the west facade of Old Nichols Library.*

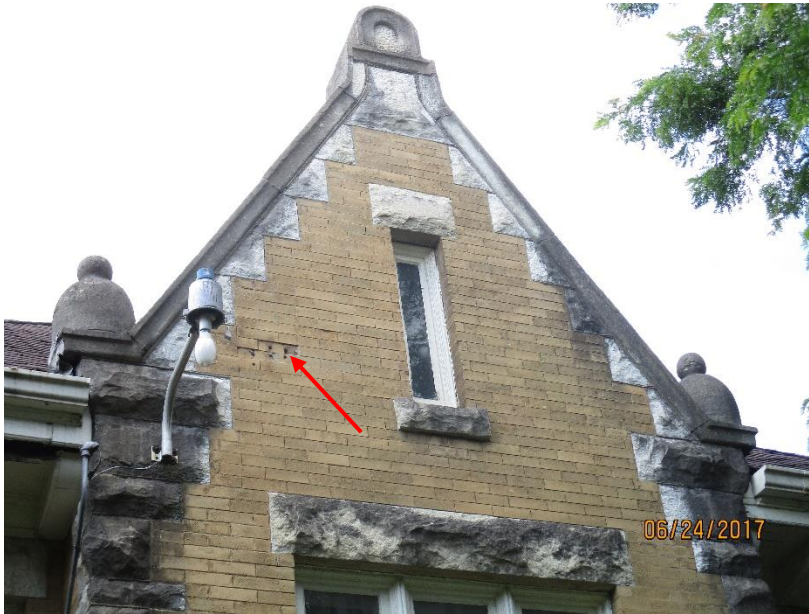
*Figure 13. Note spalls at locations previously used for anchorage.*

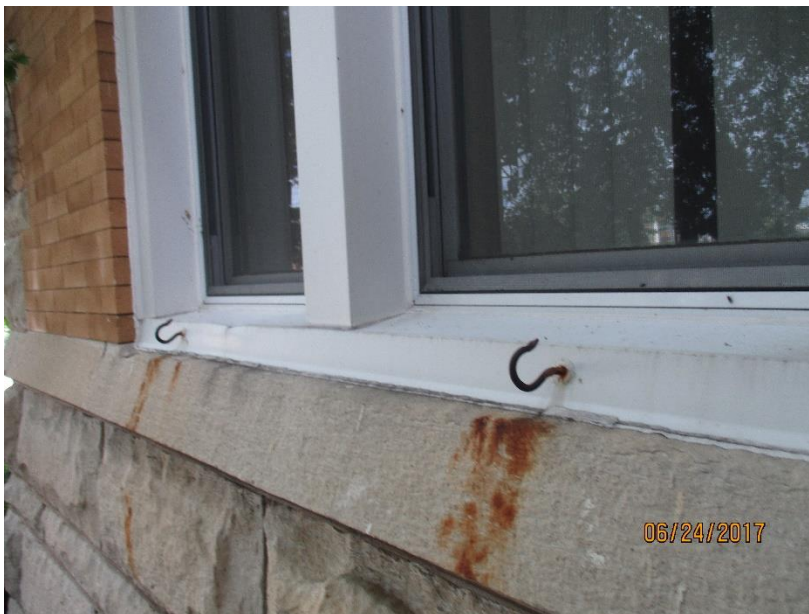
*Figure 14. Note corrosion staining.*

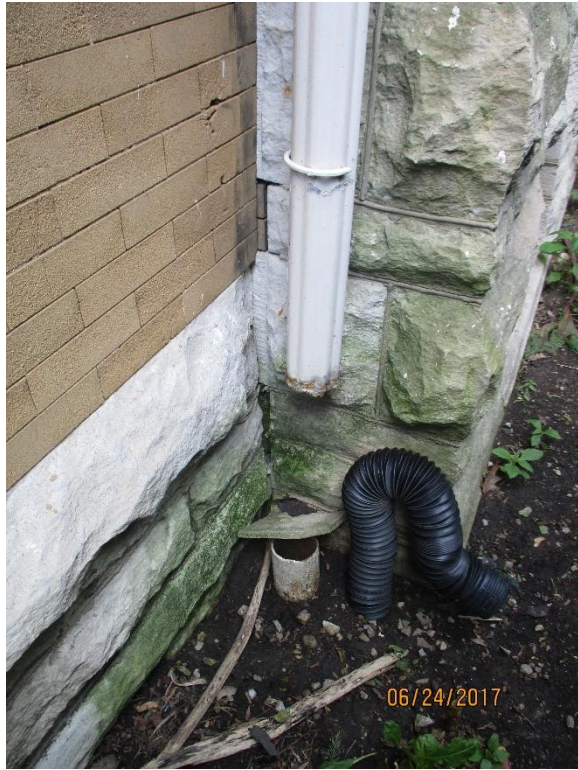
*Figure 15. Minor biological growth present on rusticated stone and improperly detailed downspout at northwest corner of the building.*

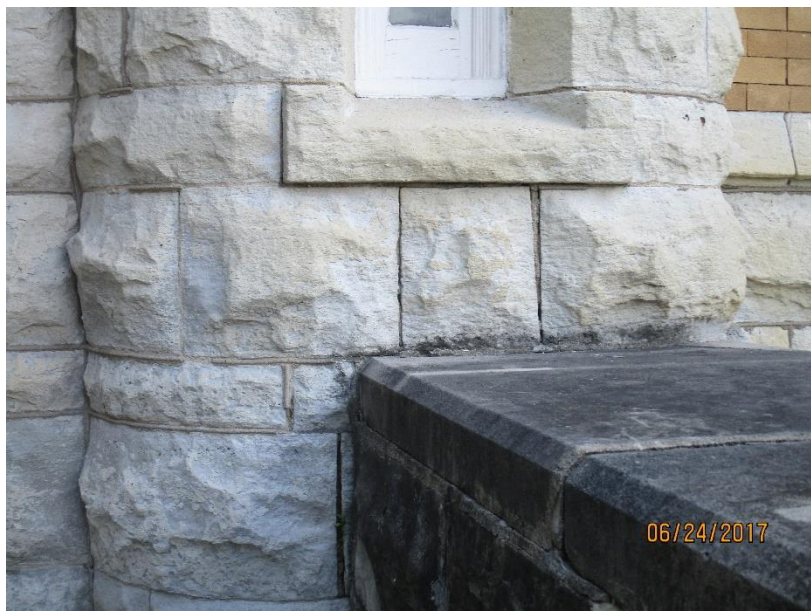
*Figure 16. Isolated limestone mortar joint erosion and cracking.*

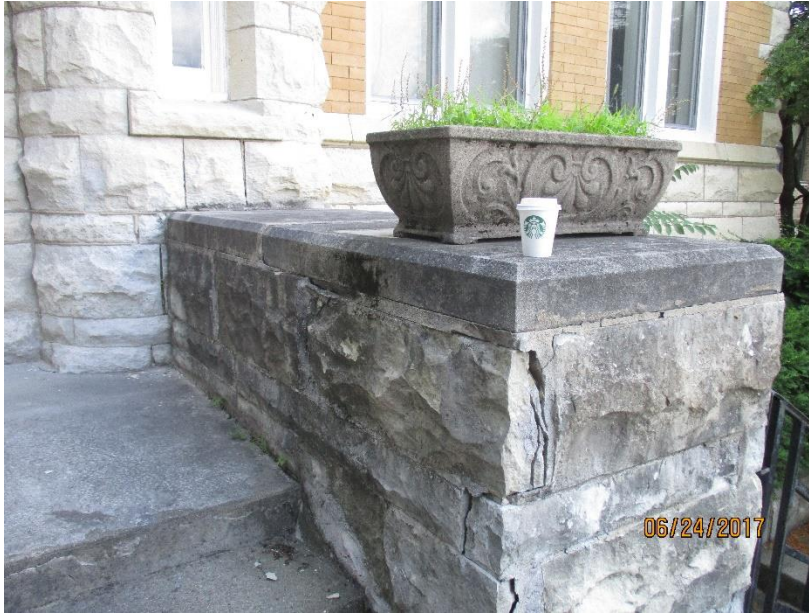
*Figure 17. Isolate mortar cracks in stairway cheek walls.*

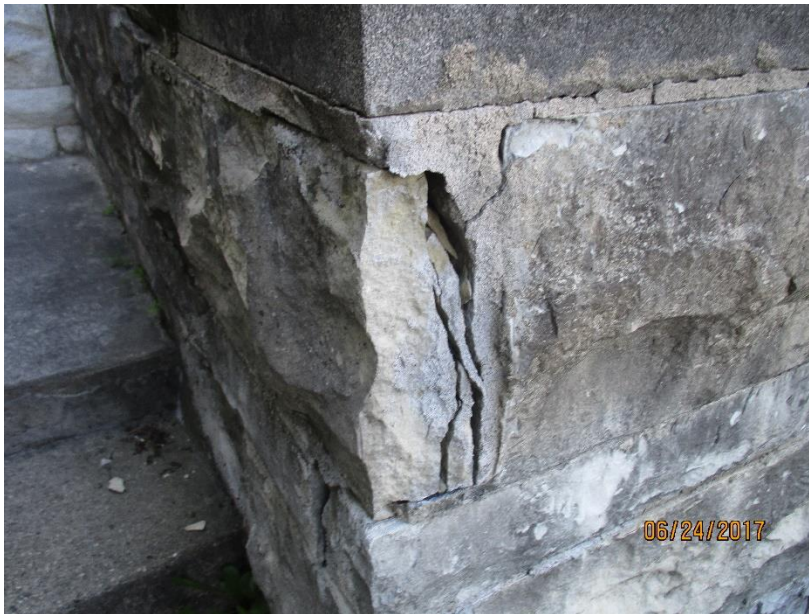
*Figure 18. Detailed view of stair cheek wall cracking.*

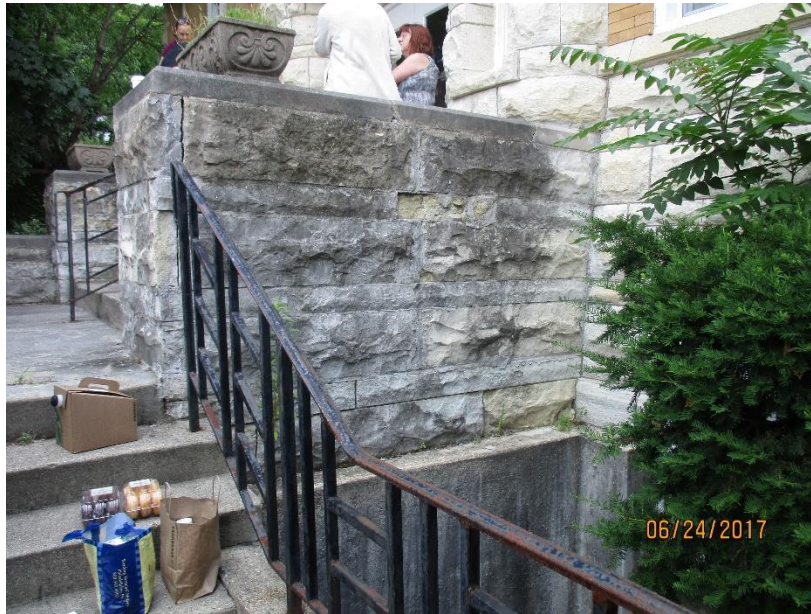
*Figure 19. Alternate view of isolated stair cheek wall cracking.*

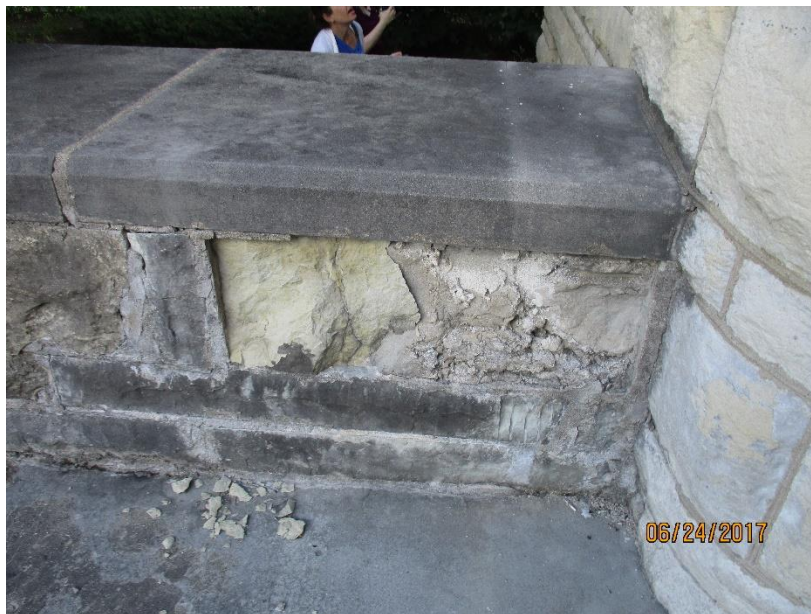
*Figure 20. Scaling and spalling of face bedded stone at stairway cheek wall.*

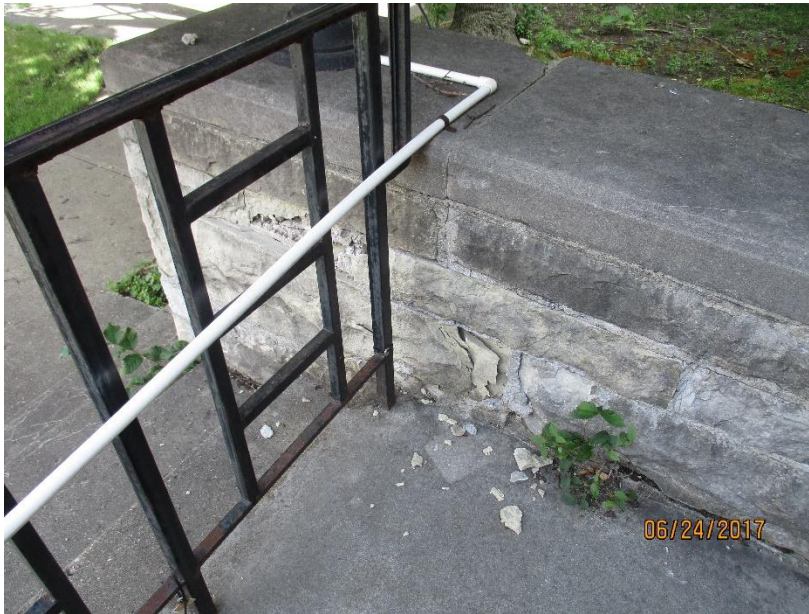
*Figure 21. Additional view of scaling/spalling face-bedded stone.*

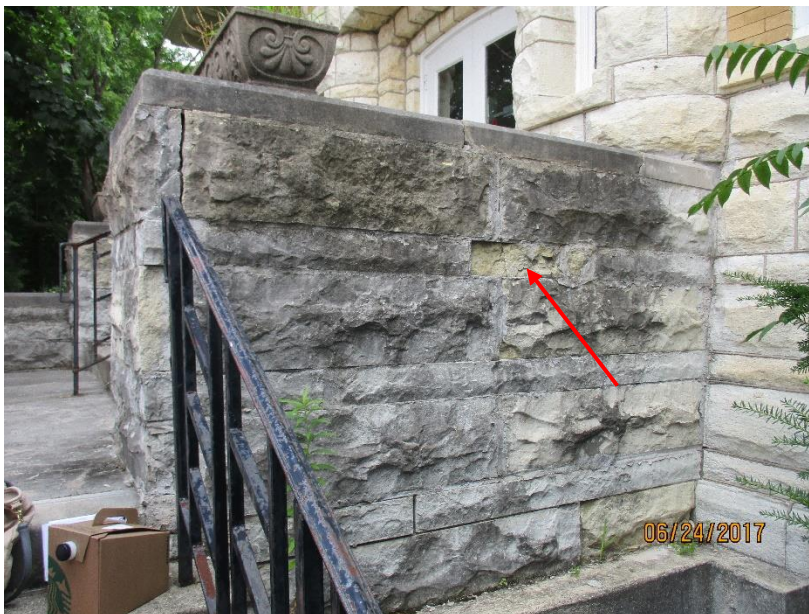
*Figure 22. Additional view of scaling/spalling of face-bedded stone.*

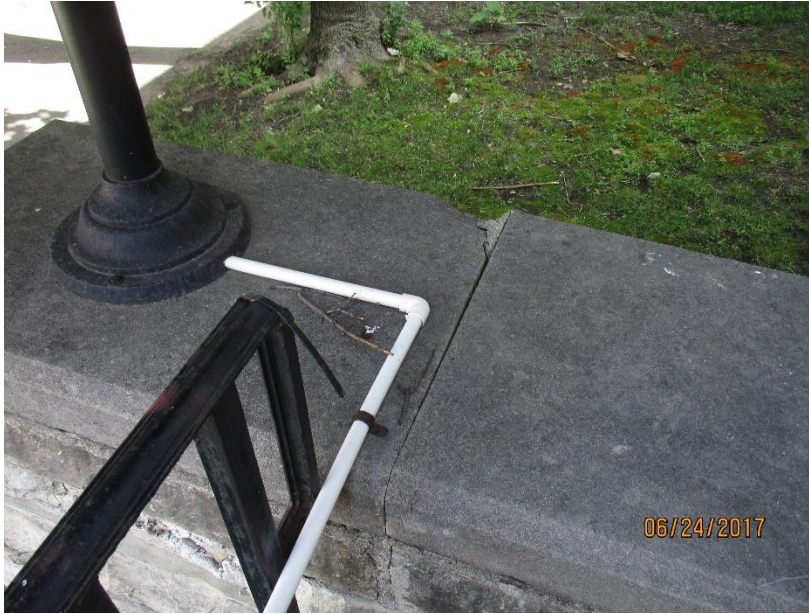
*Figure 23. Open mortar joint at coping of stairway cheek wall.*

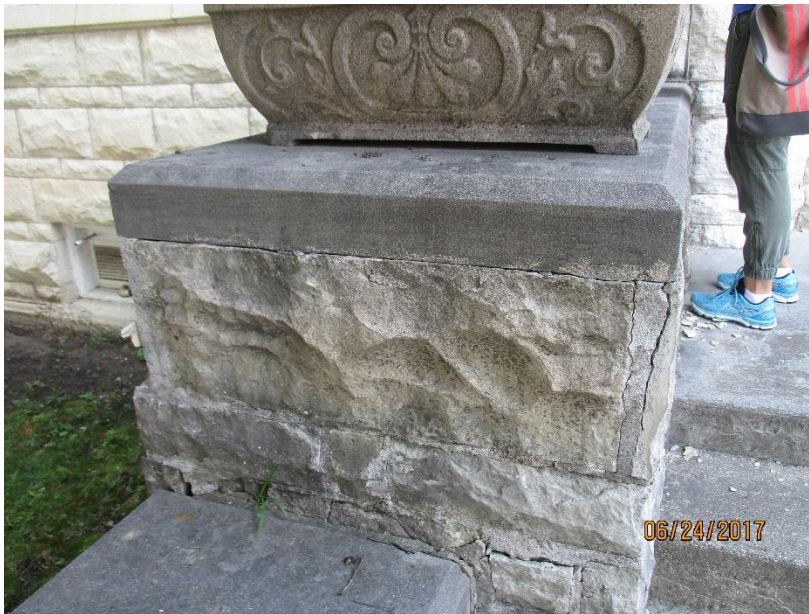
*Figure 24. Cracked and debonded mortar between stone units.*

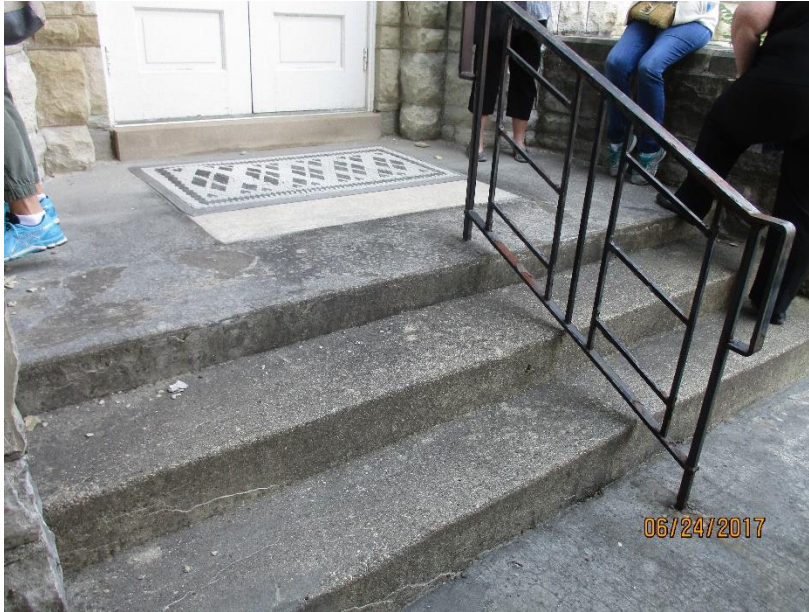
*Figure 25. Isolated hairline cracks with efflorescence on stair treads and risers.*

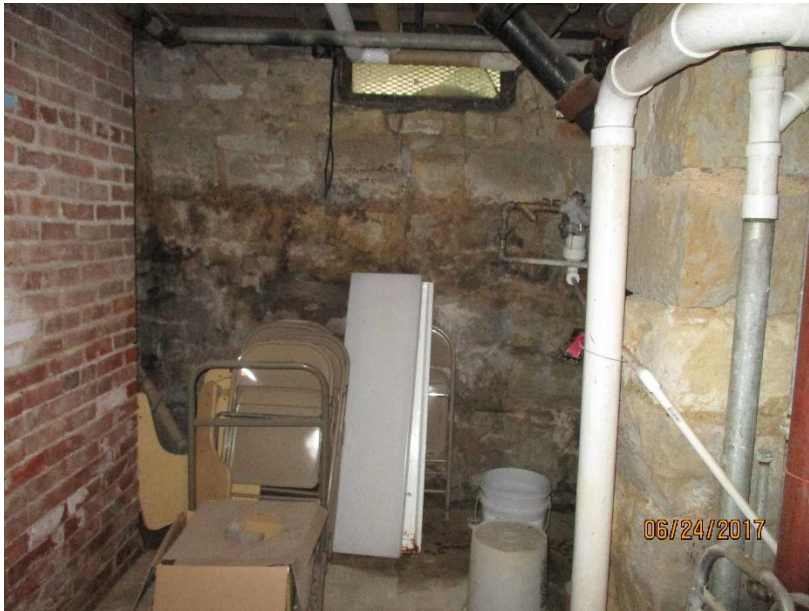
*Figure 26. Partial view of west end of north foundation wall.*

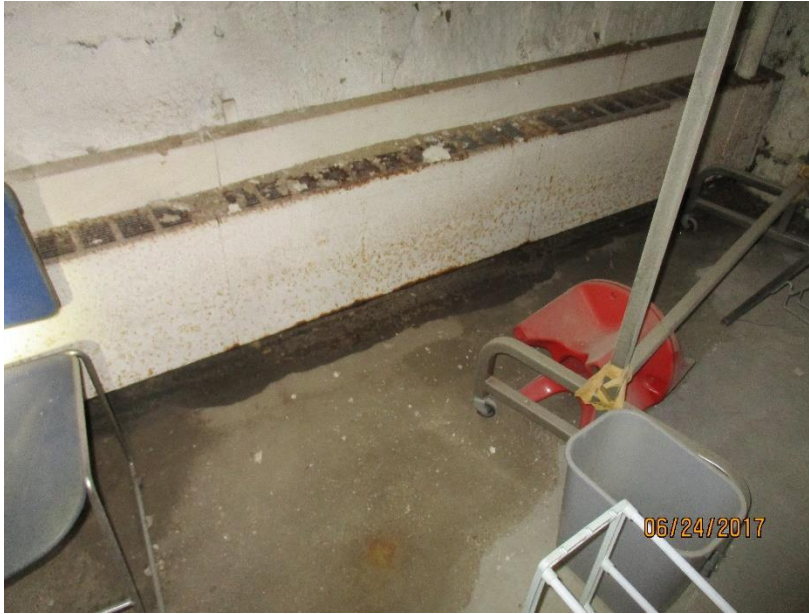
*Figure 27. Evidence of isolated water infiltration at north foundation wall.*

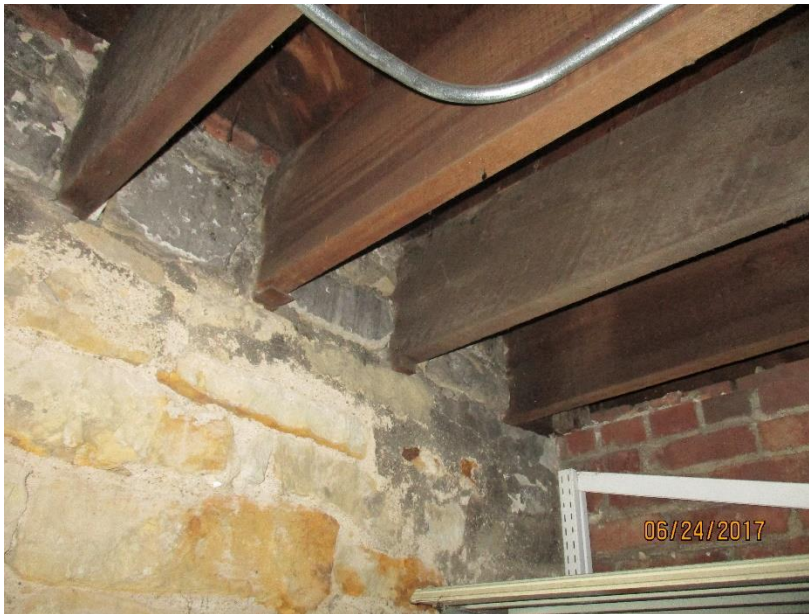
*Figure 28. No evidence of decay on wood framing.*

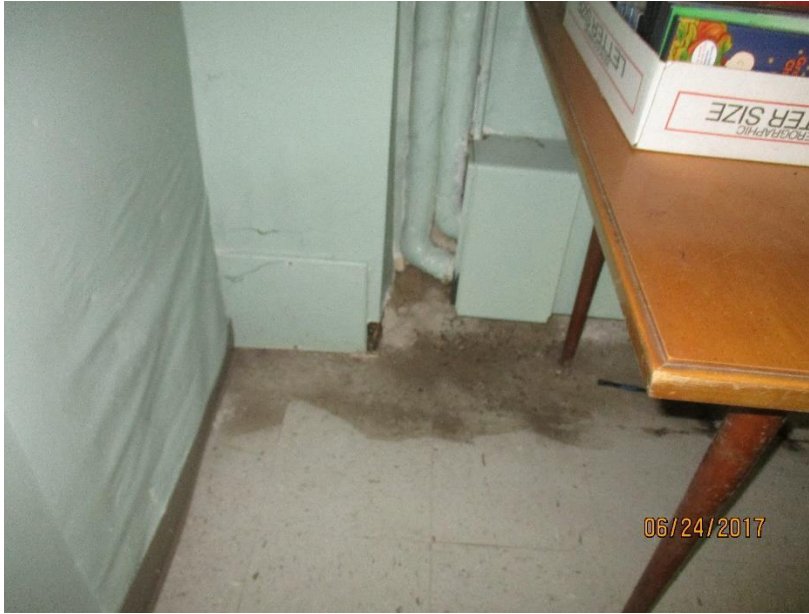
*Figure 29. Evidence of moisture, potentially from nearby radiator.*

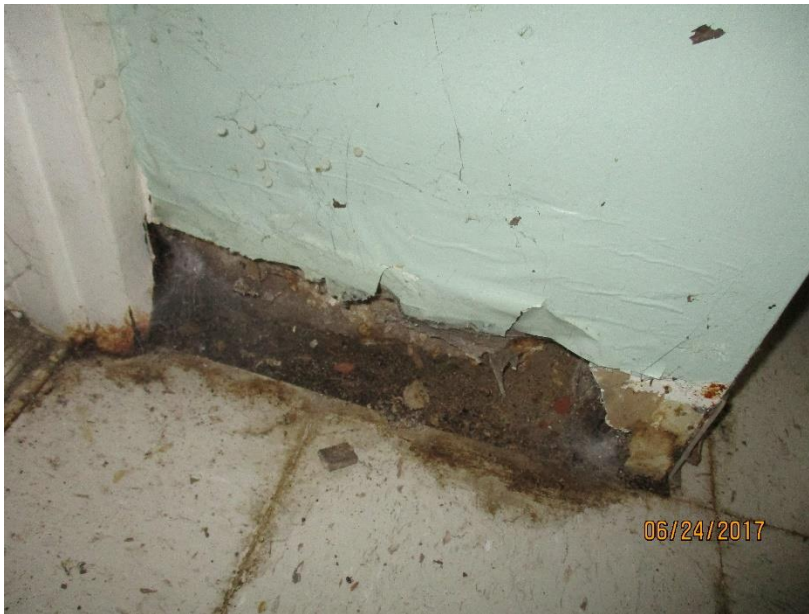
*Figure 30. Moisture related distress near emergency egress door.*

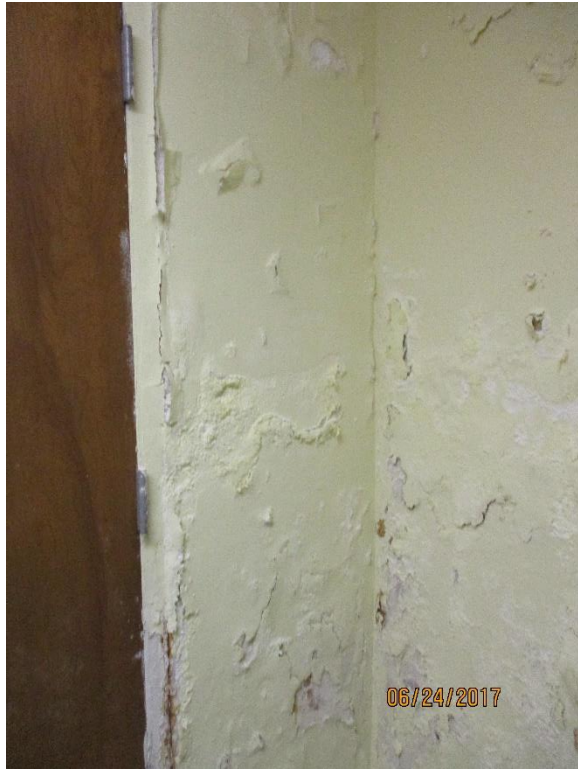
*Figure 31. Moisture related distress evident on plaster wall.*

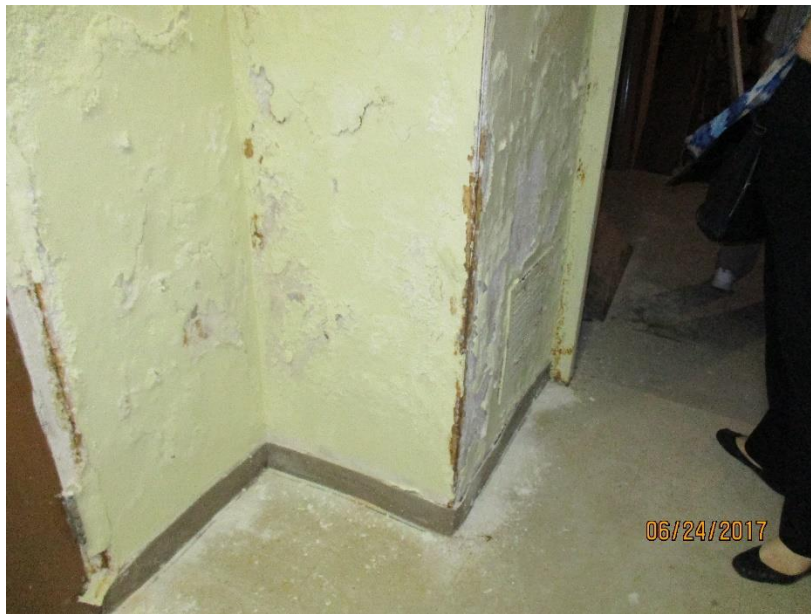
*Figure 32. Moisture related distress evident on plaster wall.*

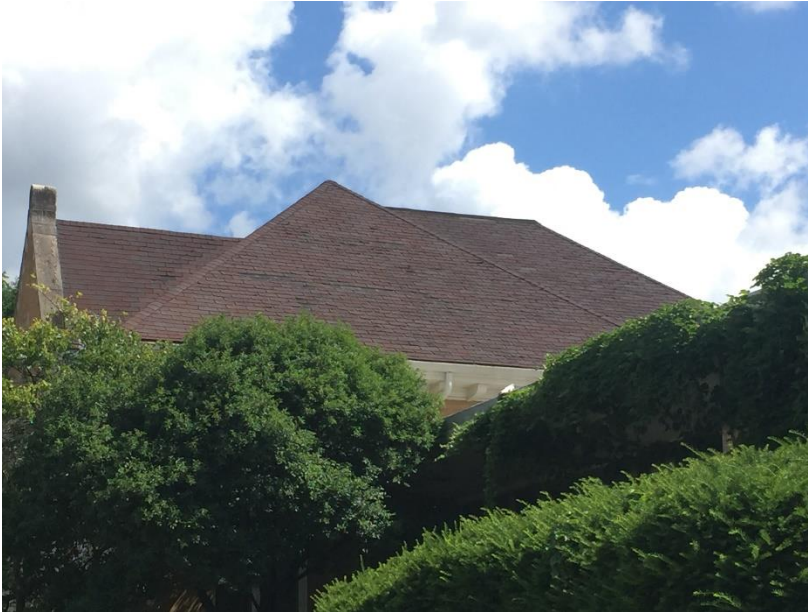
*Figure 33. South roofing face.*

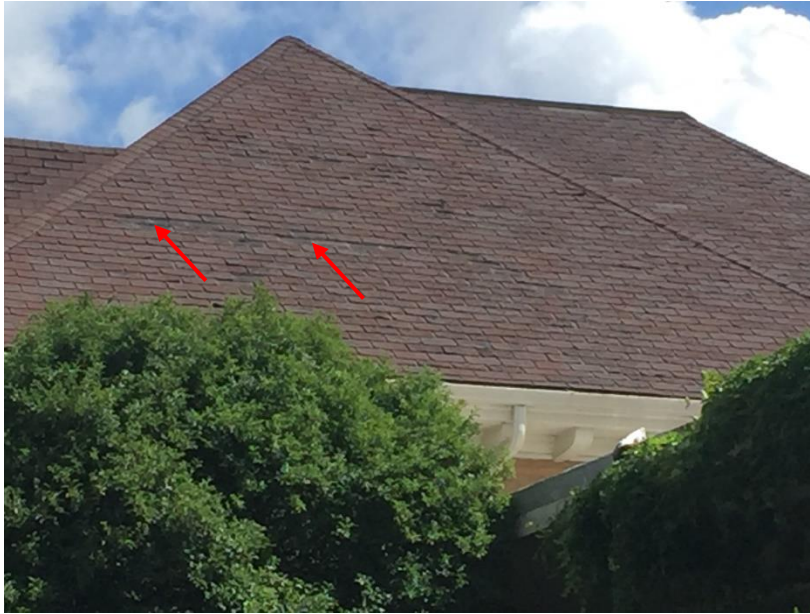
*Figure 39. General view of south roofing area with areas of missing shingle tabs.*

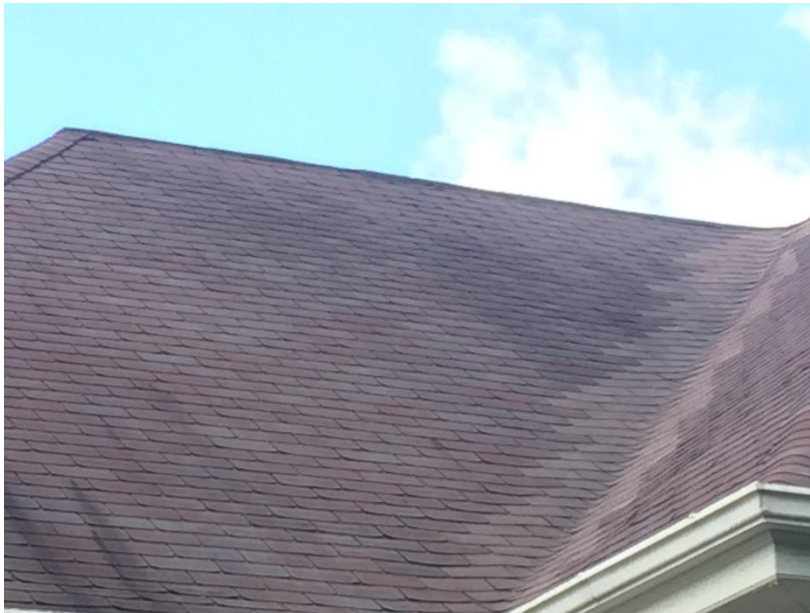
*Figure 40. Location of previous ridge repair.*

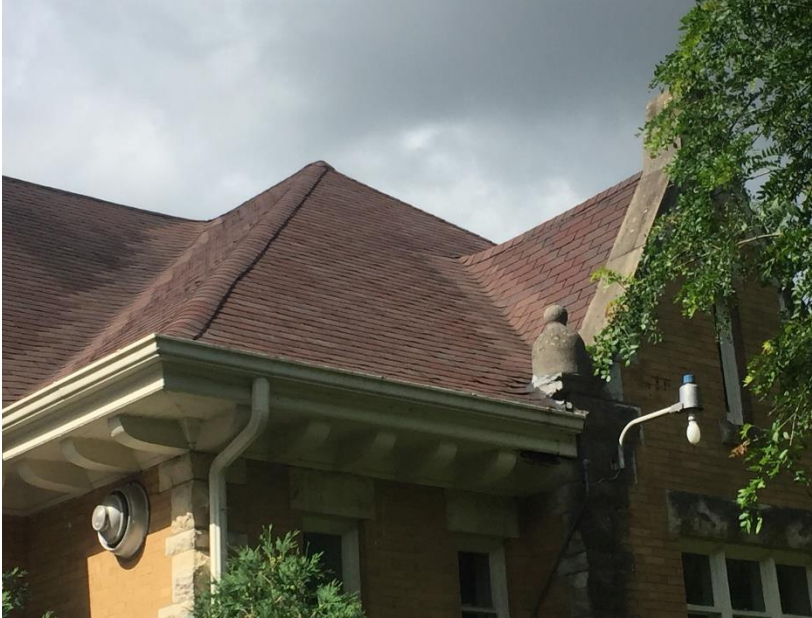
*Figure 41. Location of previous valley repair.*

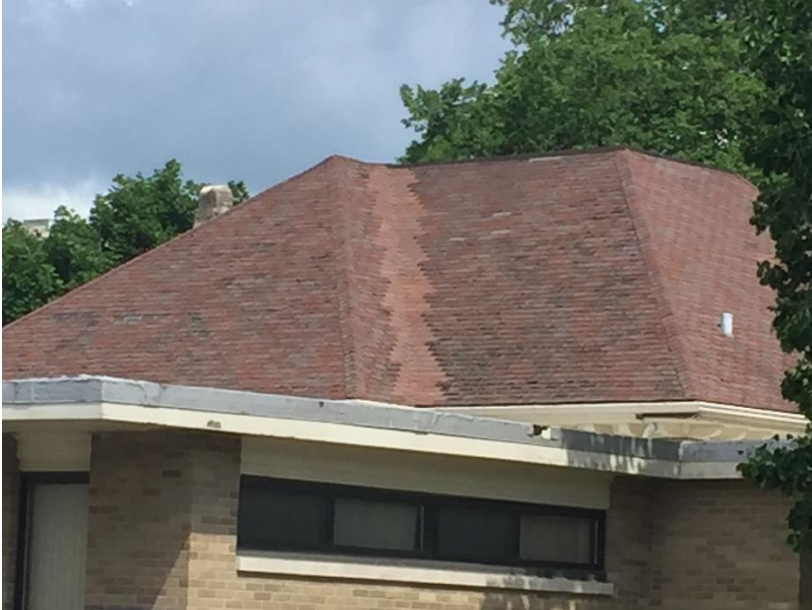
*Figure 42. Another location of previous valley repair.*

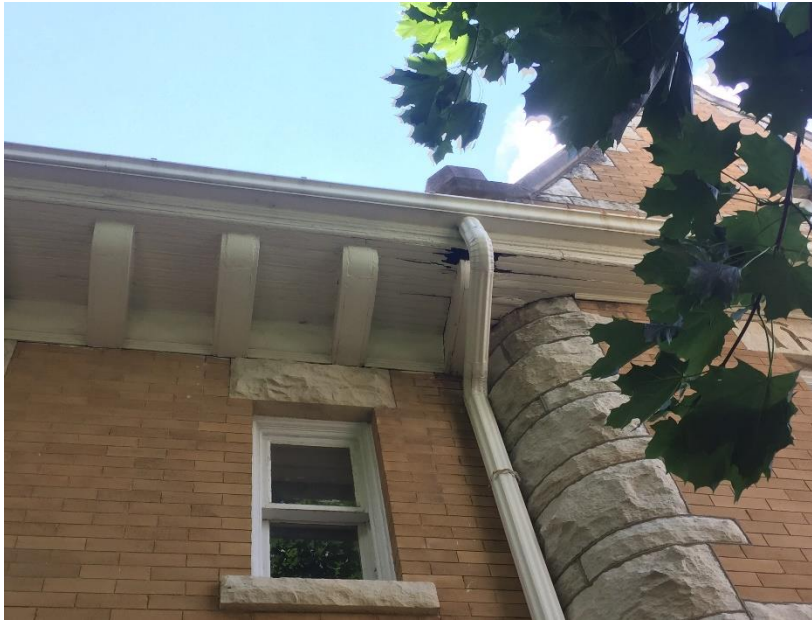
*Figure 43. Isolated wood deterioration and peeling paint at soffit and fascia.*

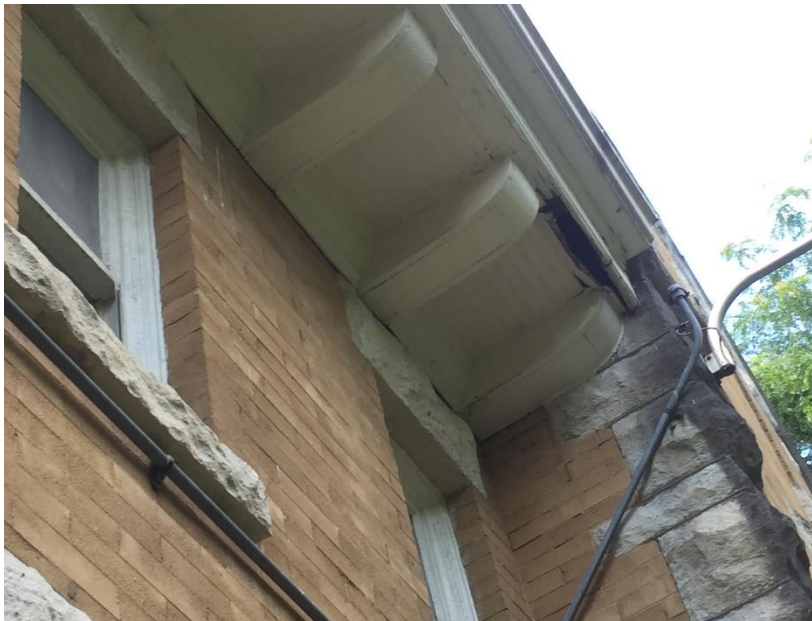
*Figure 44. Opening in soffit at the east side of the gable on the north facade.*

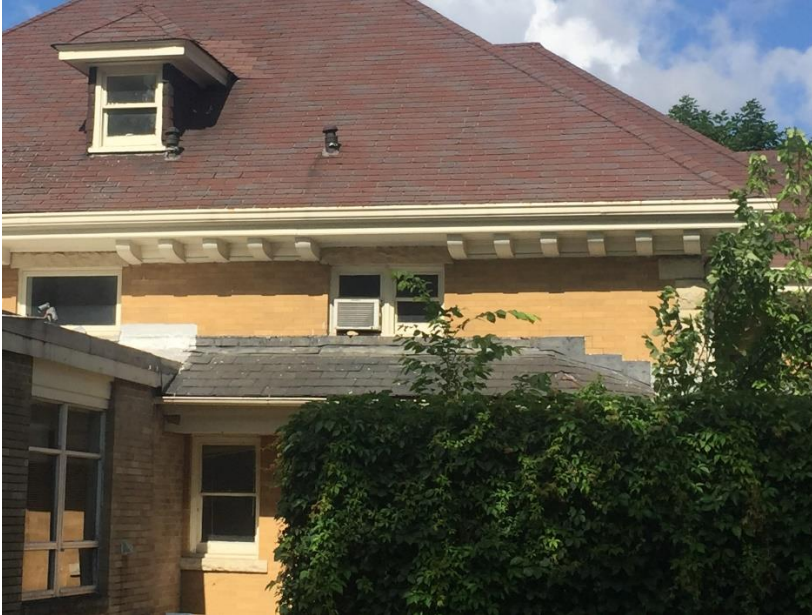
*Figure 46. Broken/missing tile.*

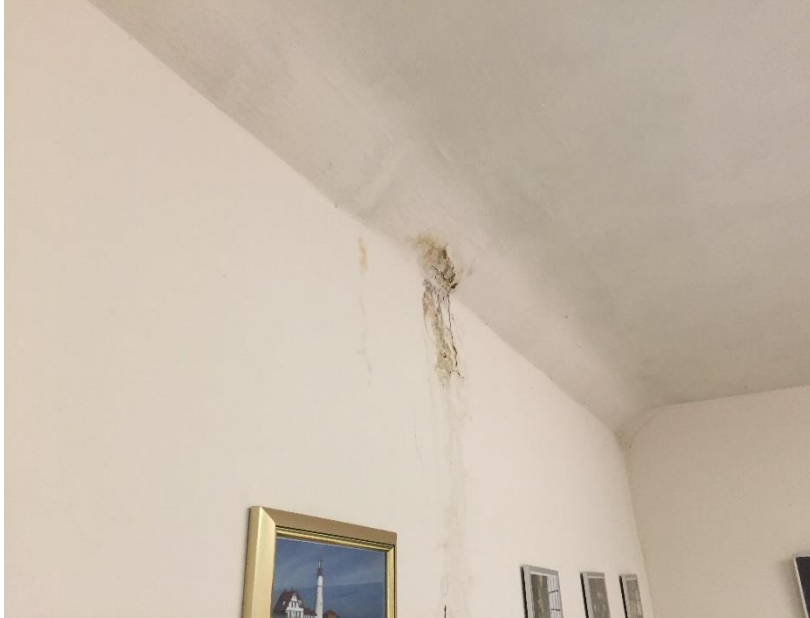
*Figure 47. Interior water staining corresponding to vent stacks on east roofing area, north of the dormer.*

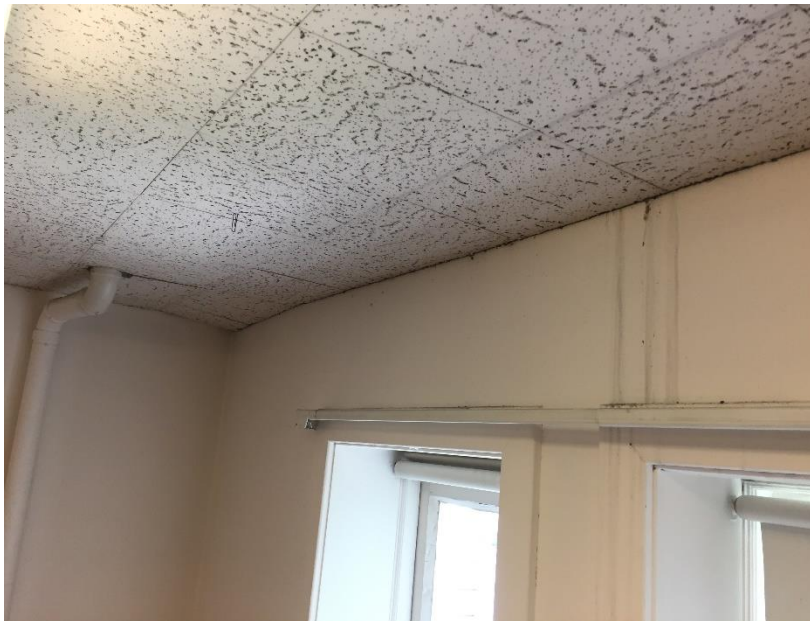
*Figure 48. Interior water staining located south of the gable on the east facade.*

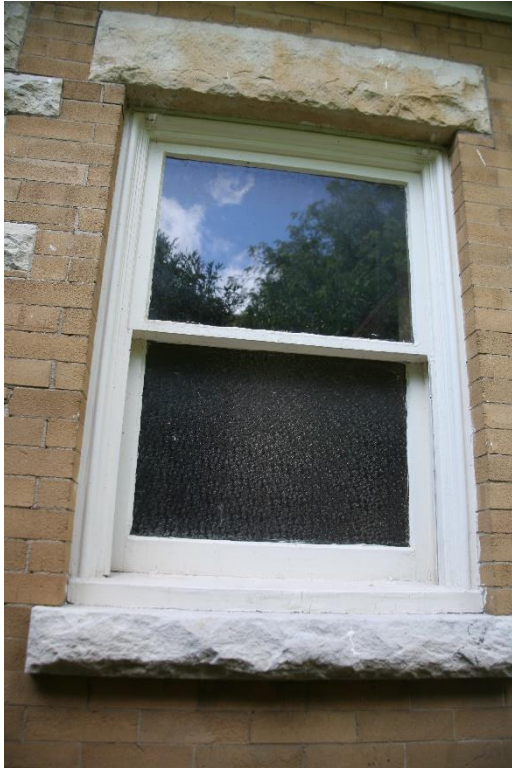
*Figure 49. View of typical wood double-hung window. This window includes privacy glass in the lower sash.*

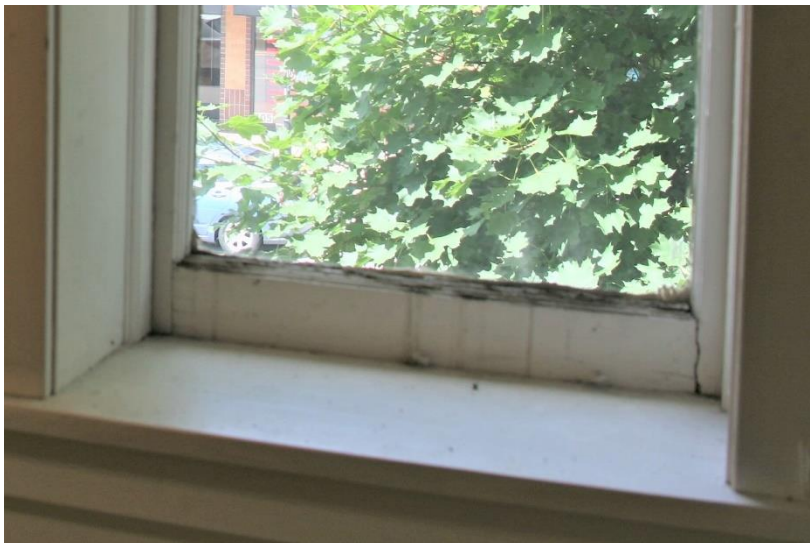
*Figure 50. View of most distressed interior paint observed.*

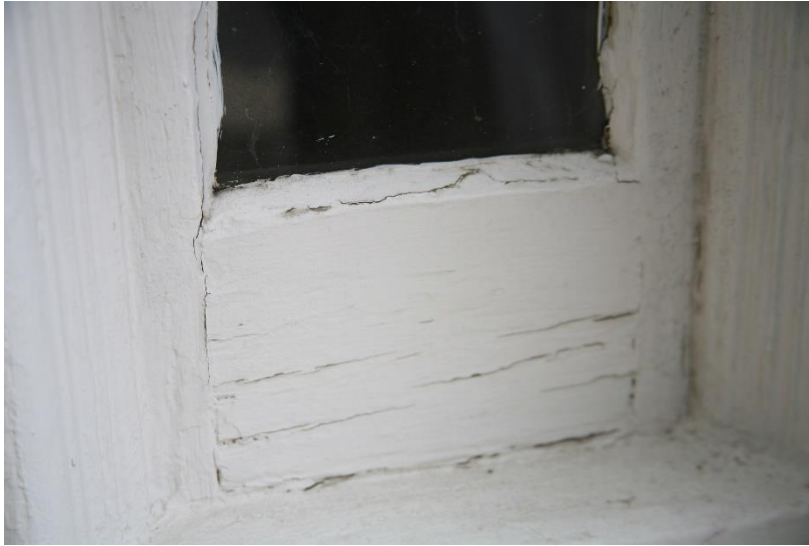
*Figure 51. View of exterior of wood window with paint distress (more significant than most) and cracked glazing putty.*

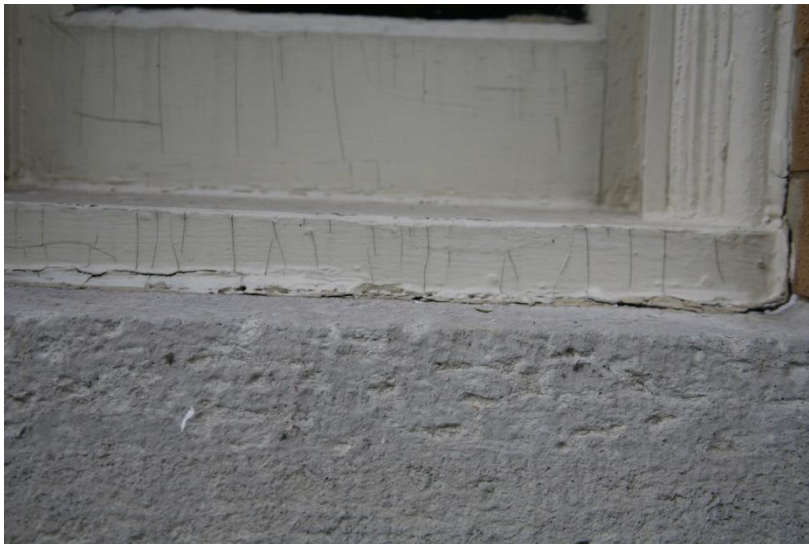
*Figure 52. Cracked/debonded perimeter sealant at connection of wood and stone sill.*

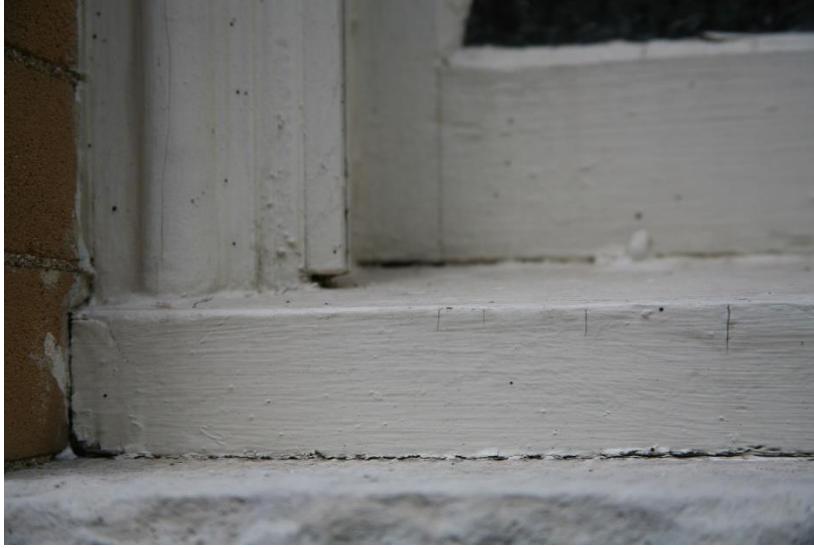
*Figure 53. No observed perimeter sealant at connection of wood and stone sill.*

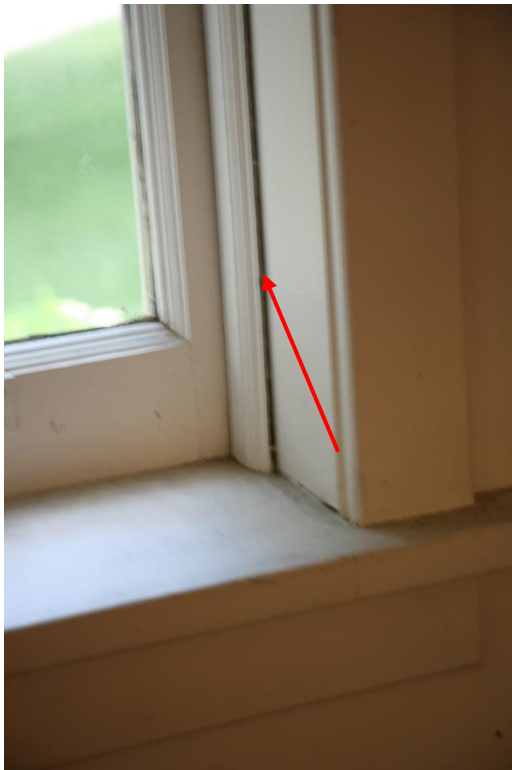
*Figure 54. Gap between interior wood stop and window frame.*

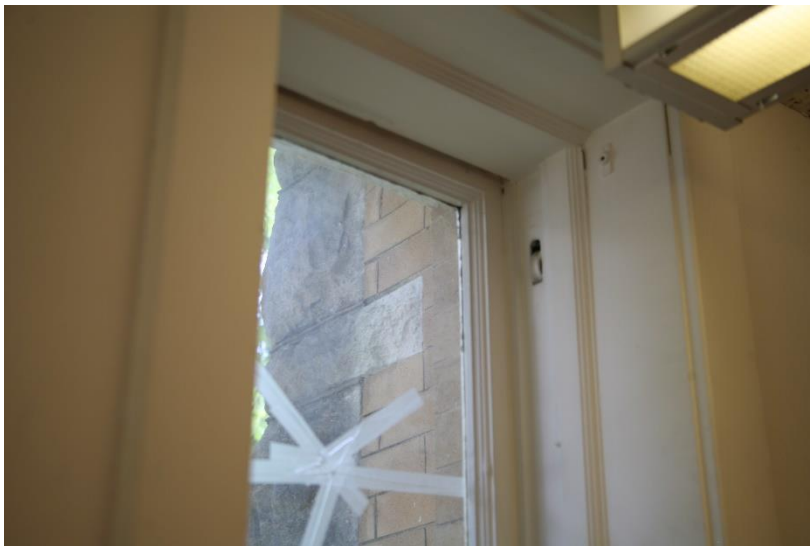
*Figure 56. View of cracked glass.*

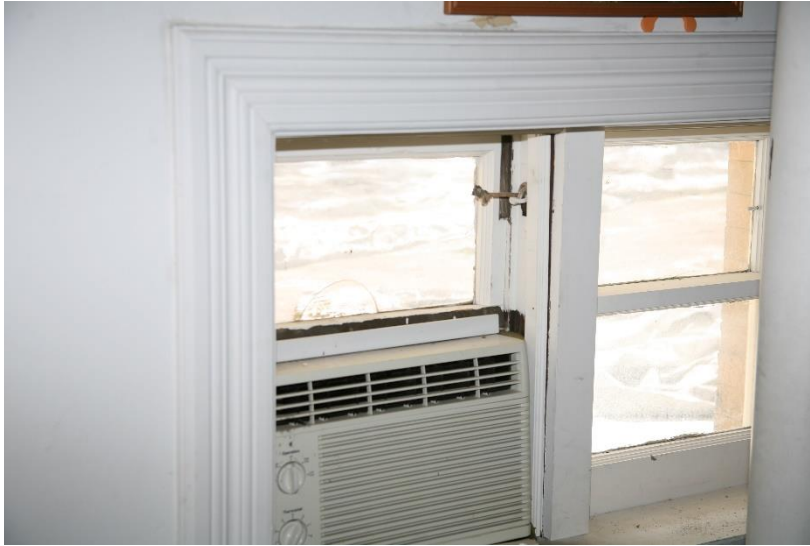
*Figure 57. Window sash modified to accommodate A/C unit.*

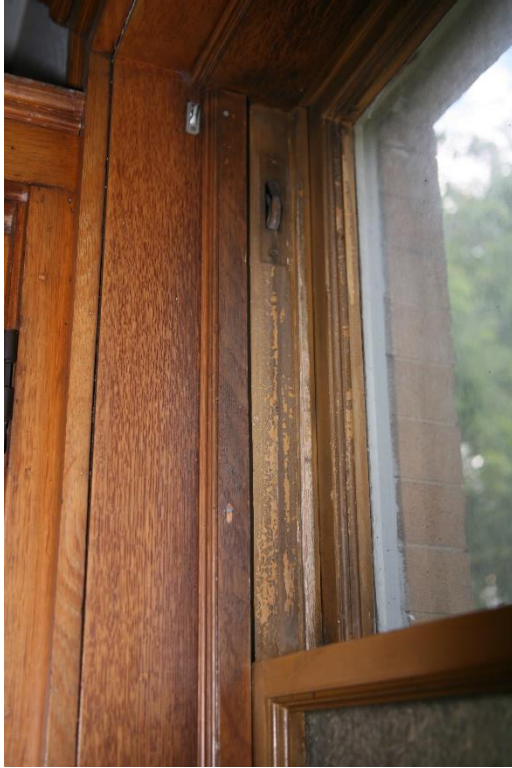
*Figure 59. View of window with missing sash cord.*

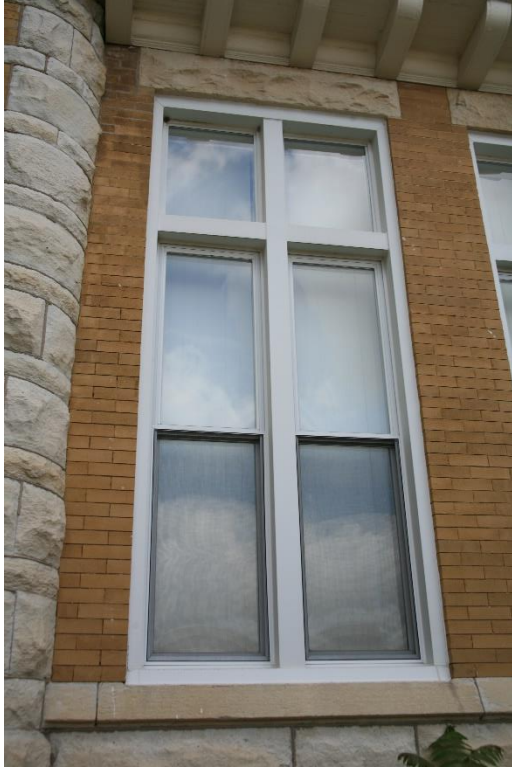
*Figure 60. View of modern replacement window on west facade.*

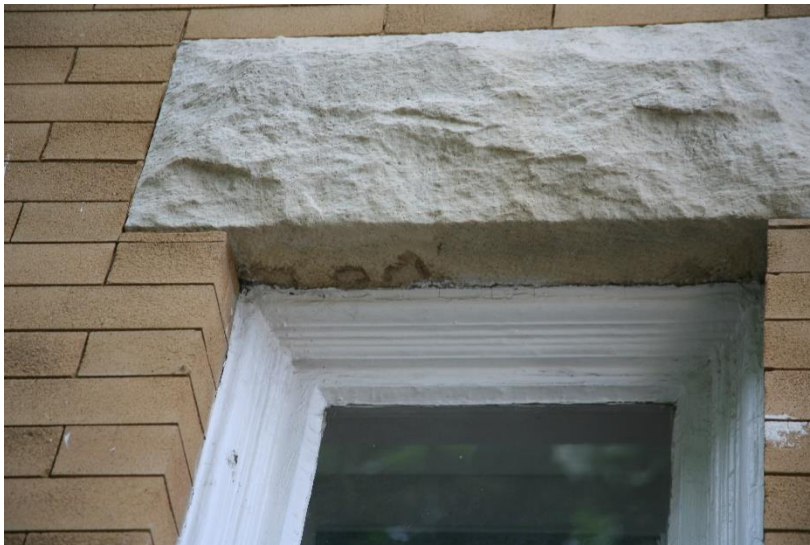
*Figure 61. View of staining due to watershed patterns on the window lintel.*

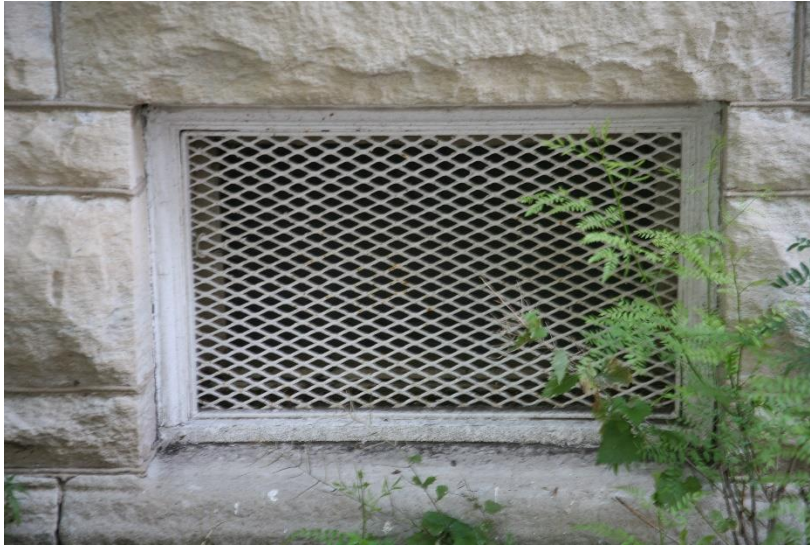
*Figure 62. Typical basement window covered with metal screening.*

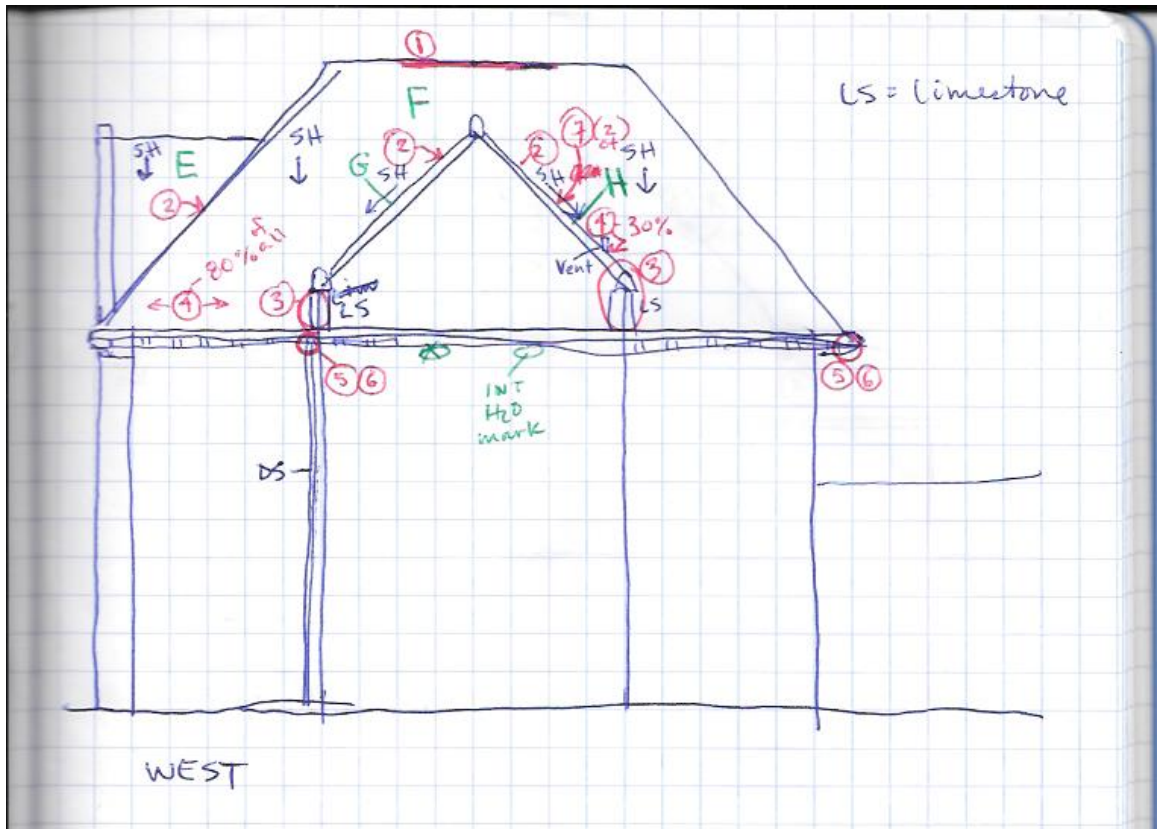
Figure 2. West roof area with condition notations.
