## OLD NICHOLS LIBRARY Limited Condition Assessment

110 South Washington Street  
Naperville, Illinois

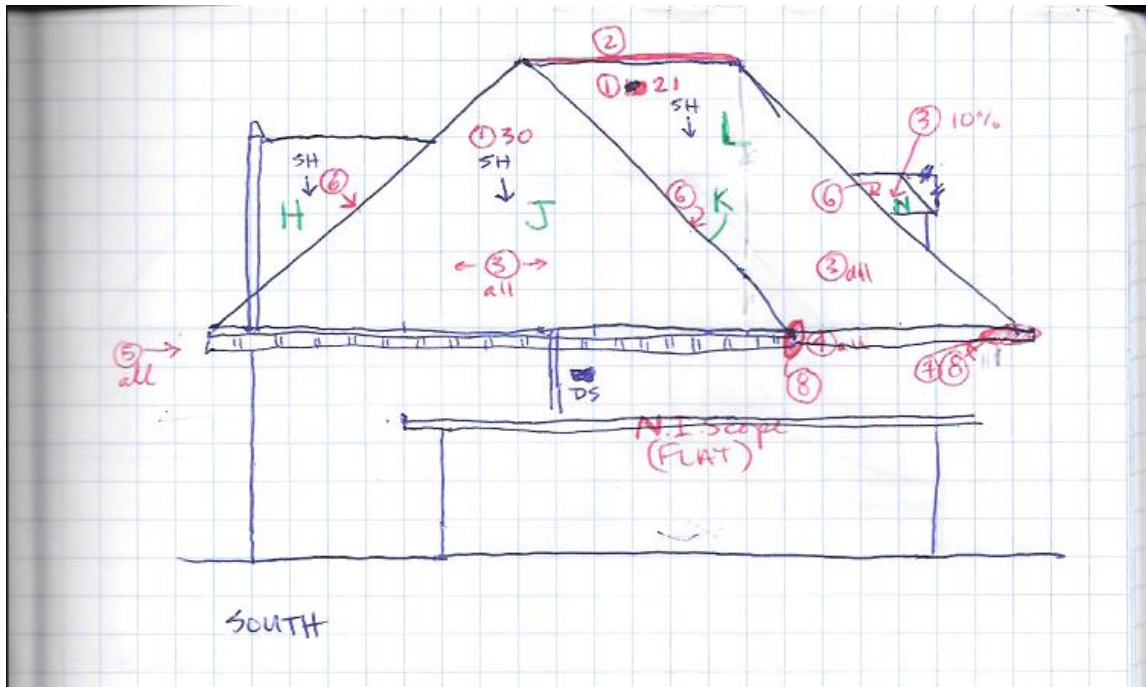
Figure 4. South roof area with condition notations.

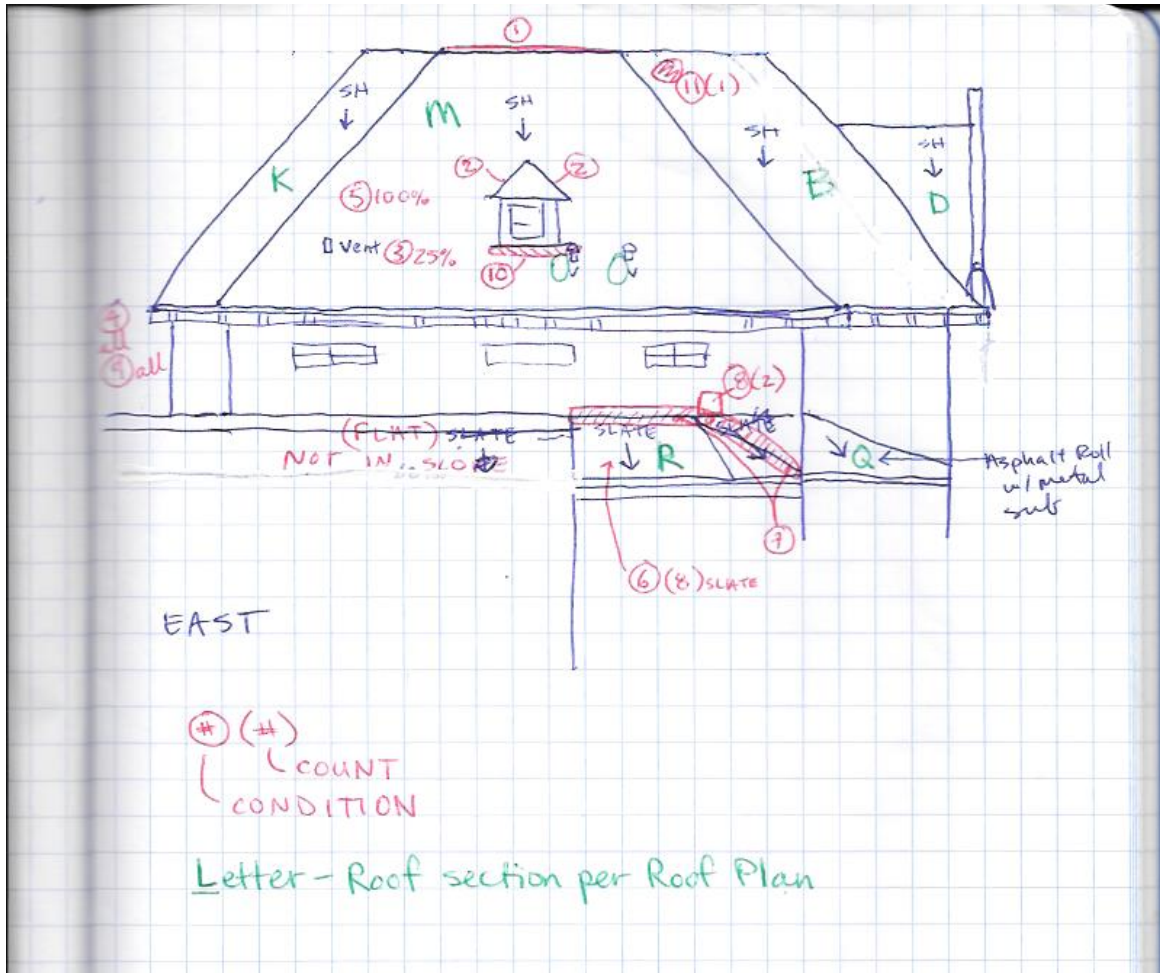
Figure 6. East roof area with condition notations.

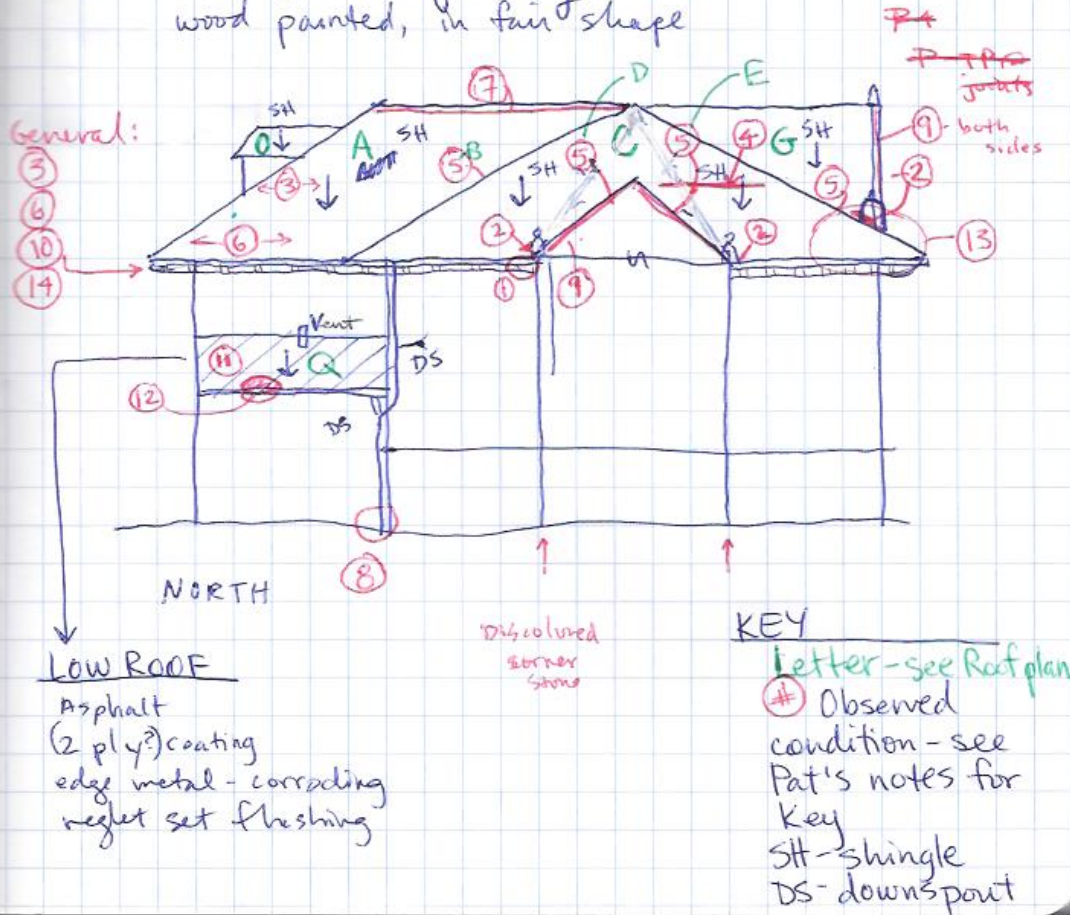
Figure 8. North roof area with condition notations.

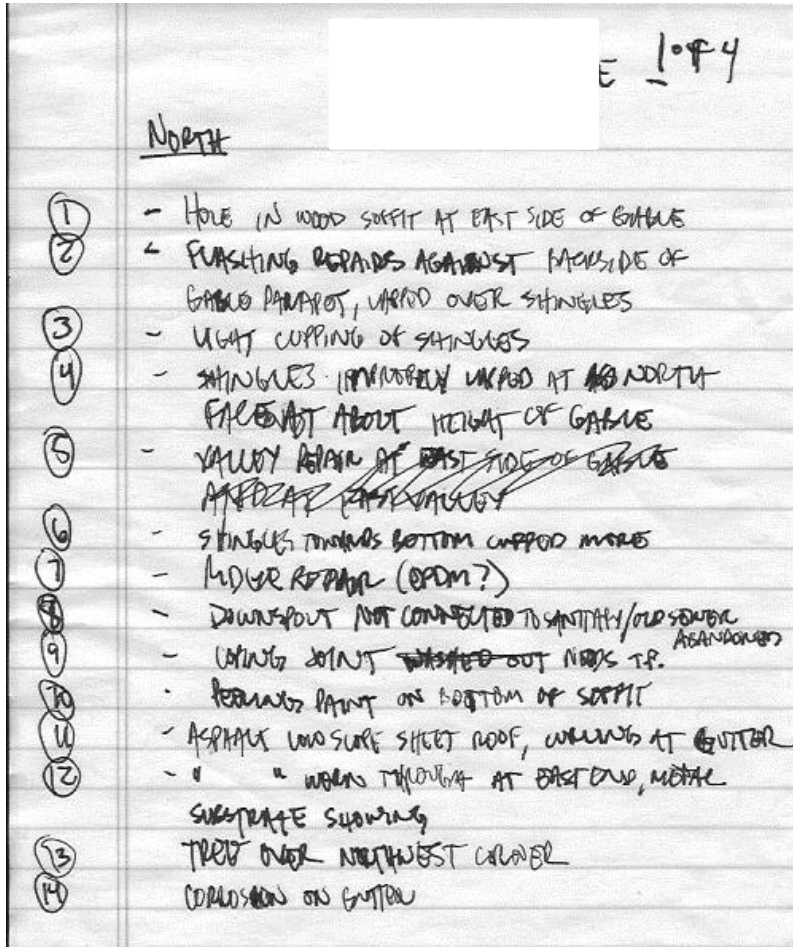
Figure 9. North roof area condition key.
