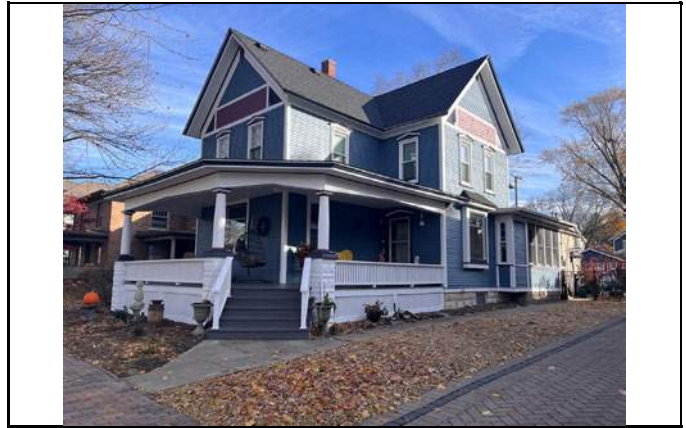
Other windows on front and side elevations appear to have been replaced after 2007 – may have been replaced without COA before 2025 COA application.

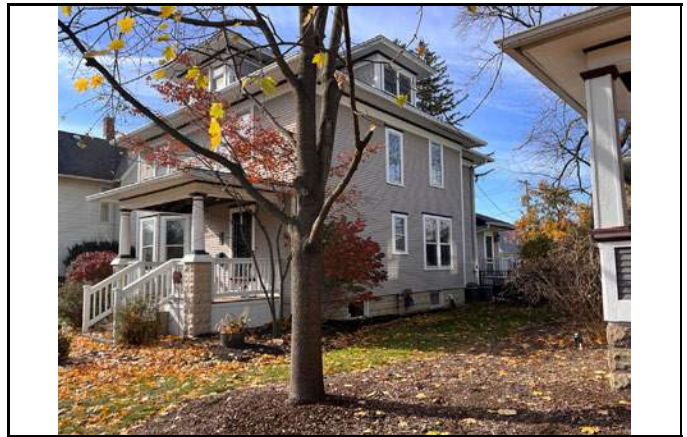
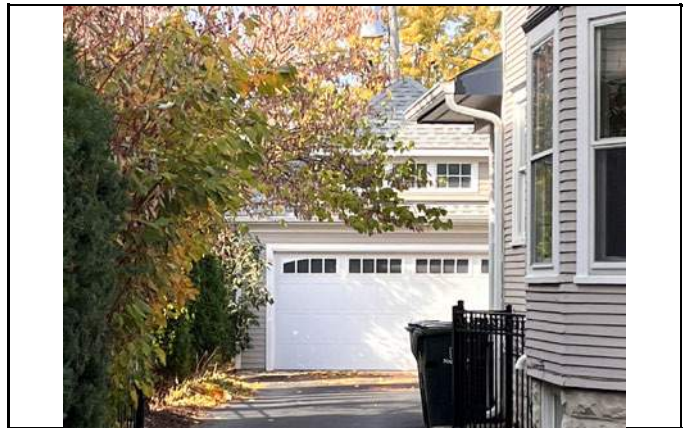
Porch railing replacement.

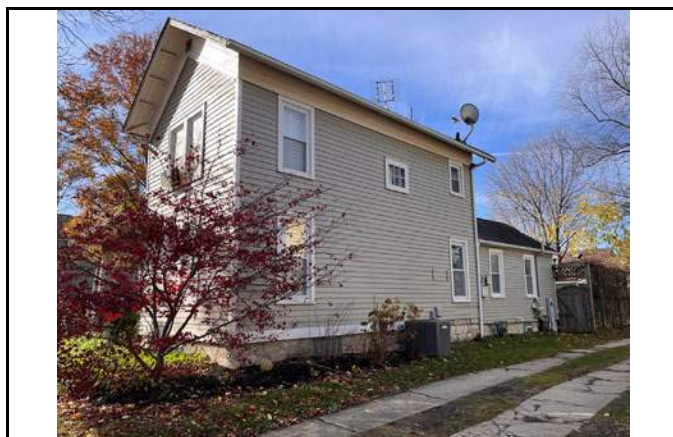
| <b>NOTES ON WORK:</b> | South deck addition. |

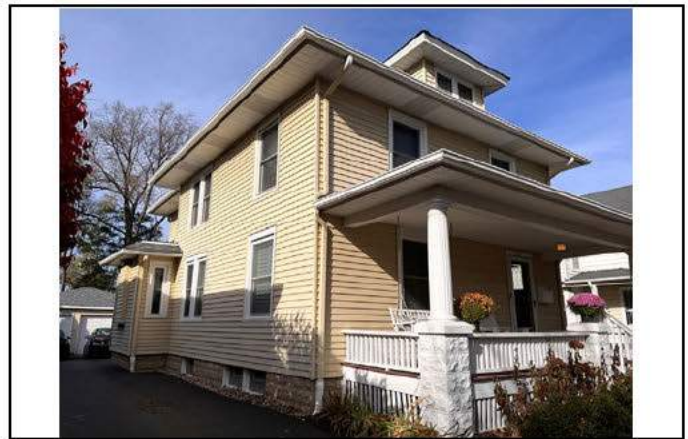
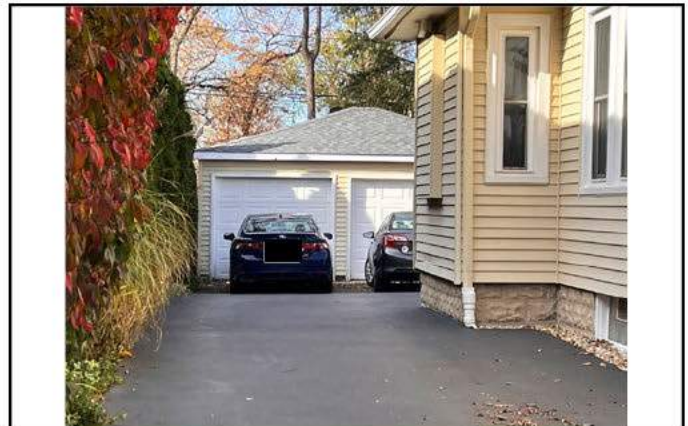
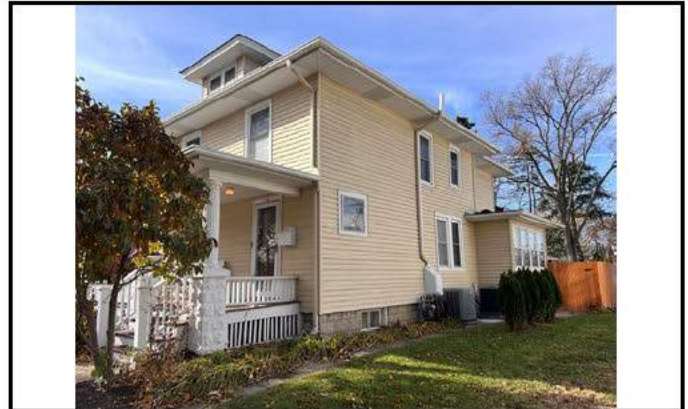
NOTES ON WORK: 2nd-story replacement windows in original openings; railing replacement at porch steps; vinyl siding replaced with what appears to be new aluminum siding.

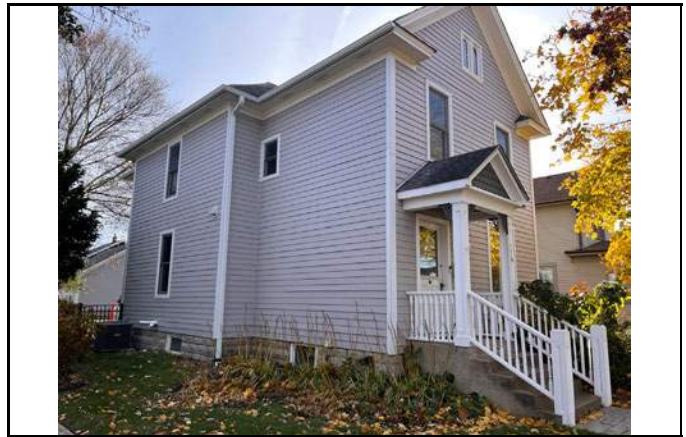
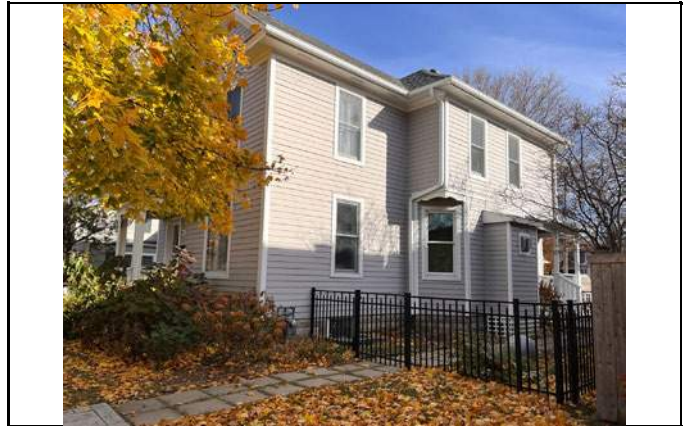
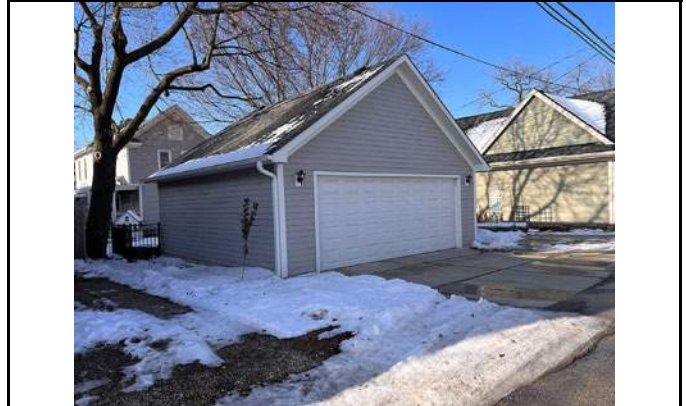
| <b>NOTES ON WORK:</b> | Replacement windows in original and altered openings on front and side elevations; bump-out on south window bay; porch railings. |
