| STREET # | 108 |
| STREET | CENTER |

**GENERAL INFORMATION**

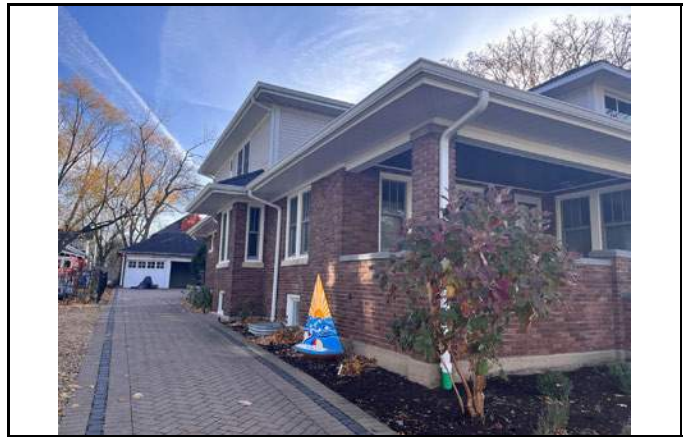
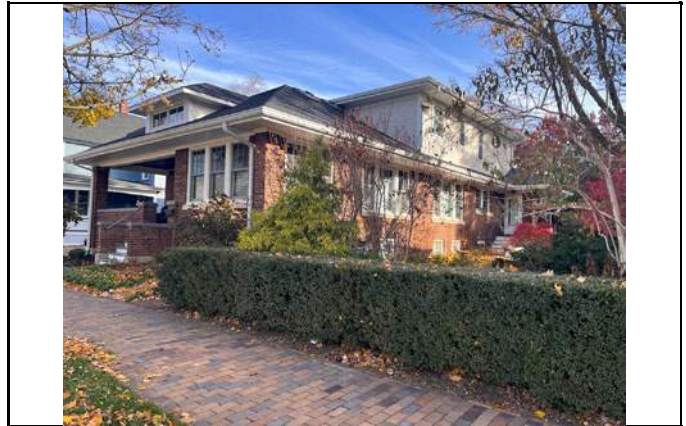
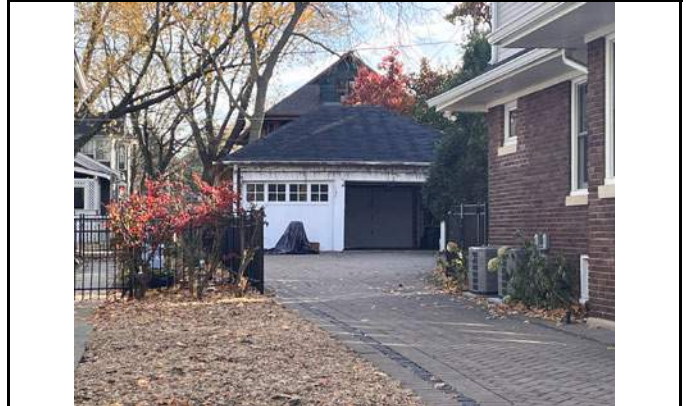
| ALTERATIONS | Second story rear addition (not historic); glass block in rear/north window (not historic); Aluminum siding under eaves. Post-2007 -- Aluminum or vinyl 3/1 double-hung replacement windows on front and side elevations; four single-light windows in dormers replaced with two 2-light windows; basement-level egress window installed on north elevation; vertical wood siding on second-story addition replaced with what appears to be Hardie board siding; removal of south dormer and second-story addition (COA approved). | | |

| COA COMPLIANCE NOTES: | Vertical board siding on existing non-historic north 2nd-story addition replaced with fiber-cement siding (likely at the same time as the south addition was constructed). |

| NOTES ON WORK: | Replacement double-hung windows on front and side elevations. |

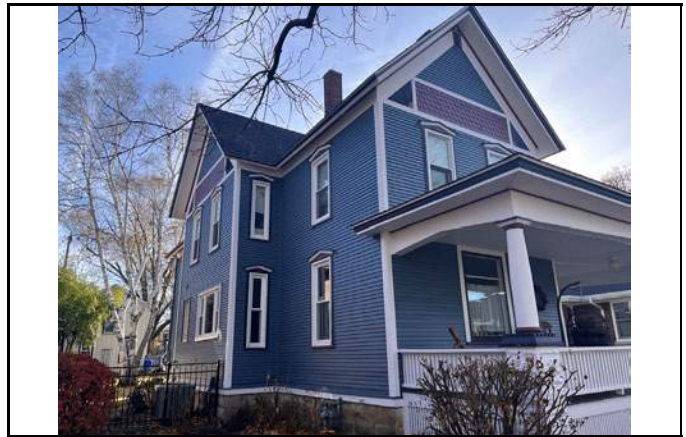
| ALTERATIONS | Replacement wraparound porch (historic-1910s); glass block and 3-part window on first story of north bay; 1 story rear porch addition; 1 story south sun porch addition. Post-2007 -- exterior repainted; asphalt shingle roof replaced (COA approved); exterior repainted; most double-hung windows on front and side elevations visible from the street appear to be Aluminum replacement windows | | |

Other windows on front and side elevations appear to have been replaced after 2007 – may have been replaced without COA before 2025 COA application.

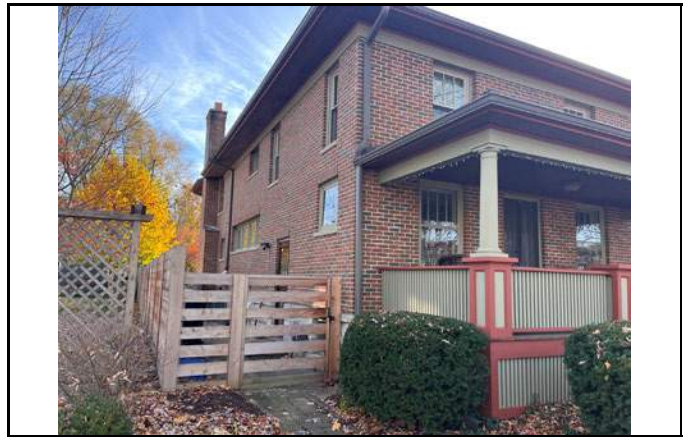
| ALTERATIONS | Brick veneering; front porch added to original house (historic--c. 1915--columns & railing may be later); two story south addition with new entry and porch (not historic); front door replaced (not historic); two story rear addition (not historic). Post-2007 -- Aluminum replacement windows in original openings with historic sash configurations (3/1 and 4/1) on 2nd story of front and side elevations. | | |

Aluminum replacement windows on second story of front façade and side elevations -- windows are in original openings and feature historically appropriate configuration.

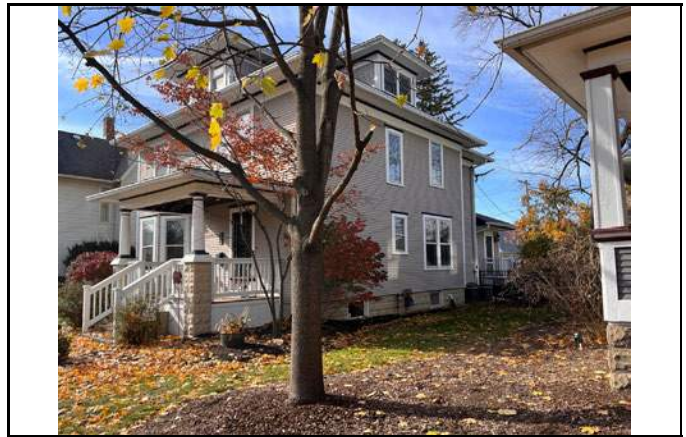
| <b>ALTERATIONS</b> | Replacement windows in dormers (not historic); front window bay addition (not historic); original full-width front porch replaced with entry porch (post-1943); rear porch addition. Post-2007 -- replacement porch railing (historically compatible); in-kind replacement of asphalt-shingle siding (COA approved). | | |

Porch railing replacement.

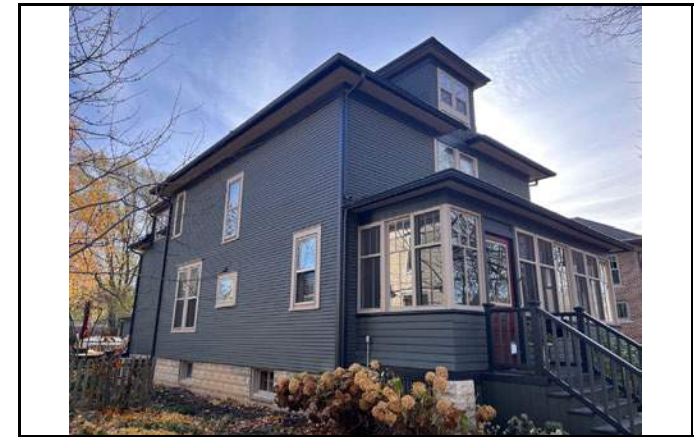
ALTERATIONS Front porch enclosed with 5-light storm windows (historic). Post-2007 -- concrete front steps and wrought iron railing replaced with painted wood steps and railings (COA approved); windows in front dormer replaced with new 1/1 double hung windows in downsized openings.

Two windows in front dormer replaced with 1/1 windows in downsized openings.

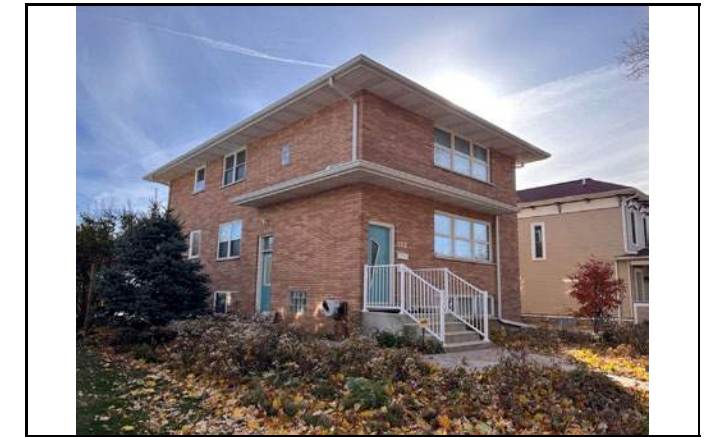
| ALTERATIONS | Post-2007 -- double-hung windows on north and south elevations visible from the street appear to be replacement windows; some basement window replacements on north and south elevations are in enlarged openings; replacement doors in front and north side entries (historically compatible); painted metal railing at steps leading to front entrance | | |

Replacement windows on north and south elevations; select basement windows replaced in enlarged openings; metal railing at front steps; replacement front and north side doors.

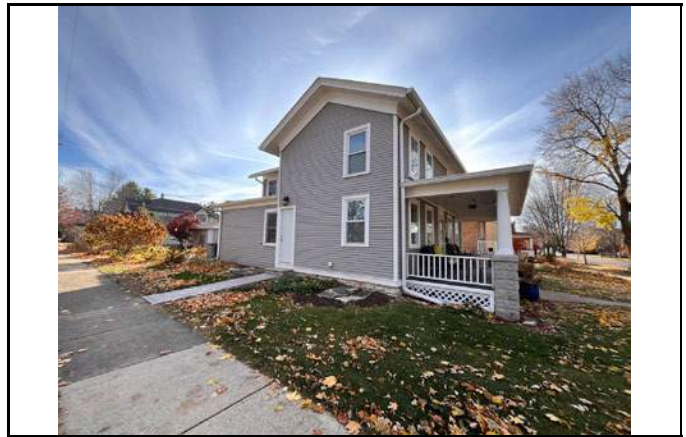
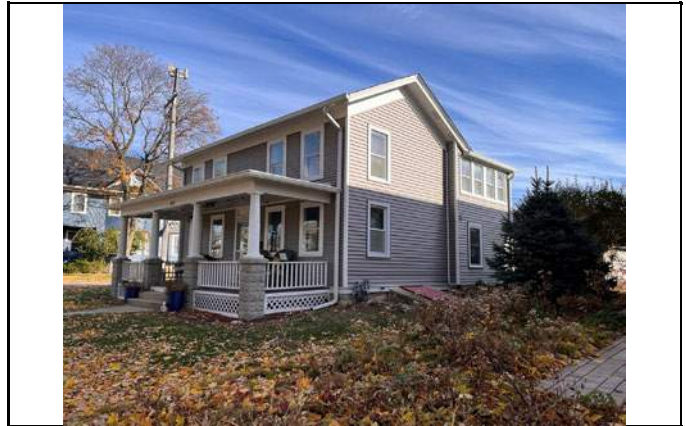
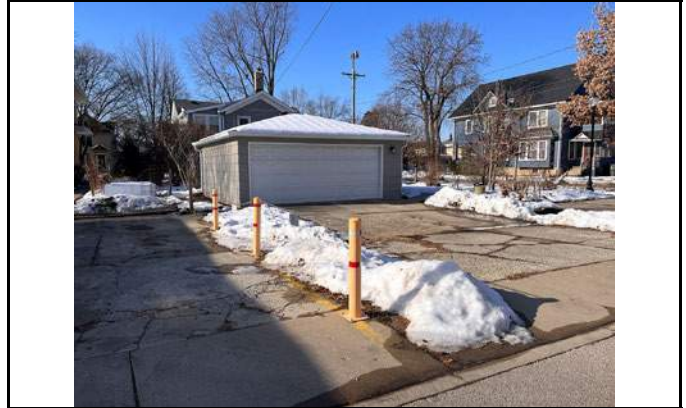
| ALTERATIONS | historic 1 story north and south side porches enclosed--2nd story added to south porch; replacement front door (1950s). Post-2007 -- 1/1 double hung Aluminum/vinyl replacement windows on north and south elevations; new front porch decking and handrails (COA approved); replacement door at secondary entrance on north elevation; concrete stoop at north entrance (not historic) replaced with smaller cast stone stoop. | | |

| <b>NOTES ON WORK:</b> | Replacement windows on north and south elevations; replacement door and stoop at north secondary entrance. |

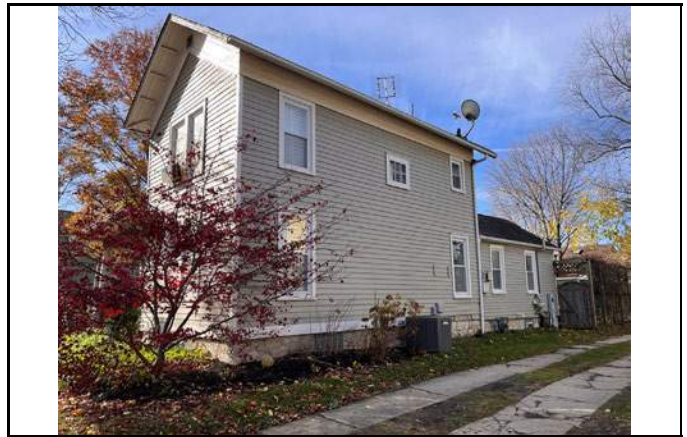
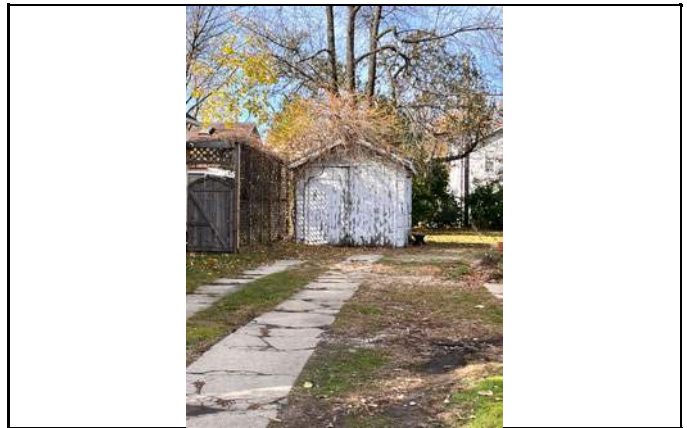
| <b>NOTES ON WORK:</b> | South deck addition. |
