Enclosed you will find our Response to the Landmark Designation Application filed for 110. S. Washington Street, known to the community as Old Nichols Library. We have made every effort to engage in a professional analysis of the actual conditions of the property and give a fair estimate of costs to restore or repair the improvement to a condition that complies with the standards for issuance of an occupancy permit under the provisions of Title 5, as specified on the City ordinance Section 1.4.1.

ORIGINAL NICHOLS LIBRARY

Building Evaluation / Facility Condition Assessment

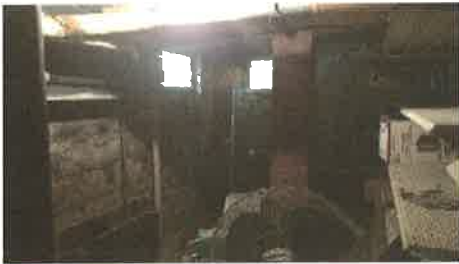
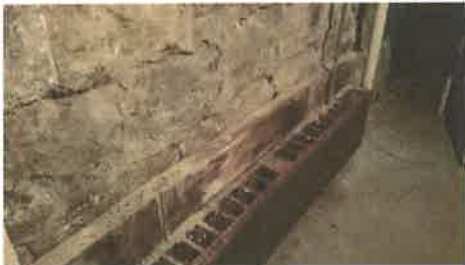
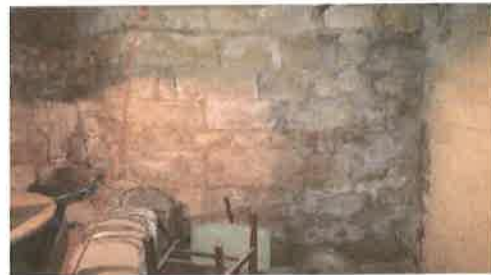
Foundations: Foundations are stone masonry type at the original library building and cast-in-place concrete at the south addition location. The stone foundations are showing signs of deterioration and water seepage at the original library structure and are in an unsatisfactory condition. Water seepage at stone foundation walls was evident at the basement level in numerous locations and flooding issues have occurred in the past based on comments made from the current user of the facility. Stone foundation walls are difficult to waterproof and typically if measures of waterproofing are attempted, they perform marginally at best.

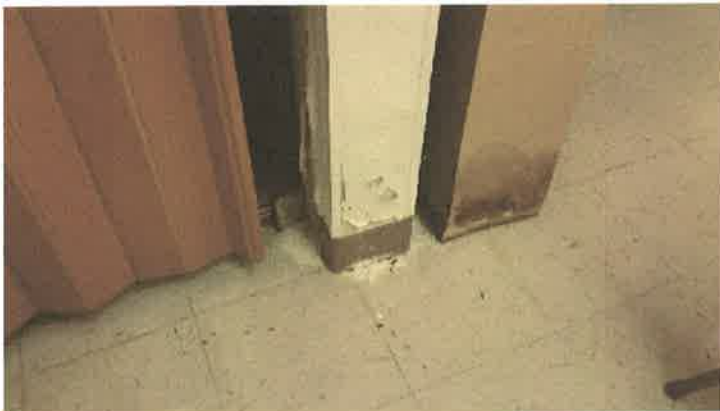
Some evidence of water damage was also noted at the south and east basement areas of the newer addition as demonstrated in the above photo.

Drywall surfaces are water damaged and several areas suggest that the basement may have flooded several times.

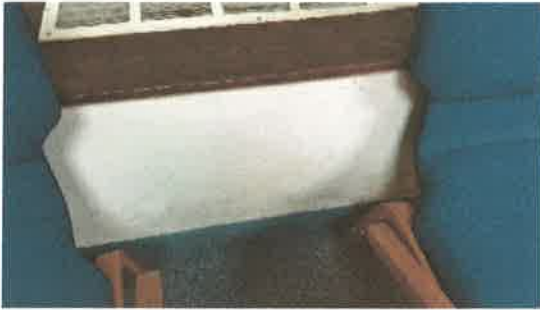
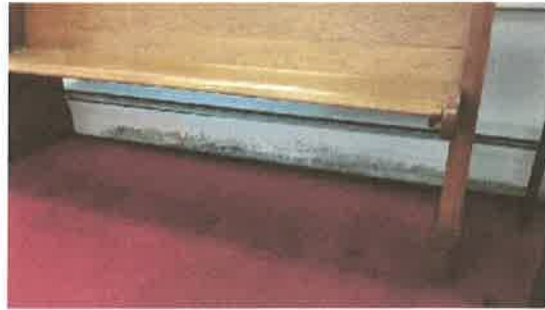
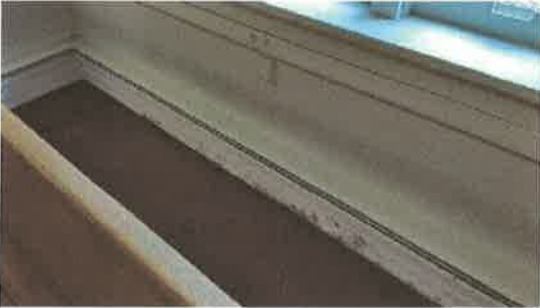
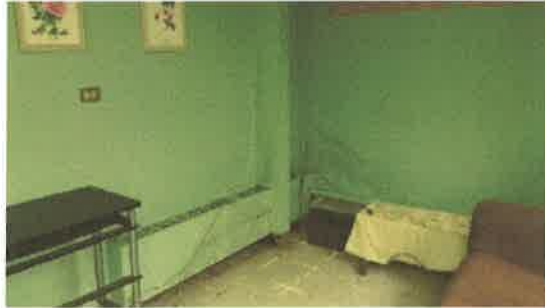
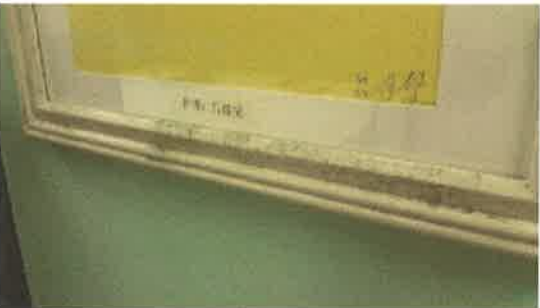
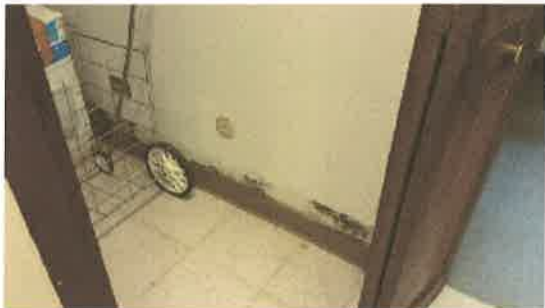
Due to water seepage, mold growth is present in the north and south basement areas. The more notable mold growth is in the north basement area of the original library structure where stone foundation systems were utilized.

Upon traversing down the stairway to the basement, a moldy smell was quite evident. Mold growth can be found on numerous surfaces and some "black mold" was also visible. The full basement area should have environmental testing performed immediately. The mold growth was so extensive that the basement area and possibly the building structure itself may need to be quarantined until a full mold remediation and basement reconstruction can be performed. Several examples of the extensive mold is shown in the photos on the following page.

It is likely that the exterior side of the stone basement foundation walls have little-to-no waterproofing systems installed. This is not an uncommon installation for structures of this age. Modern-day basement systems utilize perimeter waterproofing systems connected into a footing tile that directs water to a sump pump basin. The sump pump basin then discharges water away from the building via an on-grade discharge pipe or with a direct tie into the local storm water sewer system.

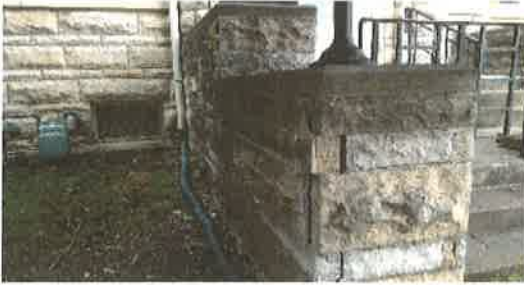
The west entrance stairway has masonry walls that flank the stairs. The northern wall has undergone deterioration as seen with the large open joints between the stone masonry. These open joints allow water to infiltrate into the masonry and further cause the deterioration.

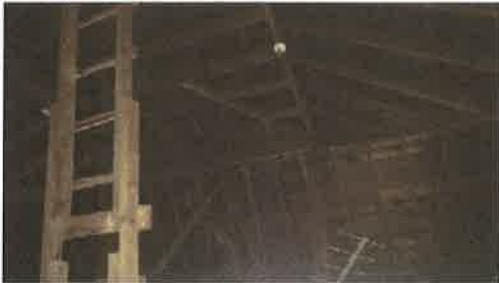
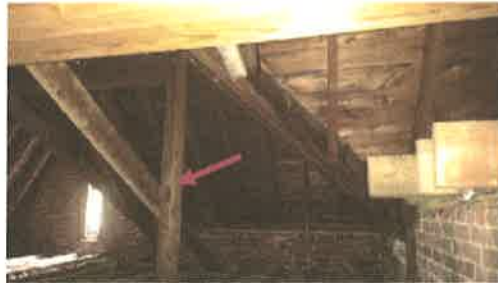
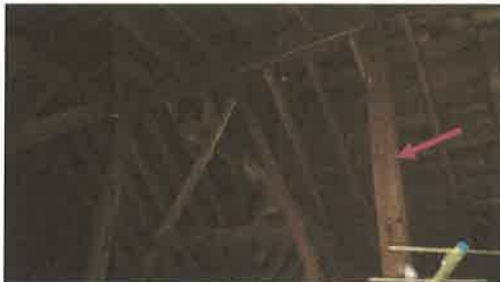
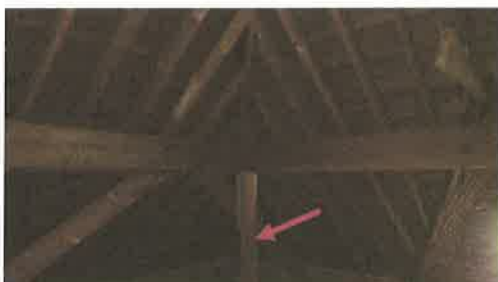
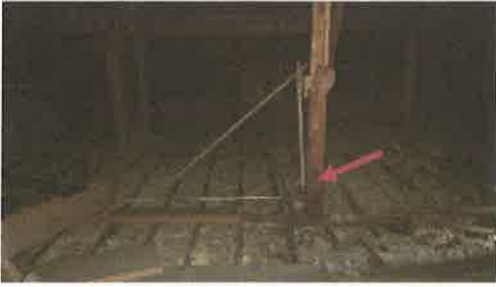
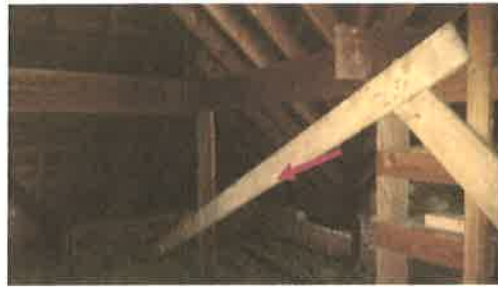
The roof structure is also comprised of traditional stick built framing supporting wood decking. It appears that structural issues were present at one point based on what appears to be random vertical post members and diagonal bracing that has been installed. These posts bear on the joists below (ceiling of the space below). These bearing locations imposed loadings to the ceiling framing which do not appear to have been designed for these additional roof loads. A re-engineering and reinforcement of the framing system would be required to adequately support the roof structure to conform to traditional engineering standards. See the photos below.

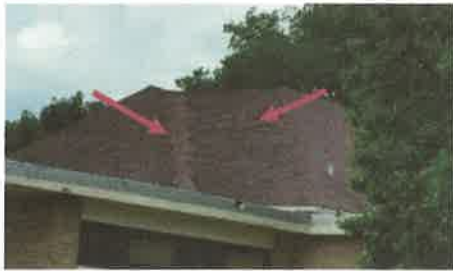
Roofing systems: Roofing systems consist of built up roofing at the south addition area and 3-tab asphalt shingles at the original library structure. The asphalt shingles at the original library area are beyond their useful life.

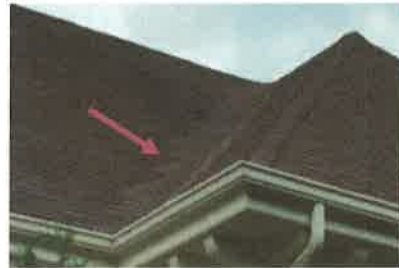
Significant cupping of the shingles at the south roof face was noted. Cupping of roof shingles is usually a sign of poor attic ventilation. Soffit and attic venting was found to be insufficient.

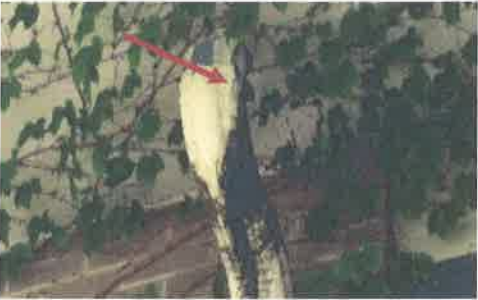
Several locations of perimeter gravel-stop counterflashing appear to have been damaged. This is likely the result of tree limb damage hitting the edges of the roof. Locations of concern are at the south and east elevations of the south addition area. The gravel stop shall be replaced at the time the roof is replaced.

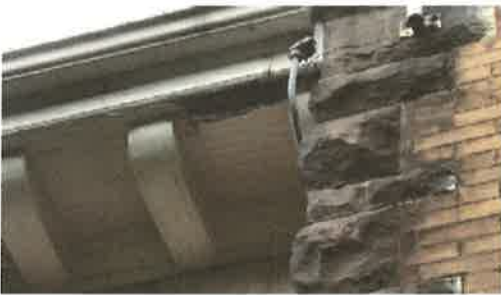
During our observation, it was observed that small animals (squirrels and chipmunks) were seen entering the structure through holes in the soffits and facias.

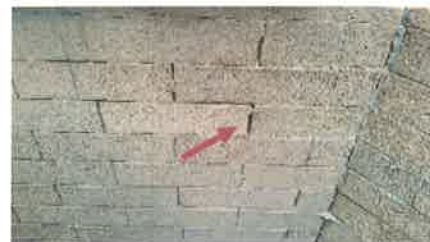
Exterior Walls: The exterior walls of the former library building are primarily buff colored brick masonry, stone masonry and include limestone accent elements at select locations. The brick masonry is in good condition for a building this age with localized areas of brick needing repairs. Several areas of the building require tuck-pointing services be performed to maintain the integrity of the structure. It shall be noted that the head joints between bricks are very tight and tuck-pointing those areas will be a challenge but is essential to maintain a watertight building.

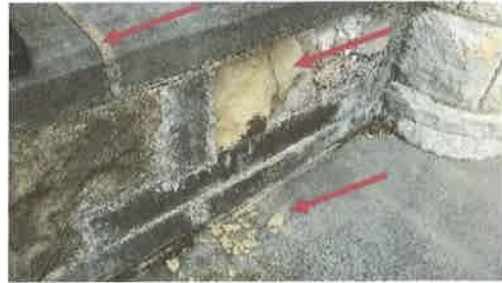
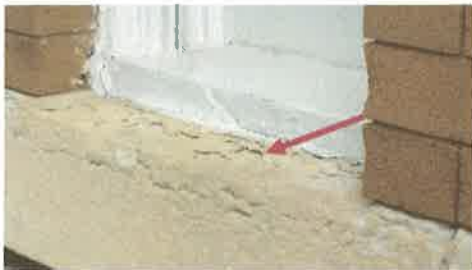
The stone masonry at the library structure is showing signs of deterioration. At the west elevation near the former building entranceway, the stairway walls are beginning to spall from moisture penetration into the wall surface. The spalled masonry is likely from the penetration of water through the limestone wall cap at open joints as shown in the photo on the right. The caps shall be removed to allow access to replace the spalled stone masonry wall elements. After stone replacement, the existing limestone caps shall either be re-installed (copings intact) or be replaced (where cracked). The underside of the limestone copings shall be replaced with metal counterflashing under the caps to divert water away from the top of the wall at the time of stone wall repairs.

Several cut stone window sills at the former library structure are beginning to crack on the top and face of the stone units. This will allow water infiltration to penetrate the unit and spall it over time due to freeze / thaw cycles. The spalled window sills shall be replaced at the spalled locations.

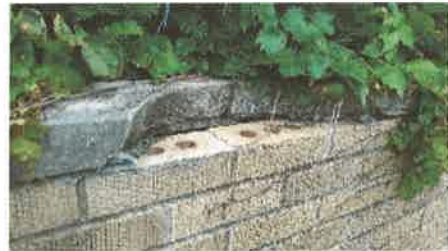
The modular brick at the south addition is in good to fair condition. Some minor masonry spalling and limestone damage was noted at the southwest corner of the building at the garden wall location.

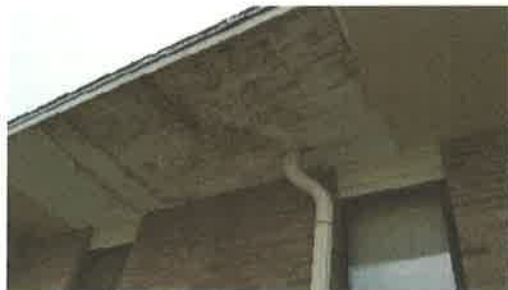
It would appear that rafter framing may also be water damaged at these locations upon review from the ground.

At the time of soffit removal and repair, any water damaged rafters shall be "sistered" with new rafter materials to match existing rafter size and then the wood soffits shall be replaced. At the time of soffit replacement, additional soffit ventilation shall be installed to increase attic ventilation as none currently exists at the former library structure.

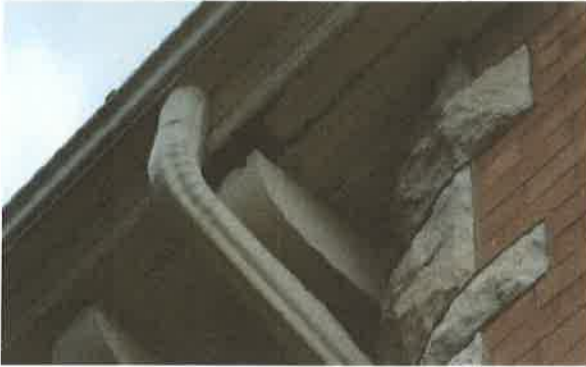
Soffit replacement (bead board) will be challenging at the original library structure due to the complex "bracket" and "ornamentation" that was added to these soffit areas. Care will need to be made to save as many original brackets for restoration and re-installation as possible. Any water damaged brackets beyond serviceable repair will need to be re-fabricated to match the existing brackets. This will likely result in increased repair and replacement costs due to the type of restoration and re-fabrication needed.

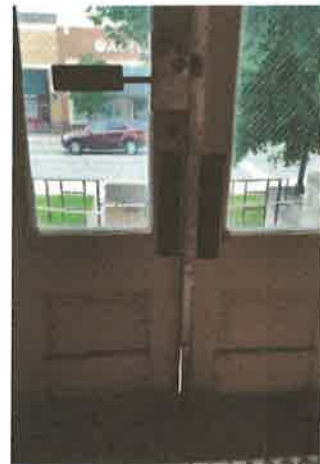
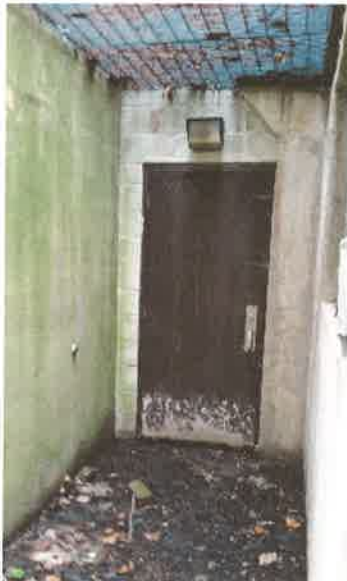
Window/Door Systems: Perimeter door systems consist of wood, aluminum and steel installations. Aluminum door systems in aluminum framing are installed at the south addition main entrance at the west façade of the building. The door system is in good condition. The hardware in this location is in poor condition. The door closers have failed and require replacement. Perimeter sealant systems at this location need to be removed and replaced.

Wood doors in wood frames are installed at the west façade of the former library building. These doors are in unacceptable condition and shall be replaced. Note that daylight can be seen at the lower section of the doorway and the base of the door is water-stained and rotten. See the photo at the right.

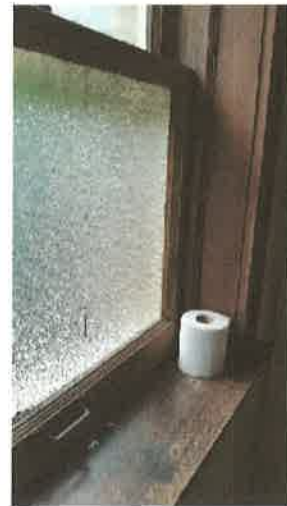
The windows at the balance of the first floor and basement areas of the original library structure are painted wood with single pane glazing that are believed to be from the original structure. The majority of the original windows are in unacceptable condition. Many cannot operate, have broken panes of glass or have had their sash cords removed. Here is a broken unit at the north façade of the building and another showing the cut sash cords.

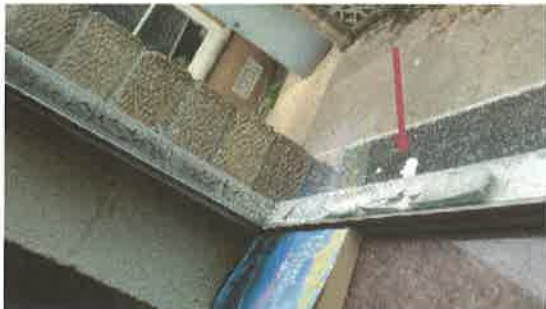
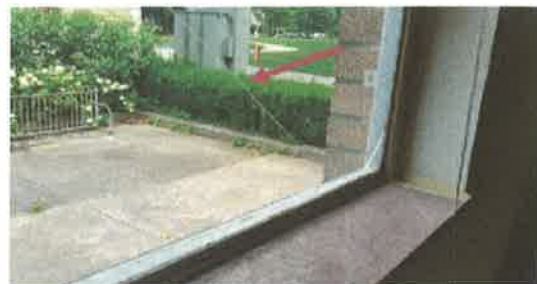
At the east side of the building on the first floor near the current kitchen and meeting rooms, existing aluminum window systems are aluminum with single glazing. The glazing compounds have all deteriorated and the windows are in poor condition. These windows should be replaced with energy efficient aluminum framing units. A picture of the failed glazing compound is shown below with a picture of cracked glazing at the same opening.

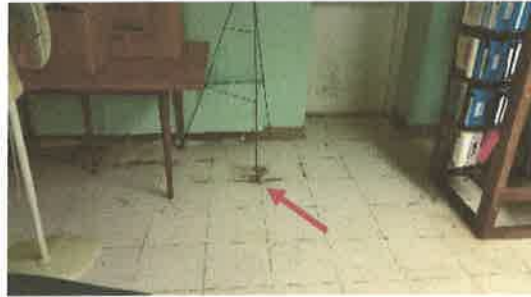
Interior Floors: Newer ceramic tile floors have been installed at the south addition main lobby area. The flooring in this location is in good condition. The flooring in the balance of the addition consists of combinations of vinyl composition floor tile (VCT), carpeting and sealed concrete surfaces. The lower level VCT flooring is in poor condition. Some tile could be removed by hand likely due to the excessive moisture in the concrete slab or from a flood event. The VCT at the south addition at the lower level shall be replaced in its entirety when the basement mold remediation work is performed.

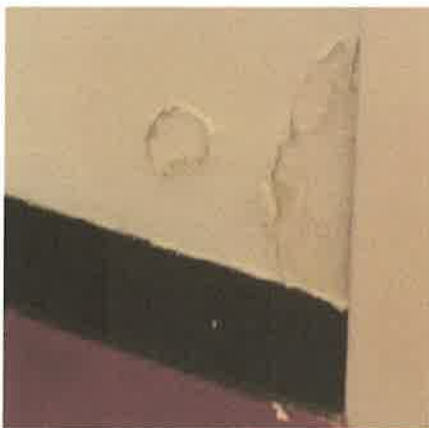
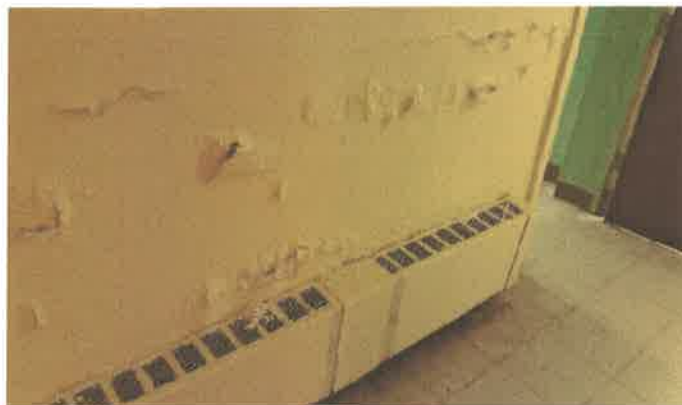
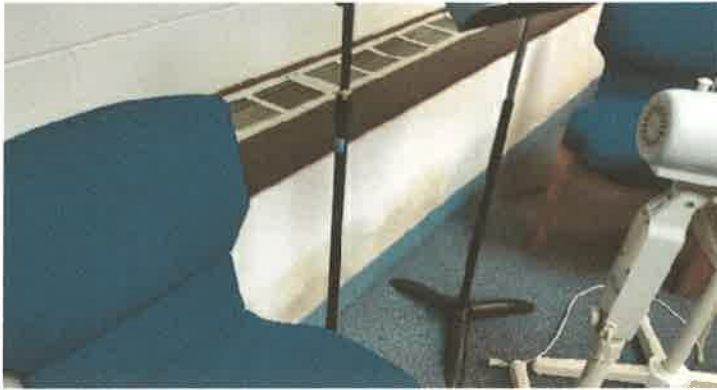
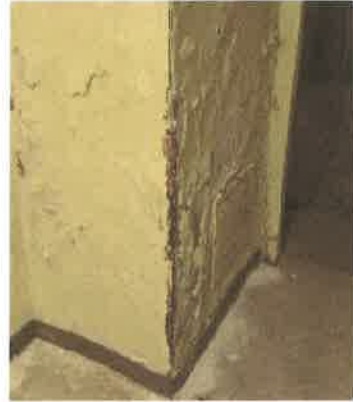
Interior Walls: Walls at the south addition are primarily drywall types that are painted. Drywall adjacent to windows or steam baseboard heaters are exhibiting signs of water infiltration or mold growth. Wall surfaces at the former library building are combinations of drywall and plaster with sections of the basement appearing to be parged plaster over stone foundation systems. All water or moisture damaged drywall or plaster surfacing should be removed and replaced. The extent of drywall / plaster replacement cannot be determined at this time but is expected to be extensive due to the mold and moisture conditions witnessed. A few photos of mold or water damaged walls follow:

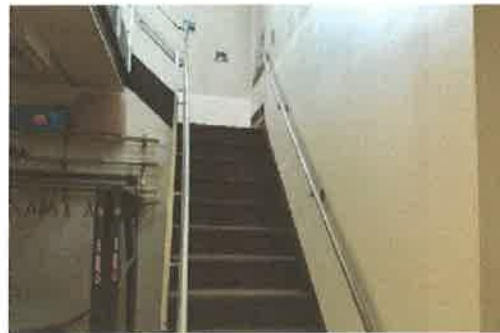
The carpeted interior stairway at the former library area that leads to the second floor level is not code-compliant. Stair risers, handrails and treads do not meet the requirements for modern day staircases. If the building is converted to a public use, this stairway will need to be replaced and brought up to code.

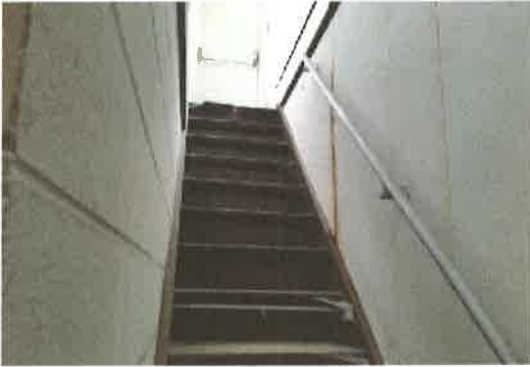
An exit staircase from the south addition basement to the exterior is shown in the photo at the left. Handrails in this staircase are not code-compliant and should be replaced. Handrails should extend to each landing level and should be on both sides of the staircase.

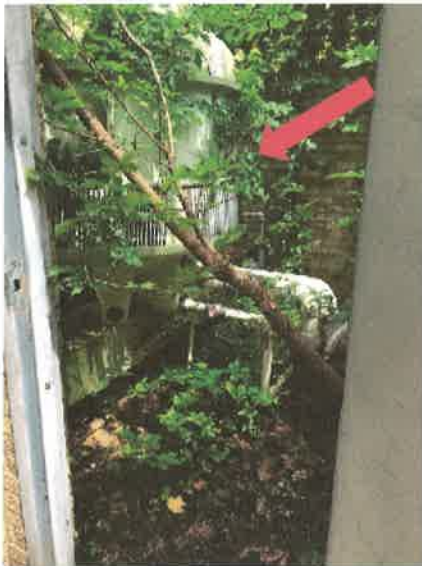
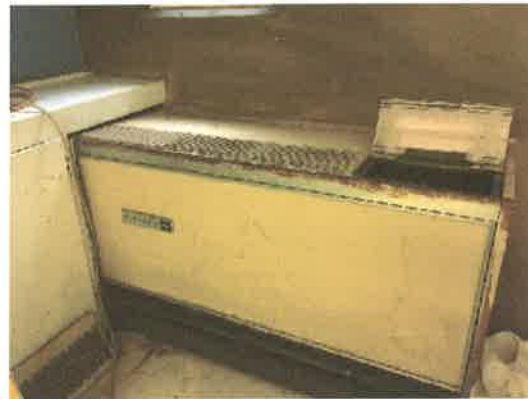
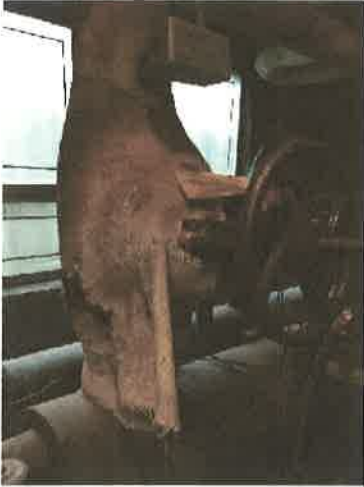
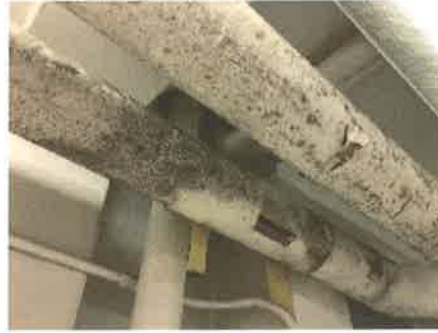
The unit ventilators are in poor condition with corrosion (especially in the lower level) and parts missing. Additional heating units include cabinet unit heaters and fin tube radiators. These units are also in poor condition. Heating and cooling water is pumped to the terminal units through insulated pipes. The insulation has mold growth along the length of the pipes. The pipe fittings appear to be insulated with asbestos compound. The two boilers are near their median service life. The original building controls were pneumatic. A direct digital controller has been installed, although the extent of the control is unknown. Restroom exhaust fans are also in poor condition.
