## Craftstone Architects, Inc.

14150 S Route 30, Suite 201  
Plainfield, Illinois 60544

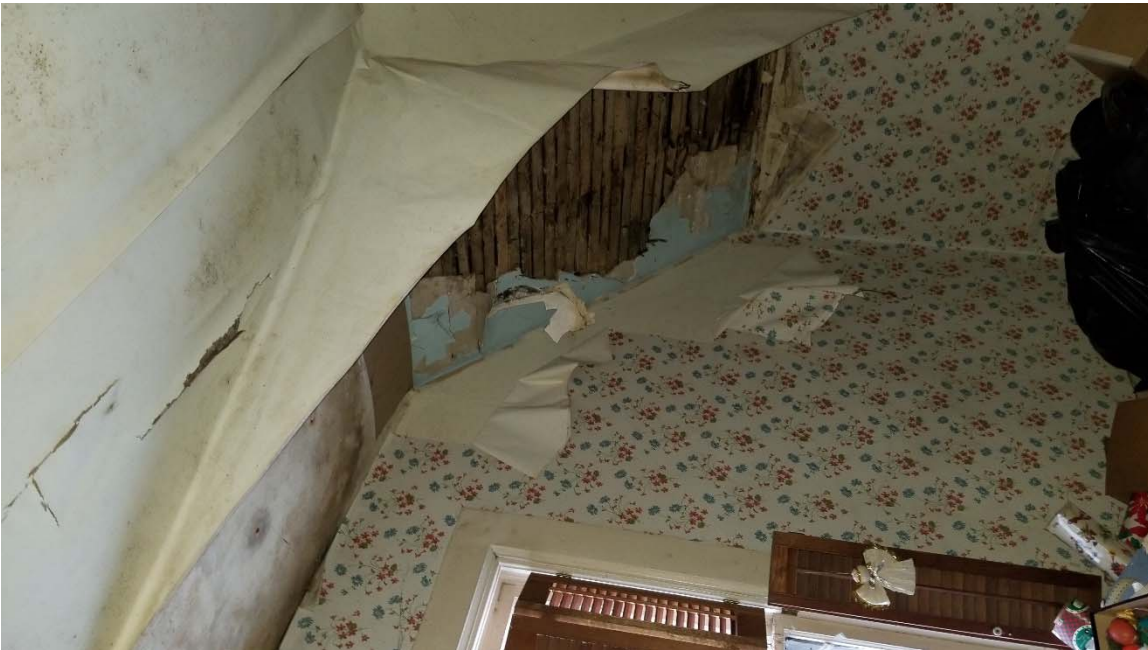
Image 6 – 2<sup>nd</sup> floor southeast bedroom with ceiling falling in and showing signs of mold due to water damage

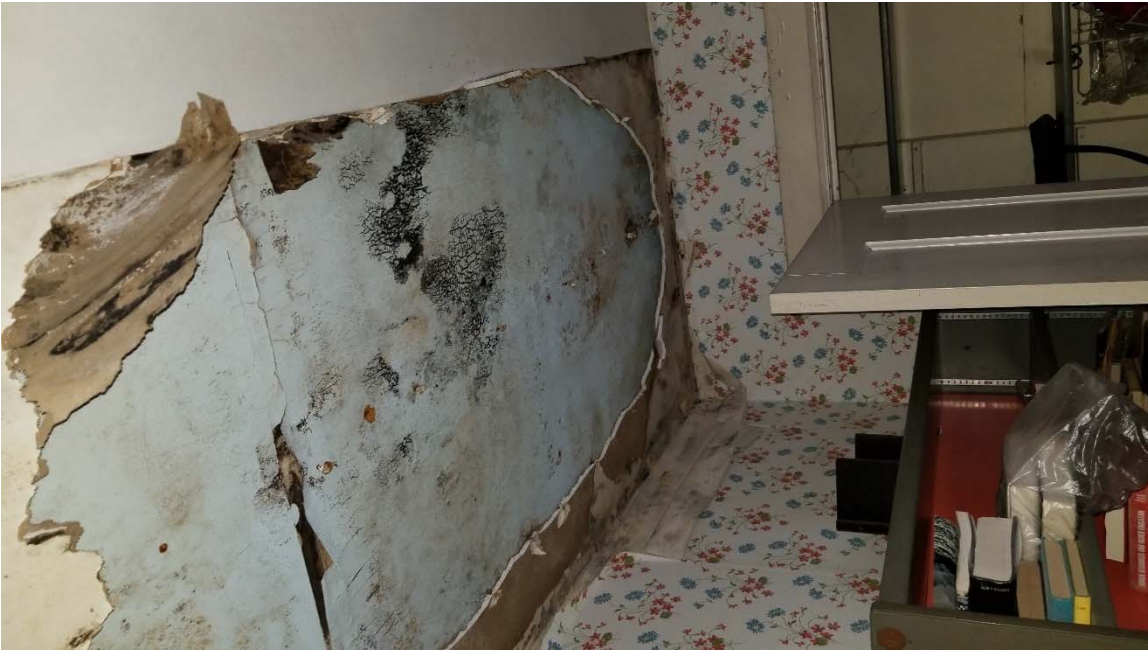
Image 7 - 2<sup>nd</sup> floor southeast bedroom with ceiling falling in and showing signs of mold due to water damage

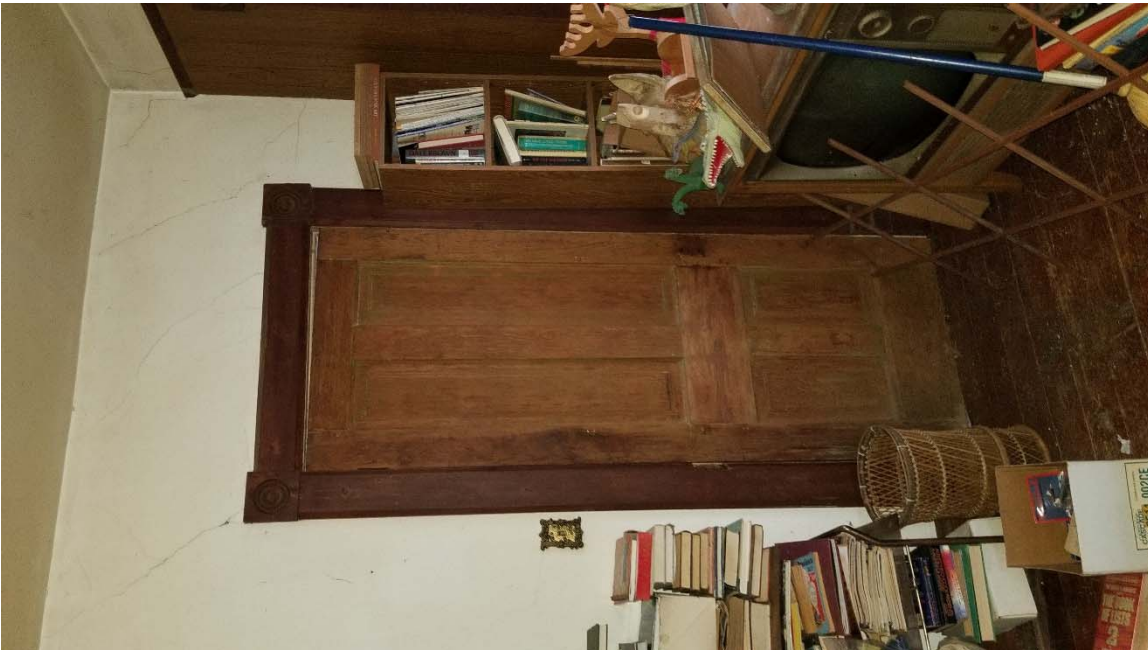
Image 8 – Door to foyer from front living room that is no longer square in jamb and stuck closed

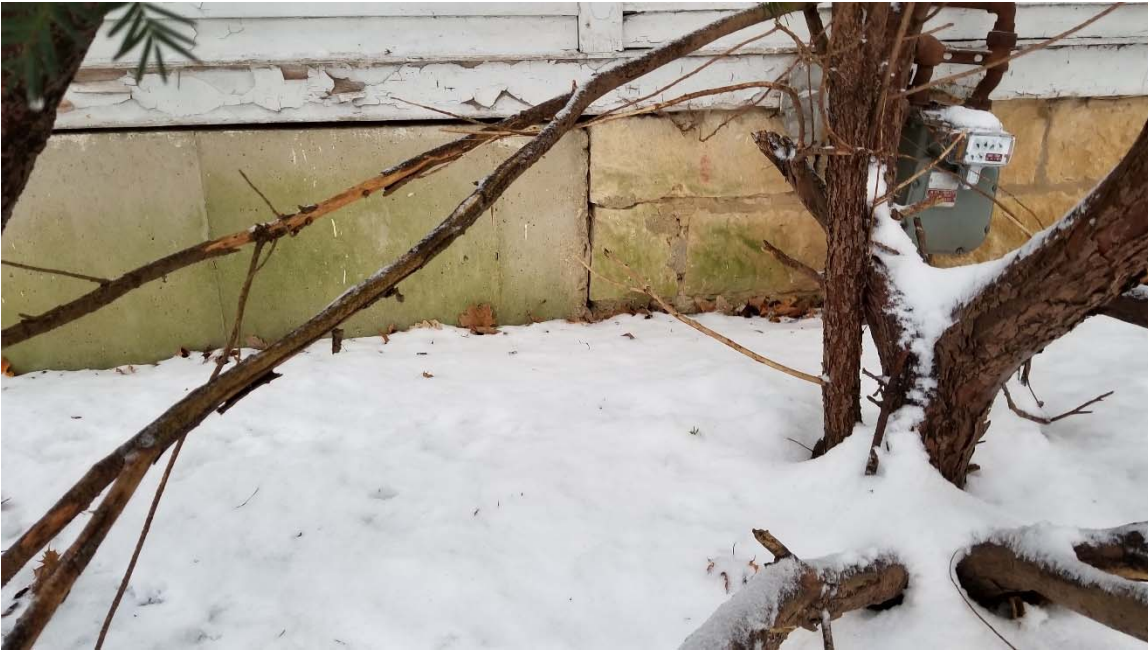
*Image 9 – Concrete foundation dropped or settling at stone foundation. Stone foundation has signs of cracking also.*

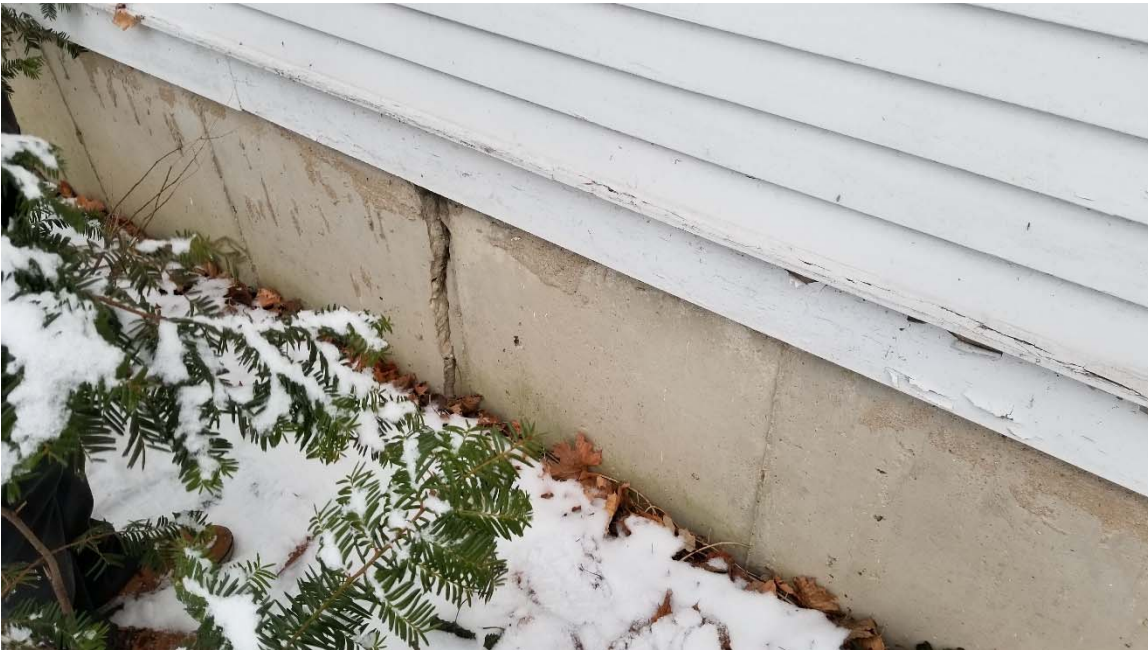
*Image 10 – Concrete foundation with significant crack with separation in foundation.*

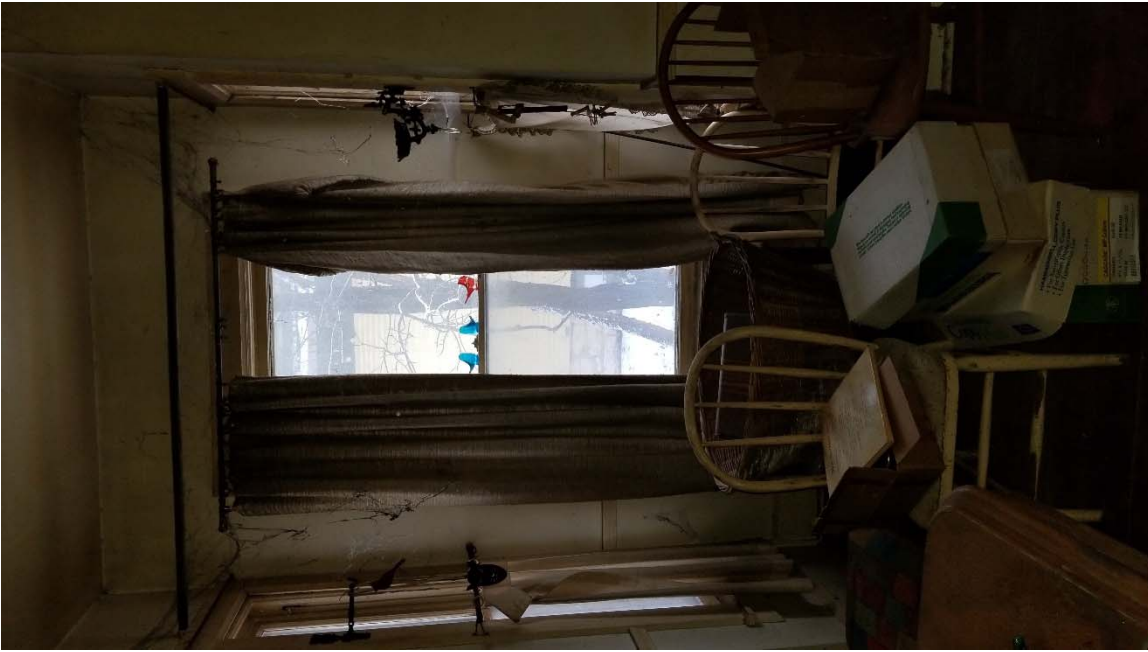
*Image 11 – Bay bump out at dining room from inside with floor, walls and ceiling dropping at outside wall.*

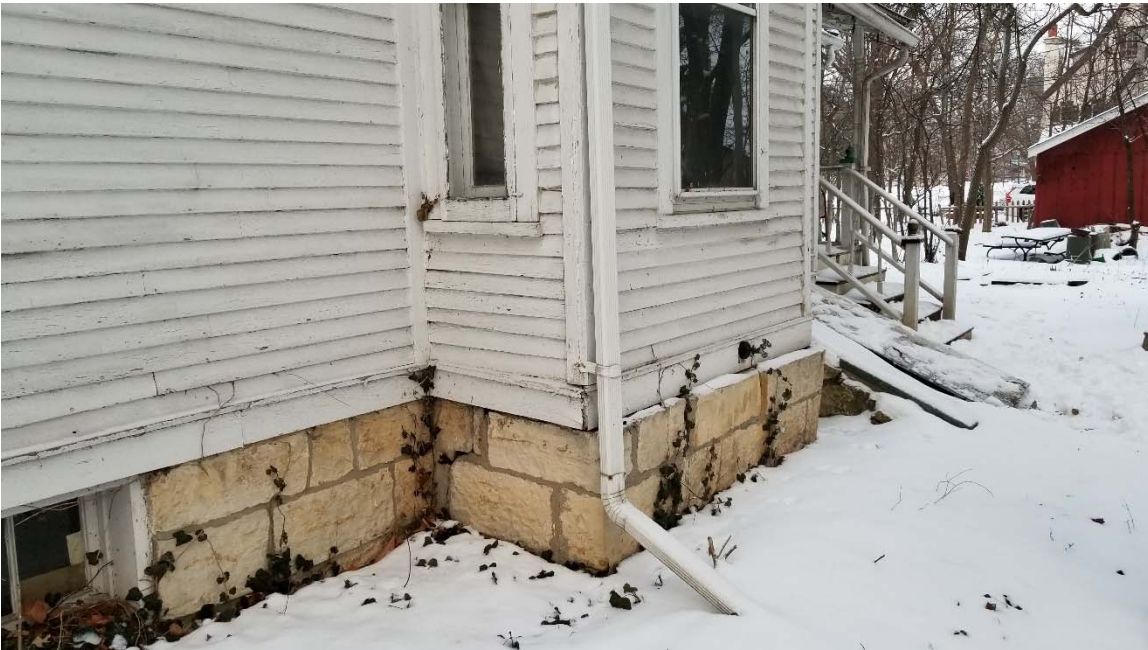
*Image 12 – Bay bump out at dining room with dropped floor, walls & ceiling. Foundation cracked and pulled away from main foundation.*

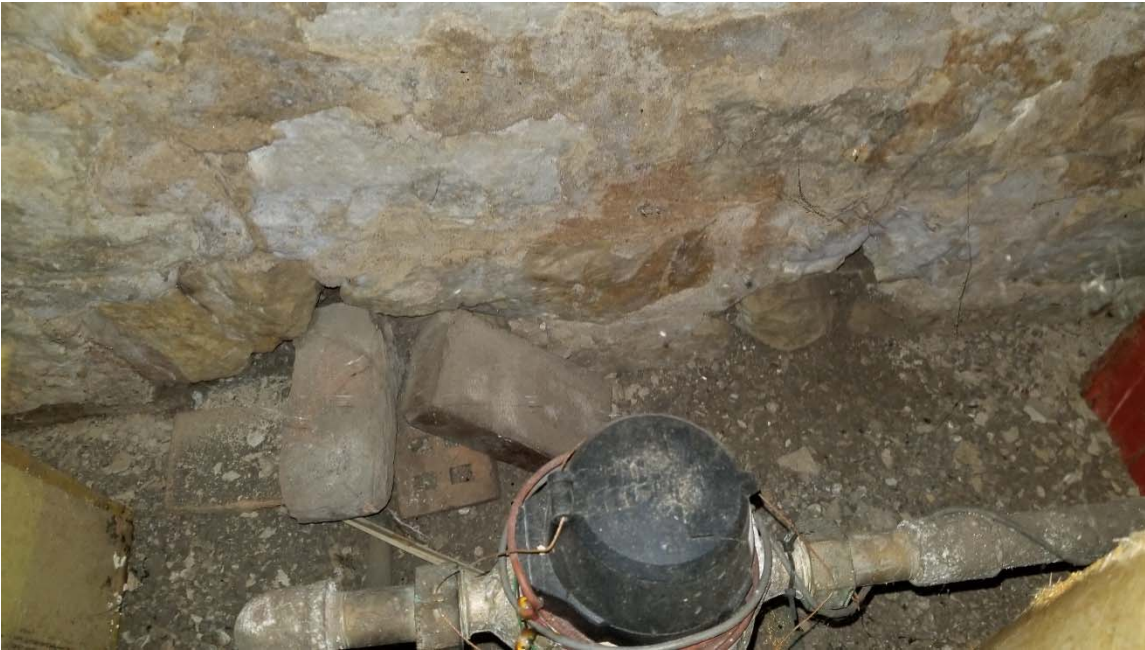
*Image 13 – water meeting with copper connections to lead water piping. Also, bottom of wall where bricks and stones located have holes where water and debris is filtering into basement.*

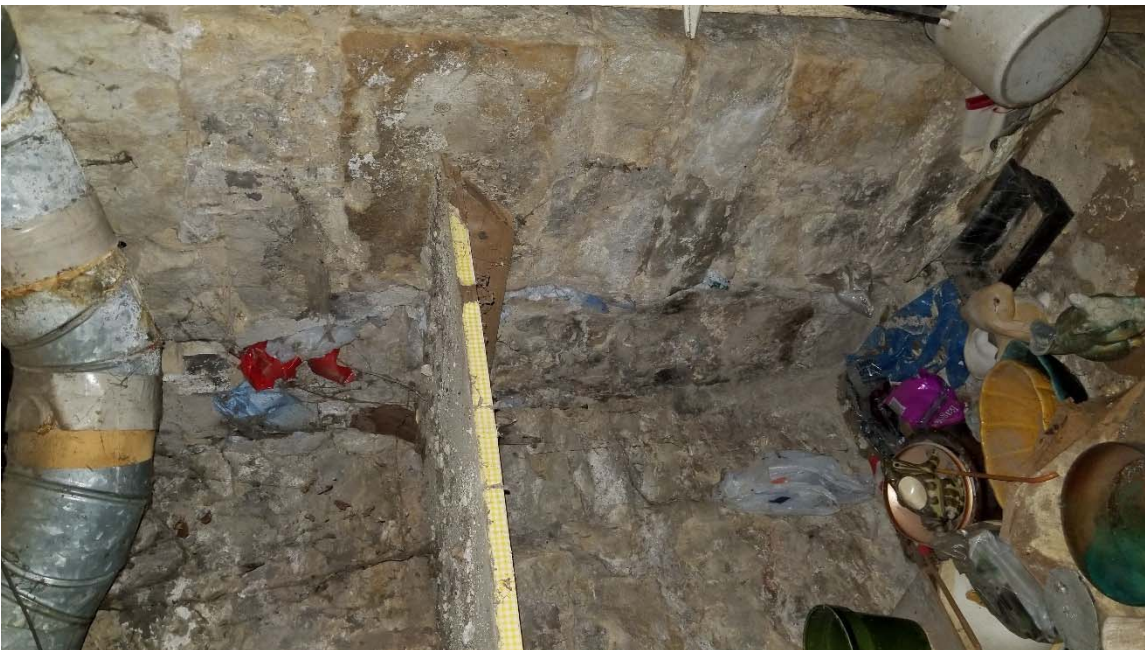
*Image 14 – Ductwork is corroding and stone foundation has signs of patching large cracks with plastic bags shoved in cracks and towards bottom one of the cracks appears to be filled with silicone caulk.*

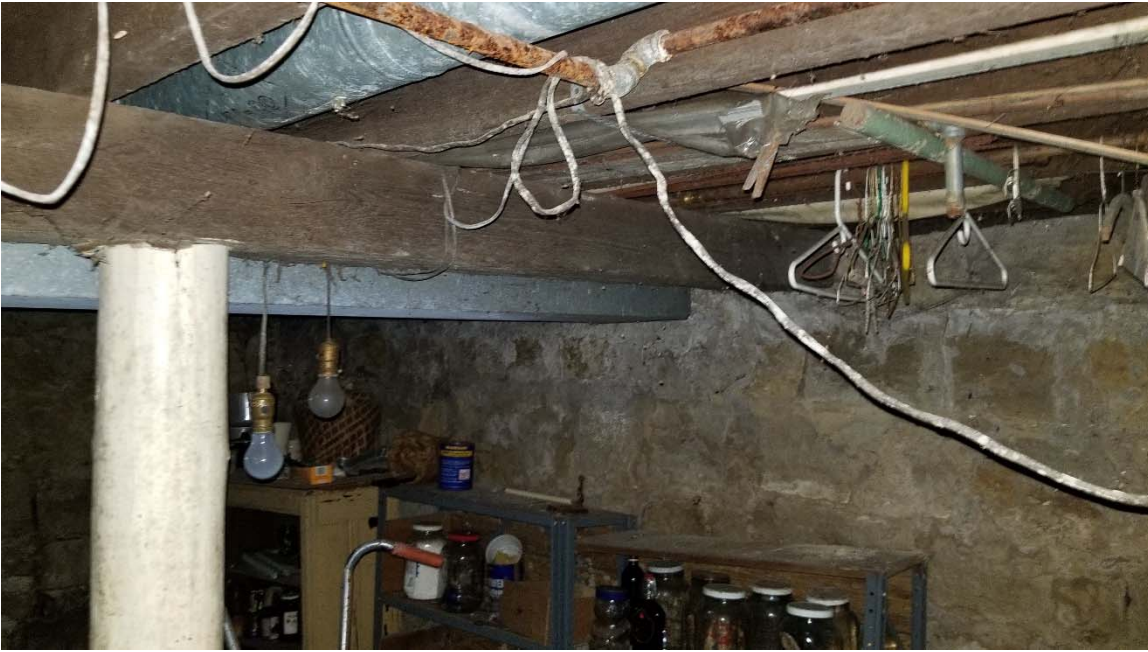
*Image 15 – Undersized basement wood beam with lights hanging from ceiling with rope cord*

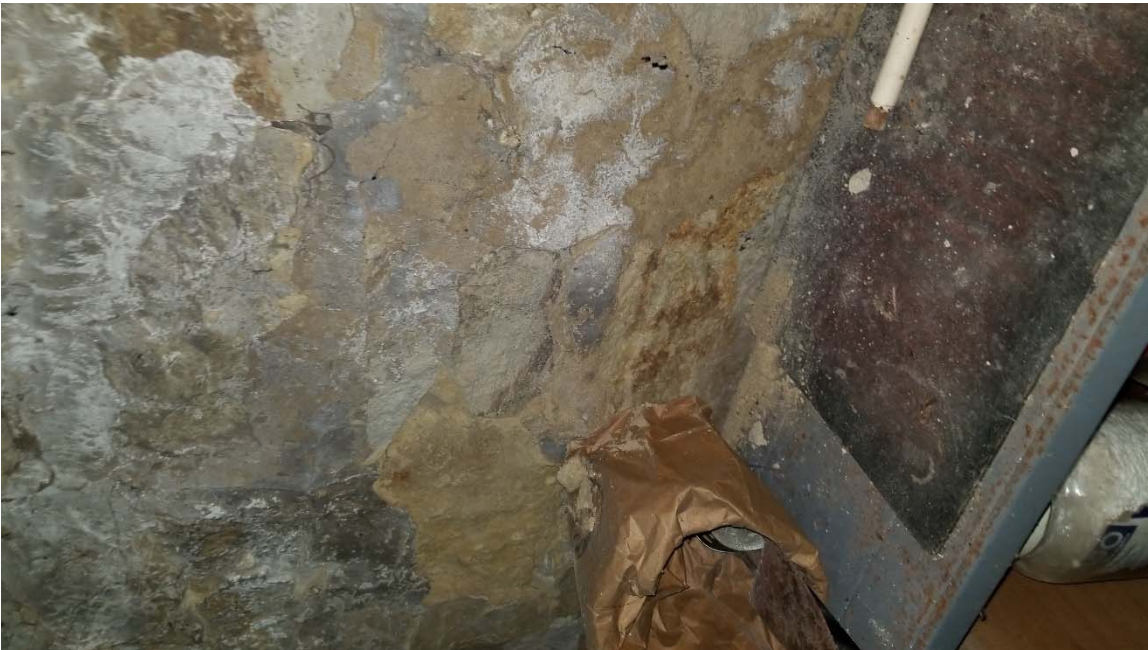
*Image 16 – Stone foundation joints patched and if rubbed with finger, is rubs off as can be seen with sand sitting on wood ledge.*

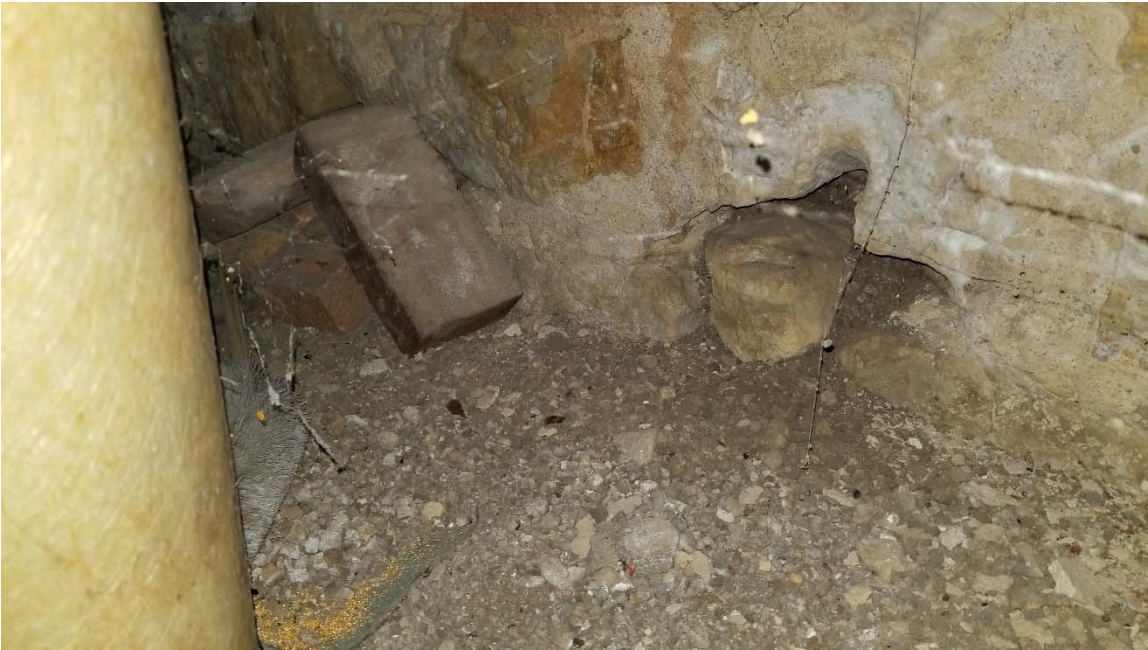
*Image 17 – Stone foundation wall plugged with stone and brick with signs of water and sediment entering basement from outside.*

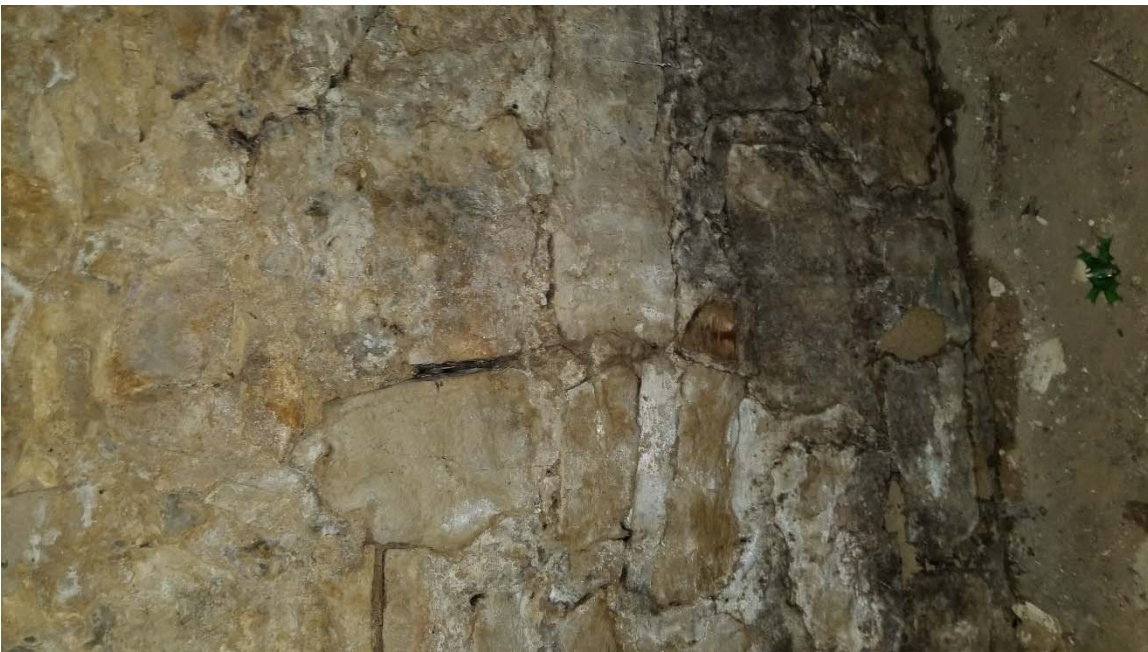
*Image 18 – Stone foundation cracks with signs of seepage.*

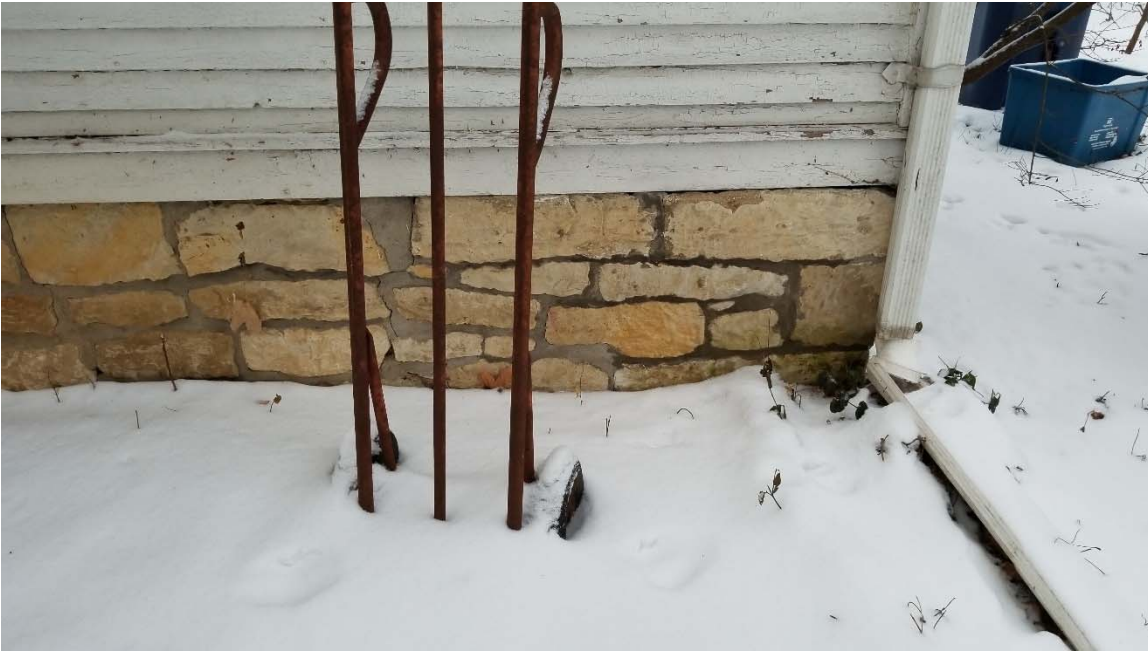
*Image 19 – Stone foundation with signs of patching*

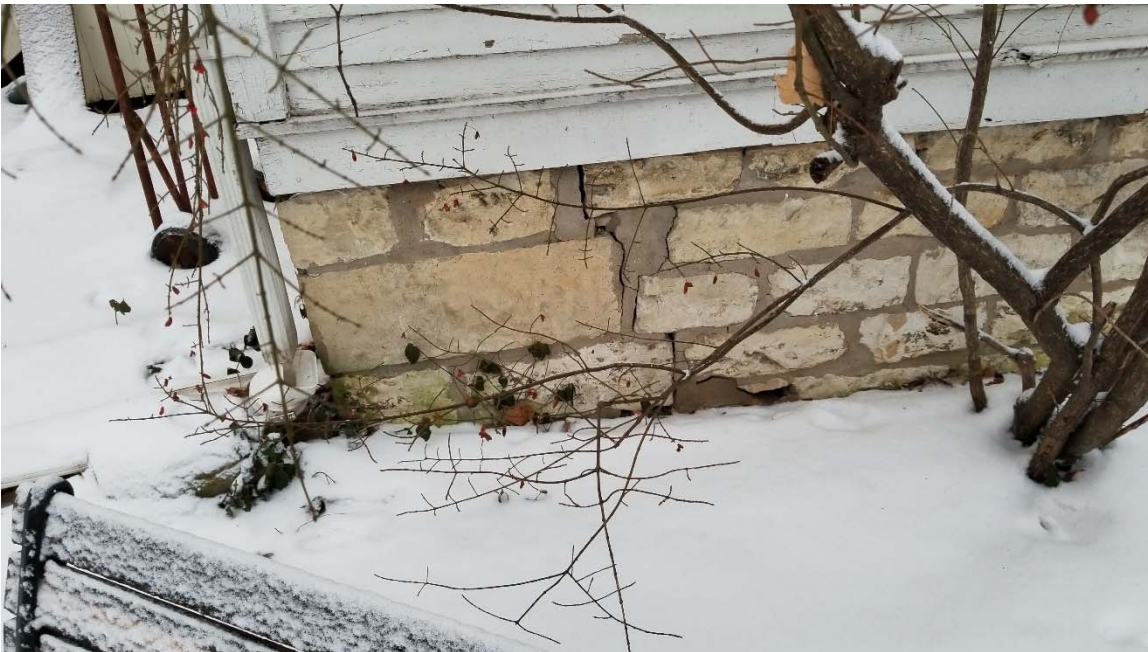
*Image 20 - Stone foundation with signs of patching*

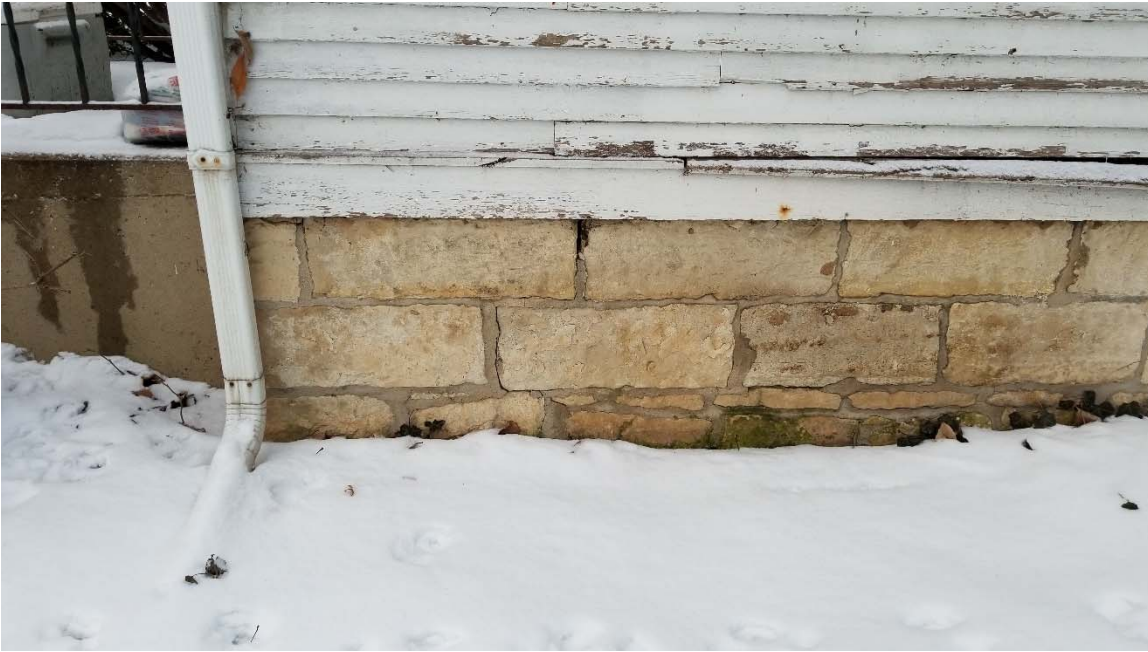
*Image 21 - Stone foundation with signs of patching*

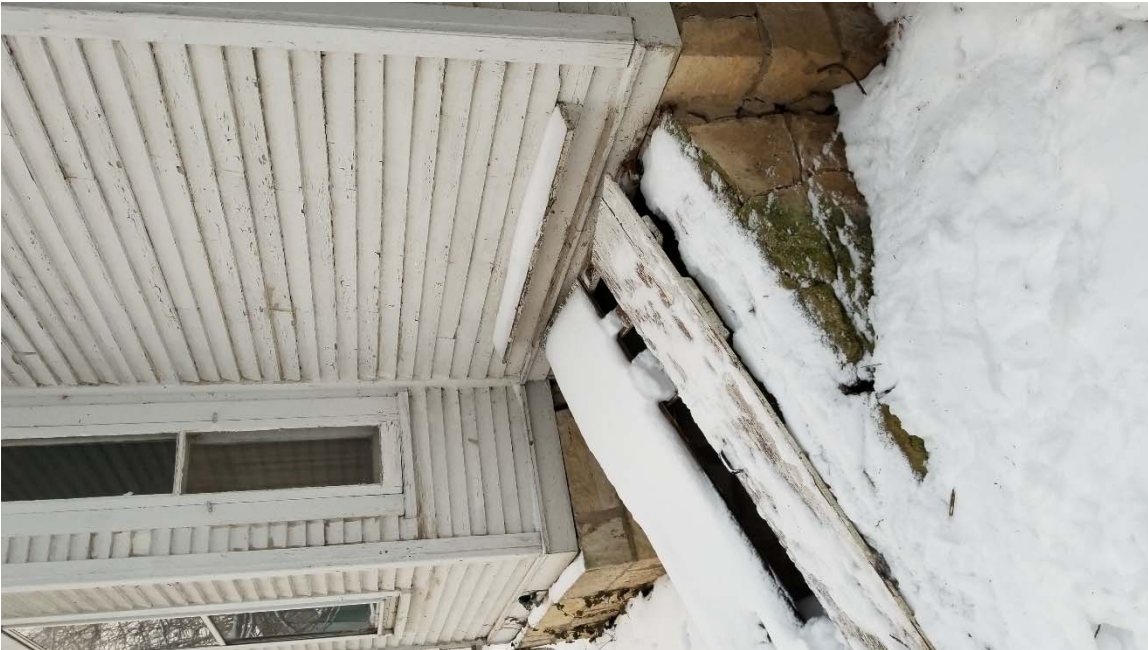
*Image 22 – Stone foundation at exterior basement access pulling away and failing.*

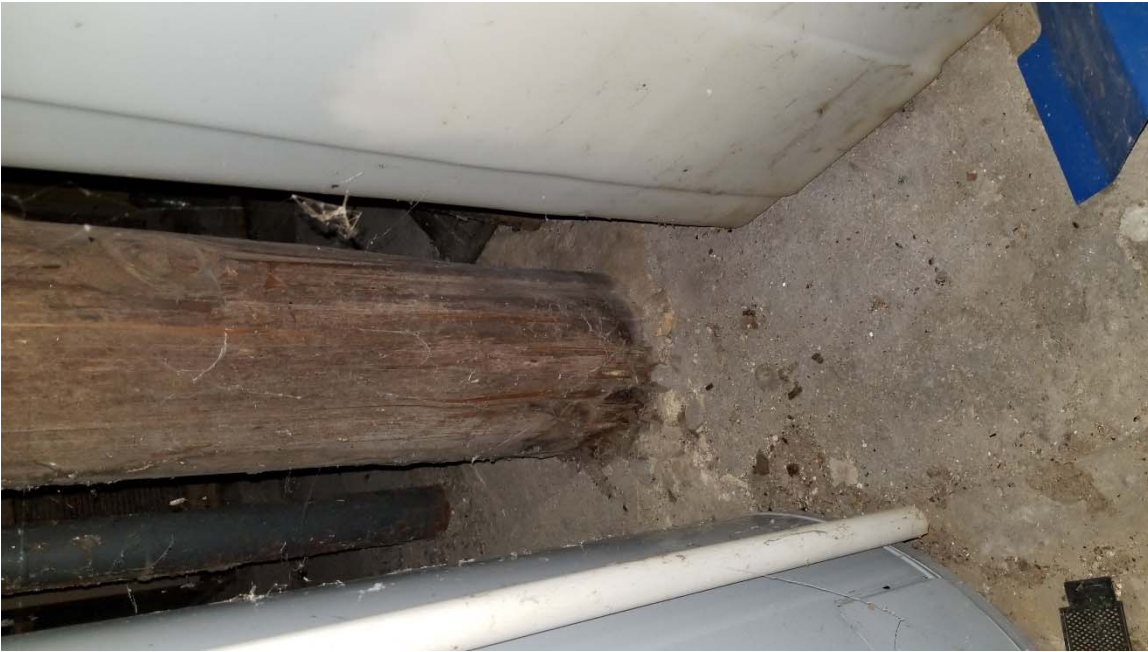
*Image 23 – Rotting wood post in basement supporting middle beam*

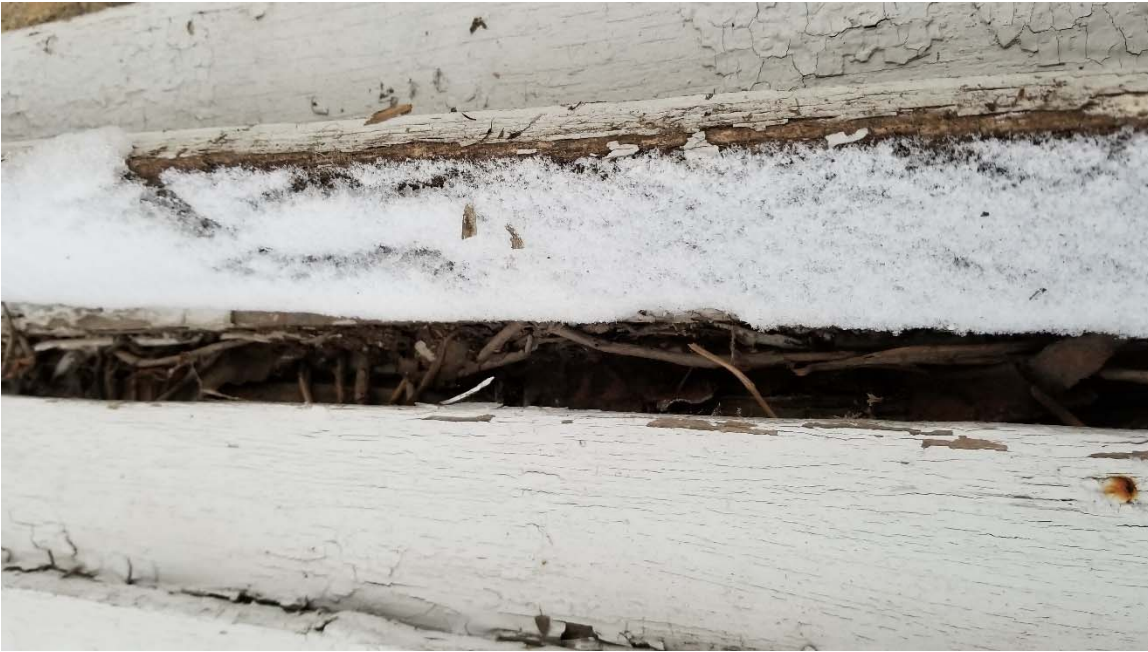
*Image 25 – Plant material found under siding and in wall on south side exterior wall*
