PREPARER ORGANIZATION GRANACKI HISTORIC CONSULTANTS

NAPERVILLE

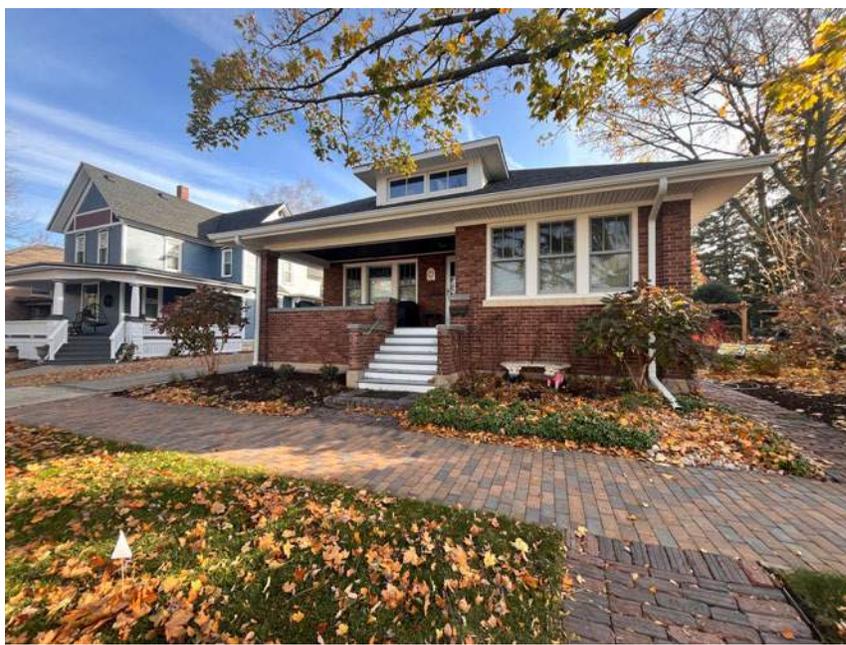
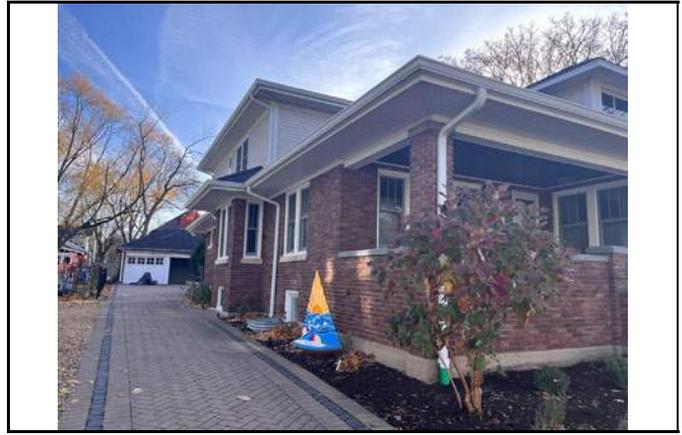
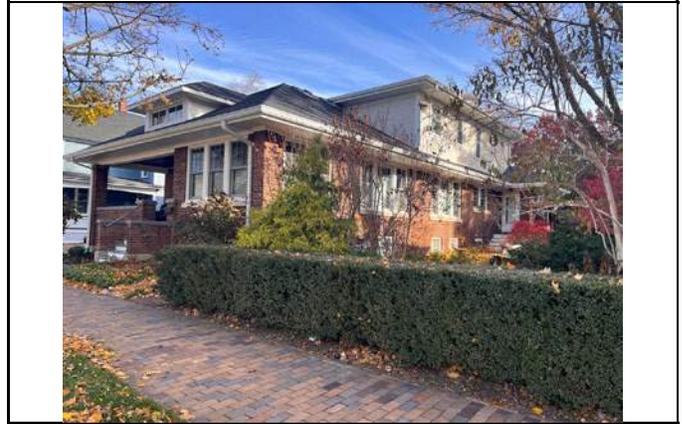
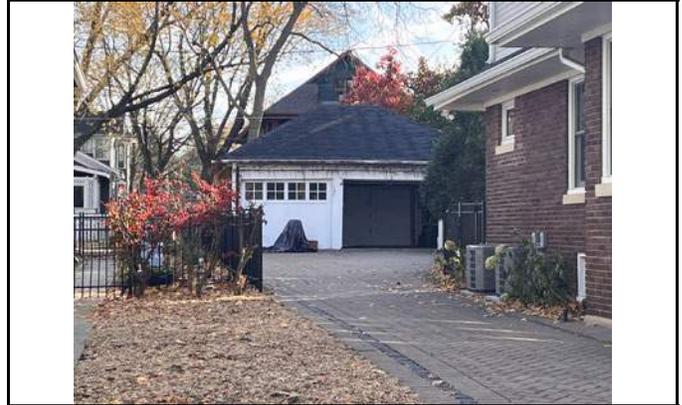
COA COMPLIANCE NOTES: Vertical board siding on existing non-historic north 2nd-story addition replaced with fiber-cement siding (likely at the same time as the south addition was constructed).

NOTES ON WORK: Replacement double-hung windows on front and side elevations.

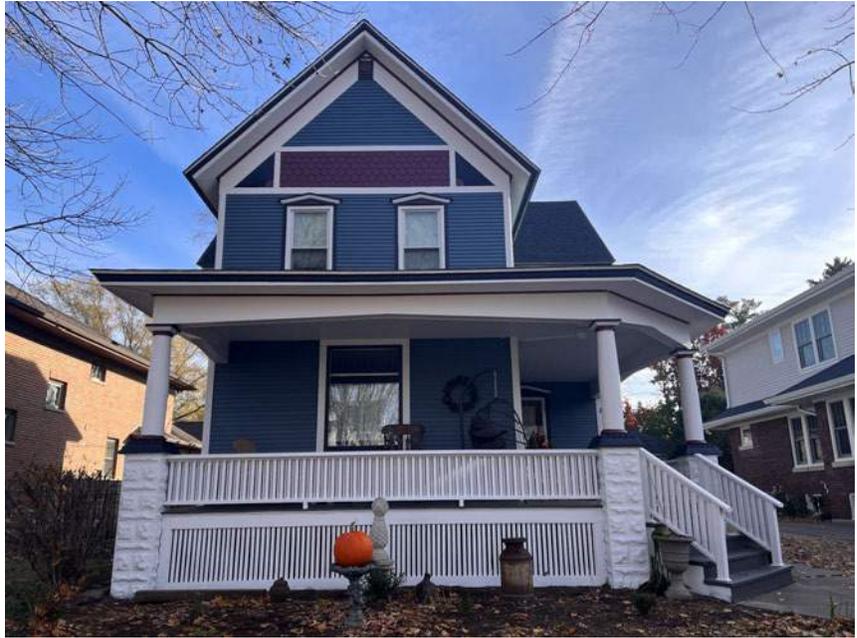
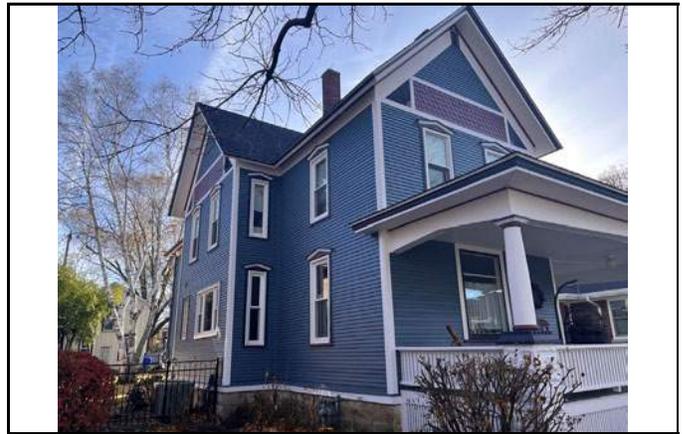
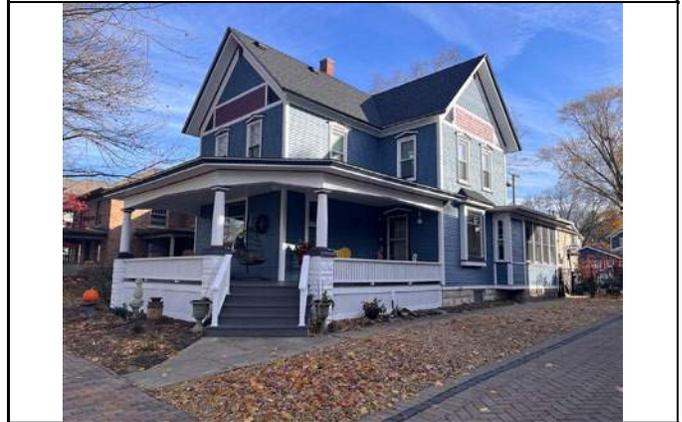
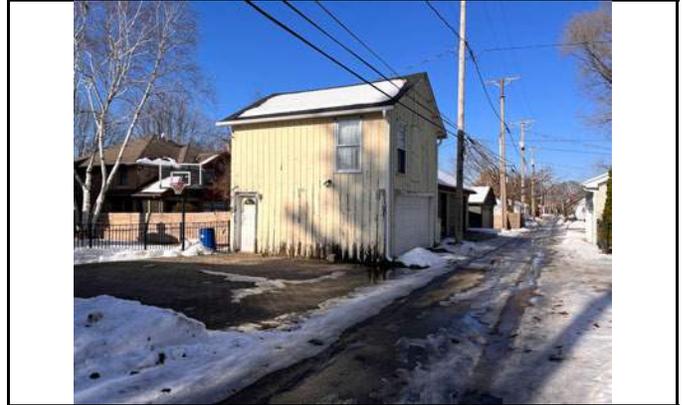
NOTES ON WORK: Other windows on front and side elevations appear to have been replaced after 2007 – may have been replaced without COA before 2025 COA application.

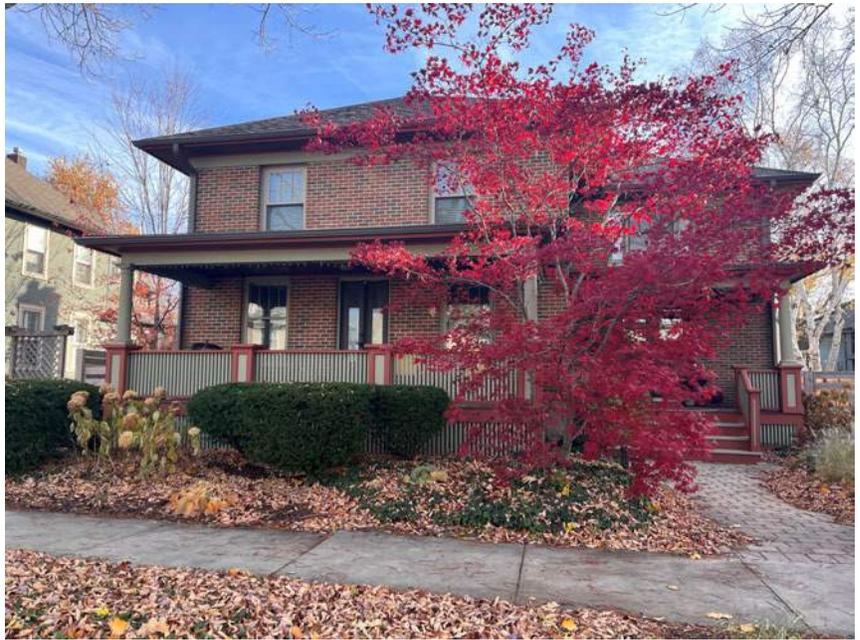
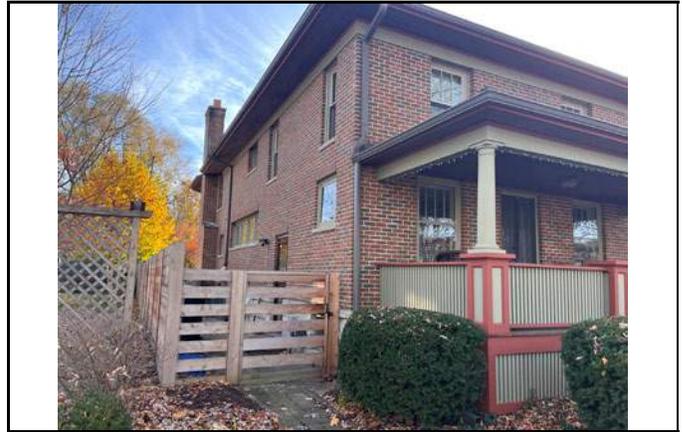
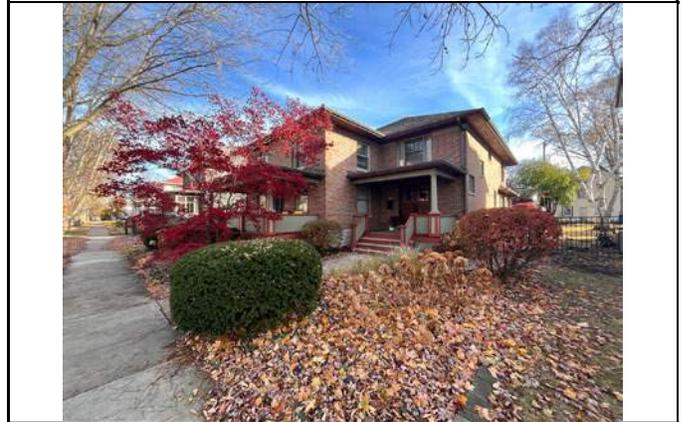
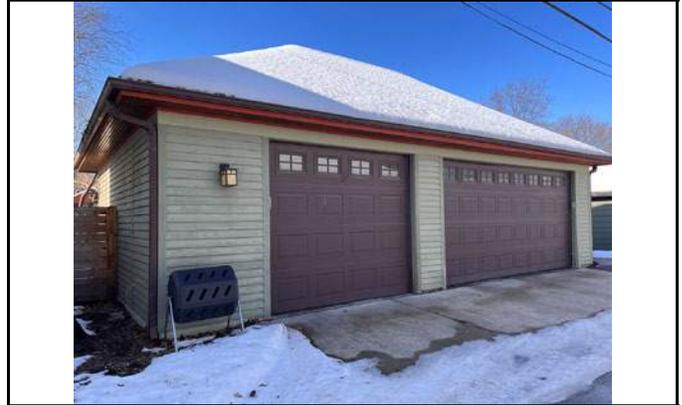
NOTES ON WORK: Aluminum replacement windows on second story of front façade and side elevations -- windows are in original openings and feature historically appropriate configuration.

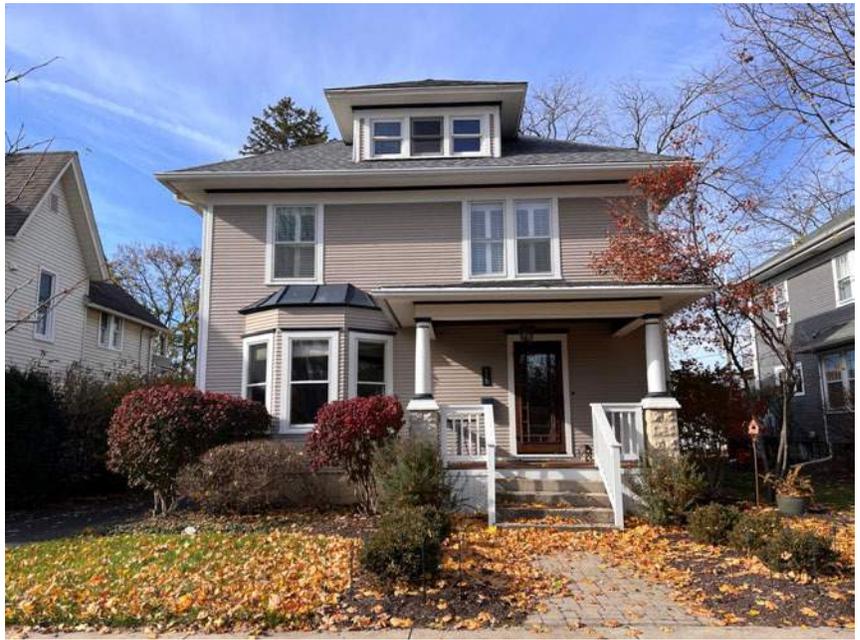
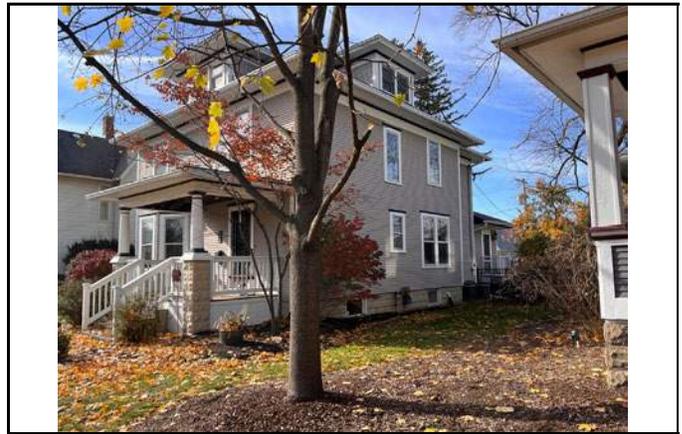
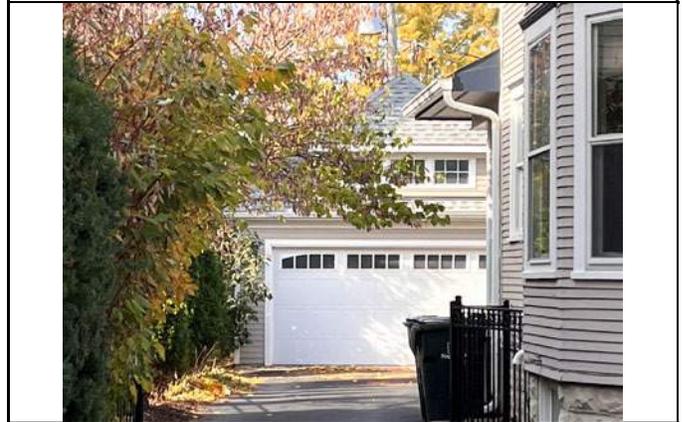
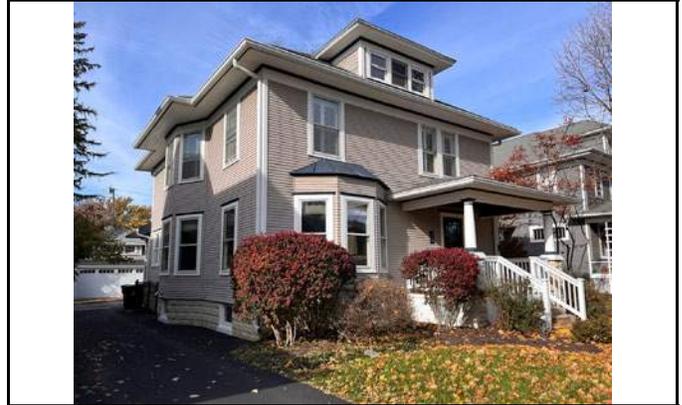
NOTES ON WORK: Porch railing replacement.

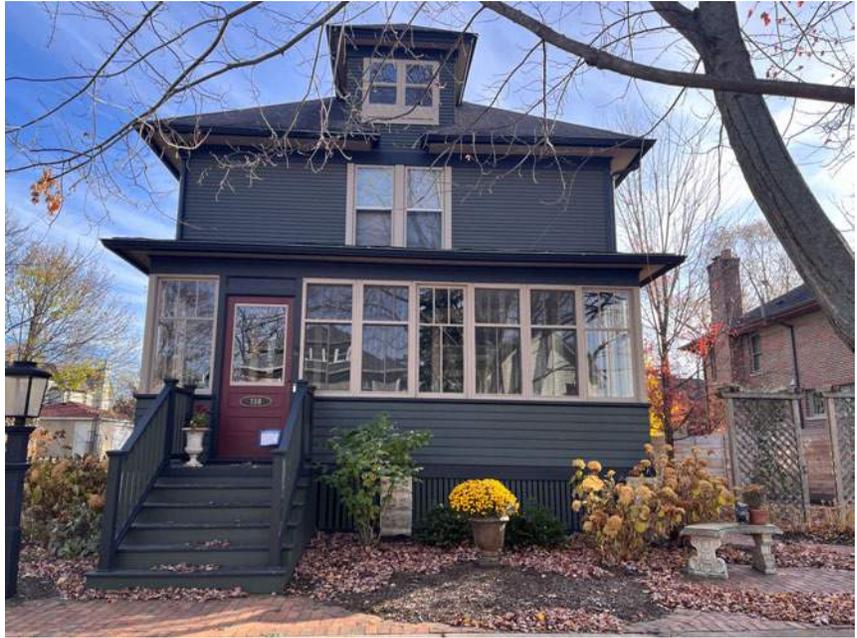
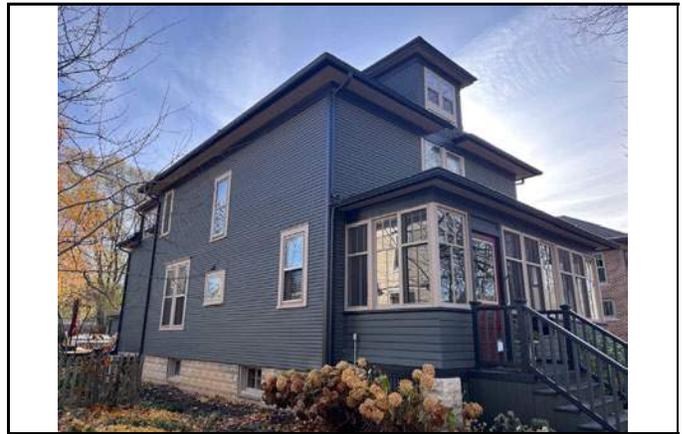
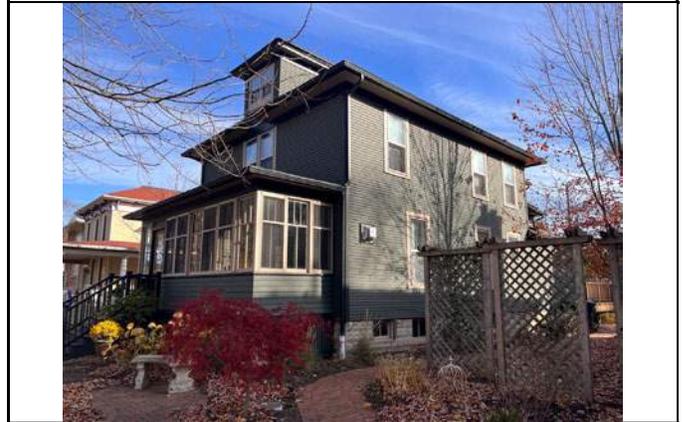
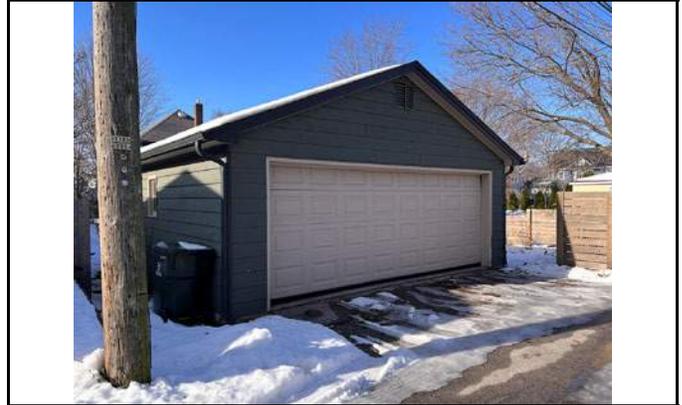
NOTES ON WORK: Two windows in front dormer replaced with 1/1 windows in downsized openings.

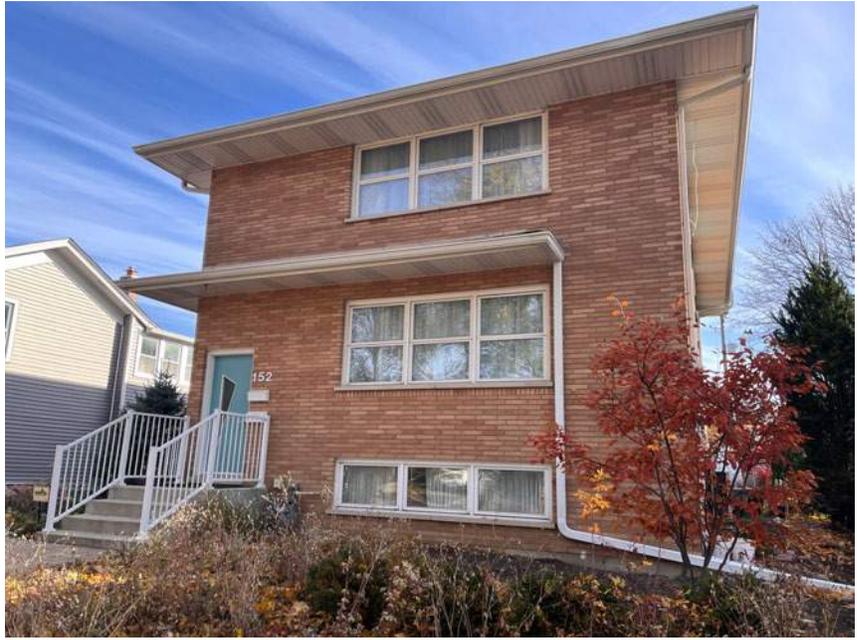
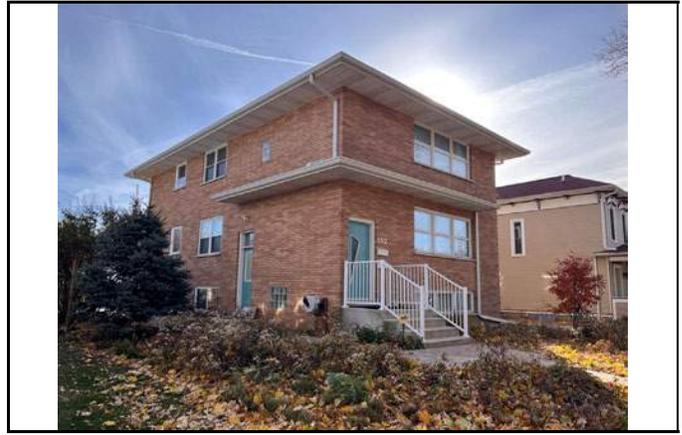
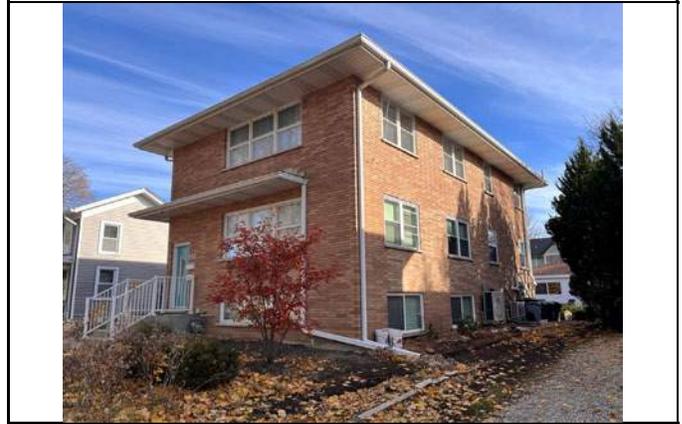
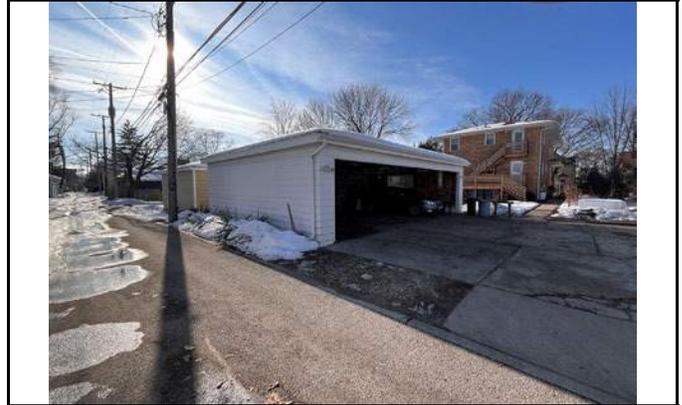
NOTES ON WORK: Replacement windows on north and south elevations; select basement windows replaced in enlarged openings; metal railing at front steps; replacement front and north side doors.

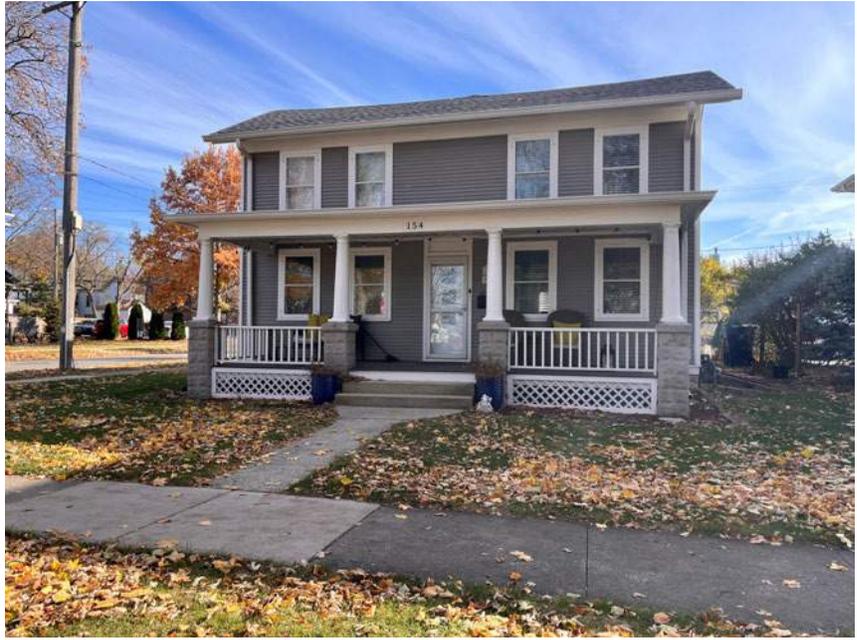
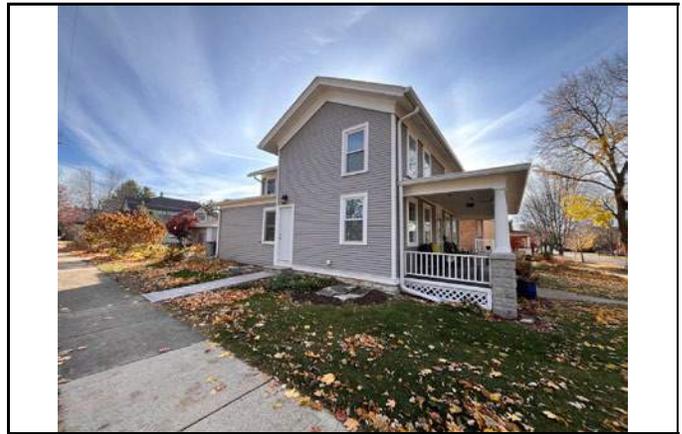
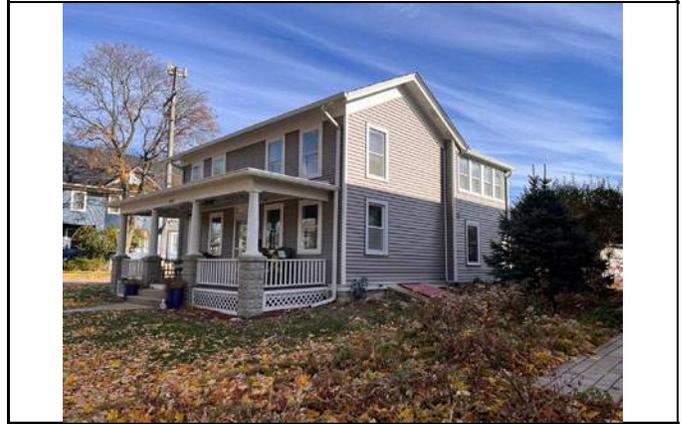
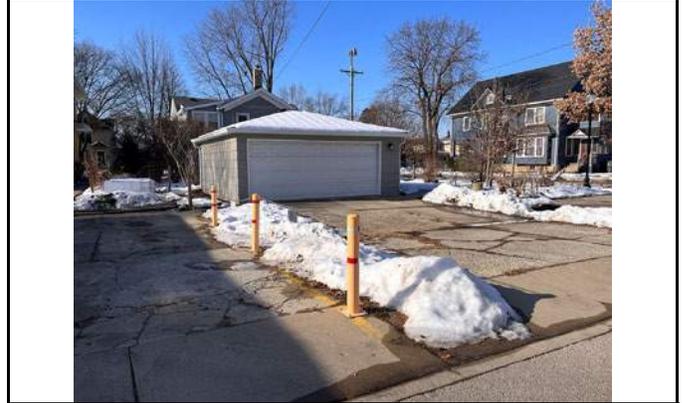
NOTES ON WORK: Replacement windows on north and south elevations; replacement door and stoop at north secondary entrance.

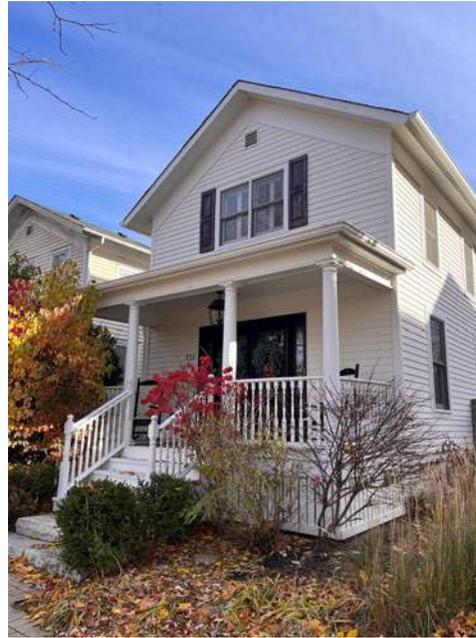
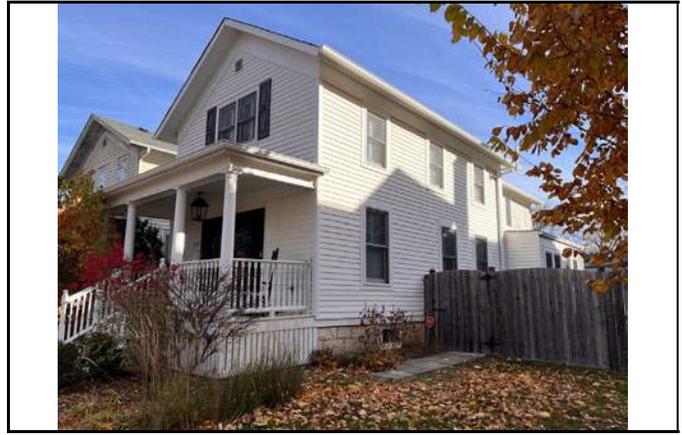
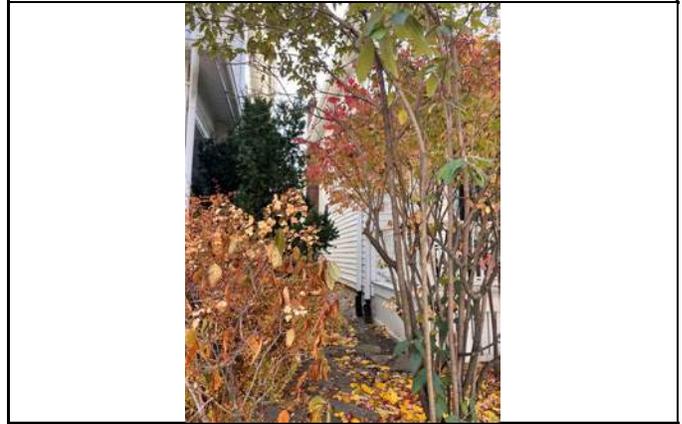
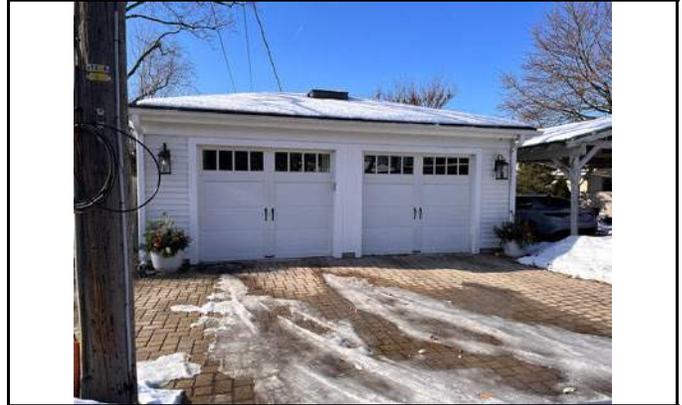
NOTES ON WORK: solid porch knee wall replaced with turned wood railing; front door removed and center window under porch converted to main entrance and fitted with double-leaf door and sidelights; decorative shutters added to 2nd-story window opening on front façade

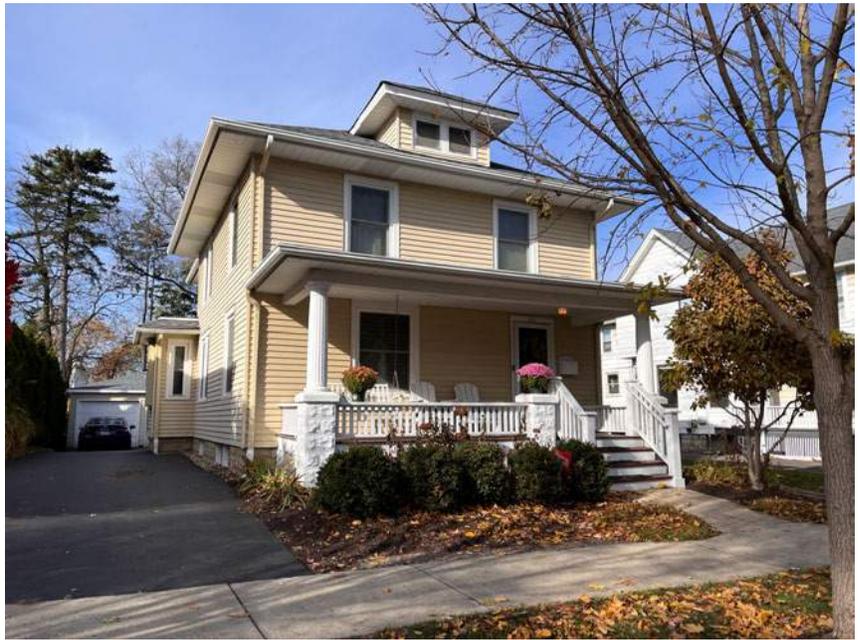
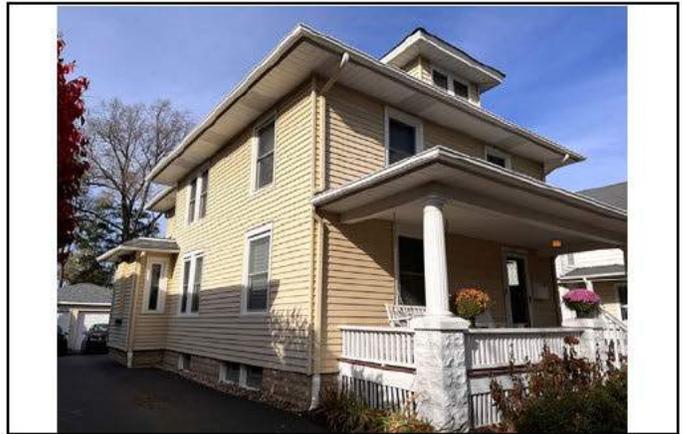
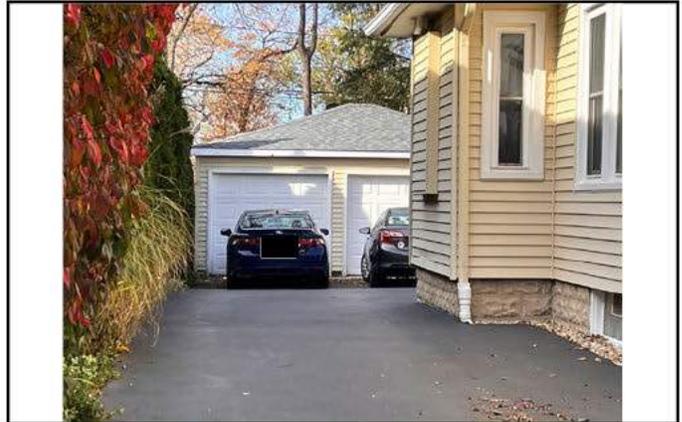
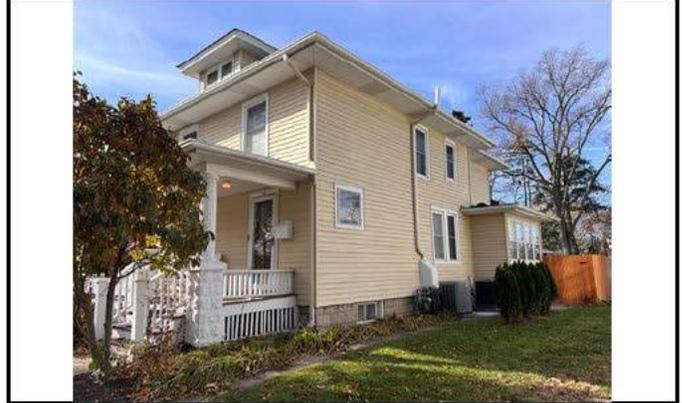
NOTES ON WORK: 2nd-story replacement windows in original openings; railing replacement at porch steps; vinyl siding replaced with what appears to be new aluminum siding.

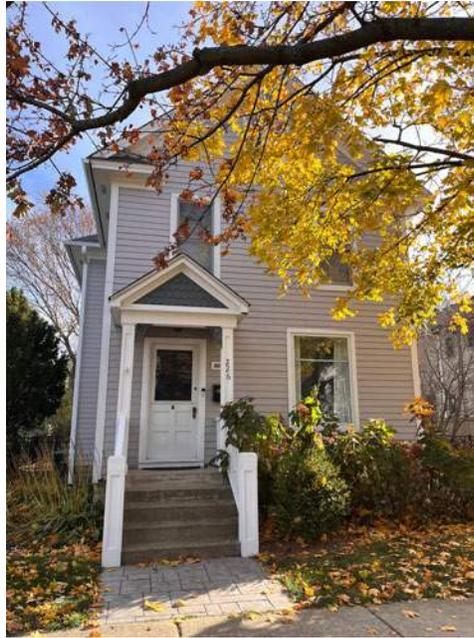
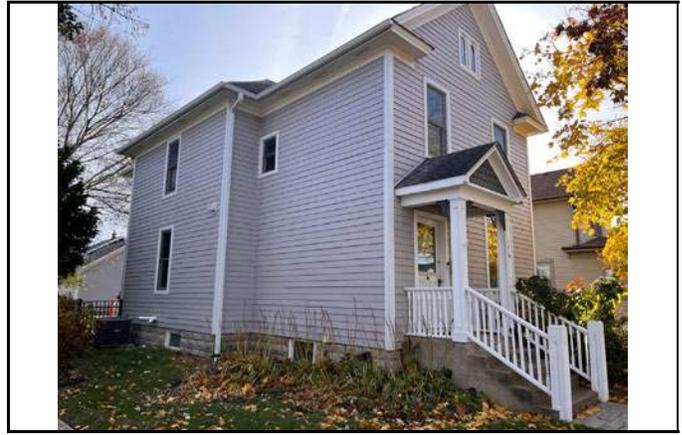
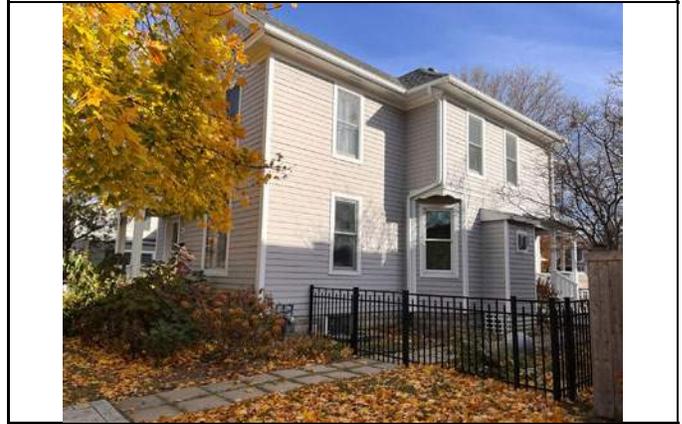
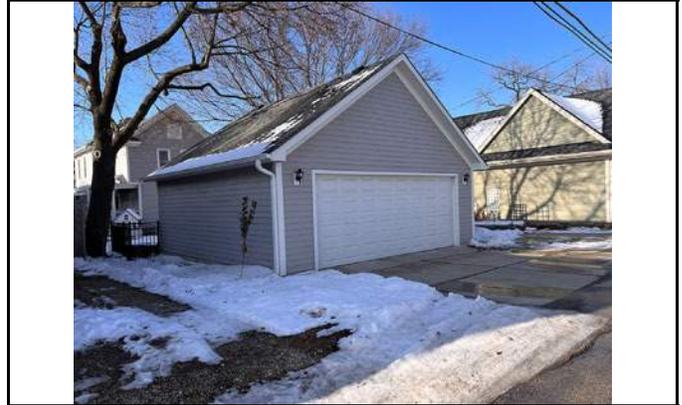
COA COMPLIANCE NOTES: Board width of replacement siding does not match historic wood siding.

NOTES ON WORK: Replacement windows in original and altered openings on front and side elevations; bump-out on south window bay; porch railings.

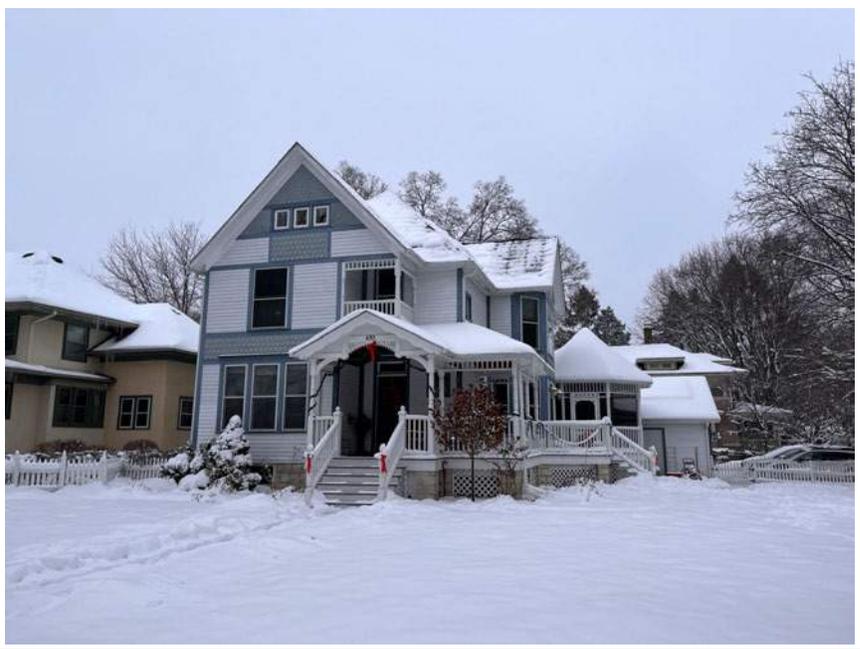
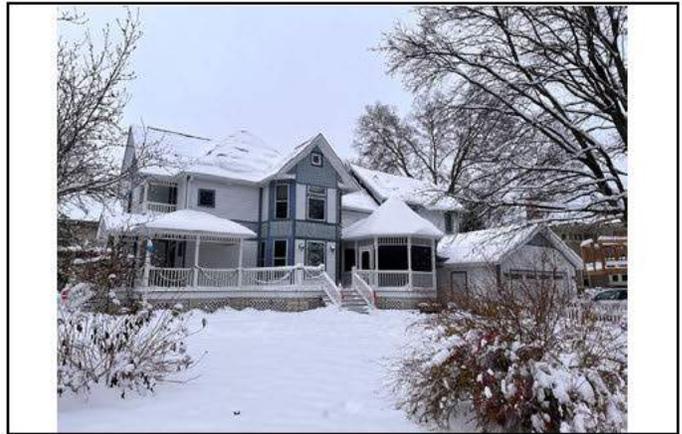
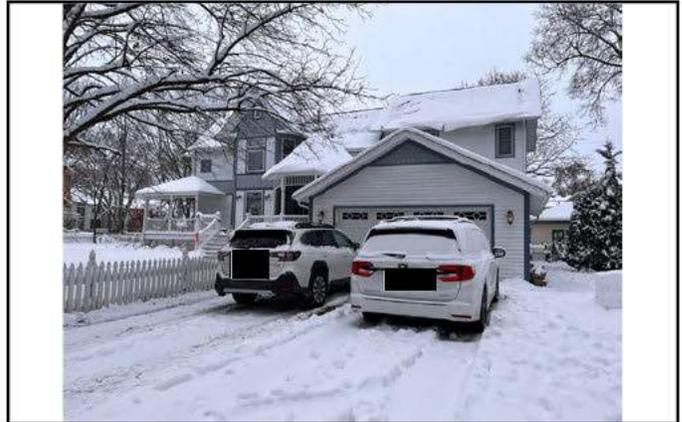
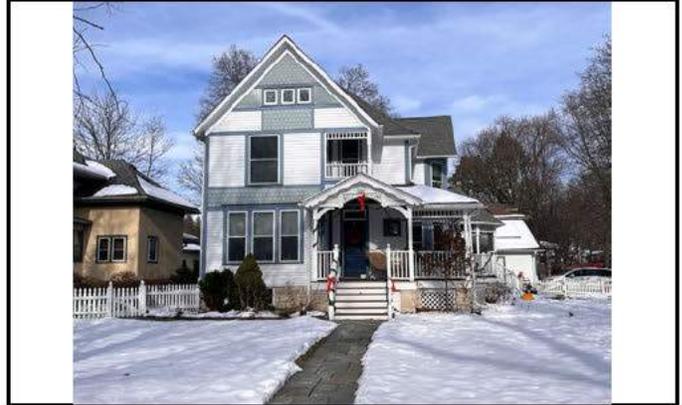
NOTES ON WORK: Replacement siding; solar panels on east slope of roof near southeast corner and on east slope of roof on rear bay.
