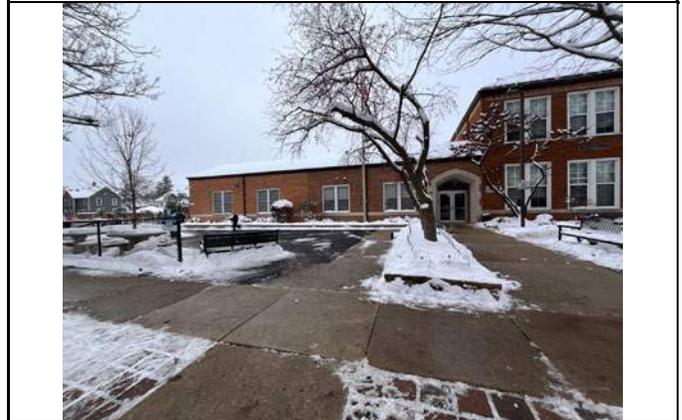
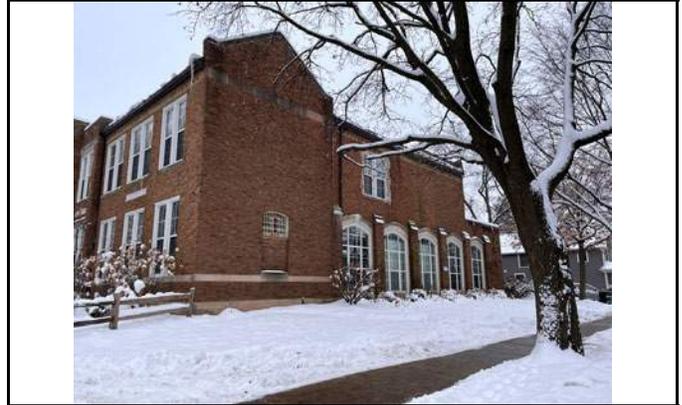
NOTES ON WORK: Replacement multi-light windows in arched openings at first story of north elevation.

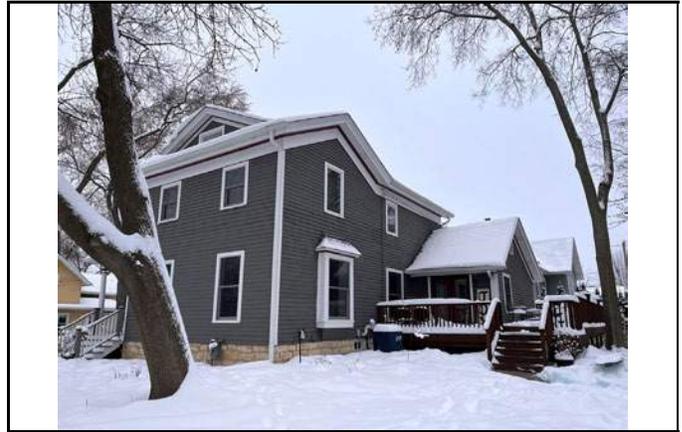
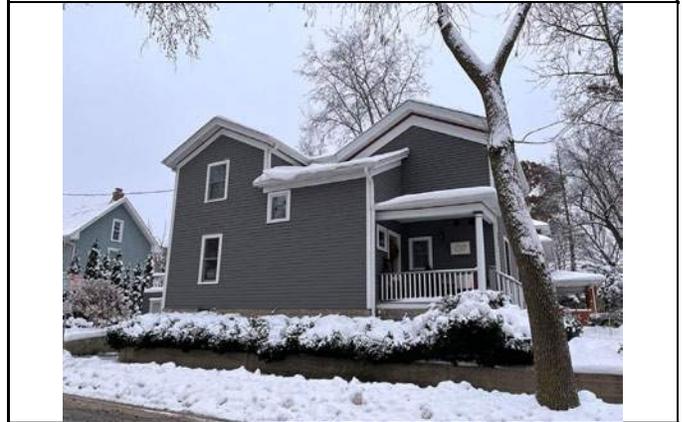
COA COMPLIANCE NOTES: South deck addition; replacement windows in original and altered openings; replacement railings at entry porch; replacement front door.

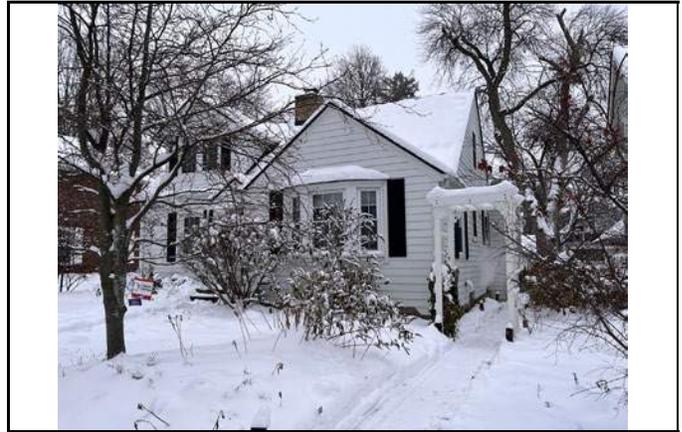
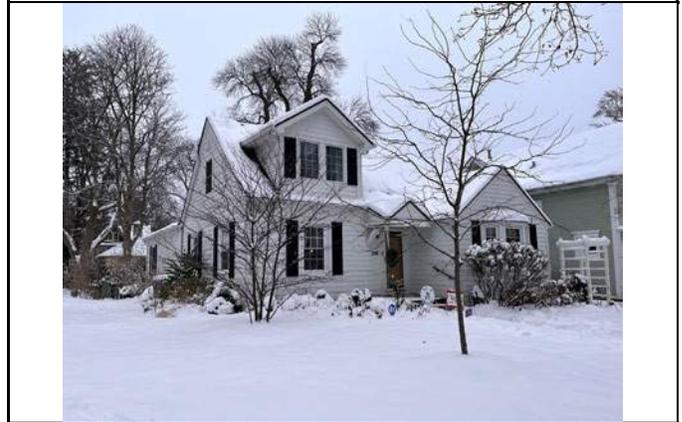
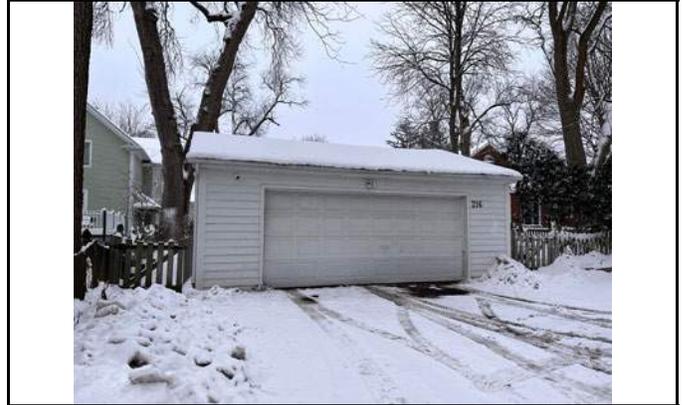
NOTES ON WORK: replacement siding; 6/6 and 4/4 double-hung vinyl replacement windows throughout; replacement entry steps; shed-roof entry canopy replaced with gabled canopy; south entry porch enclosed

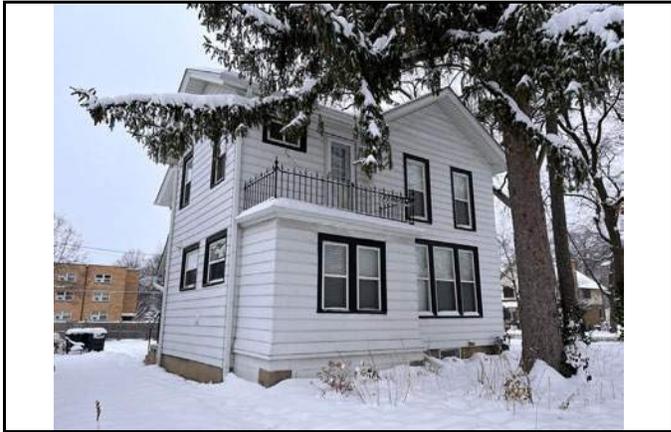
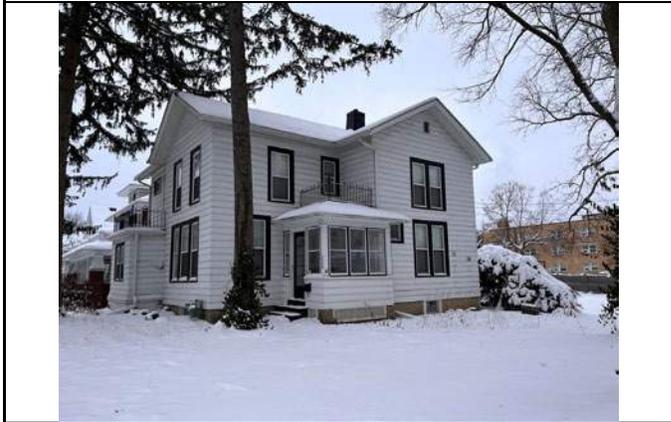
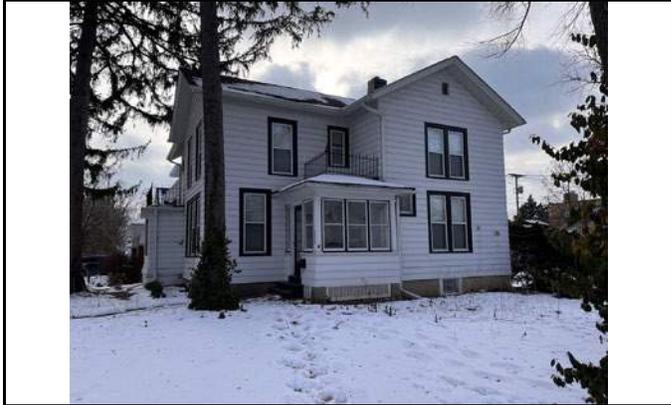
NOTES ON WORK: 1/1 double-hung Aluminum replacement windows throughout.

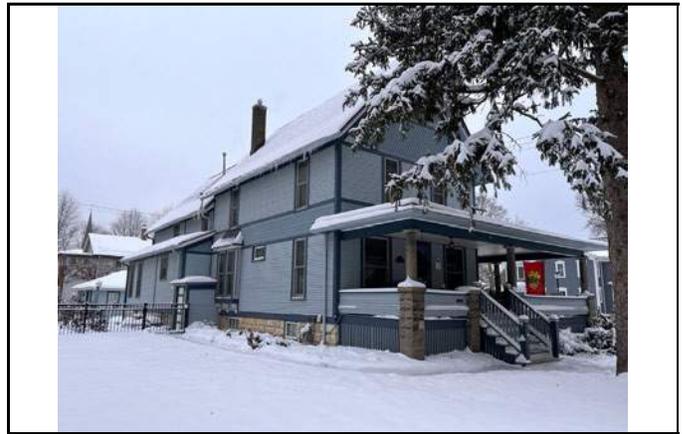
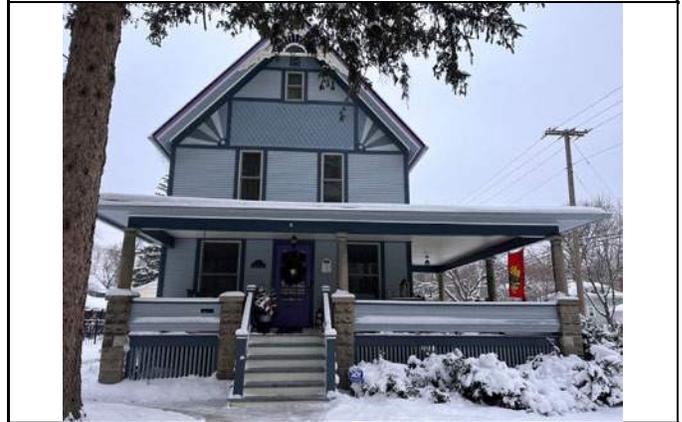
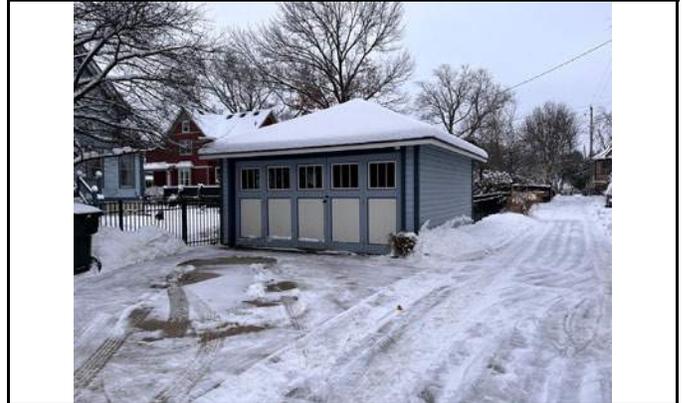
NOTES ON WORK: Most 1/1 windows appear to be Aluminum/vinyl replacement windows. Railings added to front porch steps.

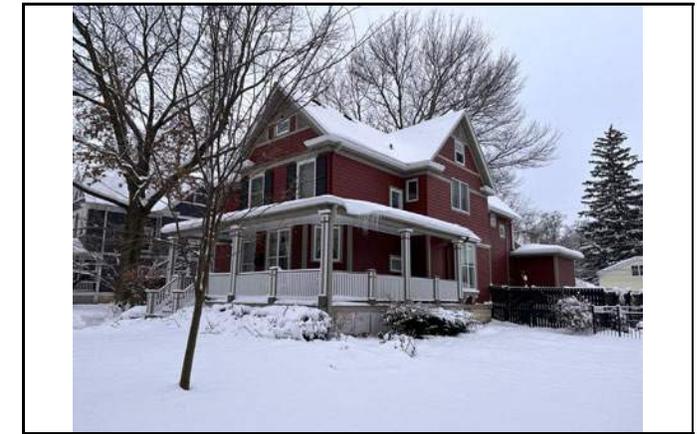
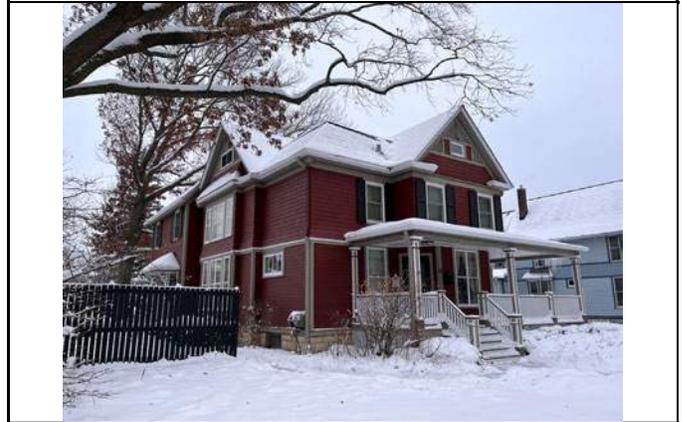
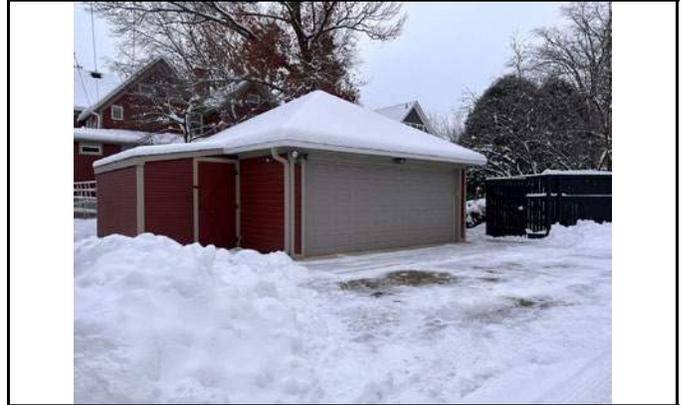
NOTES ON WORK: 1/1 replacement windows on second story of front façade and upper floors of north bay.

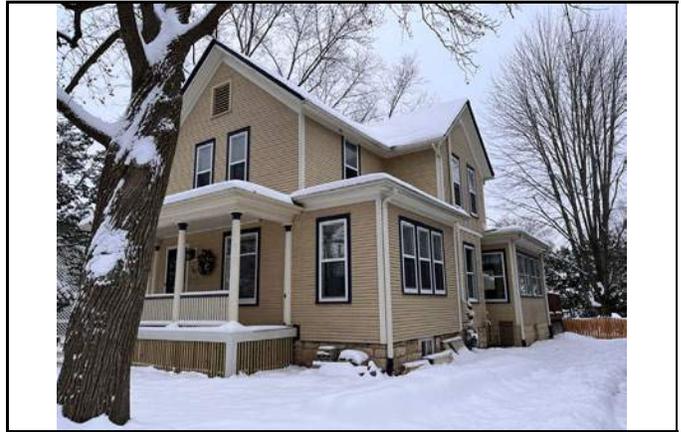
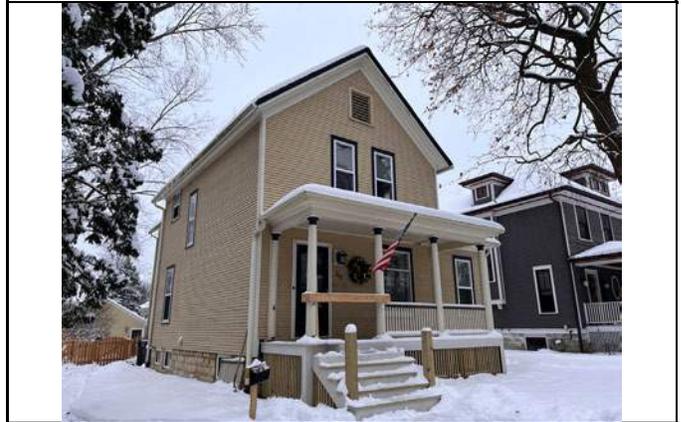
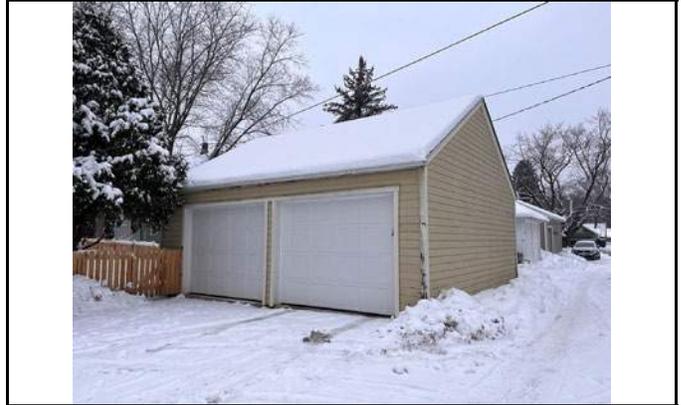
NOTES ON WORK: Porch steps being replaced.

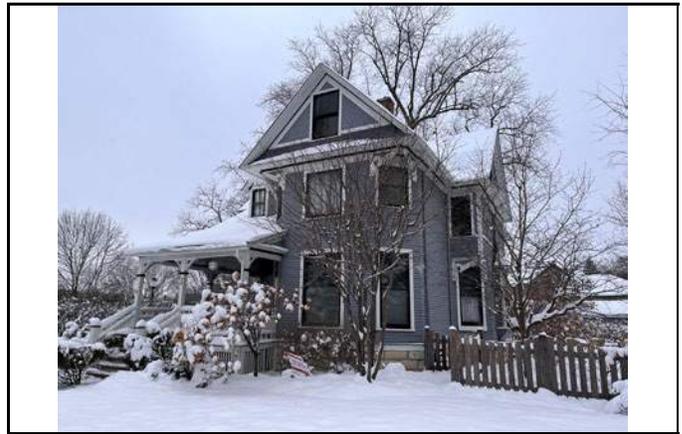
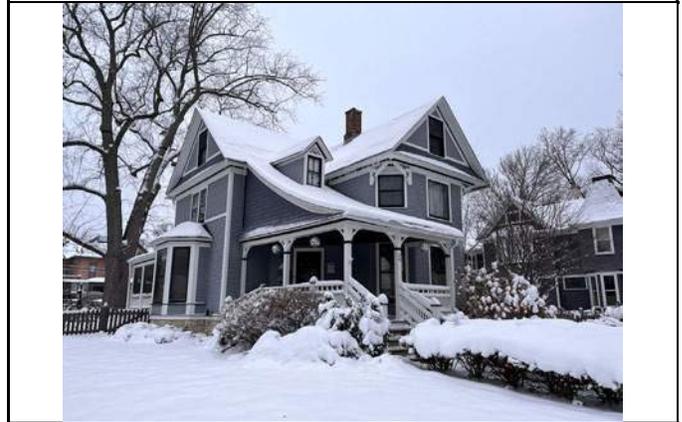
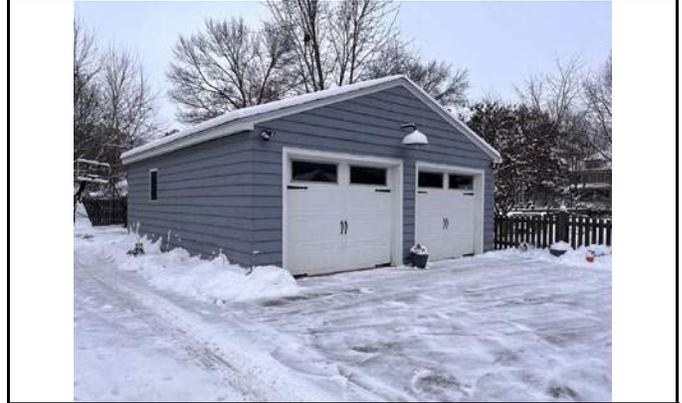
NOTES ON WORK: replacement windows under front and side gables appear to be in enlarged openings

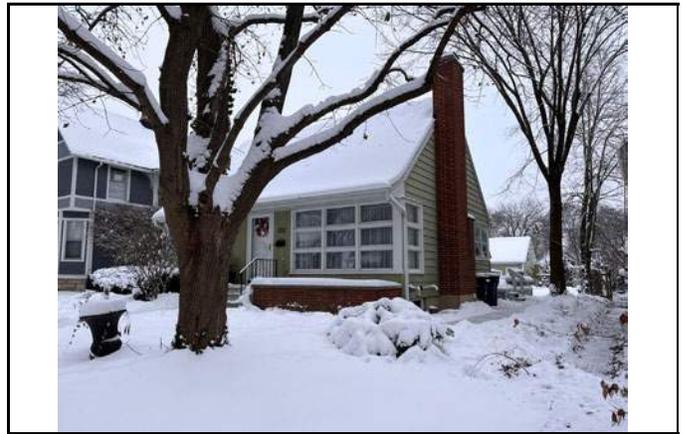
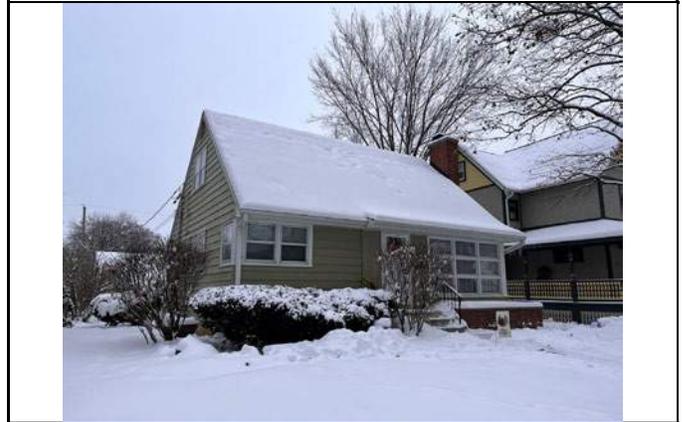
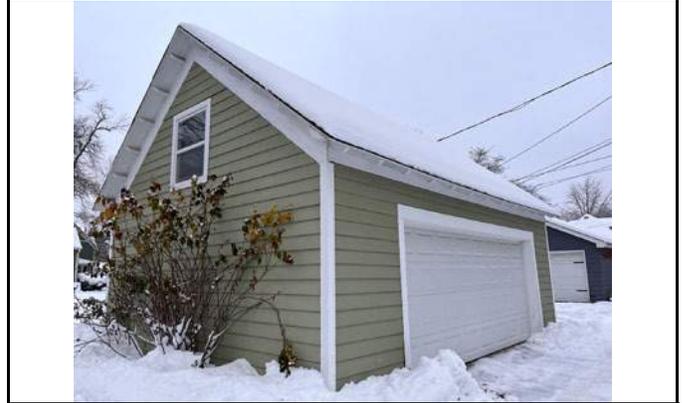
NOTES ON WORK: Replacement front door.

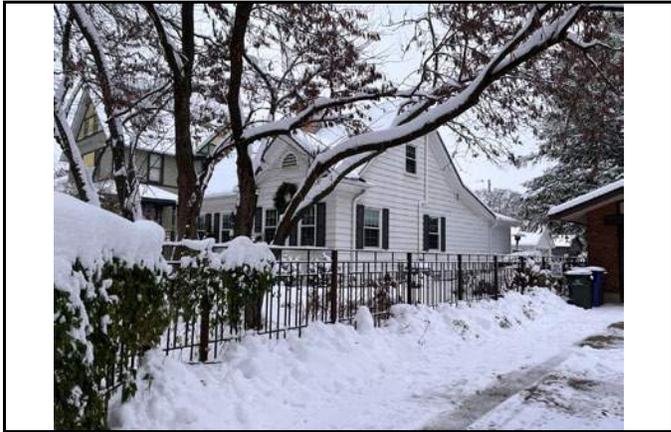
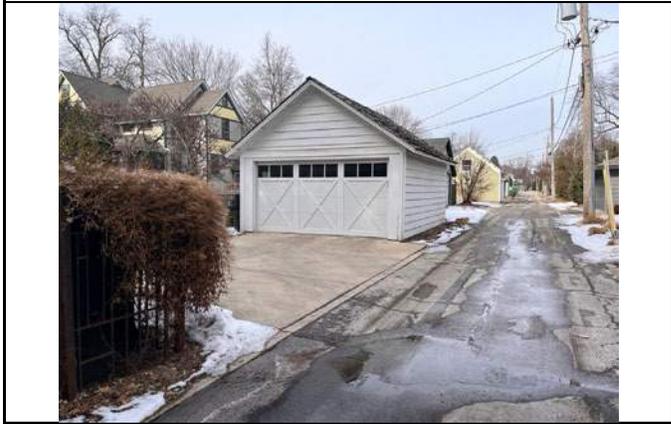
NOTES ON WORK: Replacement windows
