STREET #	32
DIRECTION	S
STREET	SLEIGHT
SUFFIX	ST
PIN	0818317015
LOCAL SIGNIFICANCE RATING	PS
POTENTIAL IND NR? (Y or N)	N
Contributing to a NR DISTRICT?	C
Contributing secondary structure?	C
Listed on existing SURVEY?	Local District; NR District

**GENERAL INFORMATION**

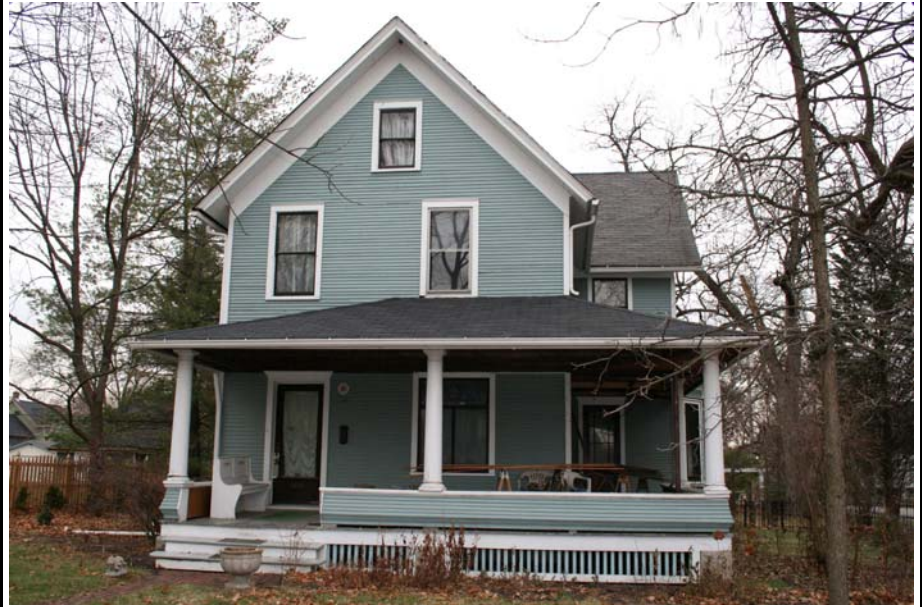
CATEGORY	building	CURRENT FUNCTION	Domestic - single dwelling
CONDITION	good	HISTORIC FUNCTION	Domestic - single dwelling
INTEGRITY	minor alterations and addition(s)	REASON for SIGNIFICANCE	Notable example of the type, with historic wraparound porch.
SECONDARY STRUCTURE	Detached garage

ARCHITECTURAL CLASSIFICATION	Gabled Ell	PLAN	irregular
DETAILS	Queen Anne	NO OF STORIES	2.5
BEGINYEAR	c. 1890	ROOF TYPE	Front gable
OTHER YEAR		ROOF MATERIAL	Asphalt - shingle
DATESOURCE	Surveyor	FOUNDATION	Stone
WALL MATERIAL (current)	Wood	PORCH	Wrap around
WALL MATERIAL 2 (current)		WINDOW MATERIAL	Wood
WALL MATERIAL (original)	Wood	WINDOW MATERIAL	Stained glass
WALL MATERIAL 2 (original)		WINDOW TYPE	double hung/fixed
		WINDOW CONFIG	1/1; 1-light
SIGNIFICANT FEATURES	Front gable bay with south side gable bay; 3-sided south window bay; historic 1/1 and 1-light wood windows		
ALTERATIONS	Rear porch addition; wrap around porch appears to be historic addition (hipped roof doesn't line up with front façade)
