| <b>STREET #</b> | 5 |
| <b>STREET</b> | SLEIGHT |

**GENERAL INFORMATION**

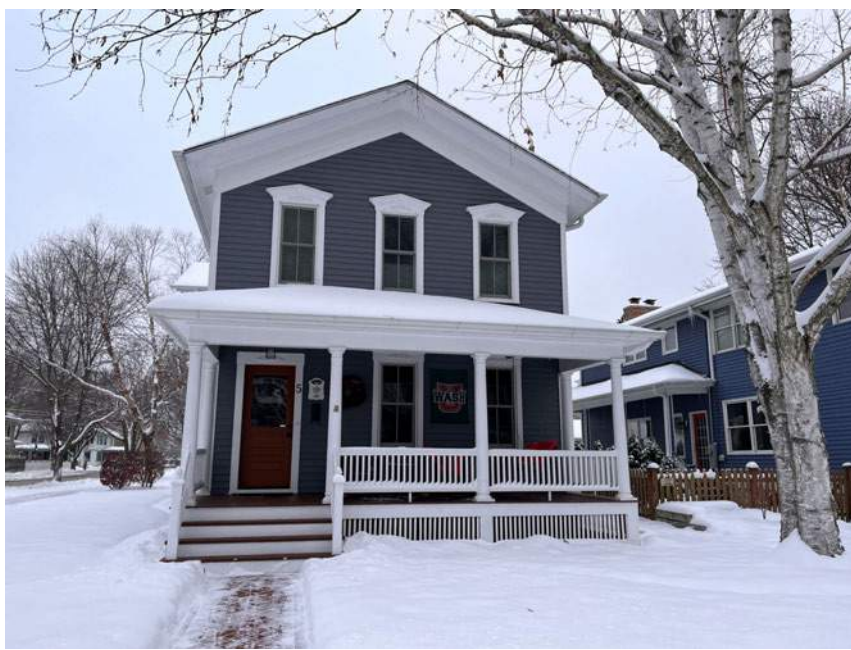
| <b>CONDITION</b> | excellent | <b>REASON for SIGNIFICANCE</b> | Solid, intact example of the Italianate style in the historic district, with historic front porch addition. If not for highly visible 2-story addition and removal of south porch, this house would be rated significant. |

| <b>ALTERATIONS</b> | Full front porch addition (historic--c. 1905). Post-2007 -- Aluminum replacement windows throughout; south/rear porch structure and rear section of house demolished and 2-story rear addition constructed (2019) | | |

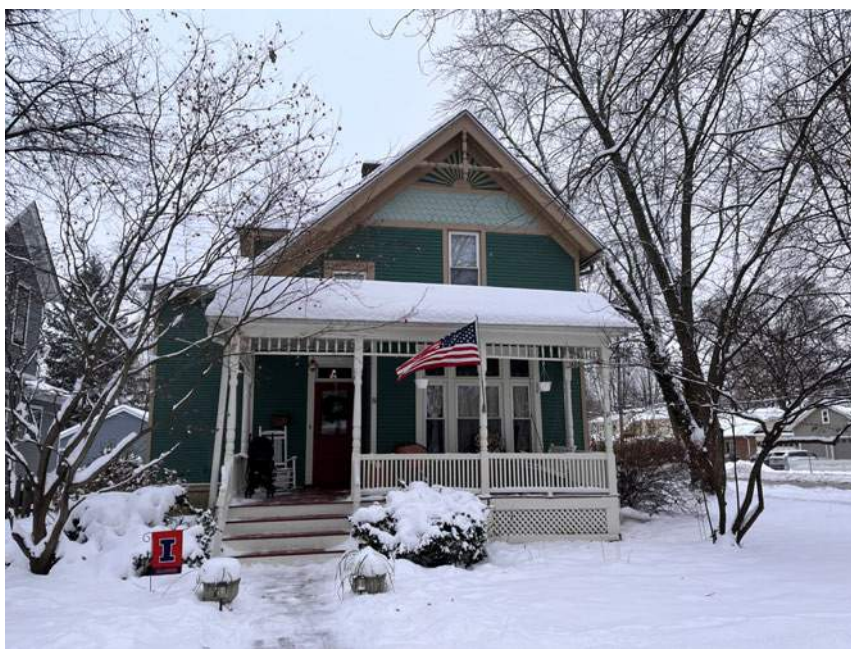
| CONDITION | good | REASON for SIGNIFICANCE | This c. 1890 Queen Anne features some historic alterations from c. 1905. |

| ALTERATIONS | Front gable bay extended north, with alterations to entry at north end under porch (historic--c. 1905); north dormer addition; north 2 story add. (historic); rear deck add. (not historic); replacement windows in original openings (not historic). Post-2007 -- no changes (exterior repainted). | | |

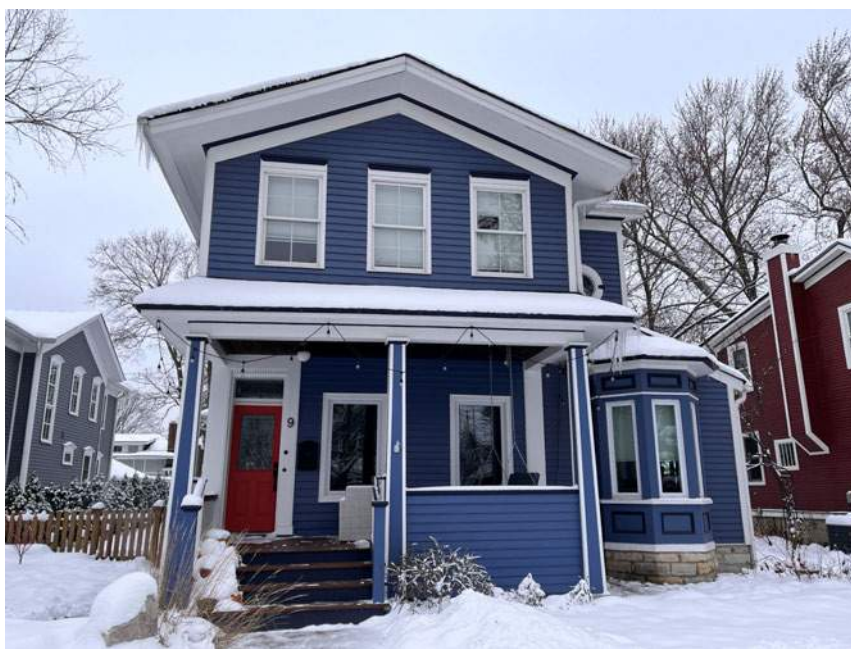
| <b>ALTERATIONS</b> | Upper level of front porch enclosed or replaced with 2nd story addition (post-1954); 2nd story addition over historic 1-story north section of original house (post-1954); 2nd-story rear addition (post-1954); replacement windows on S. elevation; 2nd-story bullseye window (not historic); polygonal bay window shows up on Sanborn maps, but materials are not historic; replacement supports/knee walls on porch (not historic). Post-2007 -- French doors under porch north of main entrance replaced with single-light windows in downsized openings; 1/1 double-hung windows in polygonal first-story window bay replaced with single-light windows; replacement |

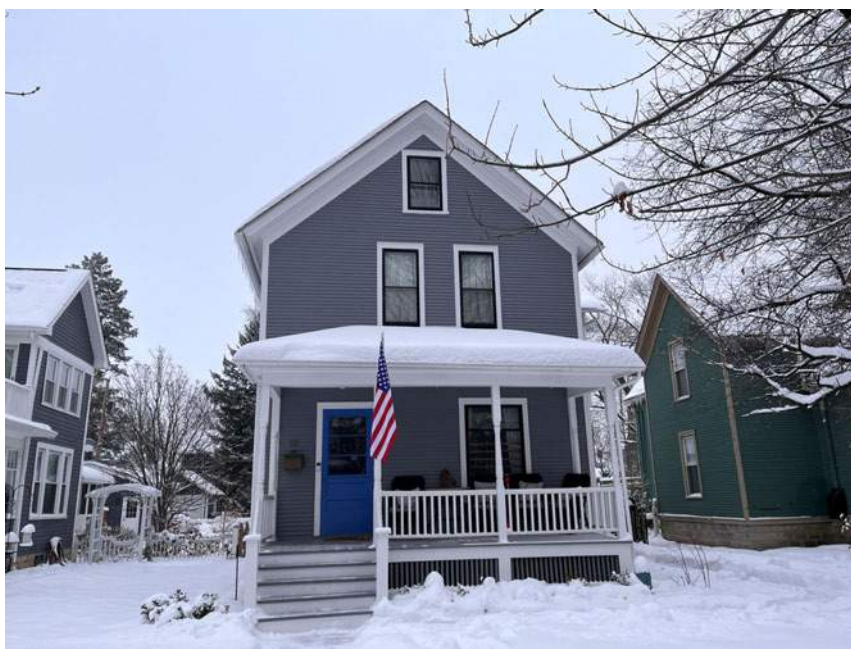
| CONDITION | good | REASON for SIGNIFICANCE | Notable example of Gable Front type, with few alterations. |

| ALTERATIONS | One story rear/south addition; replacement window in gable. Post-2007 -- in-kind asphalt shingle roof replacement; exterior repainted. | | |

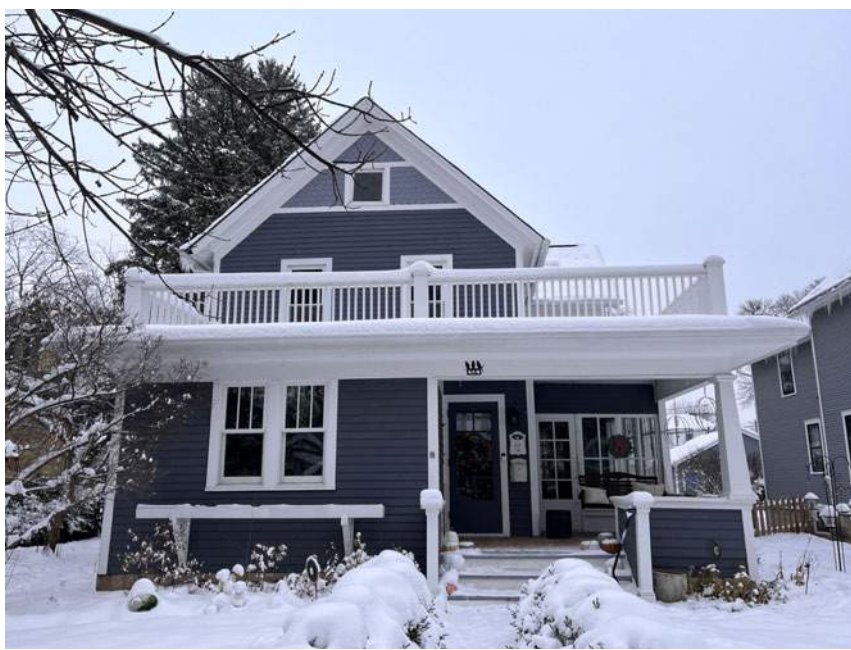
ALTERATIONS 1/1 and 3/1 aluminum/vinyl replacement windows in original openings; 1 story rear addition; rear screen porch addition. Post-2007 -- no changes (exterior repainted)

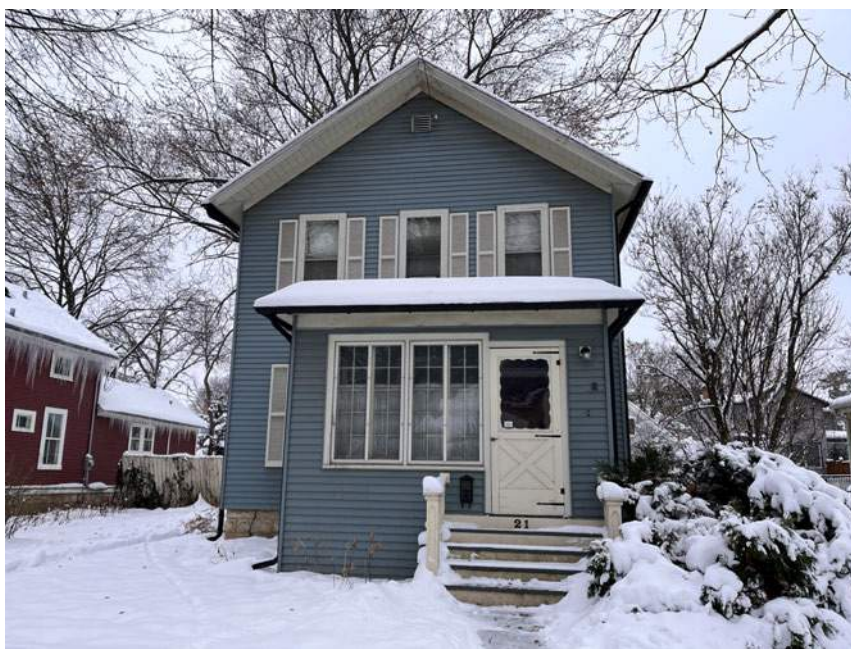
| ALTERATIONS | Vinyl siding; front porch addition (enclosed--historic alteration); fixed shutters (not historic); replacement window in downsized opening on north 1st story (not historic). Post-2007 -- no changes. |

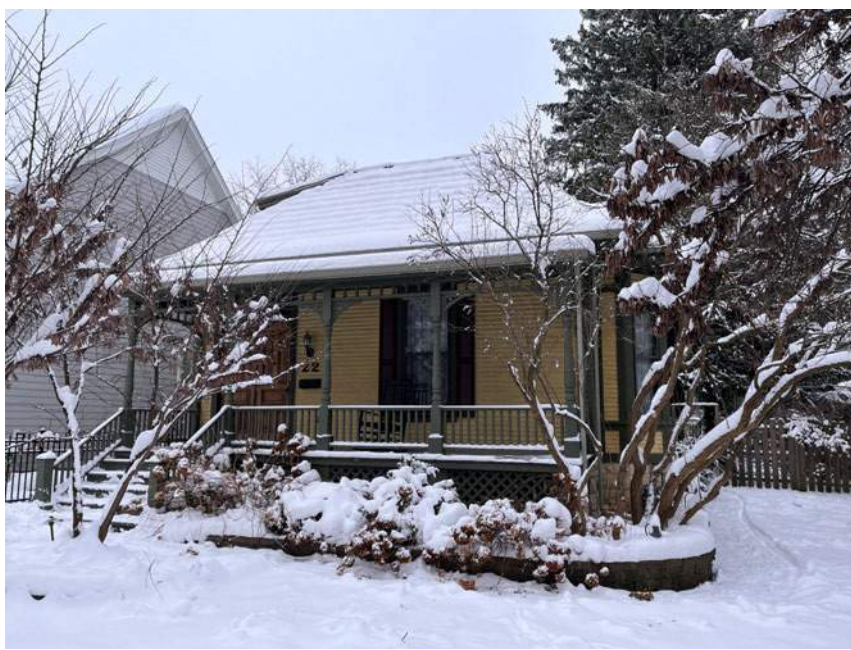
| CONDITION | good | REASON for SIGNIFICANCE | Charming late 19th-century Eastlake cottage, with relatively few alterations. |

| ALTERATIONS | Doors appear to be replacement (may be salvaged); north and south dormer additions (not historic); one-story rear addition (c. 1900). Post-2007 -- no changes. | | |

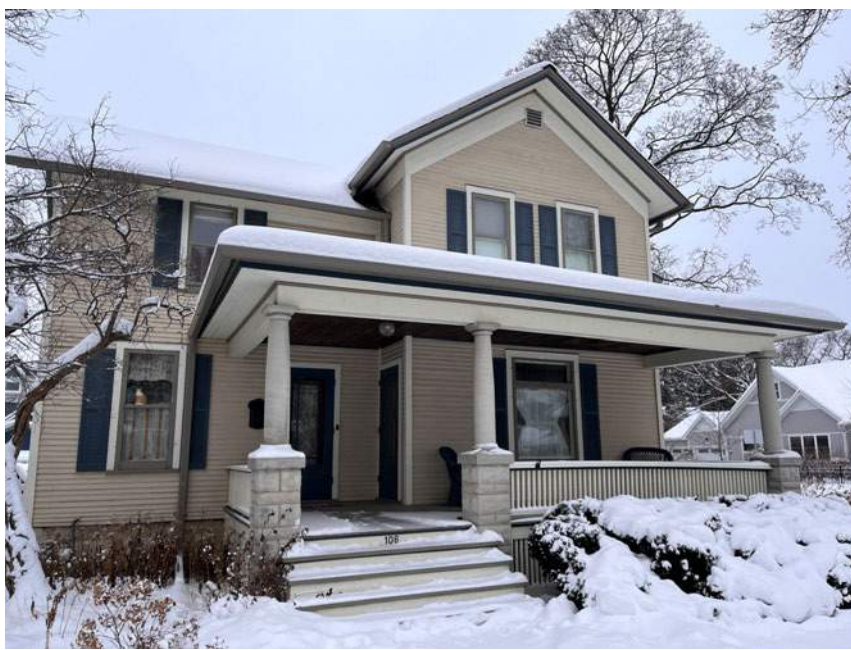
| <b>CONDITION</b> | excellent | <b>REASON for SIGNIFICANCE</b> | Relatively intact example of the L-Form vernacular type, with Italianate-style south window bay and historic (1910s) front porch. |

| <b>ALTERATIONS</b> | Replacement front porch (historic--c. 1910); 1 story rear addition (1970s). Post-2007 -- 1/1 Aluminum replacement windows at second story; replacement door at secondary entrance under rear porch. | | |

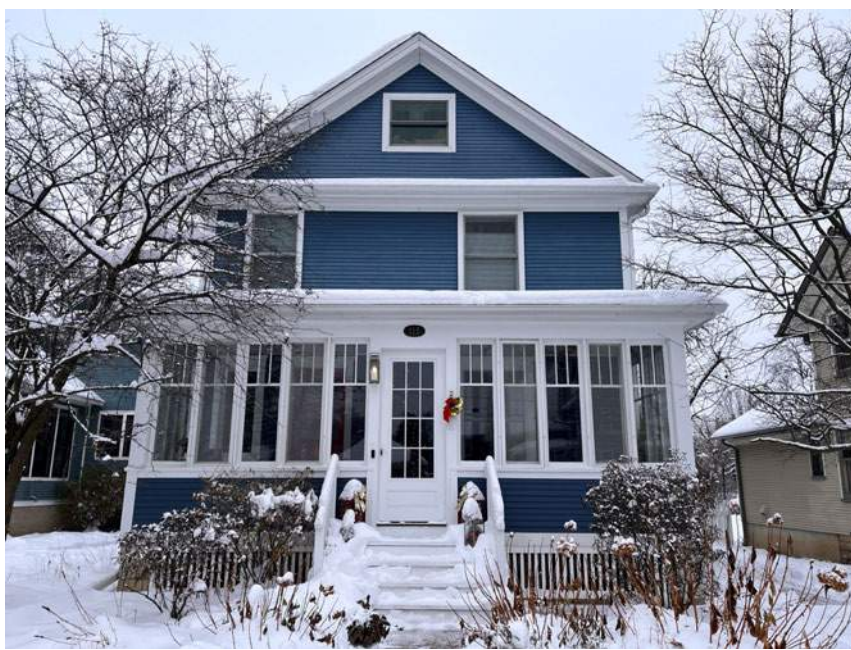
| ALTERATIONS | Front porch enclosed (post-1954); replacement front steps & railings (not historic); replacement windows on 2nd story and under front gable on façade; 1 story rear addition; fixed shutters. Post-2007 -- fiber cement board siding; in-kind replacement front porch steps/railings and door. |

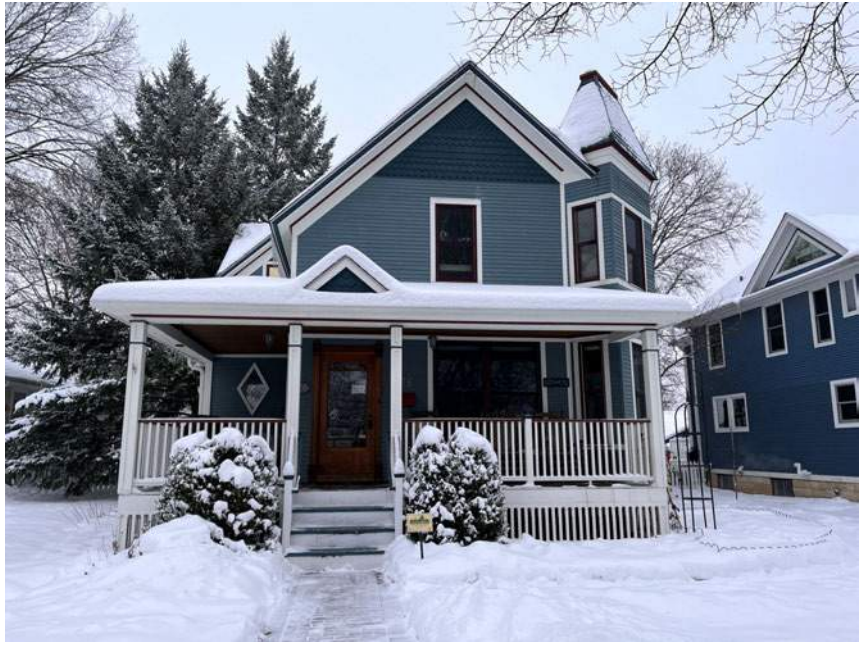
| ALTERATIONS | 1.5-story northeast addition (c. 2000)1.5-story south/rear addition (c. 2000); 1-story south addition with shed roof c. 2000); wraparound front porch (c. 2000); 1/1 replacement windows in original openings; replacement siding and shingles (historically appropriate). Post-2007 -- no changes to principal structure. Detached garage replaced. |

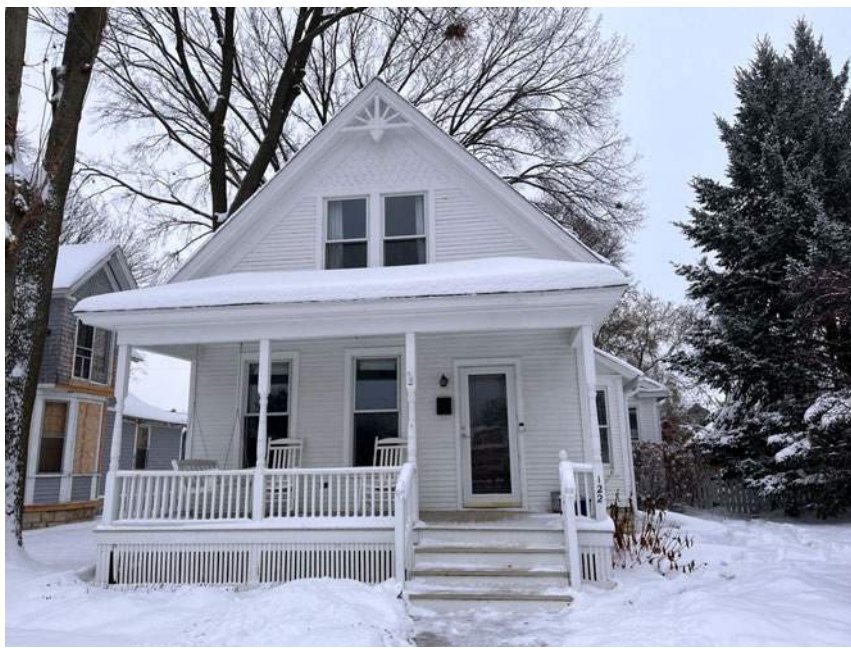
| ALTERATIONS | Replacement windows (1/1 vinyl and wood) in original openings; replacement front porch (c. 1915); shed roof on 1-story south addition (not historic); north and south dormer additions (not historic). Post-2007 -- no changes. | | |

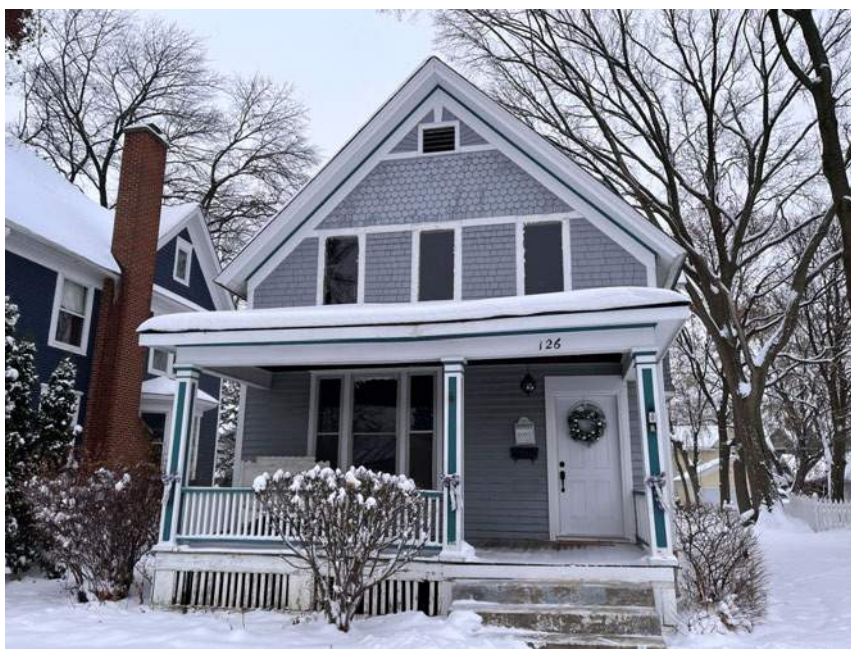
| ALTERATIONS | Shed dormer addition (historic); replacement front door; window opening at 2nd story of south projecting bay converted to doorway; 1/1 replacement windows in original openings (historic). Post-2007 -- exterior stair at south elevation removed; window openings on south elevation covered with particle board; window openings at 2nd story of front façade filled with what appear to be sheets of plexiglass; new wood exterior trim above foundation; replacement front door | | |

**COA COMPLIANCE NOTES:** At time of field work, work on rear/south porch addition had not started. Replacement front door does not match door shown on drawings included with COA application -- may be an earlier replacement door that was installed between 2007 survey and COA app.

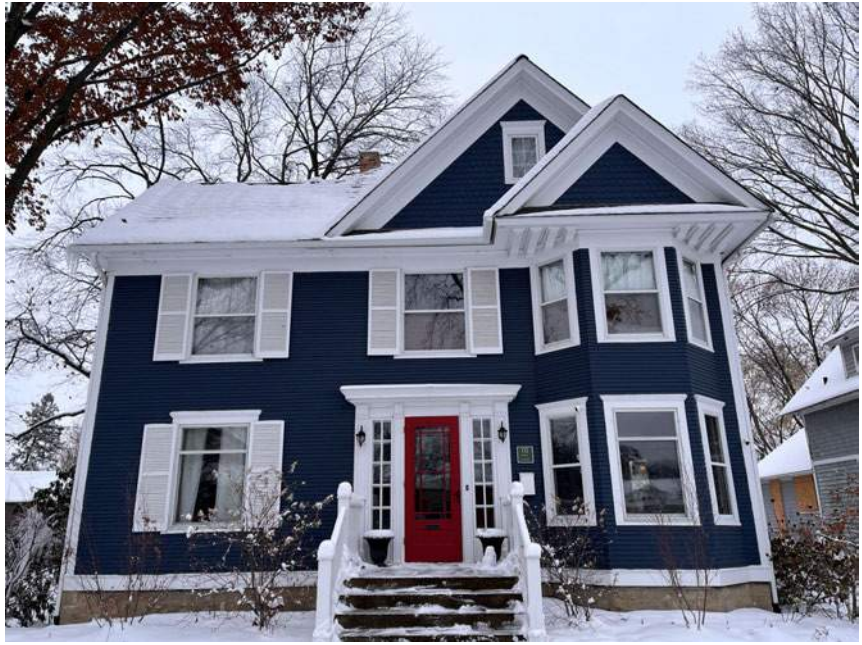
| CONDITION | excellent | REASON for SIGNIFICANCE | If not for front porch removal and alterations to entry surround, this c. 1905 Free Classic Queen Anne residence would be rated significant. |

| ALTERATIONS | Fixed shutters (not historic); two- and one-story rear additions; front entry surround w/ cornice, sidelights, & multi-light sidelights (c. 1955 -- Sanborn maps through 1954 show building with a full-width front porch); front stoop with railing (post-1954) ; replacement windows under gables (not historic). Post-2007 -- no changes (exterior repainted). | | |

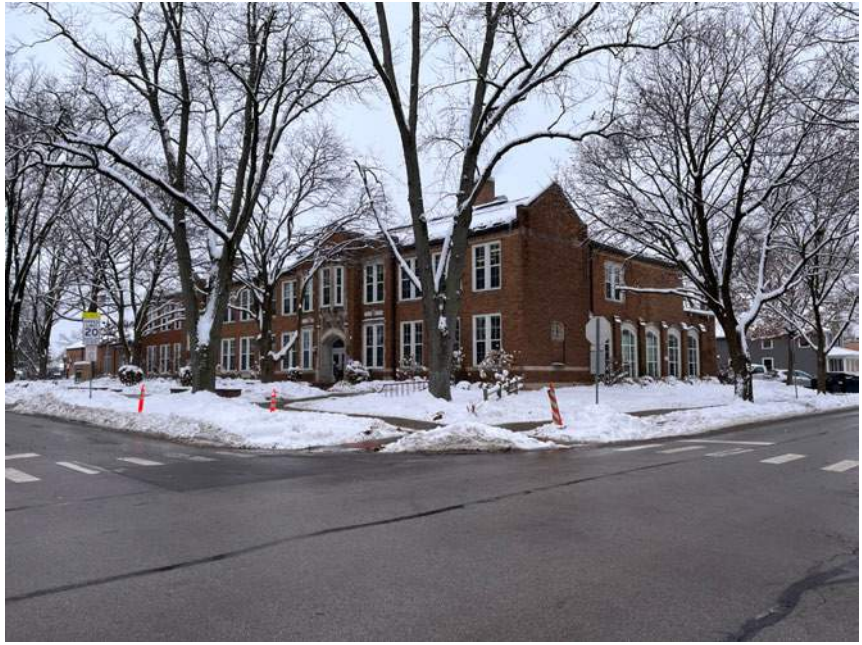
| CONDITION | excellent | REASON for SIGNIFICANCE | Even with alterations, this Gothic-Revival school remains a significant building in the district. |

| ALTERATIONS | One story south side addition (1954, extended 1982); replacement windows in original openings (not historic); replacement doors (not historic); window on north elevation partially infilled with brick. Post-2007 -- replacement multi-light windows in arched openings at first story of north elevation. | | |

Replacement multi-light windows in arched openings at first story of north elevation.

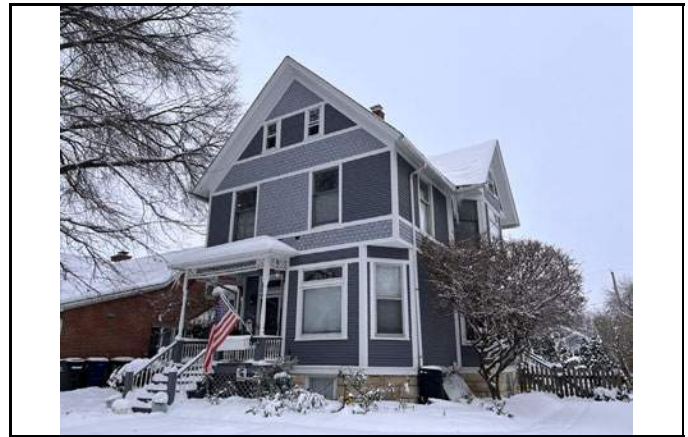
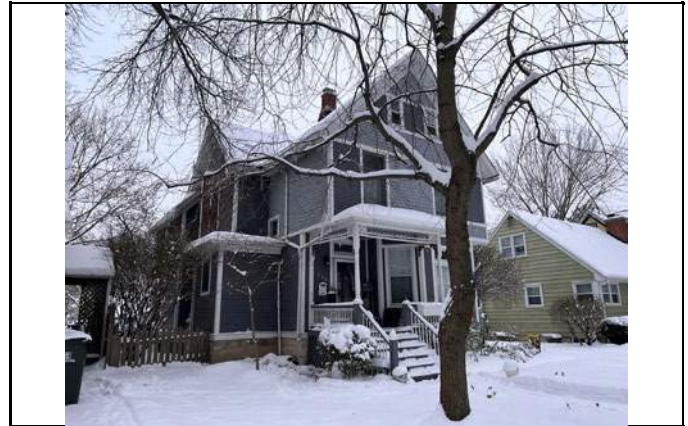
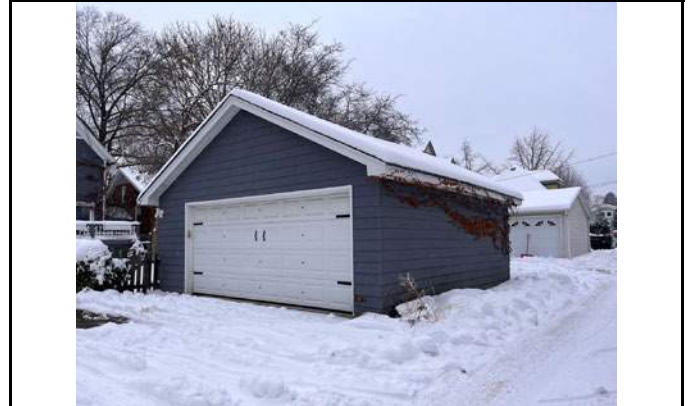
| <b>NOTES ON WORK:</b> | Replacement front door. |
