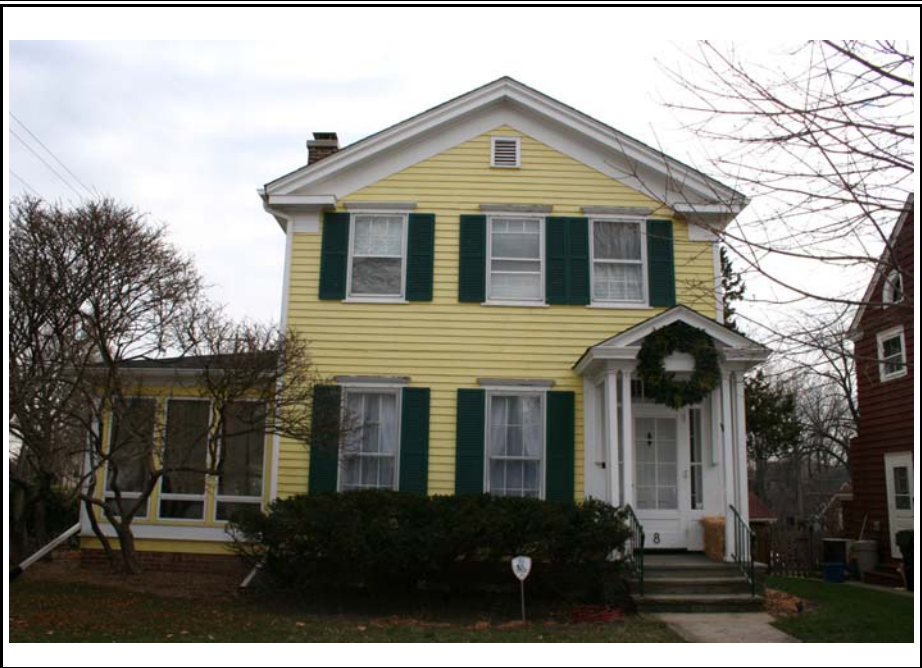
| SIGNIFICANT FEATURES | <input type="text" value="Front gable with cornice returns; historic 6/6 wood windows; front gable entry porch roof with cornice returns; multi-light sidelights and transom at entry; classical lintels on windows"/> | | |
| ALTERATIONS | <input #"="" type="text" value="One story north sun porch addition (not historic); fixed shutters; replacement columns and base on porch (not historic); first story window bay addition (south side, historic); two story rear addition; replacement brick foundation Replace escape window (admin. approved COA#11-4104)"/> | | |

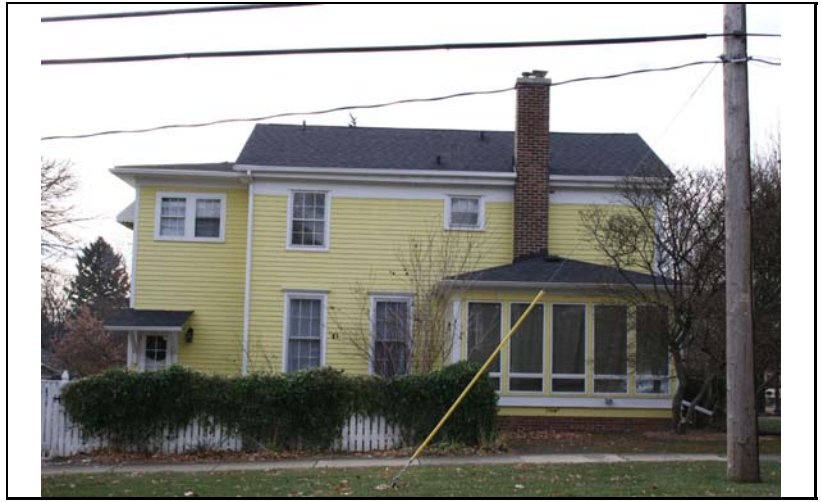
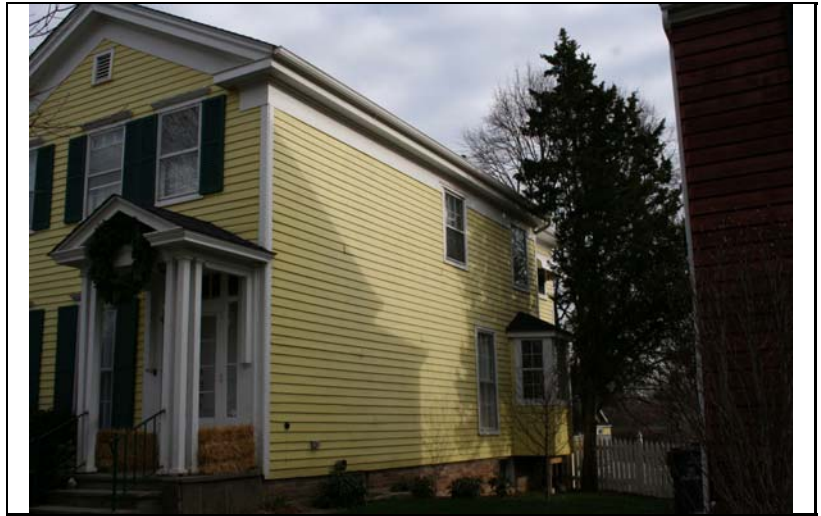
DIGITAL PHOTO ID

| ARCHITECTURAL CLASSIFICATION | <input type="text" value="Greek Revival"/> | PLAN | <input type="text" value="rectangular"/> |
| BEGINYEAR | <input type="text" value="c. 1865"/> | ROOF TYPE | <input type="text" value="Front gable"/> |
