Stormwater Management Report
1960 West Lucent Lane
Naperville, Illinois
June 12, 2025
Revised September 26, 2025

Prepared By:
Jacob and Hefner Associates, Inc.
1333 Butterfield Road, Suite 300
Downers Grove, Illinois 60515

Prepared For:
Karis Critical
2150 Goodlette-Frank Road, Suite 700
Naples, FL 34102

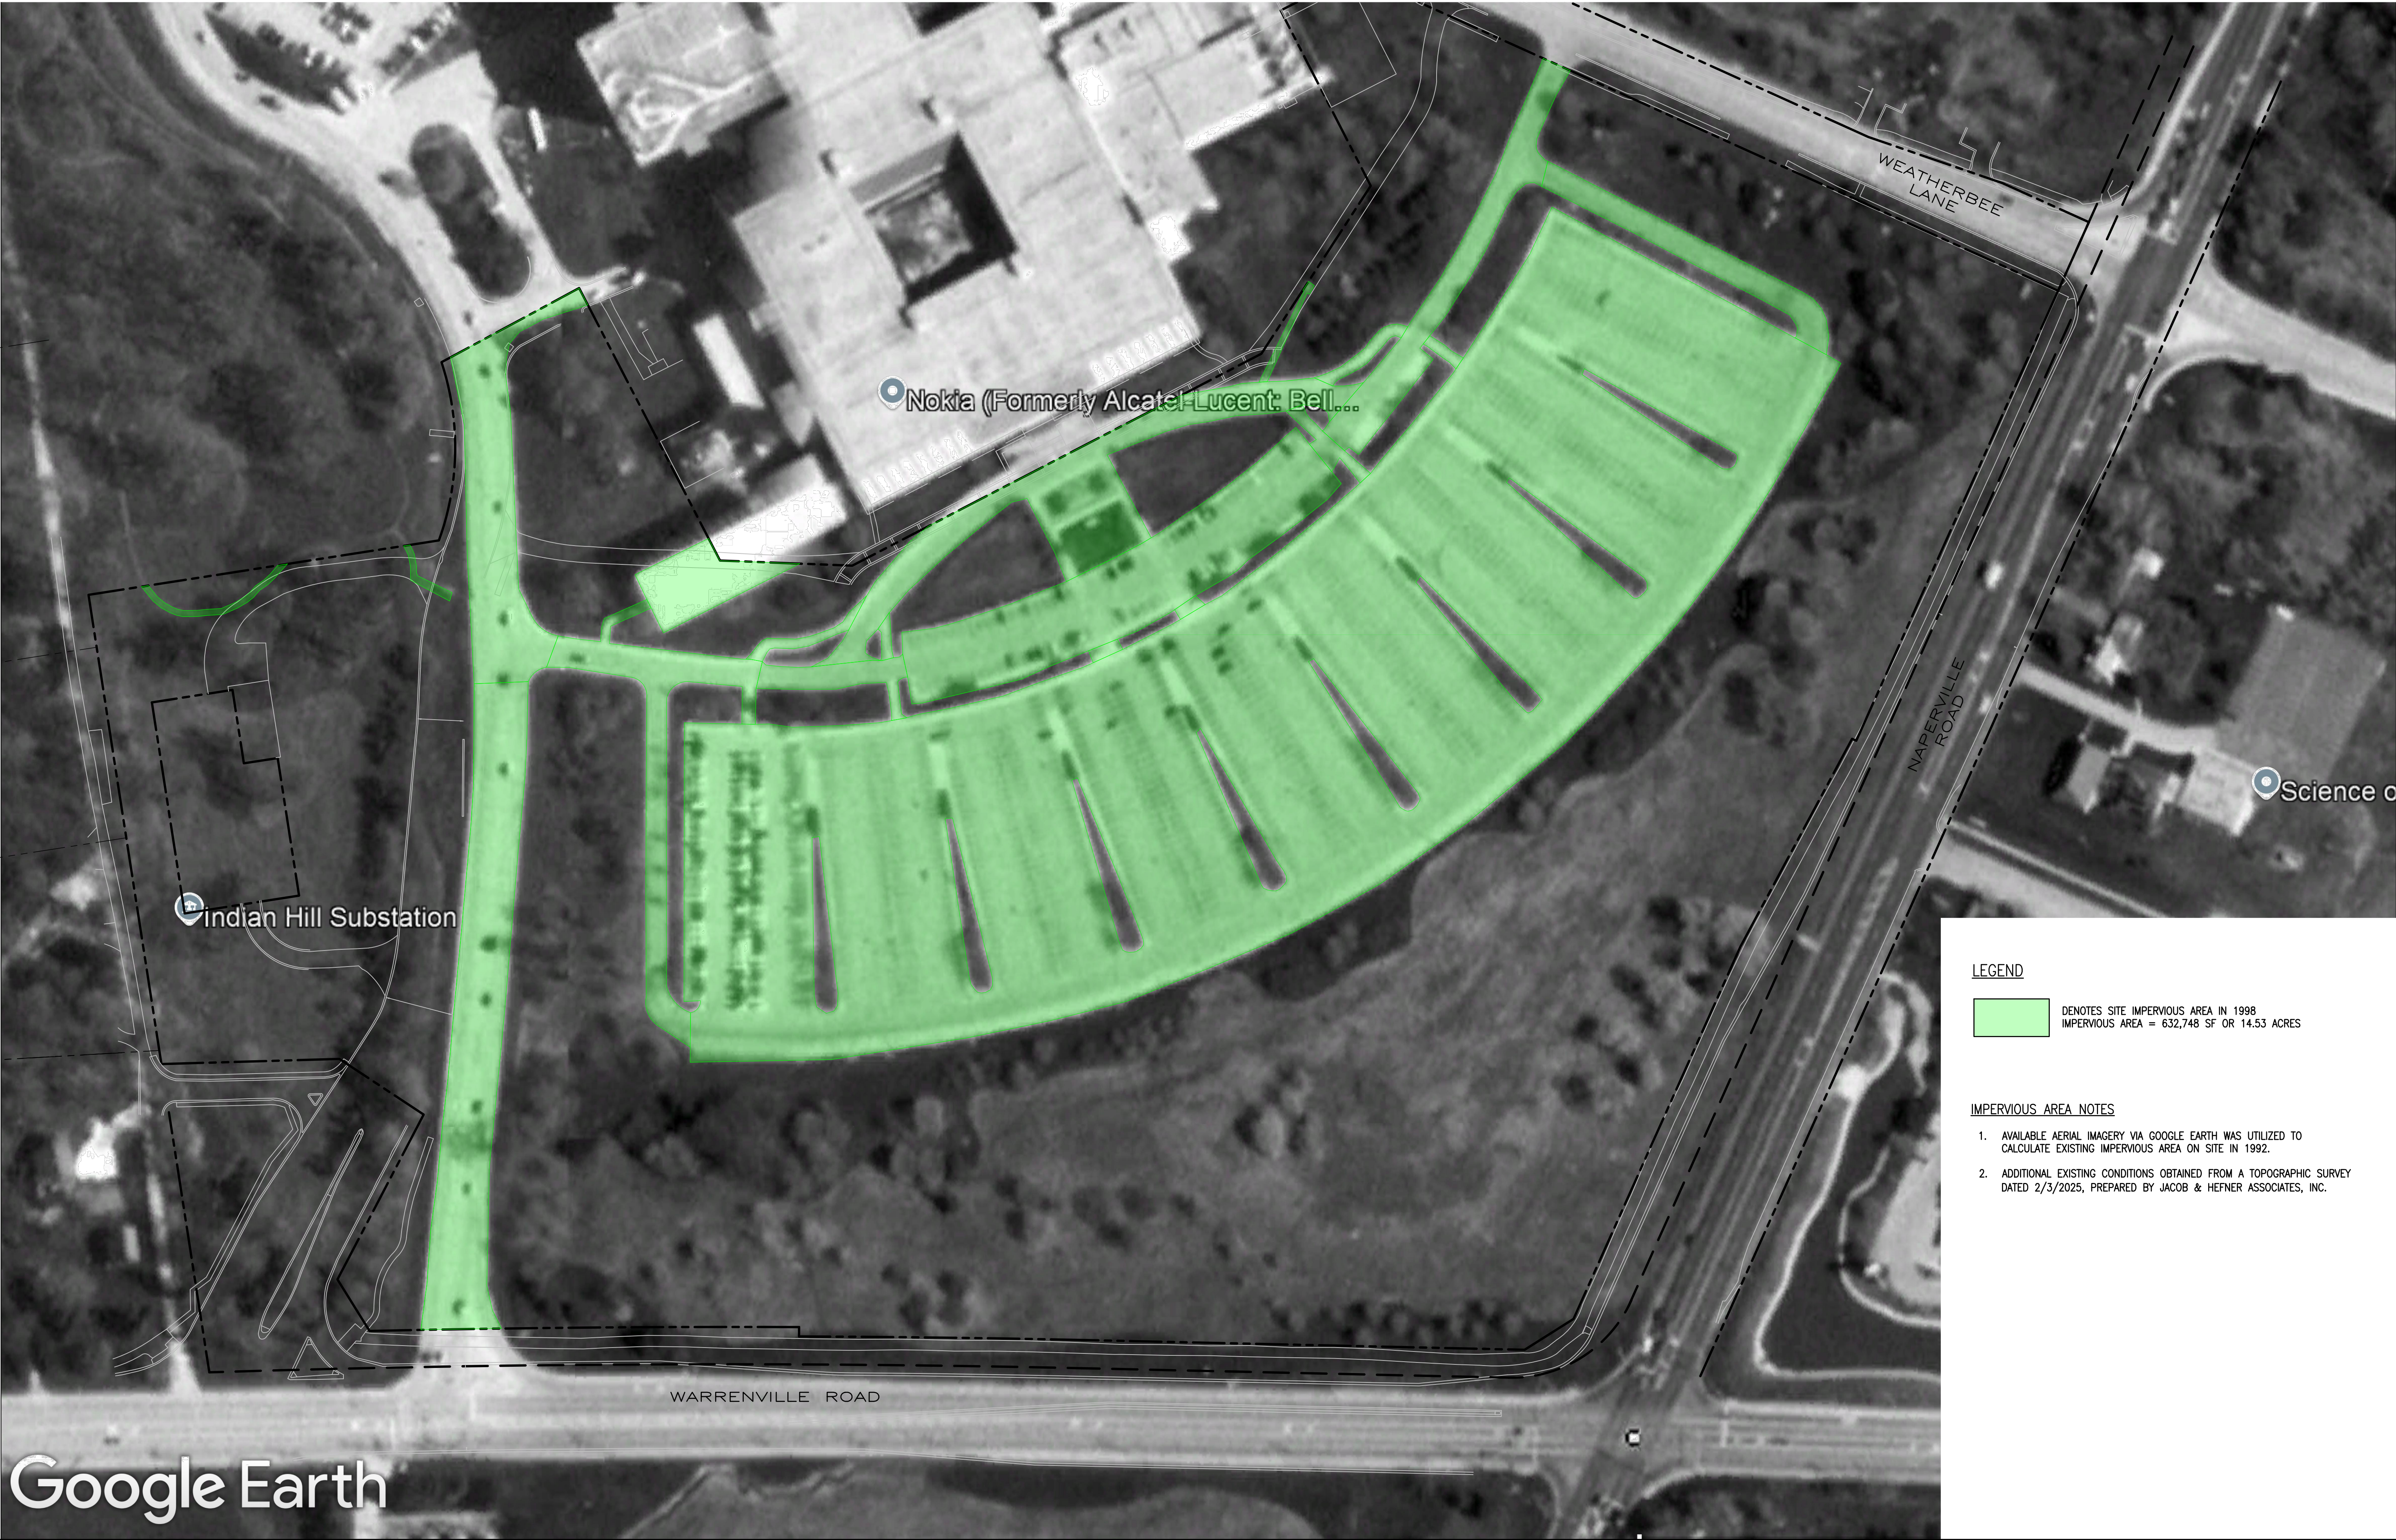
H:\H477\1\DWG\Pre\Exhibits\Stormwater\H477 1992 Impervious Area Exhibit.dwg

DENOTES SITE IMPERVIOUS AREA IN 1998
IMPERVIOUS AREA = 632,748 SF OR 14.53 ACRES

1. AVAILABLE AERIAL IMAGERY VIA GOOGLE EARTH WAS UTILIZED TO CALCULATE EXISTING IMPERVIOUS AREA ON SITE IN 1992.
2. ADDITIONAL EXISTING CONDITIONS OBTAINED FROM A TOPOGRAPHIC SURVEY DATED 2/3/2025, PREPARED BY JACOB & HEFNER ASSOCIATES, INC.

Refer to 1992, 2013, and Proposed Impervious Area Exhibits under this tab for impervious area calculations referenced in the table above.

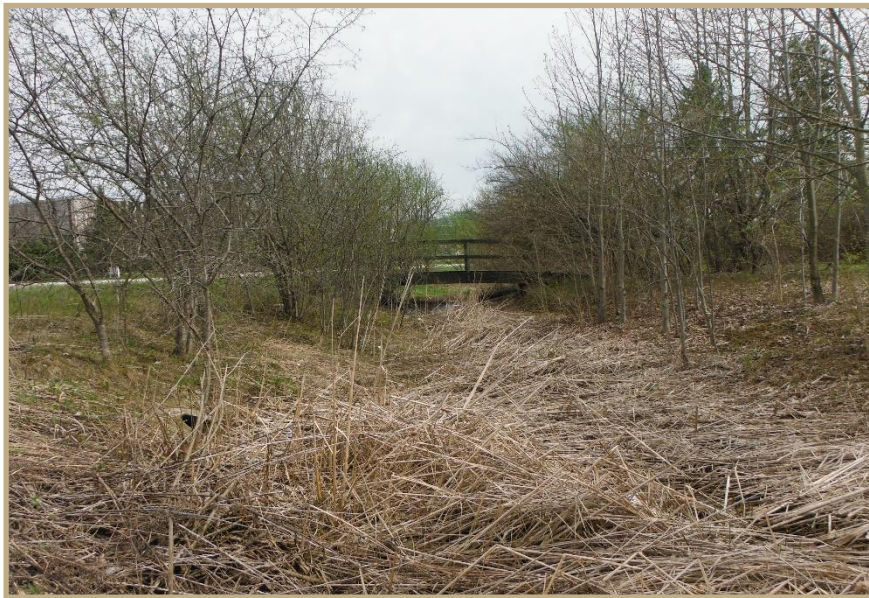
PHOTO 25

View of Area 13, a man made roadside ditch, facing south.

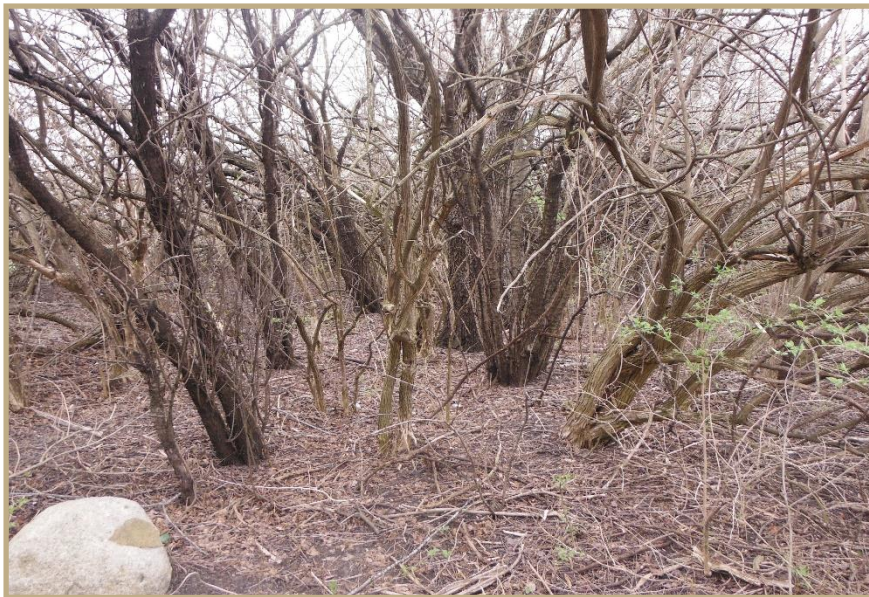
PHOTO 26

View of upland Area 14 near Data Point X01 facing north.

Soils: The soil profile at Data Point X01 consisted of 0-14 inches of black (10YR 2/1) silty clay loam mixed fill. Garbage and debris were observed in this layer. From 14 to 16 inches below the surface, the soil profile was gray (2.5Y 5/2) silty clay loam mixed fill with 10% yellowish brown (10YR 6/6) redoximorphic

Hydrology: Neither primary nor secondary wetland hydrology indicators were observed, so the hydrology criterion is not satisfied.

Conclusion: Data Point X01 fails to satisfy the vegetation and hydrology criteria; therefore Area 14 does not qualify as wetland.

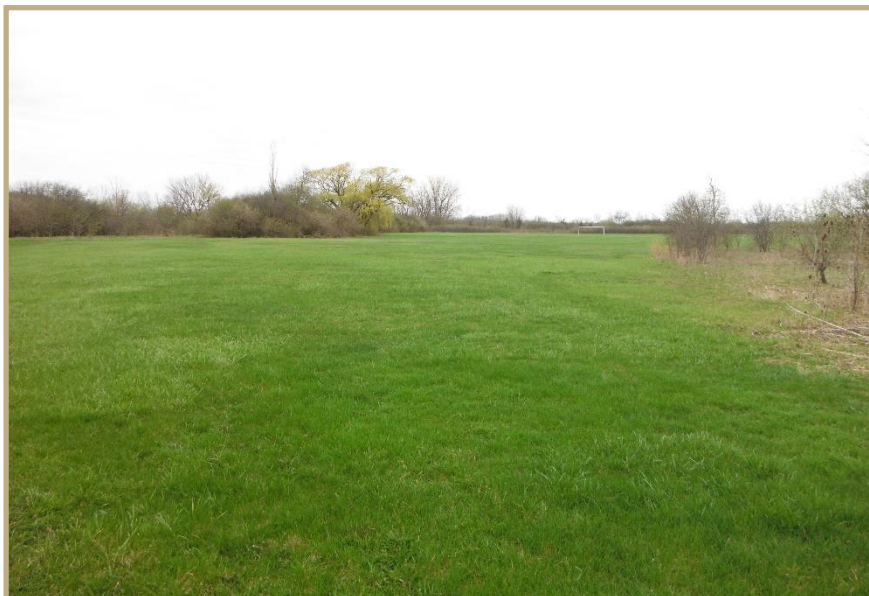
PHOTO 27

View of upland Area 15 near Data Point X02 facing southwest.

Soils: The soil profile at Data Point X02 consisted of 0-10 inches of black (10YR 2/10 silt loam mixed fill underlain by 8 inches, to a depth of 18 inches below the surface, of brown (10YR 5/4) silty clay loam mixed fill. Hydric soil indicators were not observed, so the soils criterion is not satisfied.

Hydrology: Neither primary nor secondary wetland hydrology indicators were observed, so the hydrology criterion is not satisfied.

Conclusion: Data Point X02 fails to satisfy the soil and hydrology criteria; therefore Area 15 does not qualify as wetland.

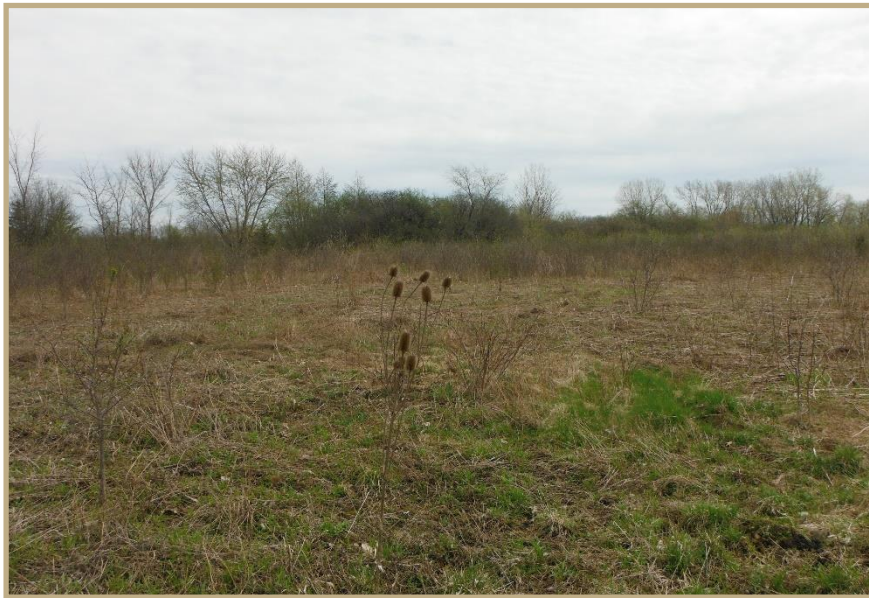
PHOTO 28

View of upland Area 16 near Data Point X04 facing northeast.

Soils: The soil profile at Data Point X04 consisted of 0-10 inches of black (10YR 2/1) silt loam underlain by 5 inches, to 15 inches below the surface, of brown (2.5Y 5/4) silty clay loam mixed fill with 5% gravel. Hydric soil indicators were not observed, so the soils criterion is not satisfied.

Hydrology: Neither primary nor secondary wetland hydrology indicators were observed, so the hydrology criterion is not satisfied.

Conclusion: Data Point X04 fails to satisfy all three criteria; therefore Area 16 does not qualify as wetland.

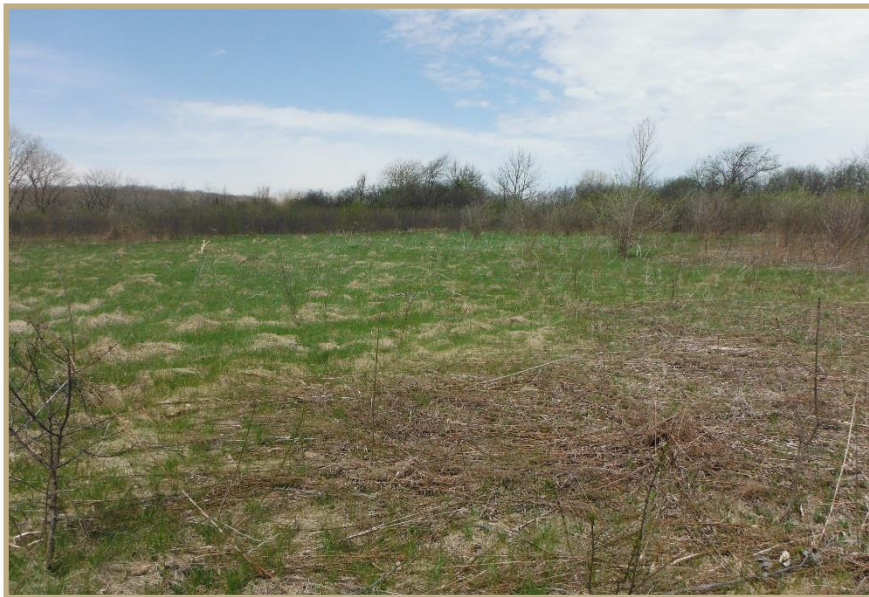
PHOTO 29

View of Area 17 near Data Point X06 facing southwest.

Hydrology: Neither primary nor secondary wetland hydrology indicators were observed, so the hydrology criterion is not satisfied.

Conclusion: Data Point X06 fails to satisfy the soils and hydrology criteria; therefore Area 17 does not qualify as wetland.
