STRUCTURAL ANALYSIS

Structural Analysis and Feasibility Report

126 N Wright St, 140 N Wright St, and 619 E Franklin Ave, Naperville, IL.

10/9/2019

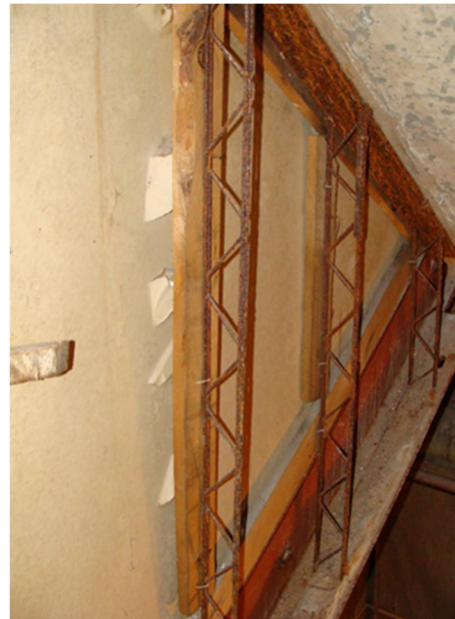
Photo #1 – Open web wall studs in 140

The Administration Building was built in 1956. It is a “T” shaped, 4 story brick masonry building originally built as a dormitory and is currently used as administrative offices. It has a concrete frame of columns and beams supporting concrete floor slabs and a sloping concrete roof. The wall infill is metal mesh and plaster with open web steel studs. (See Photo #1) In some areas the mesh and plaster has been replaced with wood furring and drywall.

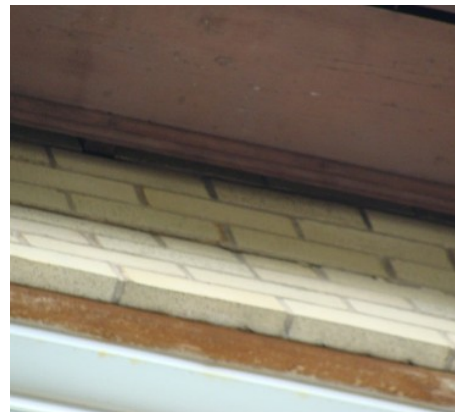
Photo #2 – Displaced brick at eave on west face of 619

At the Krejci Academy, it was noted that several feet of the top 4 courses of brick on the west exterior wall, about in the middle of the north leg, has displaced several inches at the top and were tilted. (See Photo #2) It was also observed that the roof line between the dormer and the west wall was visibly sagging as was the roof line upslope from the face of the dormer, along either side of the dormer. (See Photo #3) Similar roof line sagging was noted in the eastern side of the roof near the dormer. Further investigation found the wall top plate where the roof rafters bear on the west wall had displaced about 4 inches from the edge of the concrete slab constructed at the time the attic modifications were made. (See Photo #4)

The attic area of the Krejci Academy will require reinforcement and the rafter ends will need to be pulled back into position with through building tension ties.

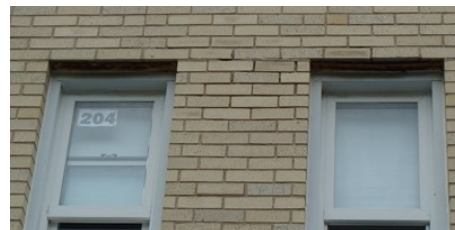
Photo #5 – Corroded lintels of 619

Many of the window and door headers have minor surface corrosion. (See Photo #5) The corroded window and door lintels should be cleaned of corrosion and repainted. Some may need to be replaced if the corrosion has progressed too far.
