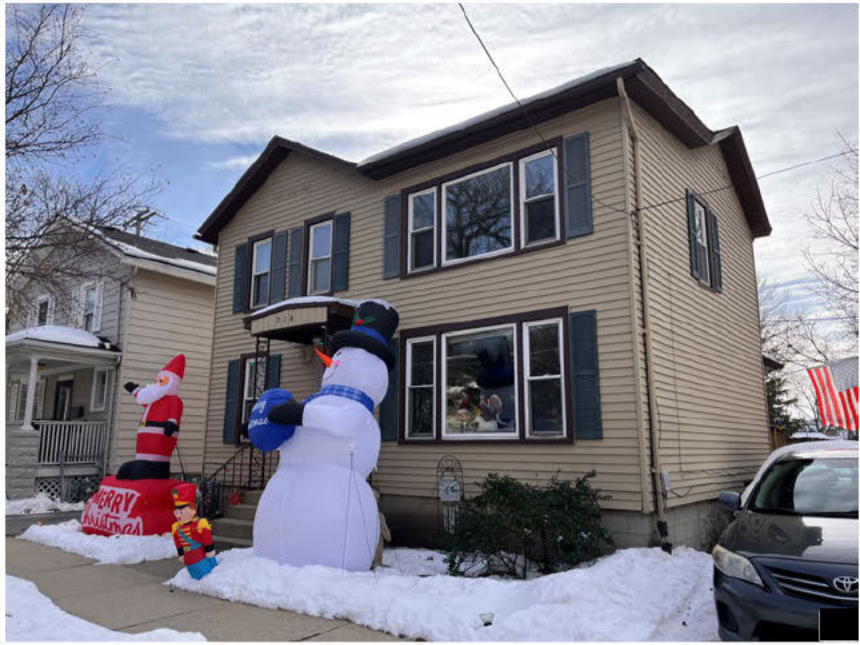
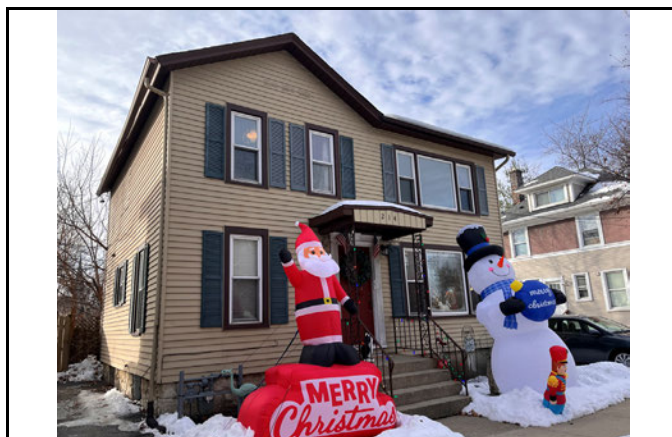
| STREET # | 214 |

| CONDITION | fair | REASON for SIGNIFICANCE | |
| INTEGRITY | major alterations and/or addition(s) | | |

| SIGNIFICANT FEATURES | Front gable bay and recessed side gable wing (now obscured by later addition) |

| ALTERATIONS | Two-story addition in front of original west wing (c. 1970); Aluminum siding; replacement front entry porch (non-historic); replacement front door (non-historic); replacement 1/1 windows in slightly downsized openings; fixed shutters; rear porch addition (non-historic). Post-2007 -- no changes. |

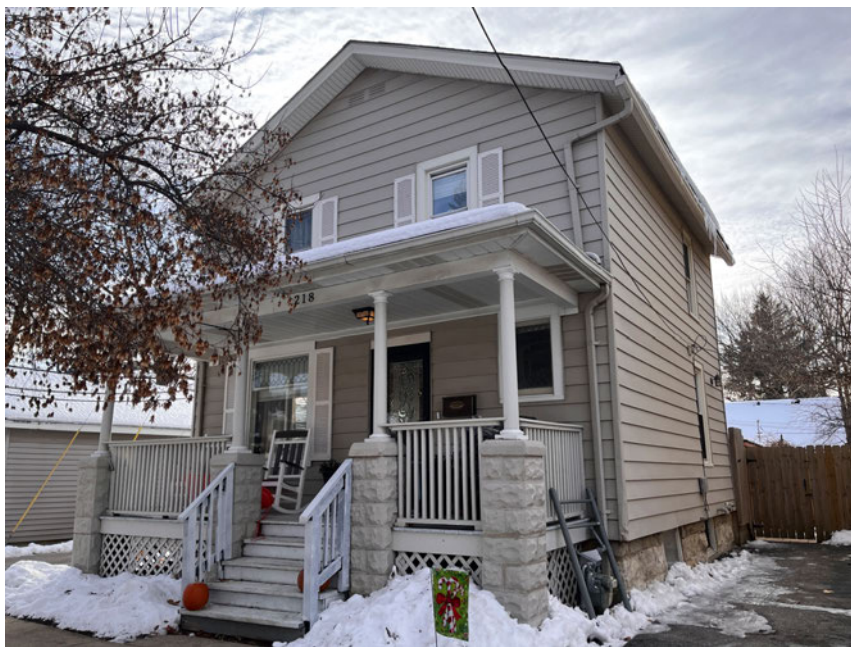
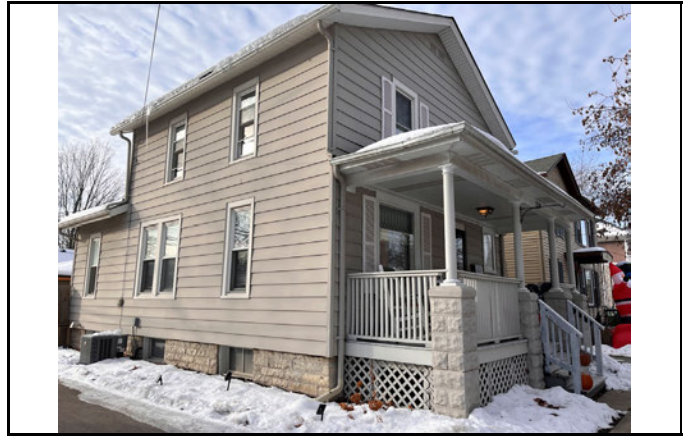
| STREET # | 218 |

| CONDITION | good | REASON for SIGNIFICANCE | |
| INTEGRITY | minor alterations | | |

| SIGNIFICANT FEATURES | Broad front gable roof and rectangular massing; single hung leaded glass and leaded glass casement (damaged) windows under porch; hipped roof full front porch with round columns on concrete block piers | | |
| ALTERATIONS | Replacement siding (not historic); vinyl replacement windows in original openings; fixed shutters; replacement door (not historic); replacement railings and columns on porch (ca. 1910). Post-2007 -- replacement front door. | | |

replacement front door.

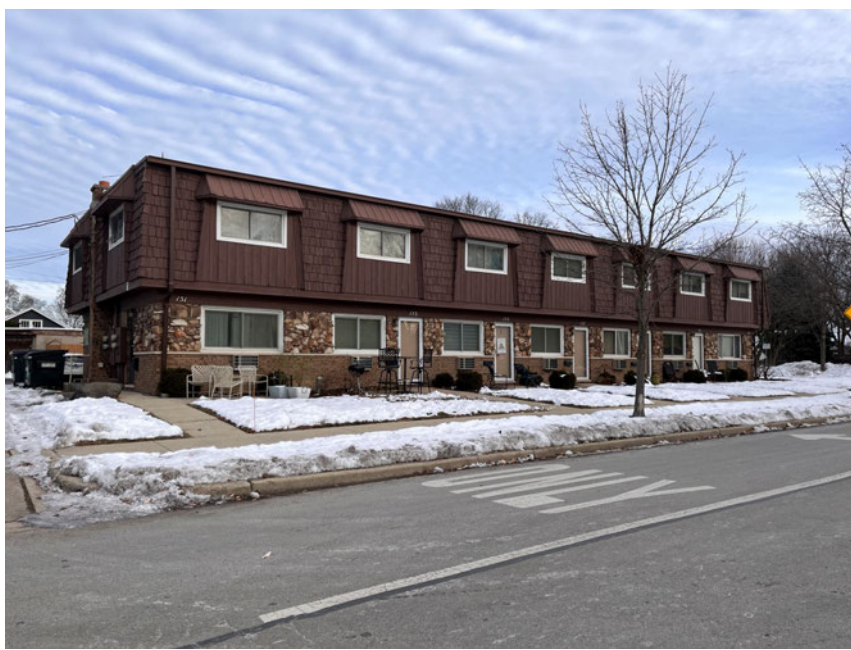
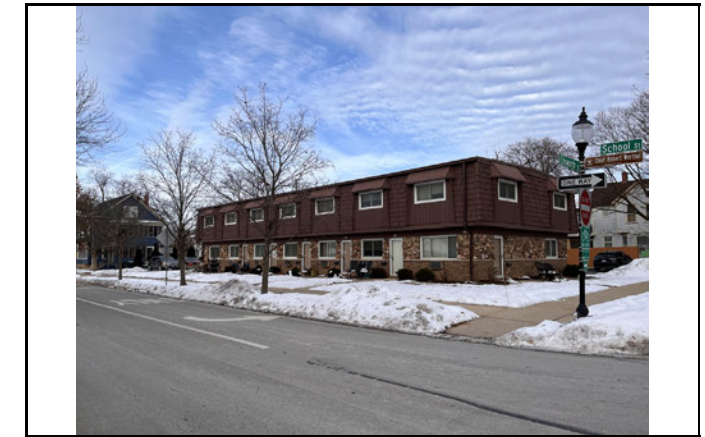
| STREET # | 151-163 |

| CONDITION | good | REASON for SIGNIFICANCE | |
| INTEGRITY | minor alterations | | |

| SIGNIFICANT FEATURES | Mansard roof that encompasses second story; regularly spaced dormers with shed roofs; rock-face stone and brick at first story; sliding windows in original openings. | | |
| ALTERATIONS | Post-2007 -- some entry doors appear to have been replaced. | | |

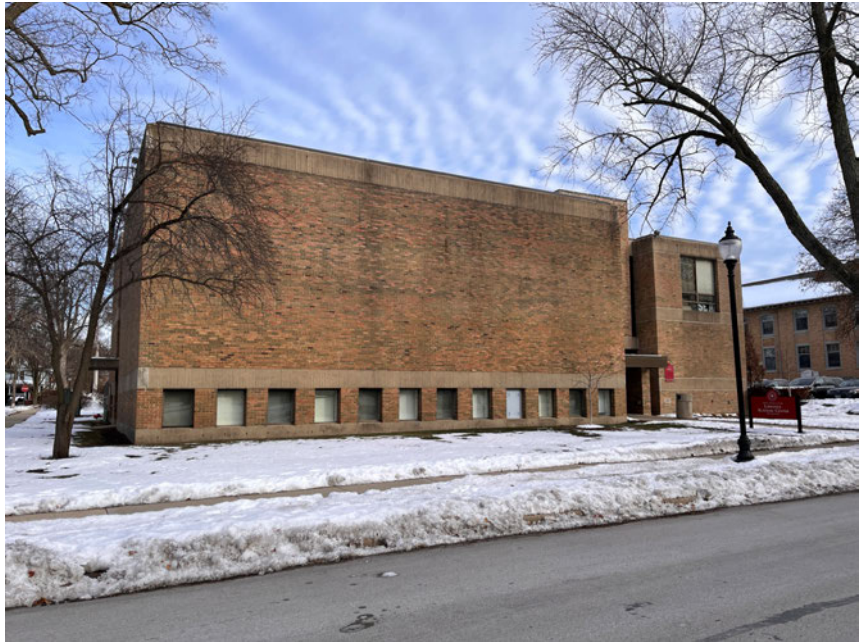
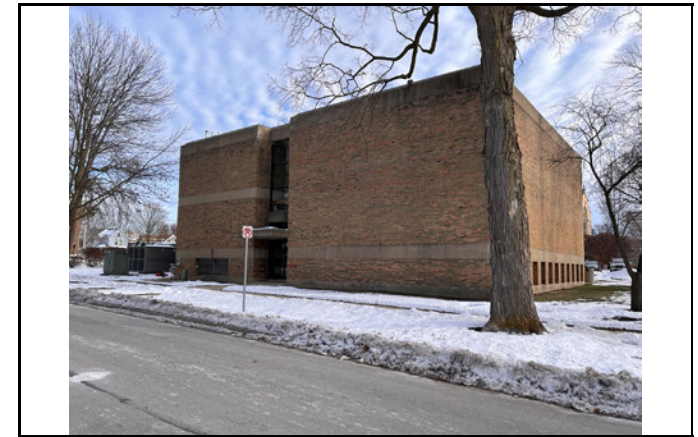
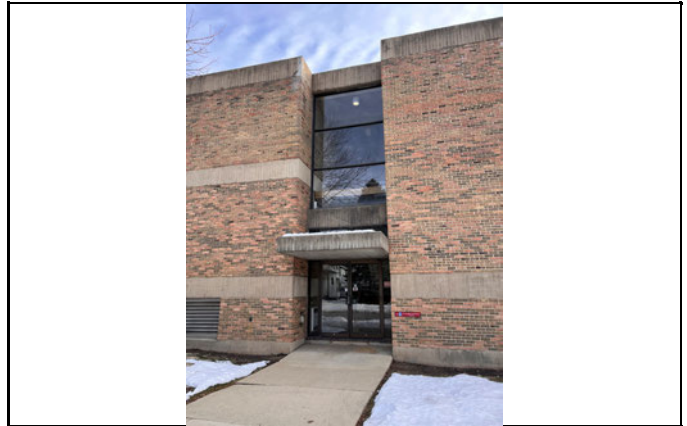
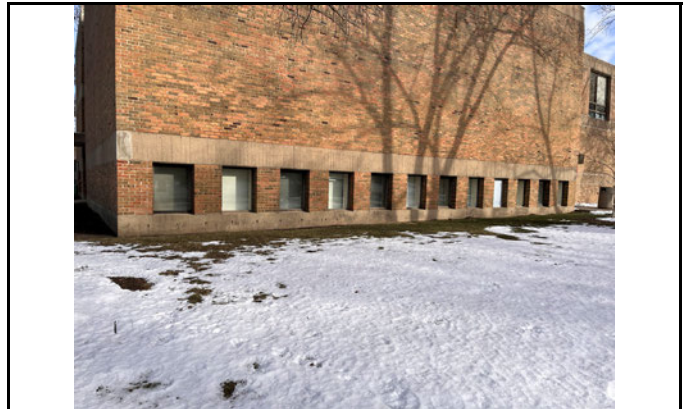
| STREET # | 309 |

| CONDITION | excellent | REASON for SIGNIFICANCE | |

| SIGNIFICANT FEATURES | Flat roof with concrete parapet (formwork on concrete is visible); multi-tonal red brick exterior walls with concrete horizontal banding; large west volume with no fenestration above raised basement level; slight taller entry bay on south elevation with cantilevered canopy over entry doors; two-story east volume with multi-light window at 2nd story; unfenestated west elevation (facing Brainard St) divided by recessed entry bay with cantilevered canopy over doors and glazing above | | |
| ALTERATIONS | Basement window boarded up on south elevation. | | |

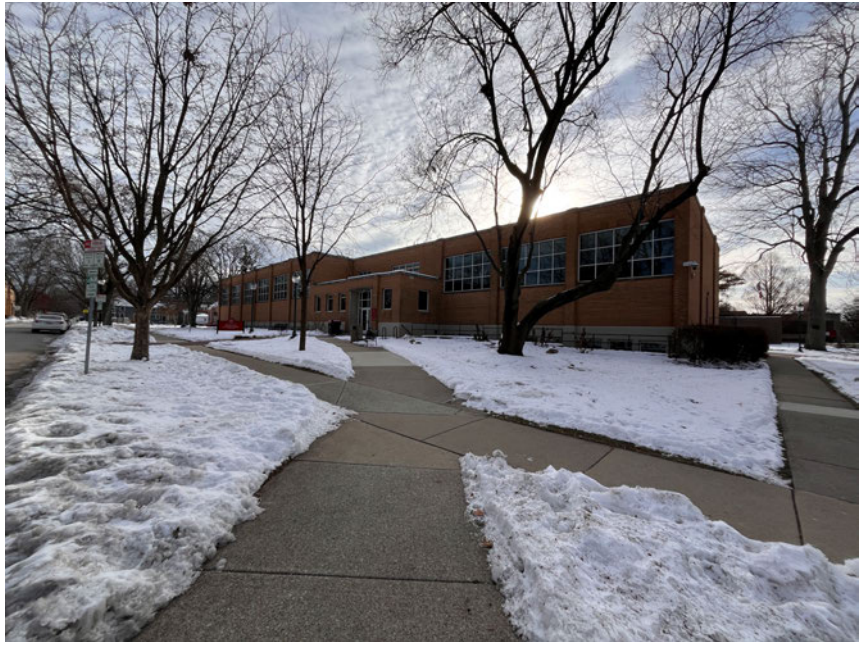
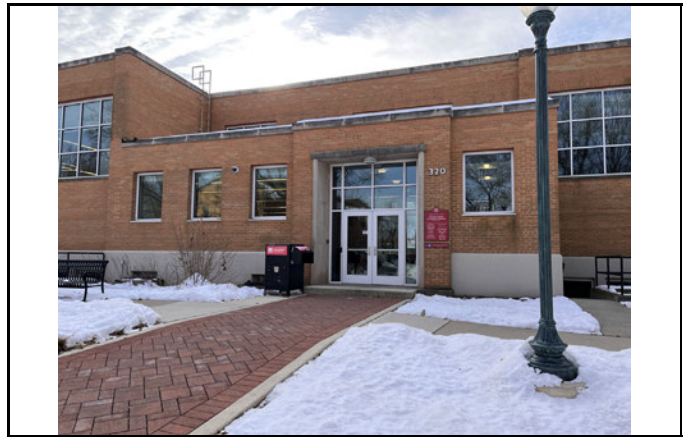
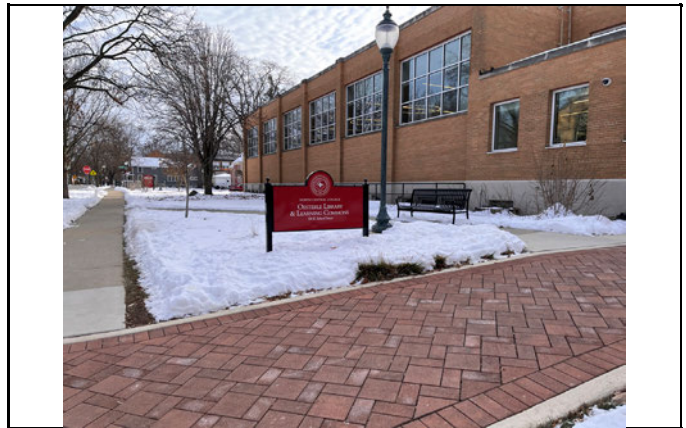
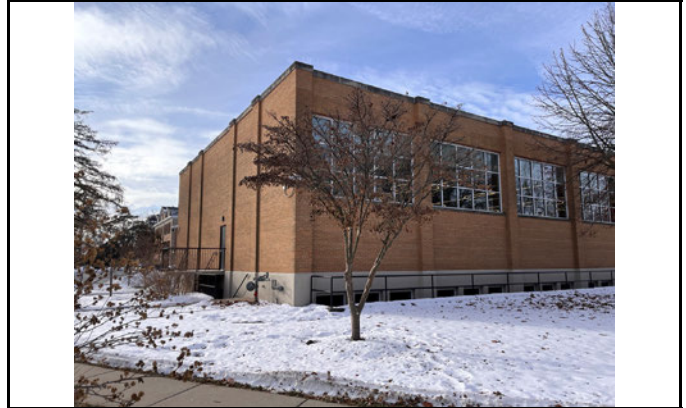
| STREET # | 320 |

| CONDITION | excellent | REASON for SIGNIFICANCE | |

| SIGNIFICANT FEATURES | Flat roof and geometric massing; broad, regular bays separated brick square piers; 1 story entry bay with flat roof | | |
| ALTERATIONS | According to NCC, building was renovated in 2005. Post-2007 -- replacement windows in original openings (configuration differs from windows present on building during 2007 survey); replacement windows | | |

| COA DECISION | COA #18-2731 - In-kind replacement of doors and windows - windows will be divided (approved 7/13/2018) | | |

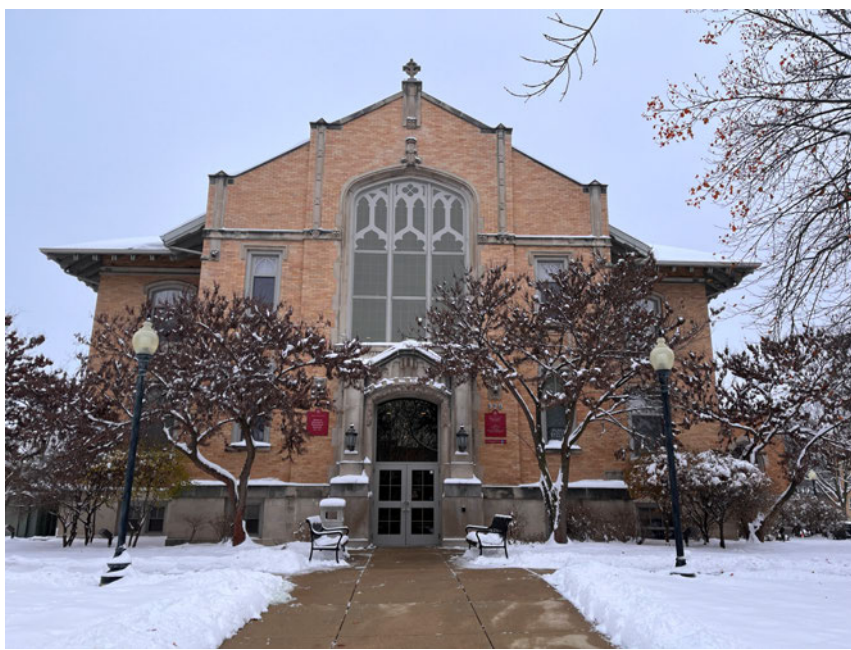
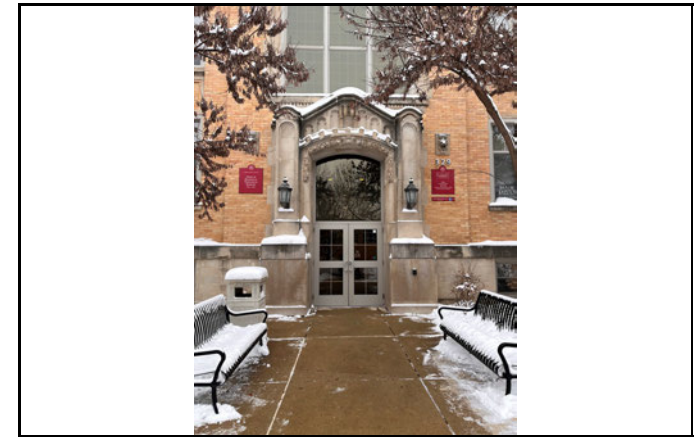
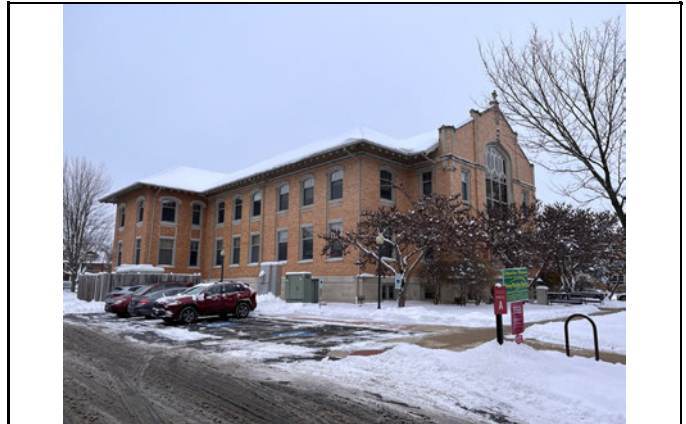
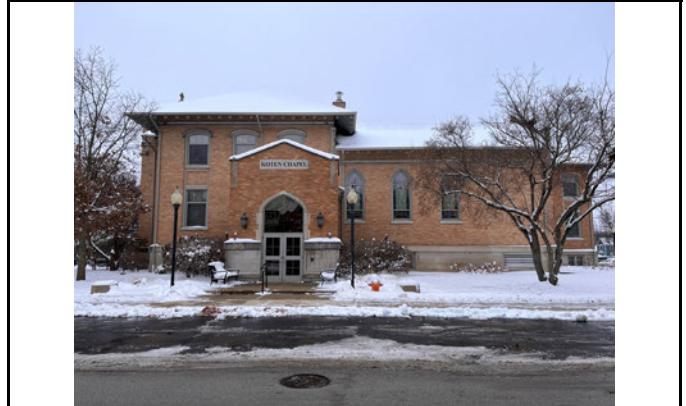
| STREET # | 329 |

| CONDITION | excellent | REASON for SIGNIFICANCE | Despite the replacement windows and east side addition, this building remains architecturally significant. |
| INTEGRITY | minor alterations and addition(s) | | |

| SIGNIFICANT FEATURES | Hipped roof w/ exposed rafter tails; front gable bay w/ stone detailing; center entry w/ elaborate stone surround & large flattened pointed arch window opening above; 2nd story segmental arch window openings w/ label molds & brick spandrel panels | | |
| ALTERATIONS | Replacement windows in orig. openings; replacement front entry doors & transoms; 2 story rear/west addition (historic); 1 story east addition (non-historic); replacement multi-light window over entry; front entry stairs removed & N entry modified (2006). Post-2007 -- no changes. | | |

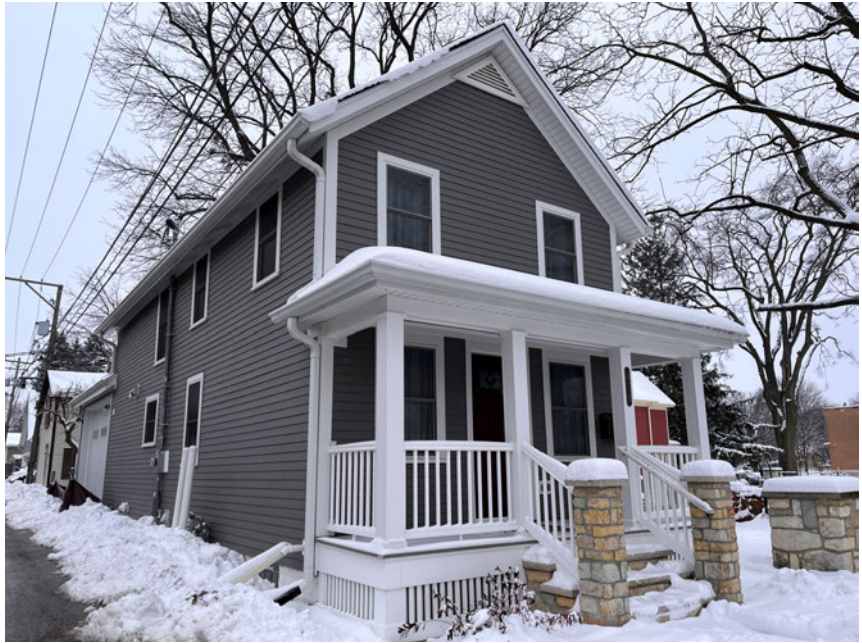
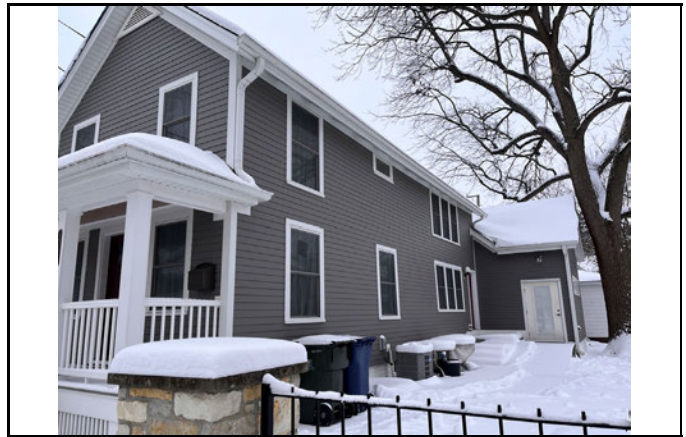
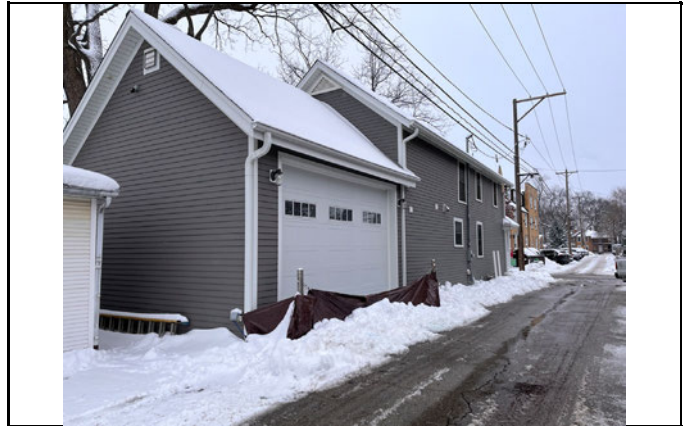
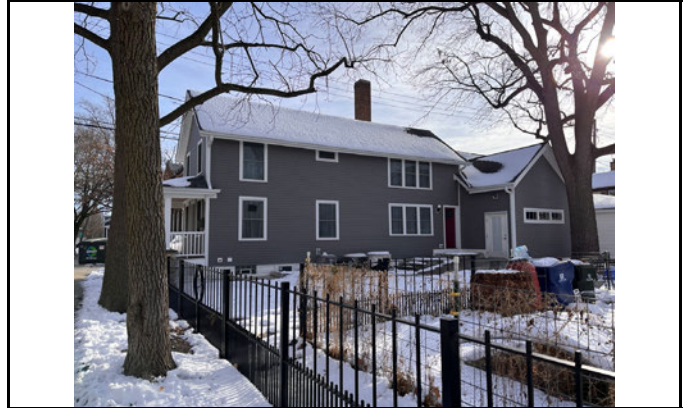
| <b>STREET #</b> | 418 |

| <b>CONDITION</b> | good | <b>REASON for SIGNIFICANCE</b> | |
| <b>INTEGRITY</b> | major alterations and/or addition(s) | | |

| <b>ALTERATIONS</b> | Replacement windows (possibly in altered openings first story of front façade); 2 story rear addition connecting building to existing garage (c. 1940). Post-2007 -- replacement siding; gable-roof canopy over entrance replaced with full-width front porch with hipped roof, square columns, and railing; addition to garage at east end; replacement front door at west entry; ramp and steps to east entry and new entry on garage addition. | | |

**HISTORIC INFO** The 1926 Sanborn map shows this 2-story building as a store, with an attached garage at the rear of the lot. A 2-story addition connecting the store building and garage were constructed sometime between 1926 and 1949.

**COA DECISION** COA #15-2157 - Renovation of and addition to attached garage (approved by HPC 9/24/2015); COA #19-3978 - In-kind door, siding, shingle replacement. Removal of chimney and shutters (approved 10/18/2019); COA #19-3978 - field change for a patio, ramp, and sidewalk changes (approved 4/17/2020)

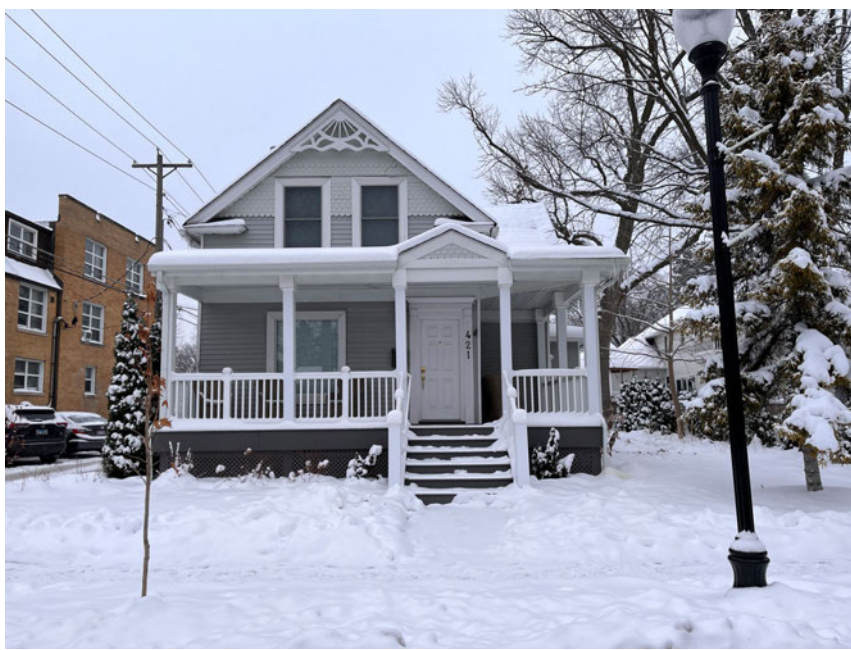
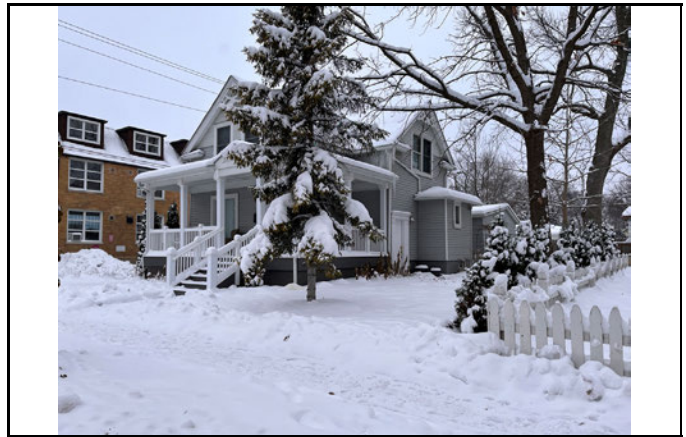
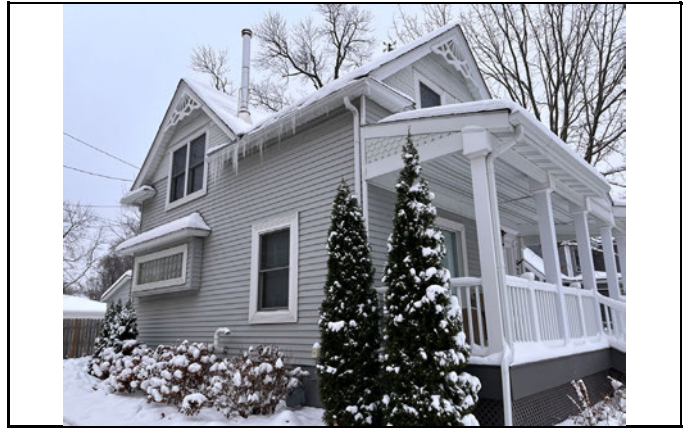
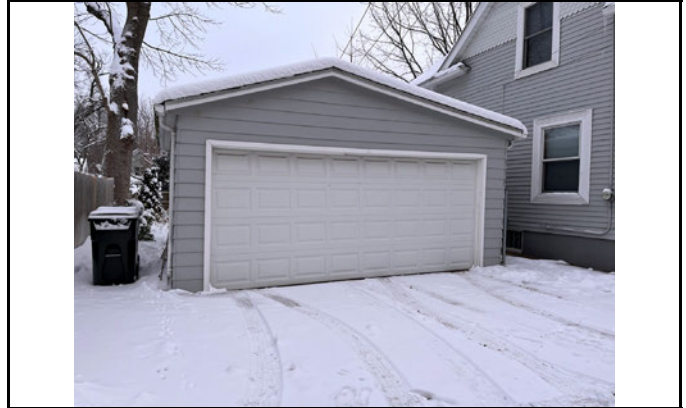
| STREET # | 421 |

| CONDITION | good | REASON for SIGNIFICANCE | |
| INTEGRITY | Minor alterations and addition(s) | | |

| SIGNIFICANT FEATURES | Front gable roof with cornice returns; 2 story east side gable ell | | |
| ALTERATIONS | Aluminum siding; replacement 1/1 vinyl windows in original openings; wood single light windows in altered openings; new entry and surround; glass block window on E side of front gable bay; E. side entry addition; 1 story E. addition; bay on W. side; vergeboard added in gable peak. Post-2007 -- aluminum siding either painted or replaced; wraparound front porch with hip/shed roof, square columns and open railings, and triangular pediment above porch entrance. | | |

**HISTORIC INFO** Sanborn maps from the early 20th century show that the house originally featured a wraparound front porch that was removed sometime after 1954.

**COA DECISION** Application for COA dated 8/5/2019 for new wraparound front porch with hip/shed roof, triangular pediment at entrance, square columns and open railings. Drawings show porch with decorative corner detailing at columns, which were not included when built.

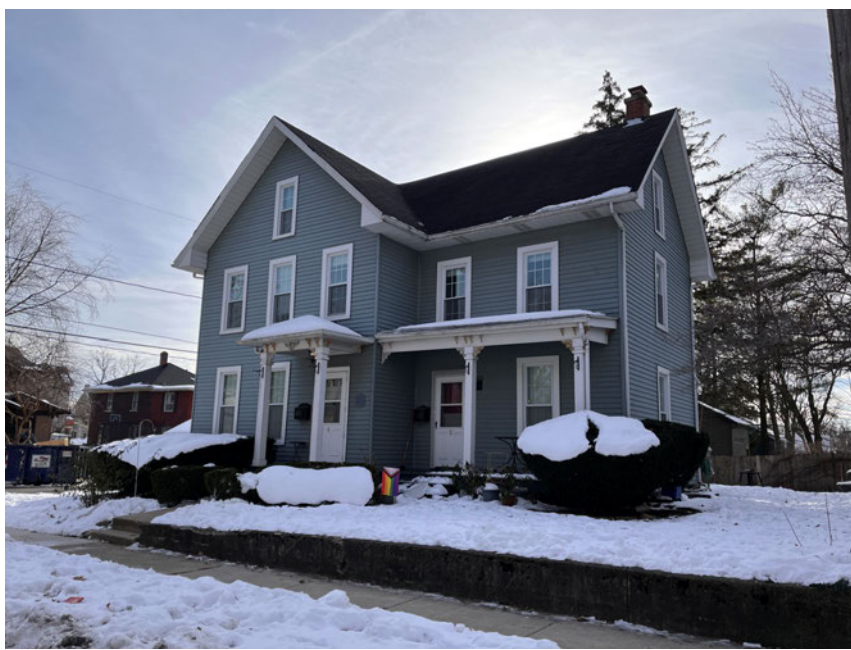
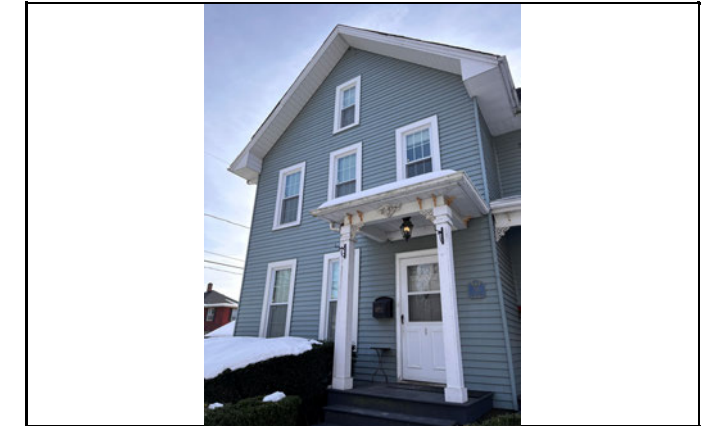
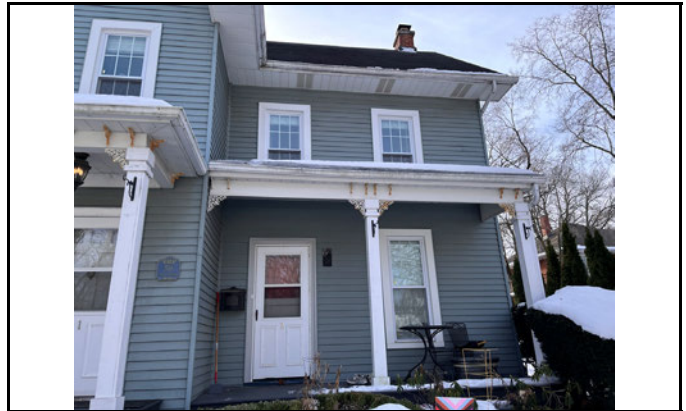
| STREET # | 516 |

| CONDITION | good | REASON for SIGNIFICANCE | |
| INTEGRITY | minor alterations and addition(s) | | |

| ALTERATIONS | Aluminum siding; original window hoods removed when re-sided (see IHSS photo); hipped-roof entry porch at entry on east bay (built sometime between 1954 and 1974); replacement doors (1940s); 1 story rear addition. Post-2007 -- historic 4/4 wood windows replaced with 6/6 Aluminum/vinyl replacement windows in existing openings. |

historic 4/4 wood windows replaced with 6/6 Aluminum/vinyl replacement windows in existing openings.

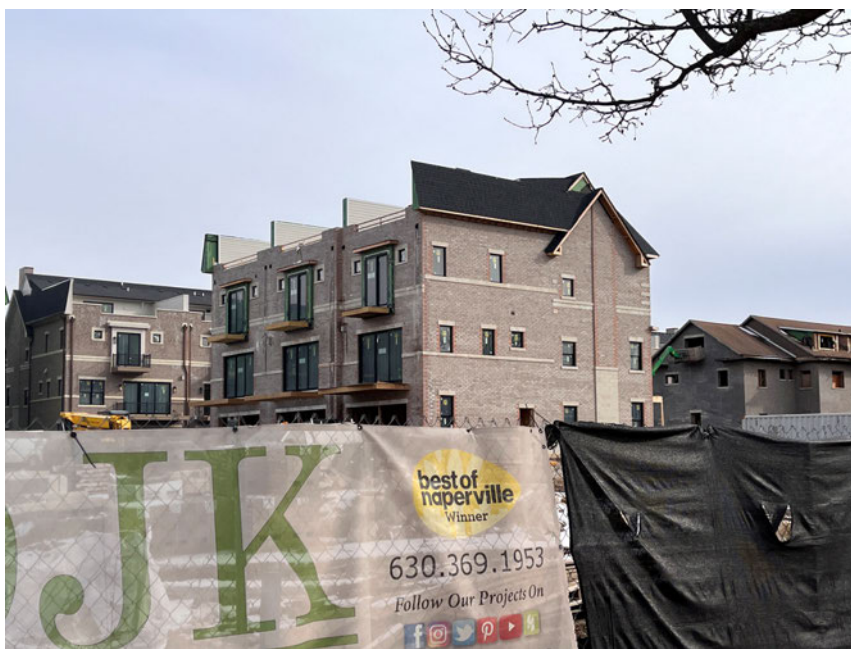
| CATEGORY | building | HISTORIC FUNCTION | Domestic - multiple dwelling |
| CONDITION | excellent | REASON for SIGNIFICANCE | |

| DATESOURCE | surveyor | FOUNDATION | Concrete |
