# Phase 1 Stormwater Management Report 1960 West Lucent Lane Naperville, Illinois June 12, 2025

Prepared By:
Jacob and Hefner Associates, Inc.
1333 Butterfield Road, Suite 300
Downers Grove, Illinois 60515

Prepared For:
Karis Critical
2150 Goodlette-Frank Road, Suite 700
Naples, FL 34102

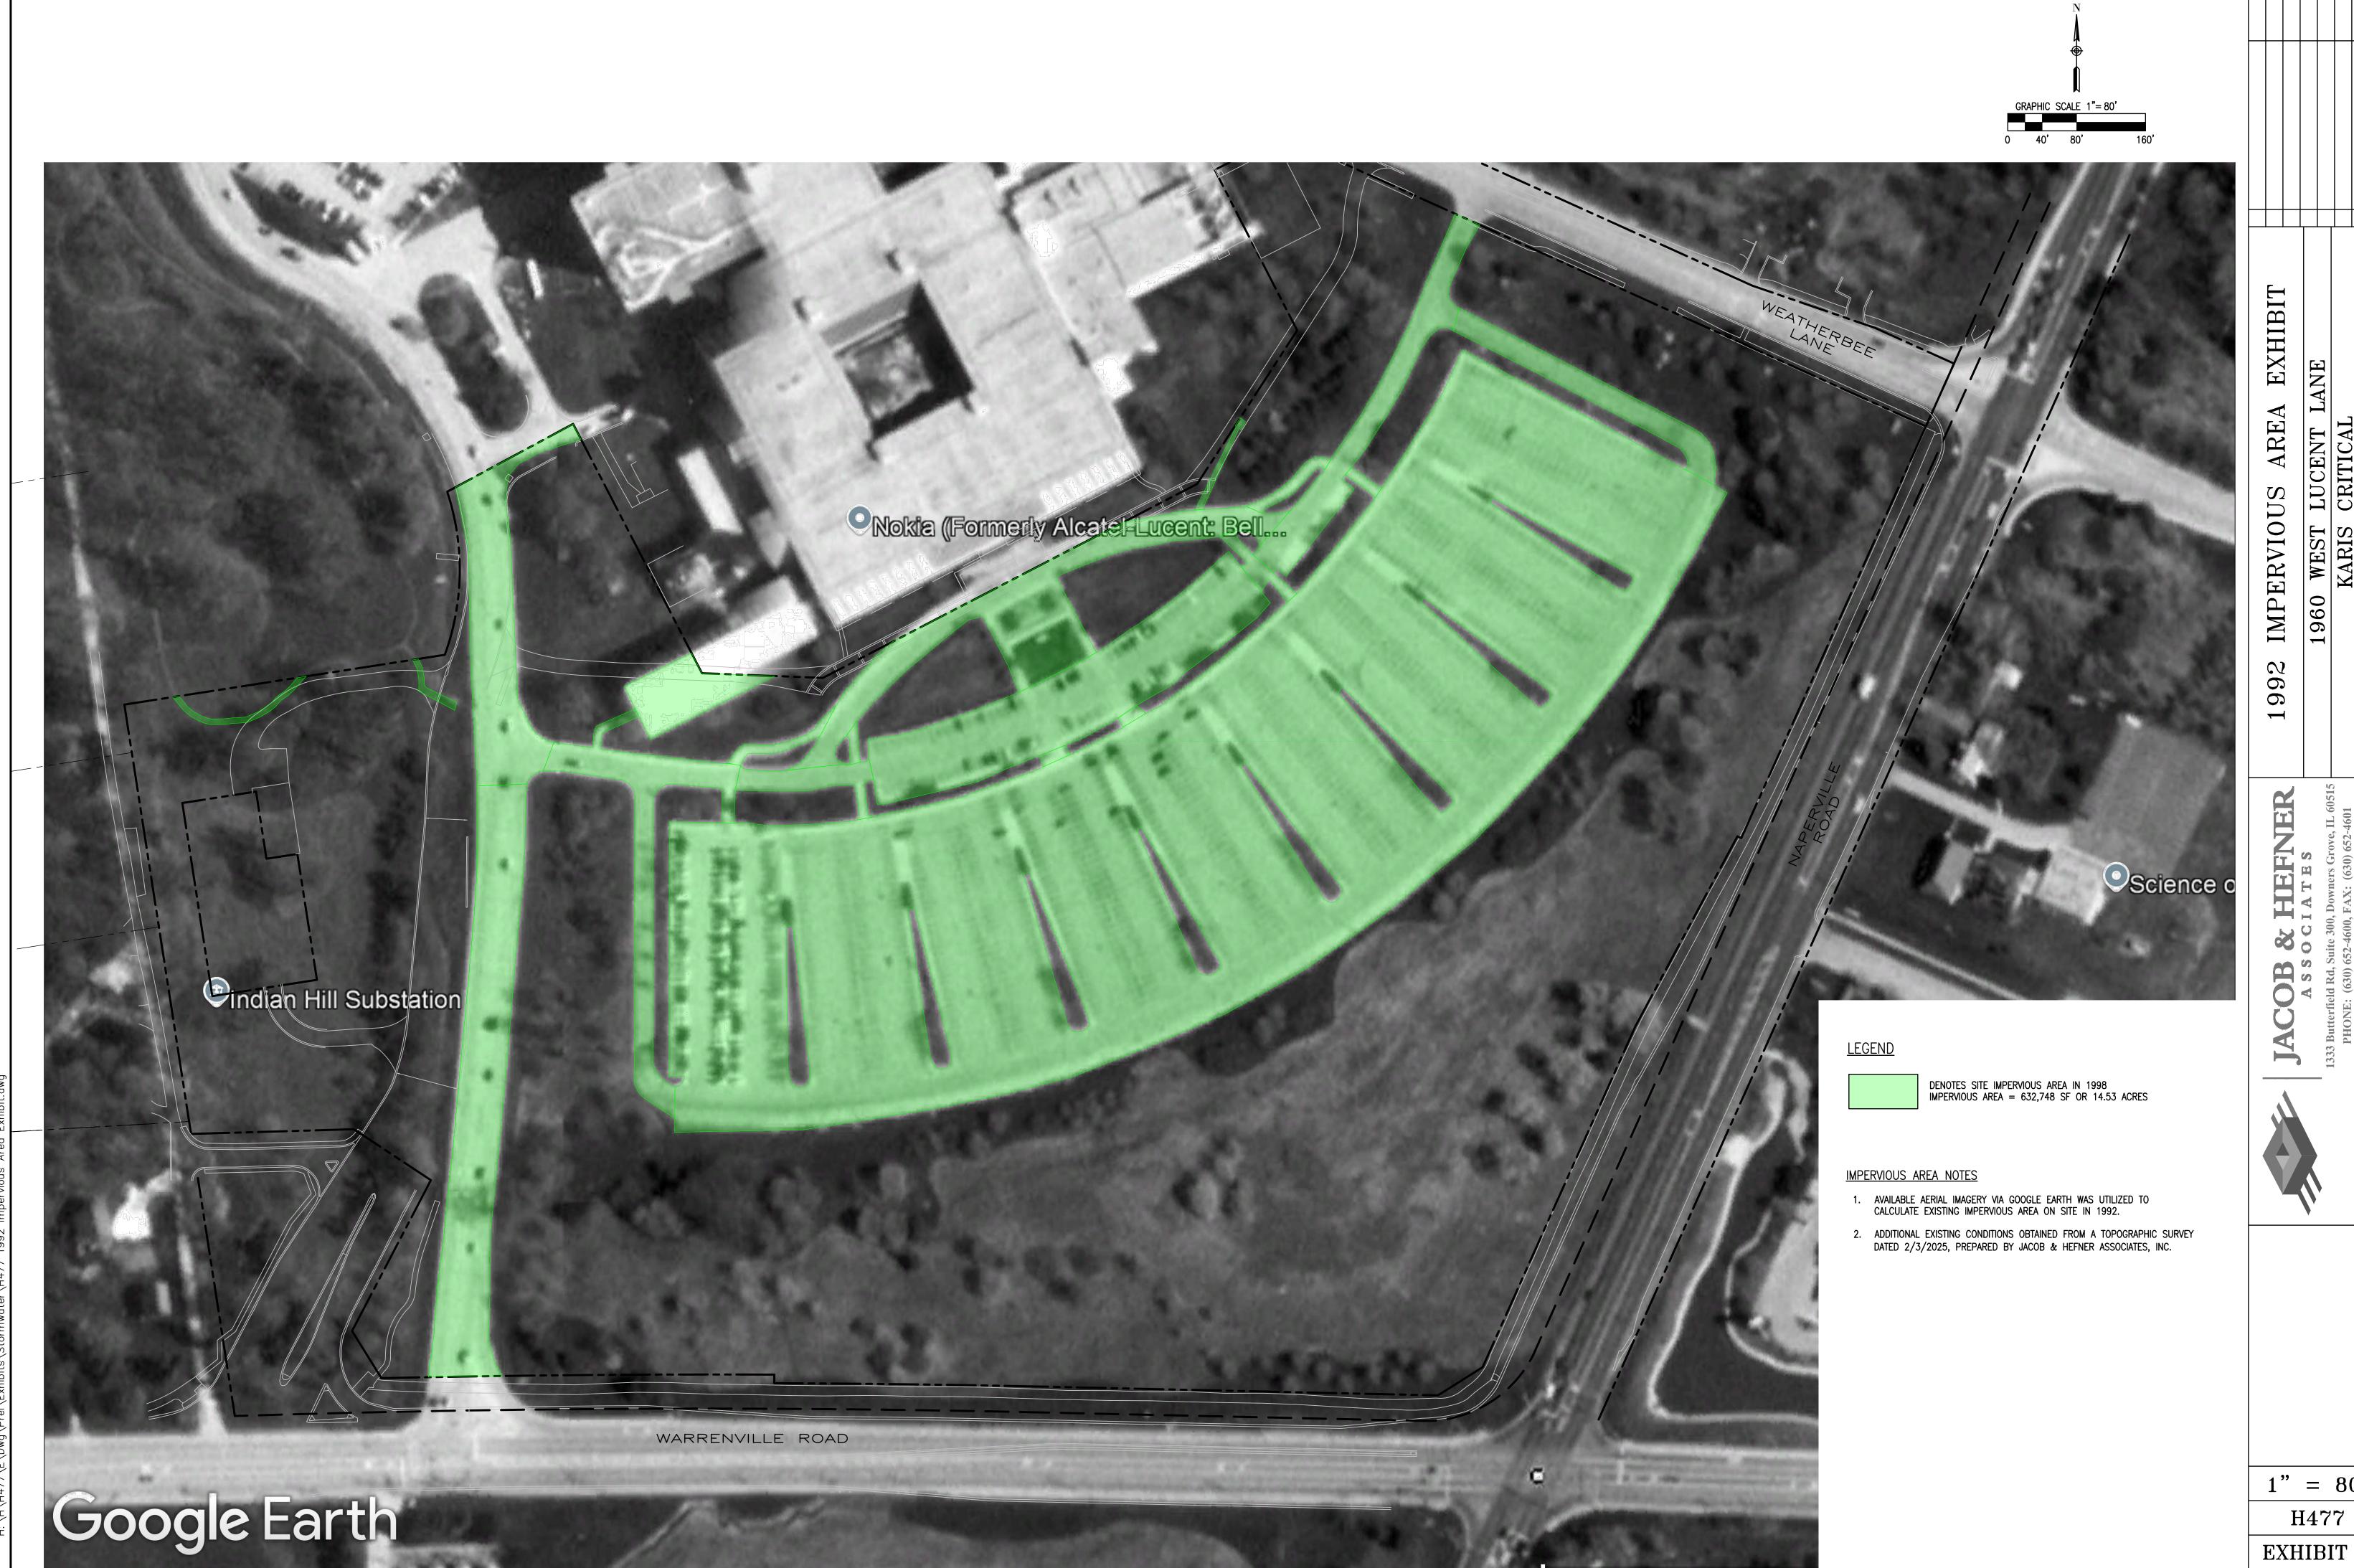
EXHIBIT 1

Refer to 1992, 2013, and Proposed Impervious Area Exhibits under this tab for impervious area calculations referenced in the table above.

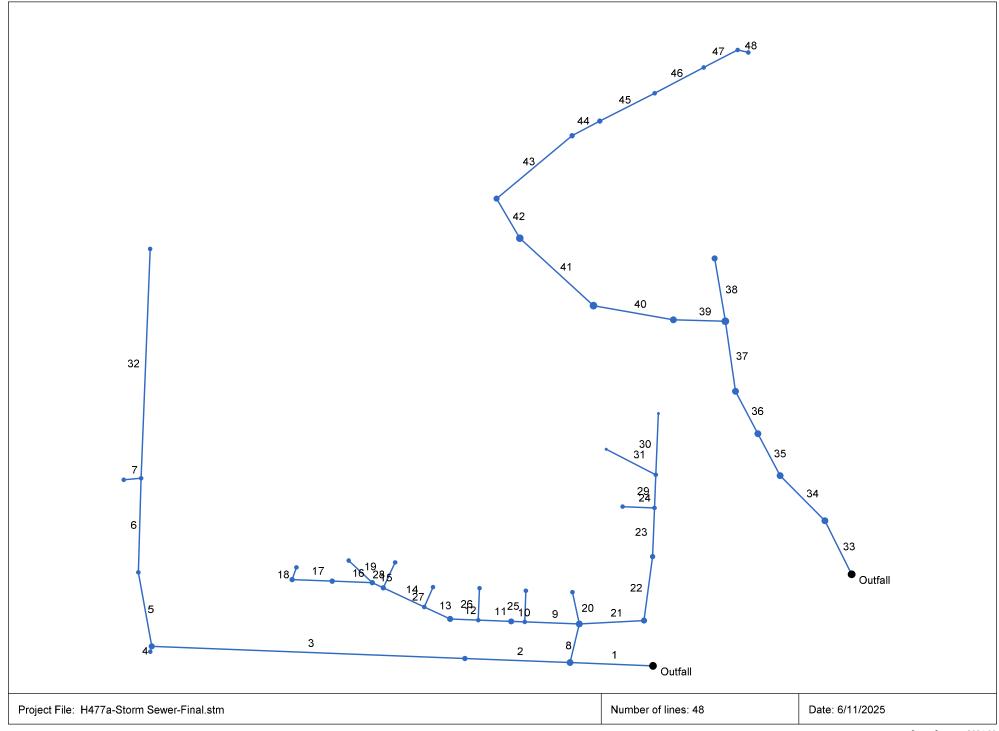
# Hydraflow Storm Sewers Extension for Autodesk® Civil 3D® Plan

# **Storm Sewer Tabulation**

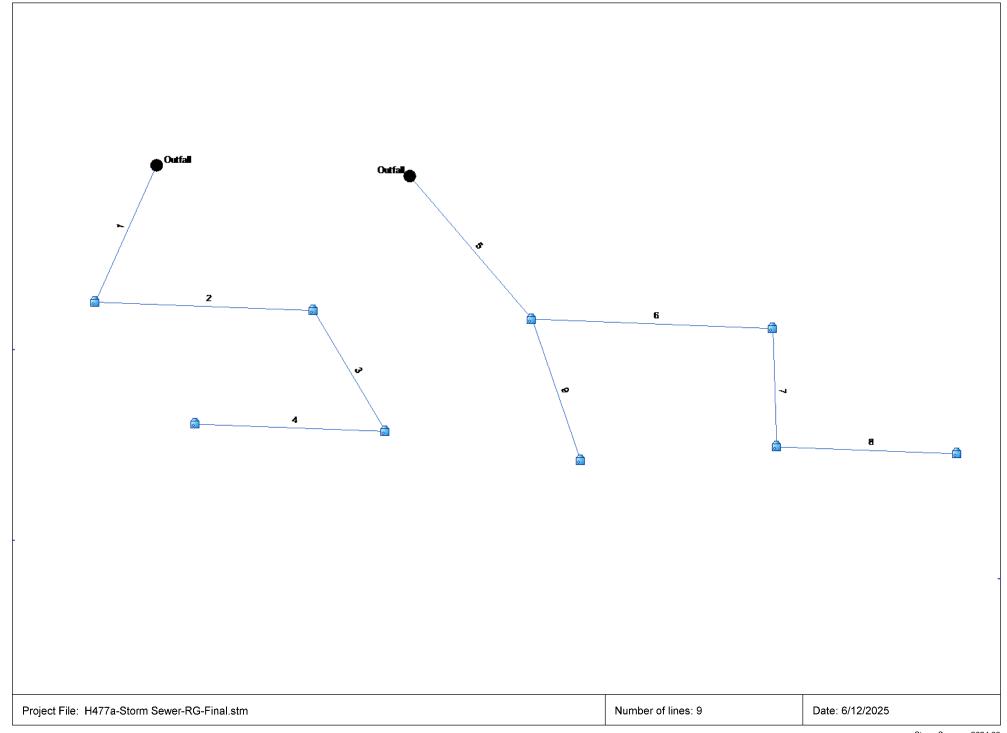
### Hydraflow Storm Sewers Extension for Autodesk® Civil 3D® Plan

### **Storm Sewer Tabulation**

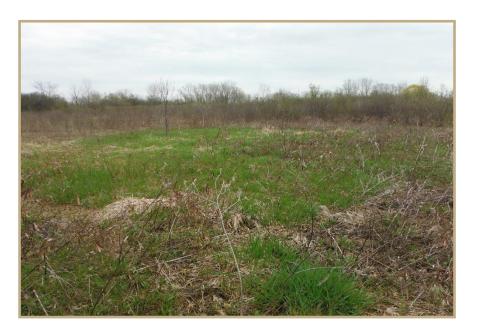
View of Area 1 facing northeast.

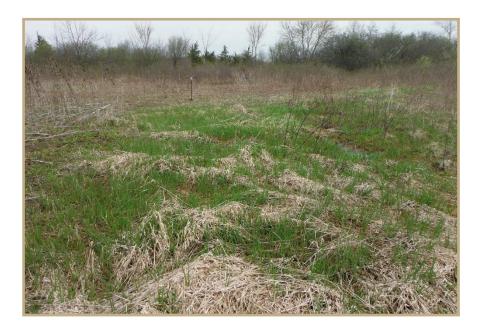
View of Area 2 facing north.

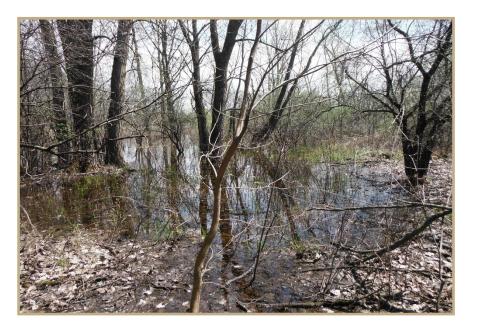
View of Area 3 facing southeast.

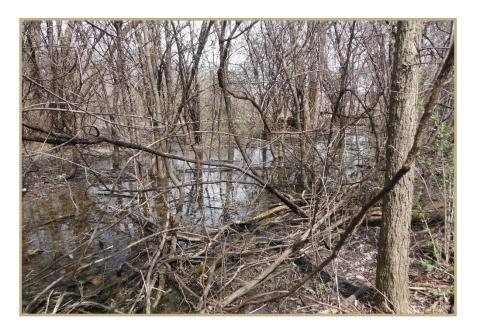
View of Area 4 facing northeast.

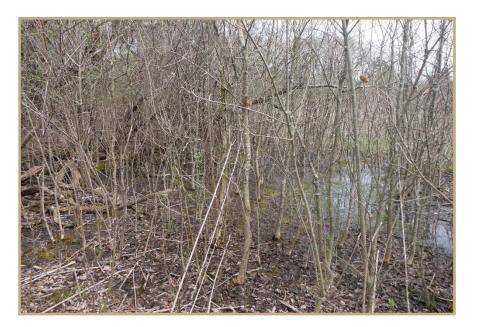
View of Area 5 facing northeast.

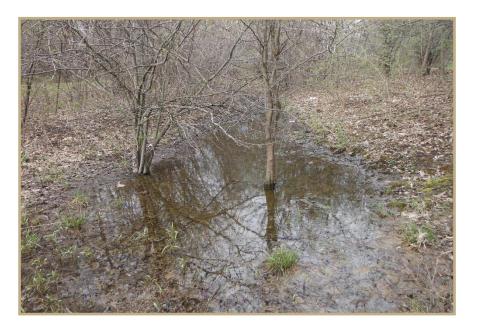
View of the drainageway in Area 6 facing north.

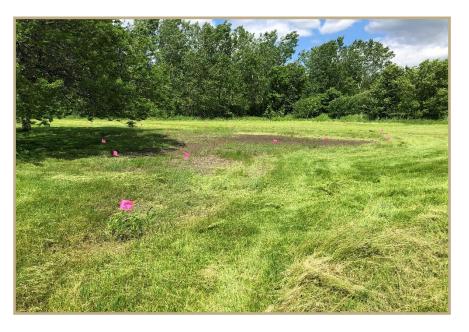
# PHOTO 21

View of Area 9 facing northeast.

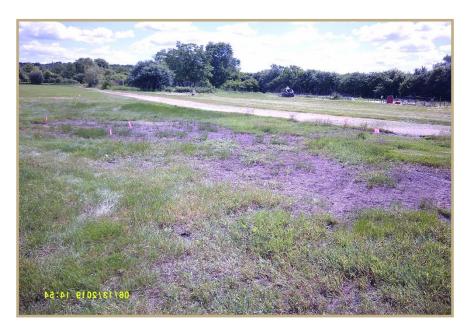
View of Area 10 facing southeast.

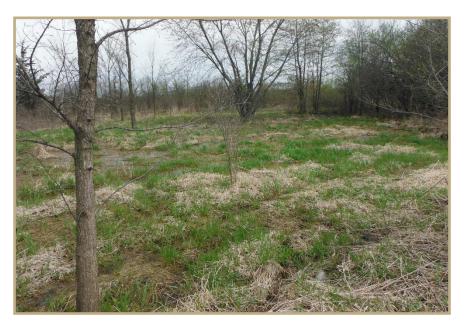
# **PHOTO 24**

View of Area 12 facing northeast.

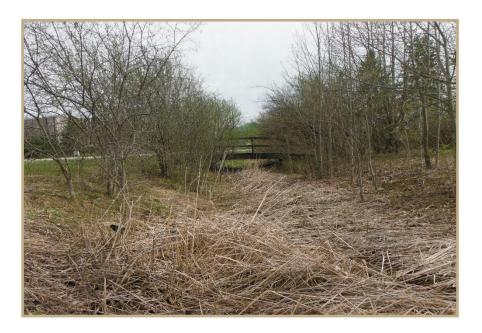
View of Area 13, a man made roadside ditch, facing south.

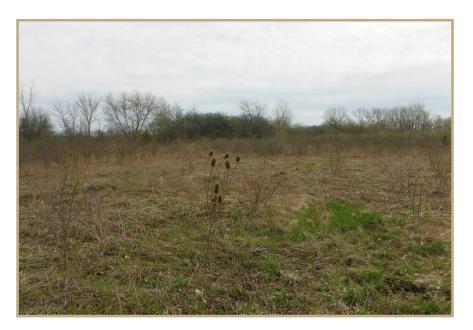
View of upland Area 16 near Data Point X04 facing northeast.

Conclusion: Data Point X04 fails to satisfy all three criteria; therefore Area 16 does not qualify as wetland.
