Phase 1 Stormwater Management Report
1960 West Lucent Lane
Naperville, Illinois
June 12, 2025

Prepared By:
Jacob and Hefner Associates, Inc.
1333 Butterfield Road, Suite 300
Downers Grove, Illinois 60515

Prepared For:
Karis Critical
2150 Goodlette-Frank Road, Suite 700
Naples, FL 34102

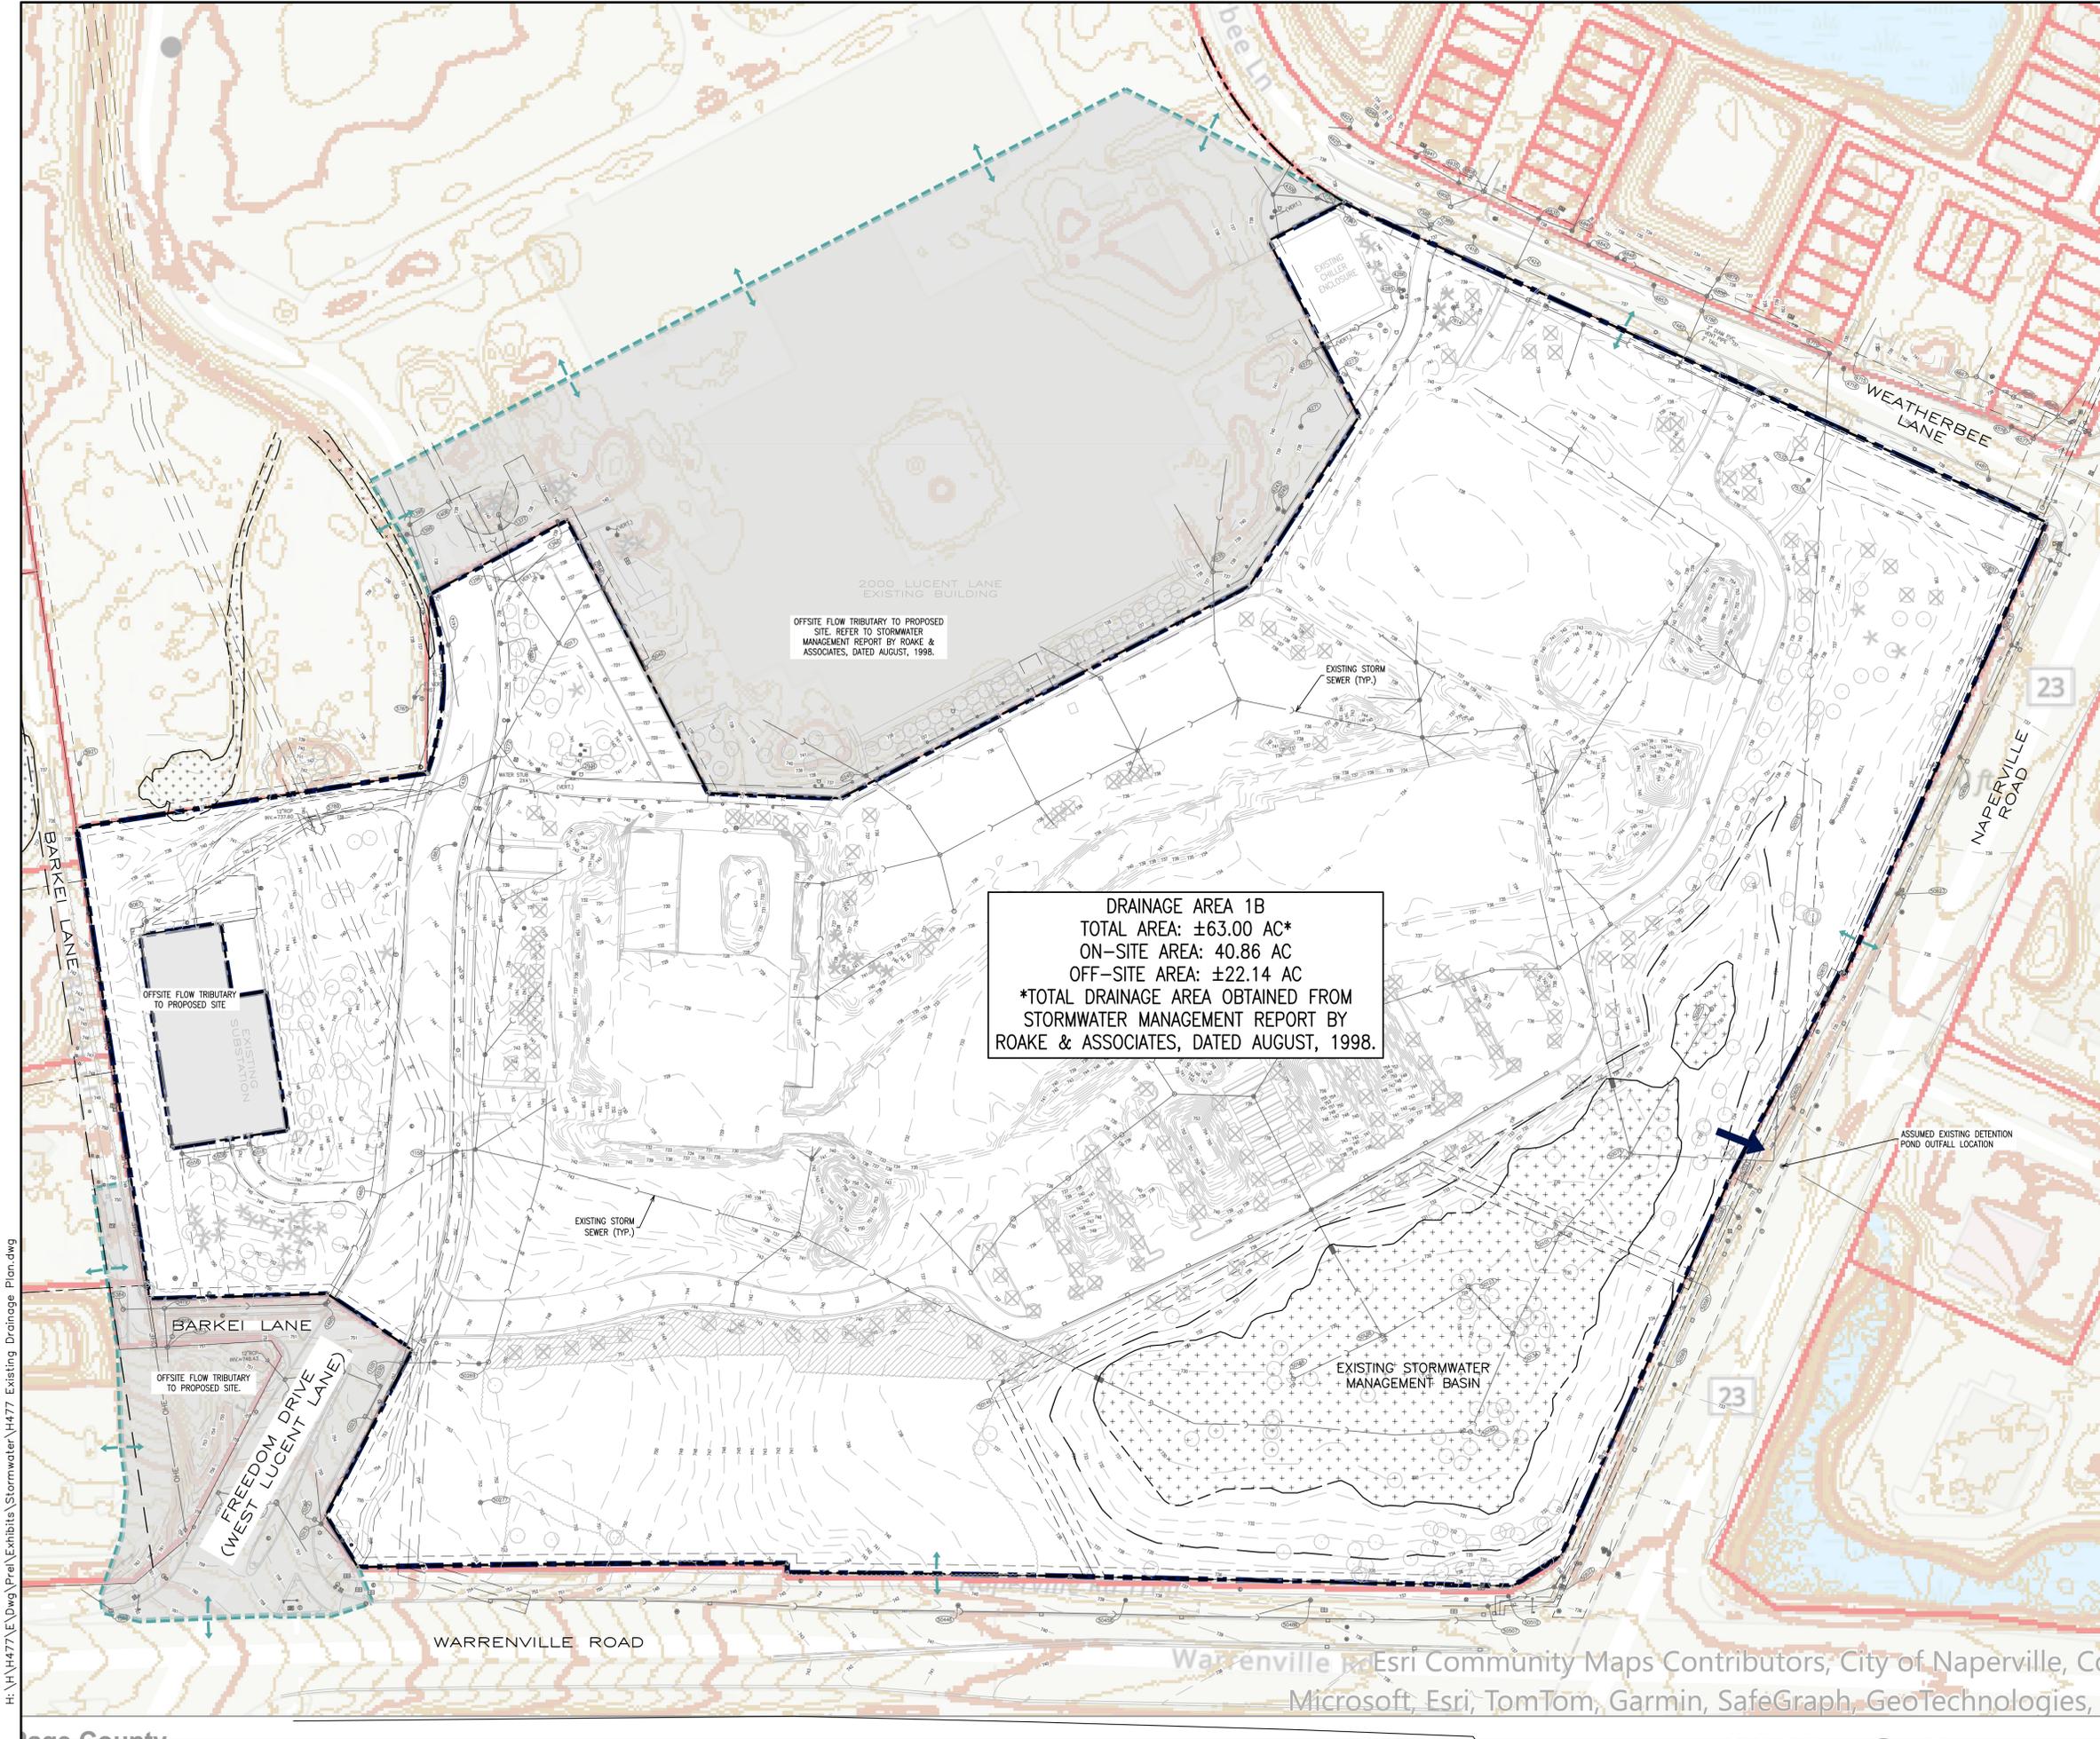
DRAINAGE AREA 1B
 TOTAL AREA: ±63.00 AC*
 ON-SITE AREA: 40.86 AC
 OFF-SITE AREA: ±22.14 AC
 *TOTAL DRAINAGE AREA OBTAINED FROM
 STORMWATER MANAGEMENT REPORT BY
 ROAKE & ASSOCIATES, DATED AUGUST, 1998.

OFFSITE FLOW TRIBUTARY TO PROPOSED SITE. REFER TO STORMWATER MANAGEMENT REPORT BY ROAKE & ASSOCIATES, DATED AUGUST, 1998.

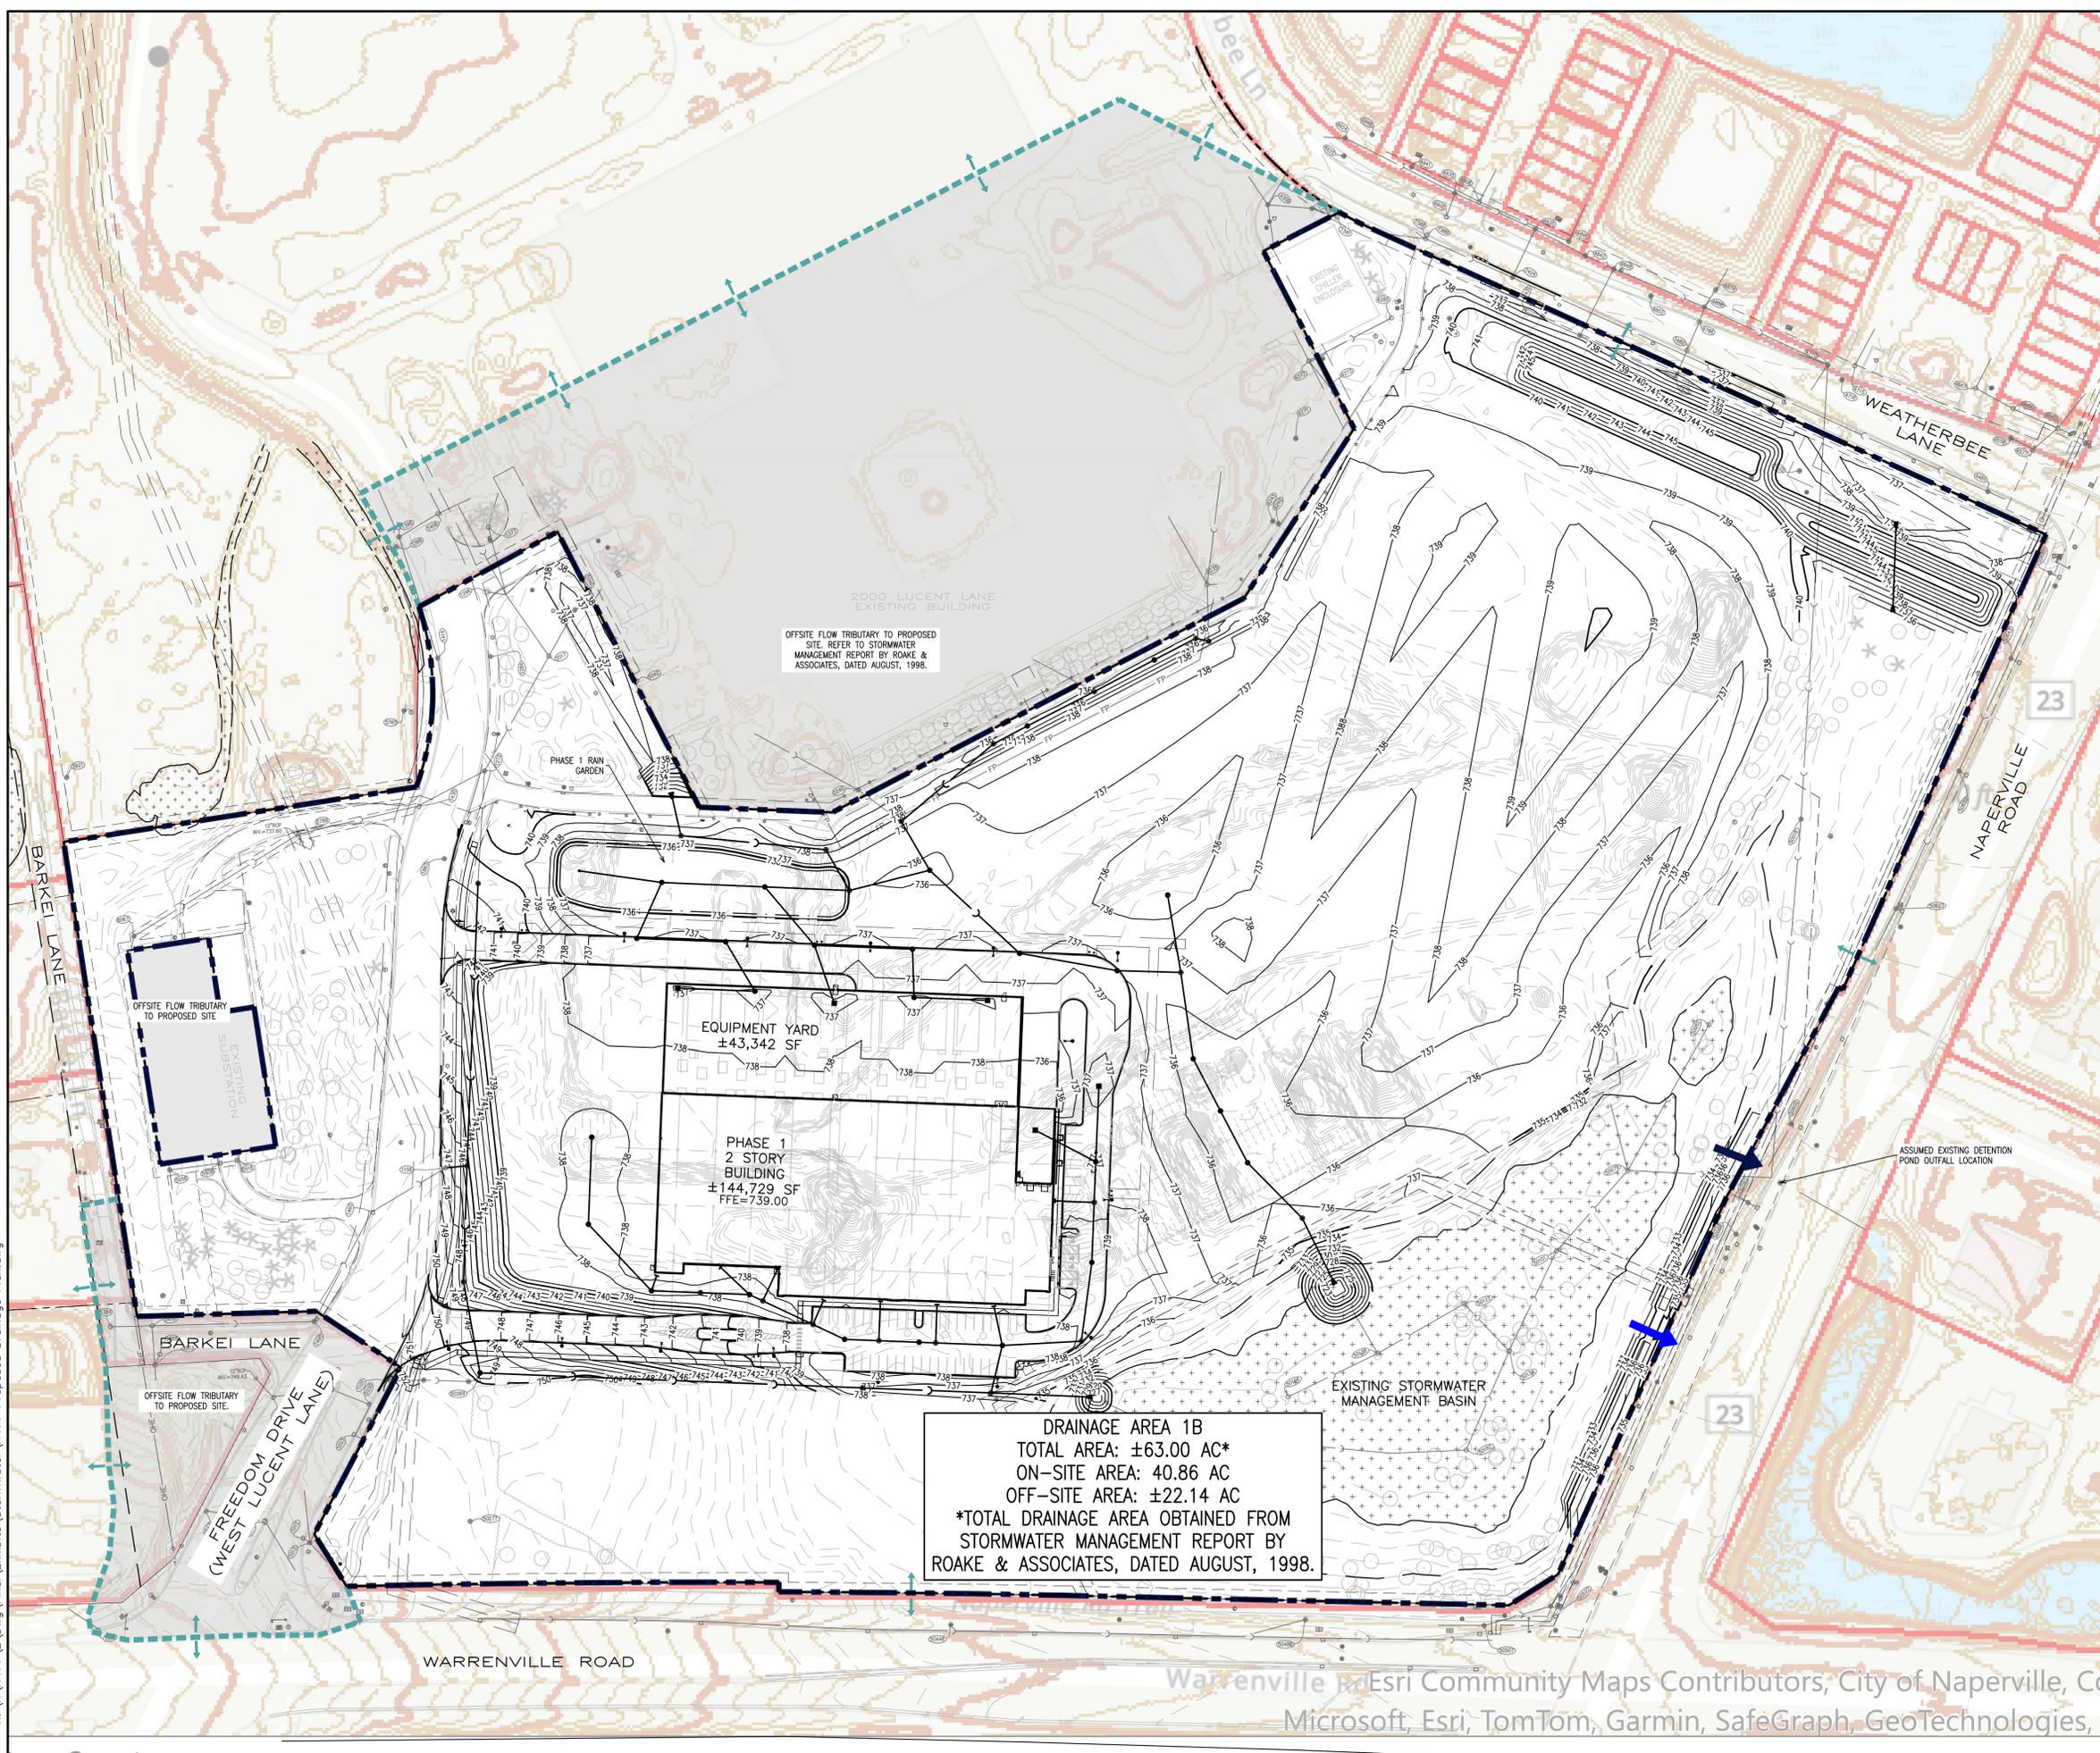
OFFSITE FLOW TRIBUTARY TO PROPOSED SITE. REFER TO STORMWATER MANAGEMENT REPORT BY ROAKE & ASSOCIATES, DATED AUGUST, 1998.

DRAINAGE AREA 1B
 TOTAL AREA: ±63.00 AC*
 ON-SITE AREA: 40.86 AC
 OFF-SITE AREA: ±22.14 AC
 *TOTAL DRAINAGE AREA OBTAINED FROM STORMWATER MANAGEMENT REPORT BY ROAKE & ASSOCIATES, DATED AUGUST, 1998.

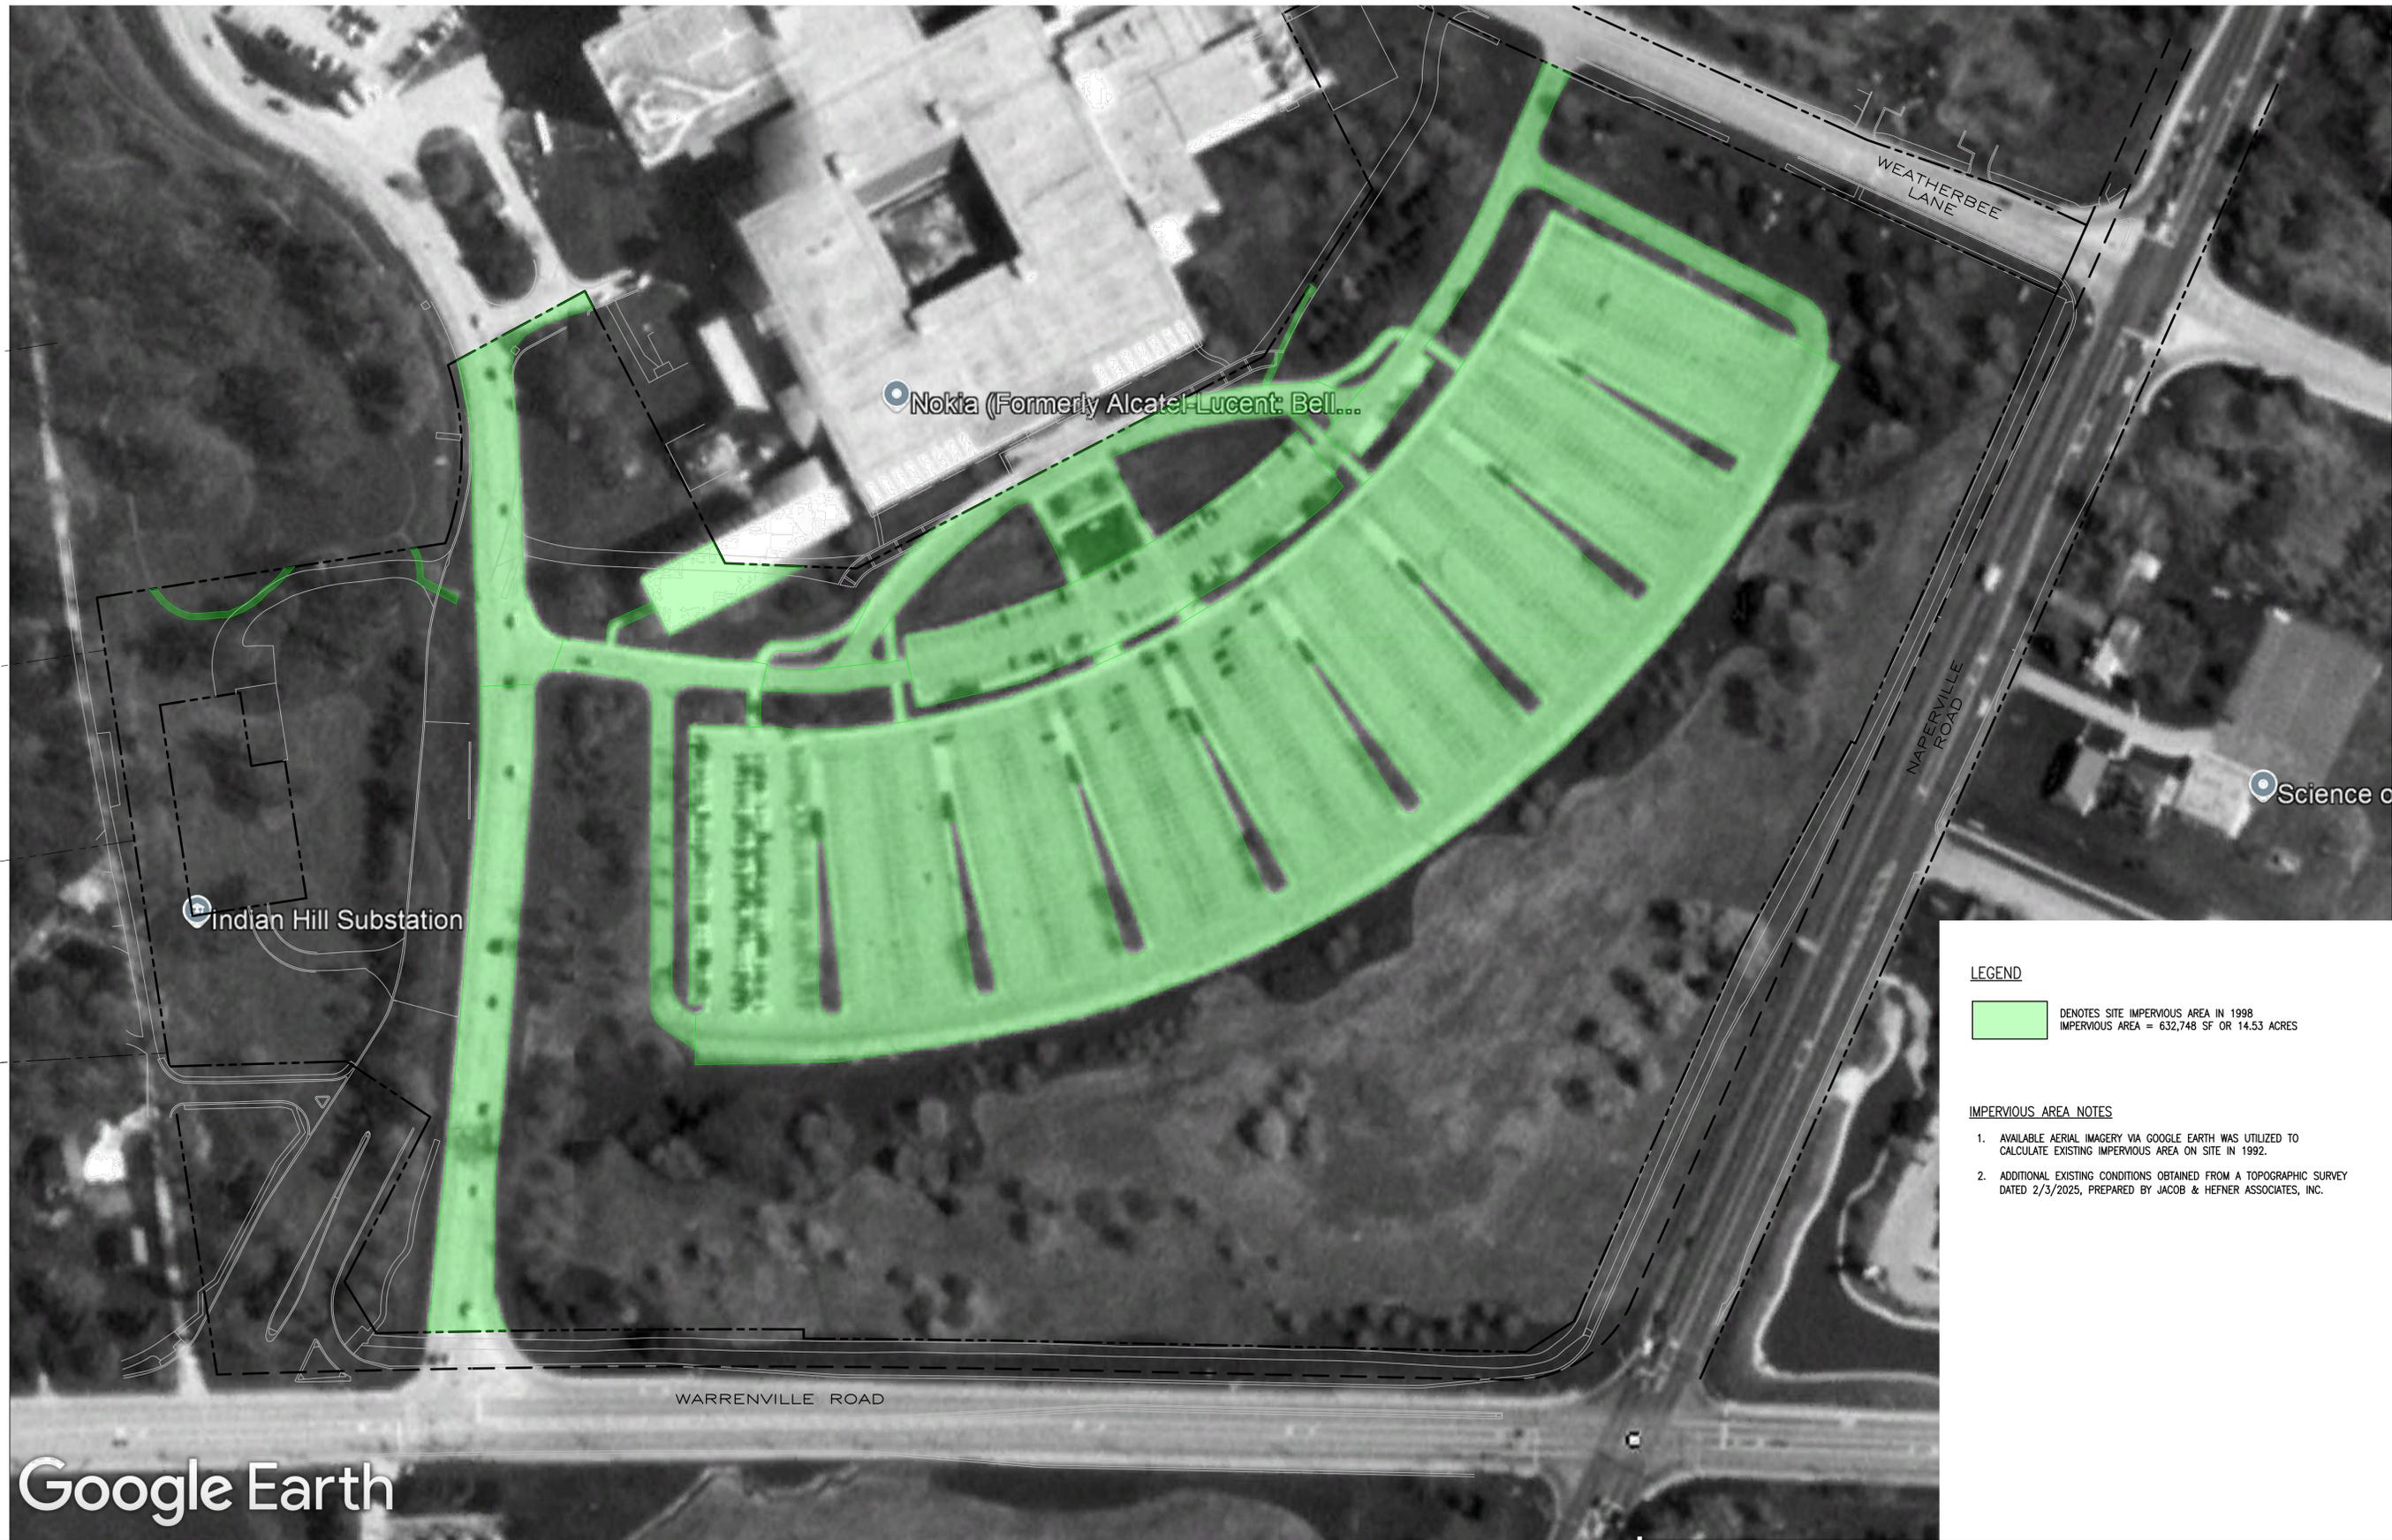
1. AVAILABLE AERIAL IMAGERY VIA GOOGLE EARTH WAS UTILIZED TO CALCULATE EXISTING IMPERVIOUS AREA ON SITE IN 1992.
2. ADDITIONAL EXISTING CONDITIONS OBTAINED FROM A TOPOGRAPHIC SURVEY DATED 2/3/2025, PREPARED BY JACOB & HEFNER ASSOCIATES, INC.

Refer to 1992, 2013, and Proposed Impervious Area Exhibits under this tab for impervious area calculations referenced in the table above.

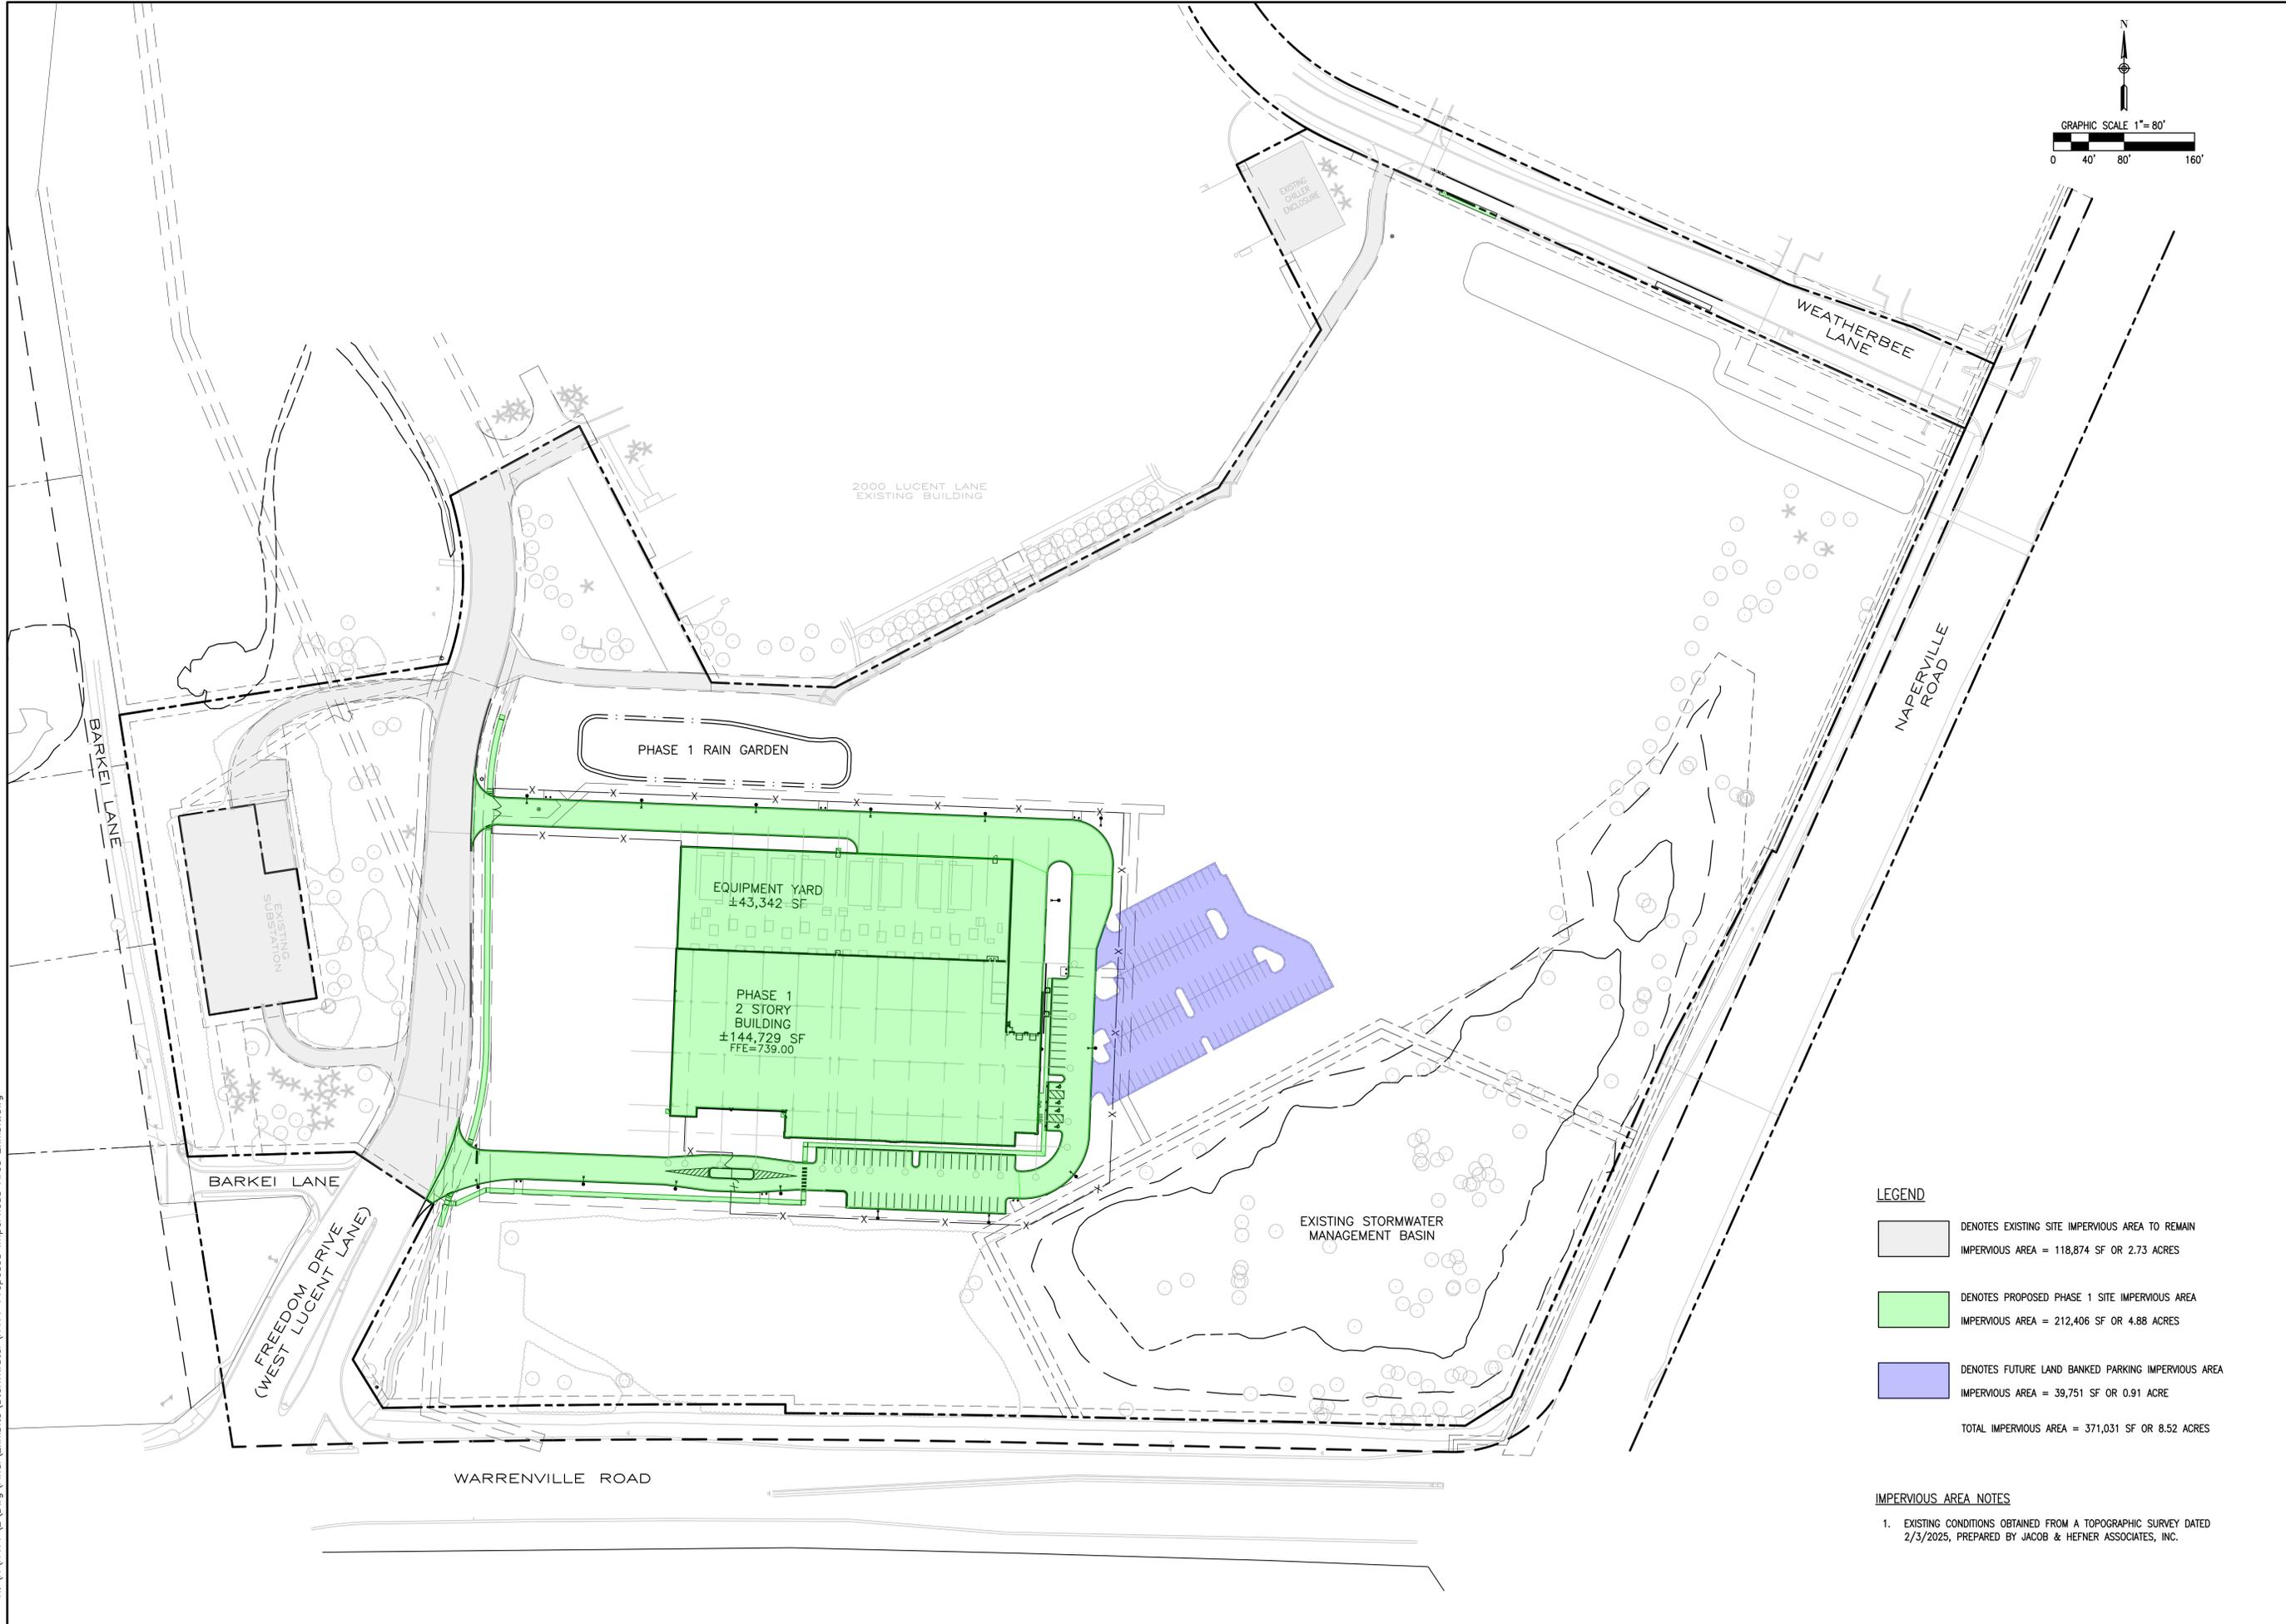
- DENOTES EXISTING SITE IMPERVIOUS AREA TO REMAIN
IMPERVIOUS AREA = 118,874 SF OR 2.73 ACRES
 - DENOTES PROPOSED PHASE 1 SITE IMPERVIOUS AREA
IMPERVIOUS AREA = 212,406 SF OR 4.88 ACRES
 - DENOTES FUTURE LAND BANKED PARKING IMPERVIOUS AREA
IMPERVIOUS AREA = 39,751 SF OR 0.91 ACRE
- TOTAL IMPERVIOUS AREA = 371,031 SF OR 8.52 ACRES

1. EXISTING CONDITIONS OBTAINED FROM A TOPOGRAPHIC SURVEY DATED 2/3/2025, PREPARED BY JACOB & HEFNER ASSOCIATES, INC.

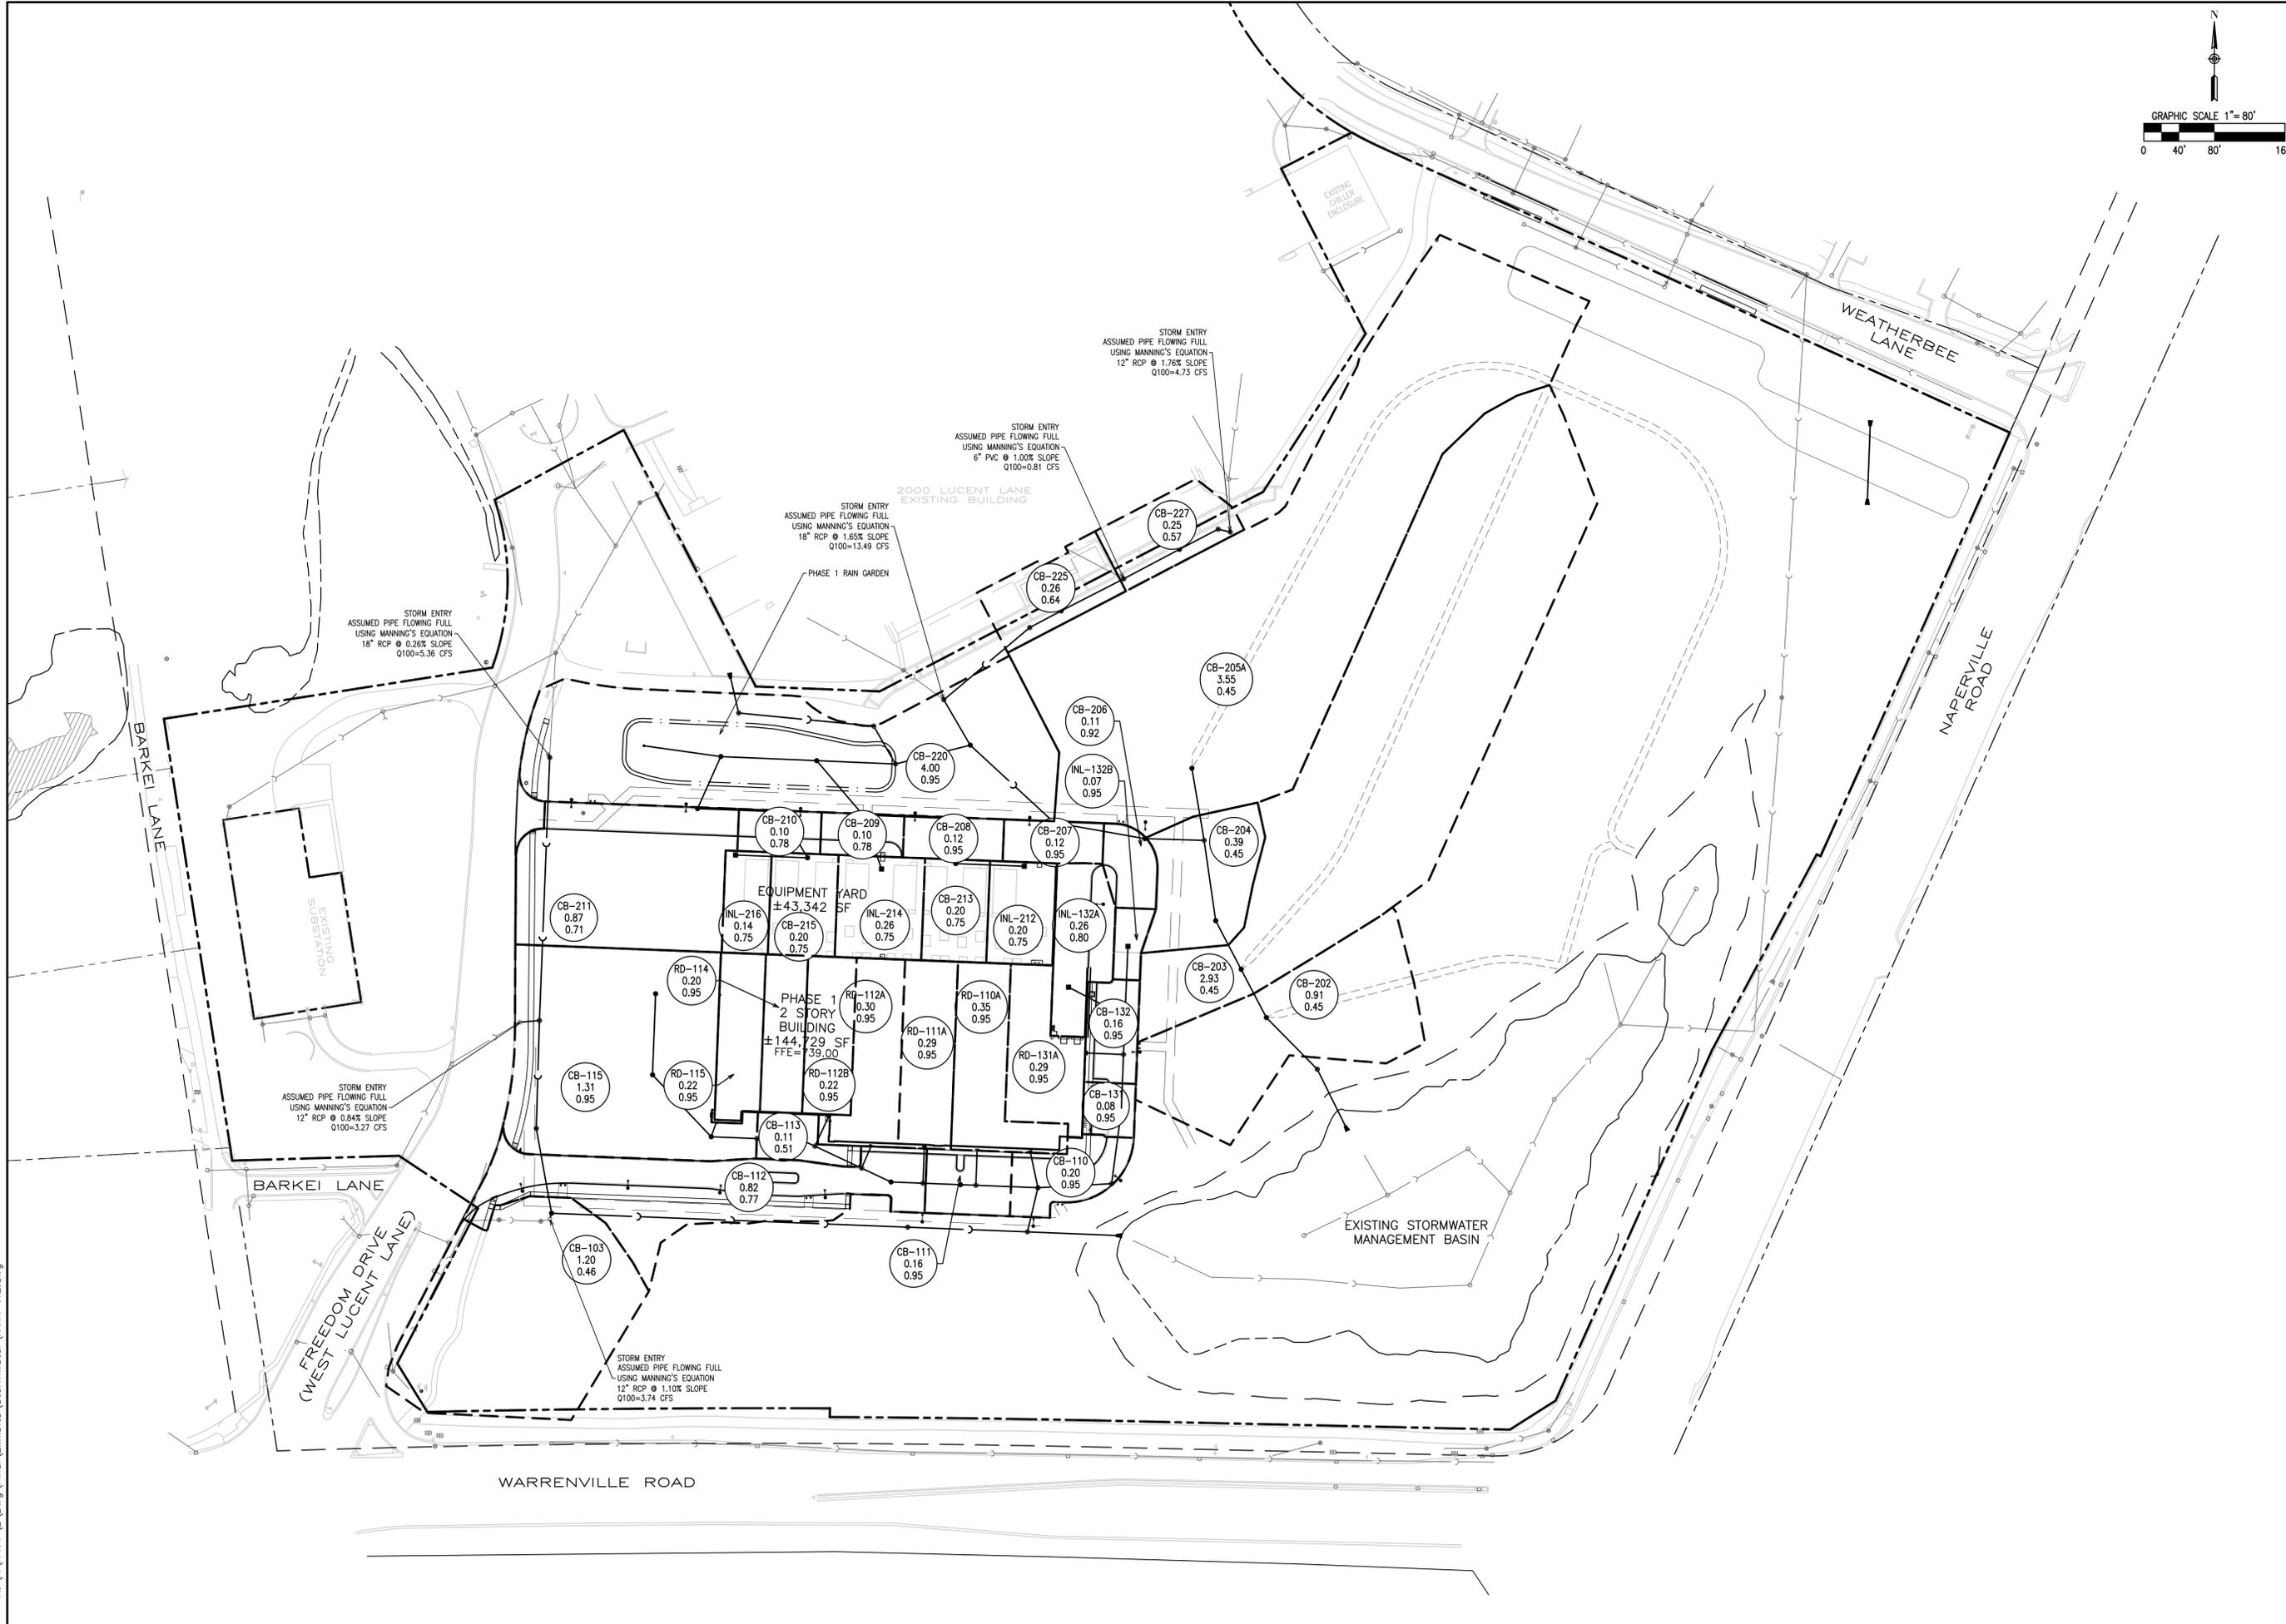
INLET TRIBUTARY EXHIBIT
1960 W LUCENT
KARISX CRITICAL
NAPERVILLE, ILLINOIS

All storm sewers with a runoff coefficient of 0.95 are assumed to have fully impervious tributary drainage areas.

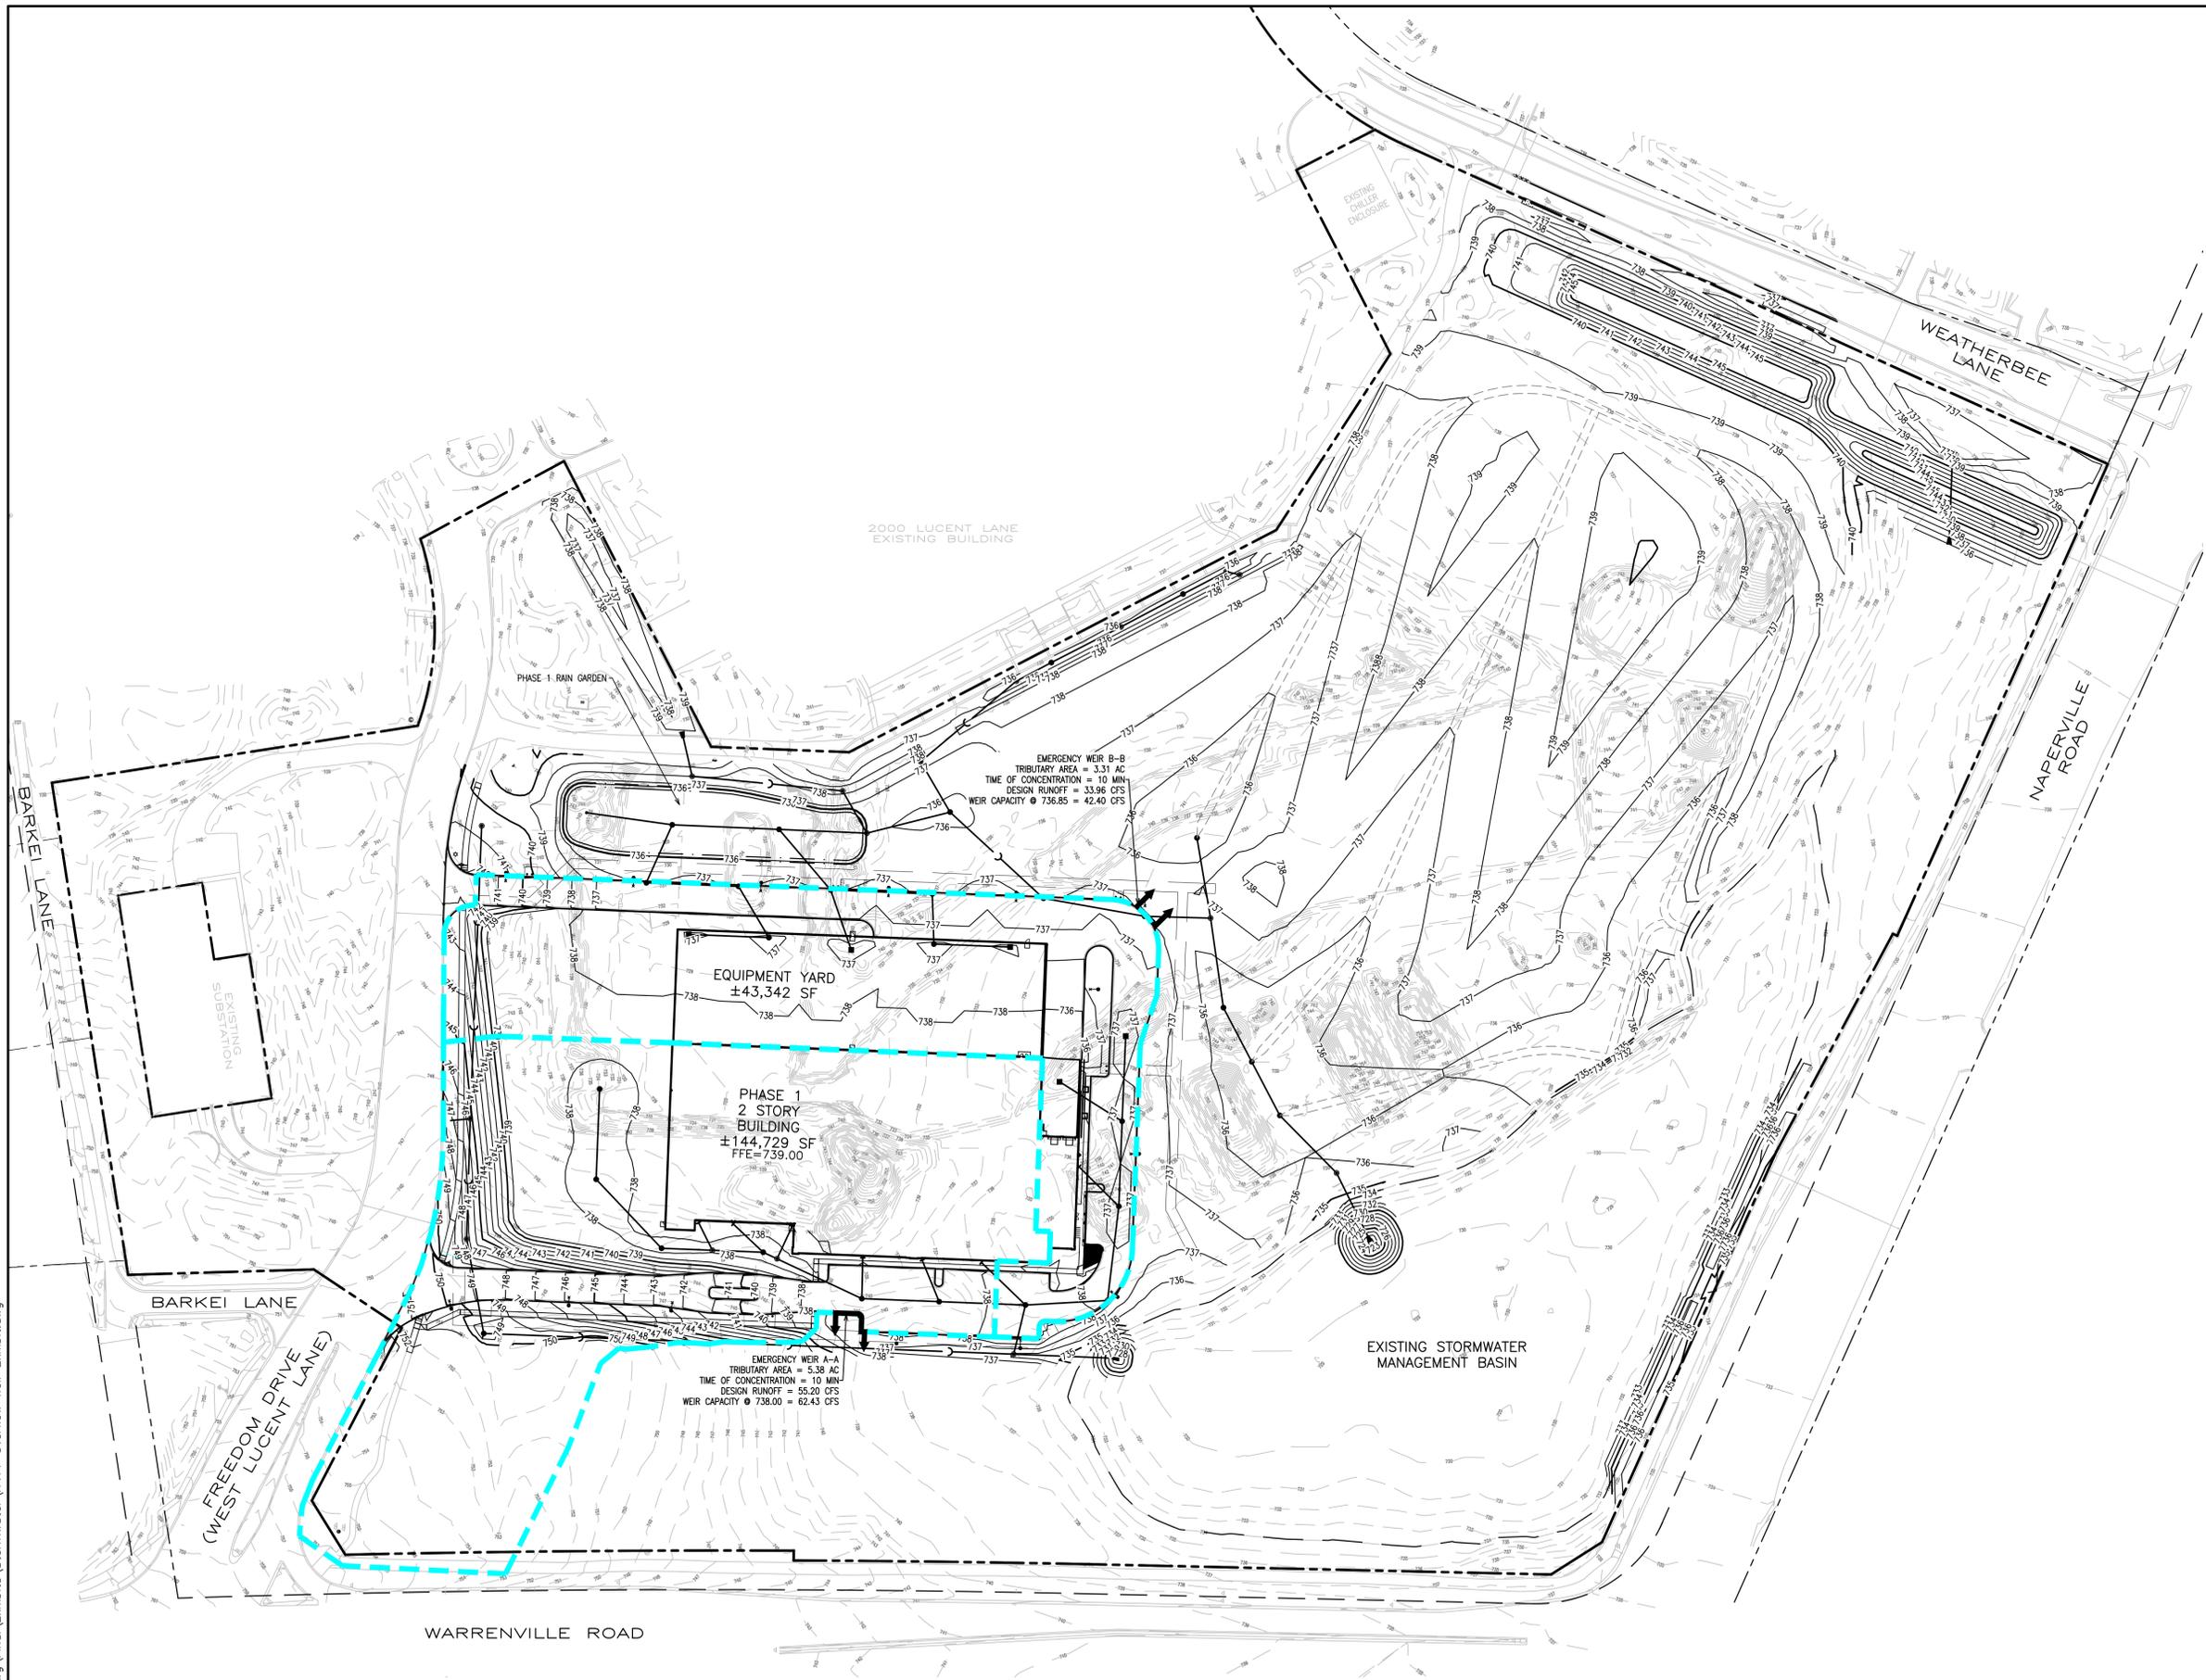
- 1) Intensity Obtained from Bulletin 75 - Northeast Section (100-year Interval)
2) Runoff utilizes the rational method. Q = C*I*A
3) Storm sewer is designed to convey the 100-year storm event, weirs are provided for emergency overflow situations only.
