Phase 1 Stormwater Management Report
1960 West Lucent Lane
Naperville, Illinois
June 12, 2025

Prepared By:
Jacob and Hefner Associates, Inc.
1333 Butterfield Road, Suite 300
Downers Grove, Illinois 60515

Prepared For:
Karis Critical
2150 Goodlette-Frank Road, Suite 700
Naples, FL 34102

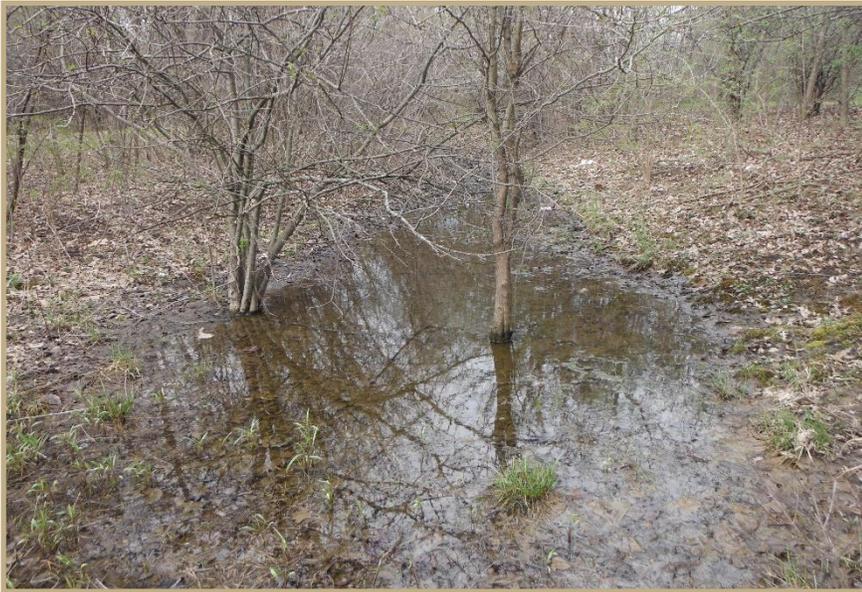
PHOTO 16

View of the drainageway in Area 6 facing north.

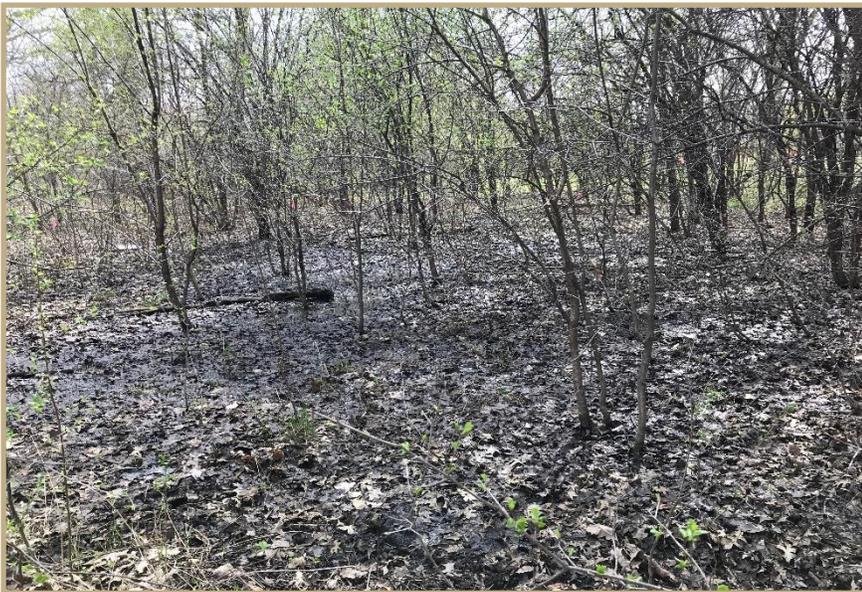
PHOTO 17

View of the emergent wetland in Area 6 facing southwest.

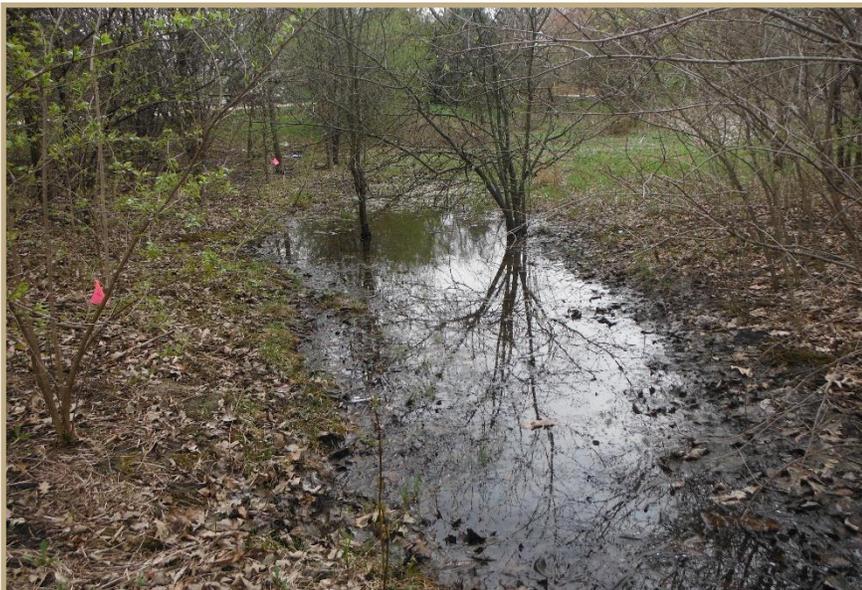
PHOTO 18

View of the drainageway in Area 6 facing south.

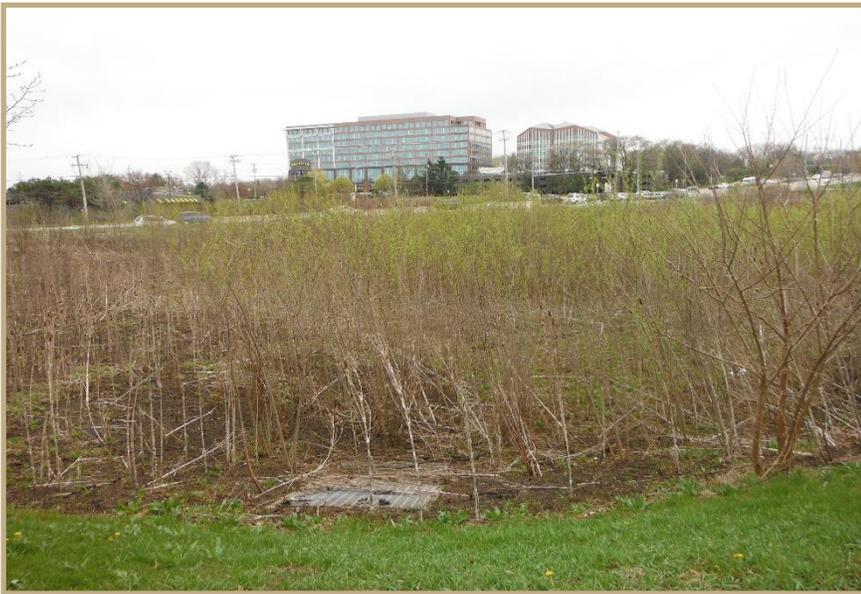
PHOTO 19

View of Area 7 facing southeast.

Area 7 (~7.30 acres) is a constructed stormwater management basin located in the southeastern corner of the subject property. Area 7 was under construction in 1972, as seen on historical aerial imagery (**Appendix VI**) and contains a portion of Rott Creek, as seen on the hydrologic atlas (Figure 4).

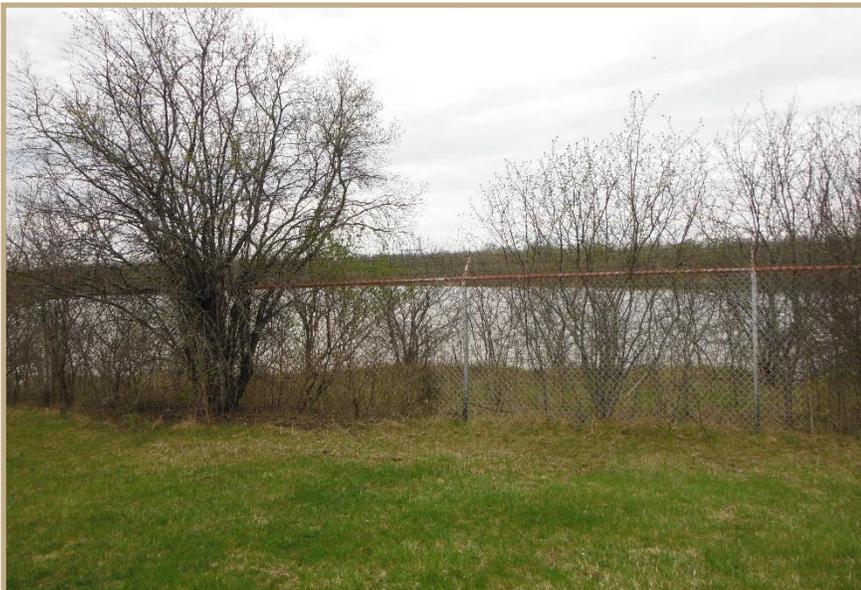
PHOTO 20

View of Area 8 facing south.

Area 8 (~15.73 acres) is a constructed stormwater management basin, known as Bell Pond, located in the western portion of the subject property. Area 8 was under construction in 1972, as seen on historical aerial imagery (**Appendix VI**) and contains a portion of Rott Creek, as seen on the hydrologic atlas (Figure 4).

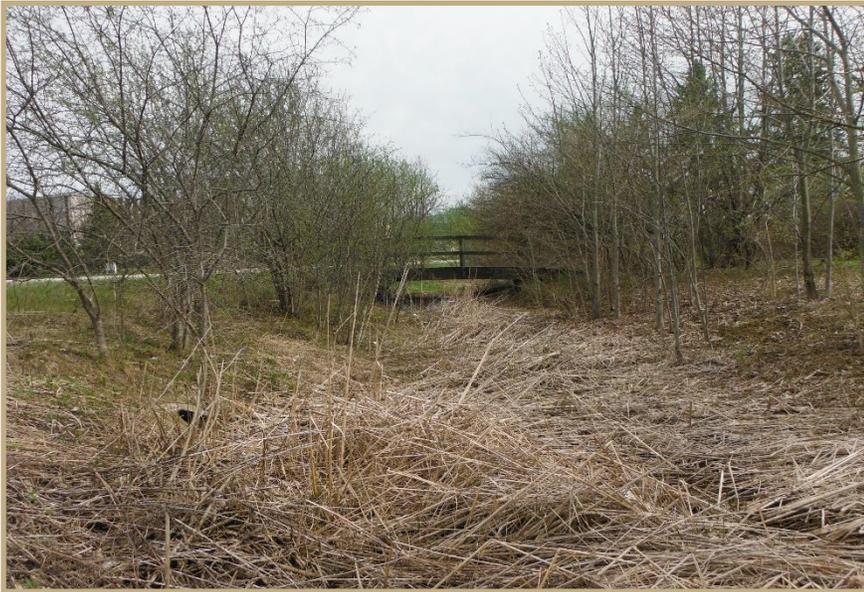
PHOTO 25

View of Area 13, a man made roadside ditch, facing south.

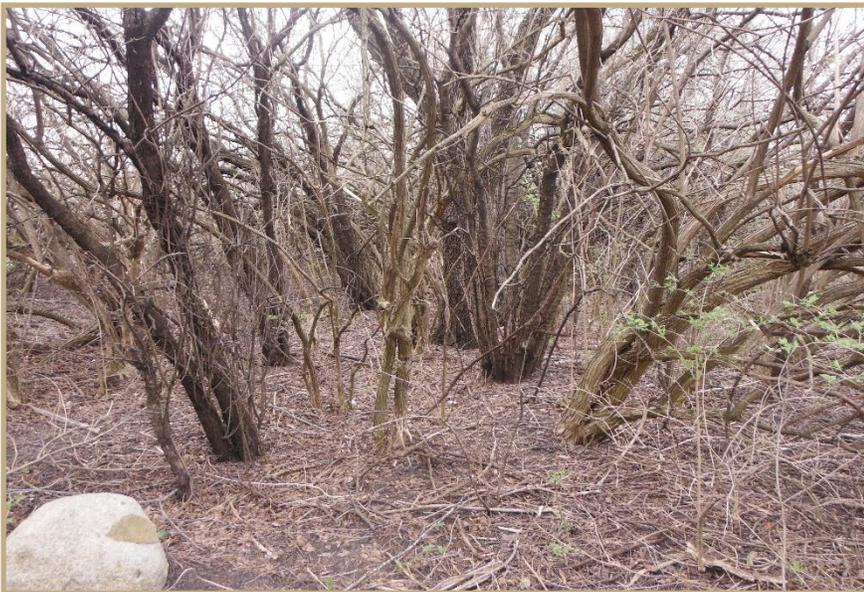
PHOTO 26

View of upland Area 14 near Data Point X01 facing north.

Conclusion: Data Point X01 fails to satisfy the vegetation and hydrology criteria; therefore Area 14 does not qualify as wetland.

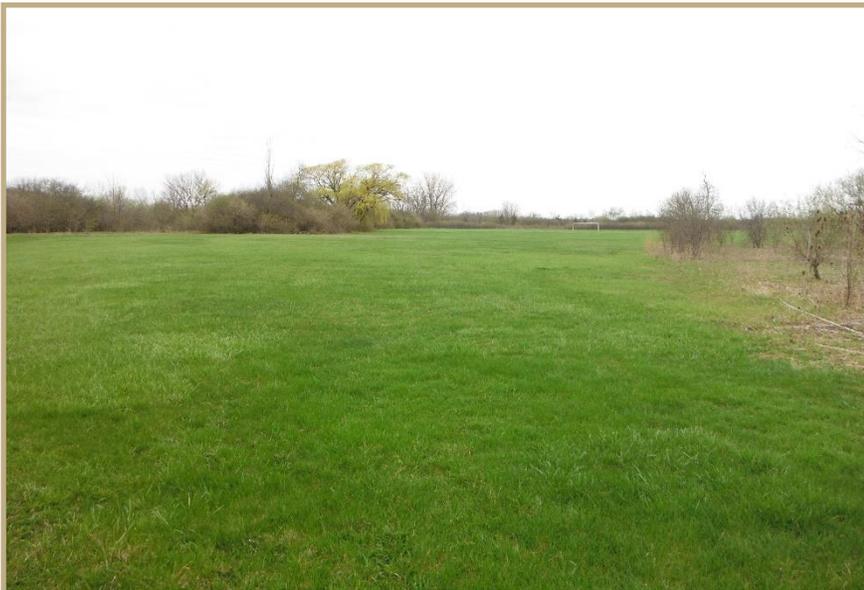
PHOTO 27

View of upland Area 15 near Data Point X02 facing southwest.

Soils: The soil profile at Data Point X02 consisted of 0-10 inches of black (10YR 2/10 silt loam mixed fill underlain by 8 inches, to a depth of 18 inches below the surface, of brown (10YR 5/4) silty clay loam mixed fill. Hydric soil indicators were not observed, so the soils criterion is not satisfied.

Conclusion: Data Point X02 fails to satisfy the soil and hydrology criteria; therefore Area 15 does not qualify as wetland.

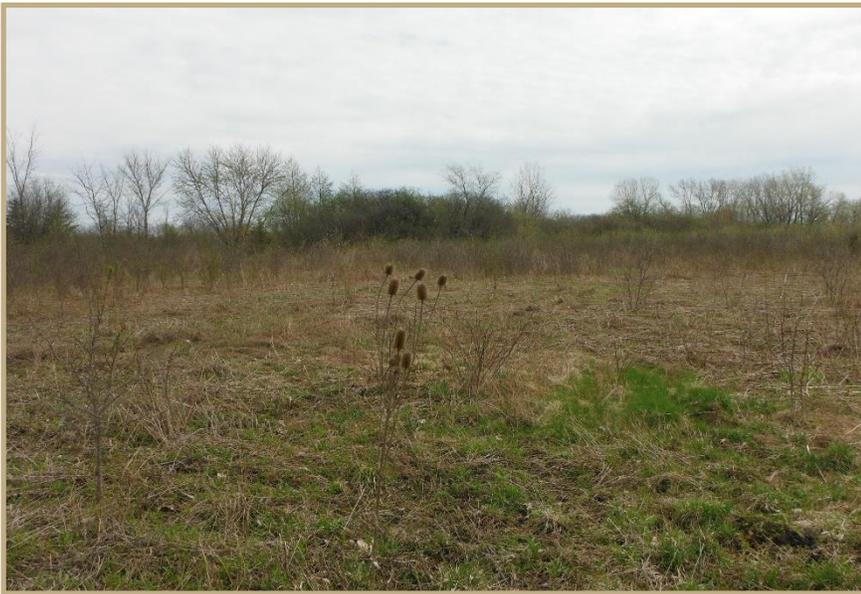
PHOTO 28

View of upland Area 16 near Data Point X04 facing northeast.

Soils: The soil profile at Data Point X04 consisted of 0-10 inches of black (10YR 2/1) silt loam underlain by 5 inches, to 15 inches below the surface, of brown (2.5Y 5/4) silty clay loam mixed fill with 5% gravel. Hydric soil indicators were not observed, so the soils criterion is not satisfied.

Conclusion: Data Point X04 fails to satisfy all three criteria; therefore Area 16 does not qualify as wetland.

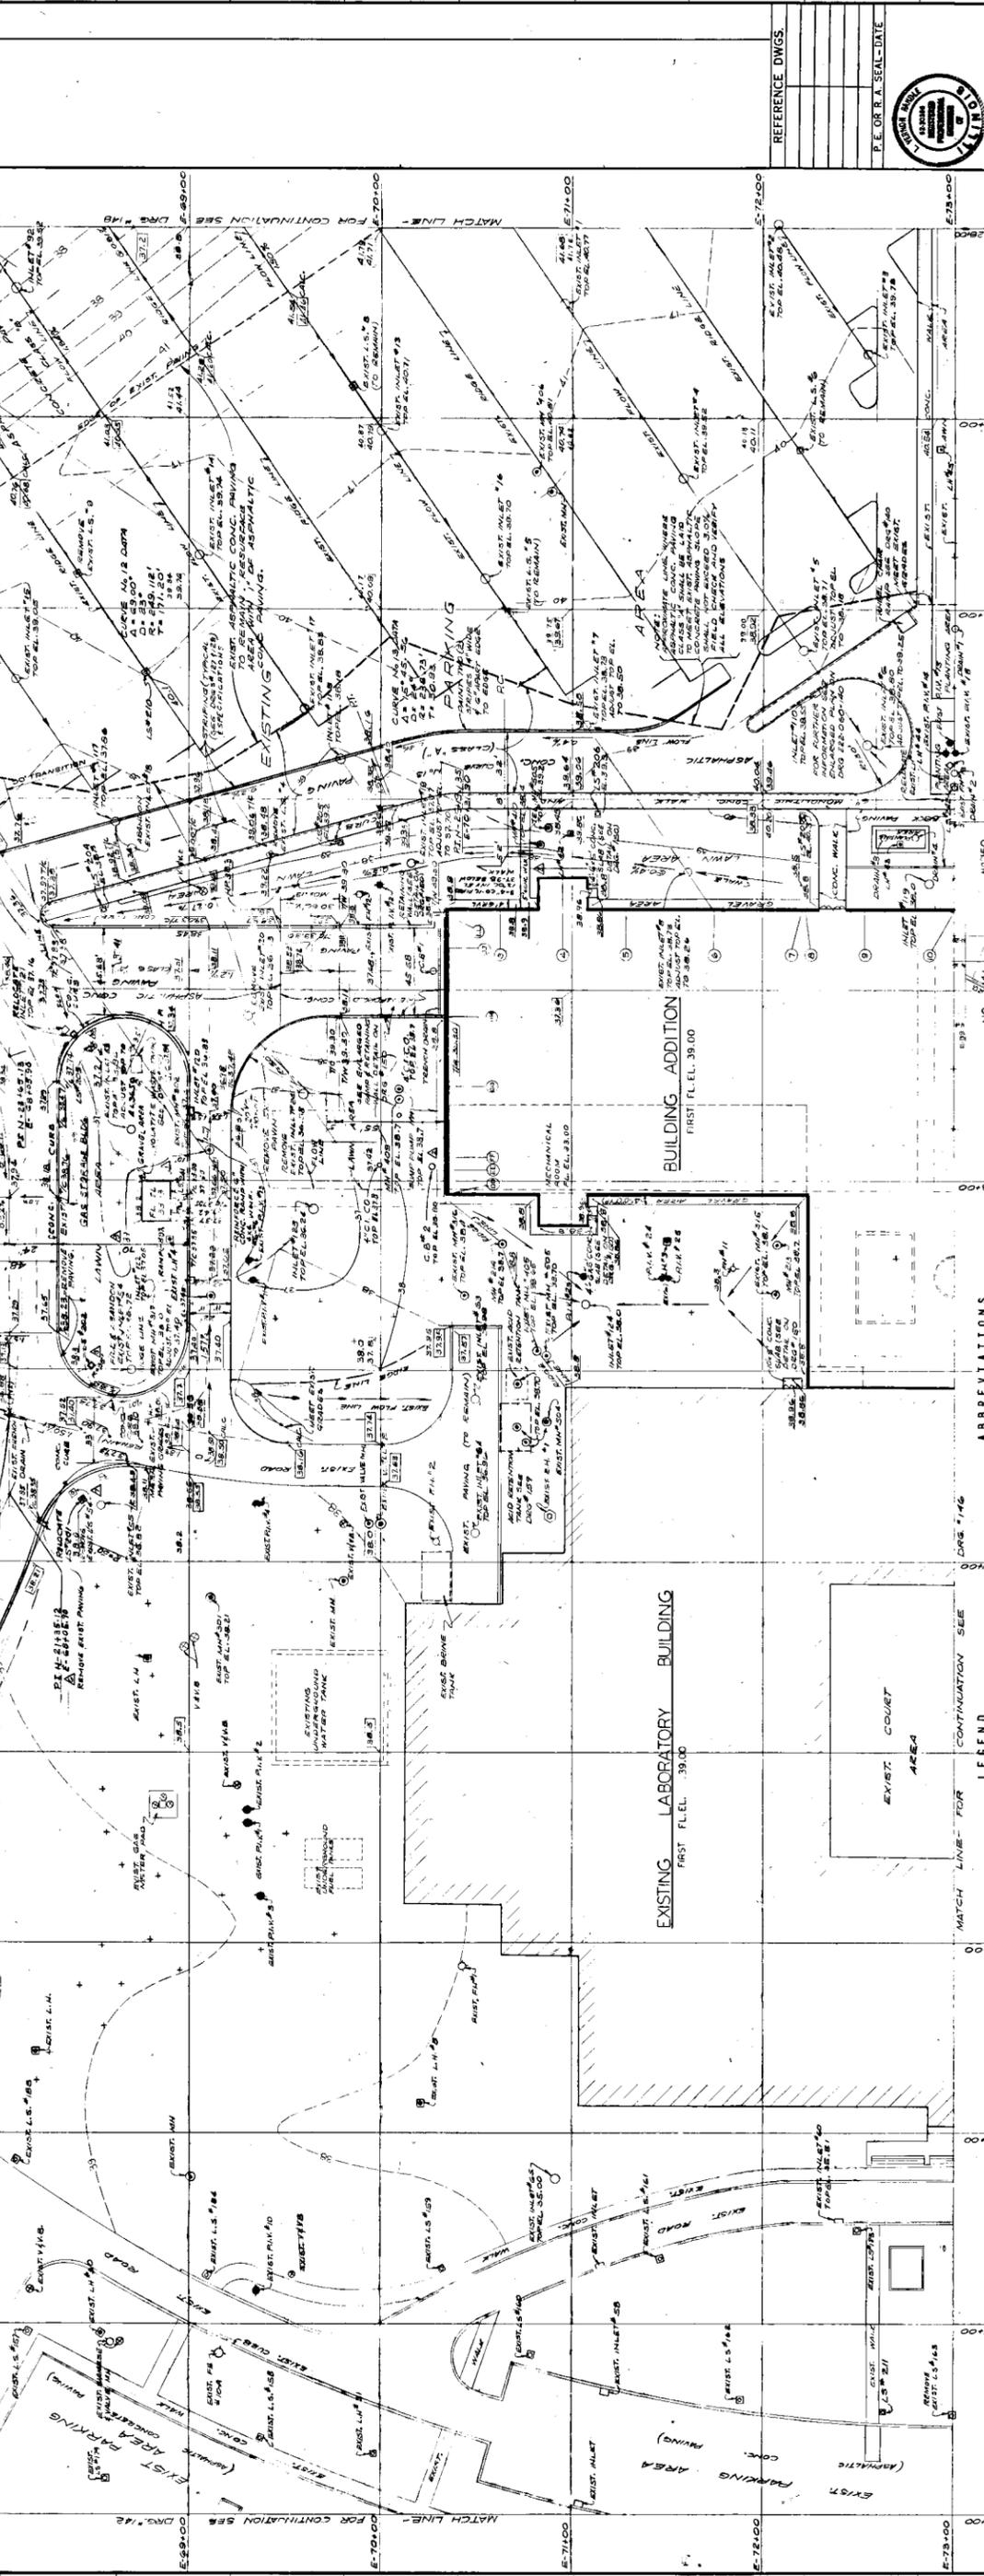
222-060-147

INDIAN HILL BELL LABORATORIES	SCALE 1"=30'
WORK YARDS	DRAWN BY H.T. SCOTT
EXISTING & FINISH GRADES AND CONTOURS	ENGINEER: [Signature]
	SUPERVISOR: [Signature]
	DATE: [Blank]

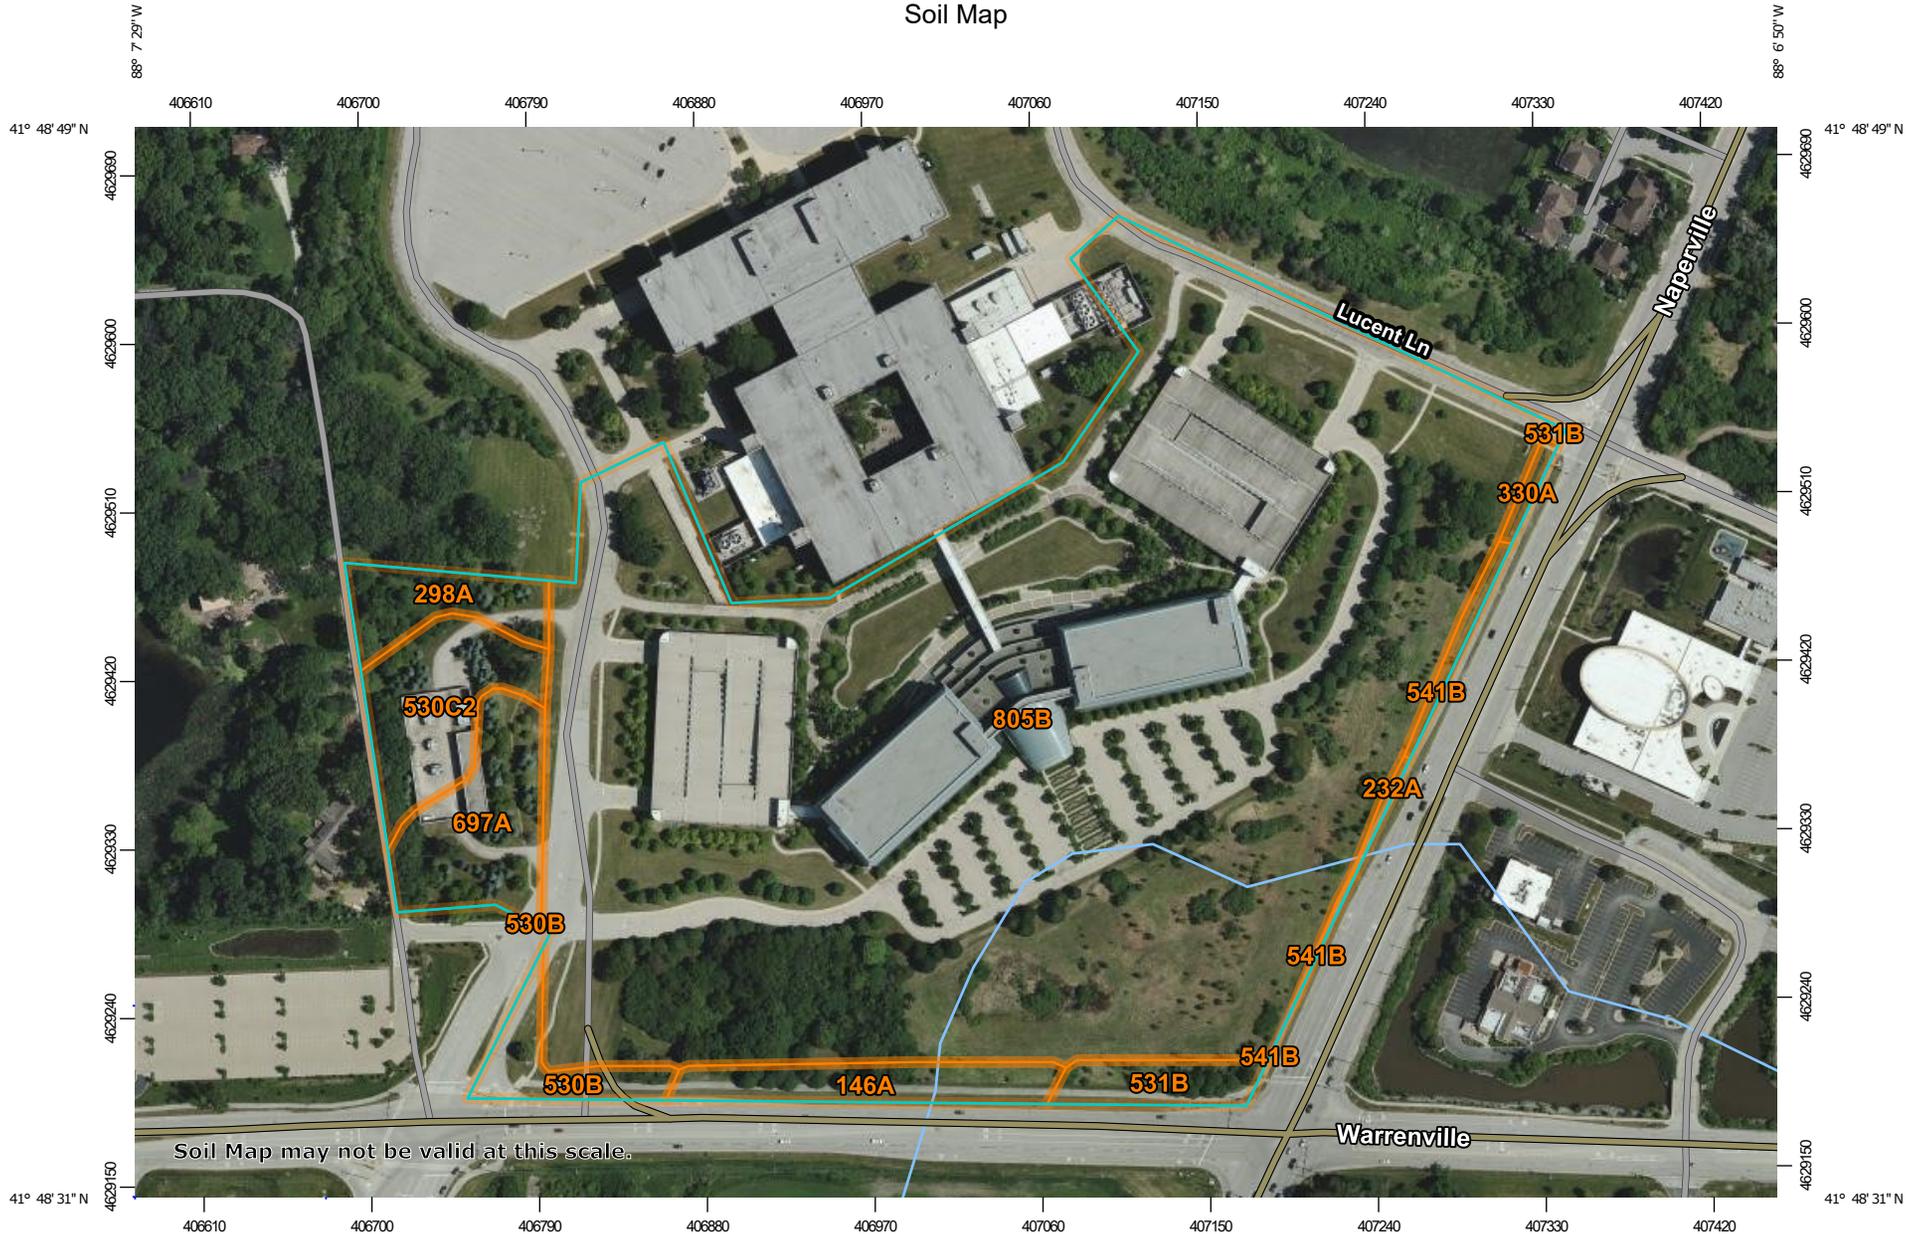
Custom Soil Resource Report Soil Map

Map Scale: 1:4,030 if printed on A landscape (11" x 8.5") sheet.

Eleven soil series are mapped on the subject property on the Soil Survey of DuPage County, Illinois (2015) Map (Figure 8) and include:
