STREET # 148
 DIRECTION N
 STREET WRIGHT
 SUFFIX ST
 PIN 0818309002
 LOCAL SIGNIFICANCE RATING C
 POTENTIAL IND NR? (Y or N) N
 Contributing to a NR DISTRICT? C
 Contributing secondary structure? -
 Listed on existing SURVEY? Local District; NR District

HISTORIC NAME Kroehler, P.E., Carriage House

SURVEYAREA NAPERVILLE

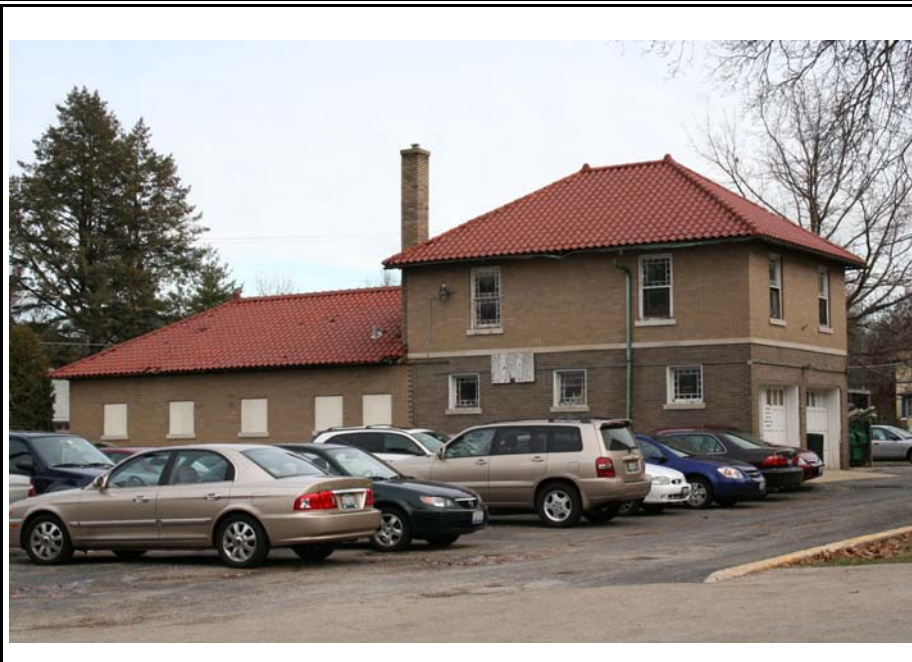
DIGITAL PHOTO ID \Images\wright148n(3).jpg

CATEGORY building CURRENT FUNCTION Domestic - secondary structure
 CONDITION good HISTORIC FUNCTION Domestic - secondary structure
 INTEGRITY minor alterations and addition(s) REASON for SIGNIFICANCE
 SECONDARY STRUCTURE

ARCHITECTURAL CLASSIFICATION Garage PLAN rectangular
 DETAILS NO OF STORIES 2
 BEGINYEAR c. 1910 ROOF TYPE Hipped
 OTHER YEAR ROOF MATERIAL Ceramic Tile
 DATESOURCE Surveyor FOUNDATION Concrete
 WALL MATERIAL (current) Brick PORCH
 WALL MATERIAL 2 (current) WINDOW MATERIAL Wood
 WALL MATERIAL (original) Brick WINDOW MATERIAL
 WALL MATERIAL 2 (original) WINDOW TYPE double hung/awning
 WINDOW CONFIG multi-light
 SIGNIFICANT FEATURES Hipped roof with ceramic tile; historic multi-light double hung and awning windows; two-bay garage doors
 ALTERATIONS Replacement garage doors; one story north addition (historic)--windows in addition boarded up
