SURVEYAREA NAPERVILLE SURVEY UPDATE

# City of NAPERVILLE

## ILLINOIS URBAN ARCHITECTURAL AND HISTORICAL SURVEY CONTINUATION SHEET

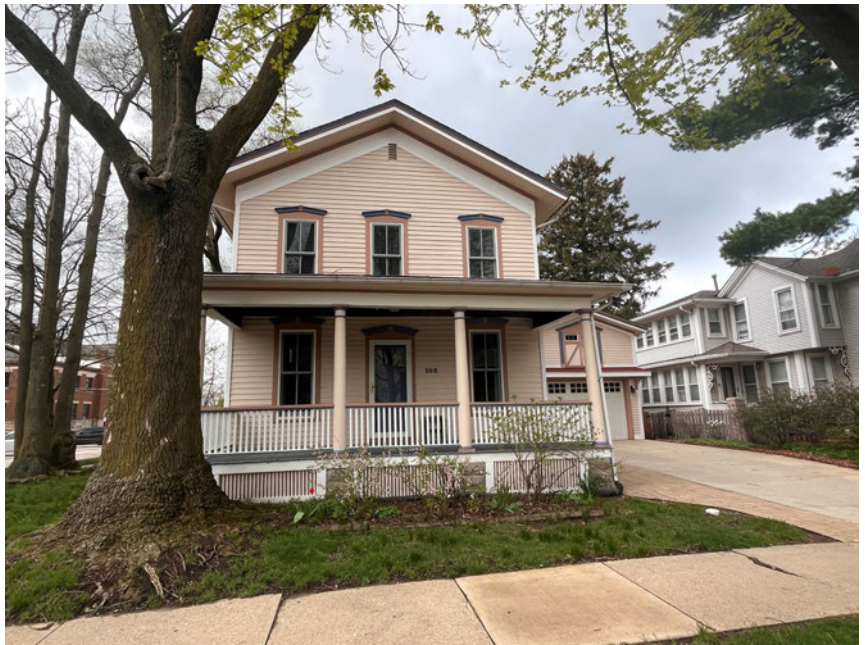
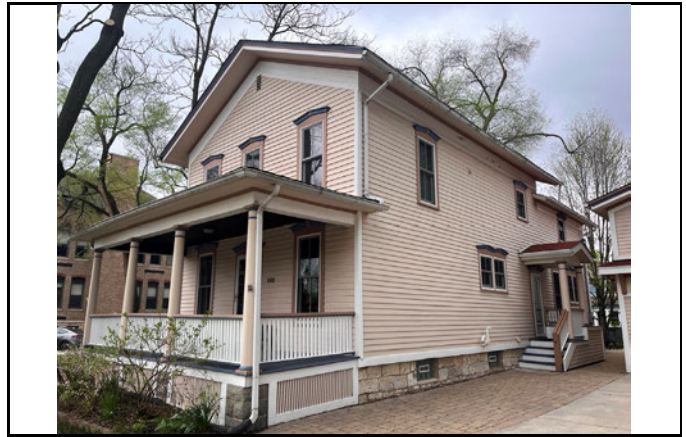
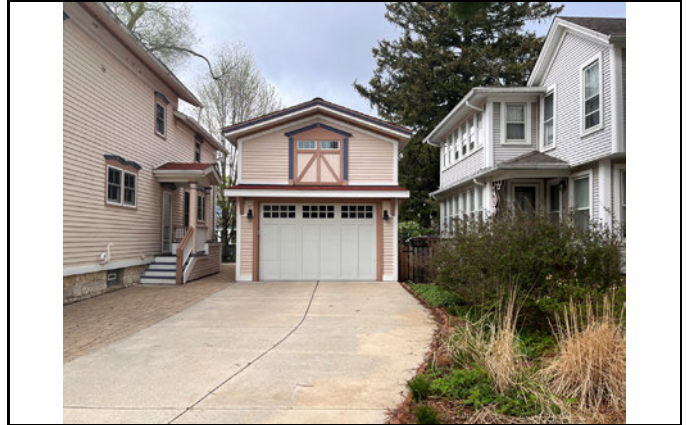
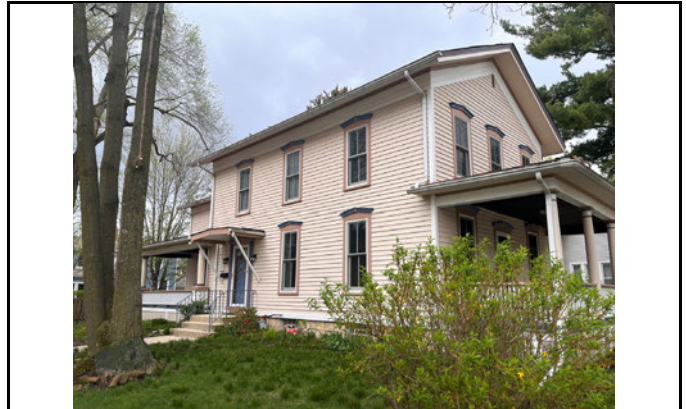
ARCHITECTURAL CLASSIFICATION	<input type="text" value="Italianate"/>	PLAN	<input type="text" value="rectangular"/>
DETAILS	<input type="text" value="Greek Revival"/>	NO OF STORIES	<input type="text" value="2"/>
BEGINYEAR	<input type="text" value="1874"/>	ROOF TYPE	<input type="text" value="Front gable"/>
OTHER YEAR	<input type="text"/>	ROOF MATERIAL	<input type="text" value="Asphalt - shingle"/>
DATESOURCE	<input type="text" value="NHS Plaque"/>	FOUNDATION	<input type="text" value="Stone"/>
WALL MATERIAL (current)	<input type="text" value="Wood"/>	PORCH	<input type="text" value="full front/side"/>
WALL MATERIAL 2 (current)	<input type="text"/>	WINDOW MATERIAL	<input type="text" value="Aluminum/vinyl"/>
WALL MATERIAL (original)	<input type="text" value="Wood"/>	WINDOW MATERIAL	<input type="text" value="glass block"/>
WALL MATERIAL 2 (original)	<input type="text"/>	WINDOW TYPE	<input type="text" value="double hung"/>

WINDOW CONFIG	<input type="text" value="2/2 vertical"/>

HISTORIC NAME	Barr, Samuel house
COMMON NAME	
ARCHITECT	
BUILDER	Barr, Samuel
ARCHITECT SOURCE	
HISTORIC INFO	
PERMITS	
LANDSCAPE	Northwest corner of Franklin and Ellsworth; front and south sidewalks; side driveway; similar setbacks; mature trees
COA DATES	9/28/2012
COA DECISION	COA #12-3641 - replacement of [north] side entry porch (approved 10/2/2012)
COA Compliance Notes	
COA Work Not Completed	
Work Not Requiring COA	Replacement windows on north secondary elevation

**Work Completed Without COA** 2/2 double-hung replacement windows on front (east) façade and south elevation (facing Franklin Avenue) -- historically compatible type and configuration

1892 Sanborn Map shows no front porch; 1898 map shows front entry porch. Current porch has no entry/steps.

“This clapboard farmhouse, built in 1874, has the massing and details reminiscent of Greek Revival, but with pedimented window heads characteristic of the 1870s date. Added at the turn of the century was the porch with its four, standard, Tuscan columns. The west end of the building has a porch from the same construction campaign and columns selected from the same catalogue, but with slightly different proportions.”

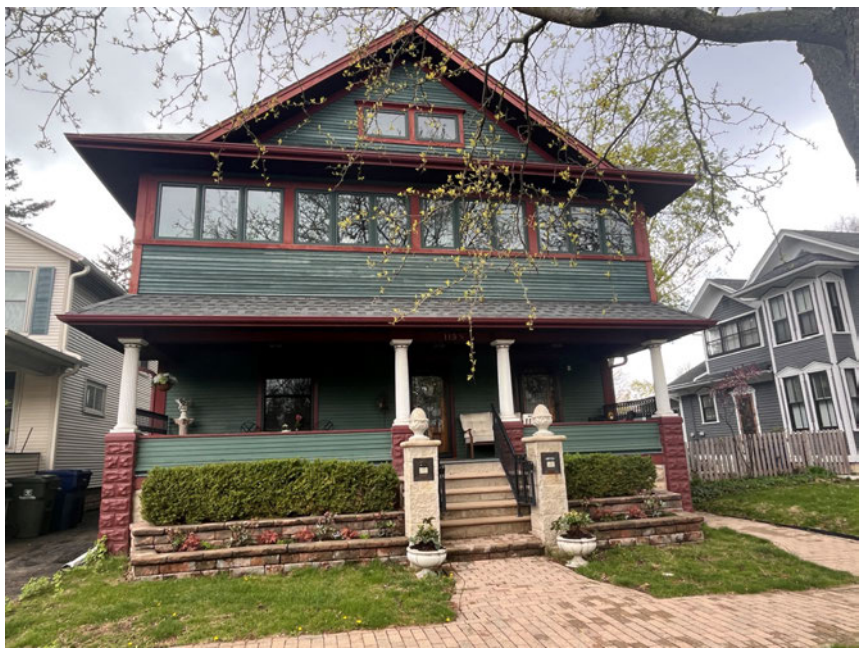
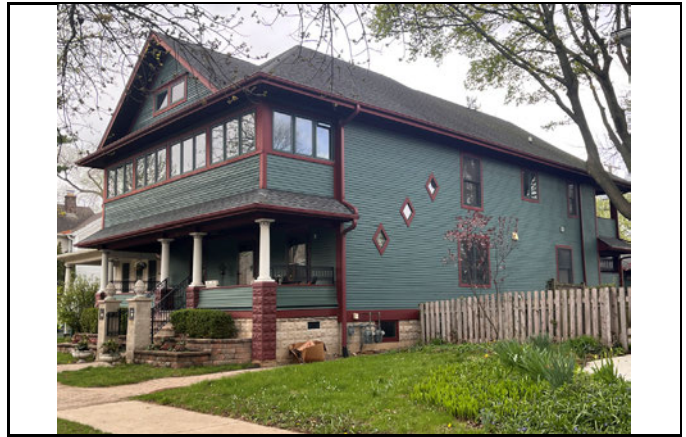
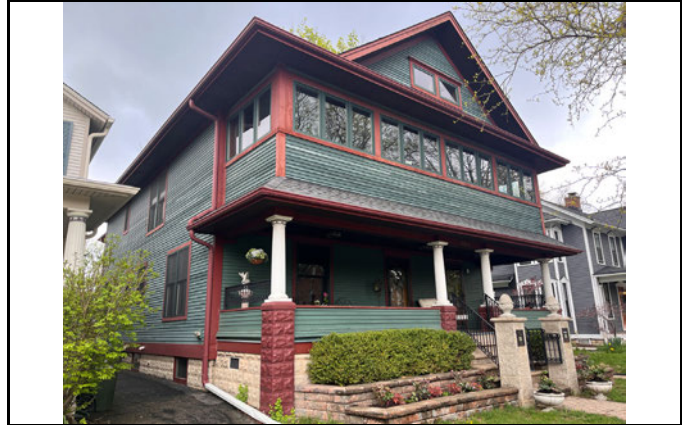
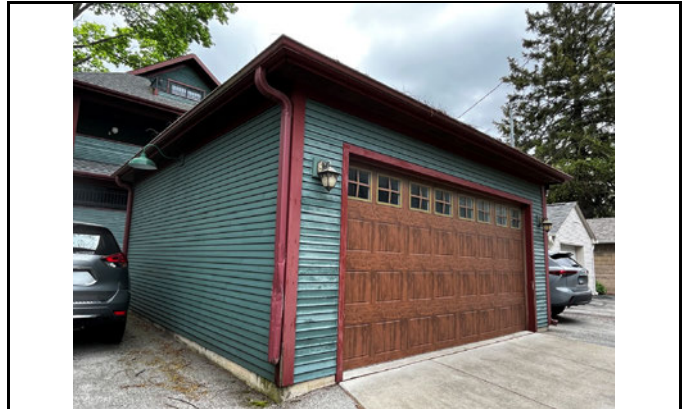
<b>HISTORIC NAME</b>	
<b>COMMON NAME</b>	
<b>ARCHITECT</b>	
<b>BUILDER</b>	
<b>ARCHITECT SOURCE</b>	
<b>HISTORIC INFO</b>	
<b>PERMITS</b>	
<b>LANDSCAPE</b>	Midblock on west side of residential street; front sidewalk; rear alley; similar setbacks; mature trees
<b>COA DATES</b>	8/20/2018;4/26/2019
<b>COA DECISION</b>	COA #18-3335 - Replacing door with window and in-kind replacement matching existing window (approved 8/22/2018); COA #19-1196 - remove window replace with door - door existed prior to 2018 (approved 4/26/2019)
<b>COA Compliance Notes</b>	
<b>COA Work Not Completed</b>	
<b>Work Not Requiring COA</b>	Replacement windows in original and altered openings on north and south secondary elevations; two-story rear addition

Replacement windows on front façade;north end enclosure of front porch evident in 2007 survey removed; cast-stone steps to front porch flanked by brick planters; wrought iron railings added above north and south knee walls at front porch.

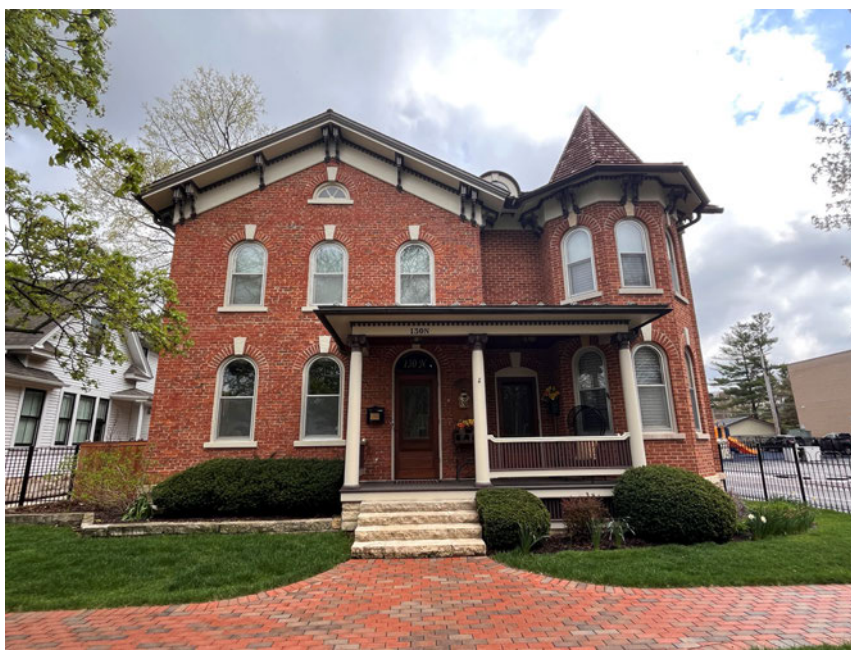
**SIGNIFICANT FEATURES** Front gable portion is original house (windows on first story appear historic); round arch window openings w/ center keystones; half round window under gable; round arch front entry; historic two-story south/rear addition constructed in 1903 (addition originally featured a second west-facing porch)

**ALTERATIONS** Paired brackets & dentils appear to be later (may be restoration); replacement windows on 2nd story or original structure (not historic); replacement door & transom (not historic); large 2 story S. side addition w/ corner tower (not historic--1990s); replacement porch (not historic-1990s); 1 story north bay addition (not historic); segmental arch window on 2nd story north elevation (not historic); chimney (not historic); rear screened porch addition (not historic). Post-2007 -- no changes.

HISTORIC INFO According to history of the house in Naperville Heritage Society address file, the house was built in 1872. See IHSS photograph for original massing of house. According to A GUIDE TO CHICAGO'S HISTORIC SUBURBS (p. 401-2), the south/rear addition was constructed in 1903 and featured a west-facing porch. The porch was removed when the large 2-story addition with corner tower was constructed in the 1990s.

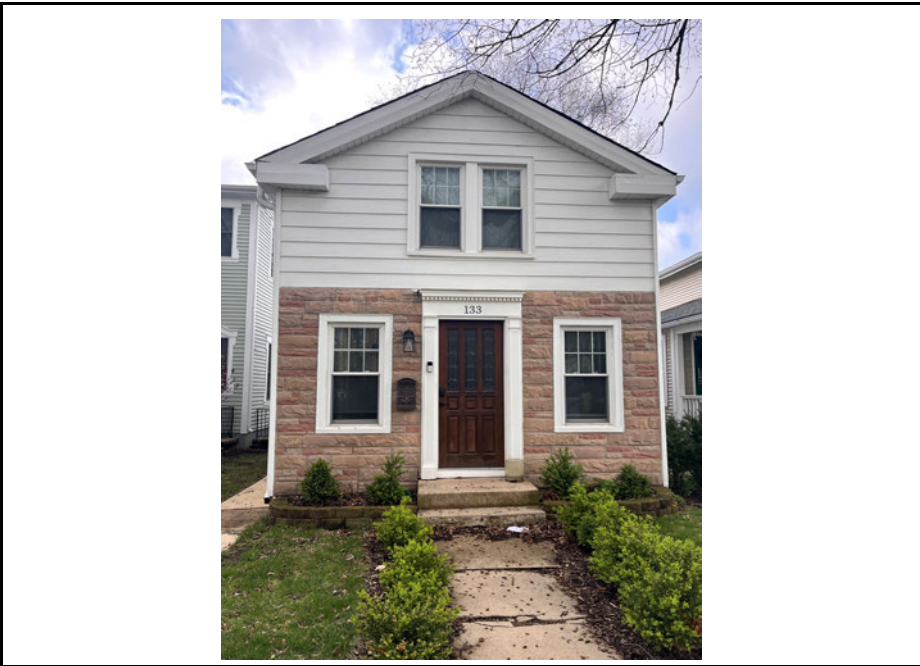
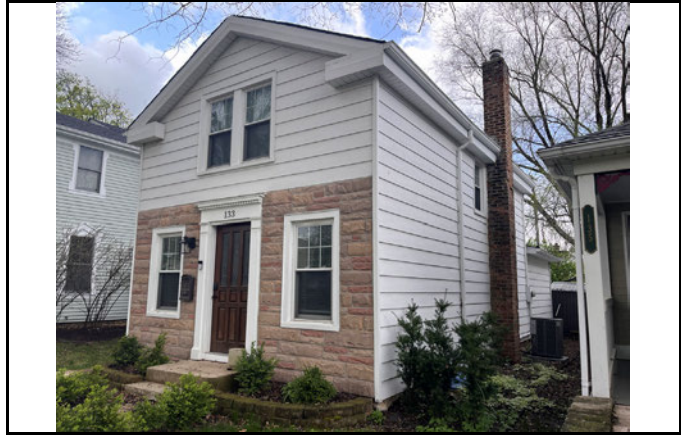
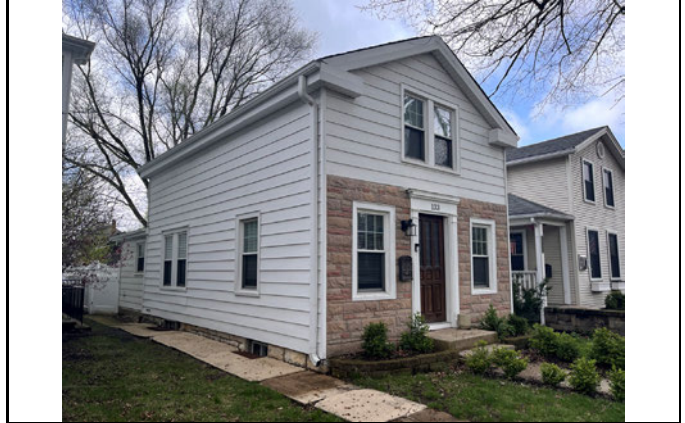
<b>HISTORIC NAME</b>	
<b>COMMON NAME</b>	
<b>ARCHITECT</b>	
<b>BUILDER</b>	
<b>ARCHITECT SOURCE</b>	
<b>HISTORIC INFO</b>	
<b>PERMITS</b>	
<b>LANDSCAPE</b>	Midblock on west side of residential street; front sidewalk; rear alley; similar setbacks; mature trees; rear wood fence
<b>COA DATES</b>	
<b>COA DECISION</b>	
<b>COA Compliance Notes</b>	
<b>COA Work Not Completed</b>	
<b>Work Not Requiring COA</b>	Replacement windows on north and south secondary elevations; aluminum siding around first story windows at west end of south elevation replaced.

<b>Work Completed Without COA</b>	6/1 vinyl replacement windows in existing openings on front façade; replacement front door;
-----------------------------------	---

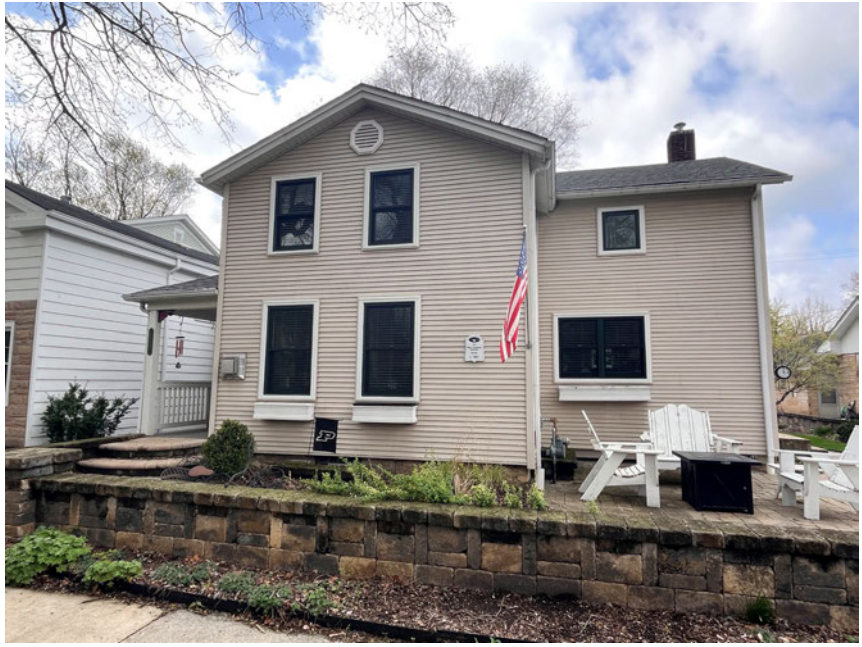
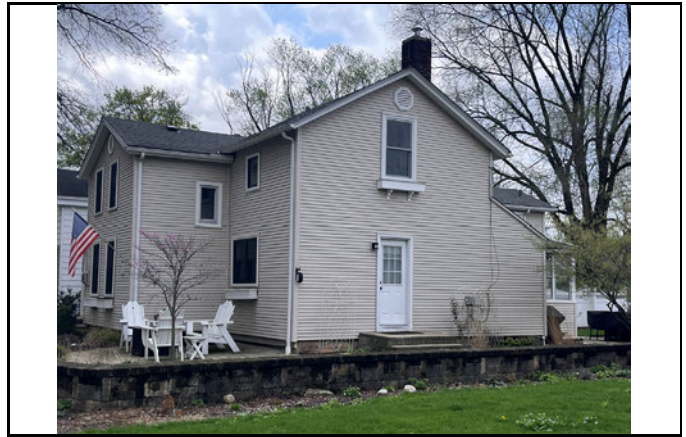
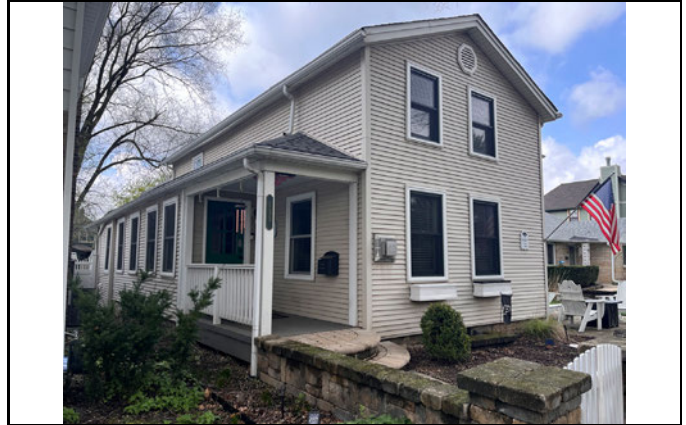
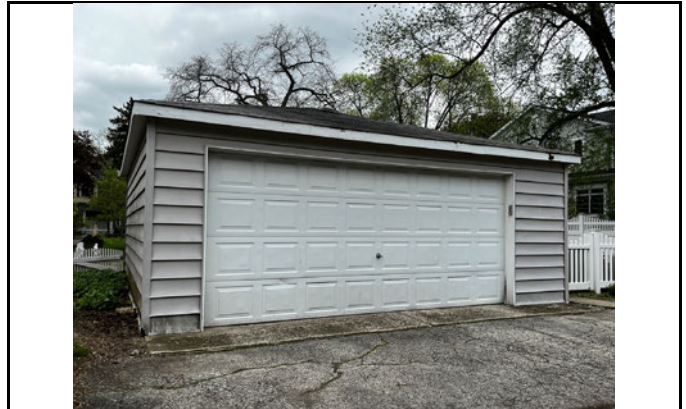
<b>HISTORIC NAME</b>	Sporlein, Mary Elizabeth House
<b>COMMON NAME</b>	
<b>ARCHITECT</b>	
<b>BUILDER</b>	
<b>ARCHITECT SOURCE</b>	
<b>HISTORIC INFO</b>	
<b>PERMITS</b>	
<b>LANDSCAPE</b>	Midblock on west side of residential street; front sidewalk; rear alley; low stone wall around lot; similar setbacks; mature trees
<b>COA DATES</b>	6/27/2016
<b>COA DECISION</b>	COA #16-2362 - In-kind replacement of front porch (approved 7/11/2016)
<b>COA Compliance Notes</b>	Porch structure does not appear to have been replaced, but porch railing is replacement.
<b>COA Work Not Completed</b>	
<b>Work Not Requiring COA</b>

Replacement windows on front façade.

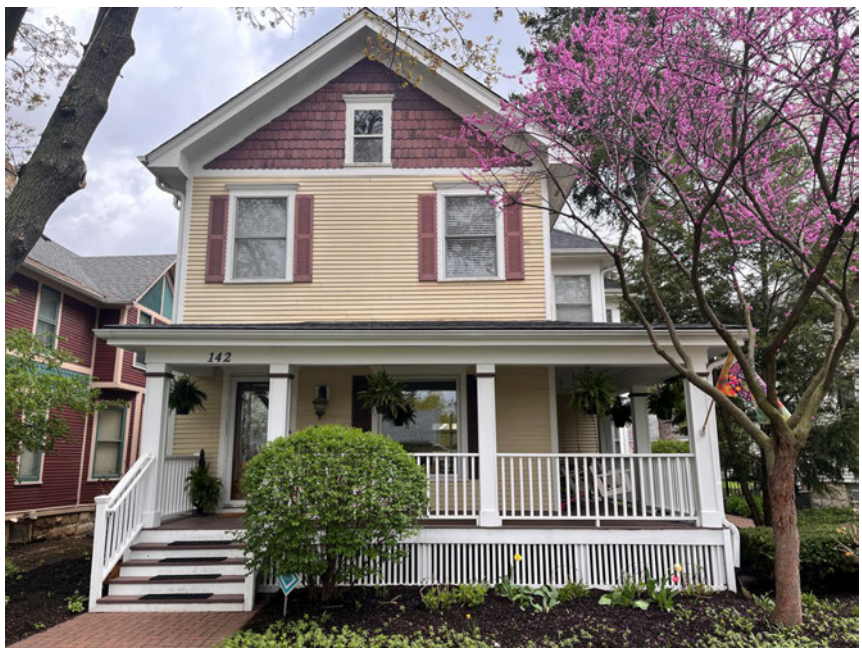
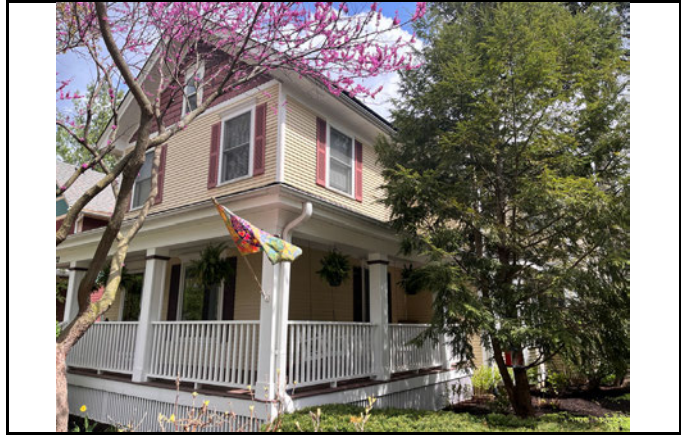
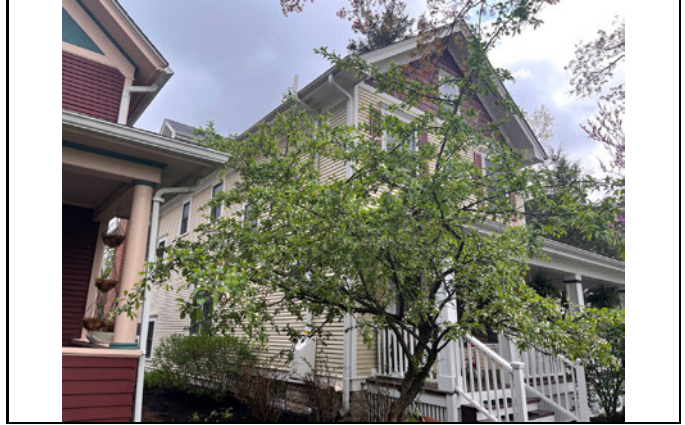
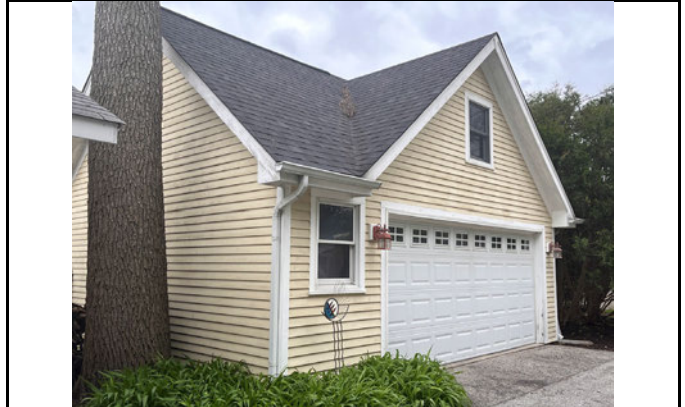
<b>HISTORIC NAME</b>	
<b>COMMON NAME</b>	
<b>ARCHITECT</b>	
<b>BUILDER</b>	
<b>ARCHITECT SOURCE</b>	
<b>HISTORIC INFO</b>	
<b>PERMITS</b>	
<b>LANDSCAPE</b>	Midblock on east side of residential street; front sidewalk; rear alley; similar setbacks; mature trees
<b>COA DATES</b>	6/28/2012
<b>COA DECISION</b>	COA #12-2252 - Front steps replacement (approved 7/3/2012)
<b>COA Compliance Notes</b>	
<b>COA Work Not Completed</b>	
<b>Work Not Requiring COA</b>

Solar panels on roof--may have been present in 2007 and not noted on survey. 2007 survey photographs do not show slope of roof where panels are located.

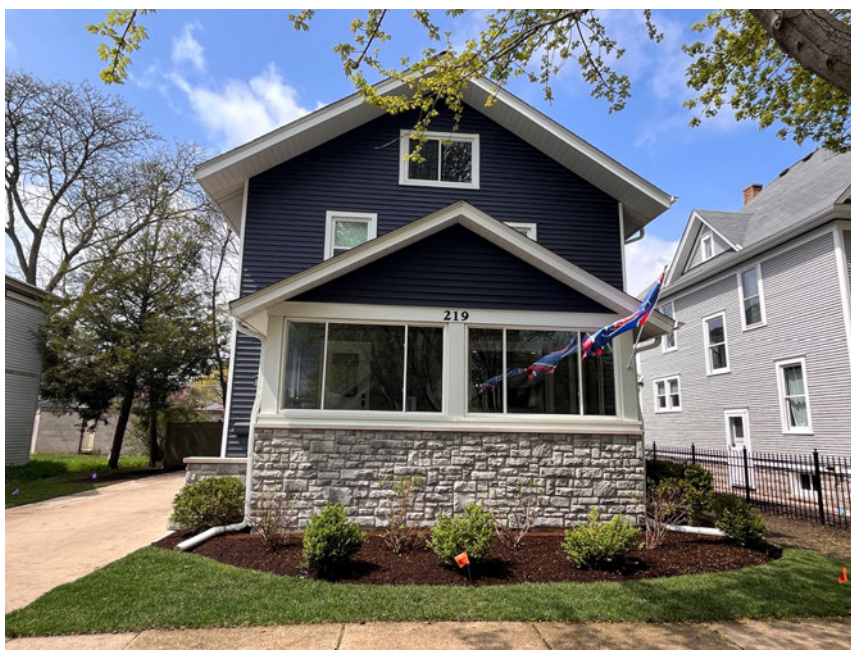
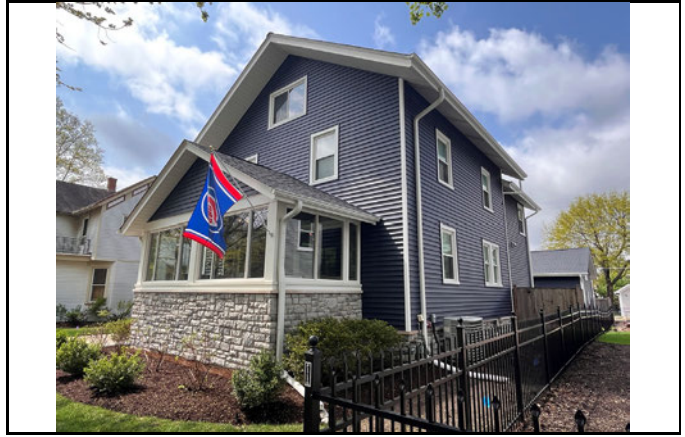
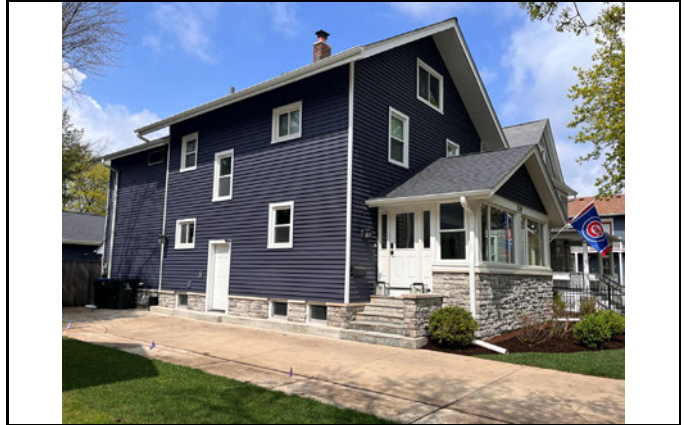
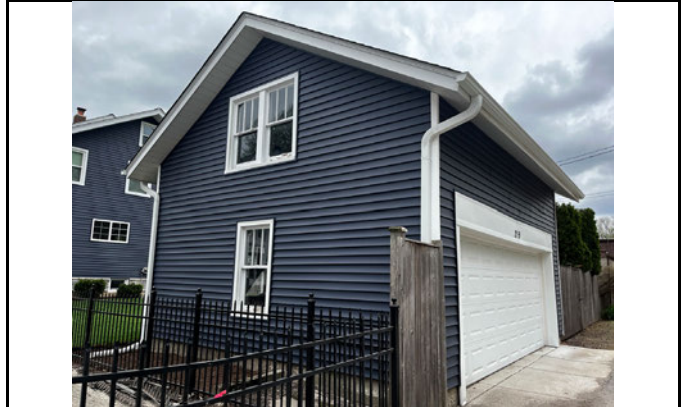
Work Not Requiring COA Replacement windows on north and south secondary elevations; replacement door at ground-level south-side entry; entry porch and entrance toward rear of south elevation removed

**Work Completed Without COA** Replacement windows on front façade, including in enclosed front porch

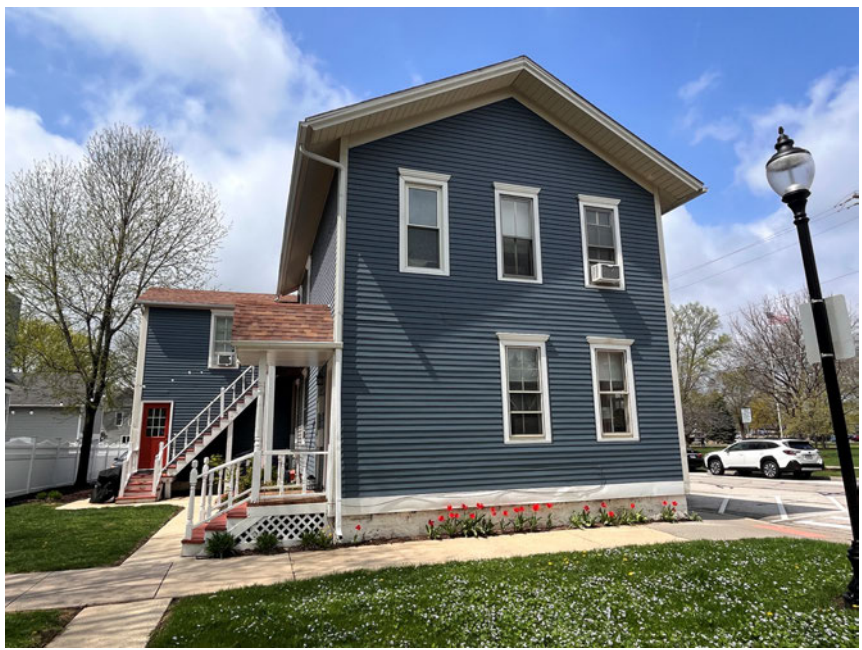
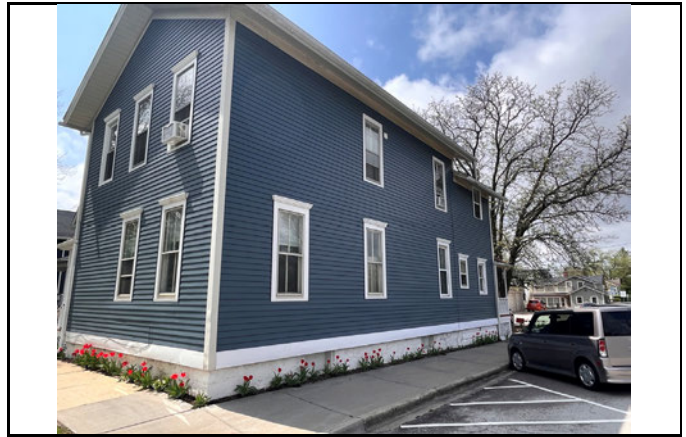
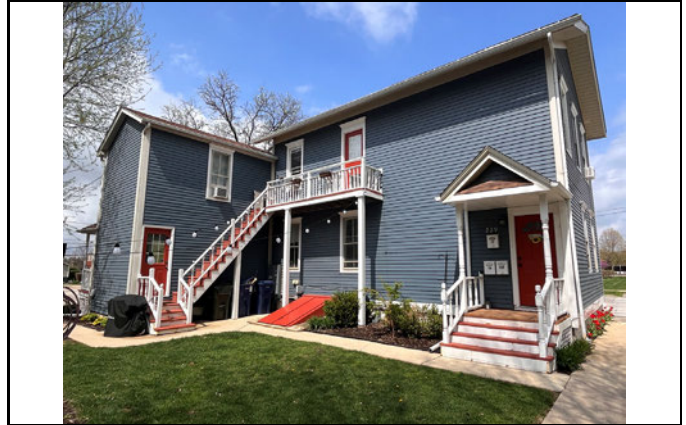
<b>HISTORIC NAME</b>	
<b>COMMON NAME</b>	
<b>ARCHITECT</b>	
<b>BUILDER</b>	
<b>ARCHITECT SOURCE</b>	
<b>HISTORIC INFO</b>	Tax records research by Naperville Heritage Society indicate that house was probably built around 1873.
<b>PERMITS</b>	Sanborn maps through 1949 show house with entry at front and no side porch.
<b>LANDSCAPE</b>	Southwest corner of Ellsworth and North; front and north sidewalks; south side yard; rear driveway; mature trees
<b>COA DATES</b>	11/14/2017
<b>COA DECISION</b>	COA #17-4764 - In-kind replacement of asphalt shingles (approved 11/14/2017)
<b>COA Compliance Notes</b>	
<b>COA Work Not Completed</b>	
<b>Work Not Requiring COA</b>

<b>Work Completed Without COA</b>	1/1 replacement windows in select openings on front façade and at west end of north elevation (facing North Avenue) at first story
-----------------------------------	--

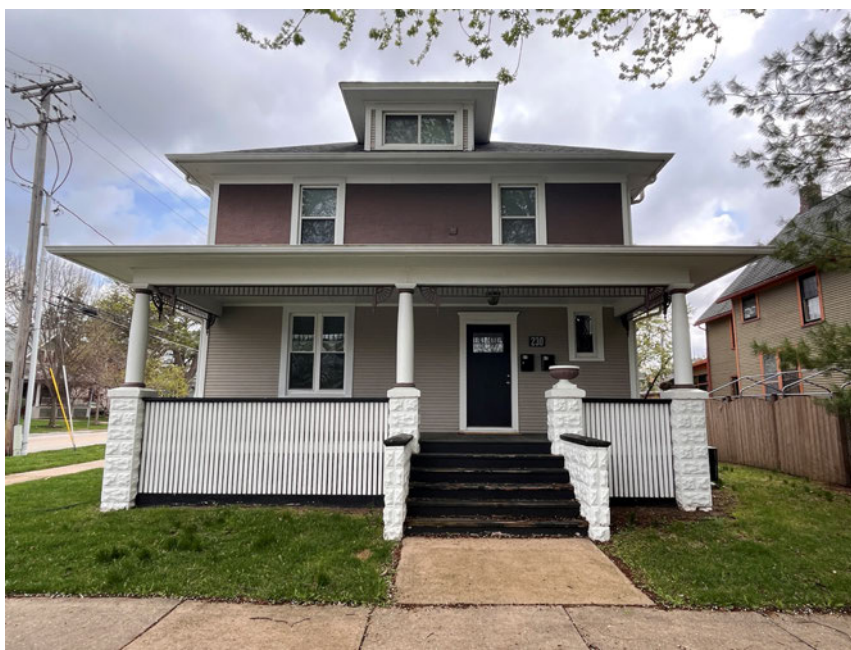
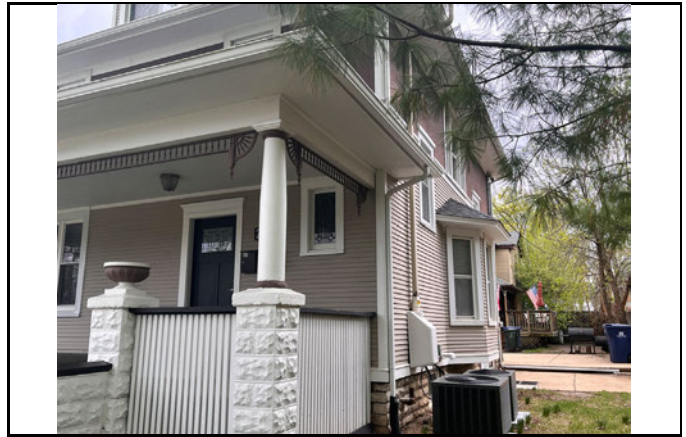
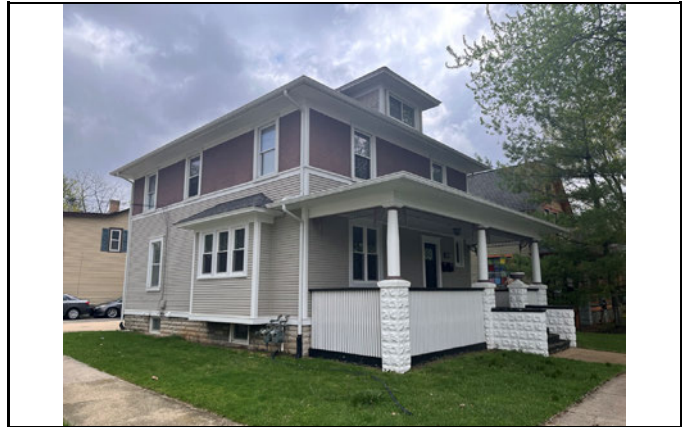
<b>HISTORIC NAME</b>	
<b>COMMON NAME</b>	
<b>ARCHITECT</b>	
<b>BUILDER</b>	
<b>ARCHITECT SOURCE</b>	
<b>HISTORIC INFO</b>	
<b>PERMITS</b>	
<b>LANDSCAPE</b>	Southeast corner of North and Ellsworth; front and north sidewalks; rear alley; similar setbacks; mature trees
<b>COA DATES</b>	11/23/2016
<b>COA DECISION</b>	COA #16-4595 - In-kind shingle replacement (approved 11/28/2016)
<b>COA Compliance Notes</b>	
<b>COA Work Not Completed</b>	
<b>Work Not Requiring COA</b>

Single window at north end of front façade under porch replaced with paired Aluminum 1/1 double-hung windows.

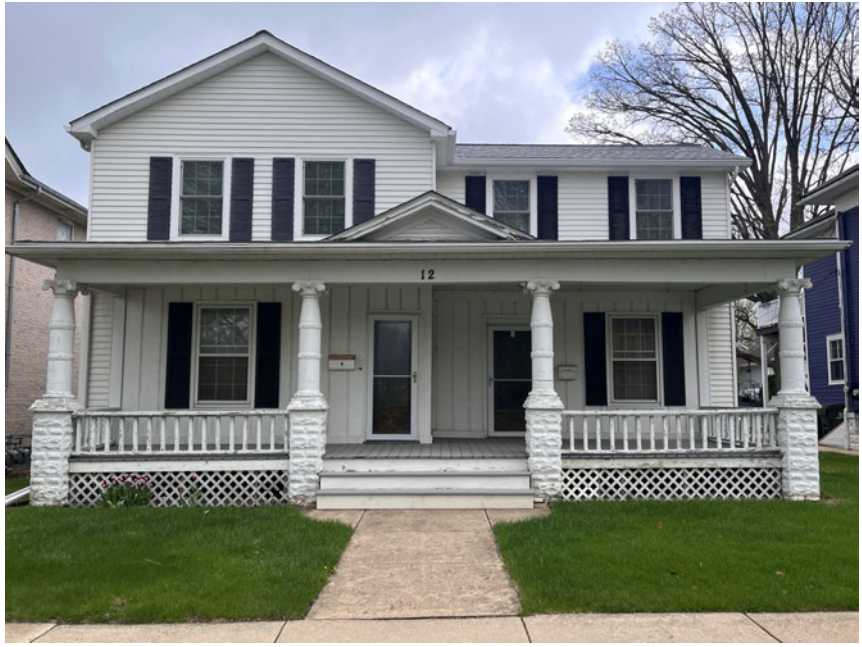
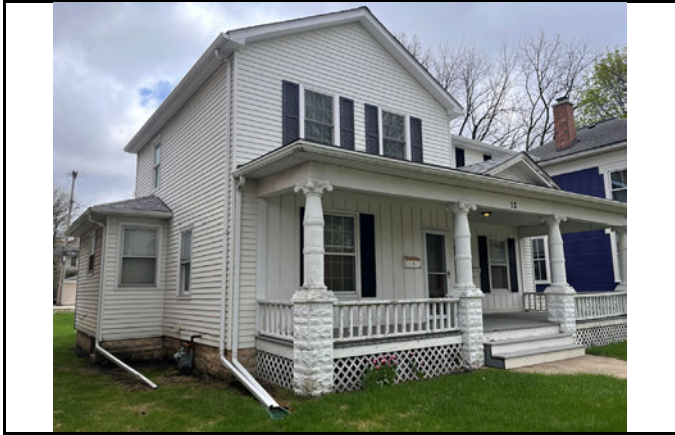
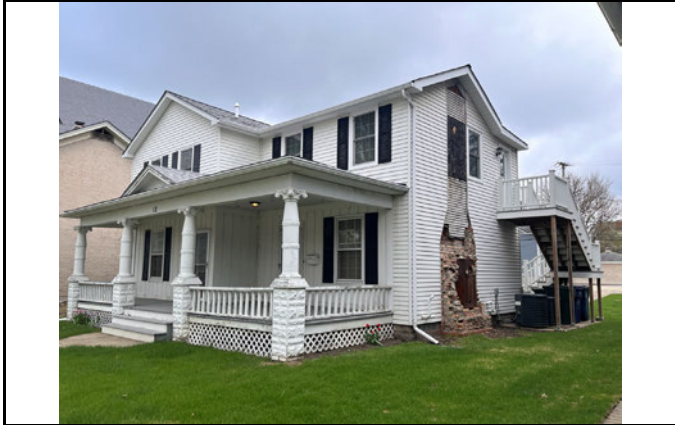
**Work Completed Without COA** Aluminum/vinyl replacement windows on 2nd story of front façade

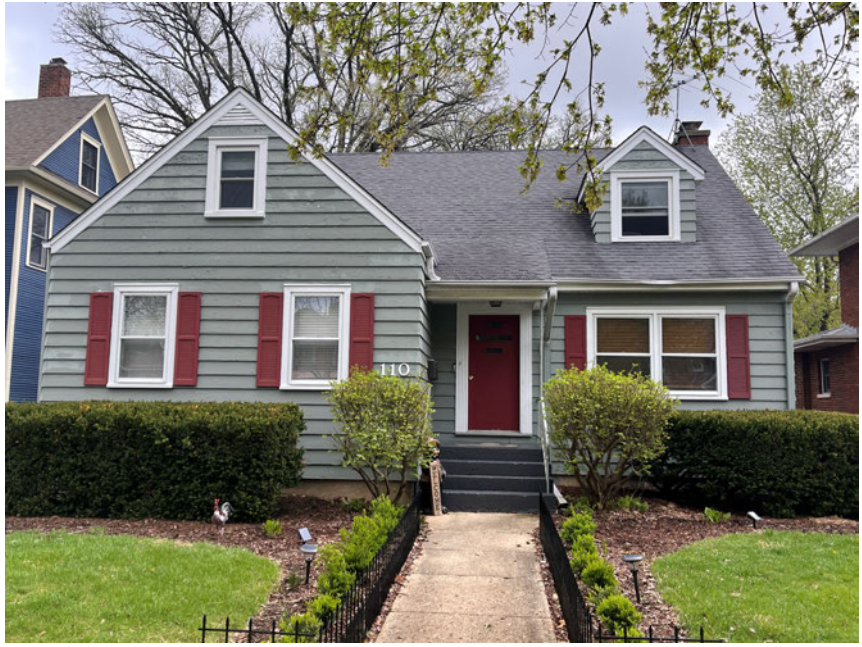
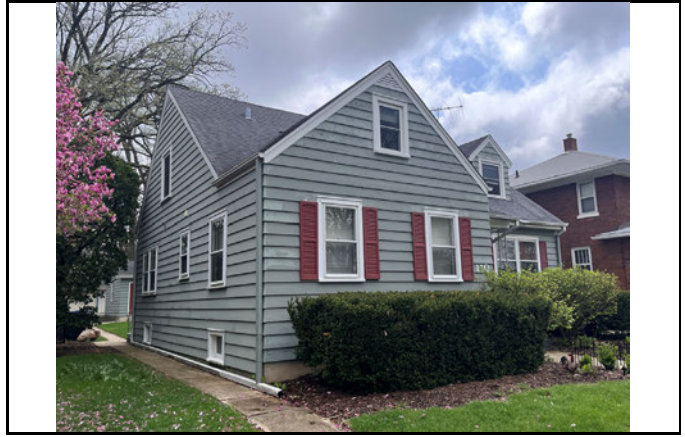
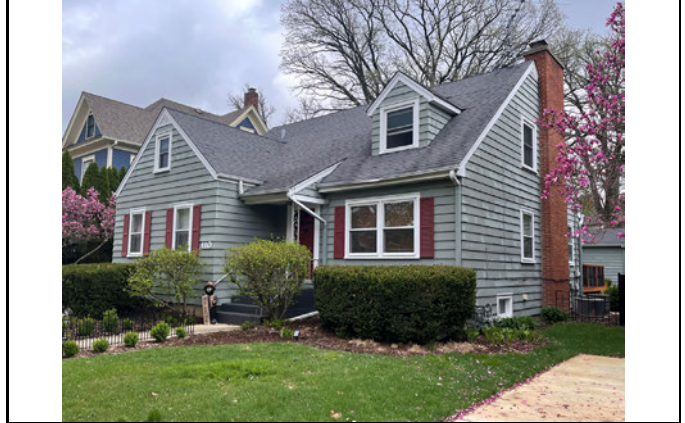
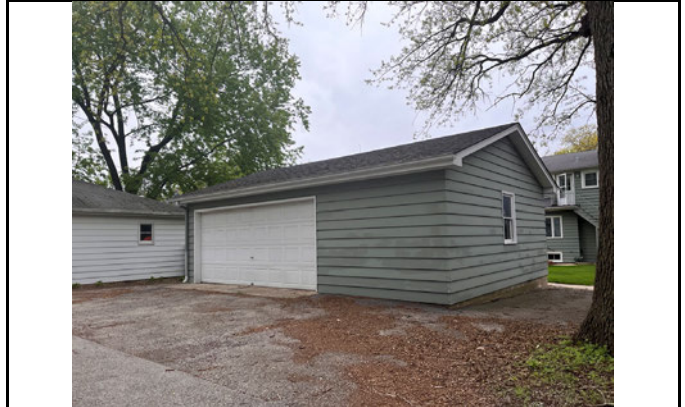
1/1 replacement windows on attic level and in front dormer.
