PREPARER Lara Ramsey

ORGANIZATION RAMSEY HISTORIC CONSULTANTS

SURVEYAREA NAPERVILLE SURVEY UPDATE

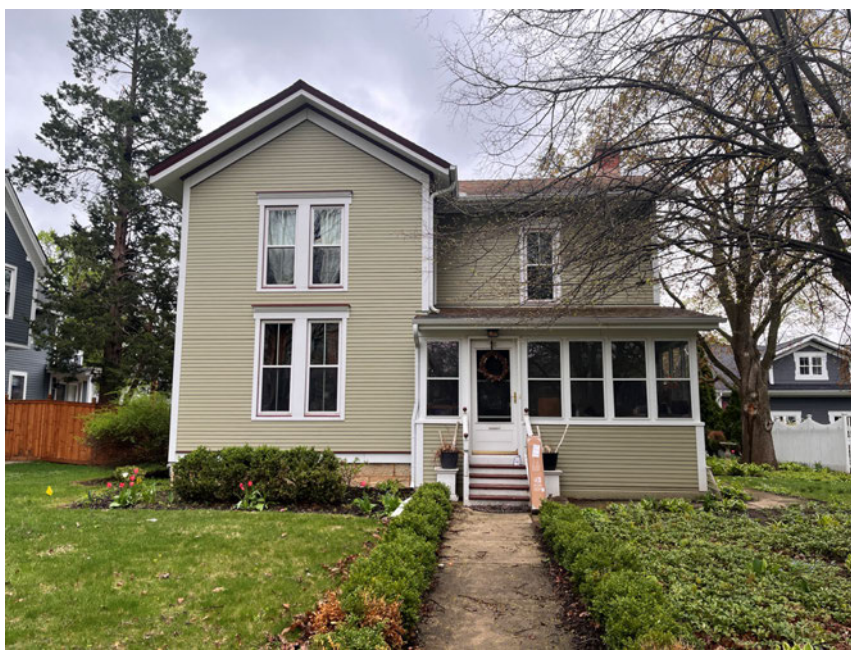
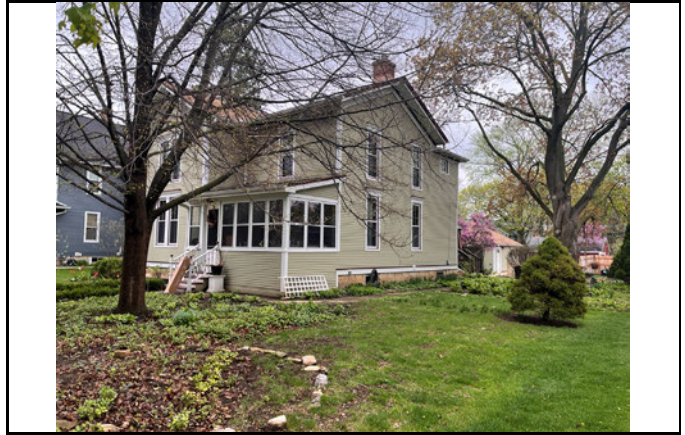
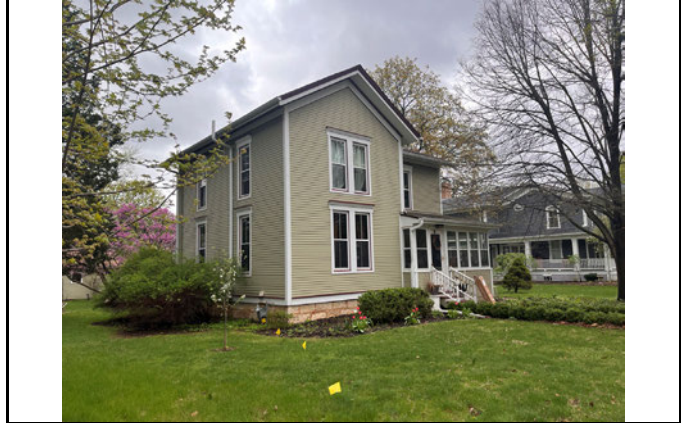
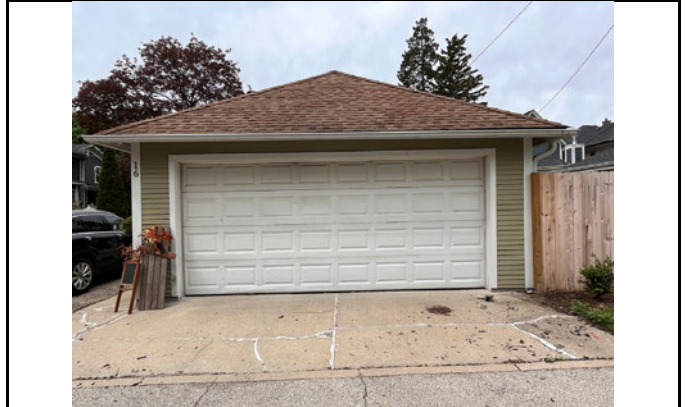
HISTORIC NAME	
COMMON NAME	
ARCHITECT	
BUILDER	
ARCHITECT SOURCE	
HISTORIC INFO	
PERMITS	
LANDSCAPE	Midblock on east side of residential street; front sidewalk; rear alley; large south side lot; mature trees
COA DATES	6/5/2013
COA DECISION	COA 13-1983 - Siding replacement with fiber cement board, roofing replacement (approved 6/10/2013)
COA Compliance Notes	
COA Work Not Completed	
Work Not Requiring COA

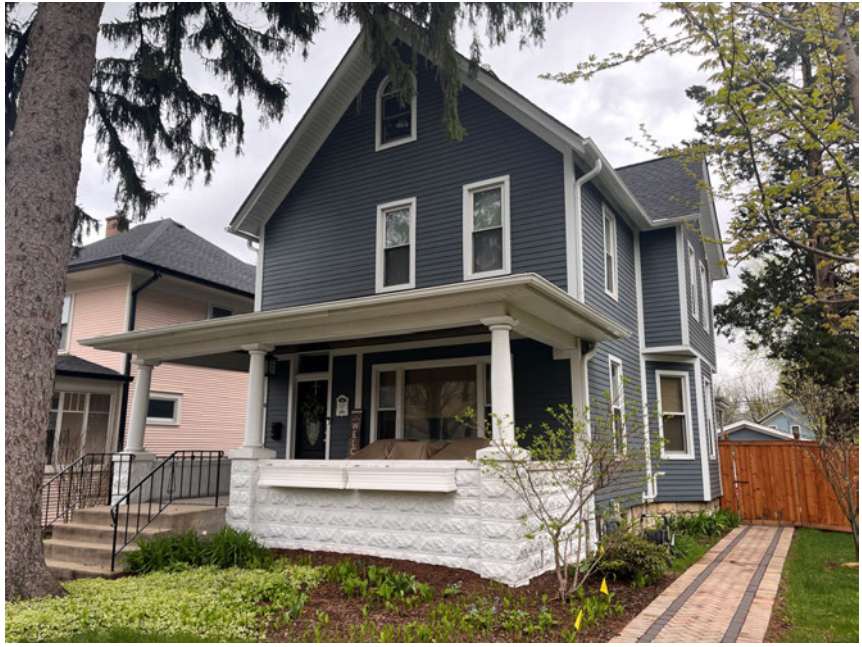
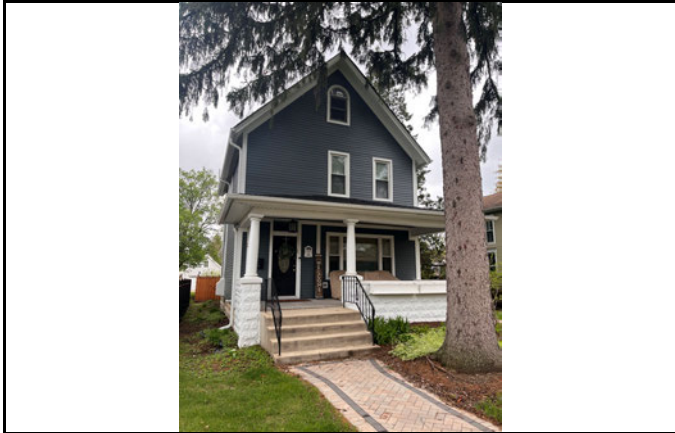
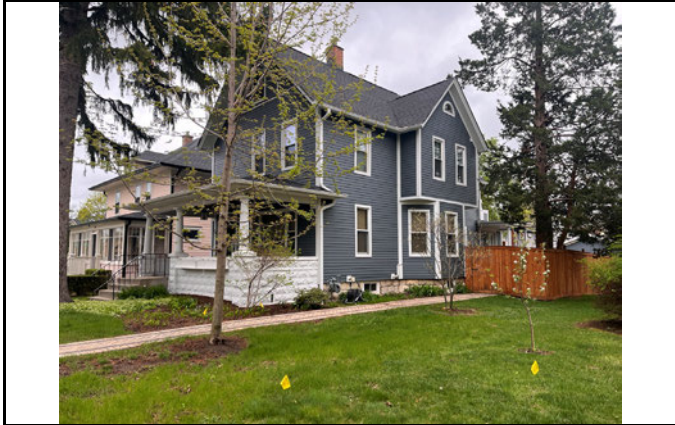
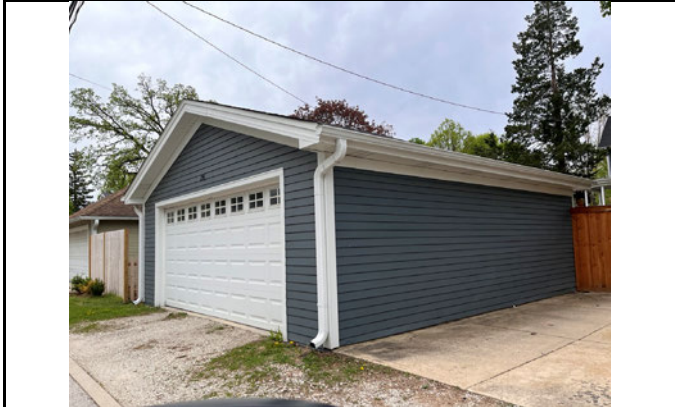
HISTORIC INFO Keiper was a Pennsylvania native and book agent. His daughter Lizzie taught at NCC for two years. The 1892 Sanborn Map indicates that the house was "unfinished" at the time of survey. The building originally featured a front entry porch on its west elevation, which was replaced with a full front porch sometime between 1898 and 1909.

COA DECISION COA #21-4614 - In-kind shingle replacement; COA #22-1356 - In-kind siding replacement (approved 6/29/2022); COA #22-1098 - In-kind siding. Shake siding and craftsman door submitted in the original petition were not approved. Subject to staff review, a front gable door can be approved admin. -- no new approved door as of 12/5/22)

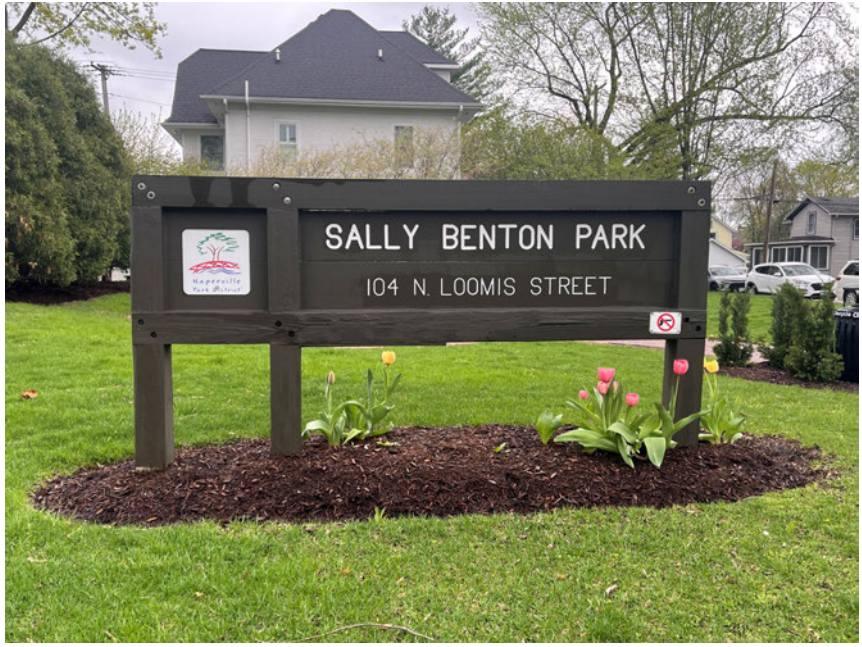
STREET # 104
 DIRECTION N
 STREET LOOMIS
 SUFFIX ST
 PIN 0818307009
 LOCAL SIGNIFICANCE RATING C
 POTENTIAL IND NR? (Y or N) N
 Contributing to a NR DISTRICT? C
 Contributing secondary structure? -
 Listed on existing SURVEY? Local District; NR District

ARCHITECTURAL CLASSIFICATION Park PLAN
 DETAILS NO OF STORIES
 BEGINYEAR c. 1970 ROOF TYPE
 OTHER YEAR ROOF MATERIAL
 DATESOURCE Surveyor/Aerial Maps FOUNDATION
 PORCH
 WALL MATERIAL (current) WINDOW MATERIAL
 WALL MATERIAL 2 (current) WINDOW MATERIAL
 WALL MATERIAL (original) WINDOW TYPE
 WALL MATERIAL 2 (original) WINDOW CONFIG
 SIGNIFICANT FEATURES Brick paved walkways and center tree
 ALTERATIONS Post-2007 -- new painted metal benches and wood sign.

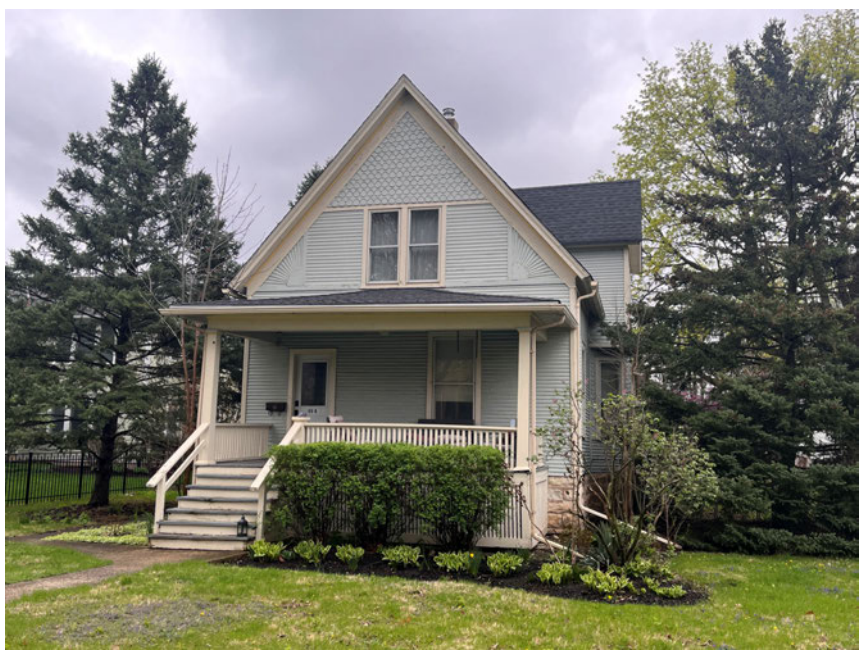
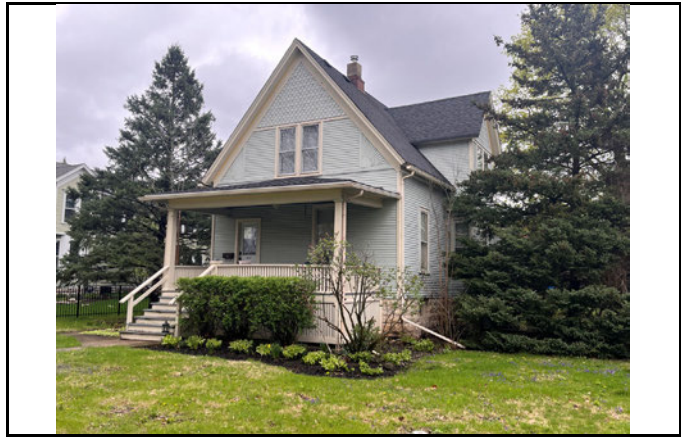
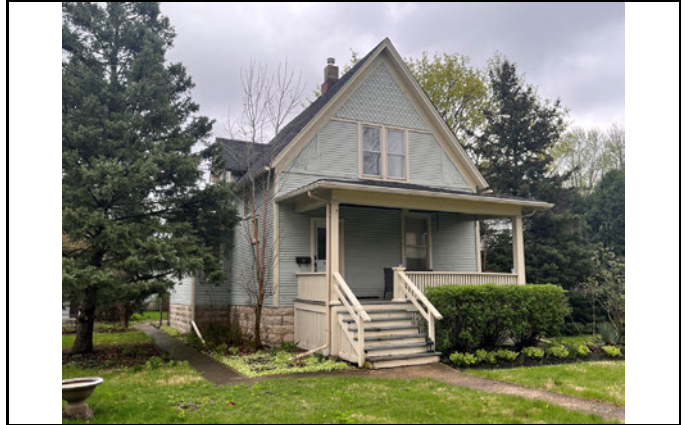
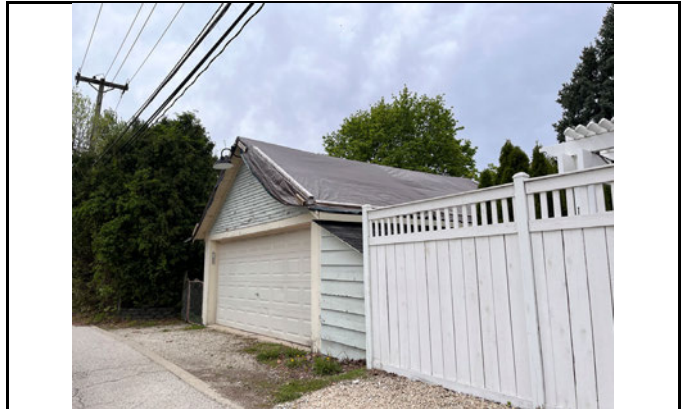
HISTORIC NAME	
COMMON NAME	
ARCHITECT	
BUILDER	
ARCHITECT SOURCE	
HISTORIC INFO	
PERMITS	1898 Sanborn shows house with front entry porch; 1909 shows full width front porch.
LANDSCAPE	Midblock on east side of residential street; front sidewalk; rear alley; rear chain link fence; similar setbacks; mature trees
COA DATES	
COA DECISION	
COA Compliance Notes	
COA Work Not Completed	
Work Not Requiring COA

Work Completed Without COA	Replacement front door.

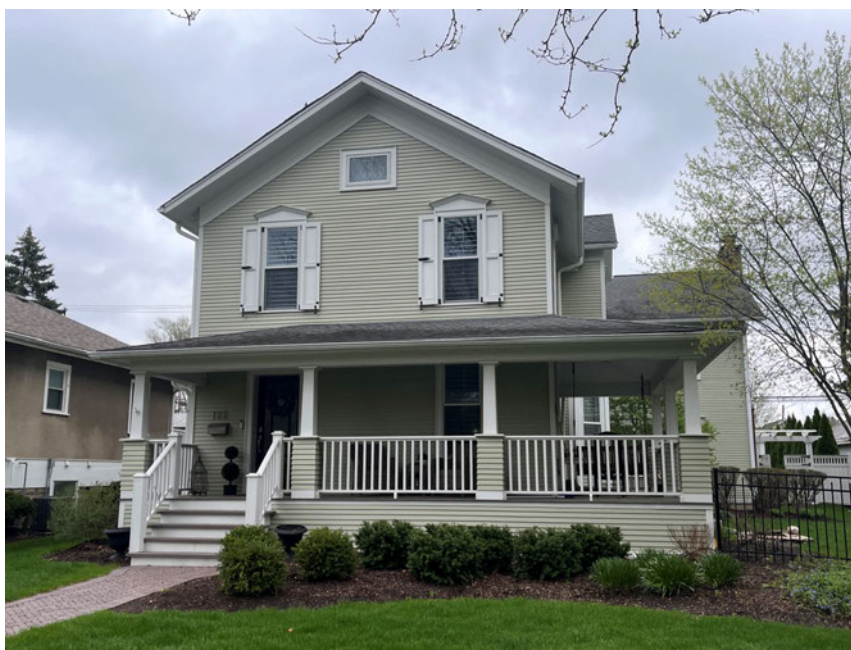
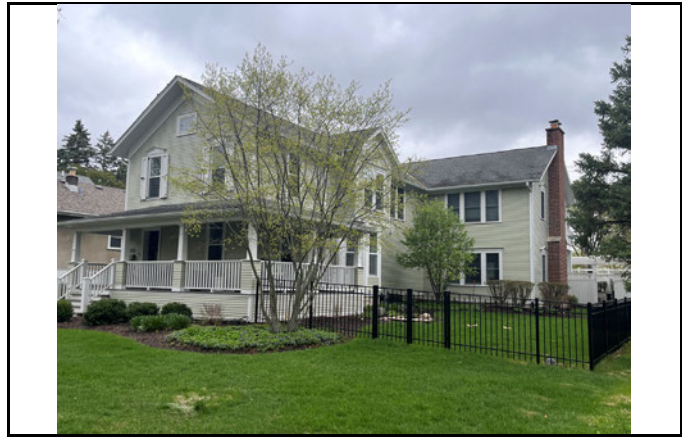
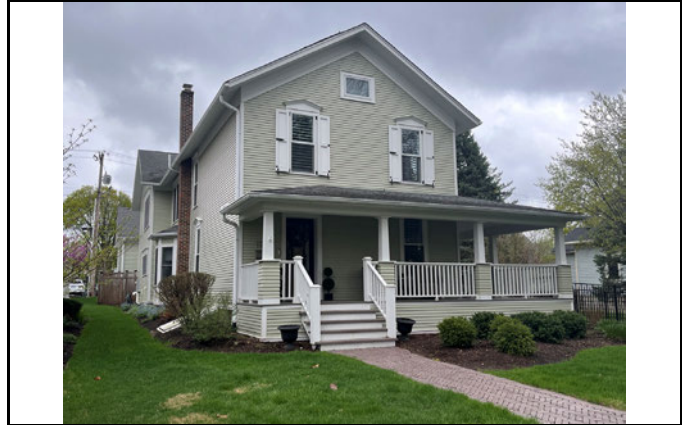
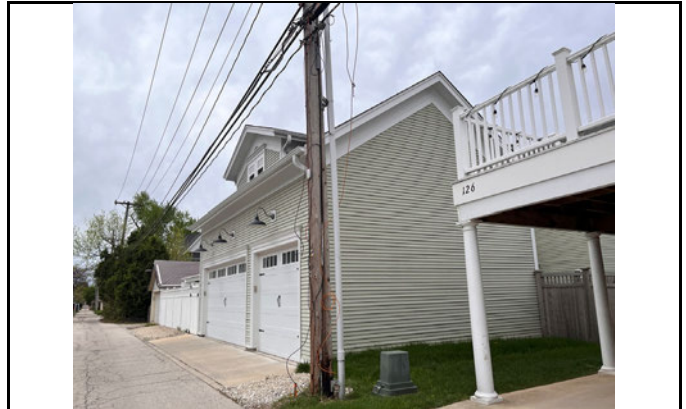
HISTORIC NAME	
COMMON NAME	
ARCHITECT	
BUILDER	
ARCHITECT SOURCE	
HISTORIC INFO	
PERMITS	
LANDSCAPE	Midblock on east side of residential street; large south side yard; rear alley; front sidewalk; mature trees
COA DATES	2/22/2018; 10/30/2023
COA DECISION	COA #23-4327 - Aluminum fence abutting front yard (approved 11/6/2023); COA #18-163 - variance for a detached garage (no COA approval in file; COA log indicates that the variance for the garage was approve, but does not provide a date).
COA Compliance Notes	
COA Work Not Completed	
Work Not Requiring COA	New detached garage

Shutters added to 2nd story windows at front façade.

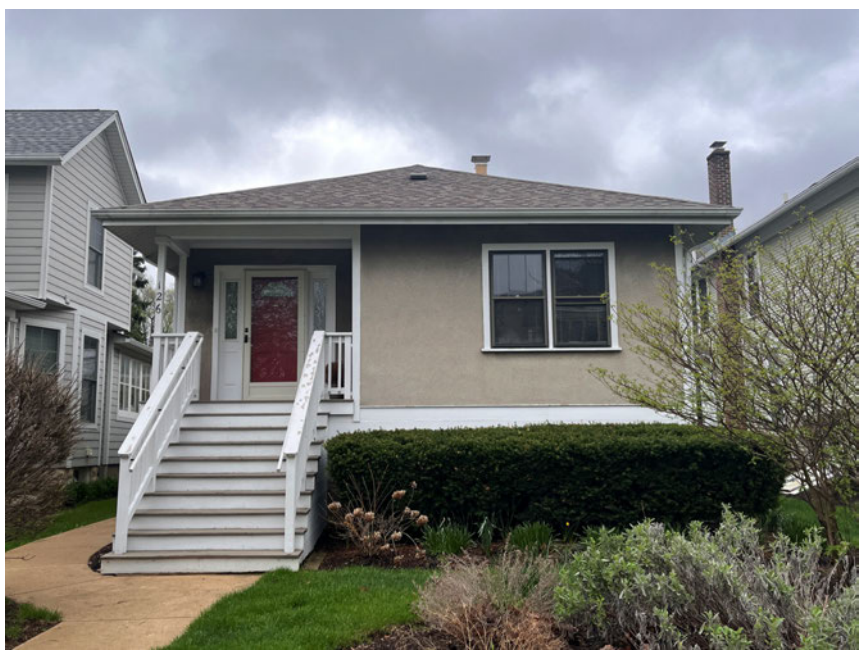
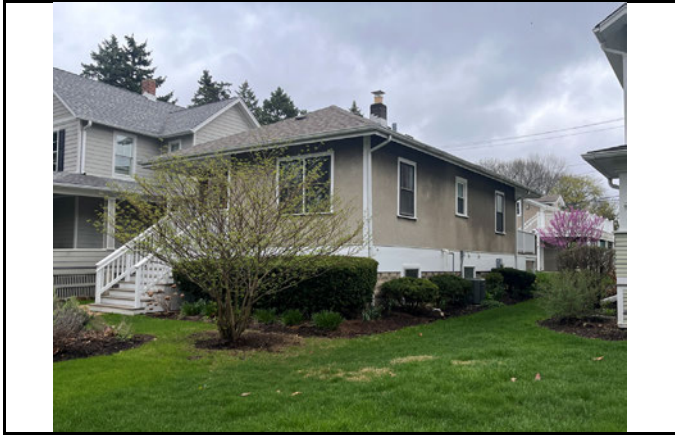
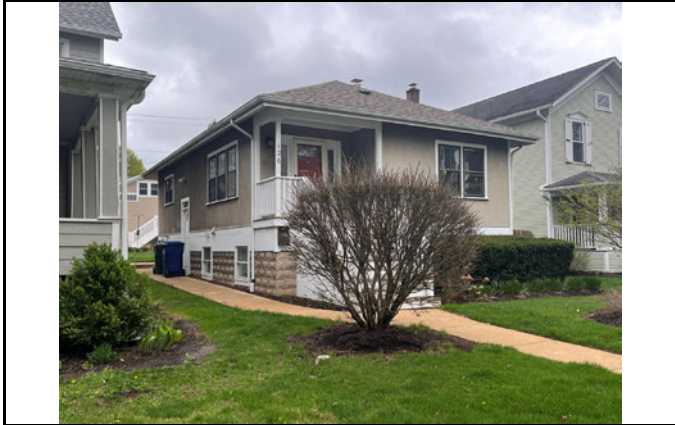
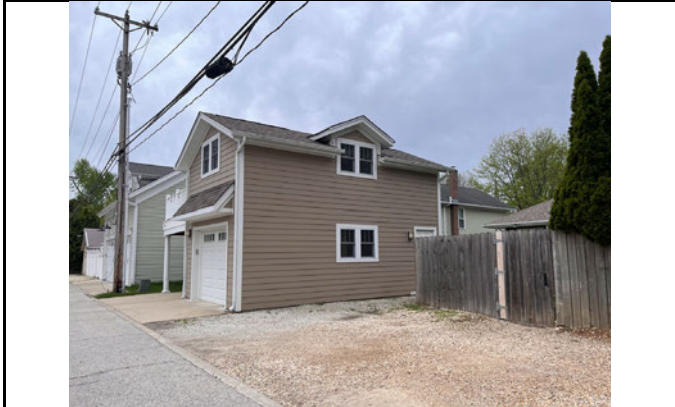
Non-historic turned porch supports and railings replaced with new square corner supports and squared wood railings (historically compatible)

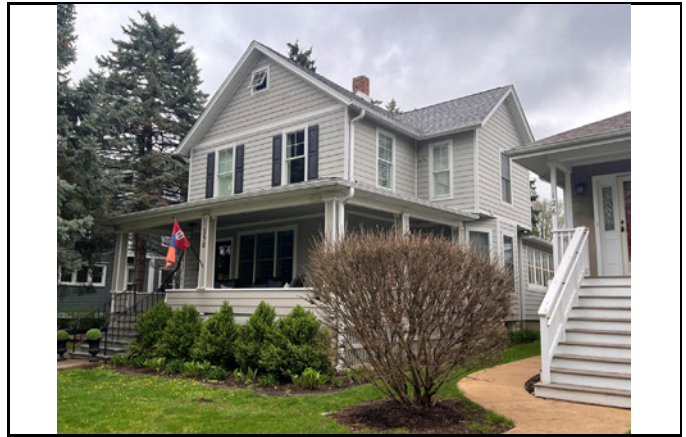
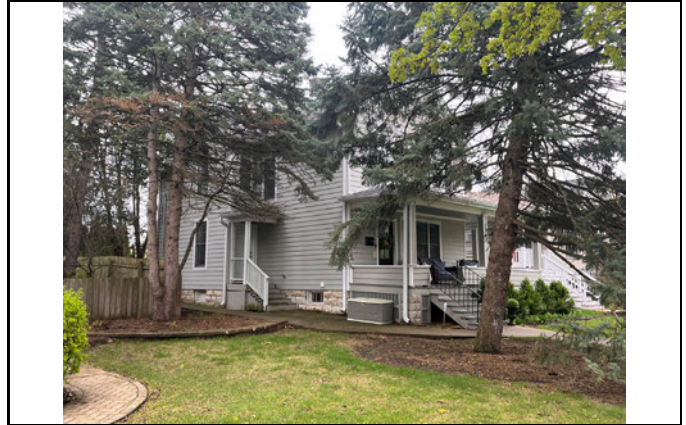
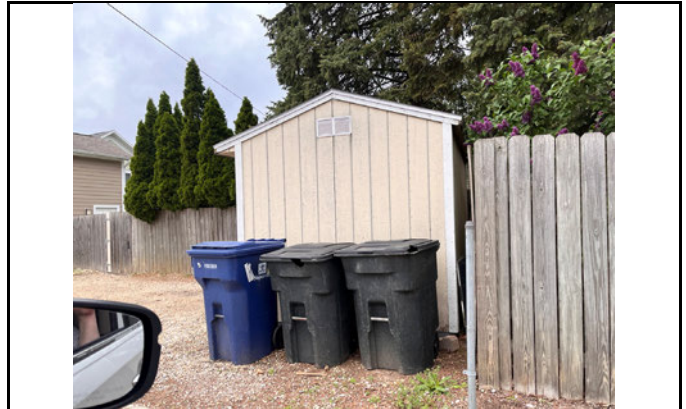
HISTORIC NAME	
COMMON NAME	
ARCHITECT	
BUILDER	
ARCHITECT SOURCE	
HISTORIC INFO	
PERMITS	1909 Sanborn Map (sheet 5) shows building with front and south side entry porches.
LANDSCAPE	Midblock on east side of residential street; front driveway; rear alley; similar setbacks; mature trees
COA DATES	11/17/2016
COA DECISION	COA #16-4282 - change in siding (approved by HPC 11/17/2016)
COA Compliance Notes	COA application was made before replacement siding was installed on all exterior elevations -- not clear if the new siding throughout was installed at this time.
COA Work Not Completed	
Work Not Requiring COA	Replacement siding on south and north secondary elevations; replacement windows on south and north elevations

Work Completed Without COA aluminum siding replaced with wider siding on front façade; 4/1 replacement windows on front façade; 4-light window in new opening under front gable; replacement front door; replacement shutters on front façade.

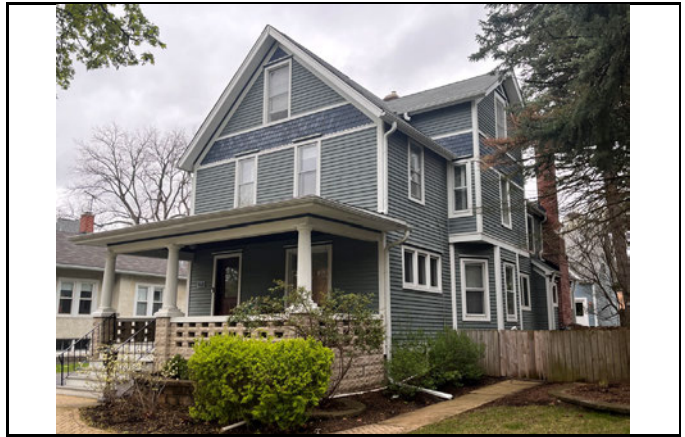
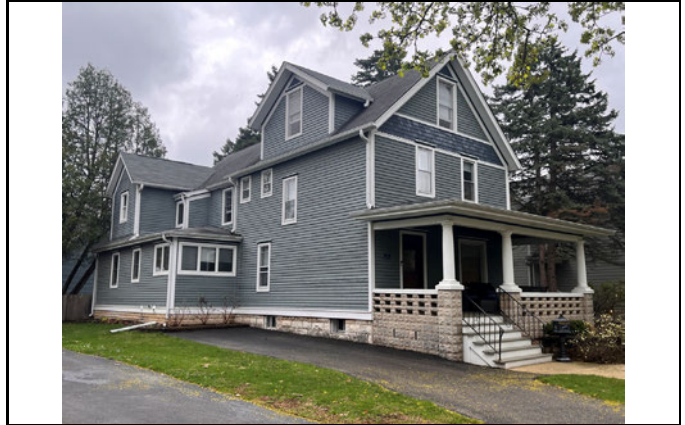
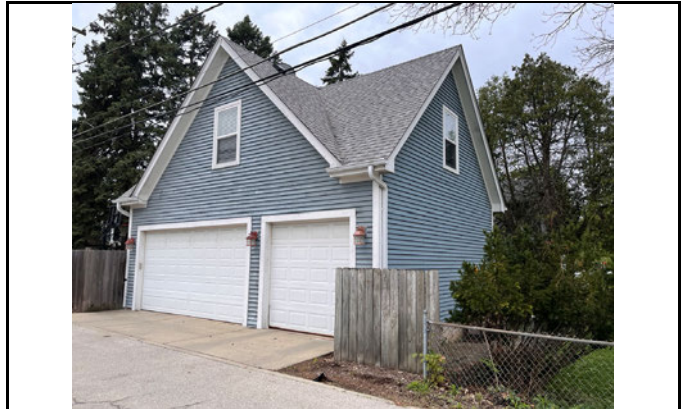
HISTORIC NAME	
COMMON NAME	
ARCHITECT	
BUILDER	
ARCHITECT SOURCE	
HISTORIC INFO	
PERMITS	
LANDSCAPE	Midblock on east side of residential street; front sidewalk; rear fence; side driveway; large south side yard; mature trees
COA DATES	1/1/2013; 7/26/2012
COA DECISION	COA #13-0043 - Siding replacement with cedar (approved 1/7/2013); COA #12-2346 - additions (approved by HPC 7/26/2012)
COA Compliance Notes	
COA Work Not Completed	
Work Not Requiring COA

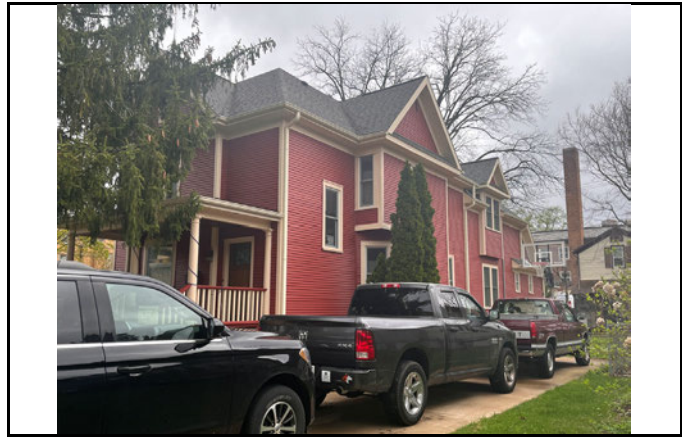
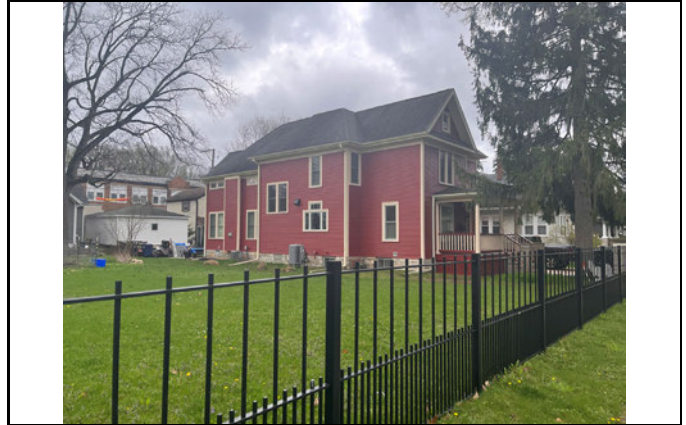
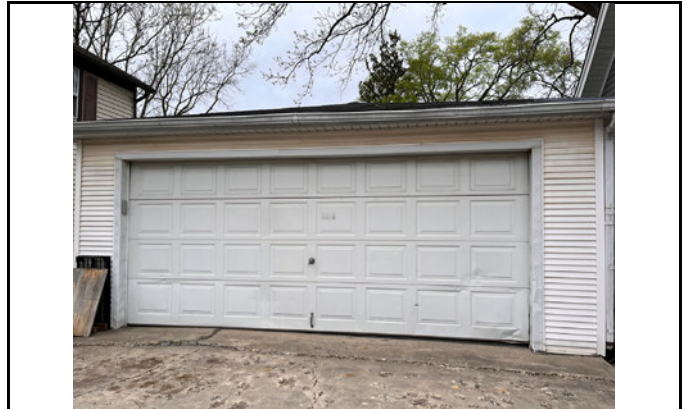
HISTORIC NAME	
COMMON NAME	
ARCHITECT	
BUILDER	
ARCHITECT SOURCE	
HISTORIC INFO	
PERMITS	
LANDSCAPE	Midblock on east side of residential street; front sidewalk; partial side driveway; rear alley; similar setbacks; mature trees
COA DATES	7/21/2010; 8/28/2010; 4/21/2023; 5/25/2023
COA DECISION	COA #10-2000 - In-kind replacement of ceiling, deck and steps of the front porch. (approved 7/21/2010); COA #10-2215 - Front porch remodeling (approved 8/26/2010), In-kind replacement of the roof and skirting of the front porch (approved 8/18/2010); COA #23-1003 - In-kind replacement of porch cedar porch railings and replacement of porch floor with wood-look composite floor material (approved 5/1/2023); COA #23-1004 - Change in material for front porch stairs (approved 5/25/23)
COA Compliance Notes	
COA Work Not Completed	
Work Not Requiring COA

Replacement front door.

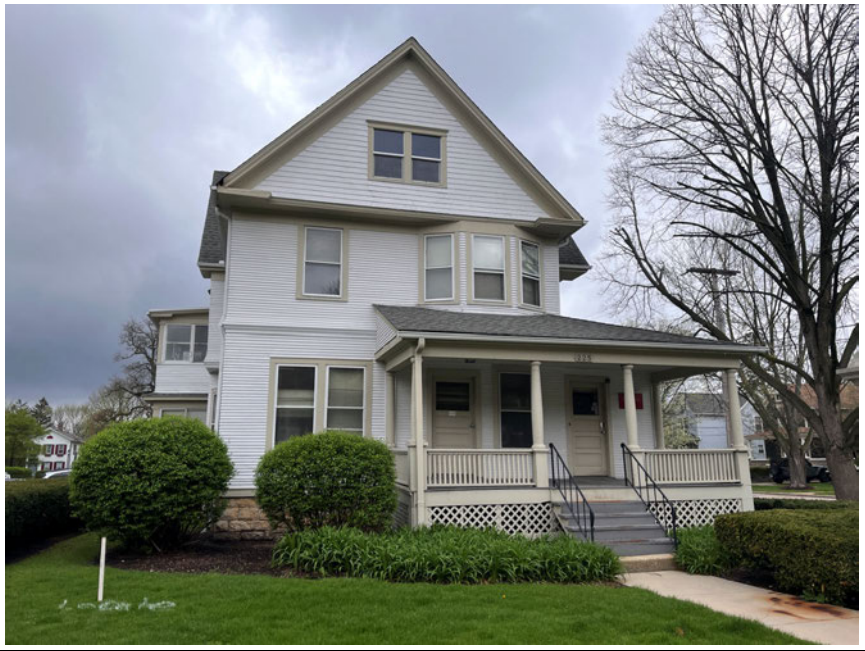
ALTERATIONS 1/1 windows are historic but not original; one-story northeast corner addition with second entrance (1950s); front porch extended north (1950s); south porch enclosed (1950s); second-story addition over south porch (1950s); basement window boarded. Post-2007 -- exterior stair at east west end of south elevation removed, doorway replaced with boarded window opening.

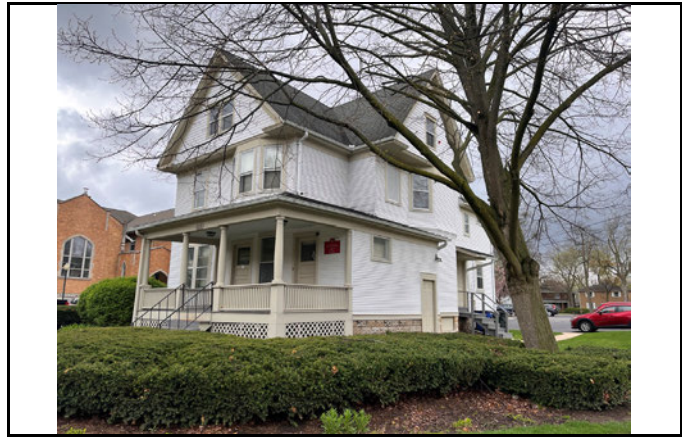
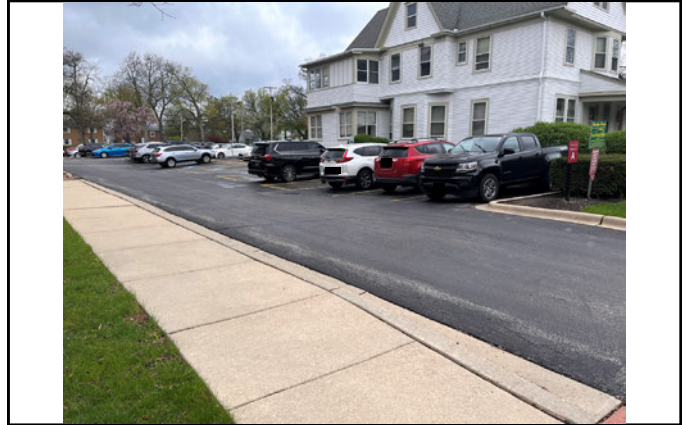
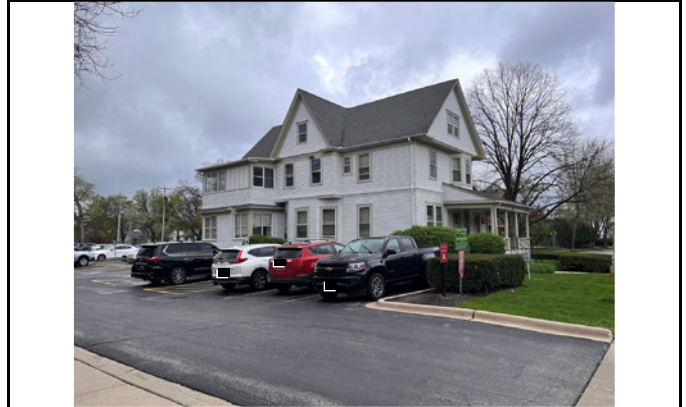
HISTORIC NAME	
COMMON NAME	NCC History/Religion/Philosophy Office
ARCHITECT	
BUILDER	
ARCHITECT SOURCE	
HISTORIC INFO	Building was acquired by NCC from the Evangelical Theological Seminary in 1976.
PERMITS	
LANDSCAPE	Southwest corner of North and Loomis; front and north sidewalks; rear parking lot; similar setbacks; mature trees
COA DATES	
COA DECISION	
COA Compliance Notes	
COA Work Not Completed	
Work Not Requiring COA	Exterior stair at east west end of south elevation removed, doorway replaced with boarded window opening.

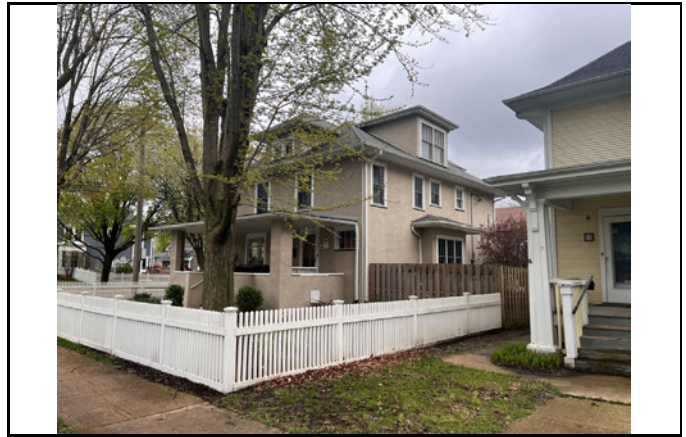
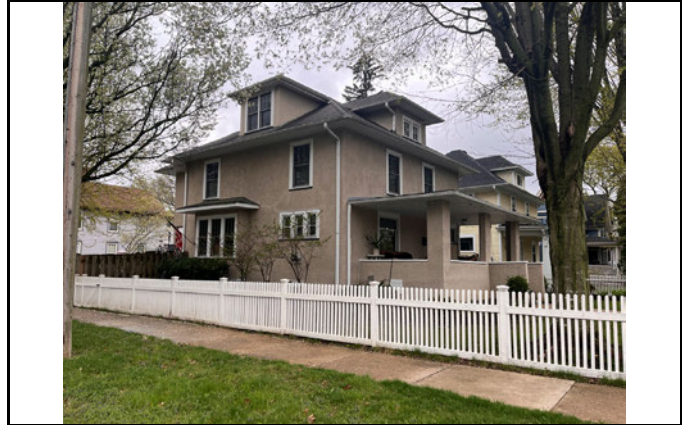
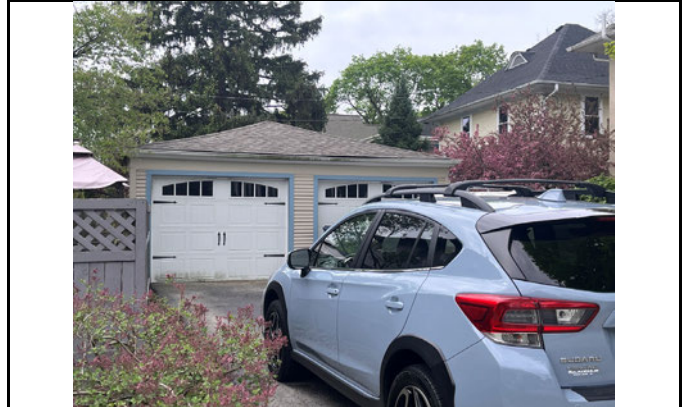
HISTORIC NAME	Wagner, Benjamin C. House
COMMON NAME	
ARCHITECT	
BUILDER	Wagner, Benjamin C.
ARCHITECT SOURCE	
HISTORIC INFO	
PERMITS	
LANDSCAPE	Southeast corner of Benton and Loomis; front and north sidewalks; rear driveway; similar setbacks; mature trees; rear wood fence
COA DATES	4/24/2008 (amended 4/24/2009 and 7/2/2009)
COA DECISION	HSC #08-07 - two-story rear addition with porch; north and south dormer additions; south window bay addition; COA 09-2555 -- COA #09-2555 - 6' tall privacy fence parallel to Loomis Street and Benton Avenue (extension granted 2/11/11)
COA Compliance Notes	
COA Work Not Completed	
Work Not Requiring COA	Windows on secondary north and south elevations appear to be historically compatible replacement windows.

Work Completed Without COA porch enclosure (1/1 windows) removed; 3/1 windows on front façade appear to be replacement windows in original openings (historically compatible type and configuration)

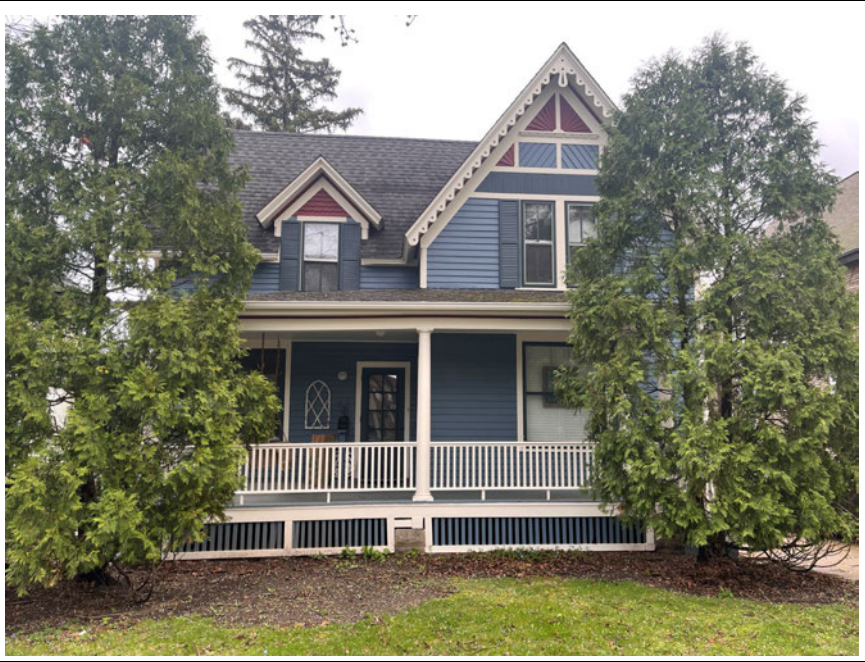
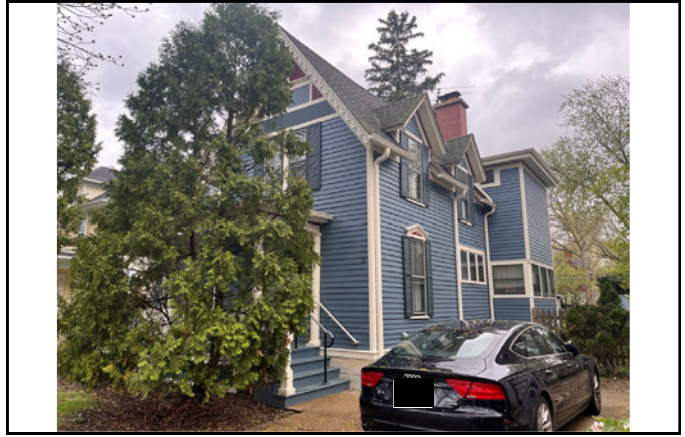
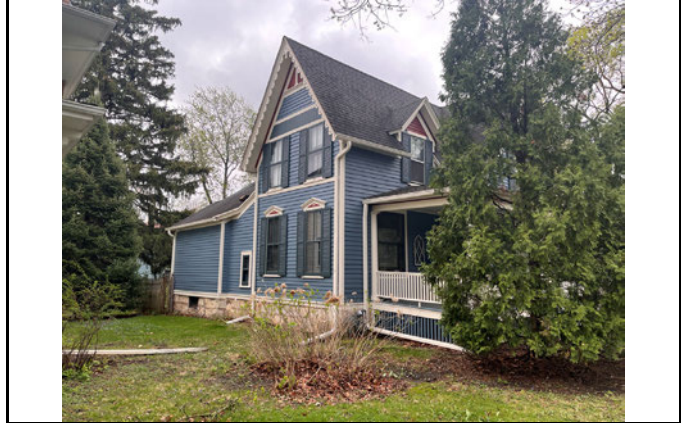
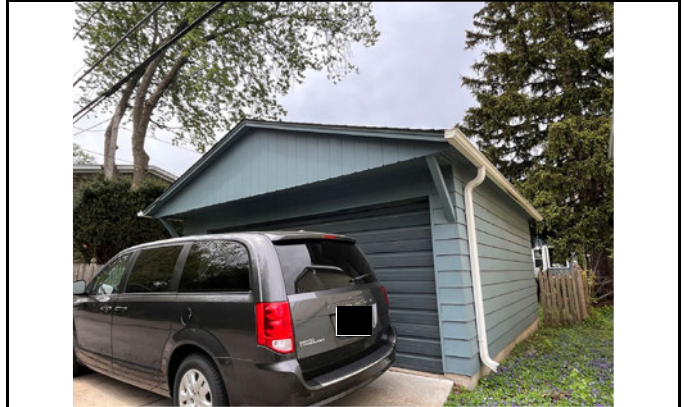
HISTORIC NAME	Saylor, Jacob House
COMMON NAME	
ARCHITECT	
BUILDER	
ARCHITECT SOURCE	
HISTORIC INFO	
PERMITS	
LANDSCAPE	Midblock on east side of residential street; front sidewalk; rear alley; similar setbacks; mature trees
COA DATES	
COA DECISION	
COA Compliance Notes	
COA Work Not Completed	
Work Not Requiring COA

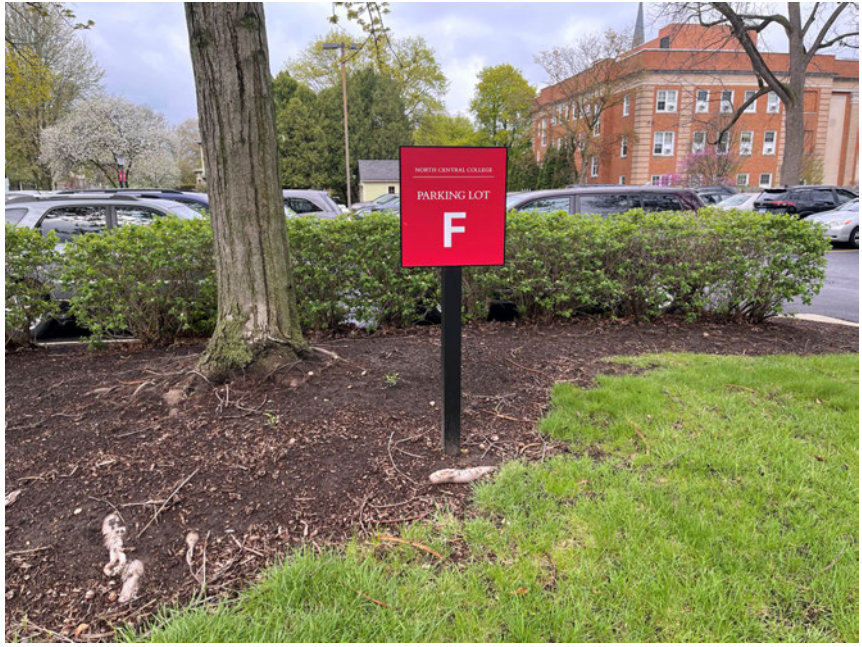
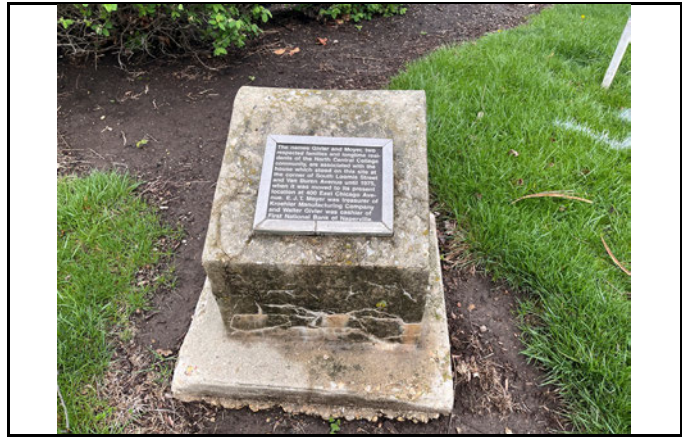
HISTORIC NAME	
COMMON NAME	NCC -- Parking Lot
ARCHITECT	
BUILDER	
ARCHITECT SOURCE	
HISTORIC INFO	Former site of house belonging to E. S. Moyer, treasurer of Kroehler Manufacturing Company, & Walter Givler, cashier at First Nat'l Bank of Naperville. House moved to 400 E. Chicago in 1975.
PERMITS	
LANDSCAPE	
COA DATES	
COA DECISION	
COA Compliance Notes	
COA Work Not Completed	
Work Not Requiring COA

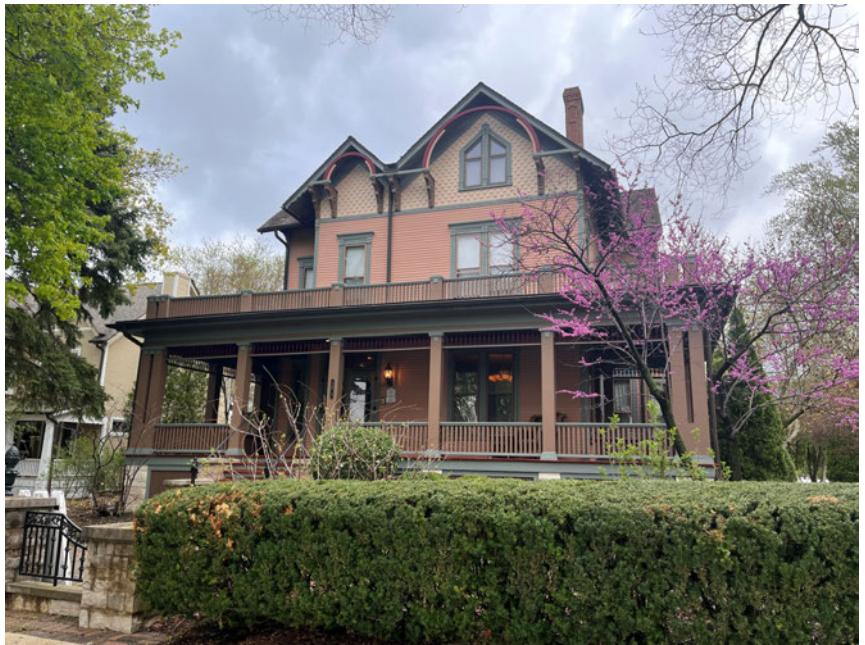
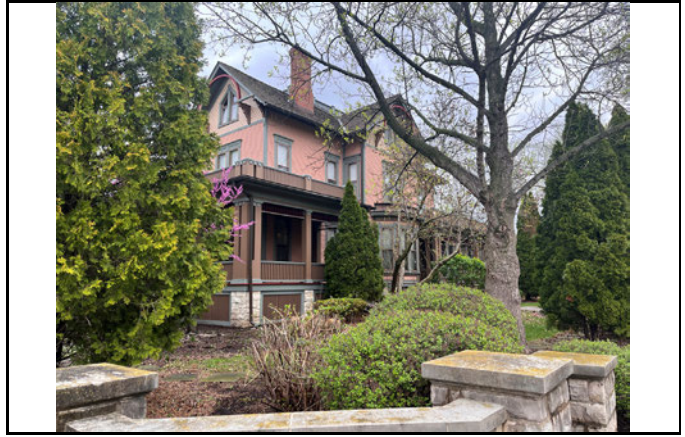
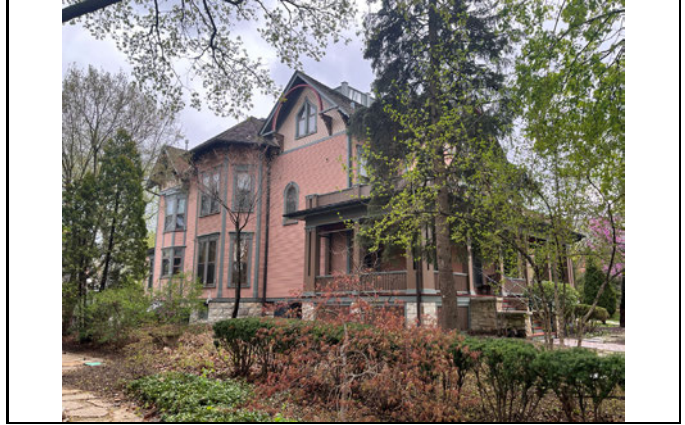
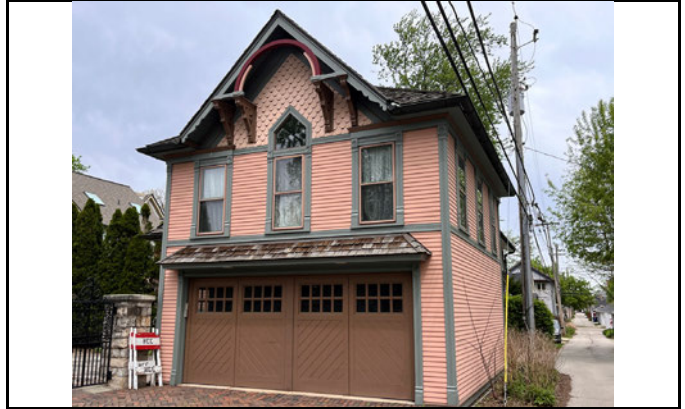
HISTORIC NAME	Smith, A. A. House
COMMON NAME	
ARCHITECT	
BUILDER	
ARCHITECT SOURCE	
HISTORIC INFO	Smith was the first president of North Central College
PERMITS	1892 and 1898 Sanborn Maps show house without any front porch. 1909 Sanborn is first to show wraparound front porch.
LANDSCAPE	Northeast corner of Van Buren and Loomis; front and south sidewalks; rear driveway/alley; stone gate posts; similar setbacks; mature trees
COA DATES	
COA DECISION	
COA Compliance Notes	
COA Work Not Completed	
Work Not Requiring COA

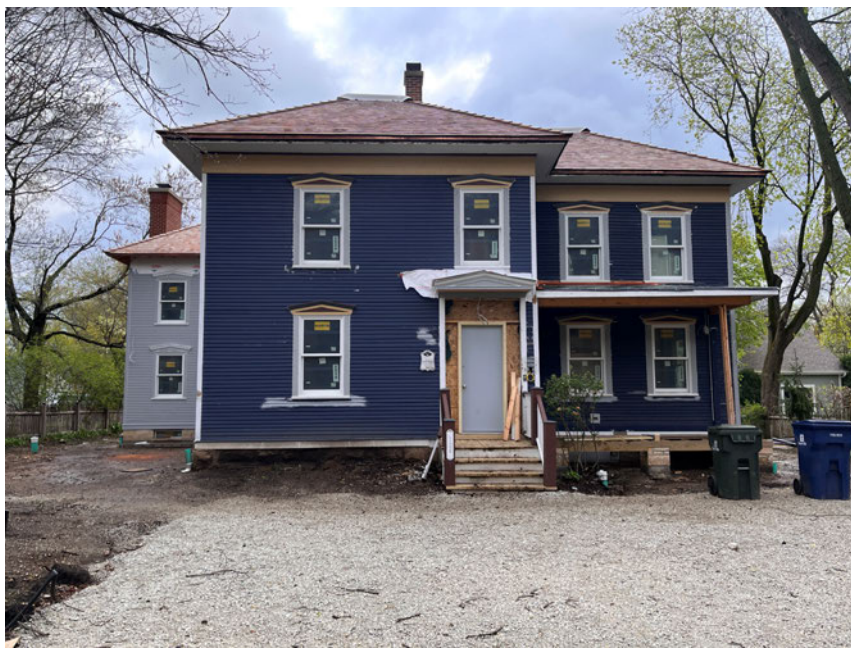
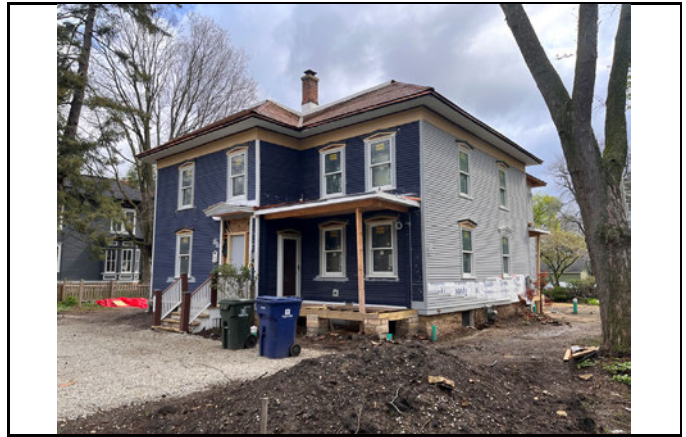
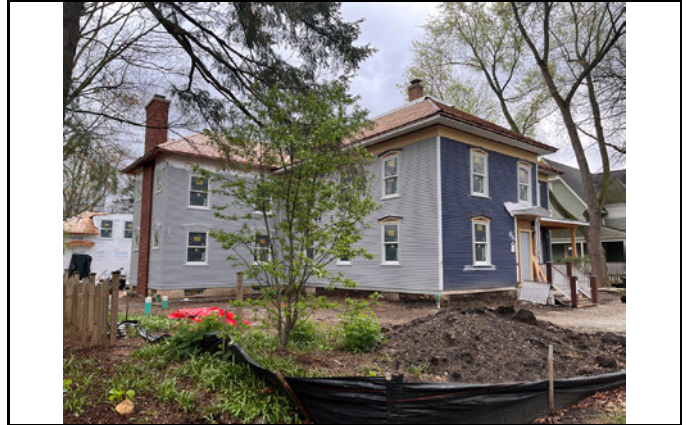
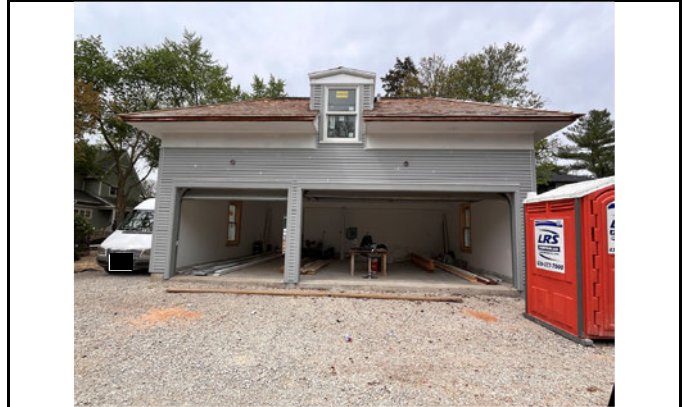
ARCHITECTURAL CLASSIFICATION	<input type="text" value="Italianate"/>	PLAN	<input type="text" value="L"/>
DETAILS	<input type="text"/>	NO OF STORIES	<input type="text" value="2"/>
BEGINYEAR	<input type="text" value="1870"/>	ROOF TYPE	<input type="text" value="Hipped"/>
OTHER YEAR	<input type="text"/>	ROOF MATERIAL	<input type="text" value="Asphalt - shingle"/>
DATESOURCE	<input type="text" value="NHS Plaque"/>	FOUNDATION	<input type="text" value="Stone"/>
WALL MATERIAL (current)	<input type="text" value="Wood"/>	PORCH	<input type="text" value="-"/>
WALL MATERIAL 2 (current)	<input type="text"/>	WINDOW MATERIAL	<input type="text" value="Aluminum"/>
WALL MATERIAL (original)	<input type="text" value="Wood"/>	WINDOW MATERIAL	<input type="text"/>
WALL MATERIAL 2 (original)	<input type="text"/>	WINDOW TYPE	<input type="text" value="double hung"/>
		WINDOW CONFIG	<input type="text" value="1/1"/>

HISTORIC NAME	Sleight, Julian House
COMMON NAME	
ARCHITECT	
BUILDER	
ARCHITECT SOURCE	
HISTORIC INFO	
PERMITS	
LANDSCAPE	Midblock on east side of residential street; front sidewalk; rear alley; picket fence; similar setbacks; mature trees
COA DATES	3/28/2024
COA DECISION	COA #24-0533 - two-story addition to a secondary façade that is visible from the right-of-way, a new covered front porch, new entryway roof, and removal of the existing fireplace chimney on the principal structure. (Approved by HPC 3/28/2024)
COA Compliance Notes	Construction for work covered in COA #24-0533 currently underway.
COA Work Not Completed	
Work Not Requiring COA

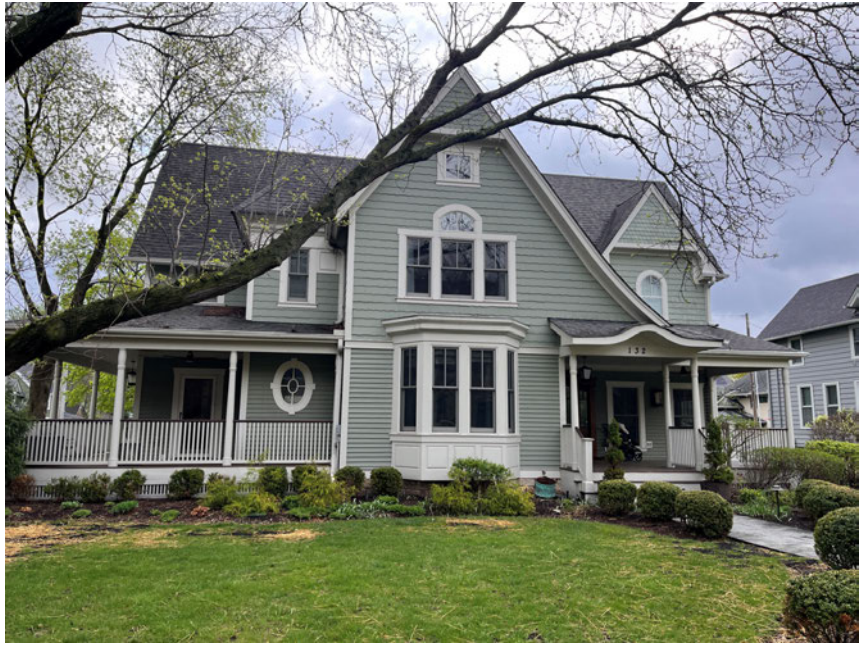
STREET # 132
 DIRECTION S
 STREET LOOMIS
 SUFFIX ST
 PIN 0818321004
 LOCAL SIGNIFICANCE RATING NC
 POTENTIAL IND NR? (Y or N) N
 Contributing to a NR DISTRICT? NC
 Contributing secondary structure? -
 Listed on existing SURVEY? Local District; NR District

CATEGORY building HISTORIC FUNCTION Domestic - single dwelling
 CONDITION construction REASON for SIGNIFICANCE
 INTEGRITY major alterations and/or addition(s)
 SECONDARY STRUCTURE -

ALTERATIONS Original house completely obscured by extensive alterations and additions currently underway—roofline raised and altered; front gable bay extended to south, with new south end porch/entry door; gable at south end of façade is new; north end porch extended; tower north of front gable bay shortened and entry door at base of tower replaced with window; replacement siding; replacement windows in altered openings; front three-sided window bay altered (new windows, new cornice, paneling below); 2-story rear addition. Post - 2007 -- no changes.

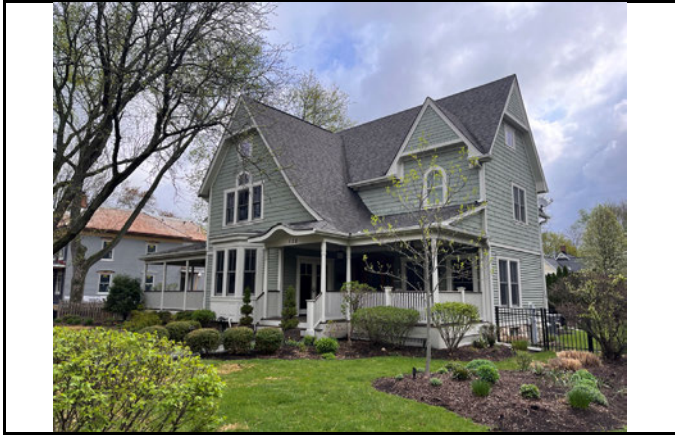
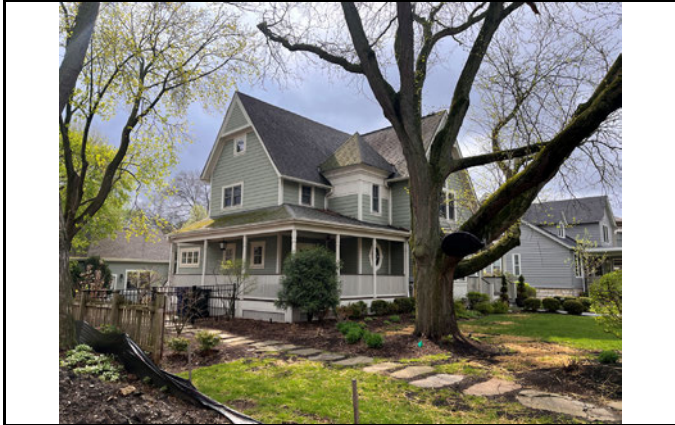
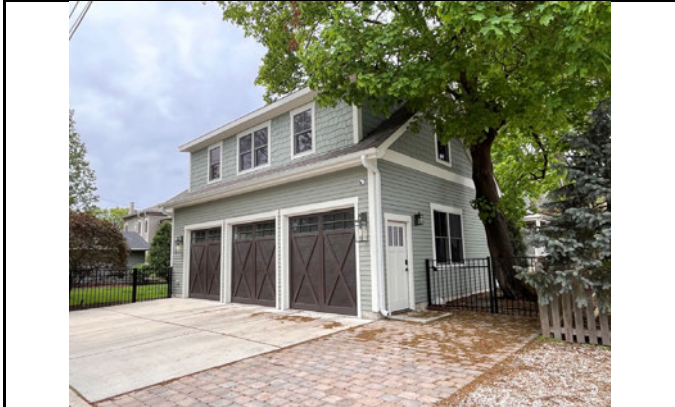
ARCHITECTURAL CLASSIFICATION No style (altered) PLAN irregular
 DETAILS NO OF STORIES 2.5
 BEGINYEAR c. 1880 ROOF TYPE Multi-gable
 OTHER YEAR 2007 ROOF MATERIAL Asphalt - shingle
 DATESOURCE Surveyor/Title FOUNDATION Stone
 WALL MATERIAL (current) Wood PORCH Front/Wraparound
 WALL MATERIAL 2 (current) WINDOW MATERIAL Aluminum Clad
 WALL MATERIAL (original) Wood WINDOW MATERIAL
 WALL MATERIAL 2 (original) WINDOW TYPE Double hung/awning
 WINDOW CONFIG 2/1 vertical; 2-light
