SURVEYDATE 11/13/2025

ORGANIZATION RAMSEY HISTORIC CONSULTANTS

SURVEYAREA NAPERVILLE SURVEY UPDATE

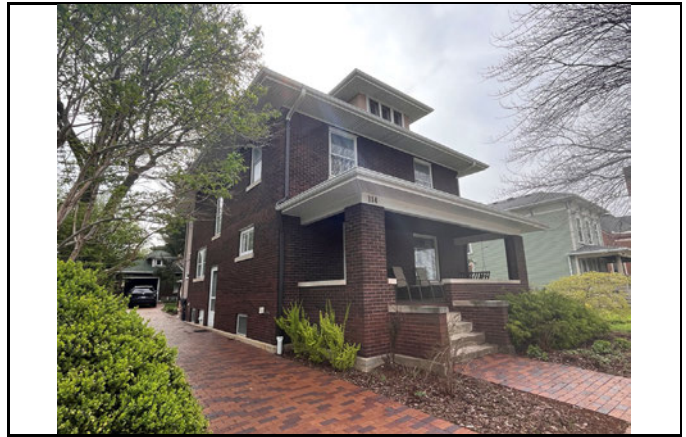
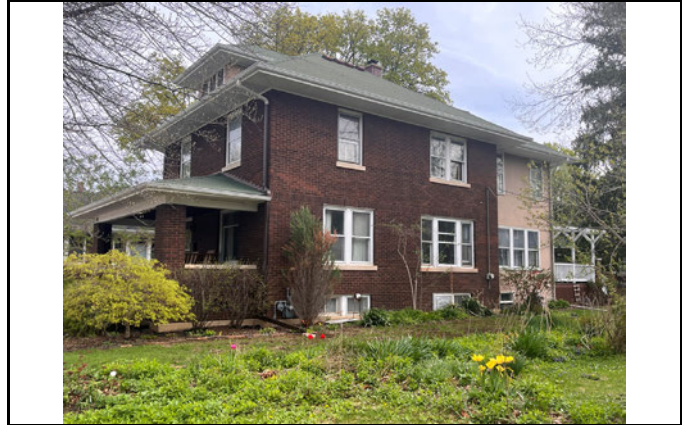
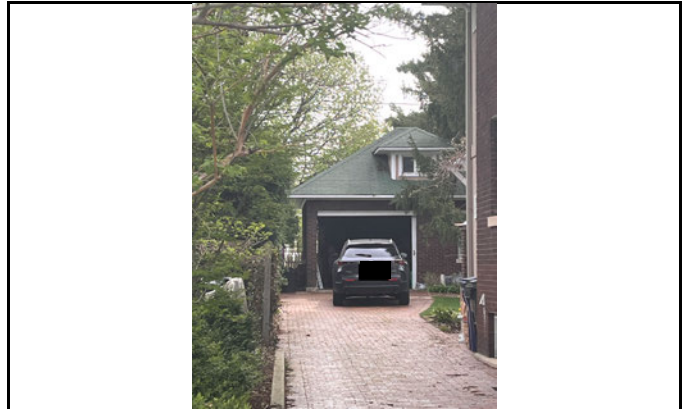
Work Completed Without COA

Aluminum siding installed under eaves

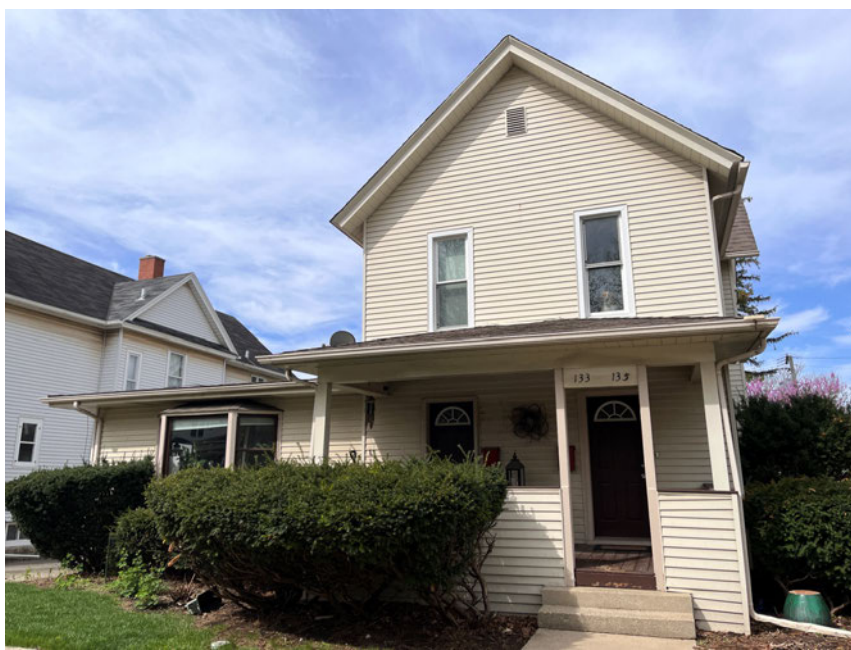
ALTERATIONS One story south addition (historic); Aluminum siding; replacement front porch (may be historic); two entry doors (non-historic); one story rear addition with below-grade garage (not historic). Post-2007 -- no changes.

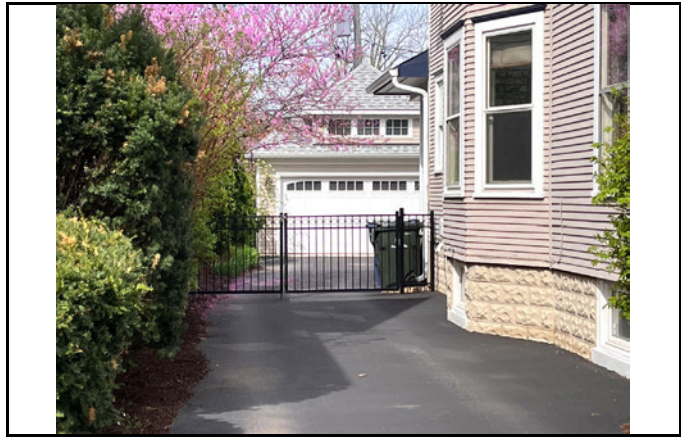
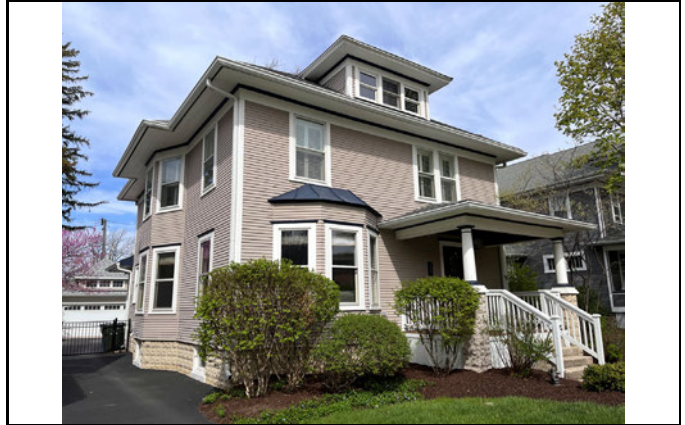
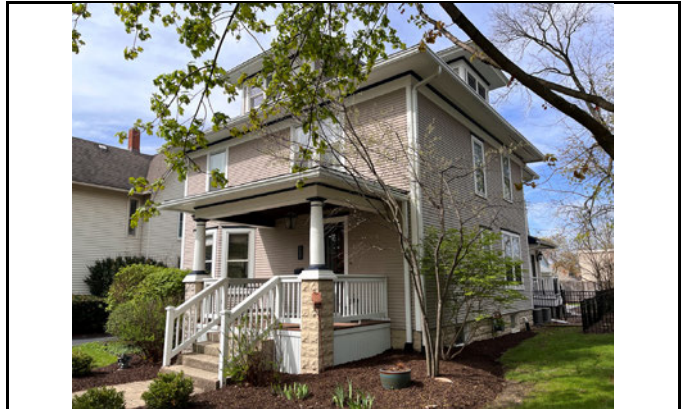
Work Completed Without COA	Porch railing replacement (historically compatible)
-----------------------------------	-----------------------------------------------------

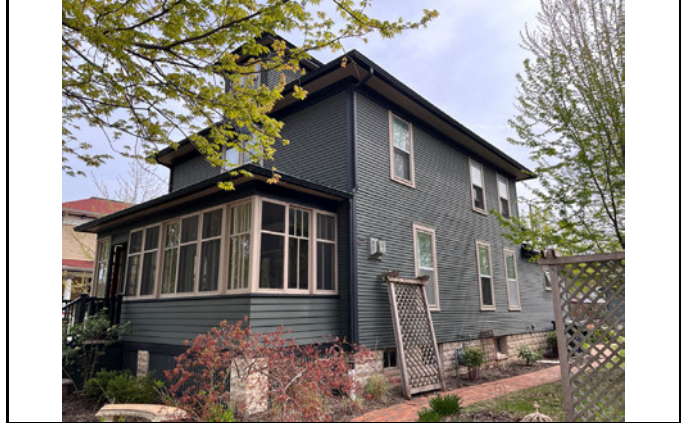
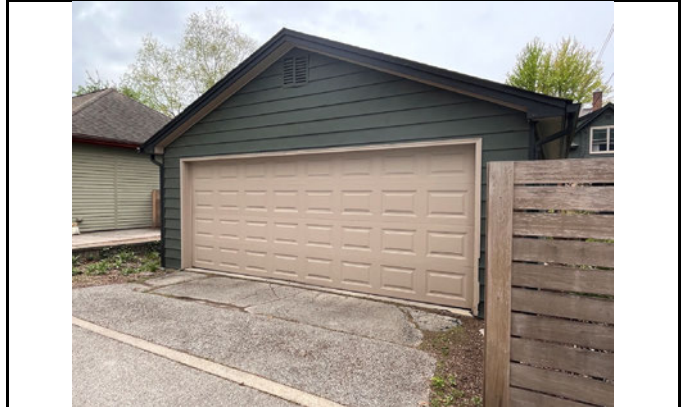
Work Completed Without COA

Two windows in front dormer replaced with 1/1 windows in downsized openings.

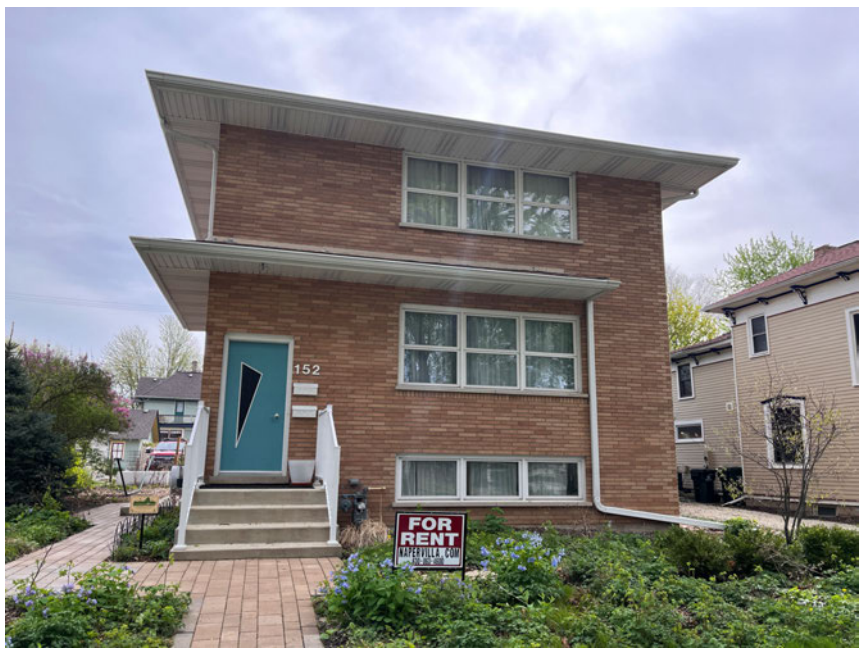
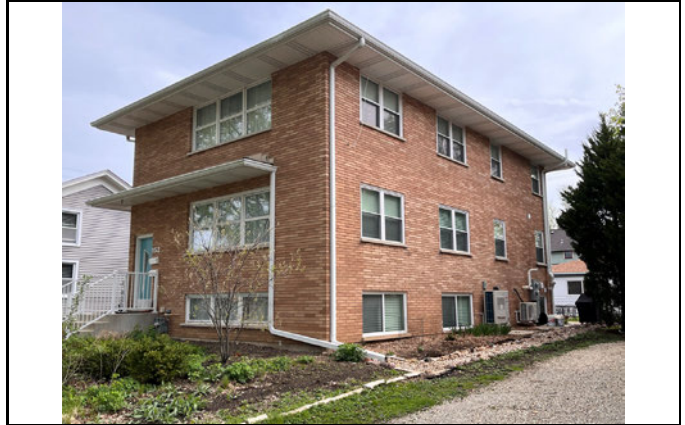
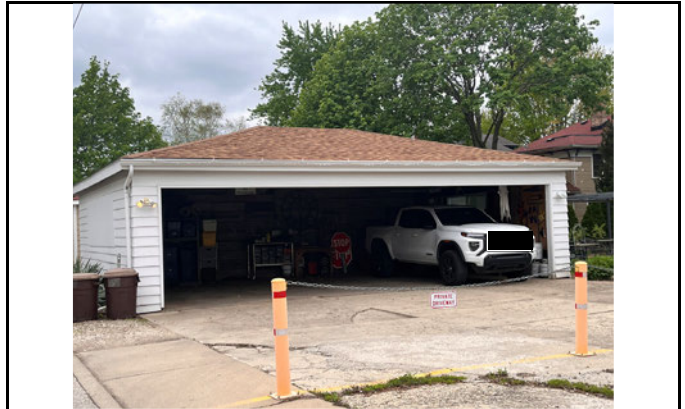
Metal railing at front steps; replacement front door (historically compatible).

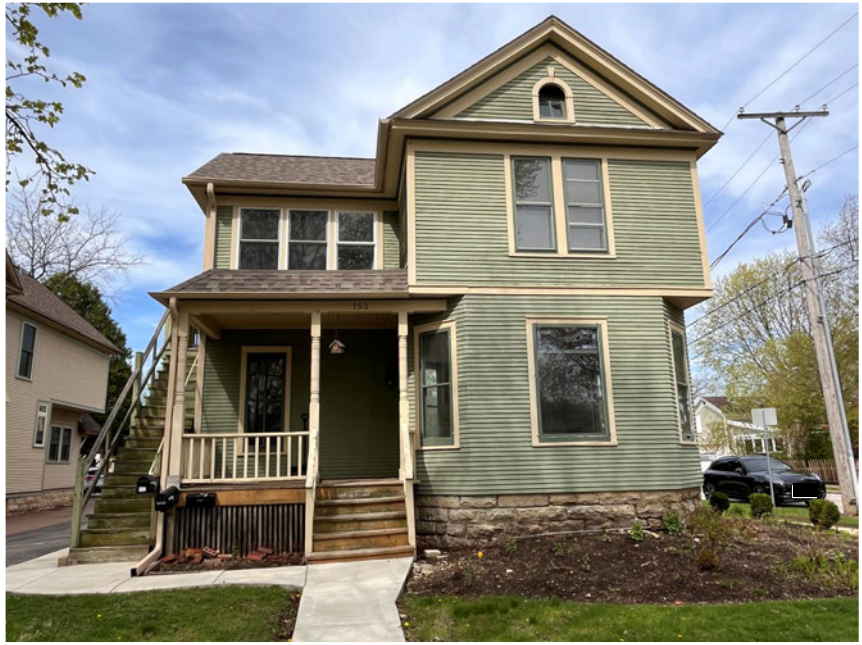
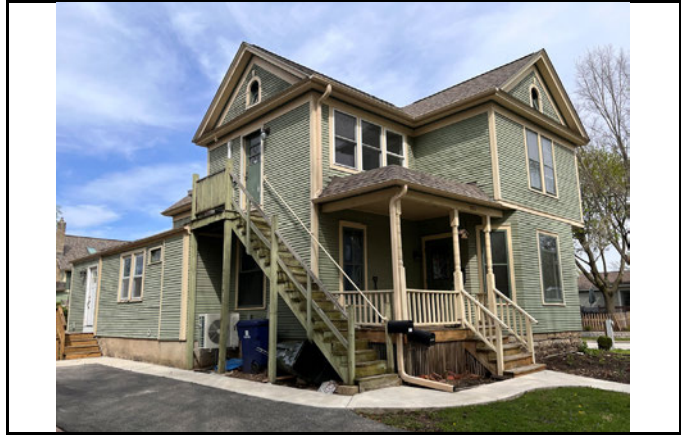
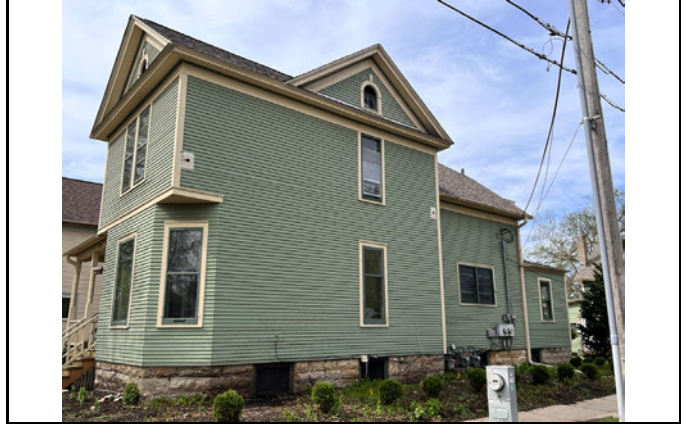
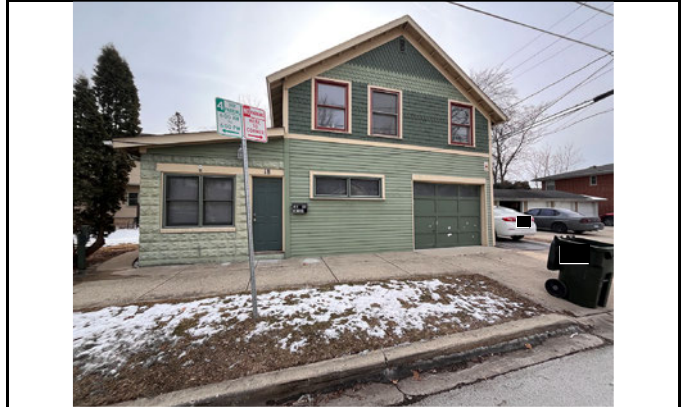
ALTERATIONS Replacement windows on 2nd story of south bay (not historic); door w/ exterior stair added to south bay (not historic) ; replacement porch (does not appear to be historic); 1 story south addition; two and one-story rear additions (historic); stained glass in front window does not appear to be historic. Post-2007 -- asphalt-shingle roof replaced in kind.

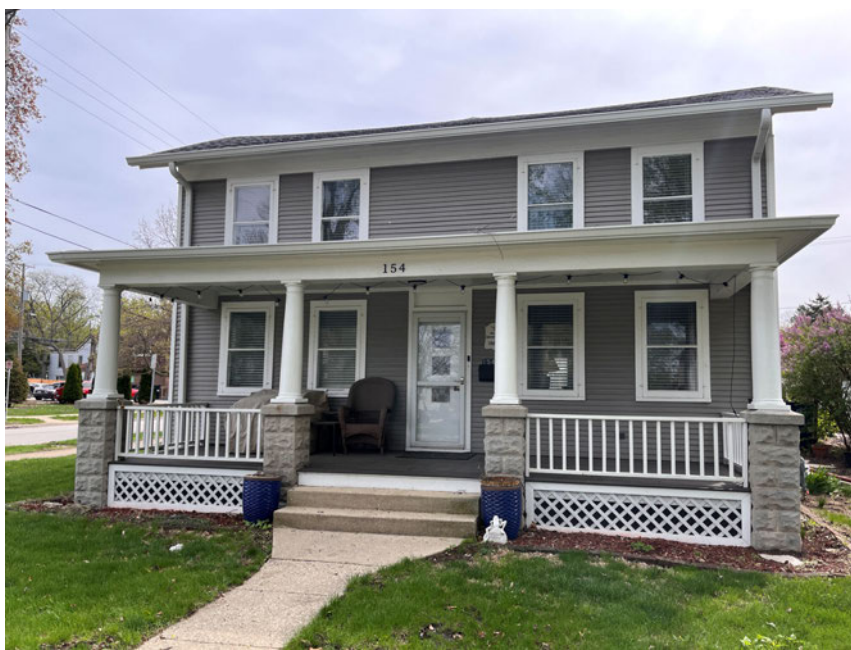
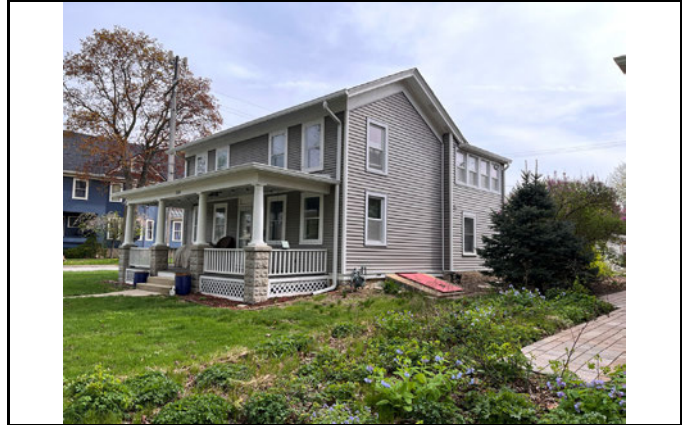
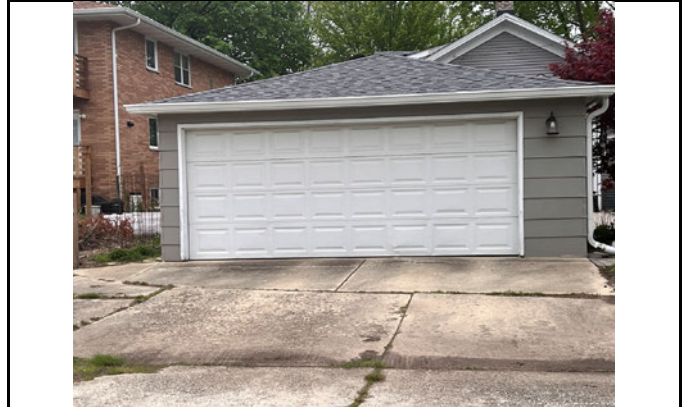
Replacement windows on street-facing north elevation (historically compatible); replacement door and stoop at north entrance.

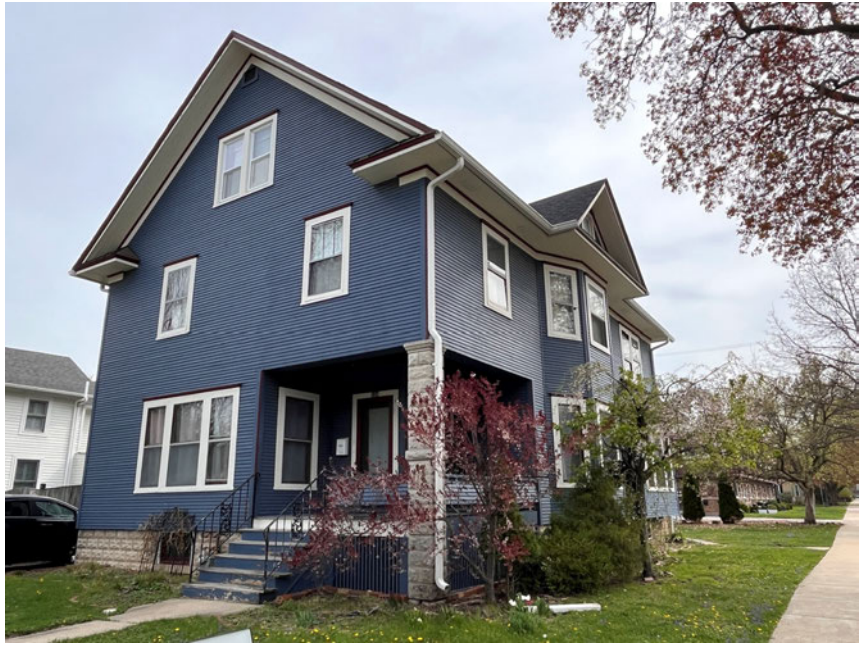
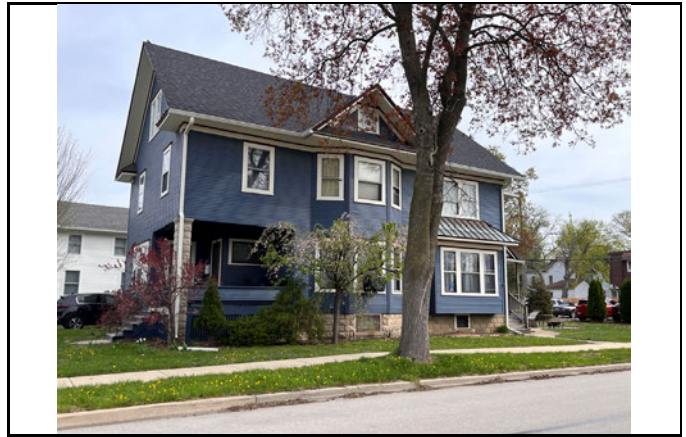
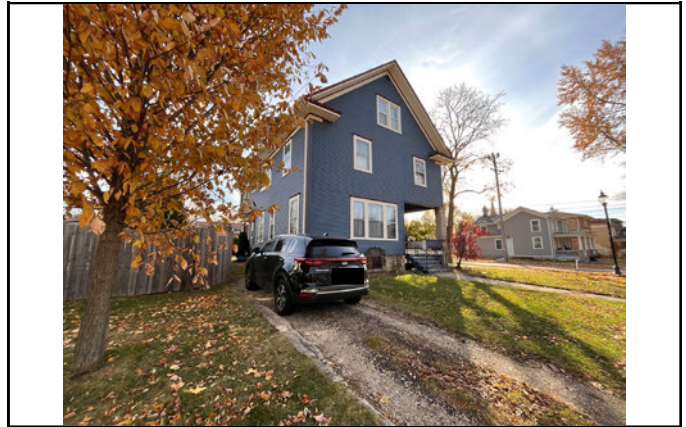
ALTERATIONS 3/1 wood replacement windows in original openings (historic); 2 story enclosed rear porch (historic); metal seam roofing on front cornice returns and south window bay (not historic). Post-2007 -- no changes.

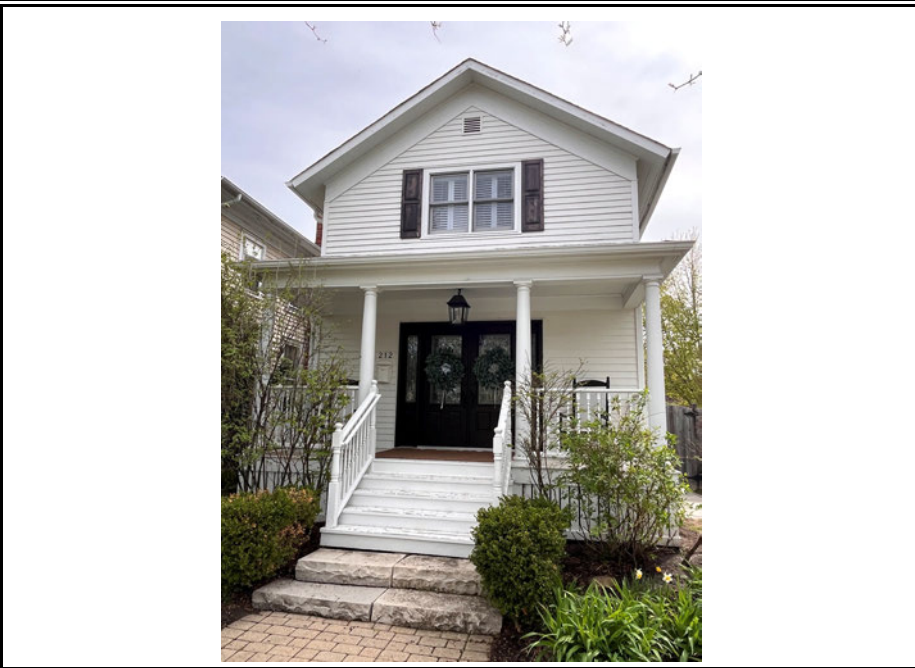
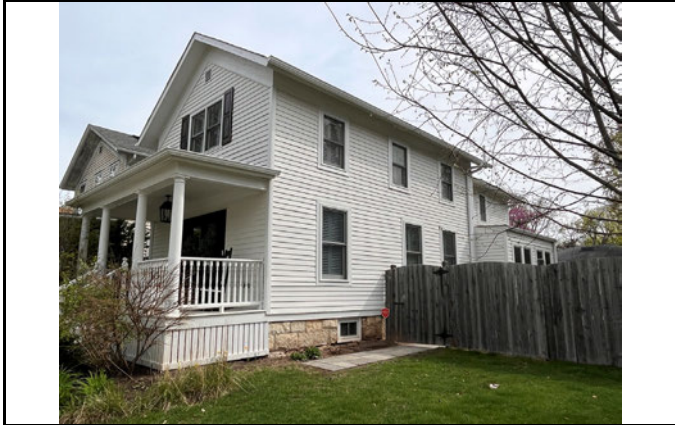
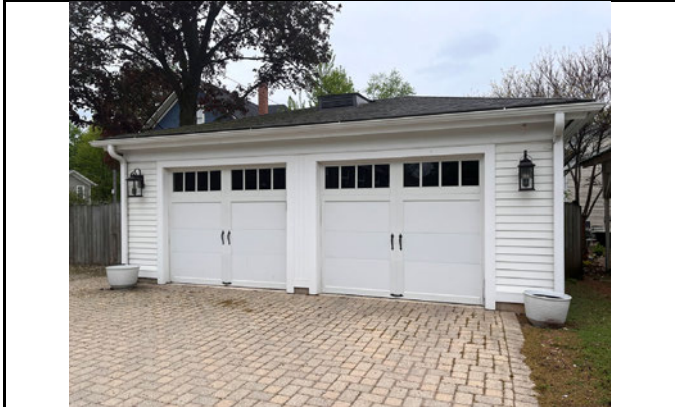
Work Completed Without COA Solid porch knee wall replaced with turned wood railing; front door removed and center window under porch converted to main entrance and fitted with double-leaf door and sidelights; decorative shutters added to 2nd-story window opening on front façade

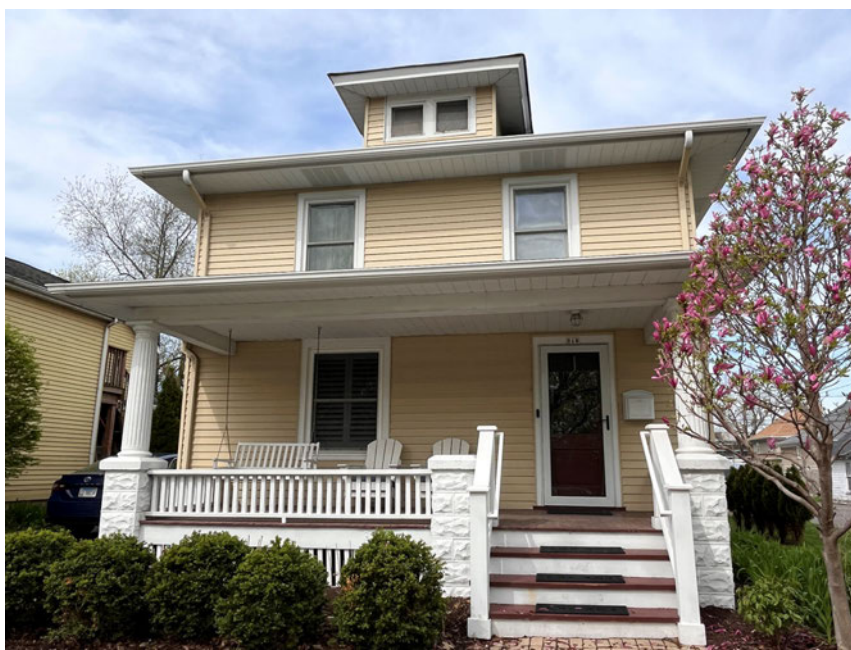
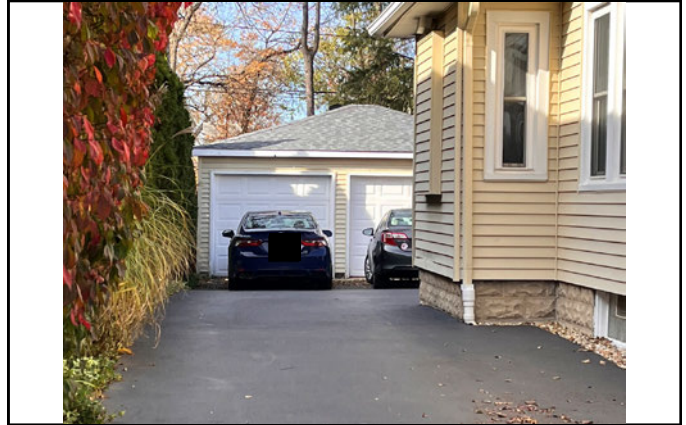
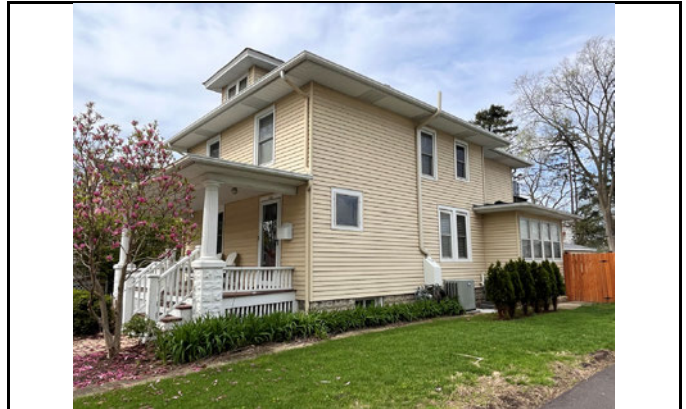
2nd-story replacement windows in original openings; railing replacement at porch steps
