| STREET # | 5 |
| STREET | COLUMBIA |
| PIN | 0818403007 |

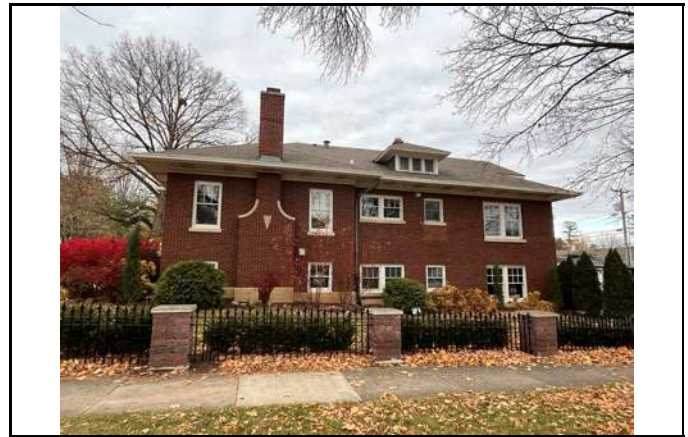
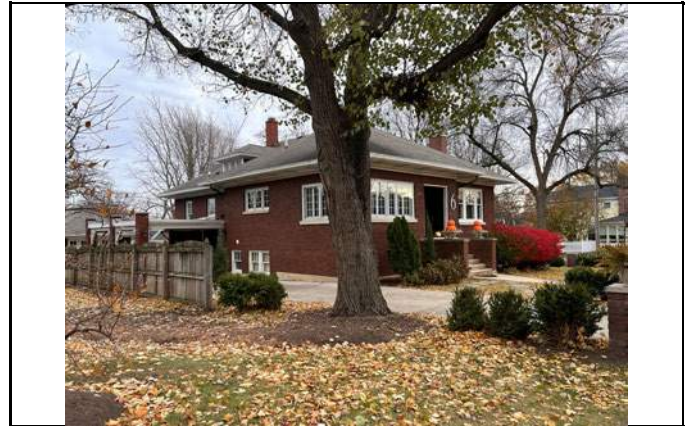
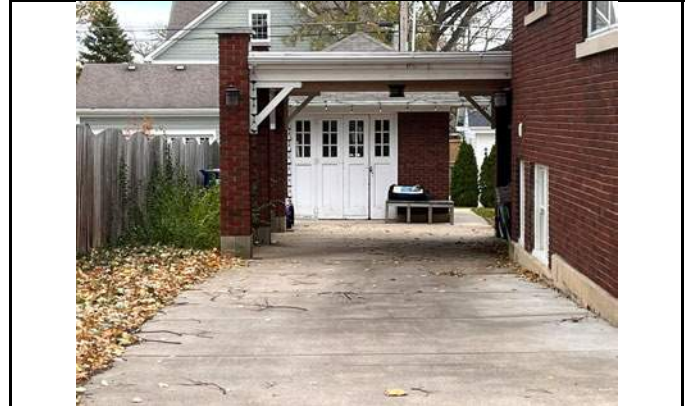
| <b>ALTERATIONS</b> | Jalousie windows in south dormer (not historic); Aluminum under eaves. Post-2007 -- porte cochere with hipped roof and square brick supports attached to north elevation (required removal of existing hipped roof canopy over north side secondary entrance); replacement French door and sidelights recessed within existing opening at front entrance; 3/1 wood window on 2nd story of south elevation replaced with new 3/1 window in downsized opening; new hipped roof canopy over rear ground-level entrance. | | |

| COA COMPLIANCE NOTES: | Work approved in COA #22-252 appears to have not been undertaken. Window replacement in south dormer (approved, COA #16-4092) also not undertaken. | | |

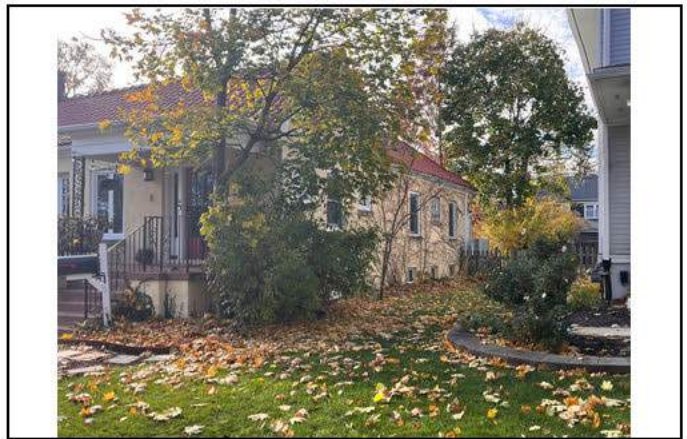
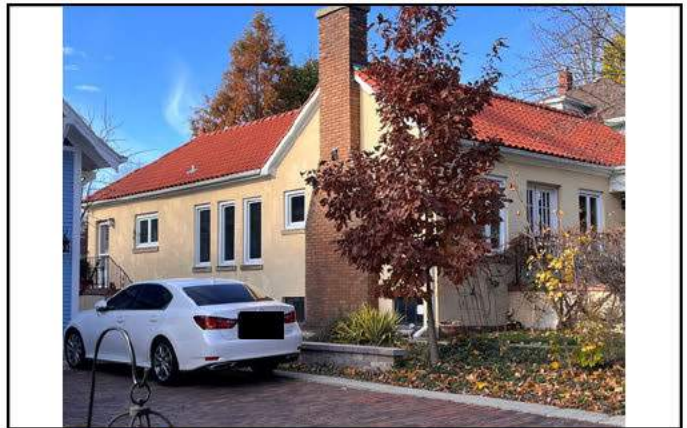
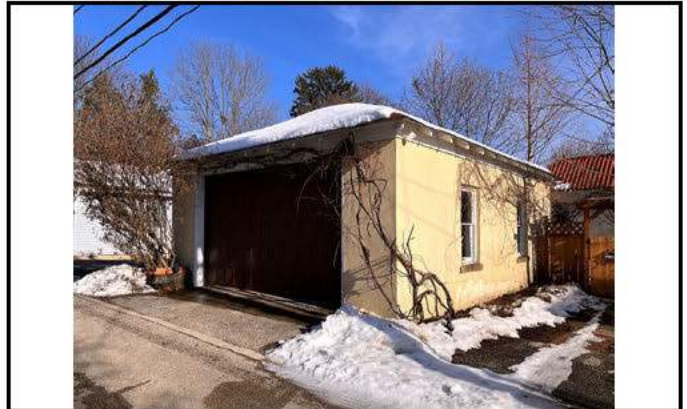
| ALTERATIONS | Replacement windows in original openings; raised terrace addition south of front porch; wrought iron railing on porch. Post-2007 -- no changes to principal structure. Folding doors replaced with overhead door on detached garage. |

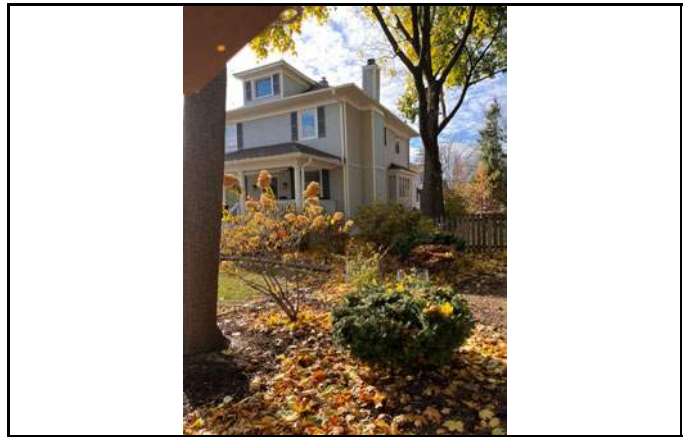
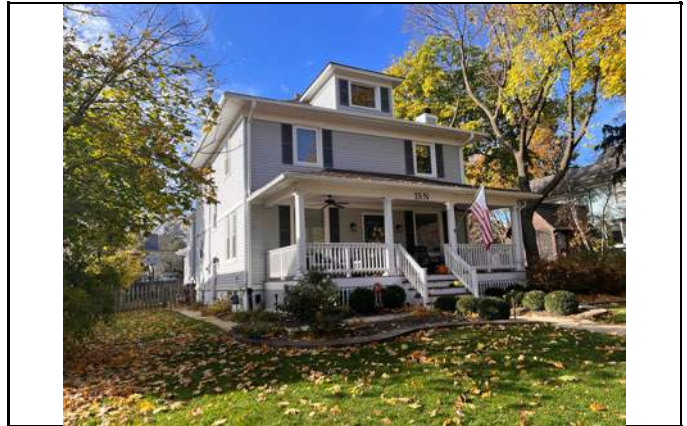
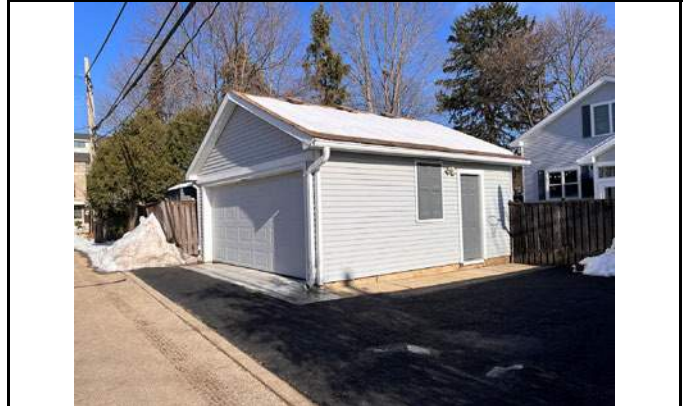
☒ ELIGIBLE WORK COMPLETED WITHOUT COA?

Replacement windows on front façade; replacement siding.

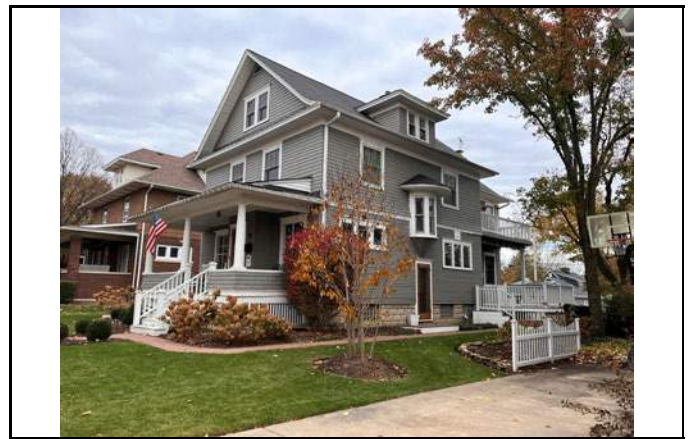
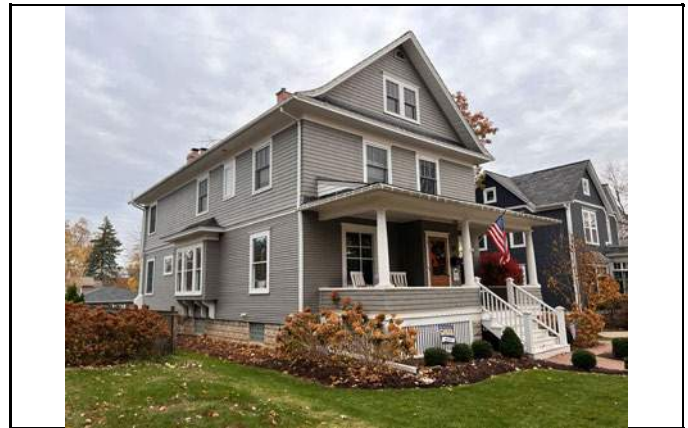
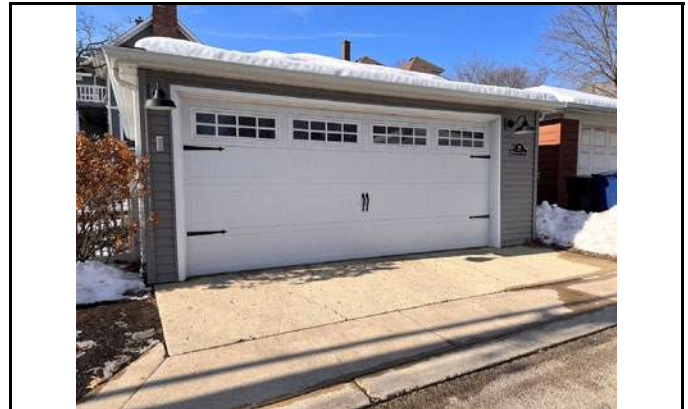
| ALTERATIONS | Front entry bay is a possible addition (historic); 2 story rear addition (1994); replacement windows in dormers and under front gable (not historic, pre-2007); rear/south porch and deck addition (not historic); fixed shutters (not historic). Post-2007 -- Aluminum replacement windows throughout (COA approved); new wood railing at steps to south/rear deck. | | |

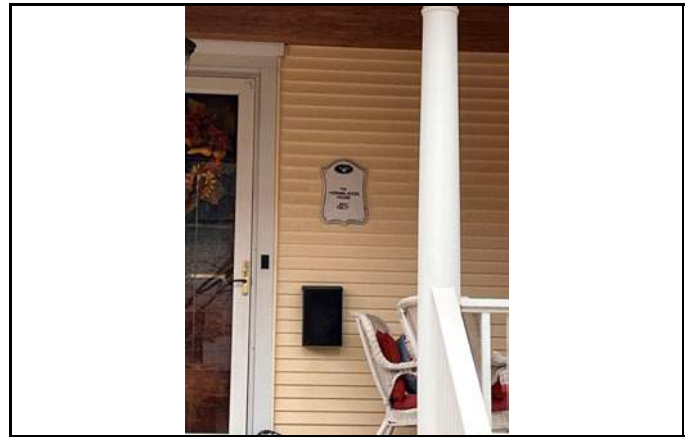
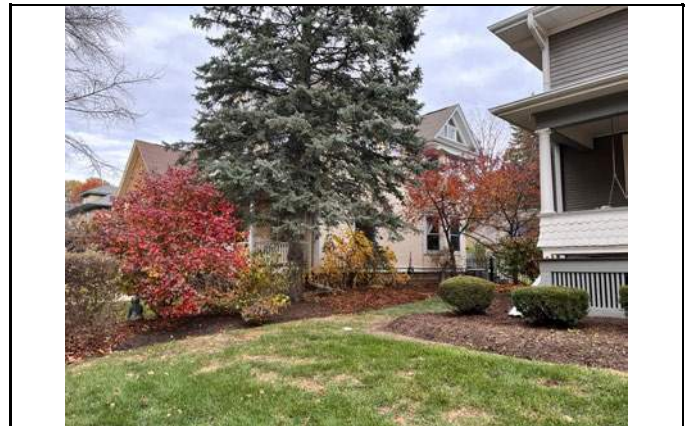
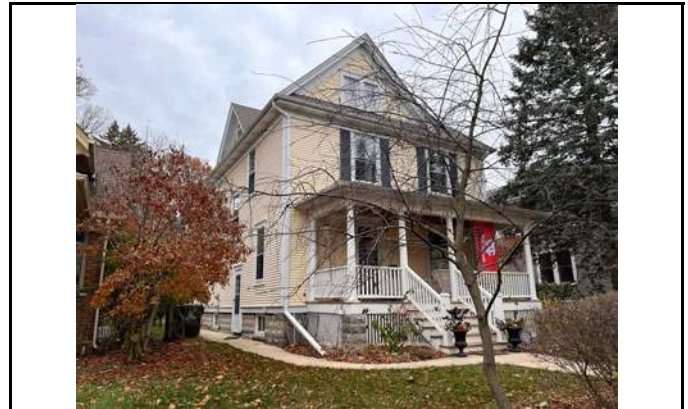
| ALTERATIONS | Gabled dormer additions (front and north--not historic); gable over south bay filled with windows (not historic); fixed shutters at 2nd story of front façade (not historic); 1 story rear addition (not historic); vinyl under eaves. Post-2007 -- replacement front porch. | | |

| <b>COA COMPLIANCE NOTES:</b> | Fascia board on replacement porch features square blocks above columns that were not present on previous porch. |

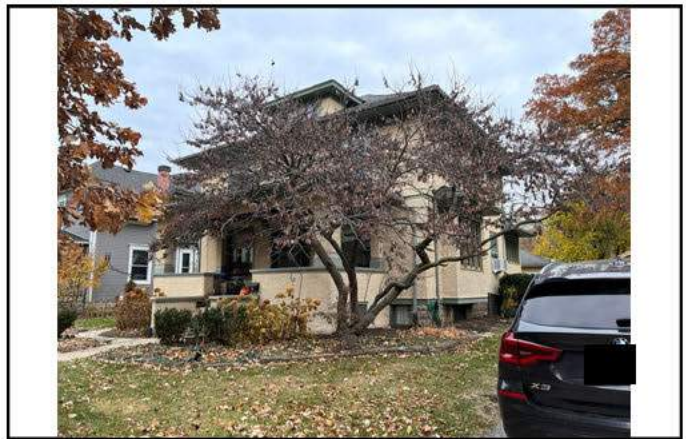
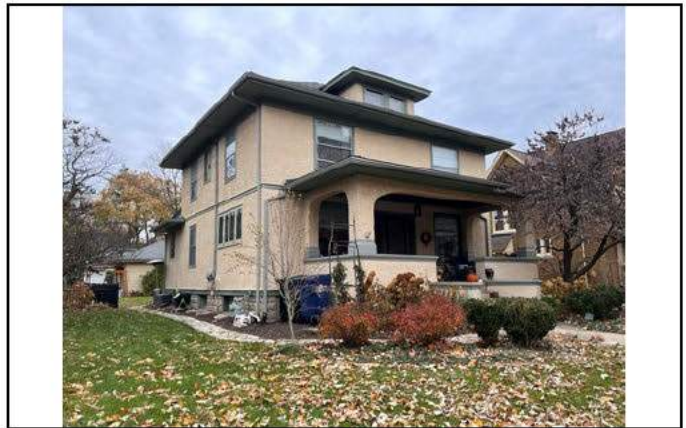
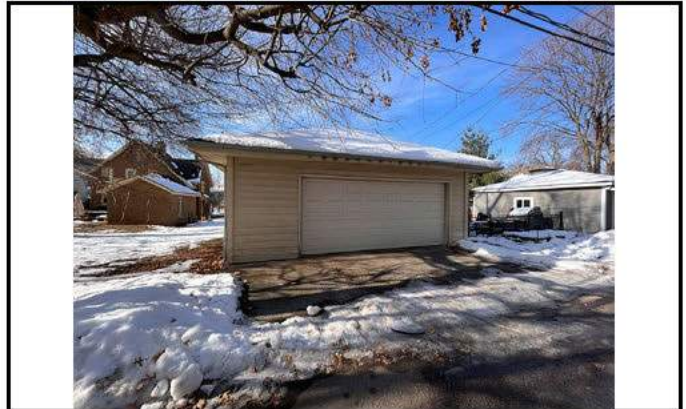
| ALTERATIONS | Glass block replacement windows on 2nd story of north elevation. Post-2007 - no changes. | | |

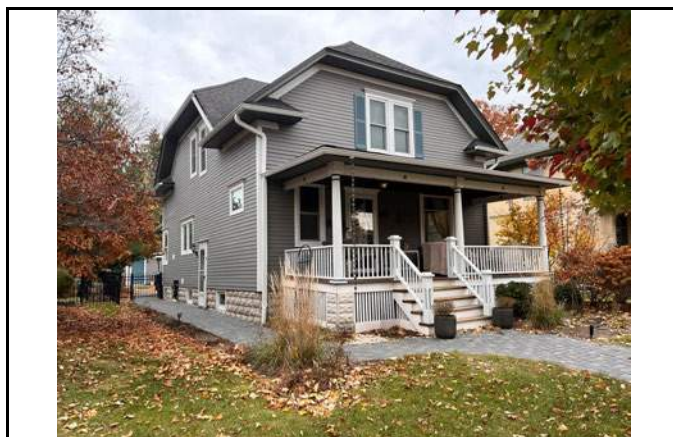
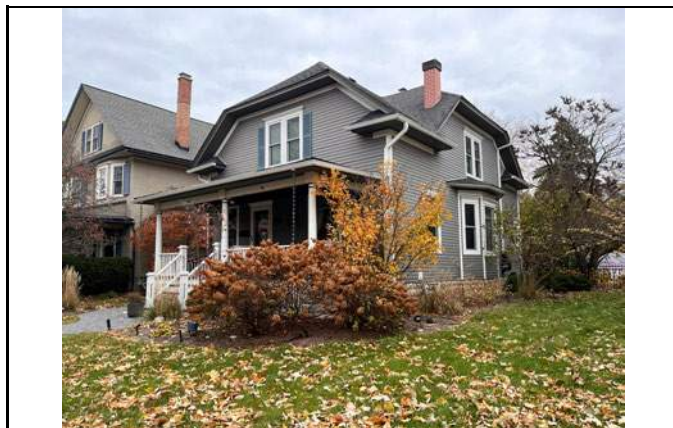
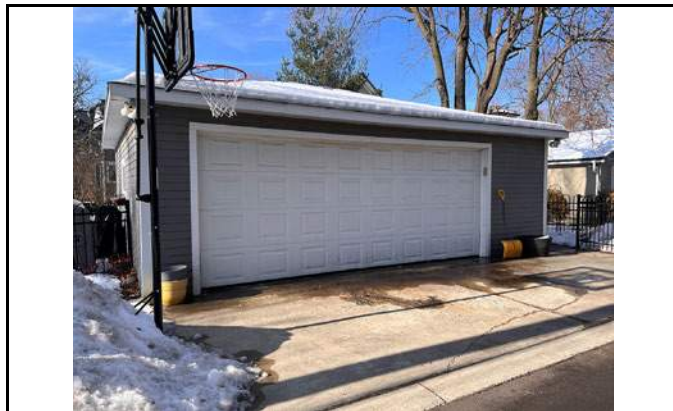
| <b>ALTERATIONS</b> | Post-2007 -- Aluminum siding replaced with fiber-cement board siding; solid knee walls on porch replaced with wood railings; replacement siding; Aluminum replacement windows in original openings. |

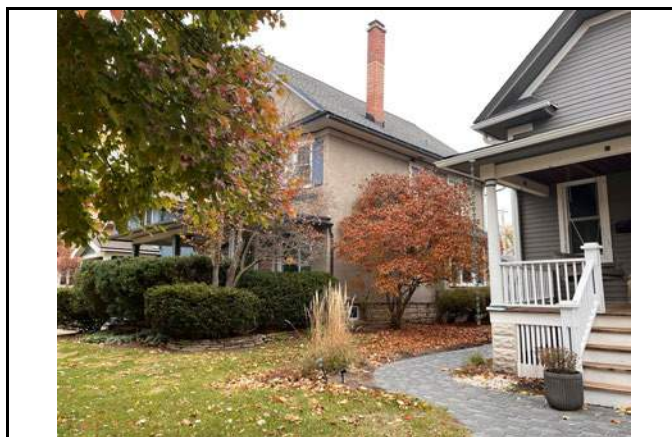
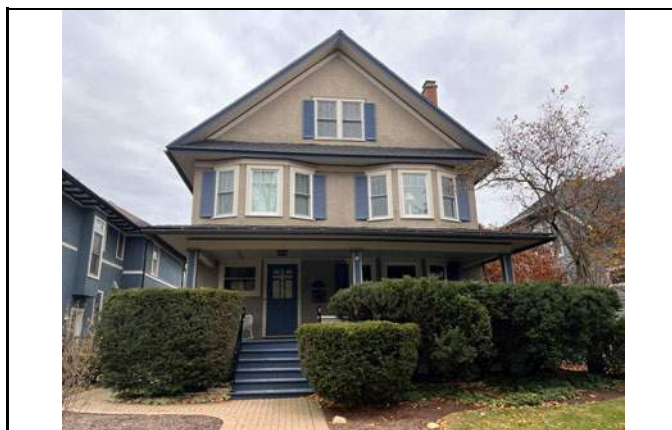
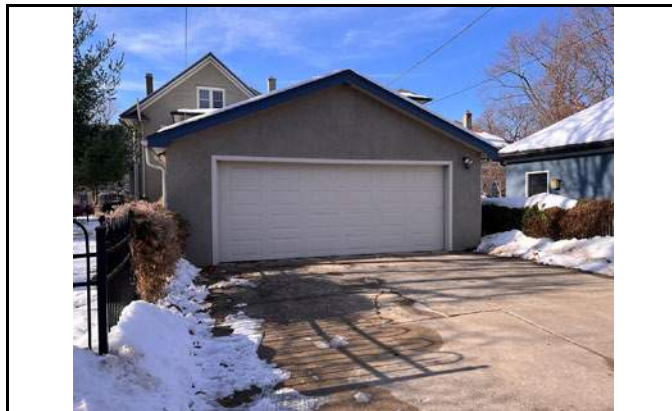
| ALTERATIONS | 3/1 replacement windows under front gable, rear gable, and north dormer (not historic); wrought iron railings at front steps; dormer addition on east (rear) elevation. Post-2007 -- 1/1 and 3/1 Aluminum replacement windows in original openings. | | |

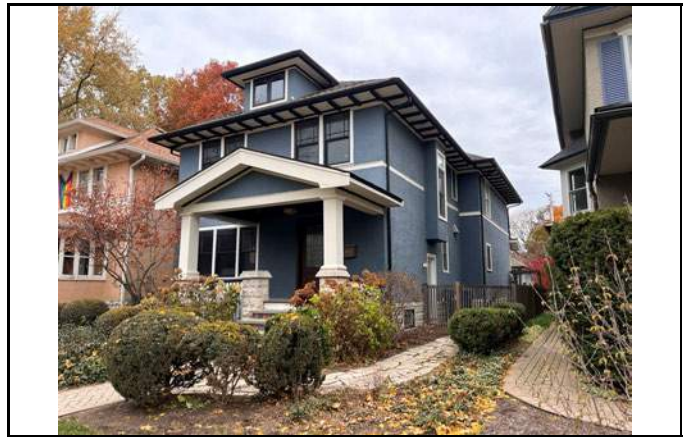
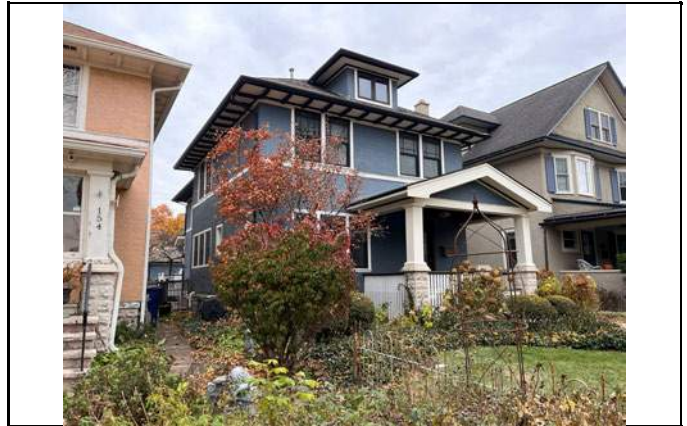
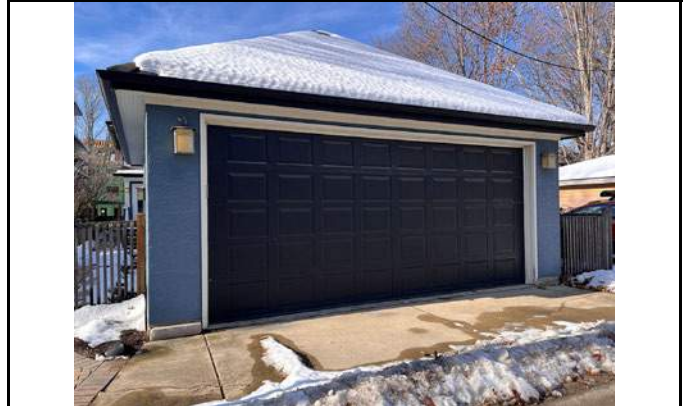
| ALTERATIONS | Replacement windows in original openings (not historic); replacement front door (not historic); two story rear addition; replacement railing and steps on front porch (not historic). Post-2007 -- no changes. | | |

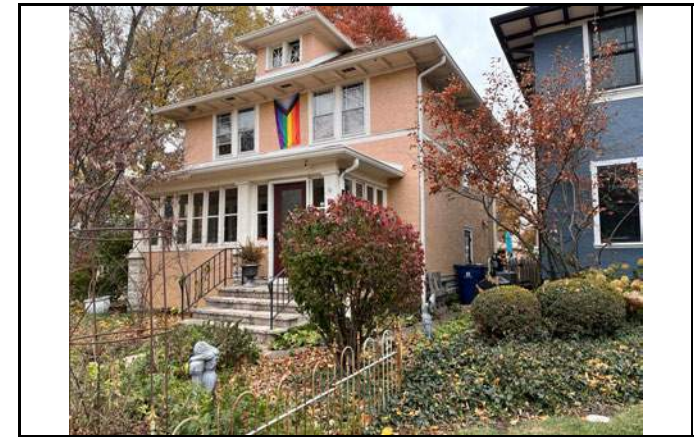
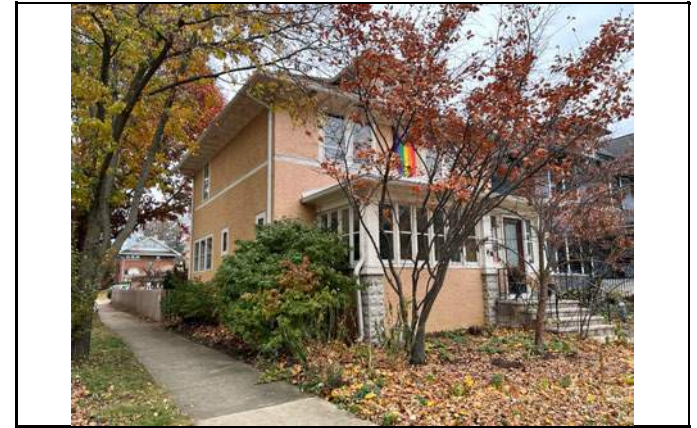
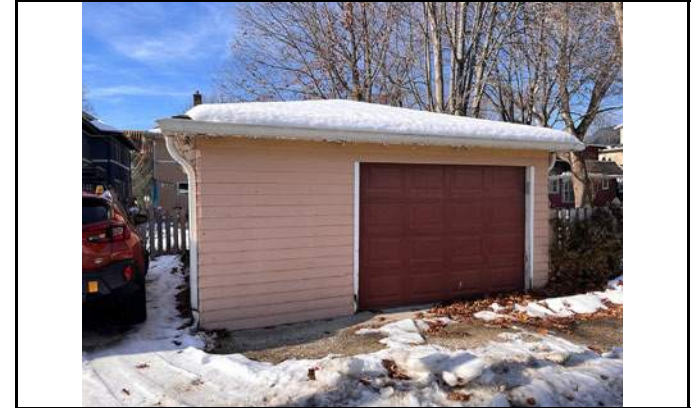
| ALTERATIONS | Front porch enclosed (c. 1920). Post-2007 -- replacement door to front porch; replacement door in south side secondary entrance. | | |

Replacement door to enclosed front porch; replacement door in south side secondary entrance opening.

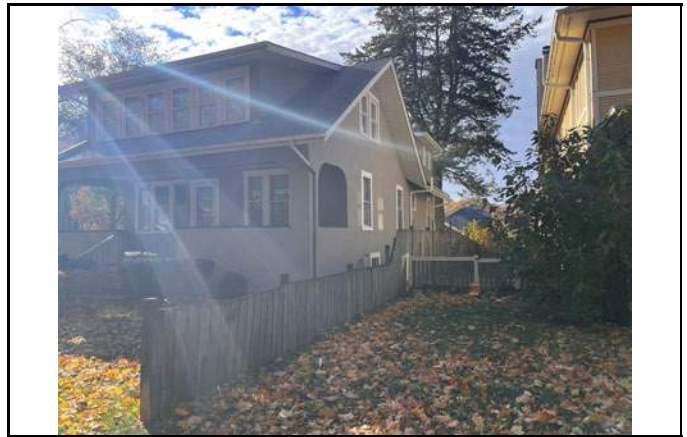
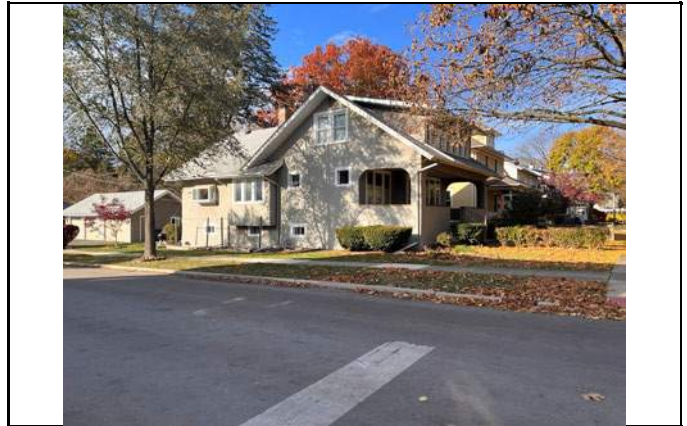
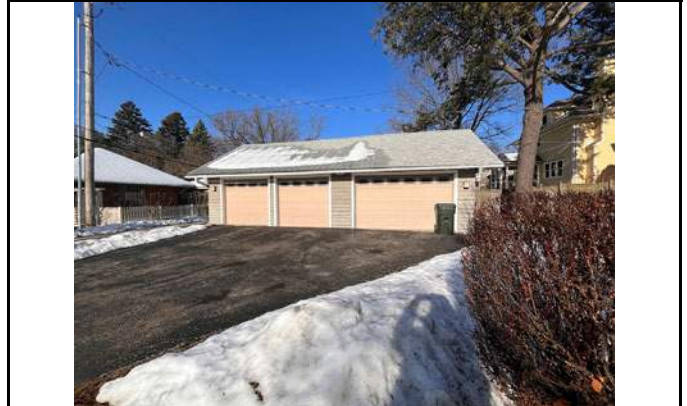
| ALTERATIONS | Enlarged front dormer with Aluminum siding and replacement windows (not historic); replacement 2nd story side windows (not historic); green house window on south elevation (not historic). Post-2007 - no changes | | |

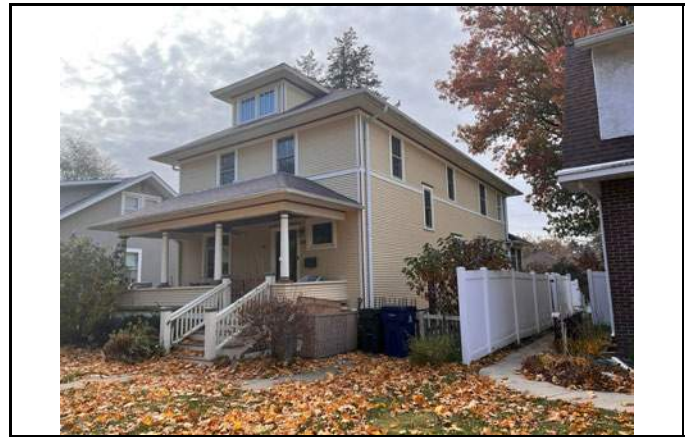
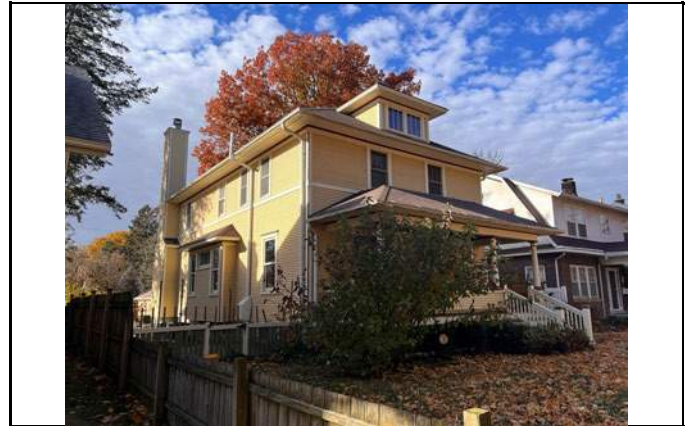
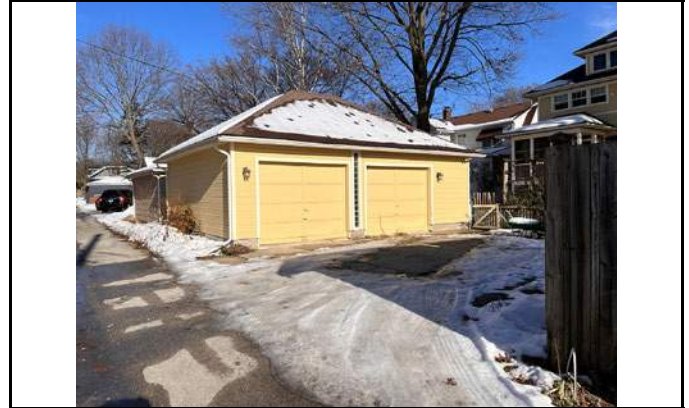
| ALTERATIONS | Post-2007 -- 3/1 Aluminum replacement windows in original openings on front and side elevations; three-light replacement windows in dormer; chimney addition to west end of south elevation; wrought iron railings at front steps replaced with painted wood railings | | |

3/1 Aluminum replacement windows in original openings on front and side elevations; three-light replacement windows in dormer; chimney addition to west end of south elevation; wrought iron railings at front steps replaced with painted wood railings

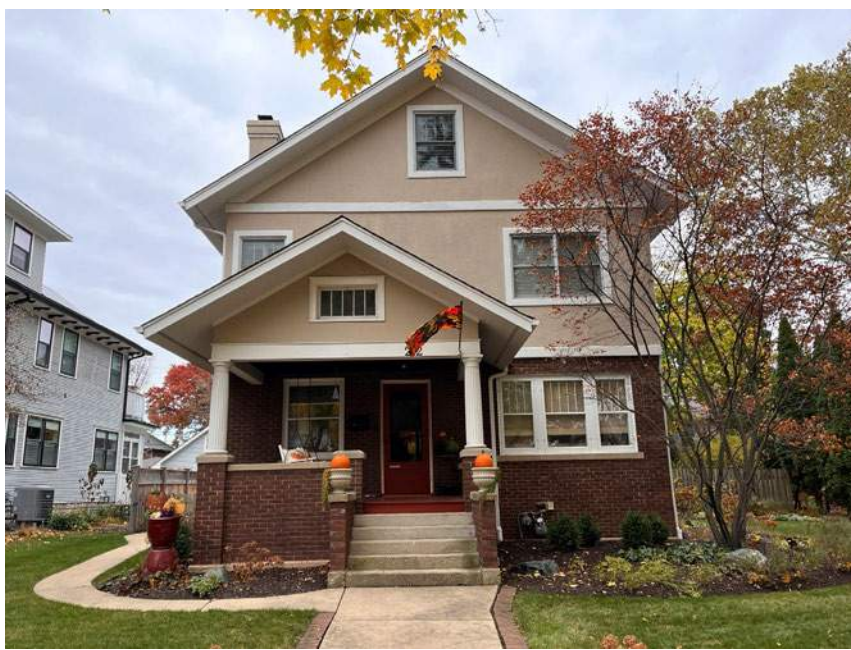
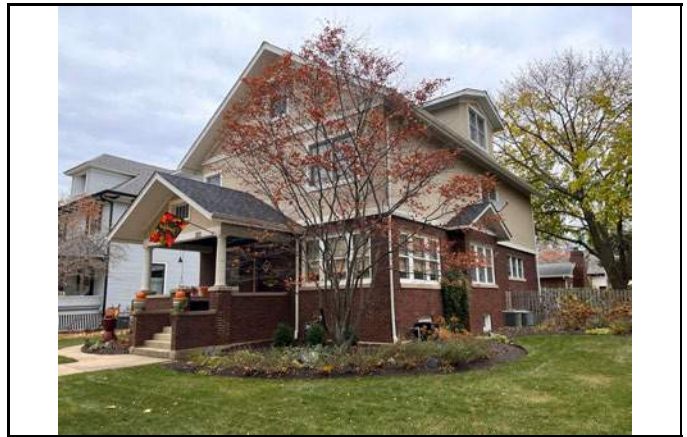
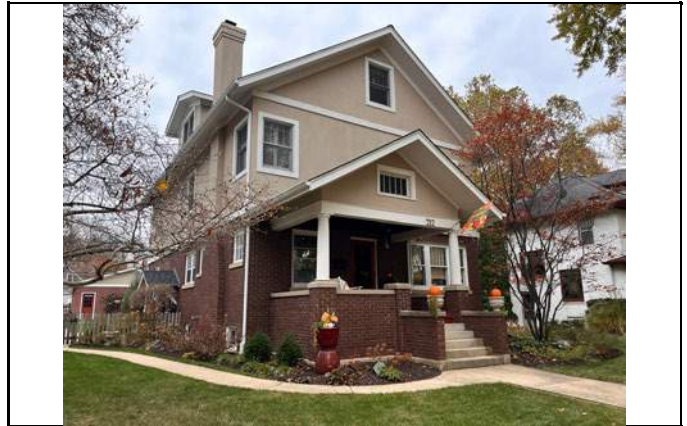
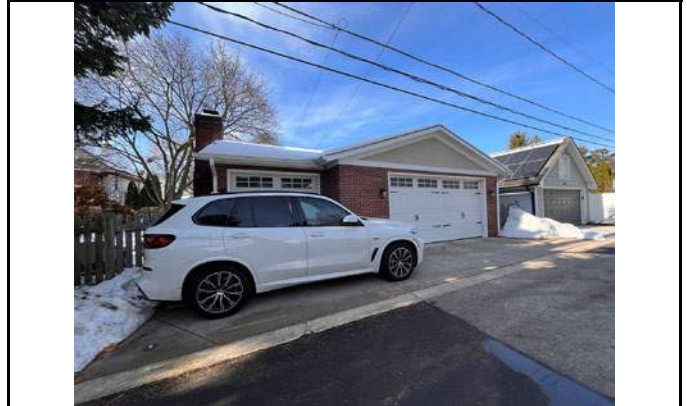
| <b>CONDITION</b> | good | <b>REASON for SIGNIFICANCE</b> | |

| <b>ALTERATIONS</b> | Original house obscured by 2nd story addition (c. 2000); front porch roof may also be replacement. Post 2007 -- no changes. |

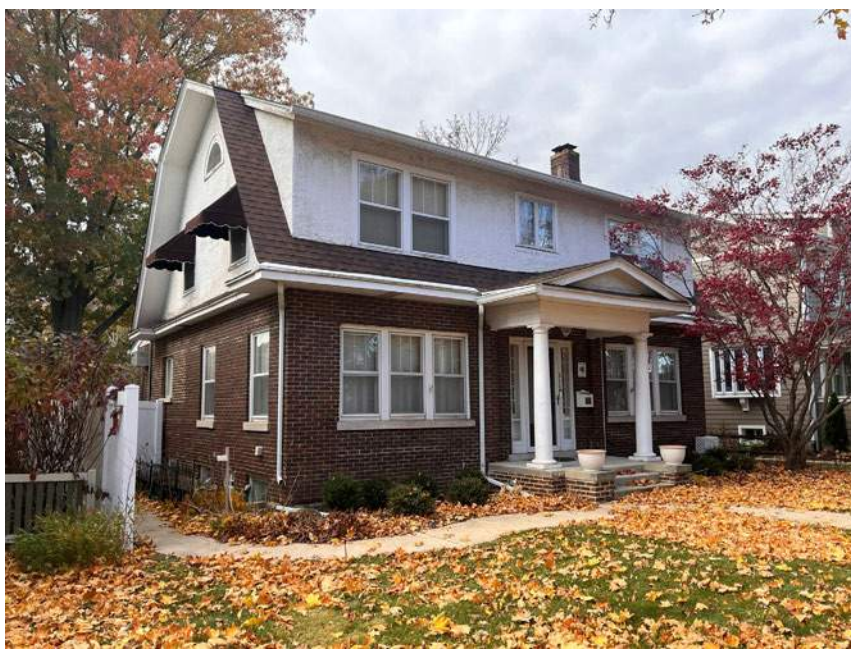
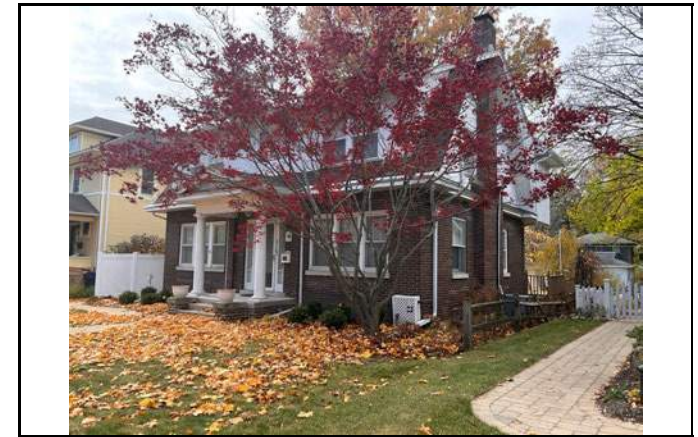
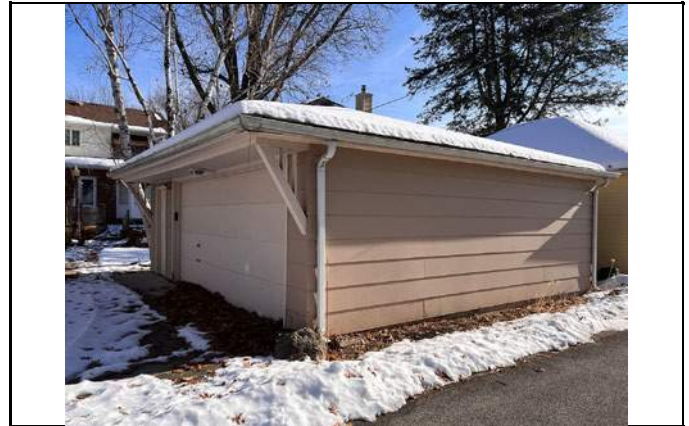
| CONDITION | good | REASON for SIGNIFICANCE | |

| ALTERATIONS | Replacement 2nd floor casement windows above front entry (not historic); one story rear addition (1985); 2nd story rear addition (not historic); rear deck (not historic). Post-2007 -- no changes. | | |

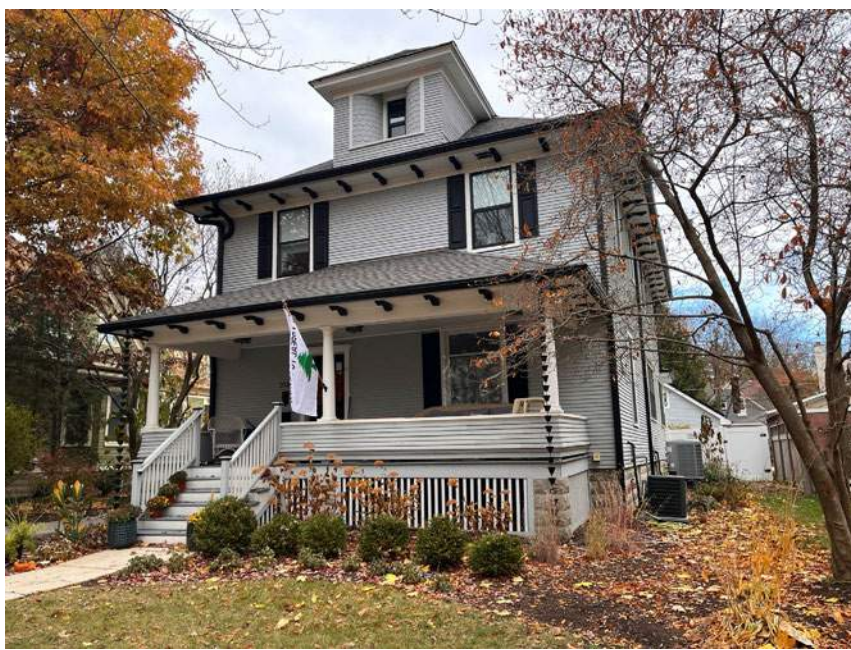
| CONDITION | good | REASON for SIGNIFICANCE | The unique hipped dormer on this classically detailed American Foursquare features rounded, shingled walls curving into the single centered window. |

| ALTERATIONS | Deck addition on roof of rear 1 story bay (not historic); wrought iron railings at front steps (not historic). Post-2007 -- replacement front door, wrought iron railings replaced with painted wood railings at porch steps; north and south dormer additions; replacement windows in altered openings on north and south elevations (pre-2018); rear porch addition (pre-2018) | | |

| NOTES ON WORK: | Replacement windows in altered openings on north and south elevations (pre-2018); rear porch addition (pre-2018). |

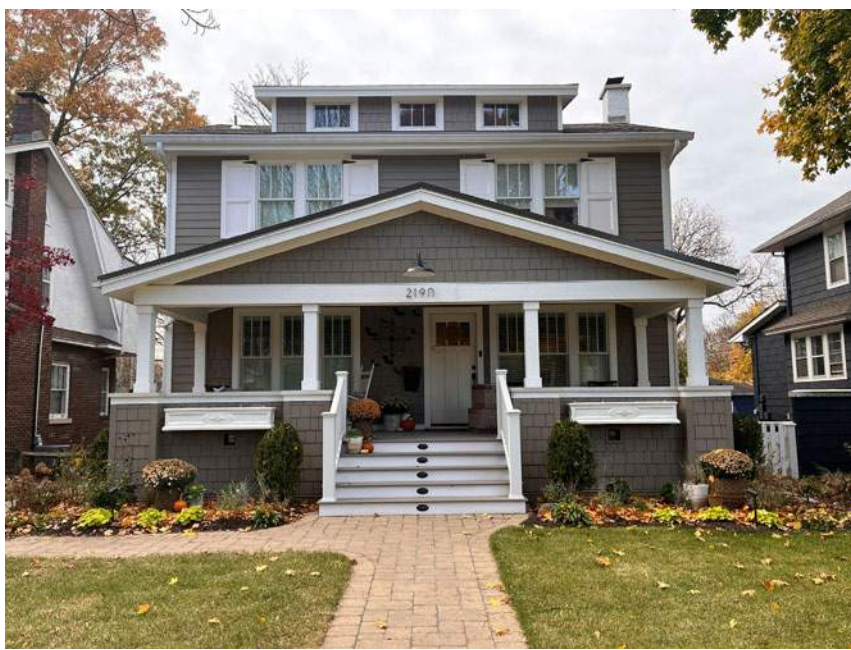
| CONDITION | good | REASON for SIGNIFICANCE | |

| ALTERATIONS | Front dormer enlarged with replacement windows; window bay addition (south); green house window (south); fixed shutters; greenhouse window on south elevation; turned wood columns on porch; two story rear addition. Post-2007 -- stucco cladding replaced with fiber cement board and shingle siding; square corner porch piers and center turned columns replaced with square wood piers; replacement wood railing at porch steps; 3/1 Aluminum replacement windows on front façade; one-story rear sunporch addition |

| NOTES ON WORK: | Aluminum replacement windows on 2nd story of front façade. |

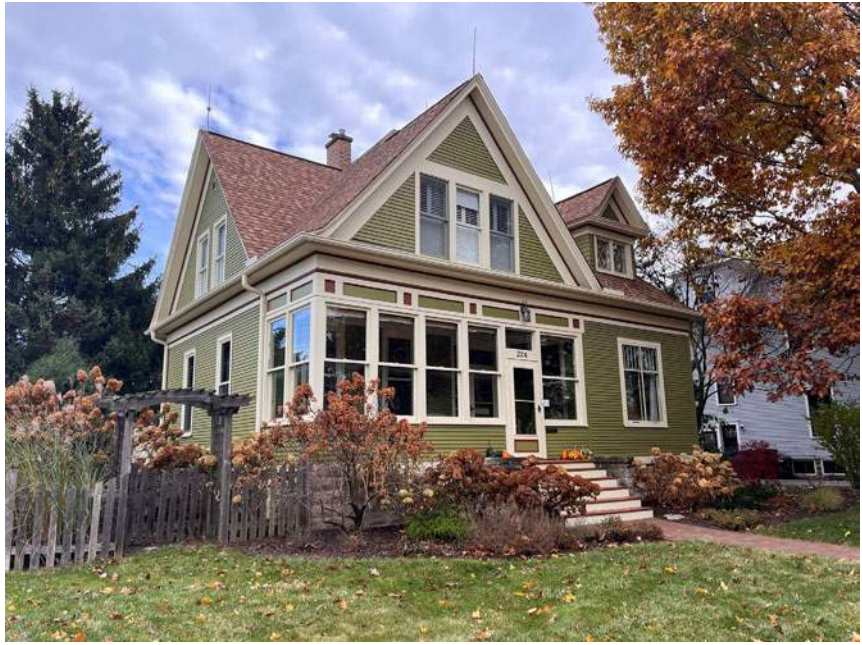
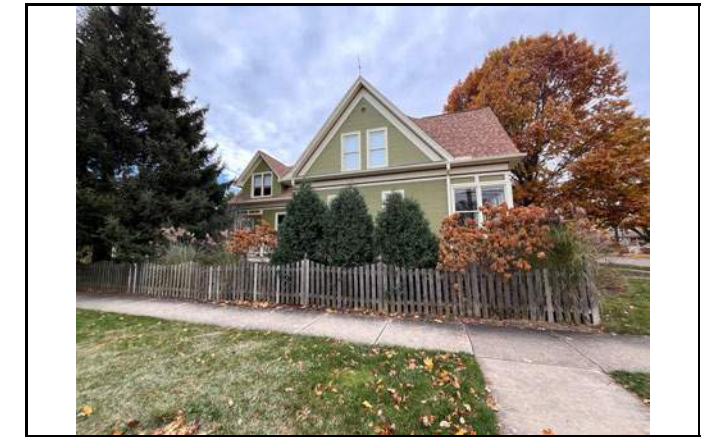
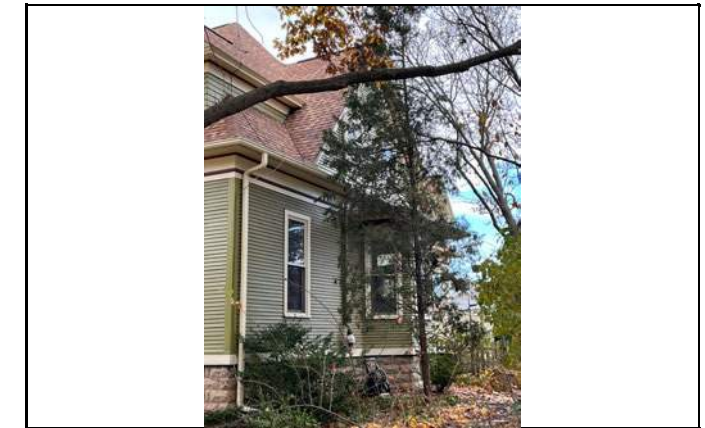
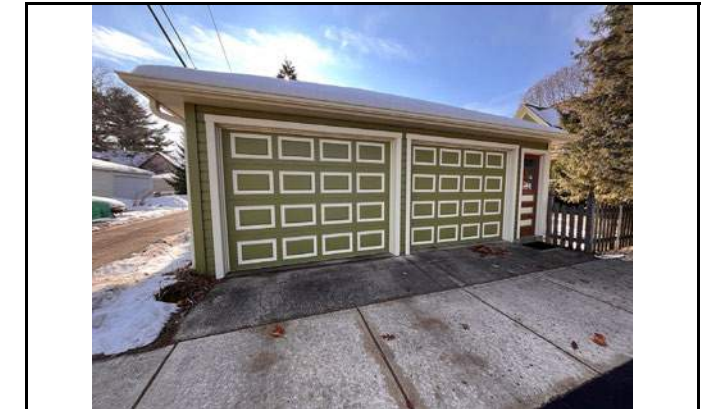
| CONDITION | excellent | REASON for SIGNIFICANCE | Good example of early 20th century Queen Anne-Free Classic. |

| ALTERATIONS | Replacement windows under gables (not historic); front porch enclosed (not historic); south and north side dormer additions; north side deck addition (not historic). Post-2007 -- no changes. | | |

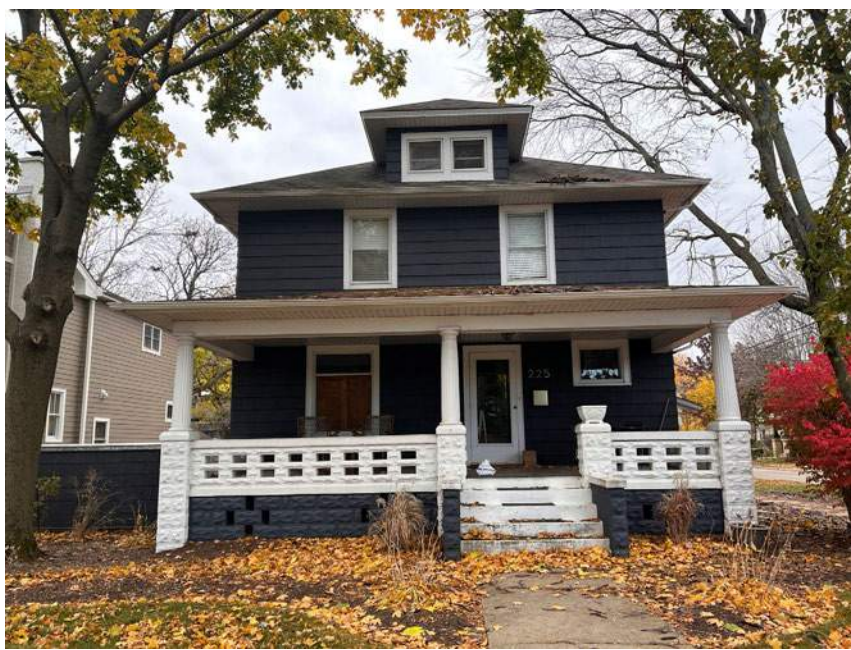
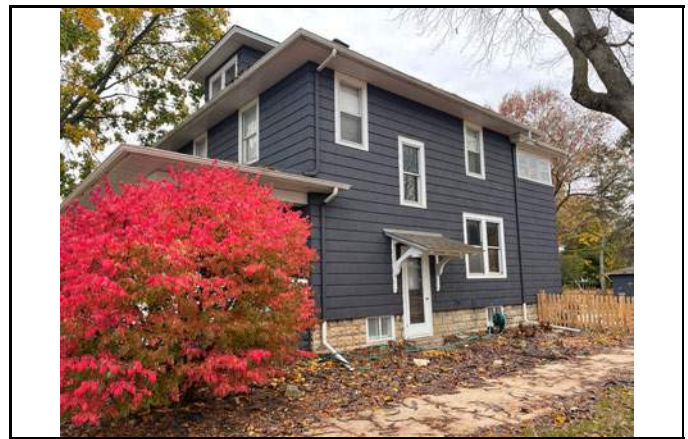
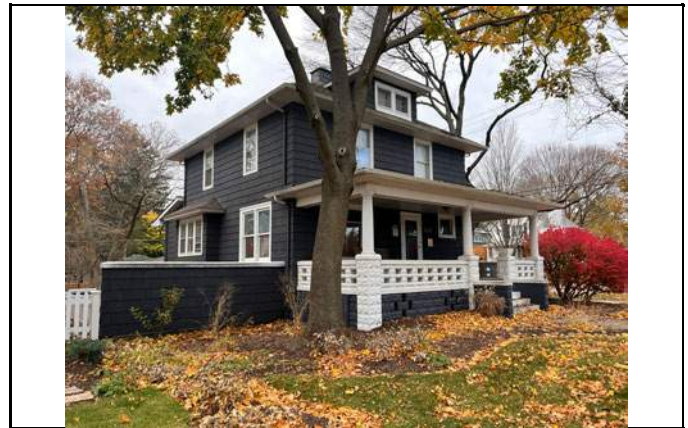
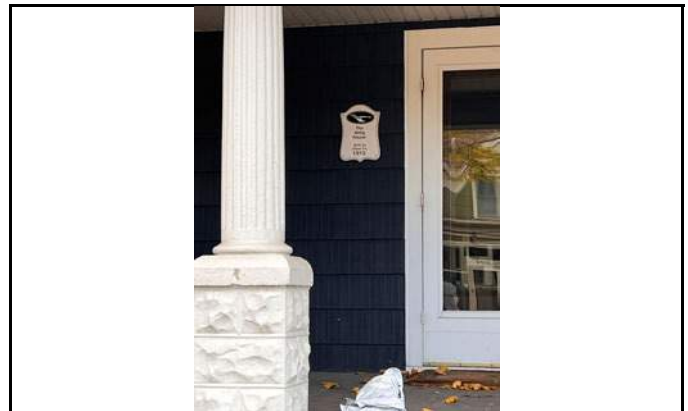
| CONDITION | excellent | REASON for SIGNIFICANCE | Handsome and well-preserved American Foursquare, with very few alterations. |

| ALTERATIONS | Aluminum siding under eaves and porch; south patio addition (not historic); replacement siding (not historic). Post-2007 -- in-kind asphalt-shingle roof replacement (COA approved); non-historic fixed shutters removed. | | |

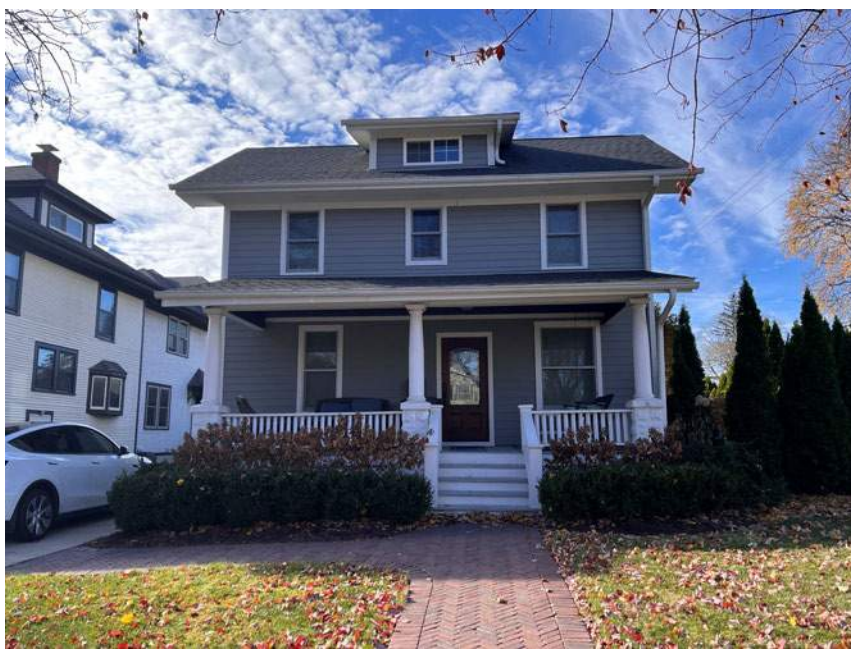
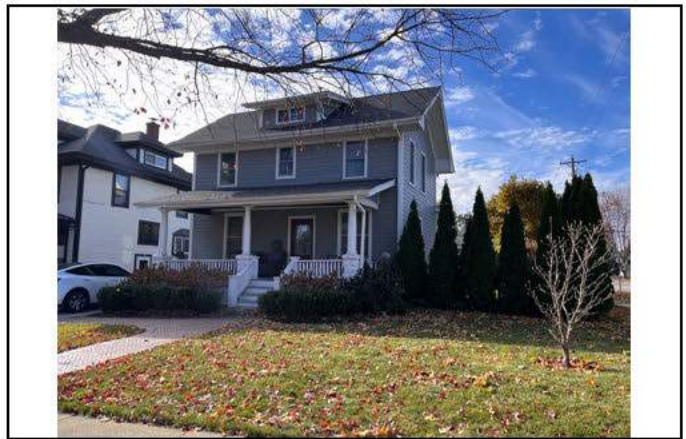
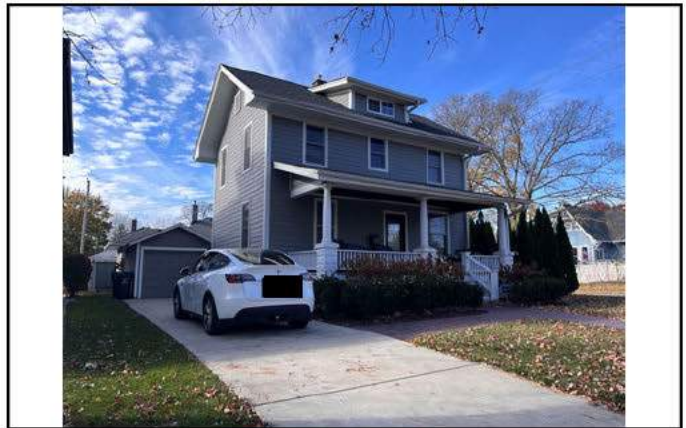
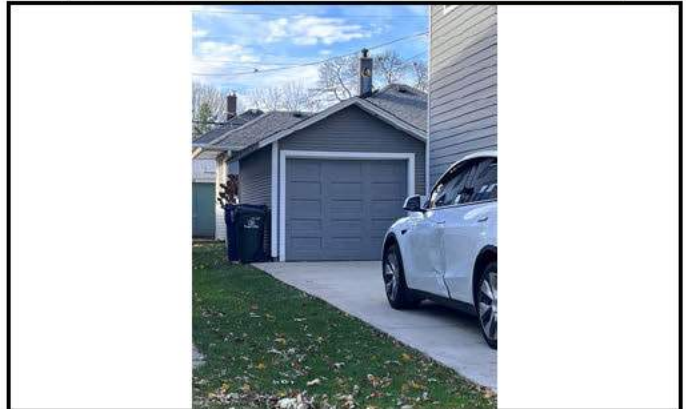
| CONDITION | good | REASON for SIGNIFICANCE | Good example of Craftsman style in the district. |

| ALTERATIONS | Replacement siding; one story rear addition (may have originally been porch that was enclosed). Post-2007 -- Aluminum replacement windows in original openings; wood shingle siding appears to have been replaced with fiber cement board siding; replacement front door | | |

Replacement windows in original openings; replacement front door; replacement siding.

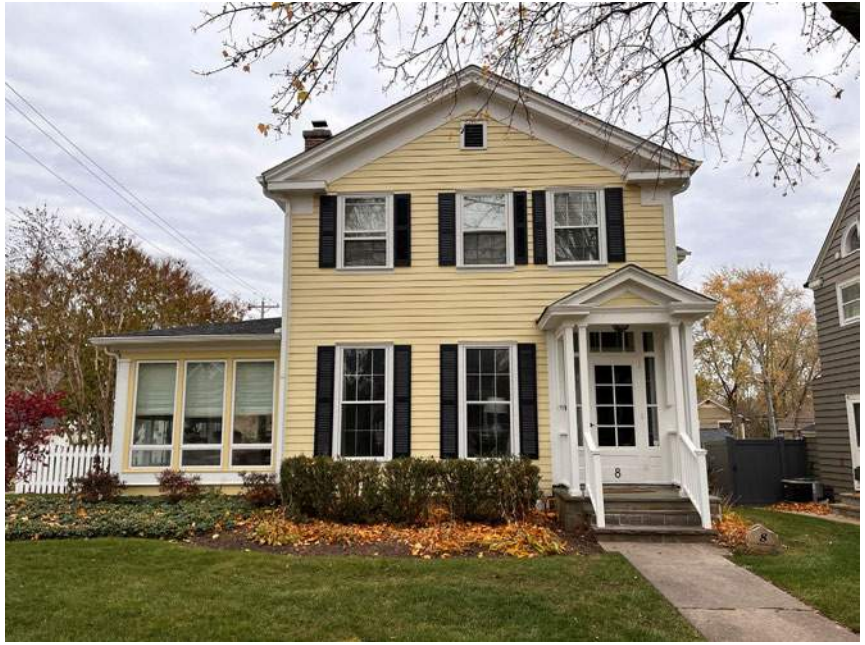
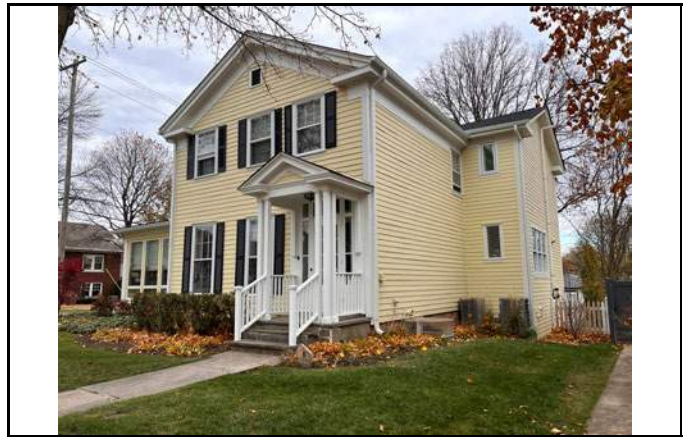
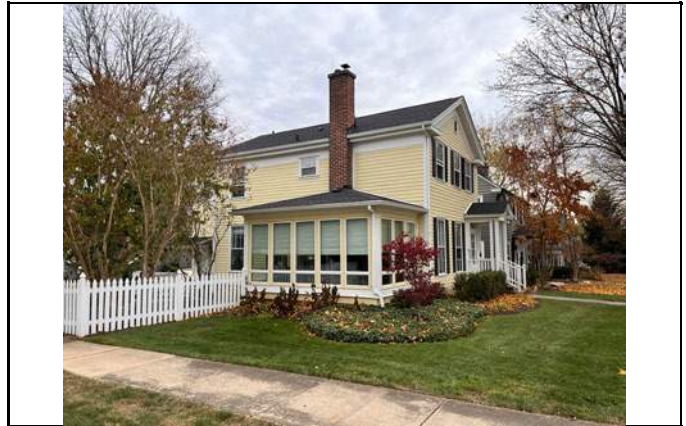
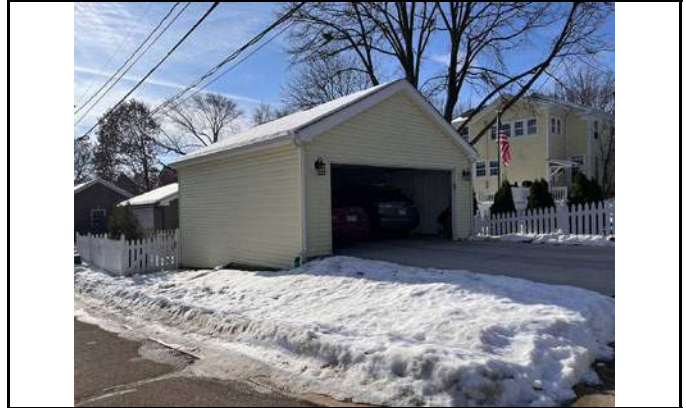
| CONDITION | good | REASON for SIGNIFICANCE | Despite alterations, this remains a good example of the Colonial Revival in the historic district. |

| ALTERATIONS | One story north sun porch addition (not historic); fixed shutters; replacement columns and base on porch (not historic); two story rear addition; replacement brick foundation. Post-2007 -- two-story south/rear addition; fiber cement board siding; in-kind asphalt shingle roof replacement | | |
