| STREET # | 5 |
| STREET | COLUMBIA |
| PIN | 0818403007 |

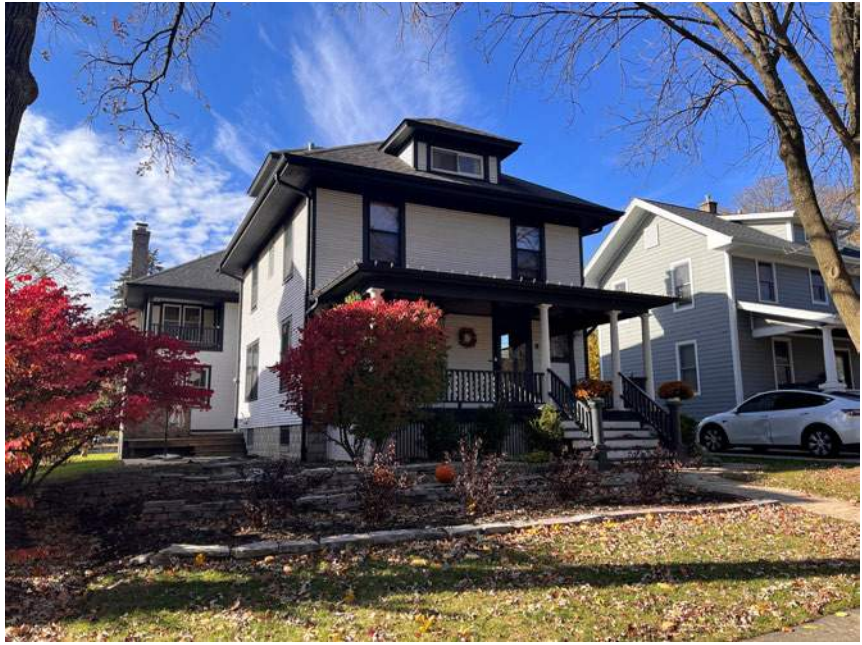
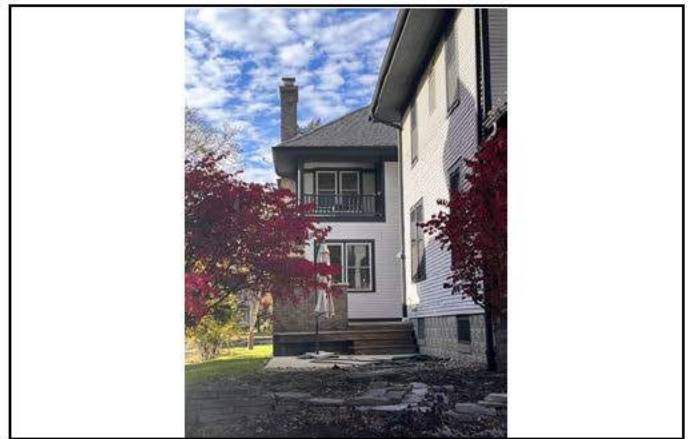
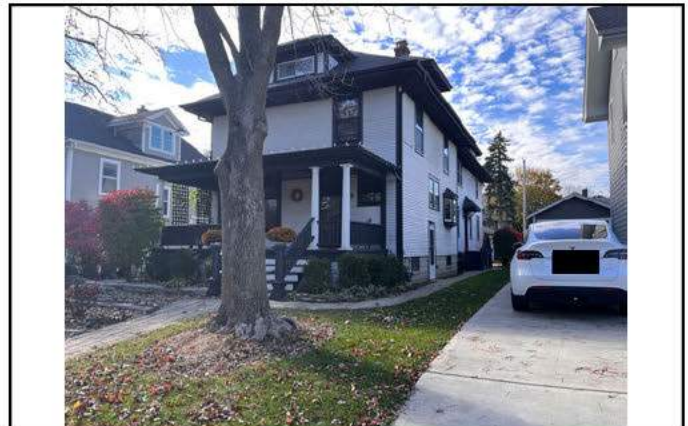
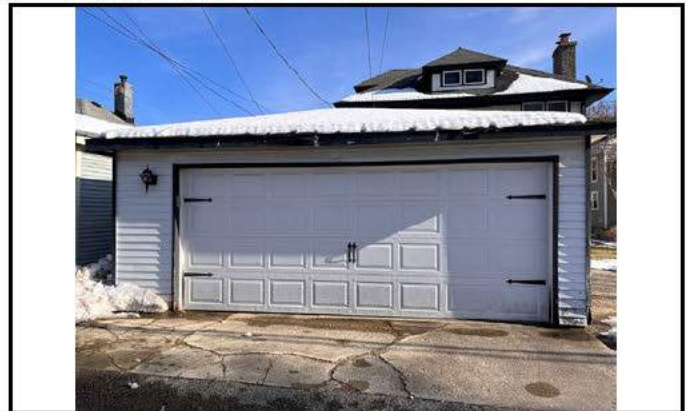
| CONDITION | excellent | REASON for SIGNIFICANCE | |

| ALTERATIONS | Replacement dormer windows (not historic). Post-2007 -- Large 2-story rear addition that extends past the south elevation and is visible from the public way. | | |

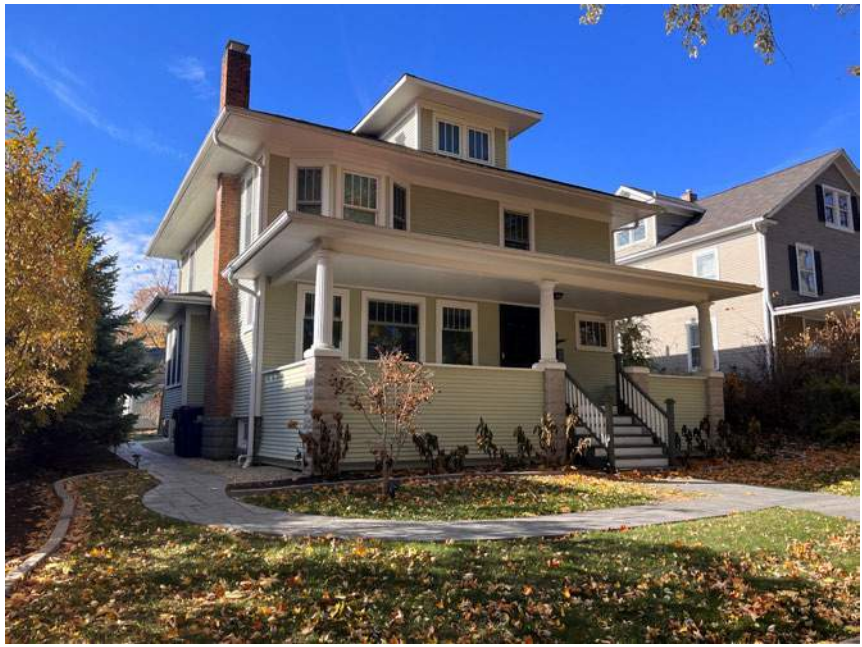
| CONDITION | good | REASON for SIGNIFICANCE | Typical example of American Foursquare type in the district. |

| ALTERATIONS | Railing at front steps is replacement (not historic); one-story rear additions and second story addition (not historic). Post-2007 -- Aluminum replacement windows in original openings throughout (COA approved); two new windows added to front façade under porch; replacement front door | | |

| NOTES ON WORK: | Replacement front door; replacement railings at porch steps. |

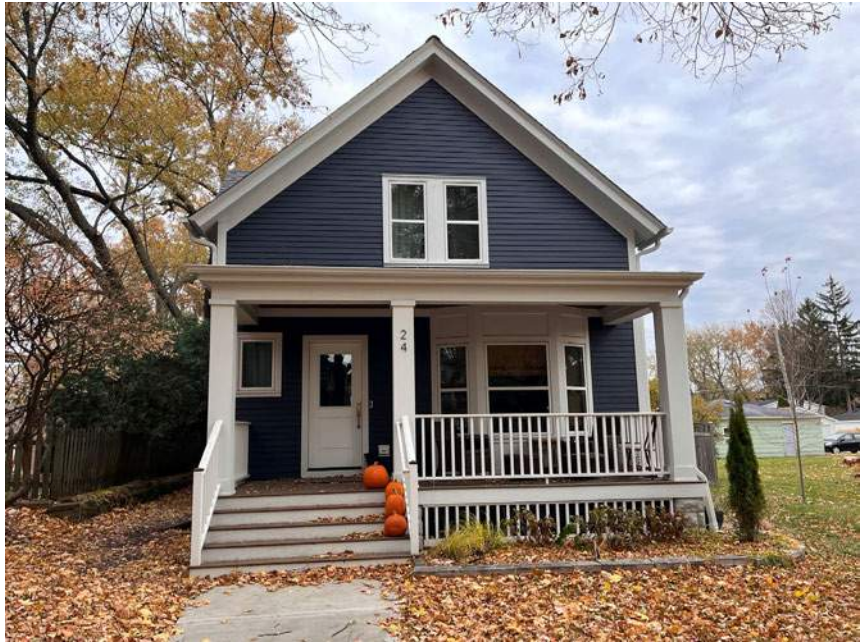
| ALTERATIONS | Square south window bay may be historic addition (3/1 wood windows--c. 1925). Post-2007 -- replacement wood siding and trim; full-width front porch with square wood columns and wood railing; Aluminum replacement windows throughout; 2-story rear addition that projects past south elevation; south oriel bay clad with painted wood panels; classical entry surround on front façade removed and replaced with simple painted trim; hipped roof on 3-sided front bay removed to accommodate new porch. | | |

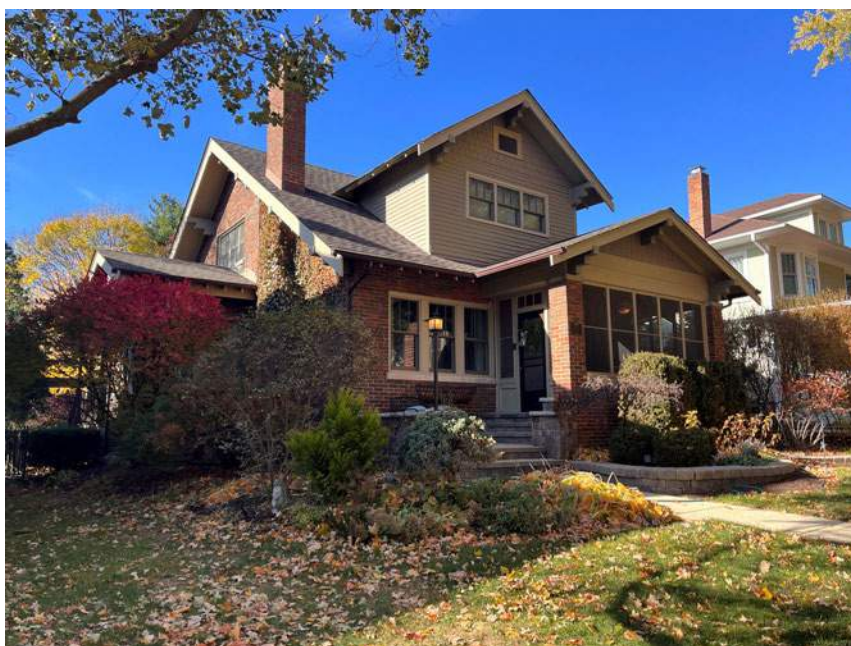
| ALTERATIONS | Front porch screened; new steps to front porch (not historic); rear addition to south sun porch; replacement windows in dormer (not historic); one story rear addition. Post-2007 -- 3/1 Aluminum replacement windows on front elevation. | | |

| NOTES ON WORK: | 3/1 Aluminum replacement windows on front elevation. |

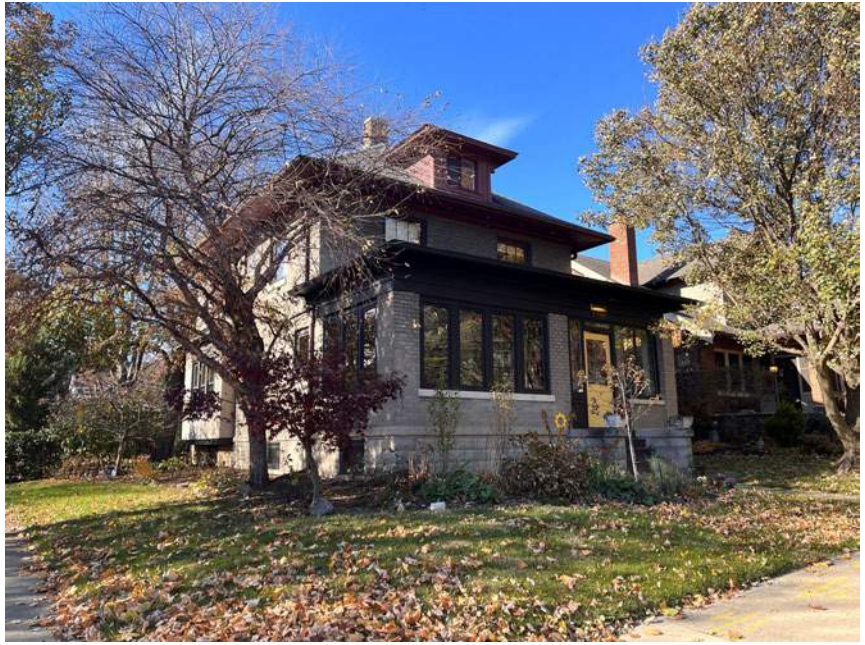
| ALTERATIONS | North end of porch enclosed w/ multi-light windows and door (not historic); replacement dormer window (not historic); replacement windows on south side bay (not historic). Post-2007 -- in-kind asphalt-shingle roof replacement (COA approved). | | |

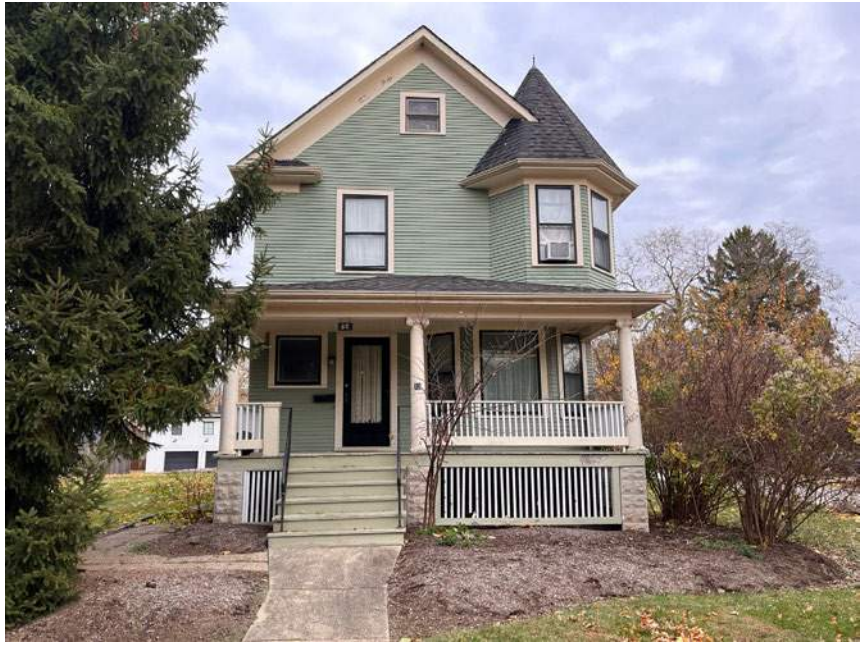
| CONDITION | good | REASON for SIGNIFICANCE | Excellent example of an early 20th century Queen Anne-Free Classic residence, with polygonal corner turret and ionic columns on porch. |

| ALTERATIONS | Replacement windows in dormer and under gable (not historic); rear deck addition (not historic). Post-2007 -- non-historic solid wood railing on front porch replaced with historically appropriate wood railing; railings added to non-historic rear deck | | |

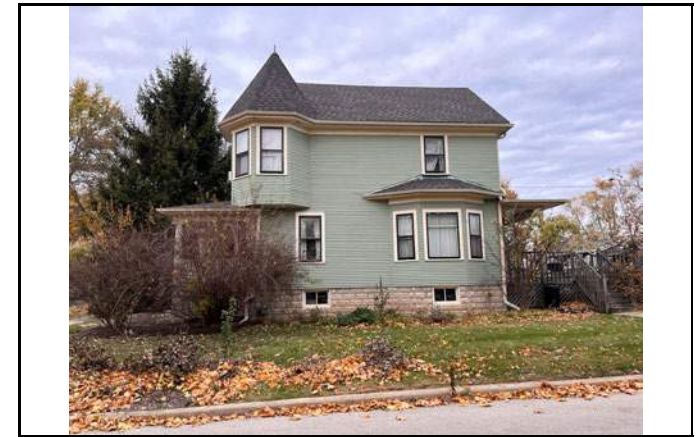
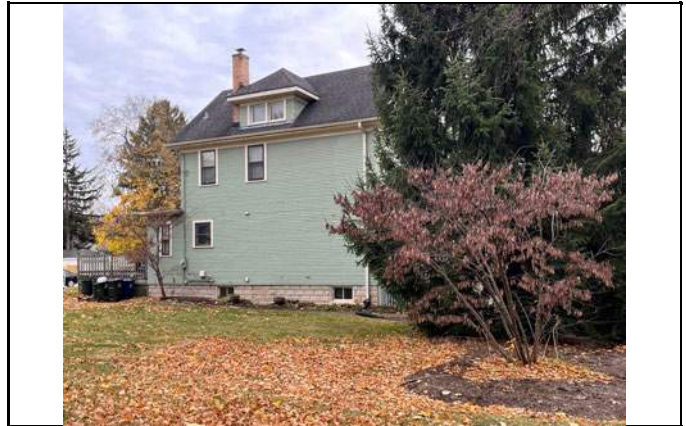
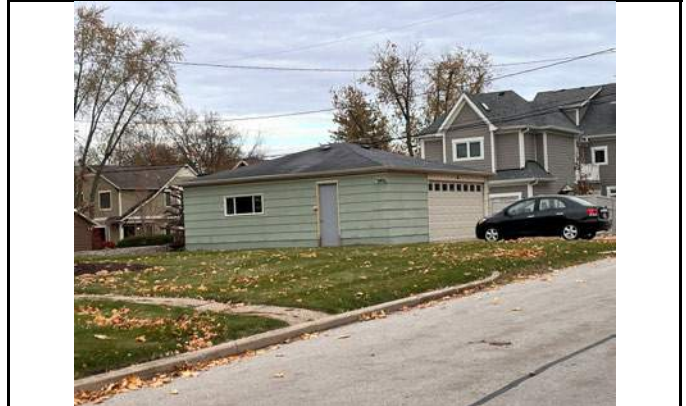
Wood railing replaced with historically compatible new wood railing at front porch.

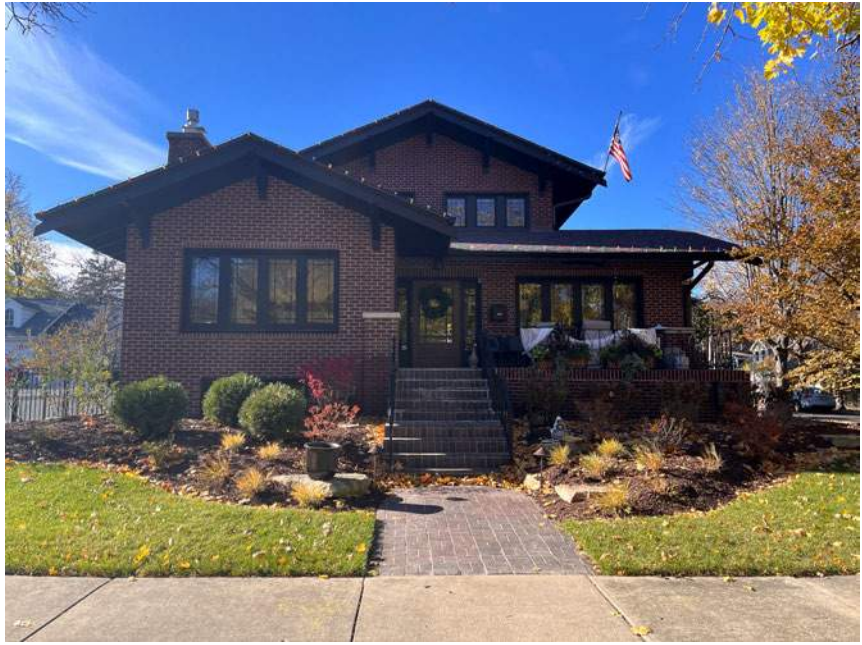
| ALTERATIONS | Brick exterior cladding (c. 2000); wrought iron railings on front patio; brick cladding (c. 2000). Post-2007 -- in-kind asphalt shingle roof replacement (COA approved). | | |

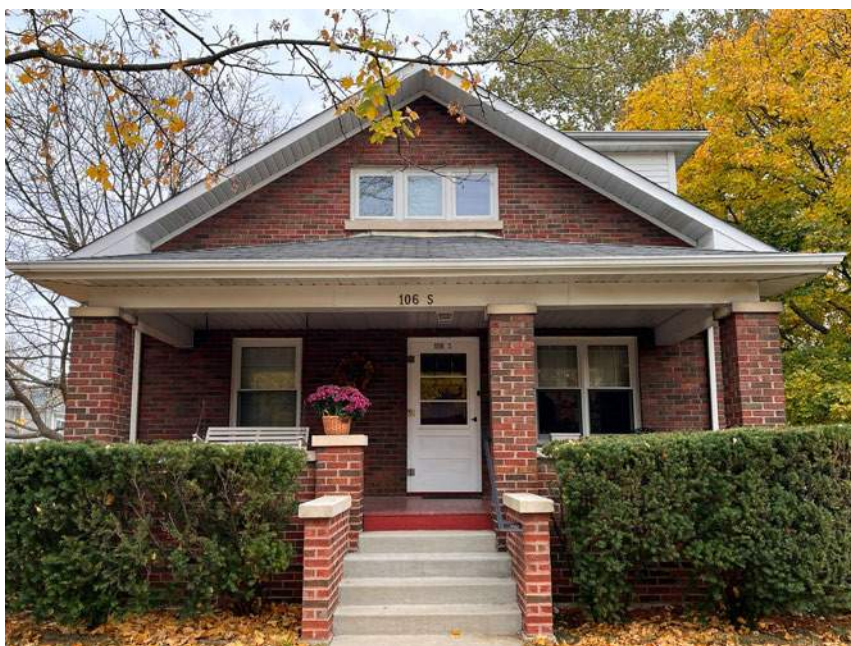
| <b>ALTERATIONS</b> | South side dormer addition (not historic) and replacement 2nd story windows in 2007; Aluminum under eaves in 1988. Post-2007 -- Aluminum replacement windows at east and west ends of north elevation; concrete front steps replaced in kind. |

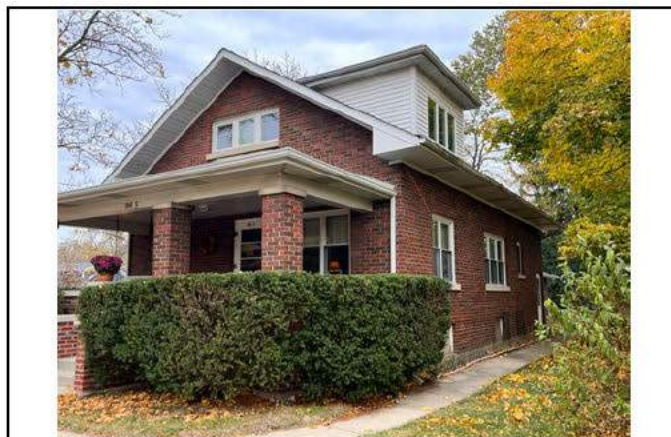
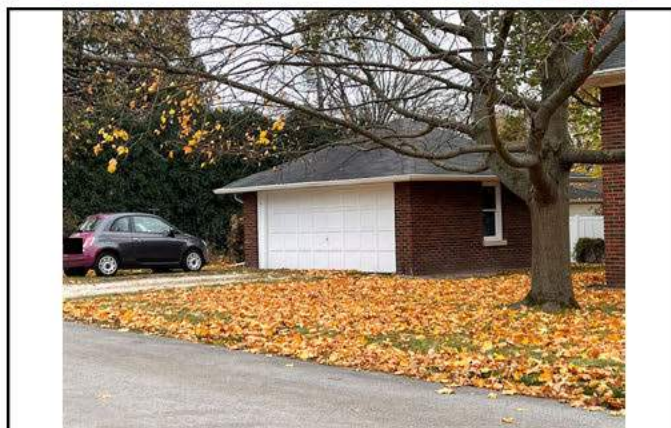
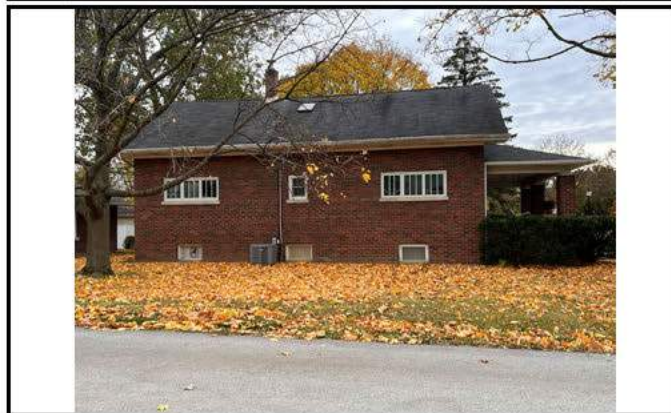
Aluminum replacement windows at east and west ends of north elevation

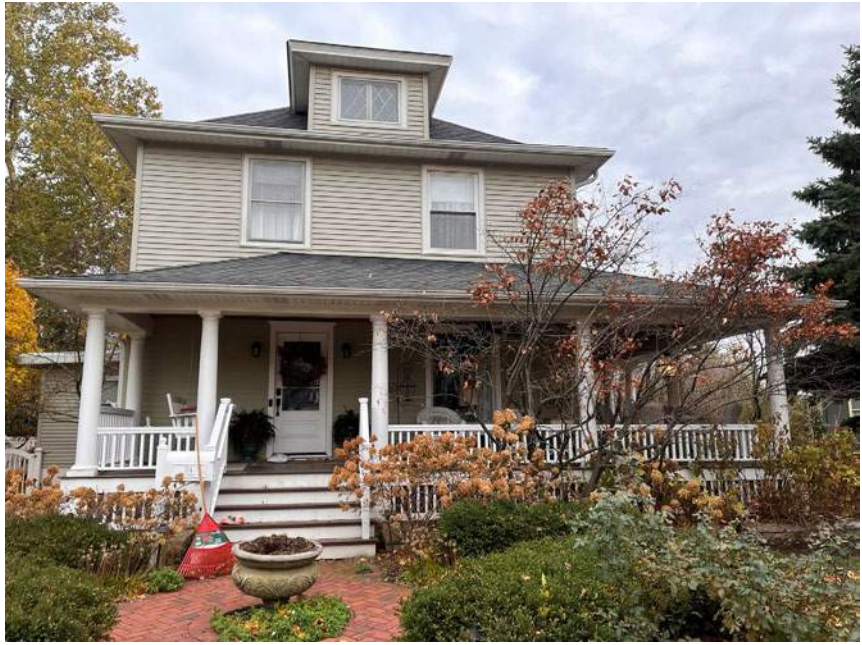
| ALTERATIONS | Two story rear addition (historic); 1 story north side addition (not historic); Aluminum siding. Post-2007 -- Historic full-front porch replaced with new wraparound front porch with historically appropriate columns and railings, and existing paired windows on south elevation converted to patio door opening onto south section of new porch (COA approved); Aluminum siding repainted or replaced |

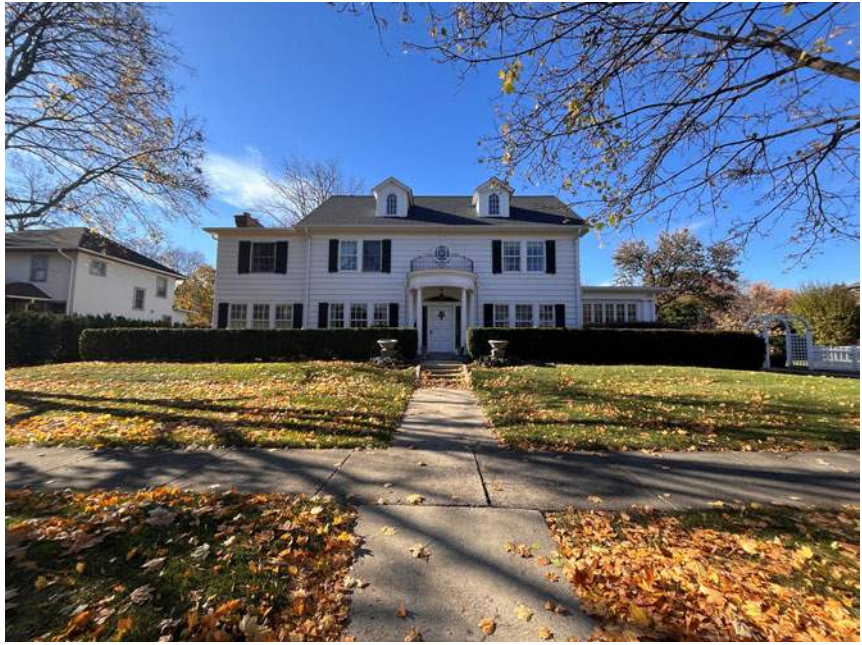
| ALTERATIONS | Replacement windows in original openings (not historic); second-story added to one-story south wing (c. 1940); one story rear addition to sun porch (not historic). Post-2007 -- no changes to principal structure; detached garage replaced with new garage/guesthouse. | | |
