CITY OF NAPERVILLE

**BID NUMBER: REQ-22-114 WORK
ORDER #4**

**ENGINEERING SERVICES FOR
CENTRAL ELEVATED WATER
TANK RELOCATION**

APPENDIX B – CENTRAL ELEVATED WATER TANK INSPECTION REPORT 10

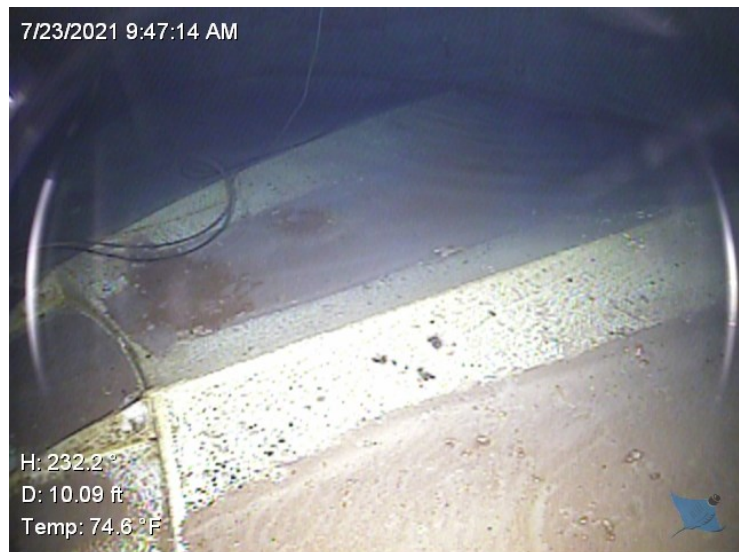
62) The bowl coating is in fair condition overall.

63) Same.

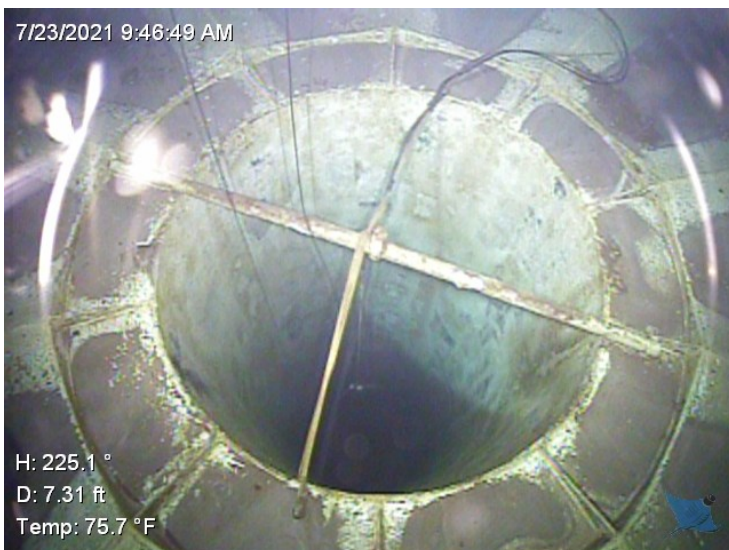
66) There is no safety grate over or around handrail the riser.
