HISTORIC NAME First Congregational Church of Naperville (1906 Building)

SURVEYAREA NAPERVILLE SURVEY UPDATE

City of NAPERVILLE
2025 HISTORIC RESOURCES SURVEY UPDATE
CONTINUATION SHEET

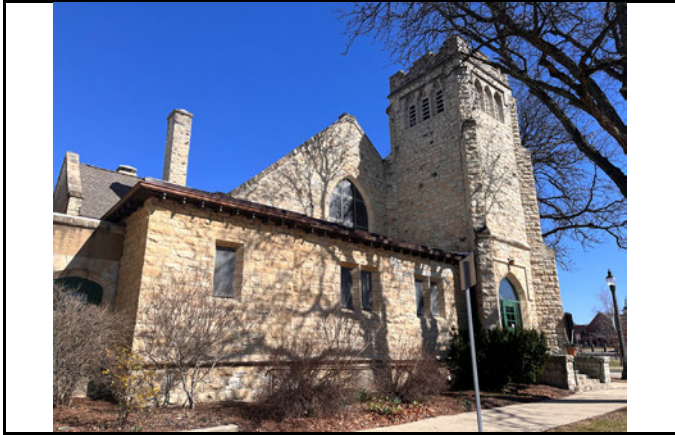
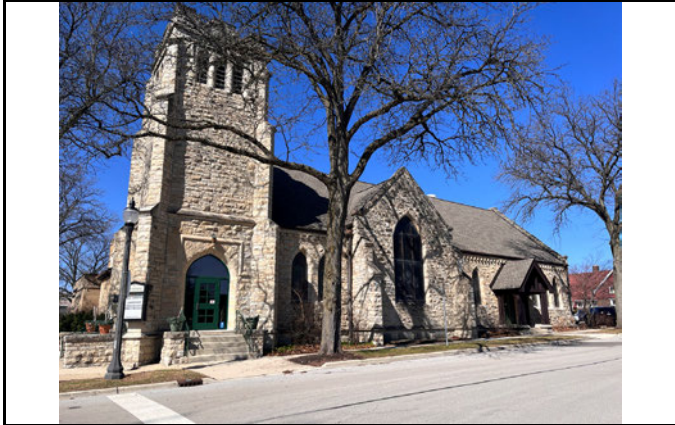
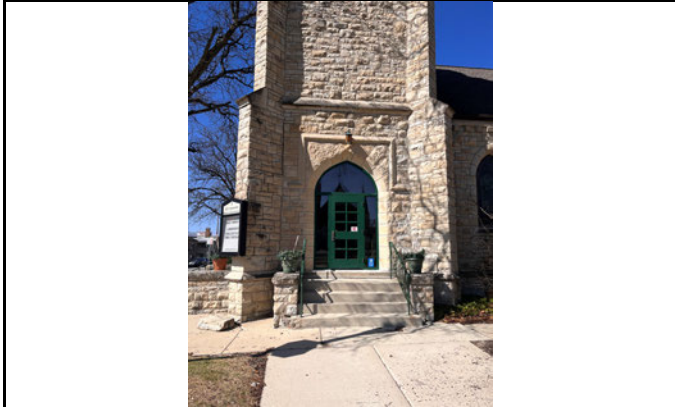
SIGNIFICANT FEATURES 1906 Building -- rough-face stone exterior; parapeted front gable main roof; prominent southeast corner entrance/bell tower with buttressed corners, pointed-arch louvered openings at belfry, and crenelated parapet; pointed-arch entrance openings on south and east walls of tower framed with limestone label molds; one-story wing extending from west wall of bell tower; projecting bay on east elevation with parapeted gable and buttressed corners; gable-roof entrance porch to original Sunday school wing at north end of east elevation

ALTERATIONS Alterations to 1906 building -- replacement entrance doors at bell tower; handrails at entrance steps; slate roof replaced with asphalt shingle; western entrance removed to accommodate 1930 parish hall addition. Two-story Late Gothic Revival west parish hall addition (1930, not included in landmark ordinance); one-story Neo-Gothic Revival west addition (1979, not included in landmark ordinance)

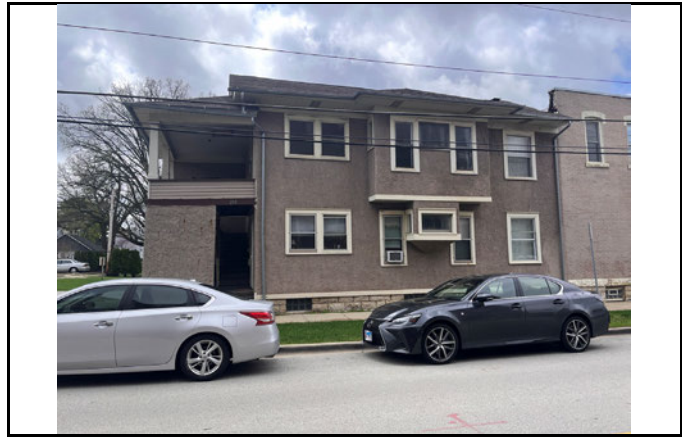
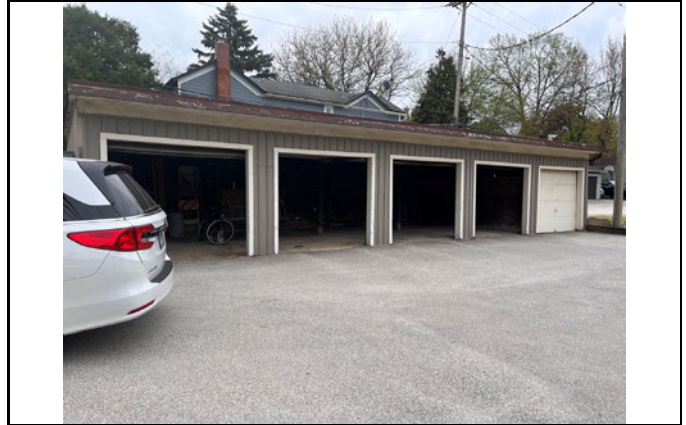
SIGNIFICANT FEATURES Sanborn maps indicate that the building was either remodeled from or built on the foundation of an early addition to building at 4-6 S. Ellsworth. The original building was a one-story frame structure (c. 1895); the second story was built between 1898 and 1909. The exterior was clad in stucco between 1909 and 1921, and the second-story projecting window bay was likely added at that time. Significant historic features include the hipped roof with overhanging eaves and second-story square projecting window bay on north elevation

ALTERATIONS 1/1 replacement windows in original openings (wood and vinyl); glass block replacement windows in basement; east 2-story porch addition (c. 1950). Post-2007 - no changes.

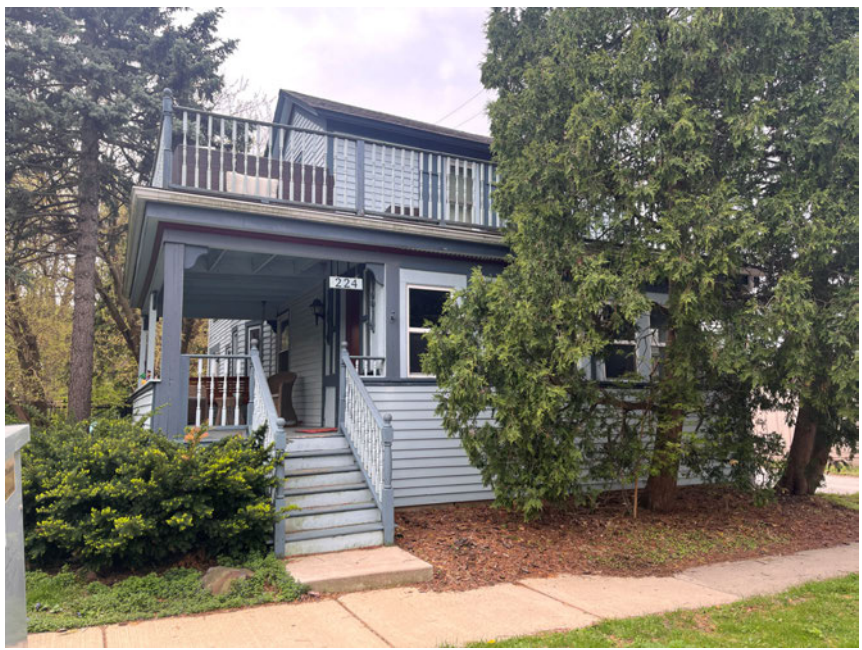
Historic 5-light wood storms in enclosed section of porch replaced with 1/1 aluminum or vinyl windows.

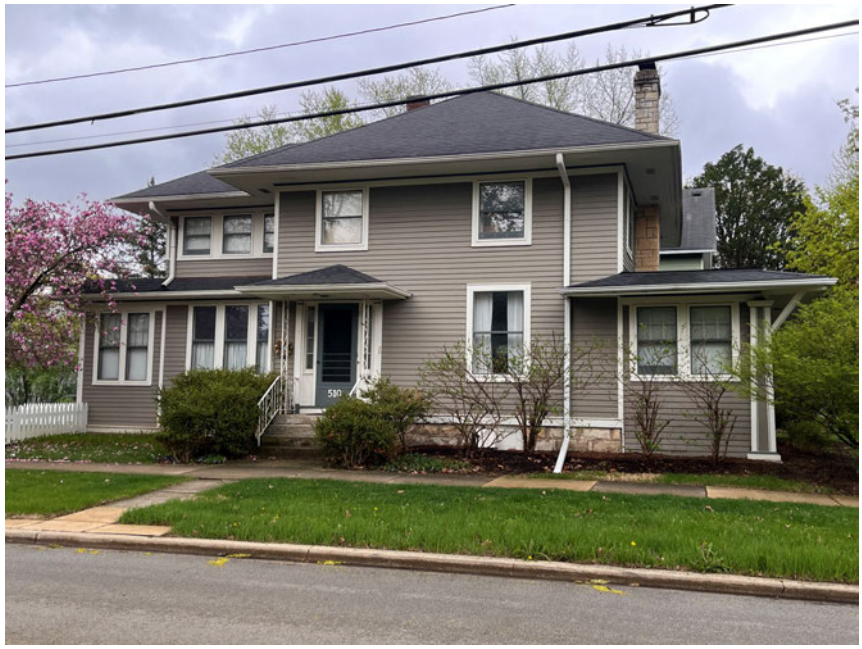
9/1 Aluminum/vinyl replacement windows on front façade.
