ORGANIZATION RAMSEY HISTORIC CONSULTANTS

SURVEYAREA NAPERVILLE SURVEY UPDATE

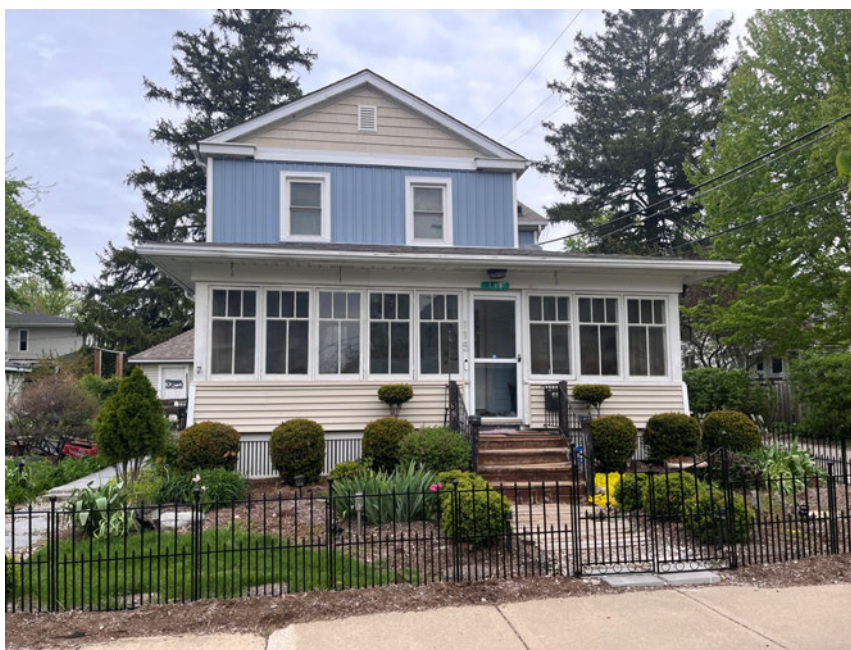
HISTORIC INFO According to owner of Bungalow on Center Street, this house was moved from the site of his house to Franklin when his house was built in the 1920s.

Work Not Requiring COA Replacement siding and windows on east and west secondary elevations.

Vertical replacement siding and replacement windows in original openings on front façade

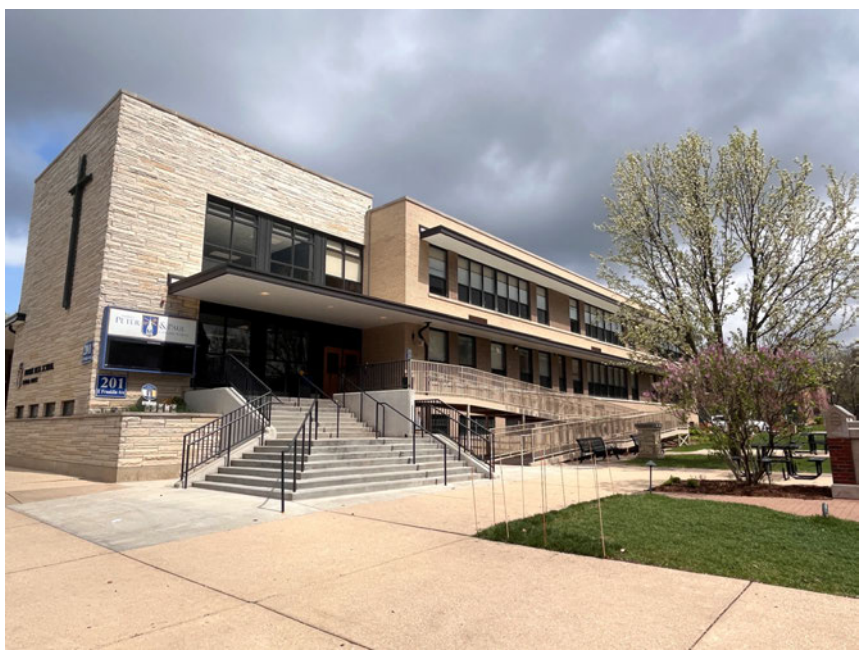
ALTERATIONS Multi-light steel windows on south elevation east of main entrance replaced with 1/1 double-hung Aluminum windows; Post-2007 -- wheelchair ramp along south elevation. New steps at southwest entrance; windows and doors at main entrance replaced with new Aluminum windows that match the original configuration

Wheelchair ramp along south elevation. New steps at southwest entrance

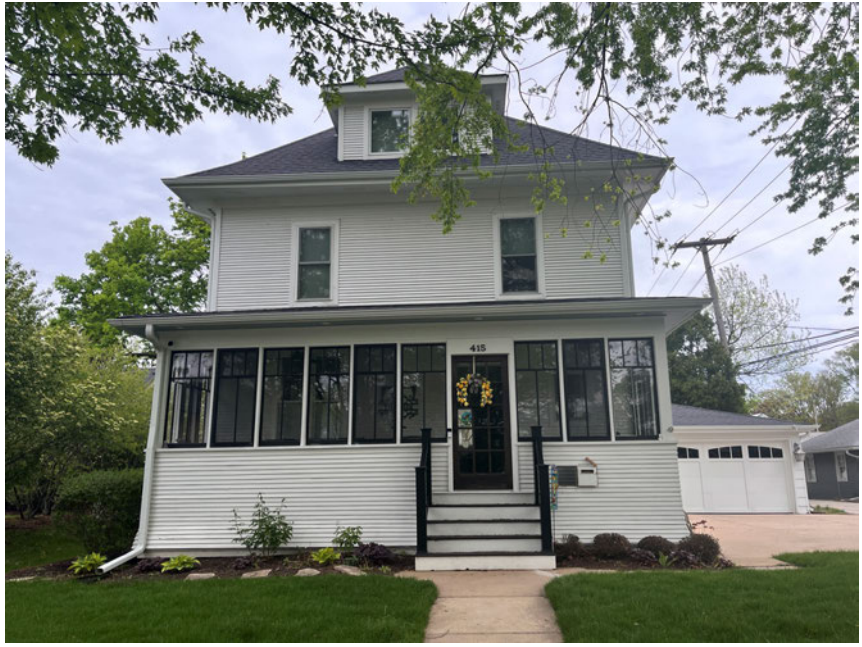
SIGNIFICANT FEATURES Rectangular massing and wood exterior siding; full-width front porch with shallow hipped roof; historic 1/1 wood windows on front elevation above porch and at first and second stories of west elevation at original structure; some historic windows also remain on east elevation; 5-light windows at porch enclosure

ALTERATIONS Replacement front door and steps (not historic); one-story rear addition/connector addition to rear garage (not historic). Post-2007 -- roof rebuilt with steeper pitch and taller front and side dormers; one story east addition at garage; 2nd-story addition over existing northeast addition between house and garage; oriel bay on east elevation extended up to create a two-story bay that pierces the roofline; some 1/1 Aluminum replacement windows in original and altered openings; replacement porch door and replacement door in ground-level east entrance; rear deck.

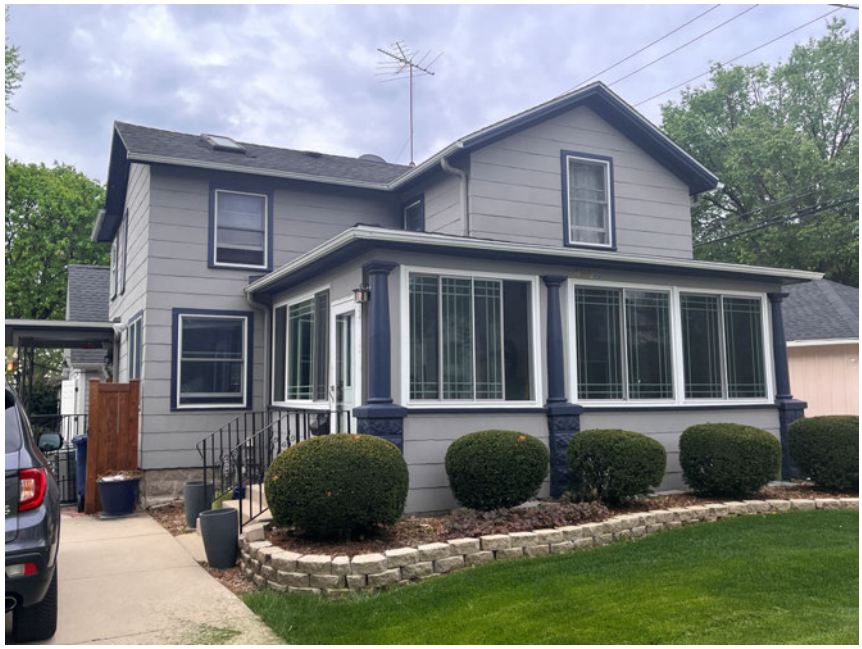
ALTERATIONS Replacement siding (1950s); front porch extended (c. 1915); 1/1 aluminum or vinyl replacement windows throughout, and in altered opening on wing; 2 story rear addition (post-1954); east side entry porch (post-1954); skylights. Post-2007 -- paired nine-light wood casement windows in porch replaced with aluminum/vinyl multi-light fixed windows; repainted.

Paired nine-light wood casement windows in porch replaced with aluminum/vinyl multi-light fixed windows.
