PREPARER	Lara Ramsey	SURVEYDATE	12/4/2025
ORGANIZATION	RAMSEY HISTORIC CONSULTANTS	SURVEYAREA	NAPERVILLE SURVEY UPDATE

ILLINOIS URBAN ARCHITECTURAL AND HISTORICAL SURVEY CONTINUATION SHEET

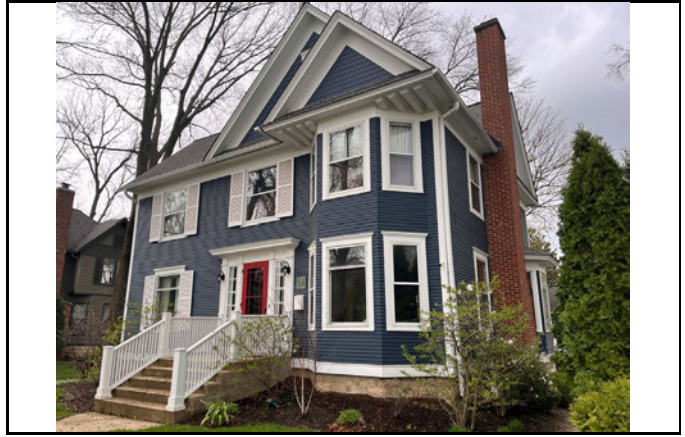
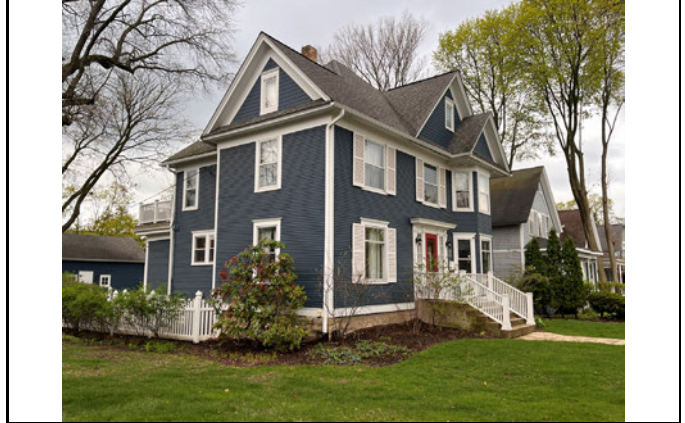
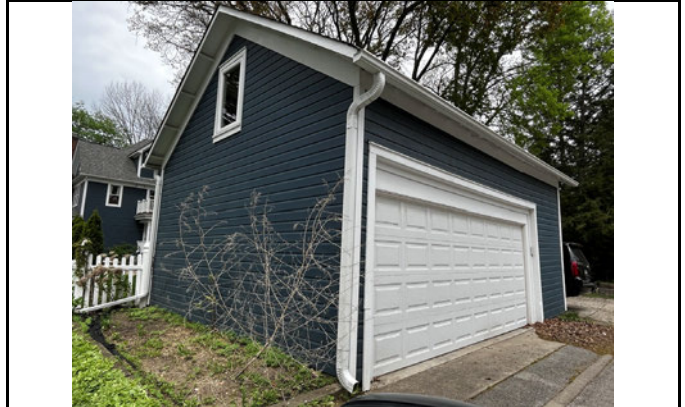
HISTORIC NAME	
COMMON NAME	
ARCHITECT	
BUILDER	
ARCHITECT SOURCE	
HISTORIC INFO	
PERMITS	
LANDSCAPE	Midblock on east side of residential street; front sidewalk; rear alley; rear picket fence; similar setbacks; mature trees
COA DATES	10/20/2010
COA DECISION	COA #10-3041 - Window replacement (approved 10/25/2010)
COA Compliance Notes	
COA Work Not Completed	Windows do not appear to have been replaced (COA #10-3041)
Work Not Requiring COA

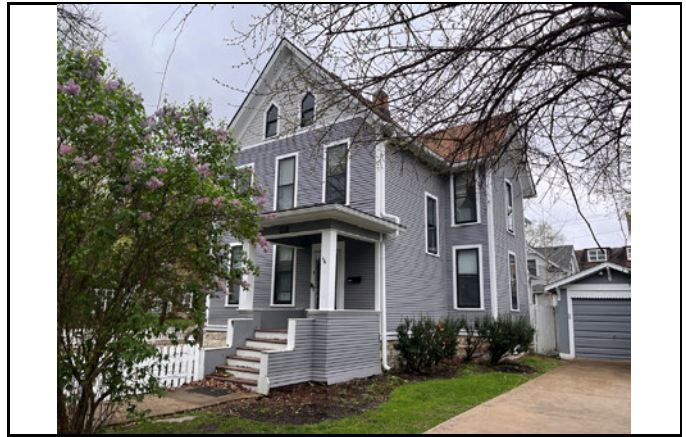
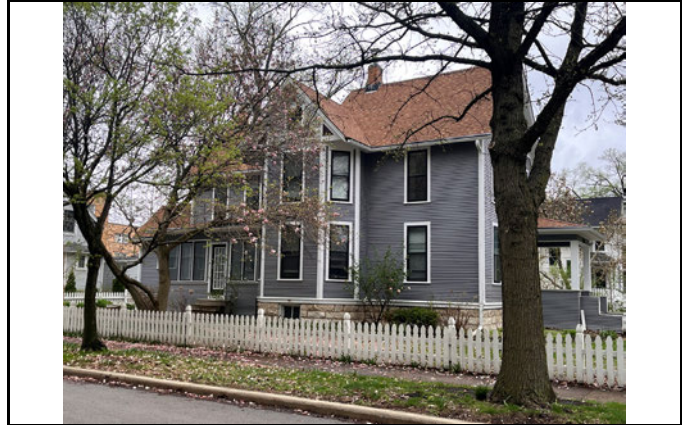
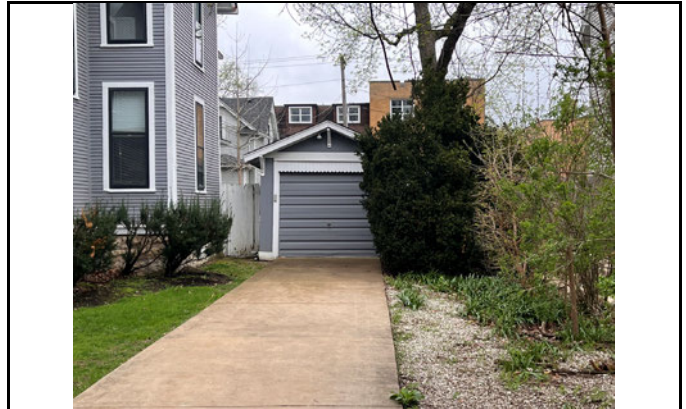
HISTORIC NAME	
COMMON NAME	
ARCHITECT	
BUILDER	
ARCHITECT SOURCE	
HISTORIC INFO	
PERMITS	
LANDSCAPE	Northwest corner of School and Sleigh; front sidewalk; side driveway; similar setbacks; mature trees
COA DATES	
COA DECISION	
COA Compliance Notes	
COA Work Not Completed	
Work Not Requiring COA	Exterior repainted.

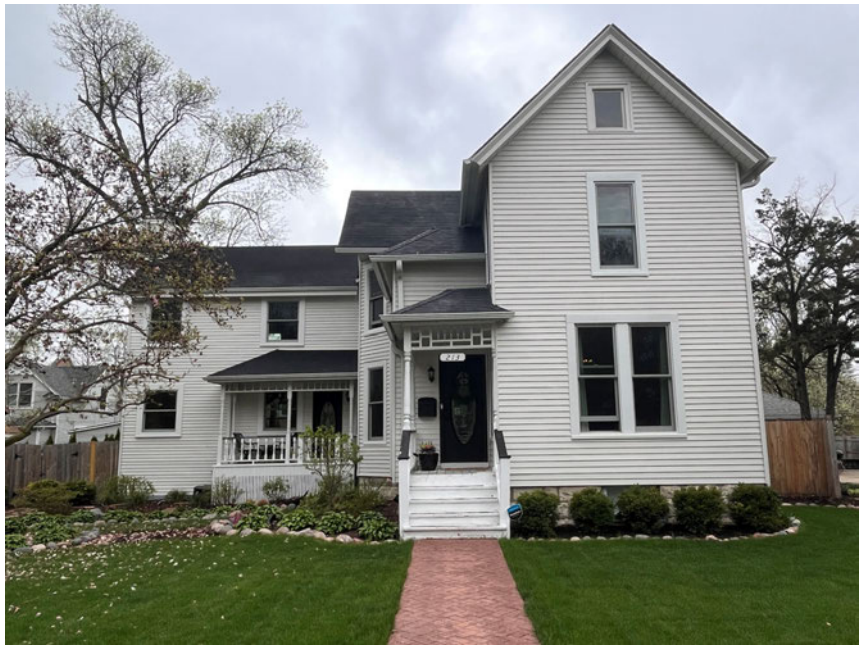
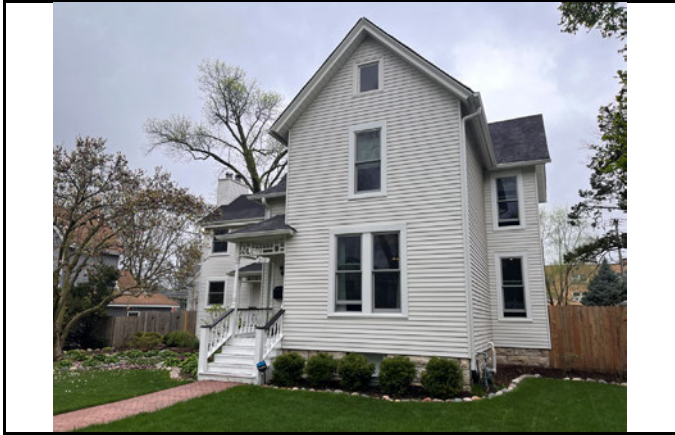
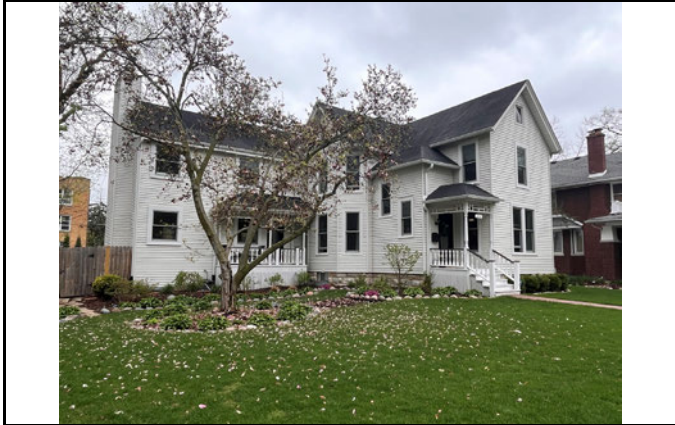
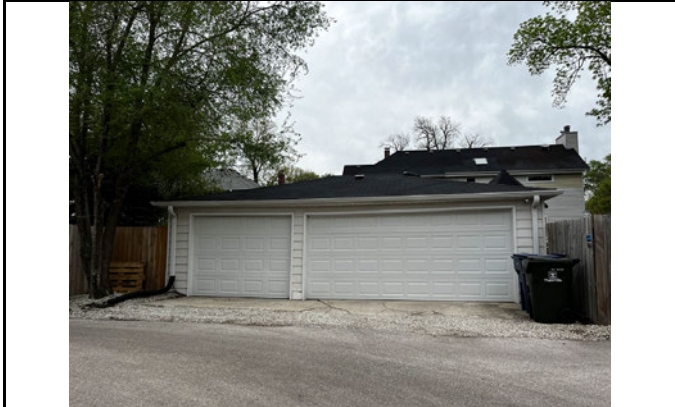
COA DECISION COA #21-5627 - Same size and style window replacement with aluminum clad wood (approved 12/16/2021)

COA Compliance Notes Trim around windows replaced with wider trim.

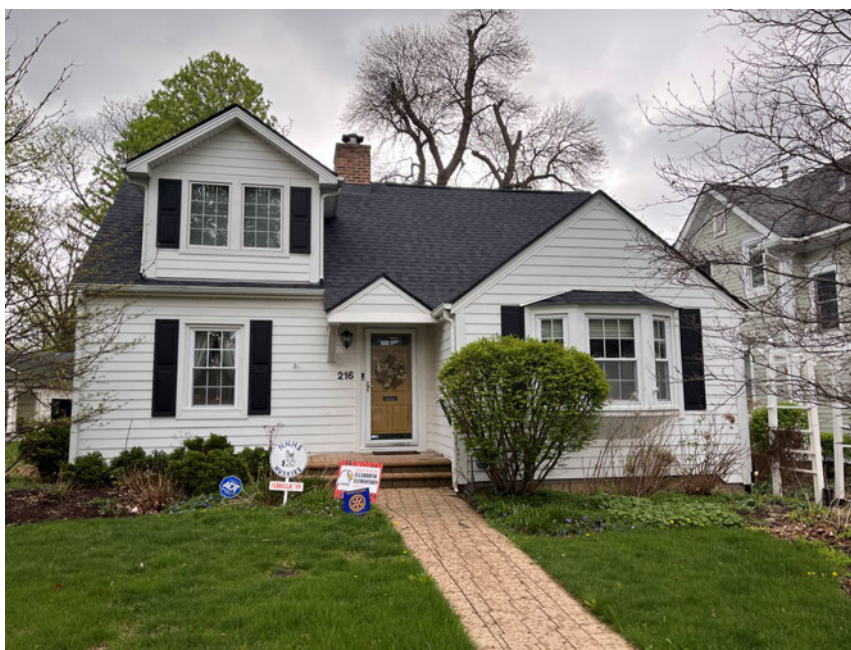
HISTORIC NAME	
COMMON NAME	
ARCHITECT	
BUILDER	
ARCHITECT SOURCE	
HISTORIC INFO	
PERMITS	
LANDSCAPE	Midblock on east side of residential street; front sidewalk; rear alley; similar setbacks; mature trees
COA DATES	
COA DECISION	
COA Compliance Notes	
COA Work Not Completed	
Work Not Requiring COA	One-story rear addition; south entry porch enclosed; replacement siding and windows on secondary north and south elevations

Replacement siding on front façade; 6/6 and 4/4 double-hung replacement windows on front façade; replacement entry steps; shed-roof entry canopy replaced with gabled canopy

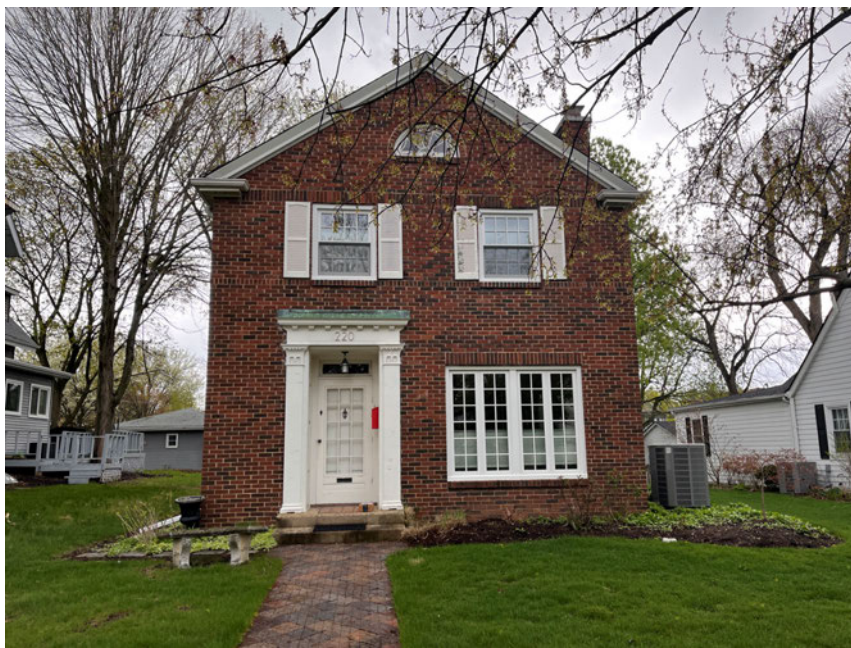
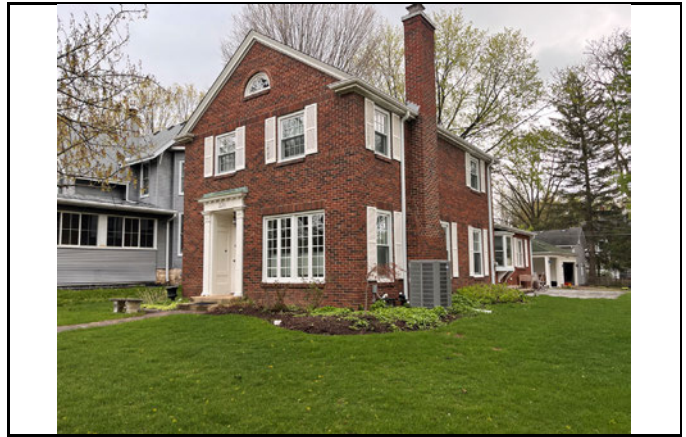
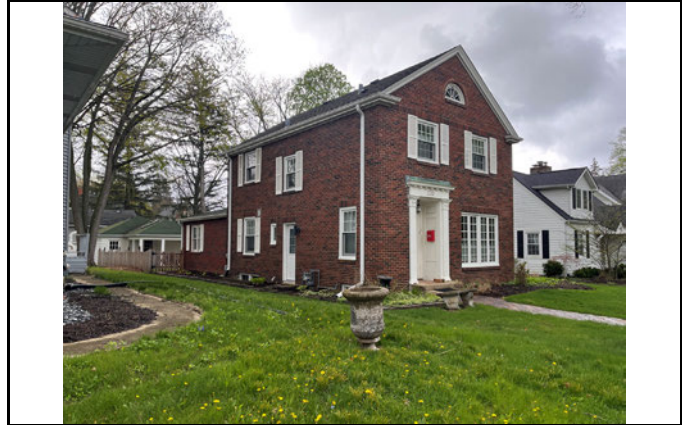
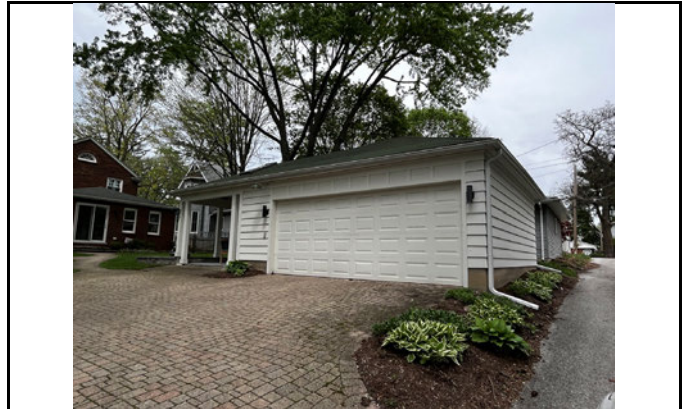
HISTORIC NAME	
COMMON NAME	
ARCHITECT	
BUILDER	
ARCHITECT SOURCE	
HISTORIC INFO	
PERMITS	
LANDSCAPE	Midblock on east side of residential street; front sidewalk; rear alley; similar setbacks; mature trees
COA DATES	8/4/2023
COA DECISION	COA #23-3000 - In-kind window replacement maintaining grid pattern and use of aluminum clad wood (approved 9/5/2023)
COA Compliance Notes	
COA Work Not Completed	
Work Not Requiring COA

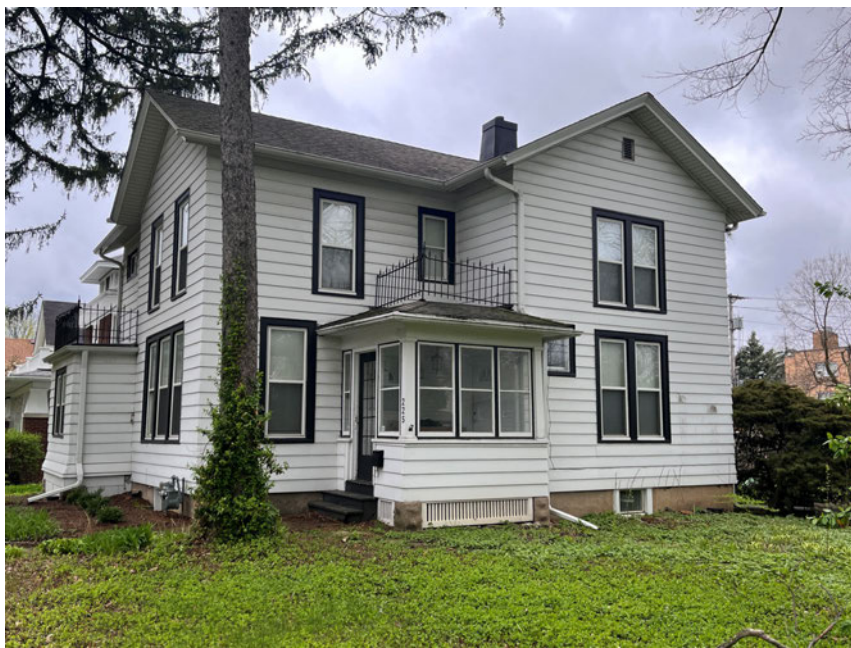
HISTORIC NAME	
COMMON NAME	
ARCHITECT	
BUILDER	
ARCHITECT SOURCE	
HISTORIC INFO	
PERMITS	
LANDSCAPE	Southwest corner of North and Sleight; front and east sidewalks; principal façade on north; mature trees; similar setbacks
COA DATES	
COA DECISION	
COA Compliance Notes	
COA Work Not Completed	
Work Not Requiring COA	Replacement windows on west elevation

Work Completed Without COA	1/1 double-hung Aluminum replacement windows on primary east and north elevations
-----------------------------------	---

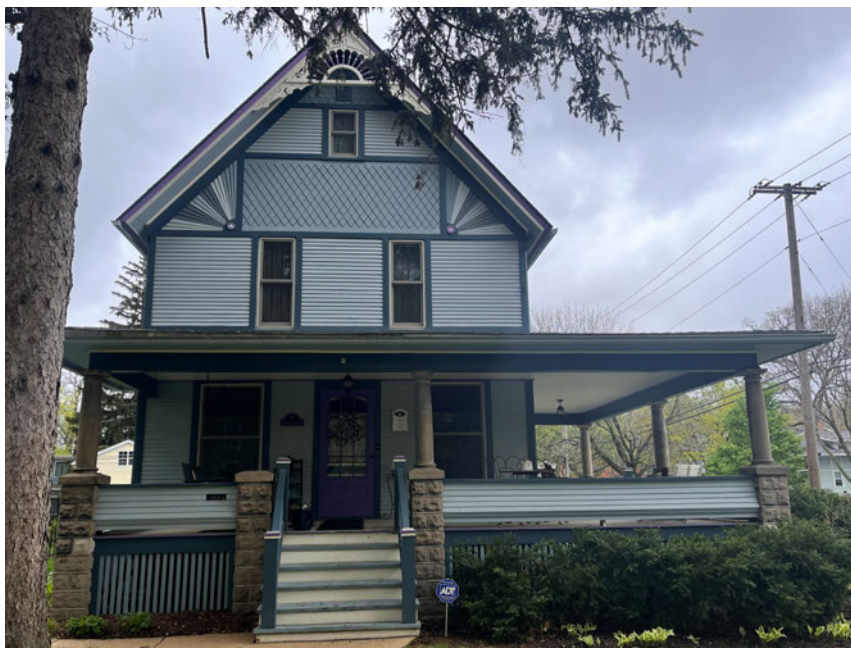
HISTORIC NAME	Lueben, Fred A. House
COMMON NAME	
ARCHITECT	
BUILDER	West, John A.
ARCHITECT SOURCE	
HISTORIC INFO	House remained in the Lueben family until the death of Helen Lueben in 1999, when it was sold to the current owners.
PERMITS	
LANDSCAPE	Southwest corner of Sleight and Benton; front and north sidewalks; rear alley; similar setbacks; mature trees
COA DATES	10/4/2012
COA DECISION	COA #12-3810 - Roof replacement (approved 10/8/2012)
COA Compliance Notes	
COA Work Not Completed	
Work Not Requiring COA	Replacement windows on secondary south elevation

Most 1/1 windows on primary east and north elevations appear to be replacement windows (compatible type and configuration). Railings added to front porch steps.

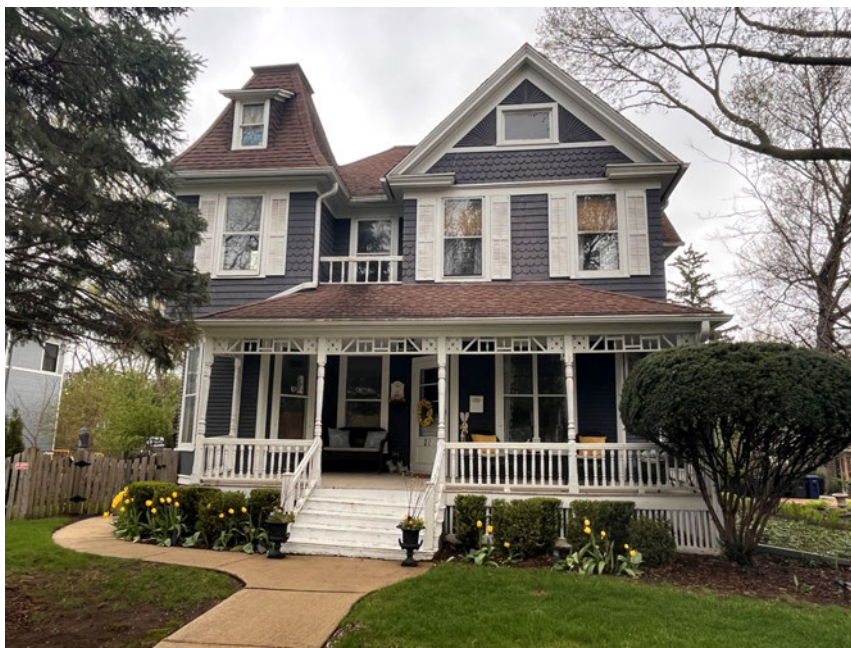
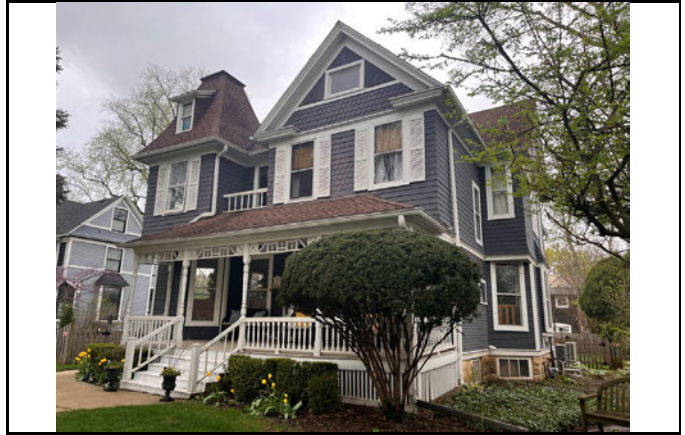
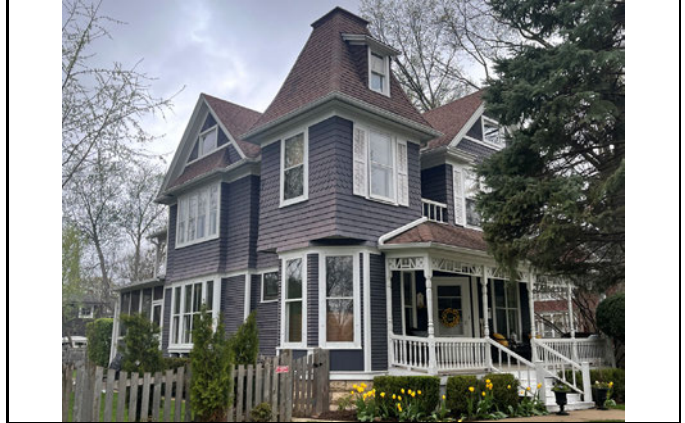
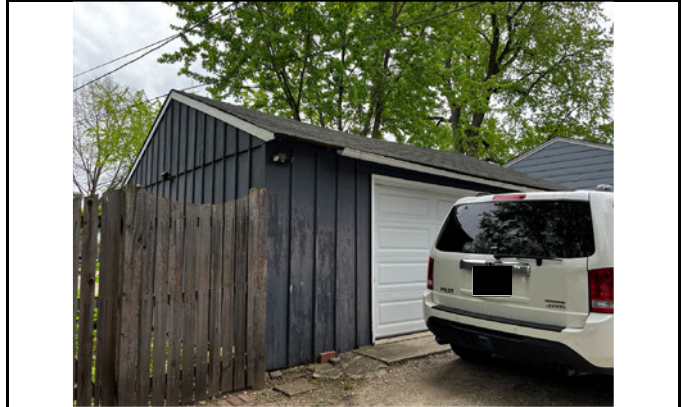
HISTORIC NAME	Strayer, Dr. Samuel S. House
COMMON NAME	
ARCHITECT	
BUILDER	
ARCHITECT SOURCE	
HISTORIC INFO	House featured on p. 404 of A GUIDE TO CHICAGO'S HISTORIC SUBURBS.
PERMITS	Plaque gives date of construction as 1884.
LANDSCAPE	Midblock on west side of residential street; front sidewalk; rear alley; similar setbacks; mature trees
COA DATES	
COA DECISION	
COA Compliance Notes	
COA Work Not Completed	
Work Not Requiring COA	Exterior repainted.

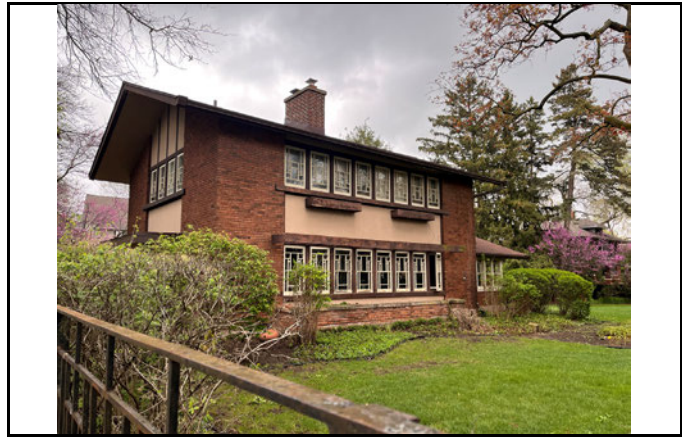
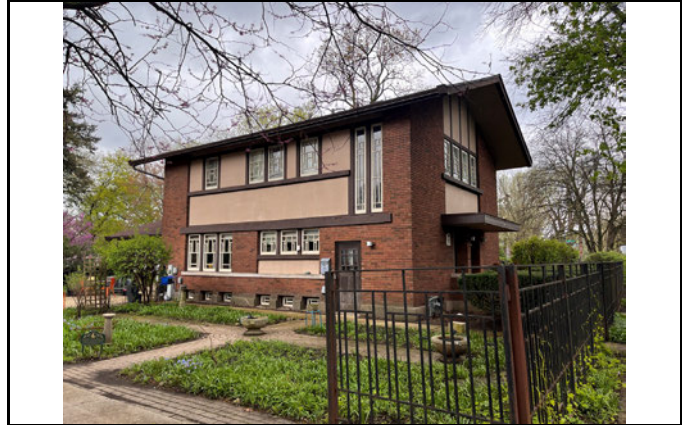
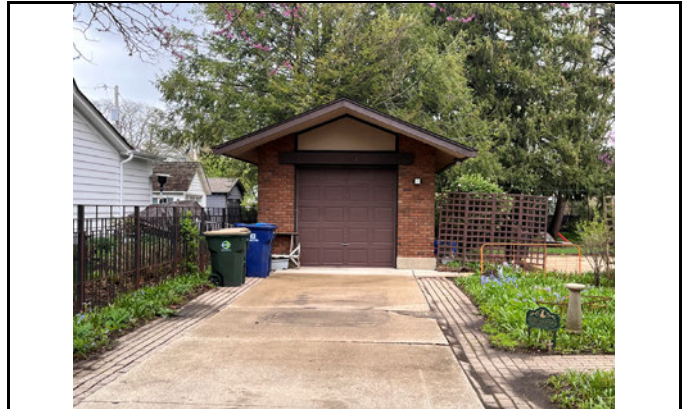
HISTORIC NAME	Givler, Rollo M. House
COMMON NAME	
ARCHITECT	Robinson, Harry
BUILDER	
ARCHITECT SOURCE	Plaque
HISTORIC INFO	According to NR Nomination, Rollo M. Givler owned and operated the CLARION, an early Naperville newspaper. Nomination dates house to 1917.
PERMITS	
LANDSCAPE	Northeast corner of Sleight and Chicago; front and south sidewalks; wrought iron fencing around lot, with design that mirrors windows on house; similar setbacks; mature trees
COA DATES	
COA DECISION	
COA Compliance Notes	
COA Work Not Completed	
Work Not Requiring COA
