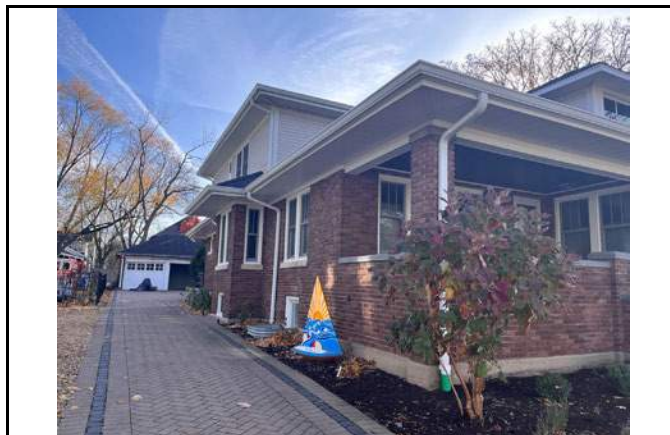
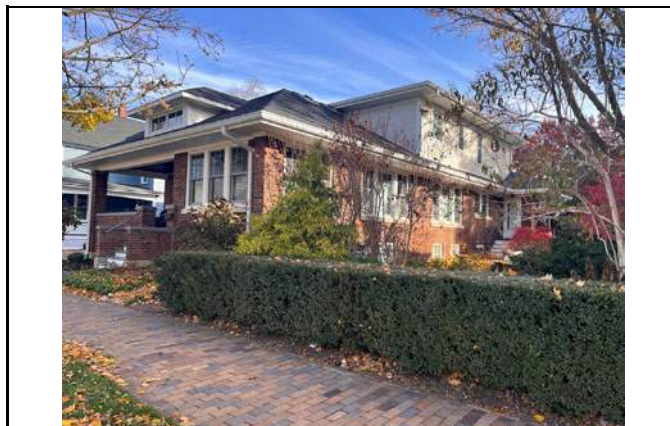
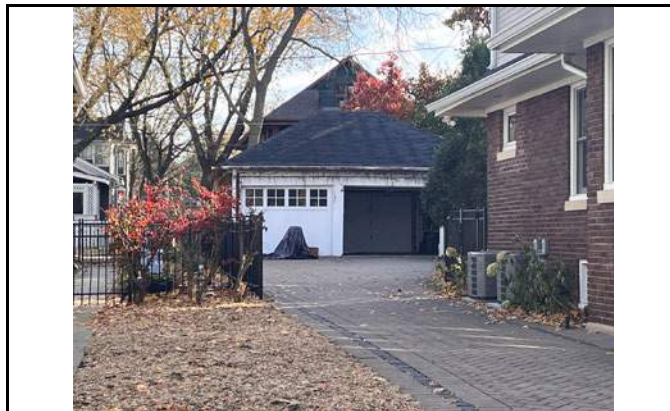
| ALTERATIONS | Second story rear addition (not historic); glass block in rear/north window (not historic); Aluminum siding under eaves. Post-2007 -- Aluminum or vinyl 3/1 double-hung replacement windows on front and side elevations; four single-light windows in dormers replaced with two 2-light windows; basement-level egress window installed on north elevation; vertical wood siding on second-story addition replaced with what appears to be Hardie board siding; removal of south dormer and second-story addition (COA approved). |

Vertical board siding on existing non-historic north 2nd-story addition replaced with fiber-cement siding (likely at the same time as the south addition was constructed).

Replacement double-hung windows on front and side elevations.

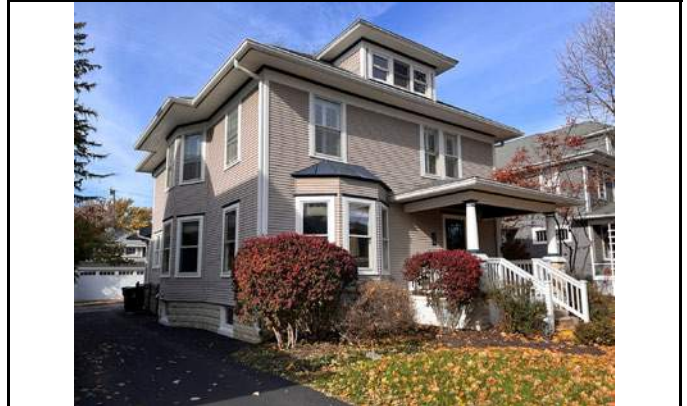
| <b>ALTERATIONS</b> | Replacement windows in dormers (not historic); front window bay addition (not historic); original full-width front porch replaced with entry porch (post-1943); rear porch addition. Post-2007 -- replacement porch railing (historically compatible); in-kind replacement of asphalt-shingle siding (COA approved). | | |

Porch railing replacement.

| <b>COA DECISION</b> | COA #17-4347 - In-kind replacement of asphalt shingles (approved 10/12/2017) |

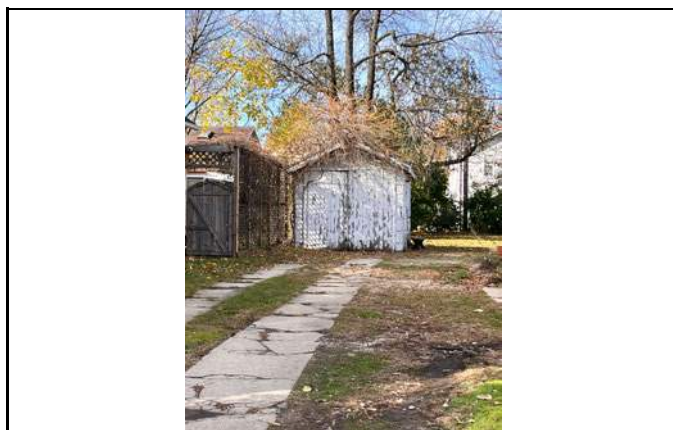
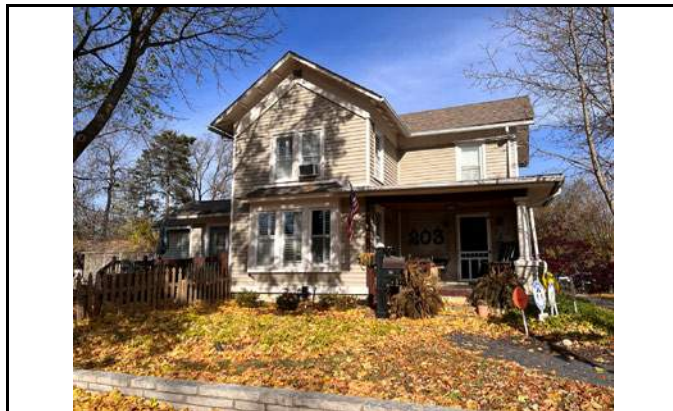
| ALTERATIONS | Replacement front porch (c. 1925); replacement vinyl windows in original openings (not historic); glass block windows in basement; square window bay addition to south elevation (post-1954); one story south addition (not historic); rear porch addition (not historic). Post-2007 -- front entrance relocated from east elevation of south-facing gable bay to south elevation of west-facing bay (COA approved); south/west deck addition. | | |

| <b>NOTES ON WORK:</b> | South deck addition. |

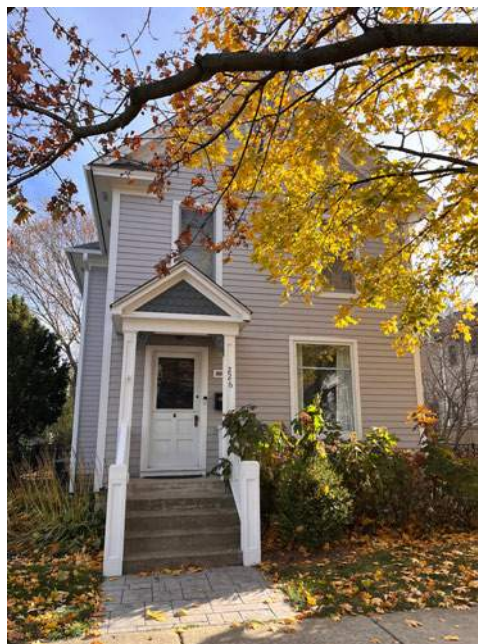
| ALTERATIONS | Front entry porch (post-1954); replacement concrete steps, possibly supports & railings, on south/rear porch (not historic). Post-2007 -- 1/1 Aluminum/vinyl replacement windows on second story of front façade on on side elevations; 2nd-story window at west end of north elevation appears to be in a downsized opening; wood siding replaced with fiber cement (wider width than previous wood siding); painted railing add to front steps; one-story bump-out constructed on south wall of three-sided first-story bay on south elevation |

| <b>COA COMPLIANCE NOTES:</b> | Board width of replacement siding does not match historic wood siding. |

| <b>NOTES ON WORK:</b> | Replacement windows in original and altered openings on front and side elevations; bump-out on south window bay; porch railings. |

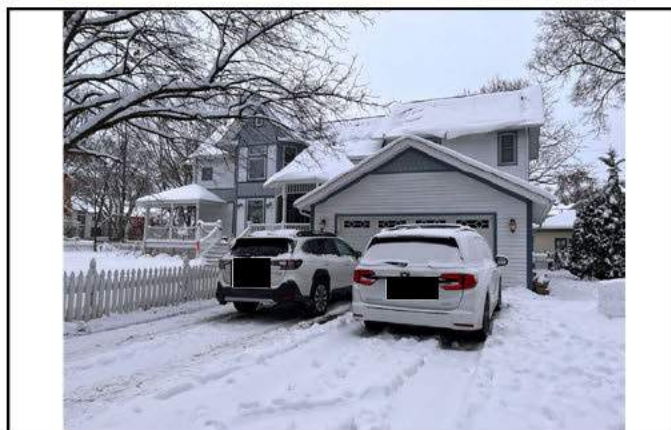
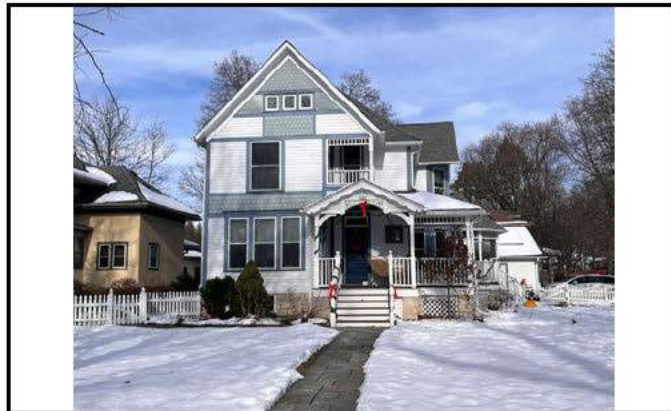
| ALTERATIONS | Replacement front porch (non-historic); east side deck addition; screened rear addition at northeast corner; replacement windows in original openings (historic); rear garage addition. Post-2007 -- solar panels added to roof at east elevation; replacement siding; multi-directional siding at base of front façade replaced with board siding. | | |

Replacement siding; solar panels on east slope of roof near southeast corner and on east slope of roof on rear bay.
