| STREET # | 108 |
| STREET | CENTER |

**GENERAL INFORMATION**

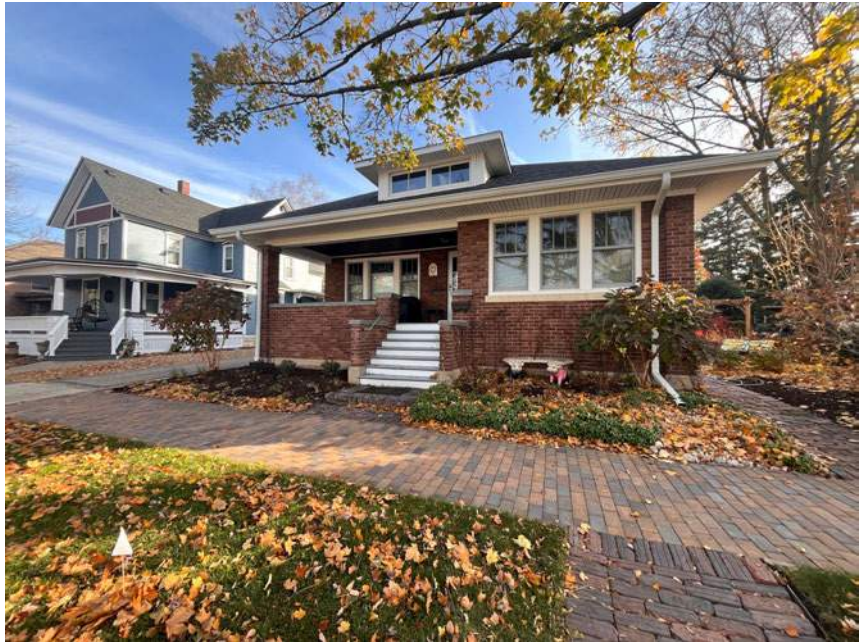
| ALTERATIONS | Second story rear addition (not historic); glass block in rear/north window (not historic); Aluminum siding under eaves. Post-2007 -- Aluminum or vinyl 3/1 double-hung replacement windows on front and side elevations; four single-light windows in dormers replaced with two 2-light windows; basement-level egress window installed on north elevation; vertical wood siding on second-story addition replaced with what appears to be Hardie board siding; removal of south dormer and second-story addition (COA approved). | | |

| COA COMPLIANCE NOTES: | Vertical board siding on existing non-historic north 2nd-story addition replaced with fiber-cement siding (likely at the same time as the south addition was constructed). |

| NOTES ON WORK: | Replacement double-hung windows on front and side elevations. |

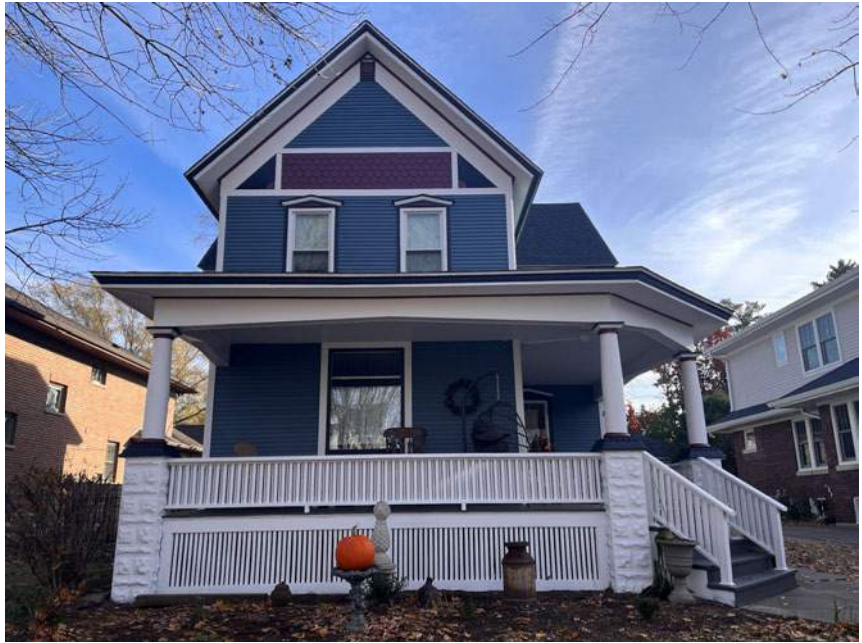
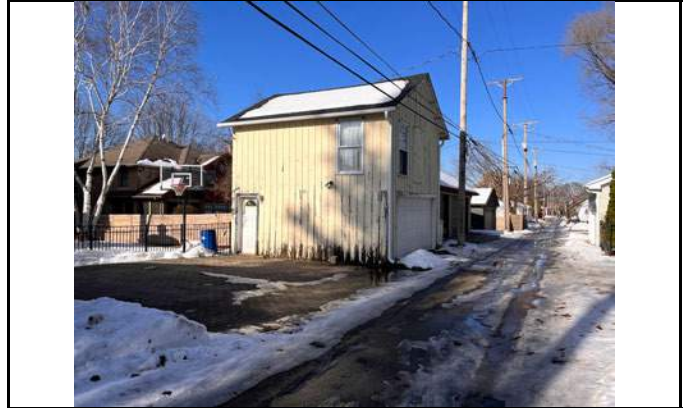
| ALTERATIONS | Replacement wraparound porch (historic-1910s); glass block and 3-part window on first story of north bay; 1 story rear porch addition; 1 story south sun porch addition. Post-2007 -- exterior repainted; asphalt shingle roof replaced (COA approved); exterior repainted; most double-hung windows on front and side elevations visible from the street appear to be Aluminum replacement windows | | |

Other windows on front and side elevations appear to have been replaced after 2007 – may have been replaced without COA before 2025 COA application.

**COA DECISION** HPC-0004-2025 - In-kind roof replacement with asphalt shingles (approved 9/8/2025); HPC-0005-2025 - In-kind replacement of two 2nd floor windows and trim using aluminum clad wood windows and wood or engineered wood trim (approved 9/10/2025)

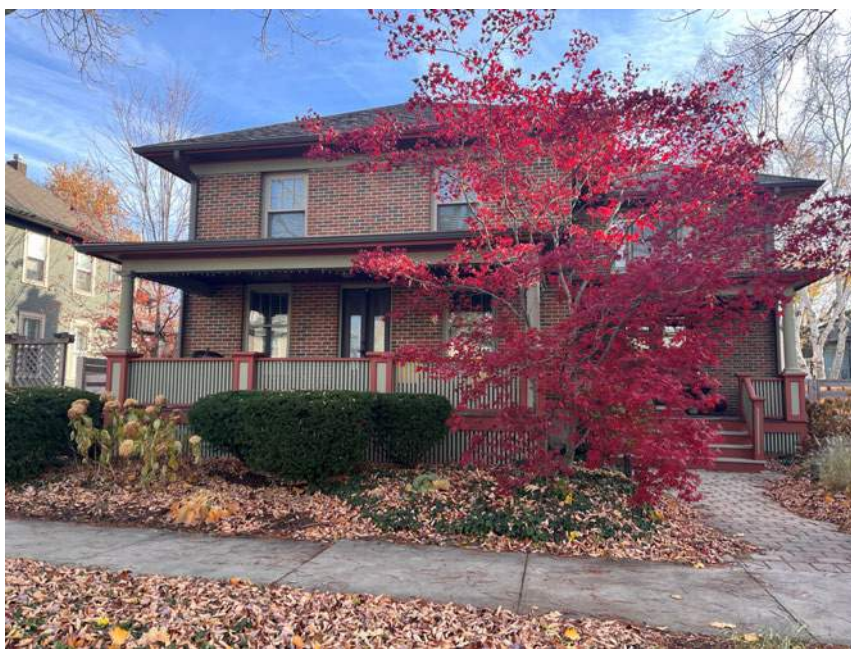
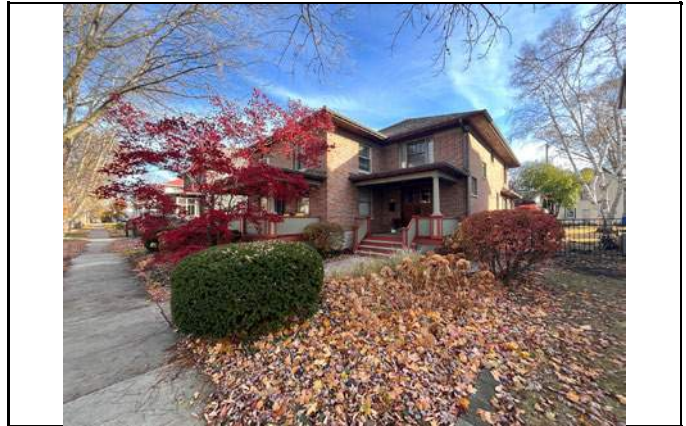
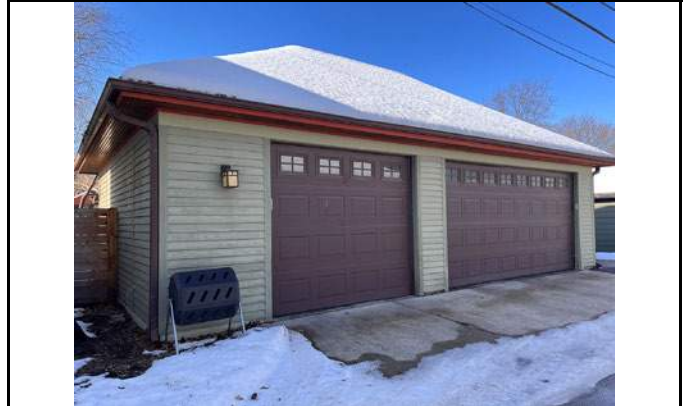
| ALTERATIONS | Brick veneering; front porch added to original house (historic--c. 1915--columns & railing may be later); two story south addition with new entry and porch (not historic); front door replaced (not historic); two story rear addition (not historic). Post-2007 -- Aluminum replacement windows in original openings with historic sash configurations (3/1 and 4/1) on 2nd story of front and side elevations. | | |

Aluminum replacement windows on second story of front façade and side elevations -- windows are in original openings and feature historically appropriate configuration.

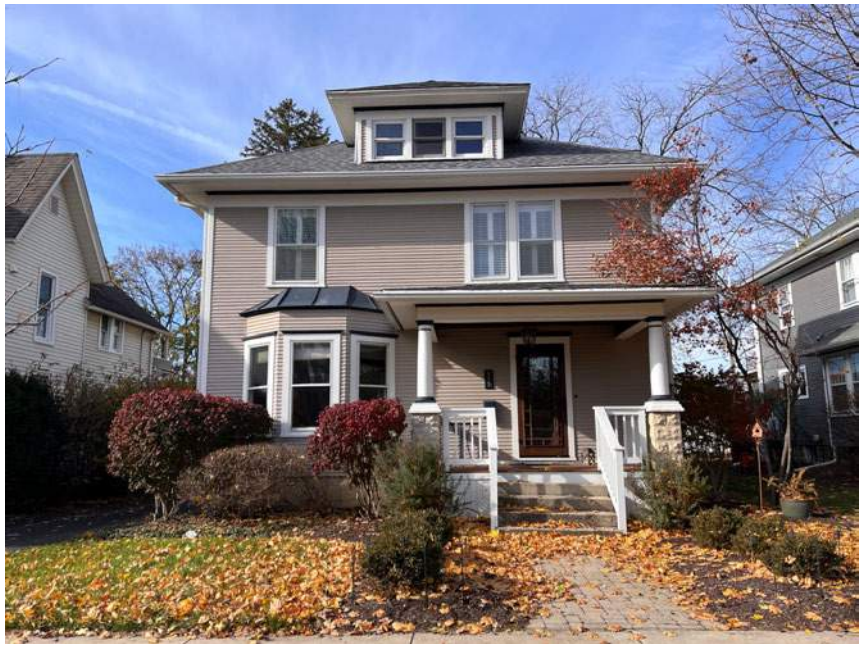
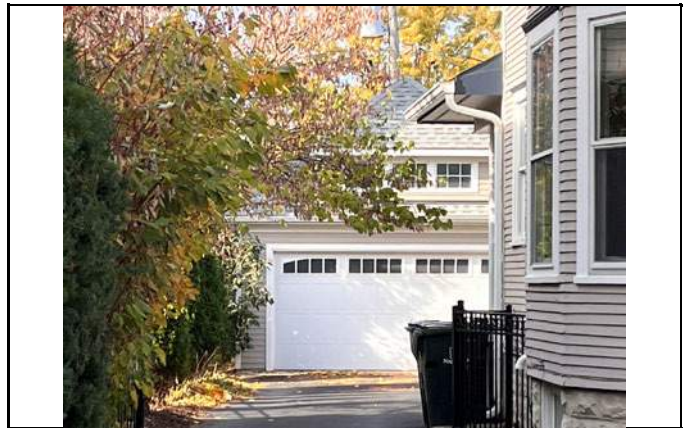
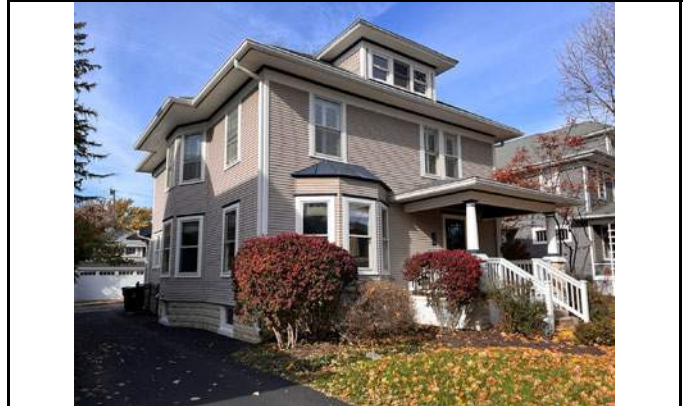
| <b>ALTERATIONS</b> | Replacement windows in dormers (not historic); front window bay addition (not historic); original full-width front porch replaced with entry porch (post-1943); rear porch addition. Post-2007 -- replacement porch railing (historically compatible); in-kind replacement of asphalt-shingle siding (COA approved). | | |

Porch railing replacement.

| <b>COA DECISION</b> | COA #17-4347 - In-kind replacement of asphalt shingles (approved 10/12/2017) |

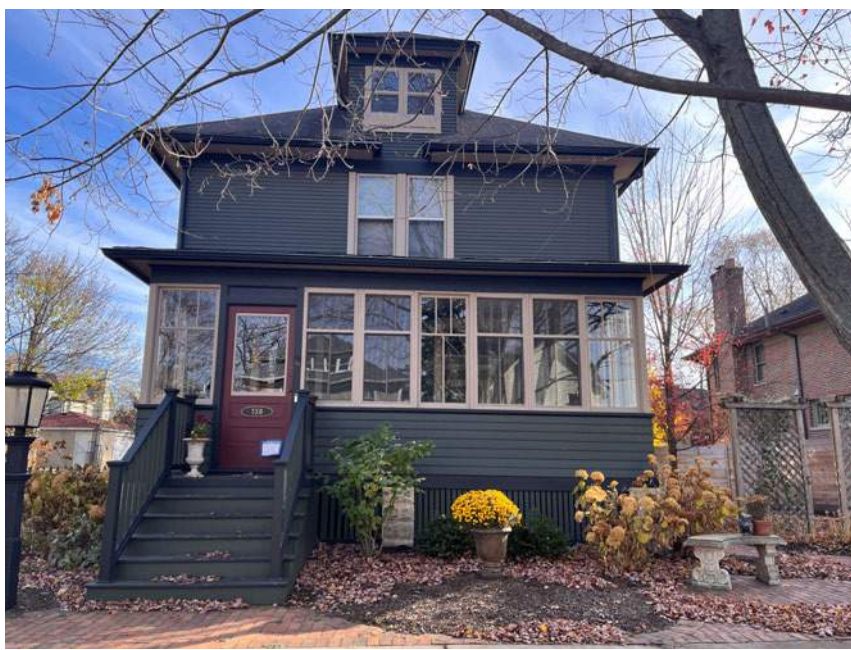
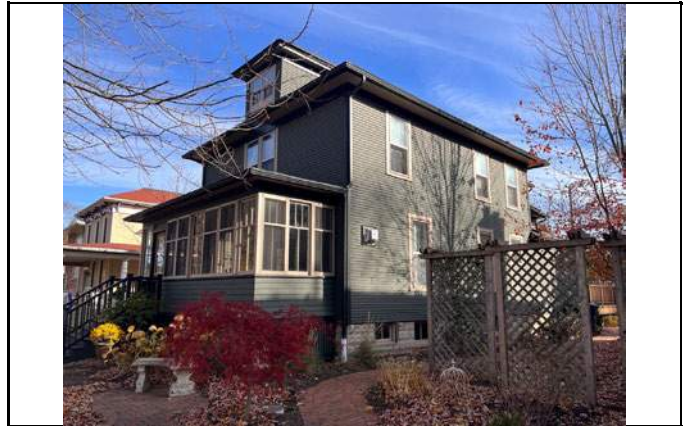
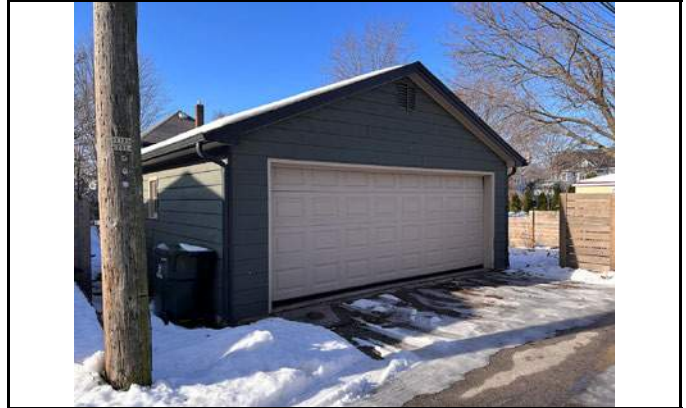
ALTERATIONS Front porch enclosed with 5-light storm windows (historic). Post-2007 -- concrete front steps and wrought iron railing replaced with painted wood steps and railings (COA approved); windows in front dormer replaced with new 1/1 double hung windows in downsized openings.

Two windows in front dormer replaced with 1/1 windows in downsized openings.

**COA DECISION** COA 19-2859 - cover existing cement steps with wood and replace railing with wood (approved 7/6/2019)

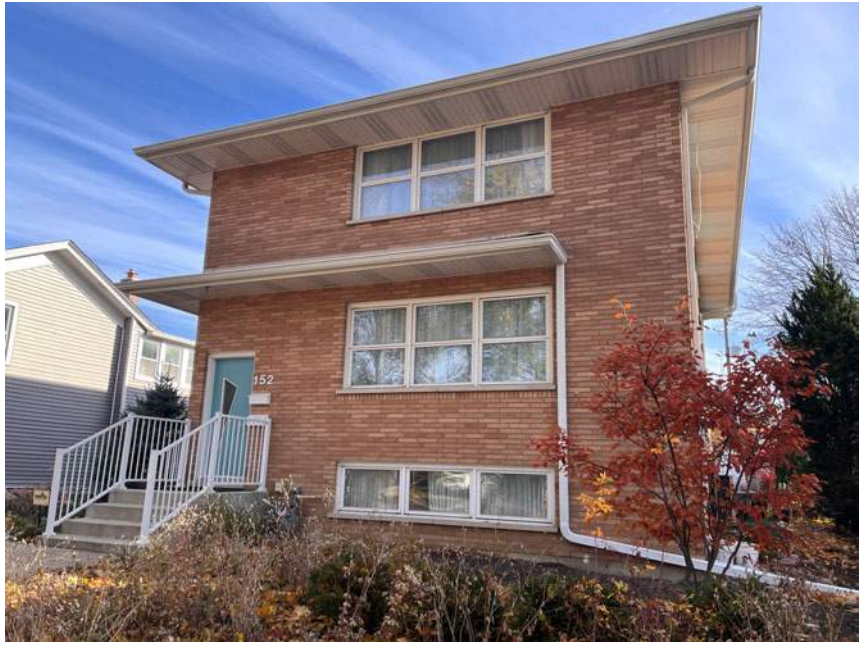
| ALTERATIONS | Post-2007 -- double-hung windows on north and south elevations visible from the street appear to be replacement windows; some basement window replacements on north and south elevations are in enlarged openings; replacement doors in front and north side entries (historically compatible); painted metal railing at steps leading to front entrance | | |

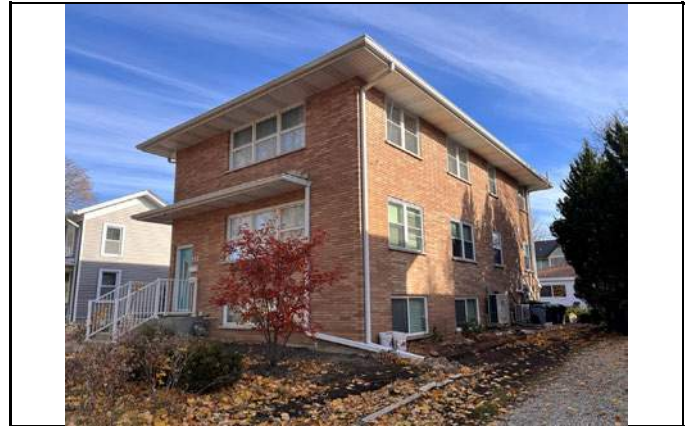
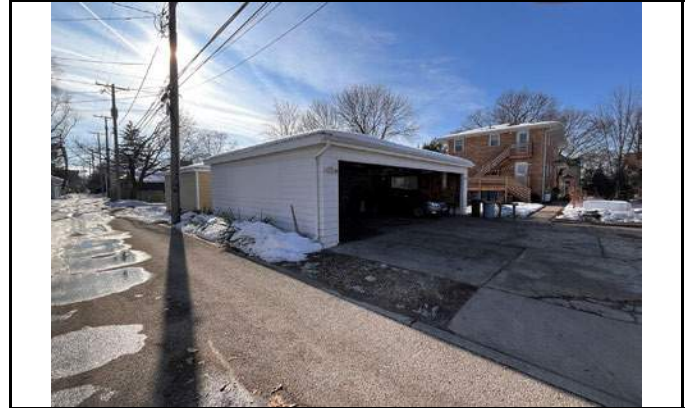
Replacement windows on north and south elevations; select basement windows replaced in enlarged openings; metal railing at front steps; replacement front and north side doors.

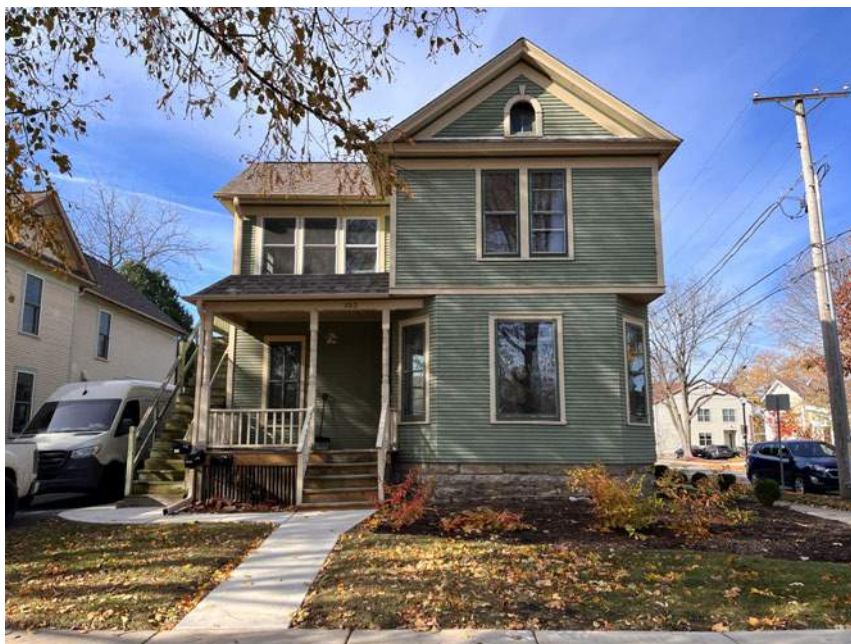
| ALTERATIONS | Replacement windows on 2nd story of south bay (not historic); door w/ exterior stair added to south bay (not historic) ; replacement porch (does not appear to be historic); 1 story south addition; two and one-story rear additions (historic); stained glass in front window does not appear to be historic. Post-2007 -- asphalt-shingle roof replaced in kind. |

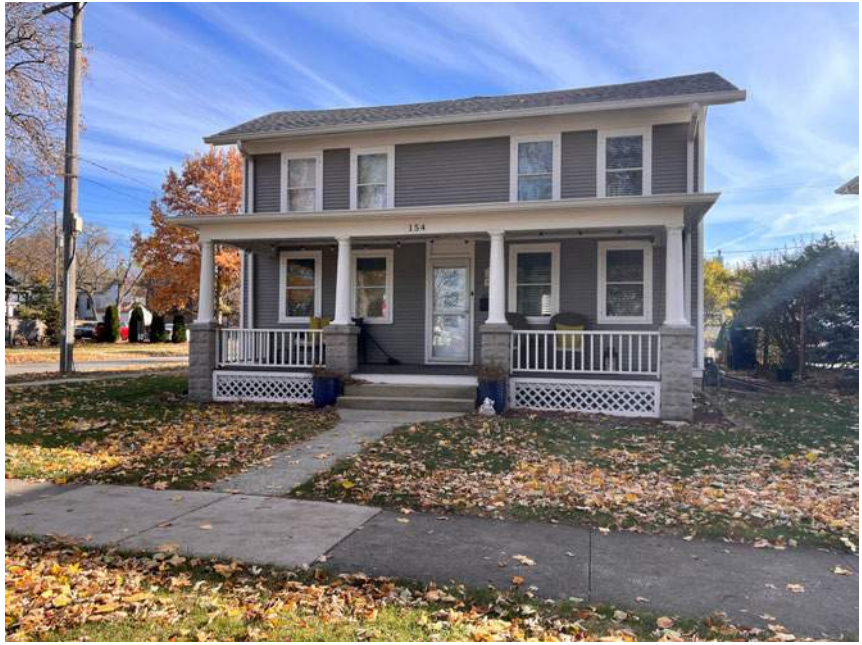
| ALTERATIONS | historic 1 story north and south side porches enclosed--2nd story added to south porch; replacement front door (1950s). Post-2007 -- 1/1 double hung Aluminum/vinyl replacement windows on north and south elevations; new front porch decking and handrails (COA approved); replacement door at secondary entrance on north elevation; concrete stoop at north entrance (not historic) replaced with smaller cast stone stoop. | | |

| <b>NOTES ON WORK:</b> | Replacement windows on north and south elevations; replacement door and stoop at north secondary entrance. |

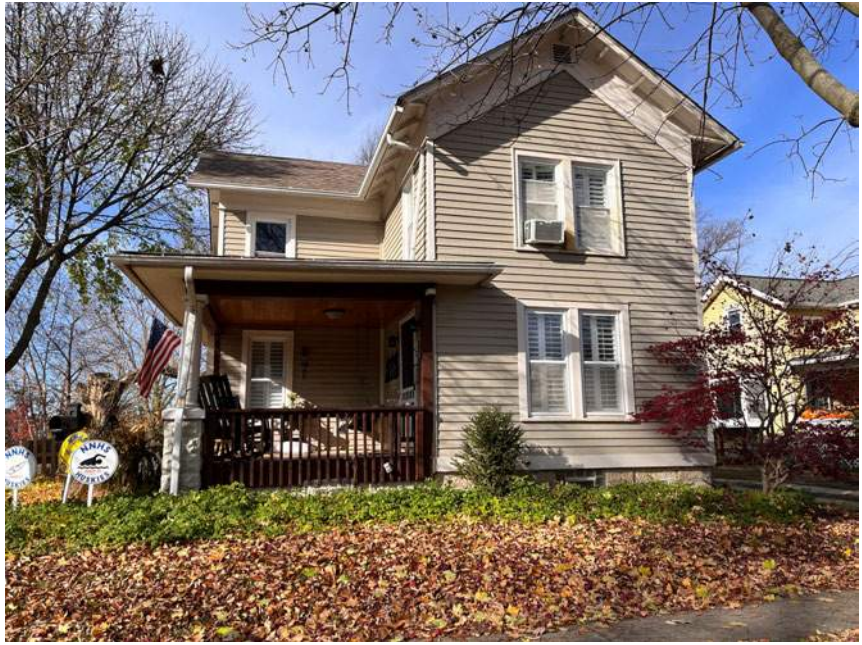
| ALTERATIONS | Replacement front porch (c. 1925); replacement vinyl windows in original openings (not historic); glass block windows in basement; square window bay addition to south elevation (post-1954); one story south addition (not historic); rear porch addition (not historic). Post-2007 -- front entrance relocated from east elevation of south-facing gable bay to south elevation of west-facing bay (COA approved); south/west deck addition. | | |

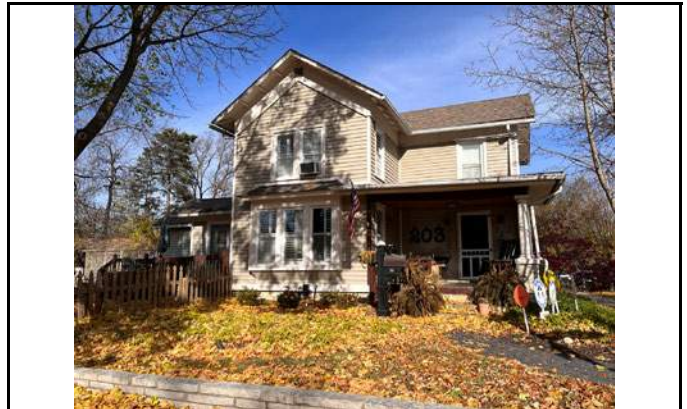
| <b>NOTES ON WORK:</b> | South deck addition. |

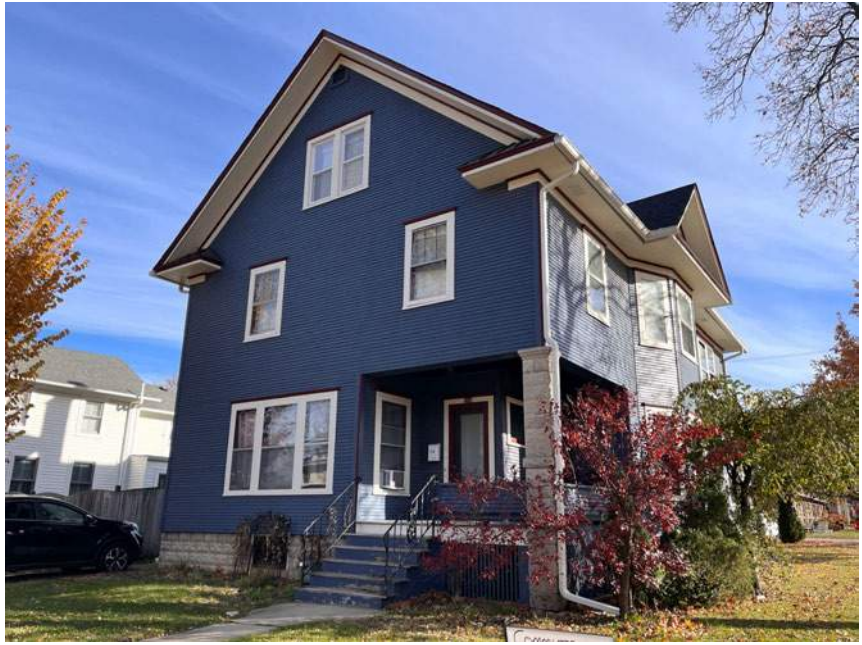
| ALTERATIONS | 3/1 wood replacement windows in original openings (historic); 2 story enclosed rear porch (historic); metal seam roofing on front cornice returns and south window bay (not historic). Post-2007 -- no changes. | | |

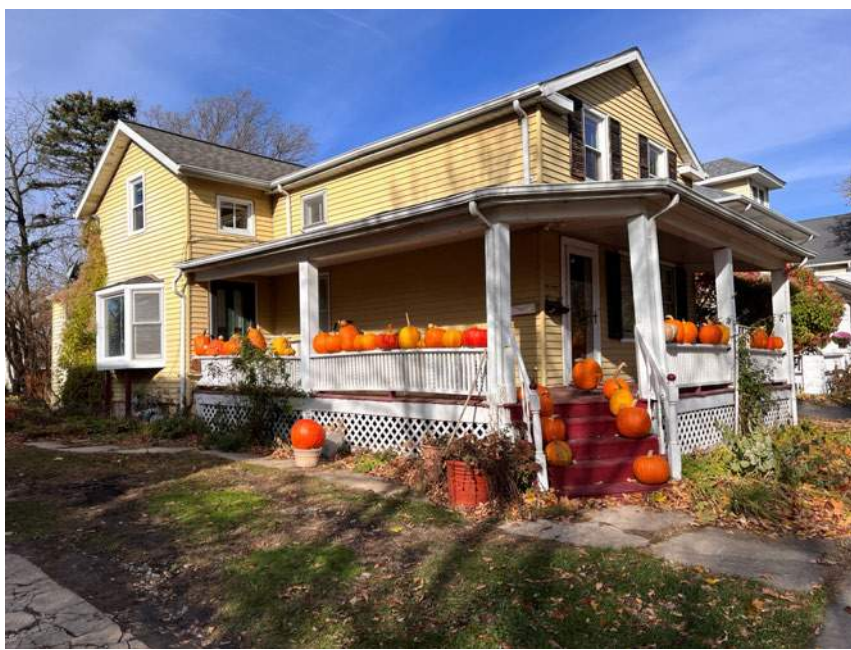
| ALTERATIONS | Aluminum siding; wraparound porch (c. 1915 -- porch columns wrapped in aluminum); 3-sided south window bay addition (not historic); early 1 story rear addition; replacement 2/2 horizontal windows in original openings (1950s); fixed shutters (not historic); replacement doors (not historic); rear/north exterior stair add.(not historic). Post-2007 - no changes. |

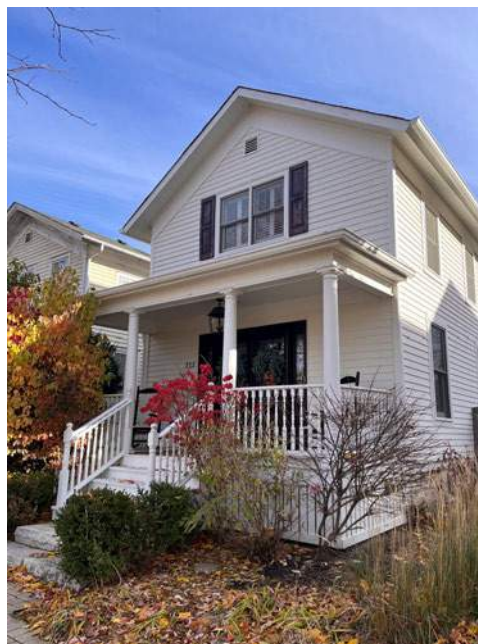
| <b>ALTERATIONS</b> | Front porch addition (c. 1950); replacement windows, some in original openings and some in downsized openings (historic); replacement front door; one and two-story rear additions. Post-2007 -- solid porch knee wall replaced with turned wood railing; front door removed and center window under porch converted to main entrance and fitted with double-leaf door and sidelights; decorative shutters added to 2nd-story window opening on front façade | | |

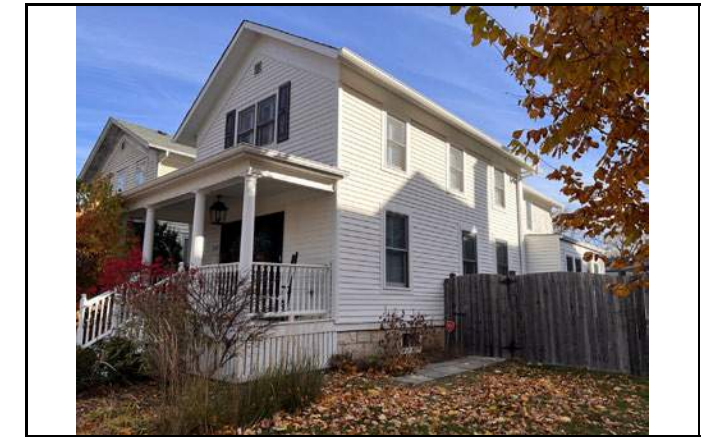
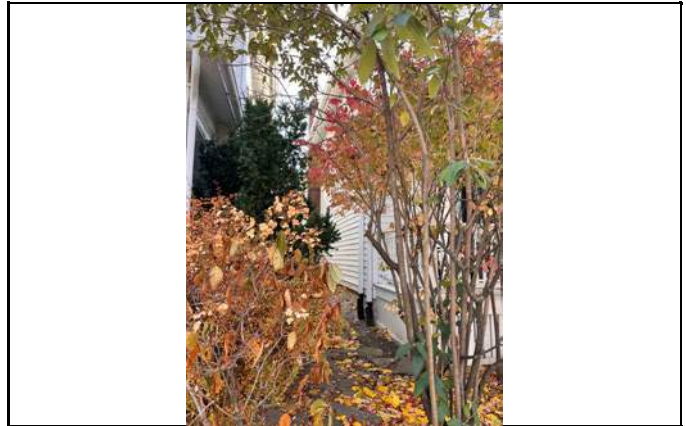
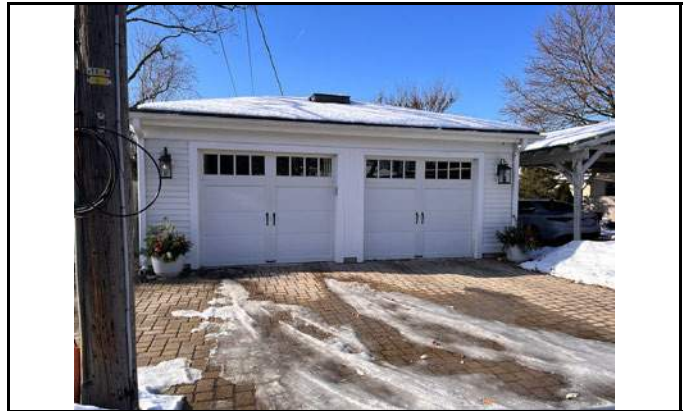
solid porch knee wall replaced with turned wood railing; front door removed and center window under porch converted to main entrance and fitted with double-leaf door and sidelights; decorative shutters added to 2nd-story window opening on front façade

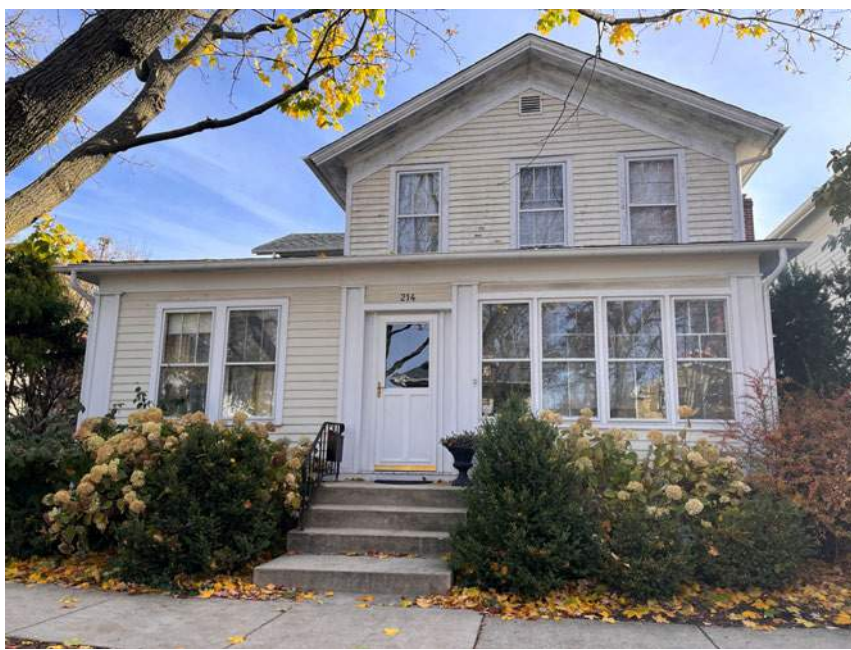
| <b>ALTERATIONS</b> | Original north side porch replaced/extended across front façade (c. 1950 - porch enclosed sometime after 1954); early 1 story rear addition (pre-1886). Post-2007 -- replacement storm door at front porch entrance. | | |

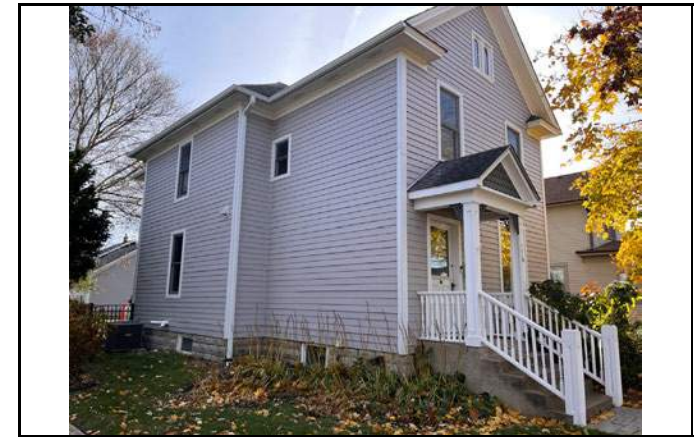
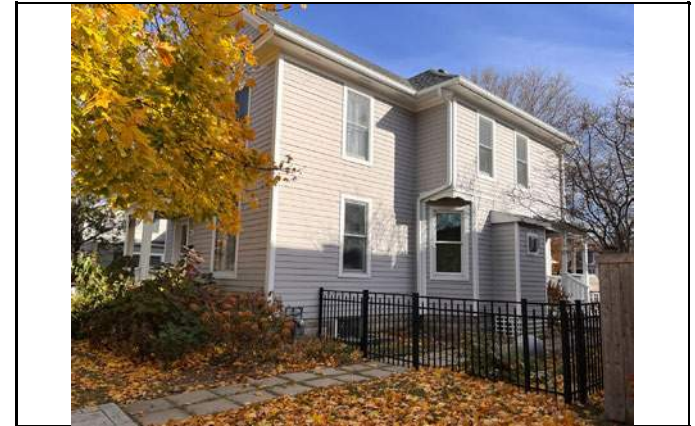
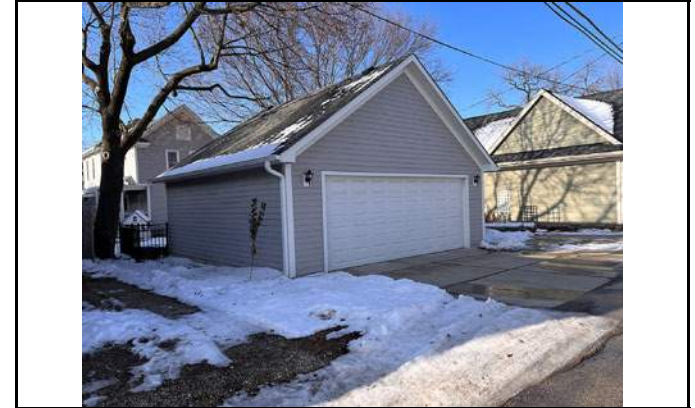
**COA COMPLIANCE NOTES:** Board width of replacement siding does not match historic wood siding.

Replacement windows in original and altered openings on front and side elevations; bump-out on south window bay; porch railings.

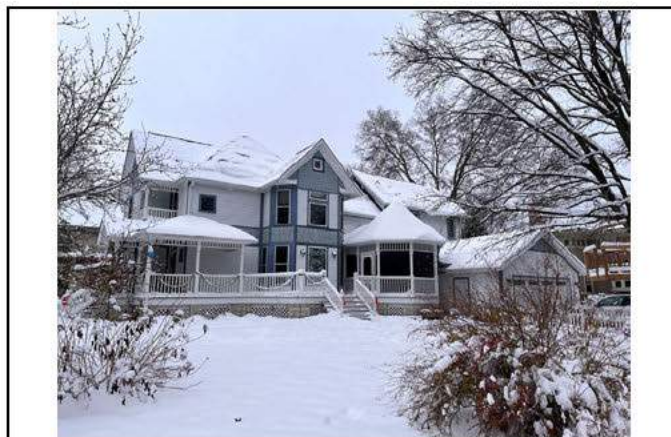
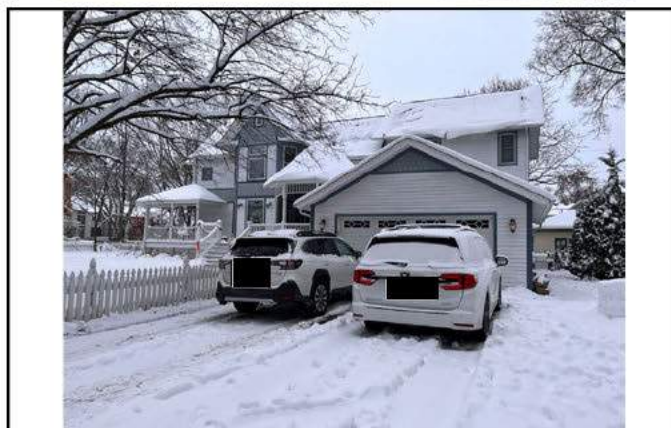
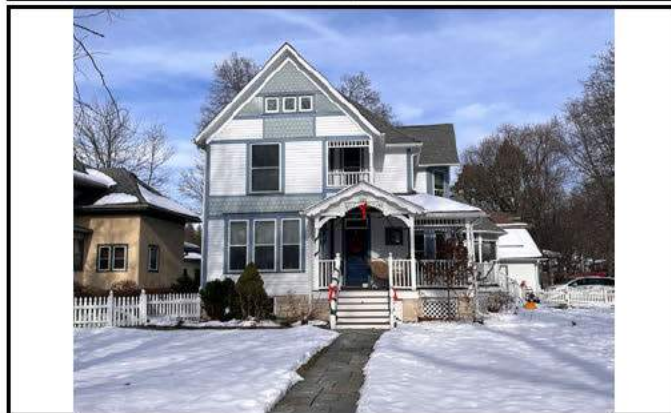
Replacement siding; solar panels on east slope of roof near southeast corner and on east slope of roof on rear bay.

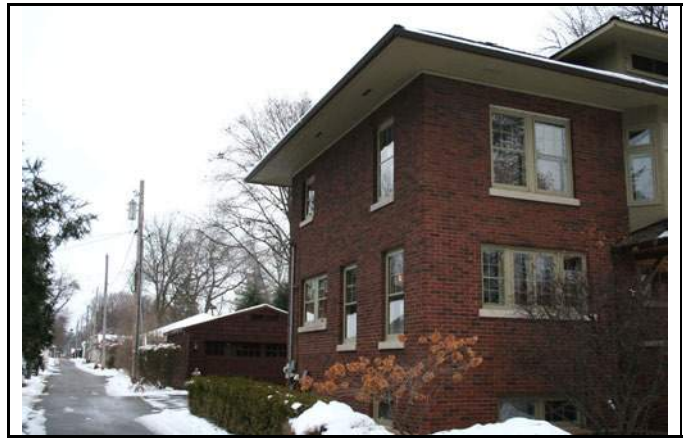
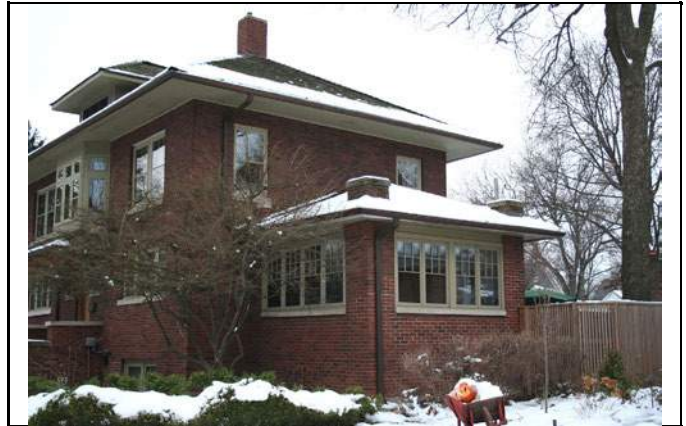
Replacement windows in east sun porch.
