Enclosed you will find our Response to the Landmark Designation Application filed for 110. S. Washington Street, known to the community as Old Nichols Library. We have made every effort to engage in a professional analysis of the actual conditions of the property and give a fair estimate of costs to restore or repair the improvement to a condition that complies with the standards for issuance of an occupancy permit under the provisions of Title 5, as specified on the City ordinance Section 1.4.1.

ORIGINAL NICHOLS LIBRARY

Building Evaluation / Facility Condition Assessment

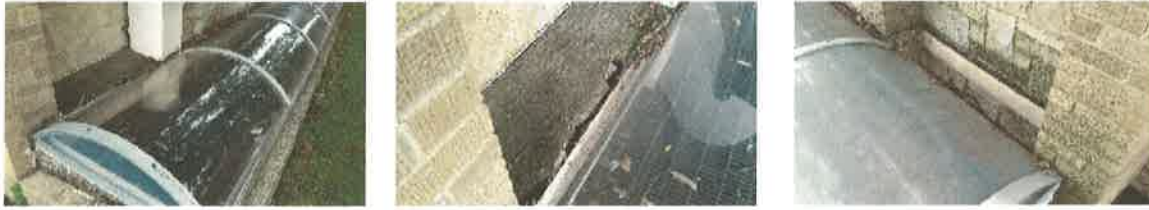
Several of the exterior downspouts at the perimeter of the building are no longer tied into the underground drainage piping as shown in the attached photos. This further suggests that the underground storm water removal systems are likely faulty and in an unacceptable condition. To remedy this, the perimeter of the building will need to be excavated to install foundation waterproofing systems with new footing tiles connected to a new sump pump system or with a direct discharge to the City of Naperville storm water sewer system. Due to multiple basement levels and outside stairway access points, an interior waterproofing solution is not recommended.

Exterior perimeter excavation will require the full removal and replacement of all foundation plantings to get the new waterproofing and drainage systems installed. This will be a rather costly expense due to the limited access points available at the building perimeter because of several architectural features such as area wells, exterior stairway structures, etc.

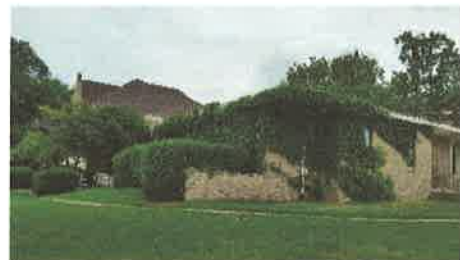
Excessive vine growth is present at the west and southwest elevations which is keeping the masonry wall damp due to limited sunlight reaching the face of the masonry to dry out the masonry surfaces.

Vines connect to the existing structure with tentacle-like root systems that have been noted to damage mortar joints and create water infiltration issues. For this reason, the vines shall be entirely removed to prevent damage to the masonry and mortar joints. After vine
