STREET #	32
DIRECTION	S
STREET	SLEIGHT
SUFFIX	ST
PIN	0818317015
LOCAL SIGNIFICANCE RATING	PS
POTENTIAL IND NR? (Y or N)	N
Contributing to a NR DISTRICT?	C
Contributing secondary structure?	C
Listed on existing SURVEY?	Local District; NR District

**GENERAL INFORMATION**

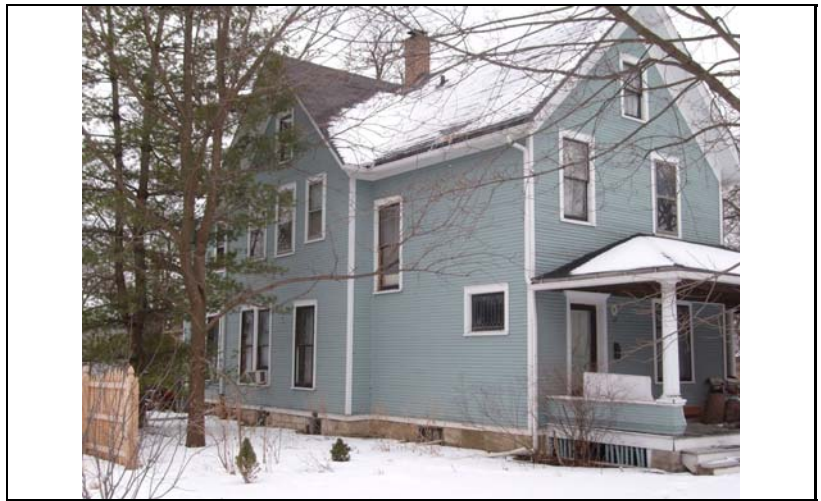
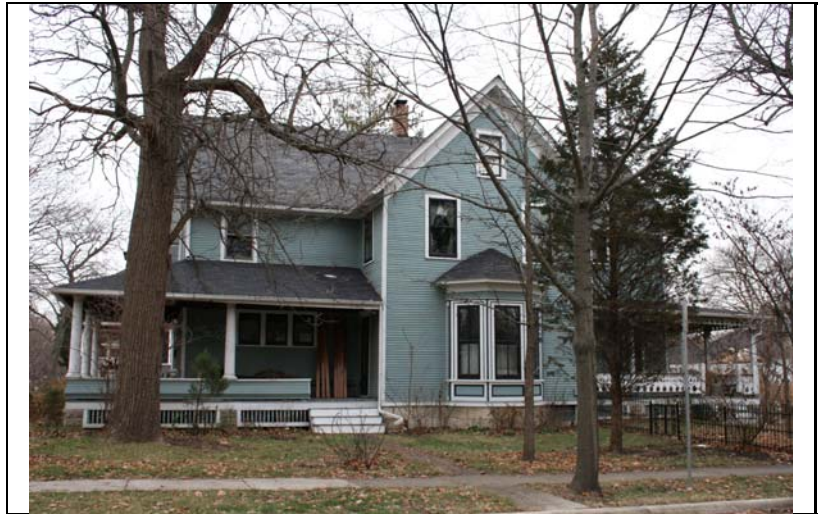
\\images\sleight0
32s.jpg

CATEGORY	building	CURRENT FUNCTION	Domestic - single dwelling
CONDITION	good	HISTORIC FUNCTION	Domestic - single dwelling
INTEGRITY	minor alterations and addition(s)	REASON for SIGNIFICANCE	Notable example of the type, with historic wraparound porch.
SECONDARY STRUCTURE	Detached garage
