| <b>STREET #</b> | 5 |
| <b>STREET</b> | SLEIGHT |

**GENERAL INFORMATION**

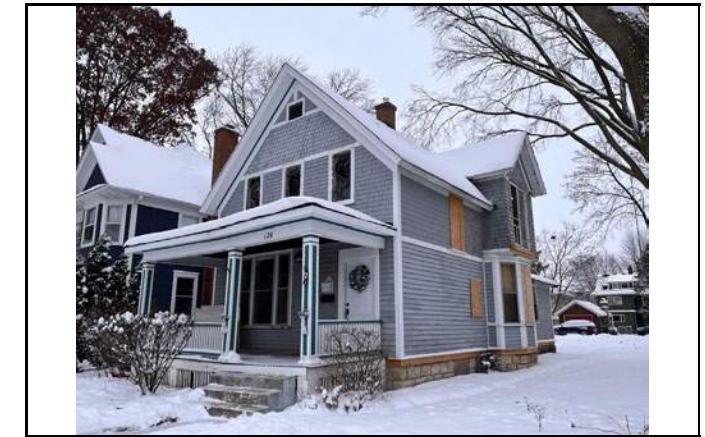
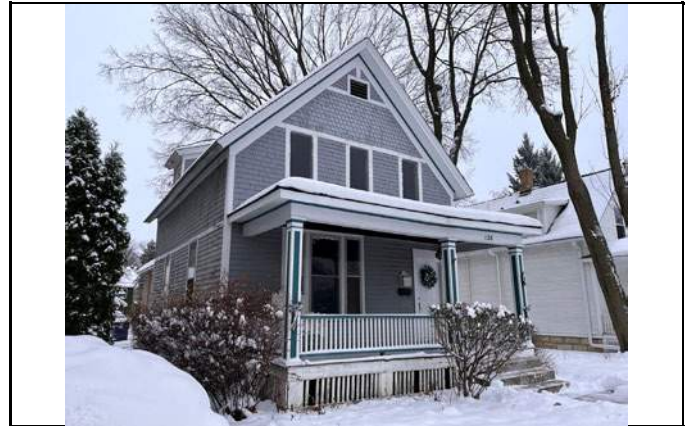
| ALTERATIONS | Shed dormer addition (historic); replacement front door; window opening at 2nd story of south projecting bay converted to doorway; 1/1 replacement windows in original openings (historic). Post-2007 -- exterior stair at south elevation removed; window openings on south elevation covered with particle board; window openings at 2nd story of front façade filled with what appear to be sheets of plexiglass; new wood exterior trim above foundation; replacement front door | | |

**COA COMPLIANCE NOTES:** At time of field work, work on rear/south porch addition had not started. Replacement front door does not match door shown on drawings included with COA application -- may be an earlier replacement door that was installed between 2007 survey and COA app.

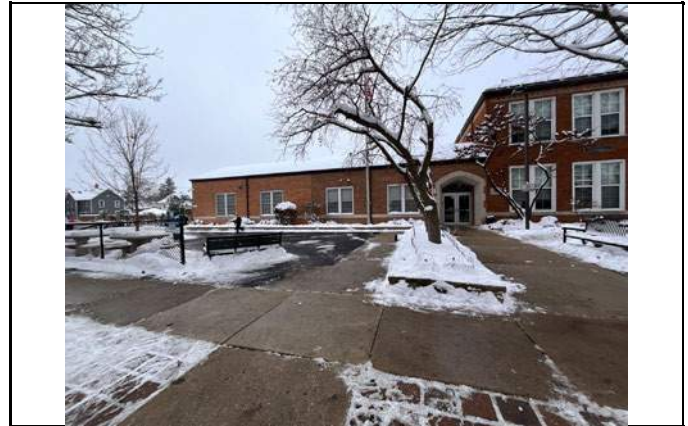
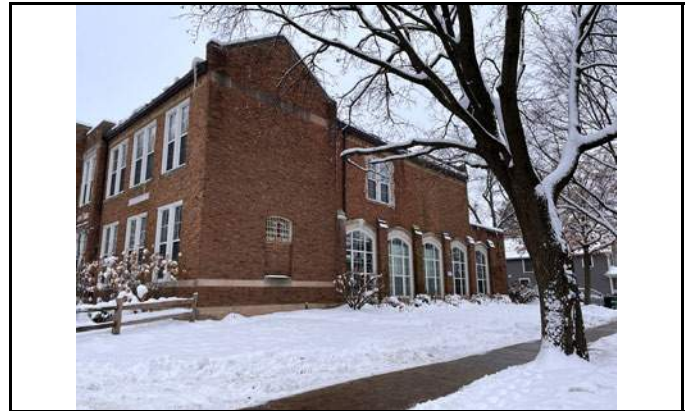
| ALTERATIONS | One story south side addition (1954, extended 1982); replacement windows in original openings (not historic); replacement doors (not historic); window on north elevation partially infilled with brick. Post-2007 -- replacement multi-light windows in arched openings at first story of north elevation. | | |

Replacement multi-light windows in arched openings at first story of north elevation.

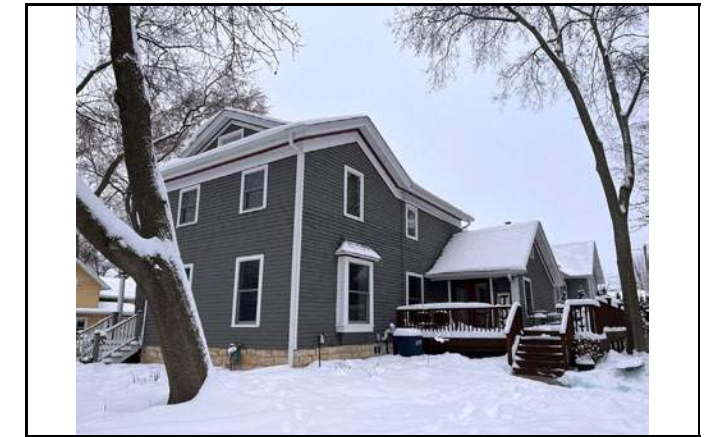
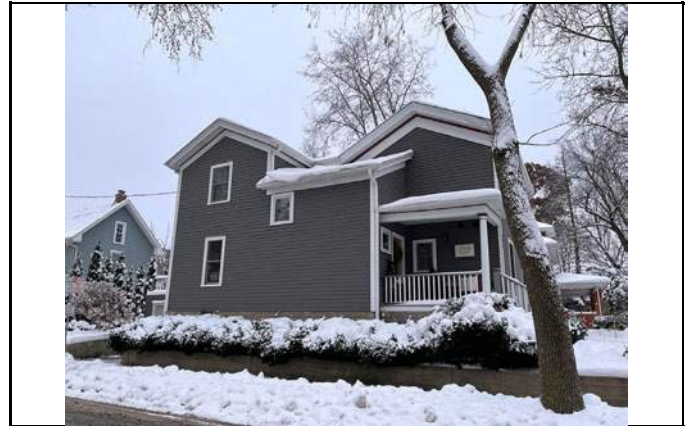
| <b>ALTERATIONS</b> | 2/1.5 story north addition and porch addition (historic--c. 1915); rear attached garage (c. 1950); original entry at north end of original house converted to window (historic). Post-2007 -- Aluminum replacement windows throughout -- window openings at 2nd story of west elevation have been downsized, and window near center of north elevation altered from 1/1 double-hung to single-light fixed window; replacement front door; replacement railings at entry porch; south deck addition; existing doorway on south wall of southeast one-story bay removed, and new French doors installed on west wall of bay to provide access to deck. |

**COA COMPLIANCE NOTES:** South deck addition; replacement windows in original and altered openings; replacement railings at entry porch; replacement front door.

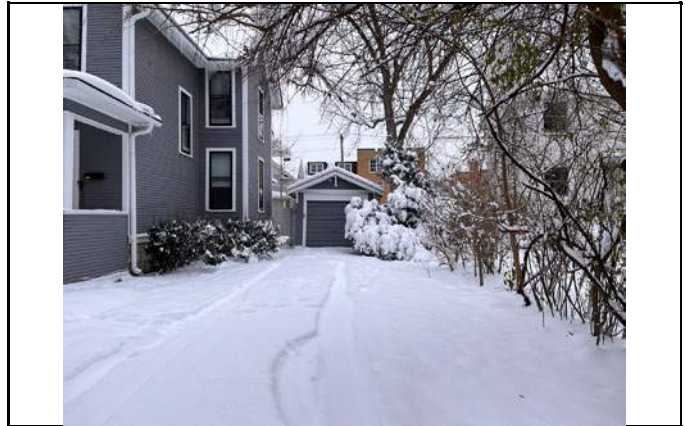
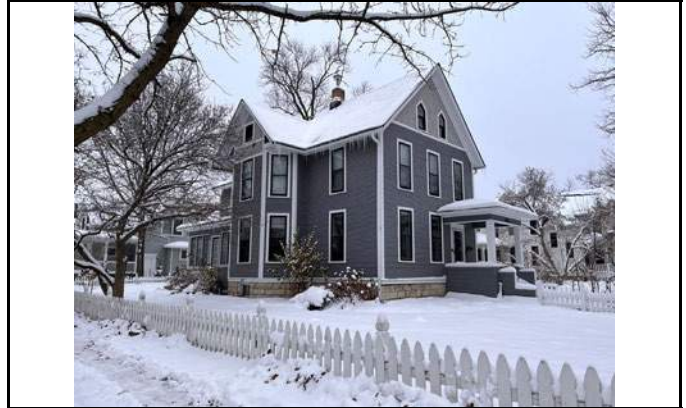
| ALTERATIONS | one-story rear/south porch enclosed; front entry porch (c. 1955--house originally featured wrap around front porch). Post-2007 -- replacement front door; exterior repainted. | | |

Replacement front door.

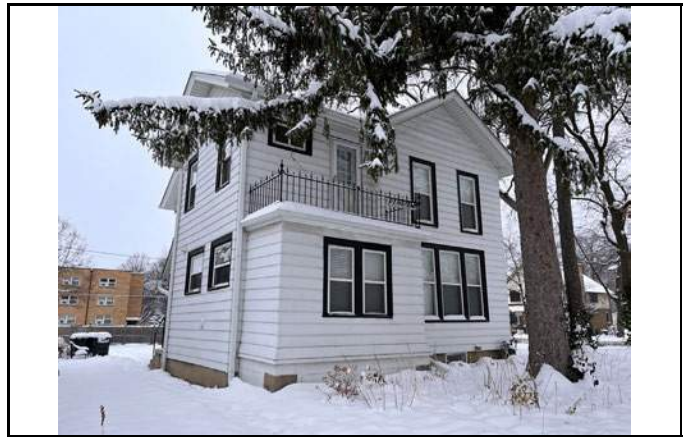
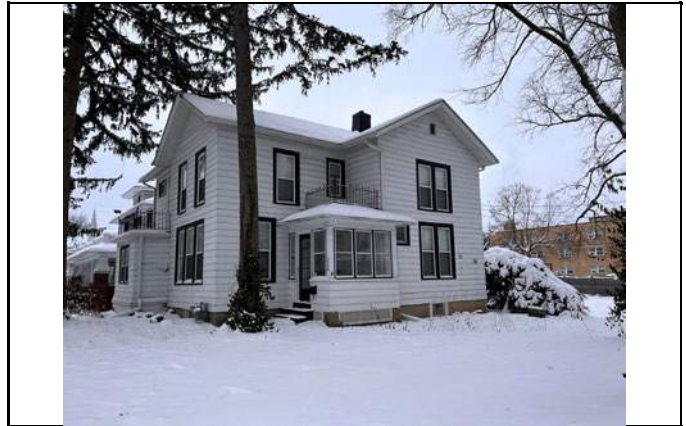
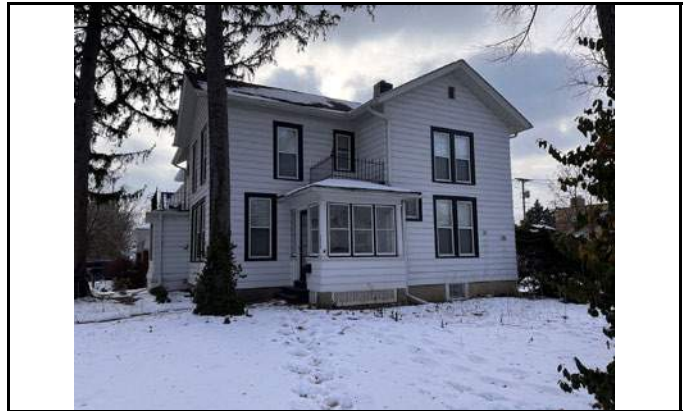
☒ ELIGIBLE WORK COMPLETED WITHOUT COA?

1/1 double-hung Aluminum replacement windows throughout.

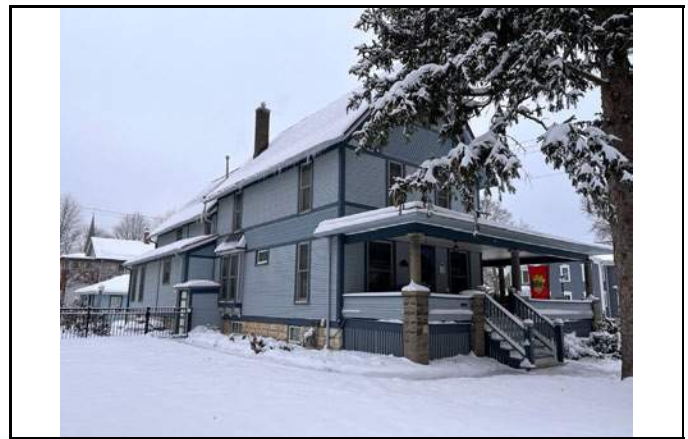
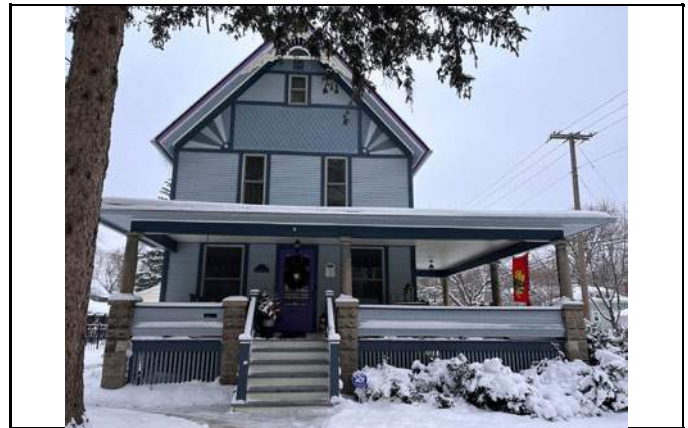
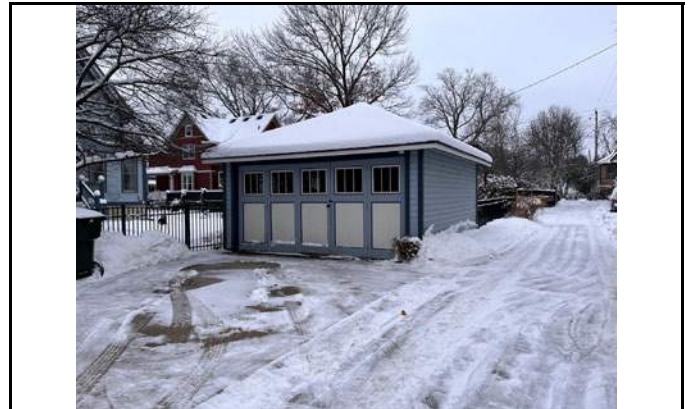
☒ **ELIGIBLE WORK COMPLETED WITHOUT COA?**

Most 1/1 windows appear to be Aluminum/vinyl replacement windows. Railings added to front porch steps.

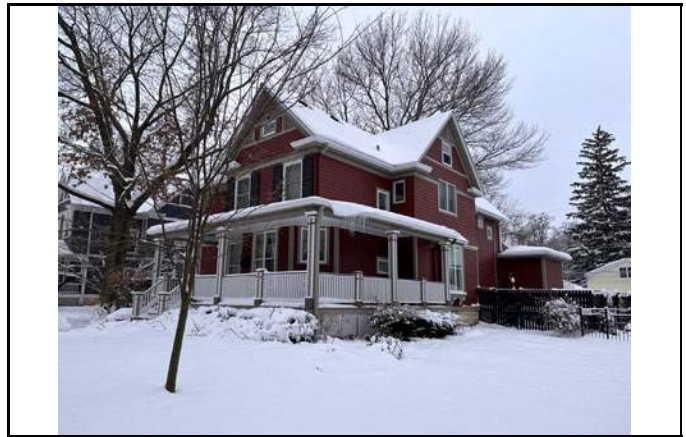
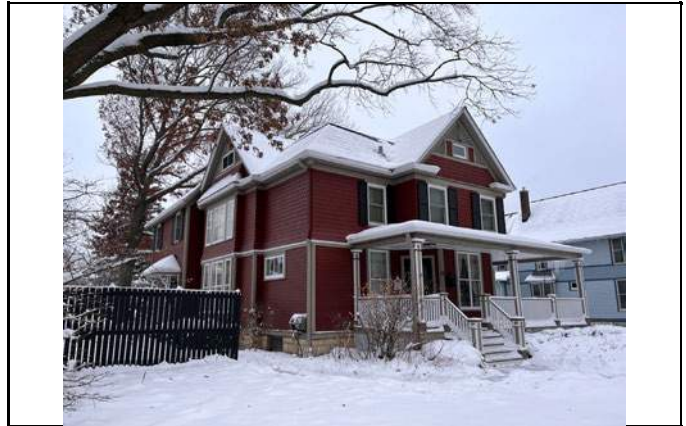
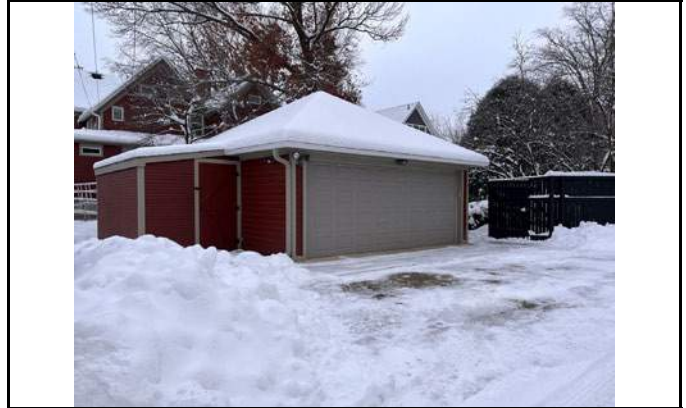
☒ ELIGIBLE WORK COMPLETED WITHOUT COA?

1/1 replacement windows on second story of front façade and upper floors of north bay.

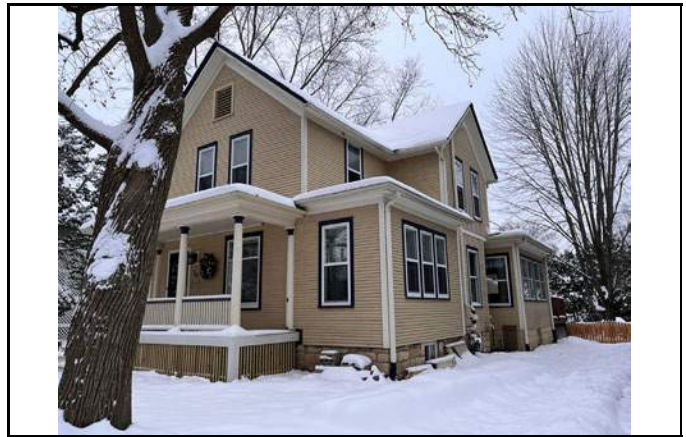
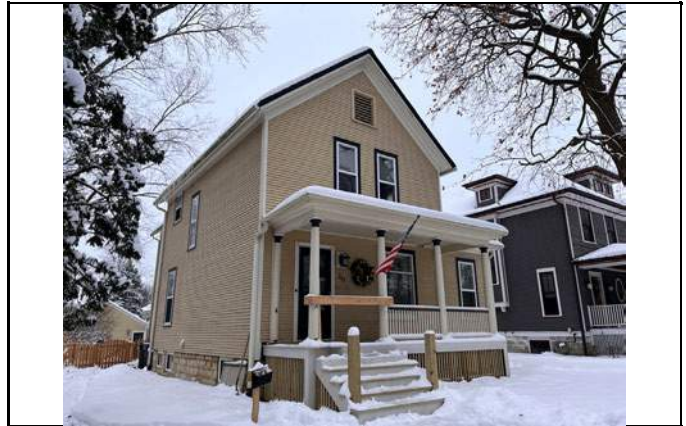
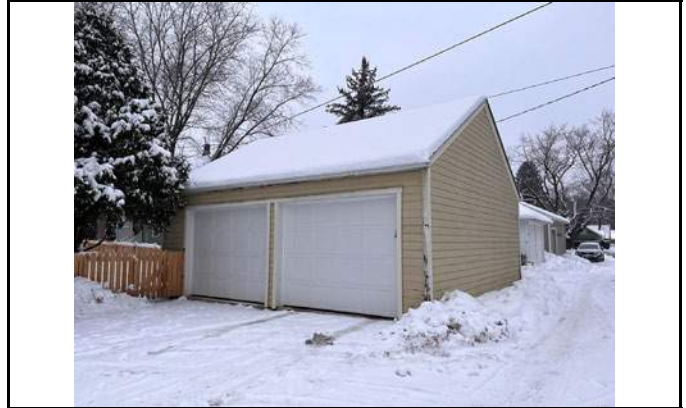
☒ ELIGIBLE WORK COMPLETED WITHOUT COA?

Porch steps being replaced.

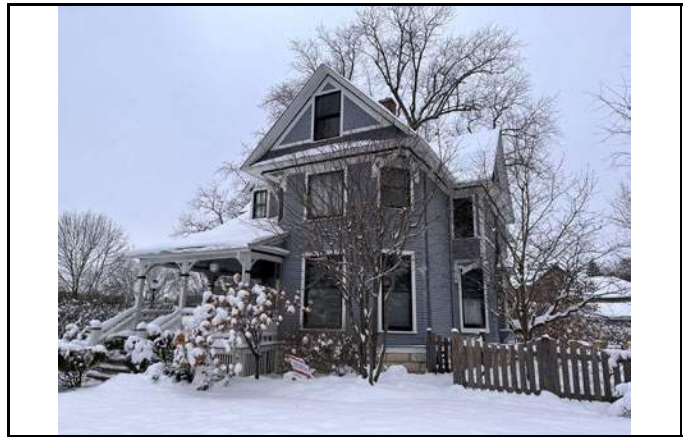
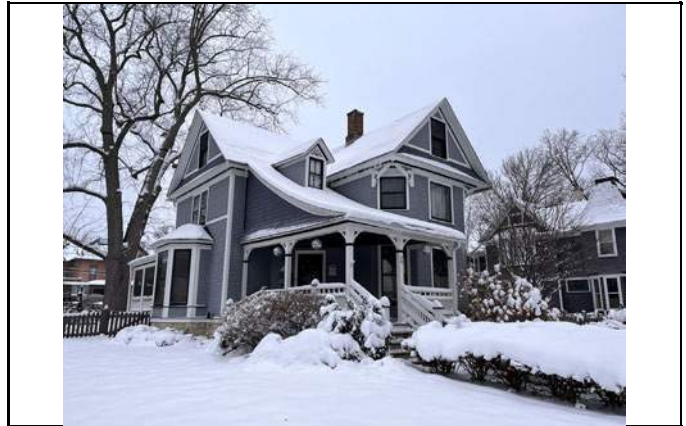
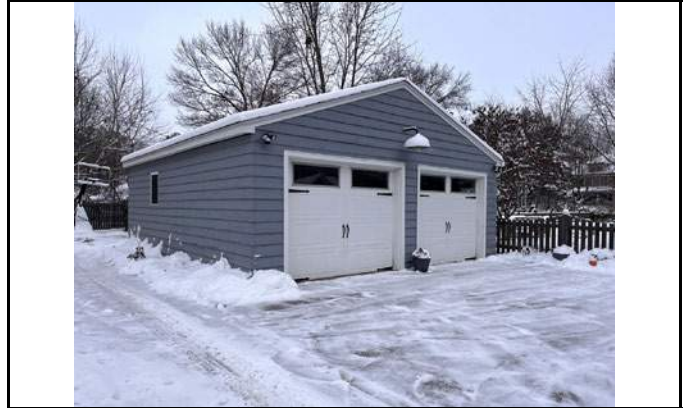
replacement windows under front and side gables appear to be in enlarged openings

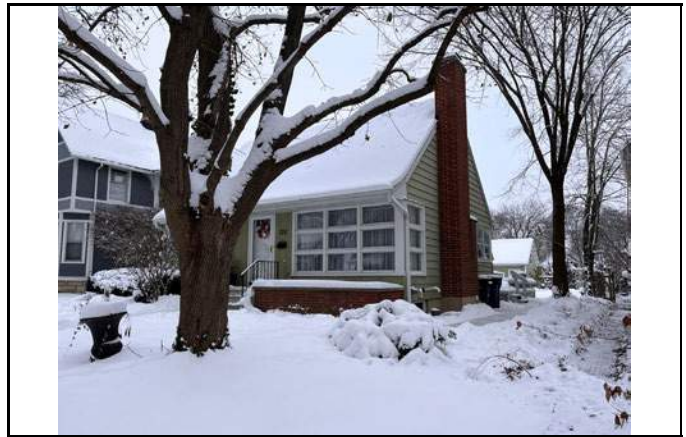
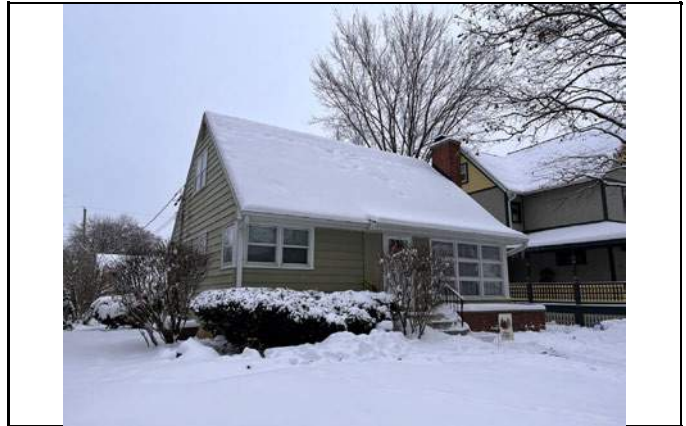
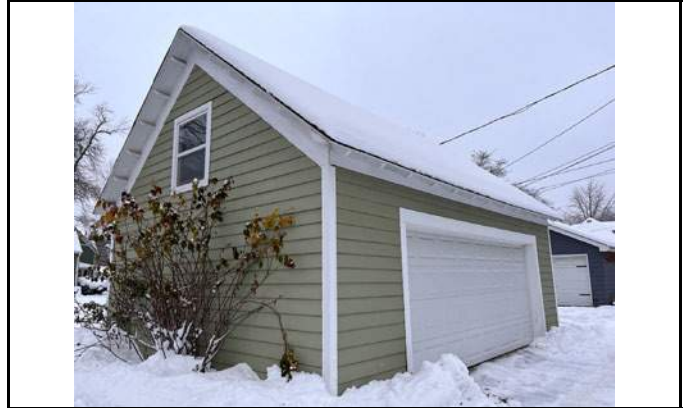
Replacement front door.

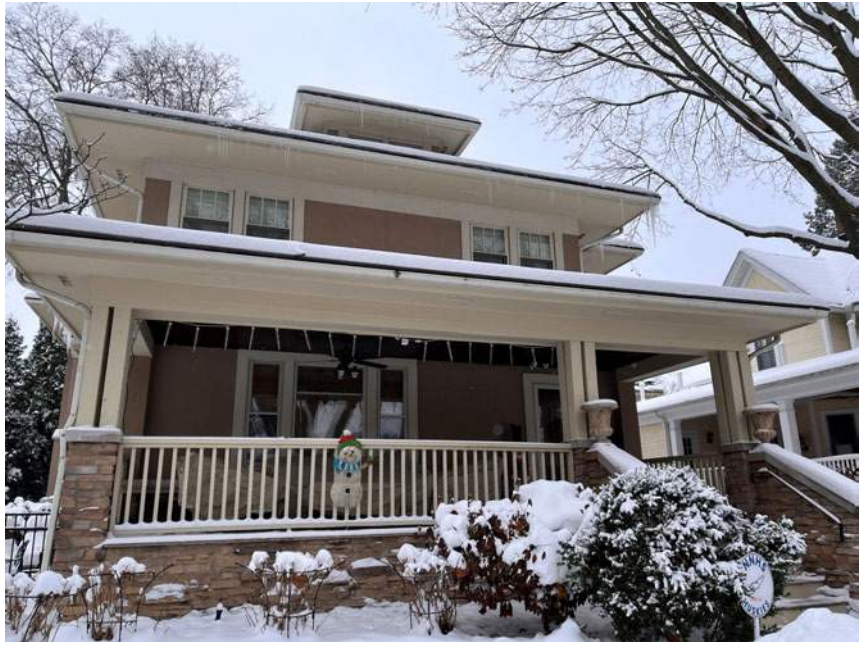
| CONDITION | excellent | REASON for SIGNIFICANCE | Good example of Prairie style in the district. |

| ALTERATIONS | Stone cladding at foundation level (not historic); porch railing replaced (not historic); 2 story rear addition (not historic); 1 story rear addition (not historic). Post-2007 --- some 3/1 windows on front and side elevations appear to be aluminum (may be replacement exterior storms); | | |

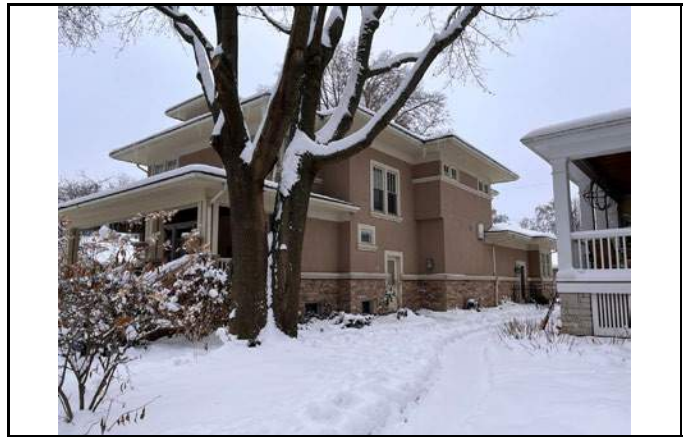
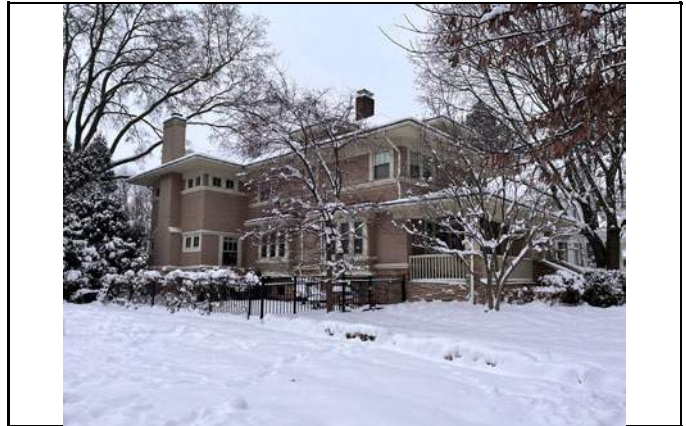
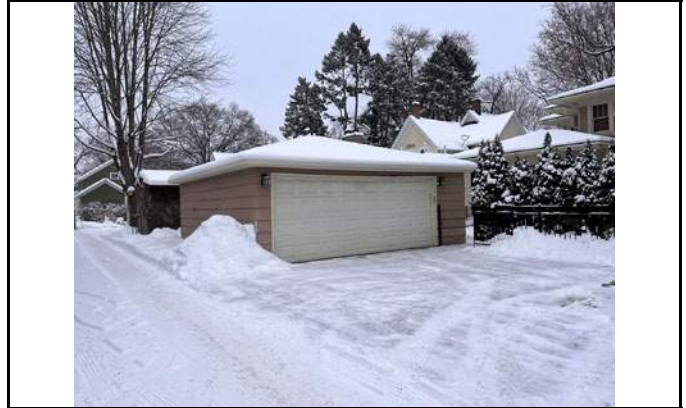
☒ ELIGIBLE WORK COMPLETED WITHOUT COA?

NOTES ON WORK:

possible 3/1 replacement windows.

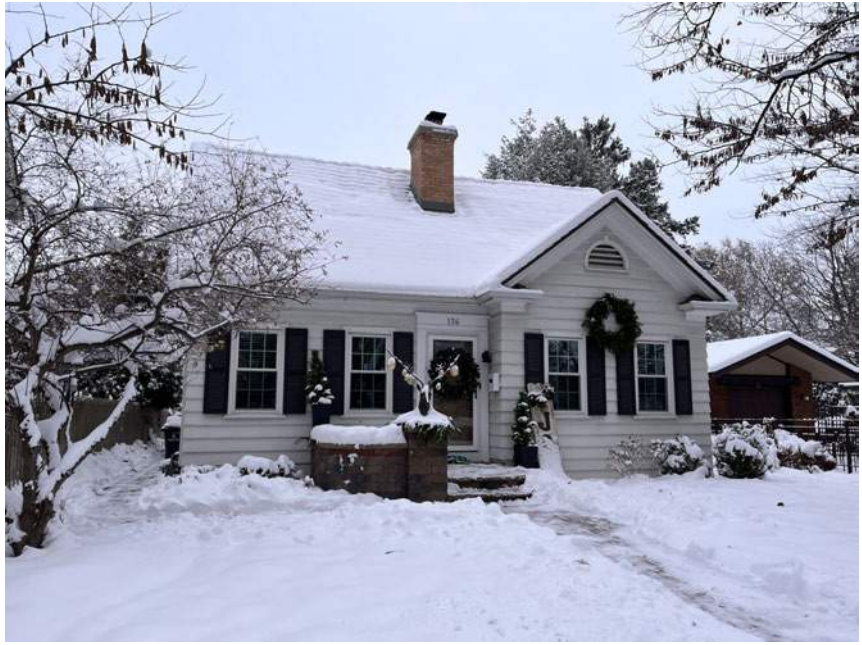
| CONDITION | excellent | REASON for SIGNIFICANCE | Charming, intact example of inter-war Colonial Revival residential design. |

| ALTERATIONS | Post-2007 -- 6/6 and 8/8 aluminum or vinyl replacement windows throughout; asphalt shingle roofing replaced with cedar shingle. | | |

| <b>COA COMPLIANCE NOTES:</b> | Asphalt shingle siding replaced with cedar shingle. | | |

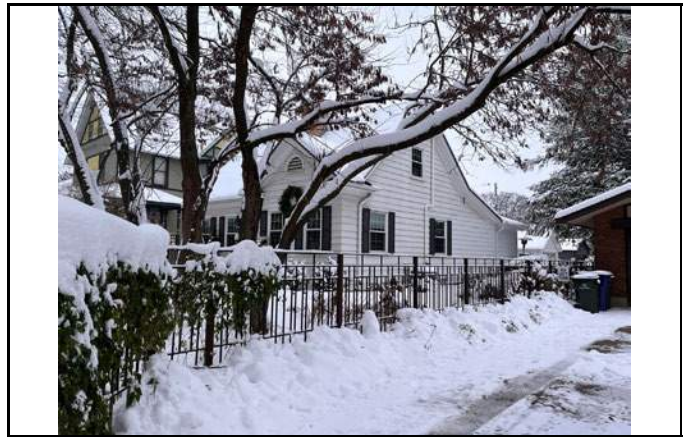
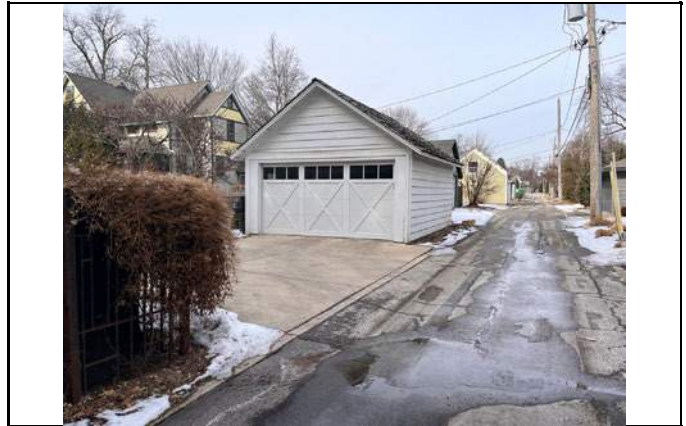
☒ **ELIGIBLE WORK COMPLETED WITHOUT COA?**

**NOTES ON WORK:**

Replacement windows

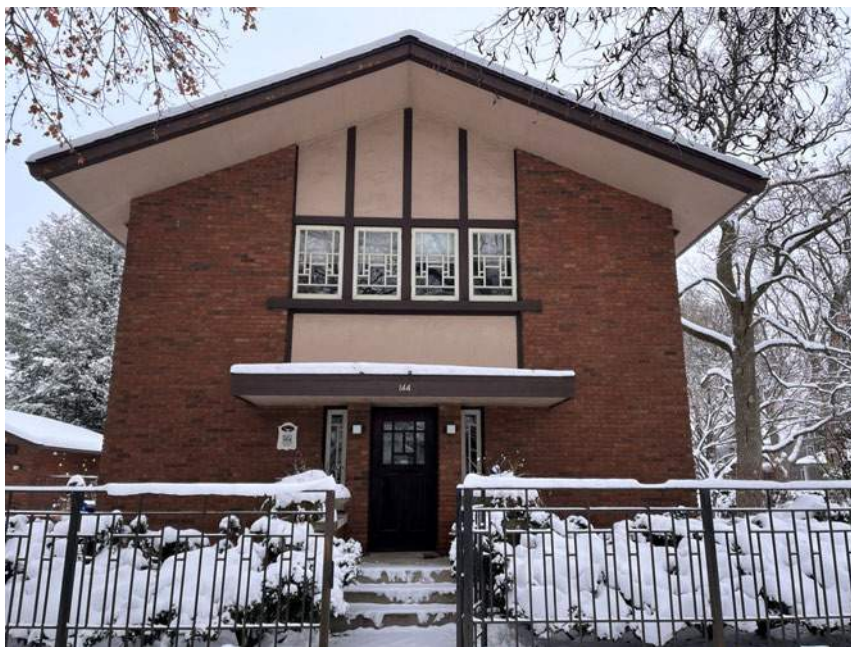
| CONDITION | excellent | REASON for SIGNIFICANCE | This distinctive Prairie School residence was designed by Harry Robinson, who worked as draftsman under Frank Lloyd Wright and Walter Burley Griffin. |
