EXHIBIT F

MASTER DRAWING SET

Casey's		Casey's	
CASEY'S CONSTRUCTION DIVISION		CASEY'S CONSTRUCTION DIVISION	
On-Commandment Rd. P.O. Box 2000, Tulsa, OK 74103-6400		On-Commandment Rd. P.O. Box 2000, Tulsa, OK 74103-6400	
1420 N. Lincoln, IL OSHTON, MO ROOF CONTRUCTION DIVISION 1420 N. LINCOLN OSHTON, MO ROOF CONTRUCTION DIVISION		1420 N. Lincoln, IL OSHTON, MO ROOF CONTRUCTION DIVISION 1420 N. LINCOLN OSHTON, MO ROOF CONTRUCTION DIVISION	
07/17/22 03/24/21 09/18/21		07/17/22 03/24/21 09/18/21	
EXTERIOR ELEVATIONS		EXTERIOR ELEVATIONS	
A-202		A-202

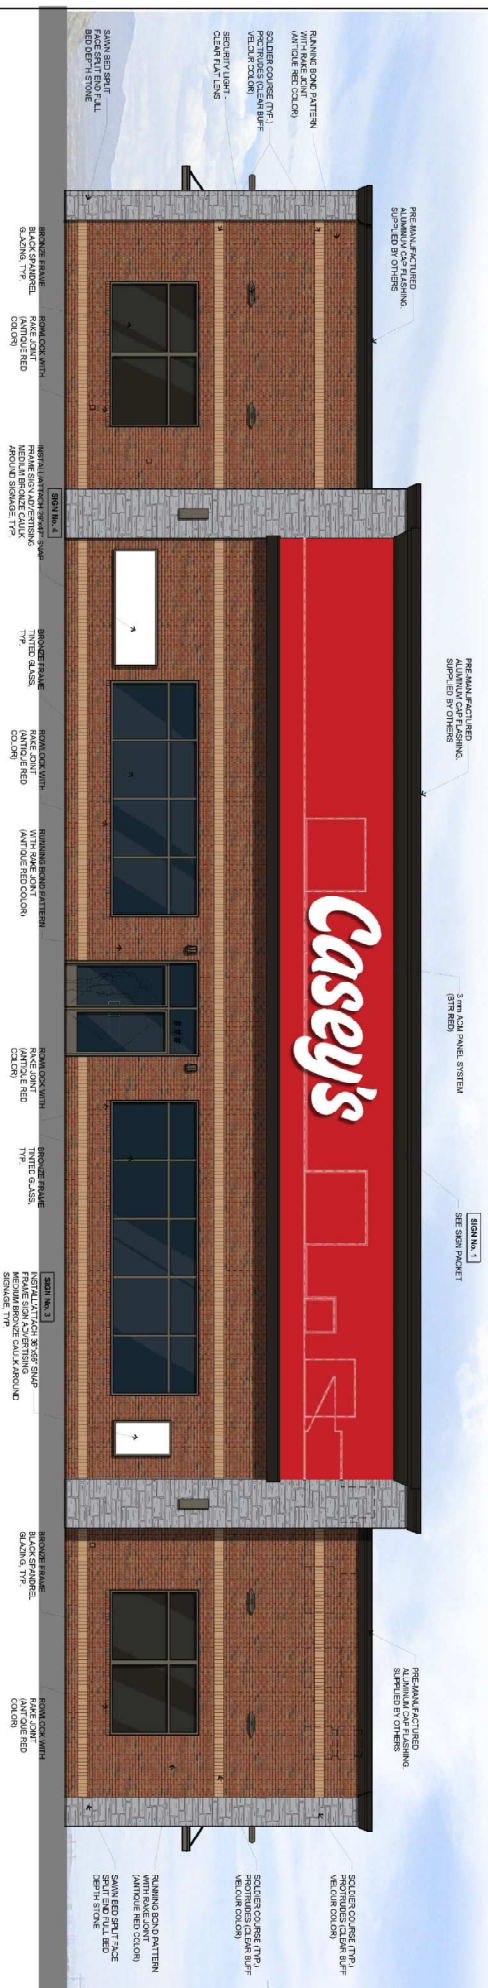
Exterior Elevation - Front of Building (Plan North)

FRONT FACADE				
Building Facade	2332			
Glazing (Windows & Storefront)	396	16.98%		
Building Facade (Sans Glazing)	1936		100.00%	
MCN Panel System (BTR RED)	484	18.61%		22.42%
Aluminum Cap Flashing	138	8.45%		10.23%
Brick	834	35.76%		43.08%
