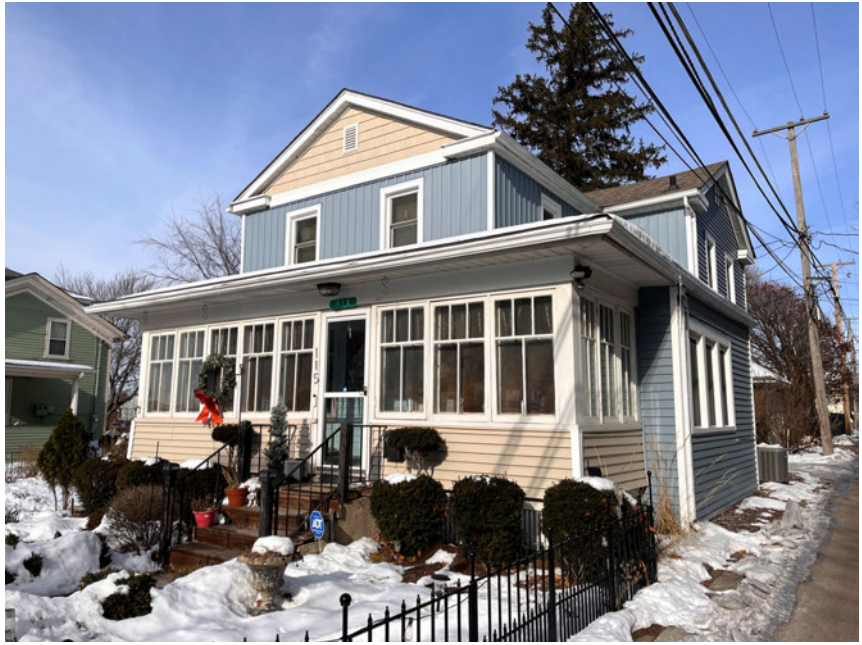
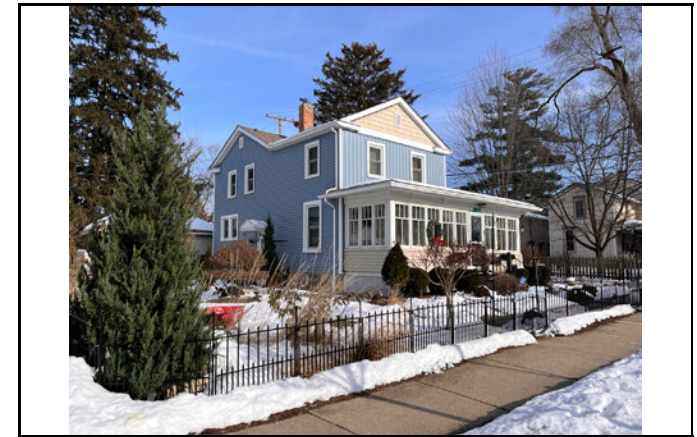
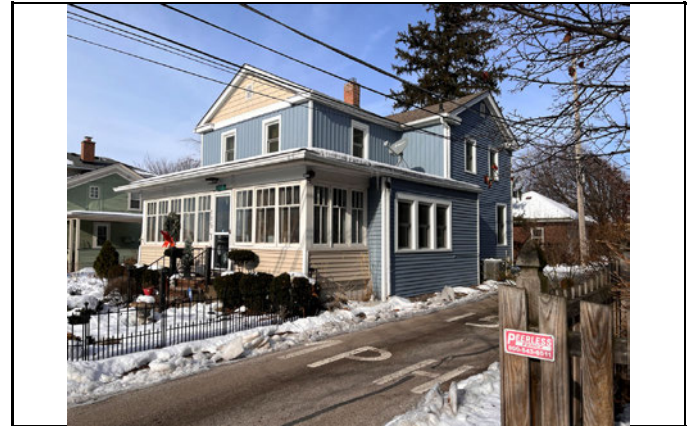
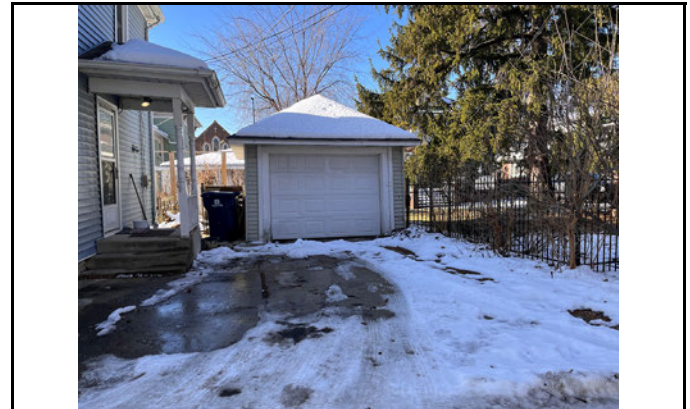
| CONDITION | good | REASON for SIGNIFICANCE | |
| INTEGRITY | minor alterations and addition(s) | | |

| SIGNIFICANT FEATURES | Front gable bay; 2 story east side ell with cornice returns | | |
| ALTERATIONS | Aluminum under eaves; wraparound front porch; 5-light windows in south section of porch (1920s, historic); east section of porch enclosed; concrete front steps (not historic). Post-2007 -- Aluminum/vinyl replacement siding and exterior trim; 1/1 Aluminum/vinyl replacement windows throughout. | | |

Replacement siding and trim; 1/1 replacement windows in original openings.

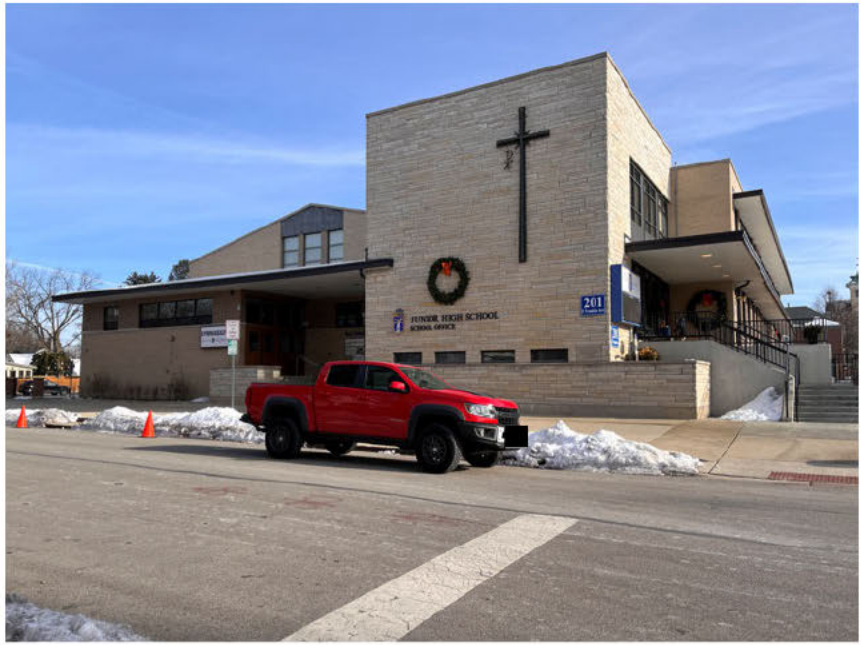
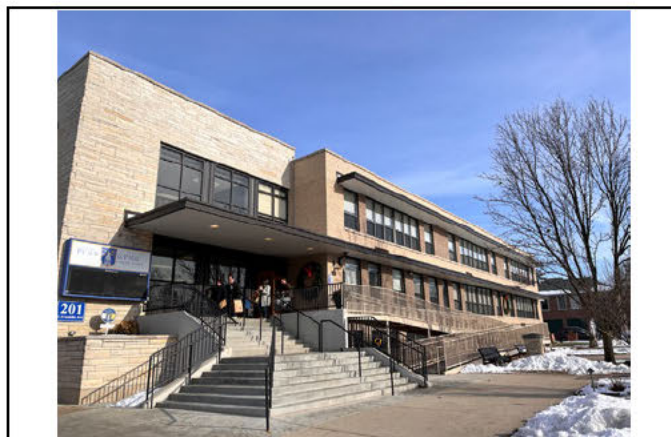
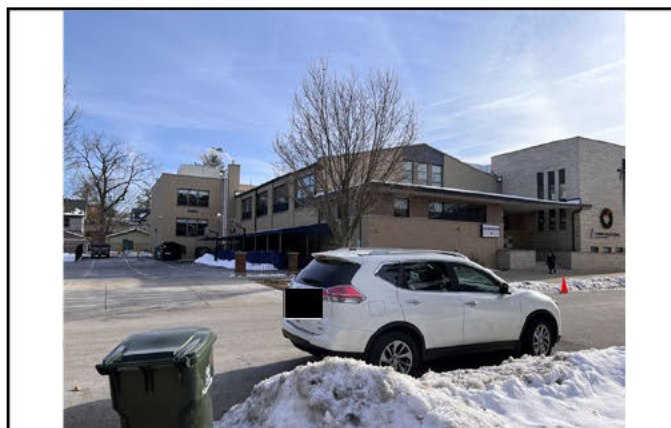
| CONDITION | excellent | REASON for SIGNIFICANCE | |

**SIGNIFICANT FEATURES** Multiple grouped volumes and a variety of exterior materials; prominent southwest corner volume with flat roof and Lannon stone exterior, with metal cross on west elevation and main entrance at south elevation; slightly projecting longer volume extends east from entrance, with ribbon windows along south elevation; cantilevered canopies over main entrance ribbon windows on south elevation; one and two-story volumes at north end of building – west one-story volume facing Ellsworth contain second entrance deeply recessed under flat roof; 2-story volume features shallow gable roof.

**ALTERATIONS** Multi-light steel windows on south elevation east of main entrance replaced with 1/1 double-hung Aluminum windows; Post-2007 -- new steps at southwest entrance; metal wheelchair ramp along south elevation; windows and doors at main entrance replaced with new Aluminum windows that match the original configuration

new steps at southwest entrance; metal wheelchair ramp along south elevation.

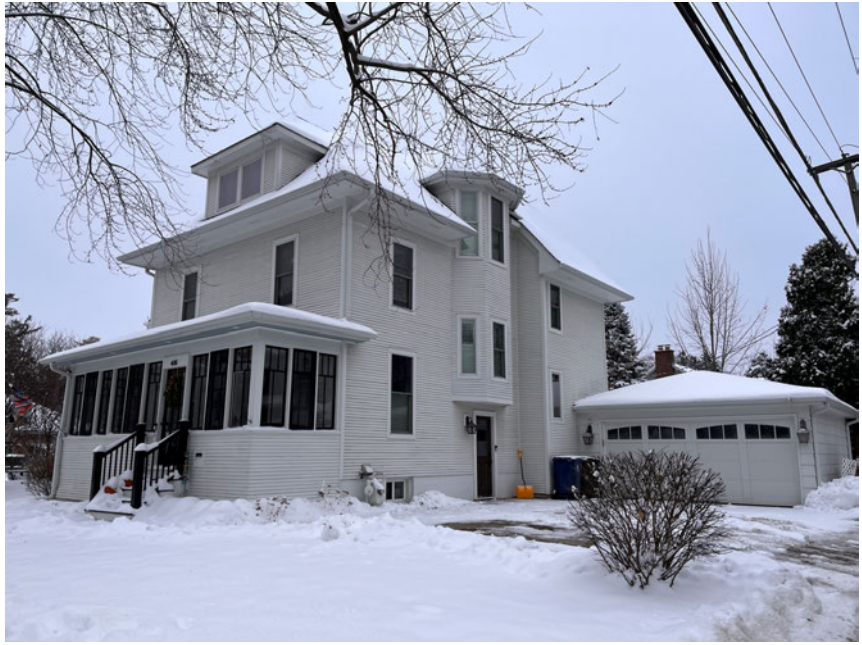
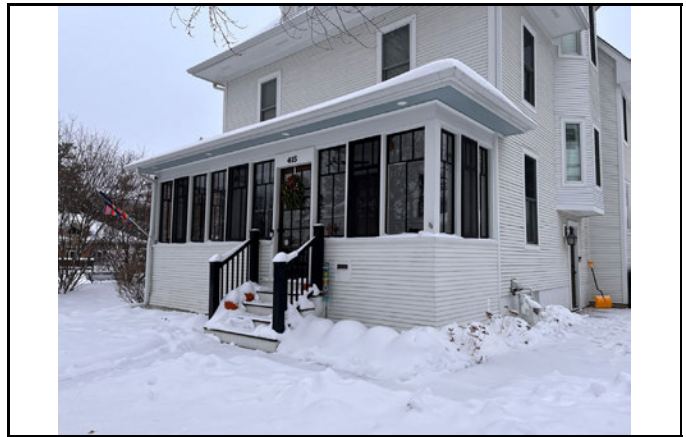
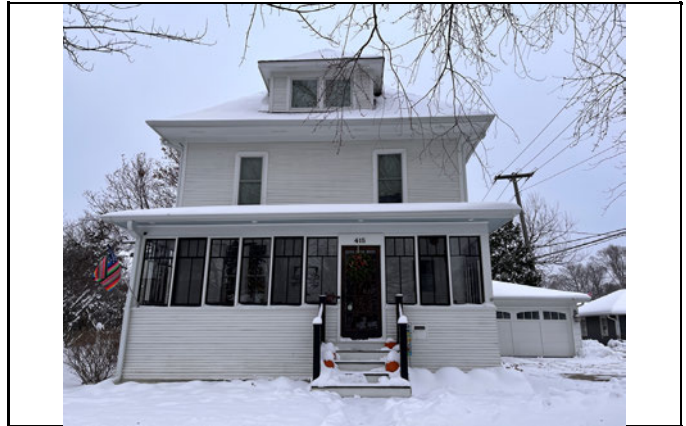
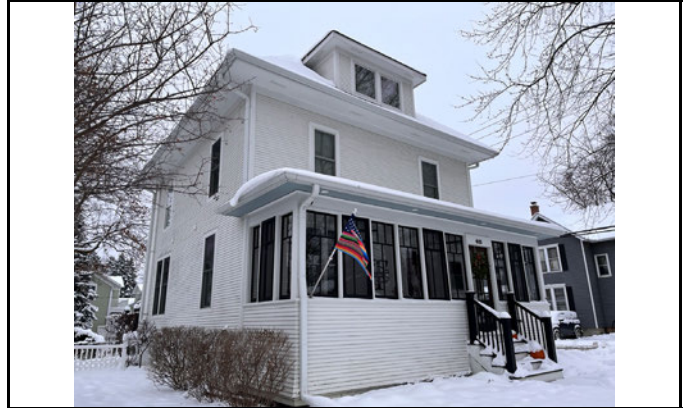
| SIGNIFICANT FEATURES | Rectangular massing and wood exterior siding; full-width front porch with shallow hipped roof; historic 1/1 wood windows on front elevation above porch and at first and second stories of west elevation at original structure; some historic windows also remain on east elevation; 5-light windows at porch enclosure |

| ALTERATIONS | Replacement front door and steps (not historic); one-story rear addition/connector addition to rear garage (not historic). Post-2007 -- roof rebuilt with steeper pitch and taller front and side dormers; one story east addition at garage; 2nd-story addition over existing northeast addition between house and garage; oriel bay on east elevation extended up to create a two-story bay that pierces the roofline; some 1/1 Aluminum replacement windows in original and altered openings; replacement porch door and replacement door in ground-level east entrance; rear deck. |

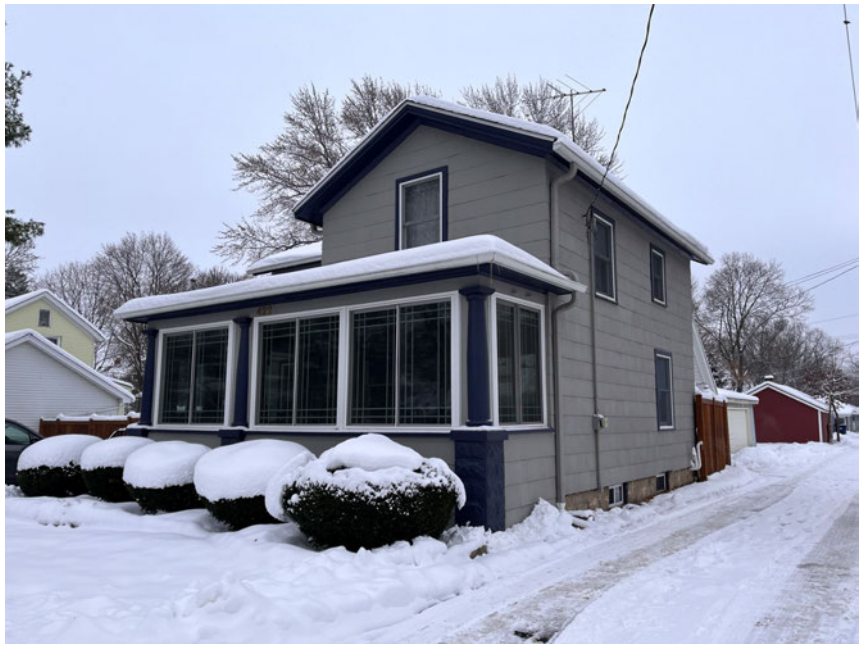
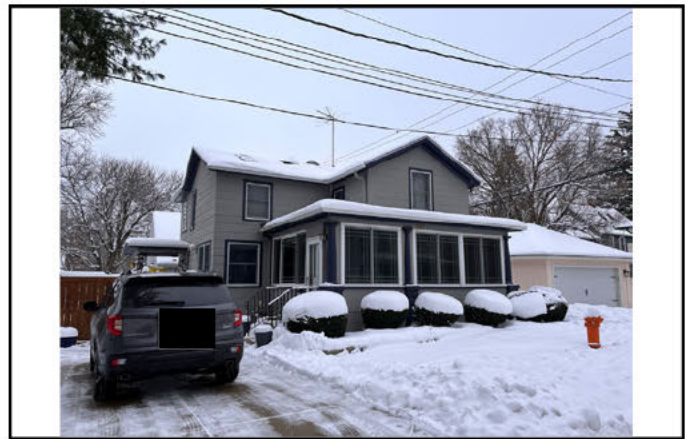
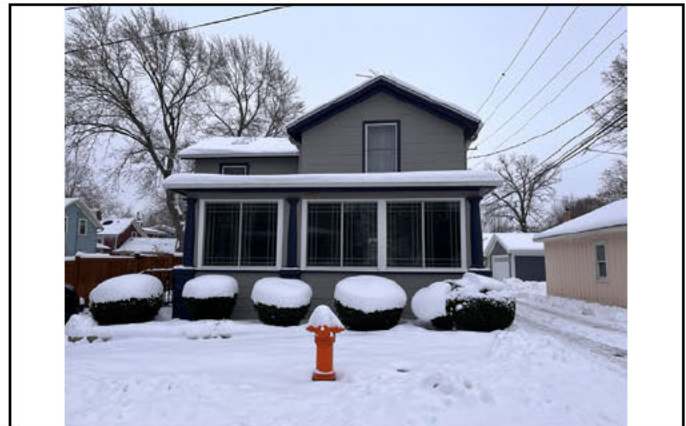
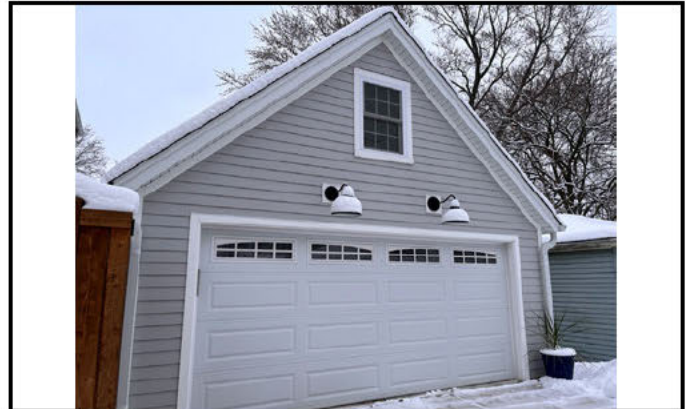
| SIGNIFICANT FEATURES | Front gable west bay with lower side gable wing -- wing was originally one story and set back from the front façade, but was extended sometime between 1909 and 1921; front porch with hipped roof and classical columns set on concrete block piers (c. 1915, later enclosed). |

| ALTERATIONS | Replacement siding (1950s); front porch extended (c. 1915); 1/1 aluminum or vinyl replacement windows throughout, and in altered opening on wing; 2 story rear addition (post-1954); east side entry porch (post-1954); skylights. Post-2007 -- paired nine-light wood casement windows in porch replaced with aluminum/vinyl multi-light fixed windows; repainted. |

paired nine-light wood casement windows in porch replaced with aluminum/vinyl multi-light fixed windows.

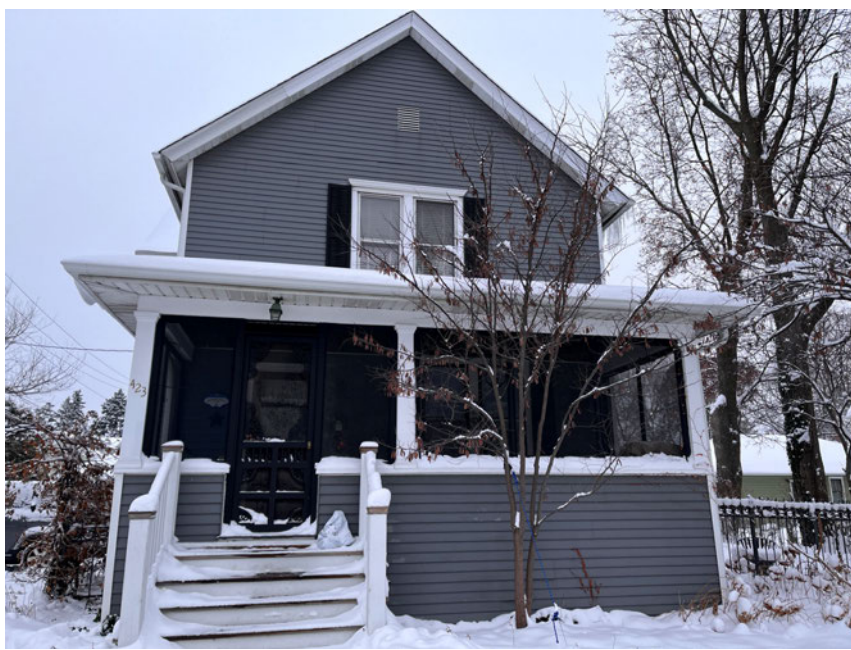
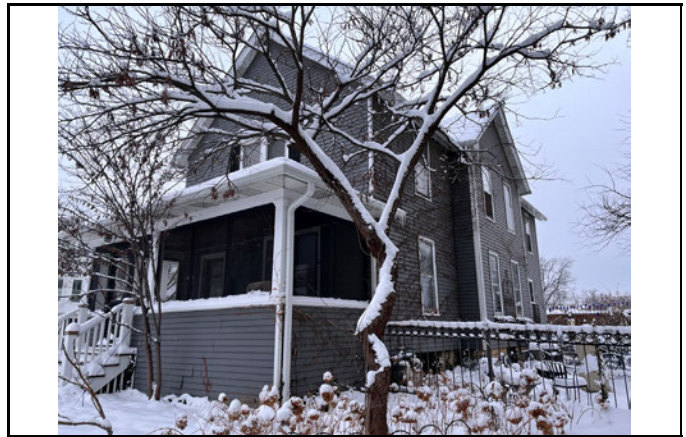
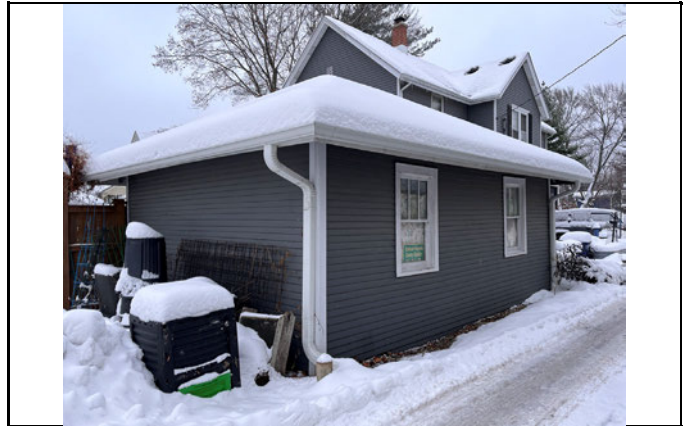
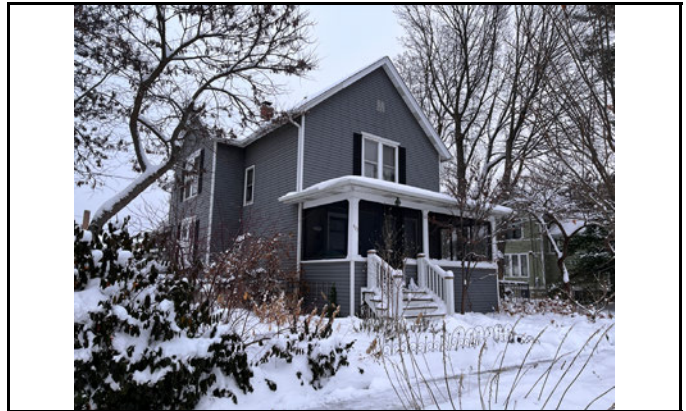
| SIGNIFICANT FEATURES | Front gable bay with 2 story side gable bays; classical lintels over paired windows; historic 1/1 wood windows; historic front porch structure with square columns | | |
| ALTERATIONS | Aluminum under eaves; vinyl siding; vinyl on porch base; replacement front steps; screens on porch; 1 story rear addition. Post-2007 -- no changes. | | |

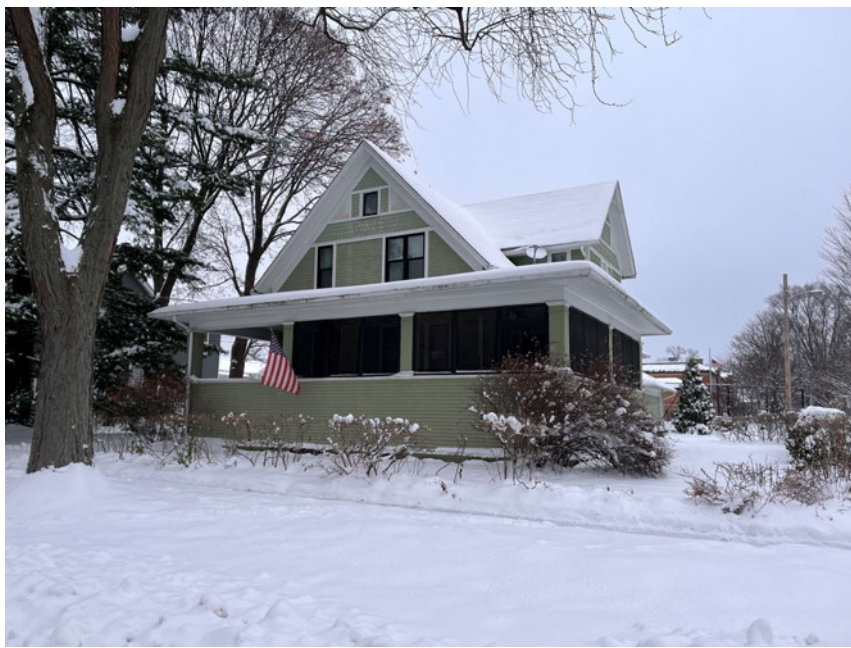
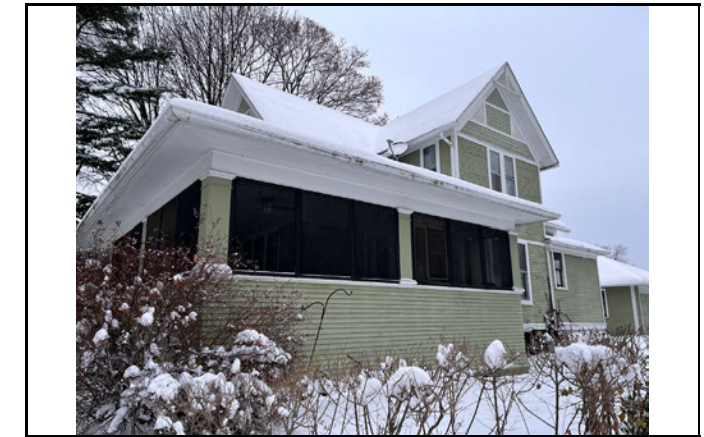
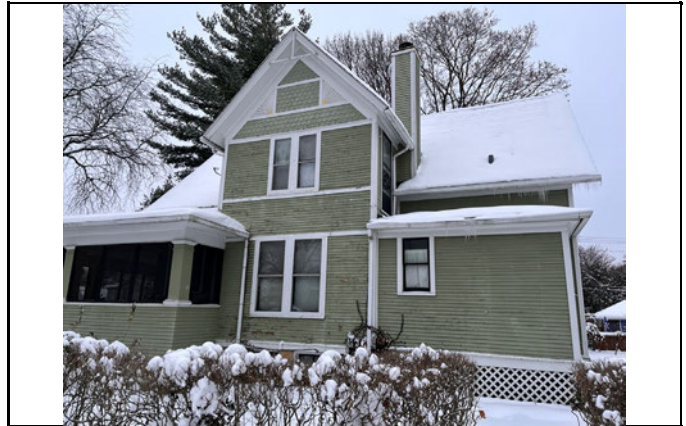
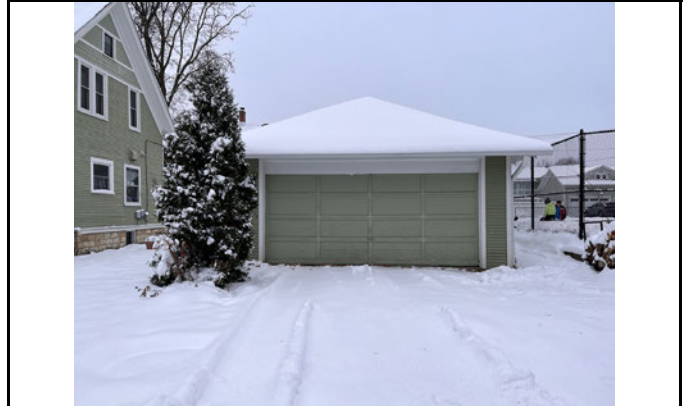
| <b>SIGNIFICANT FEATURES</b> | Broad front gable bay with east and west gabled ells; decorative wood shingles in gable; historic 1/1 double hung wood windows (may be historic replacement) |

| <b>ALTERATIONS</b> | Replacement front porch (c. 1915), partially screened; 1 story addition under porch (east side--historic); one-story southeast addition (c. 1915); one-story southwest porch addition (c. 1915). Post-2007 -- southwest porch structure appears to have been repaired/rebuilt. |

Southwest porch structure appears to have been repaired/rebuilt.
