# Exhibit Attachment - Scope

Includes:

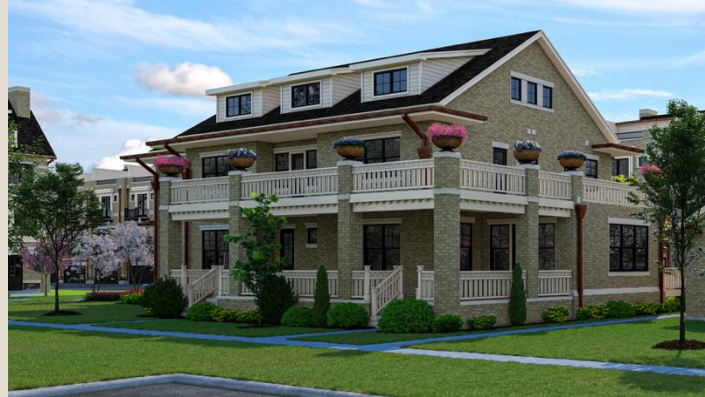
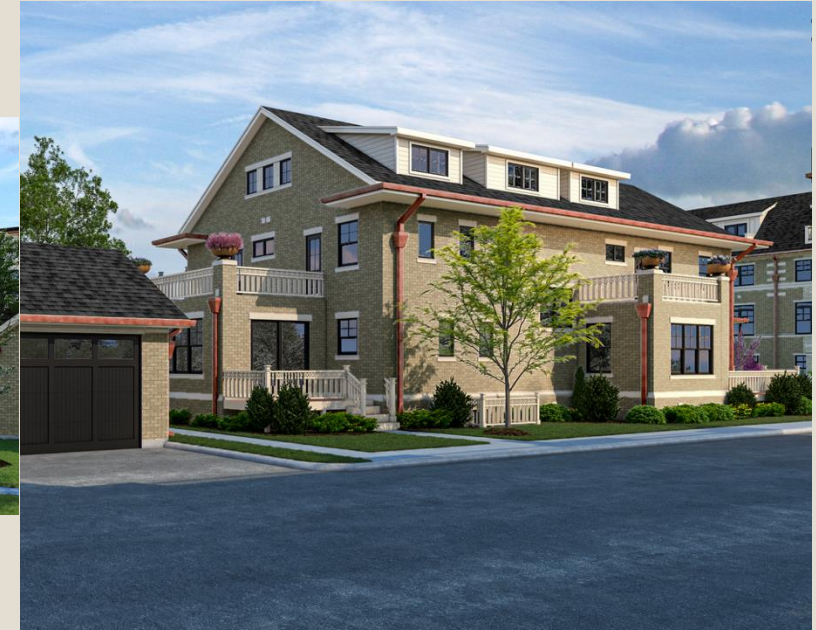
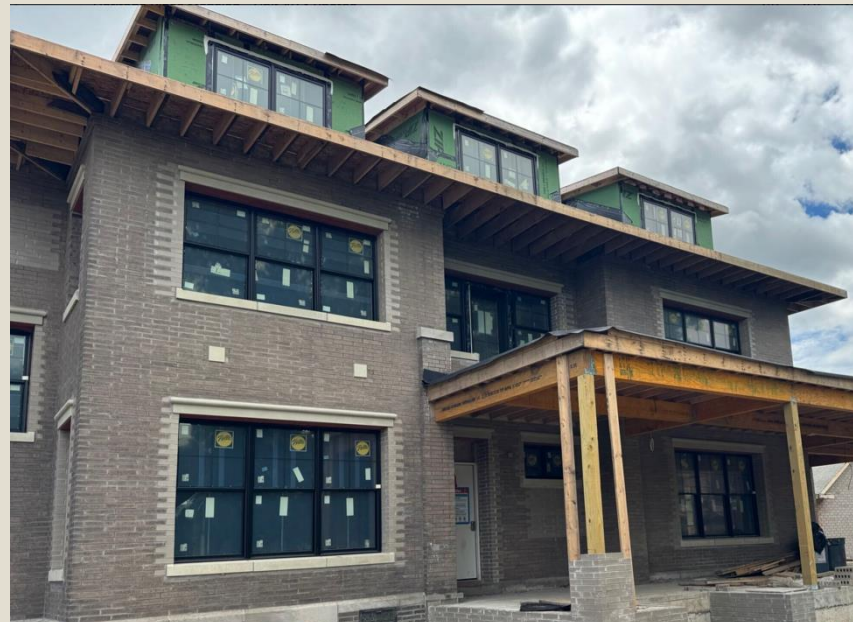
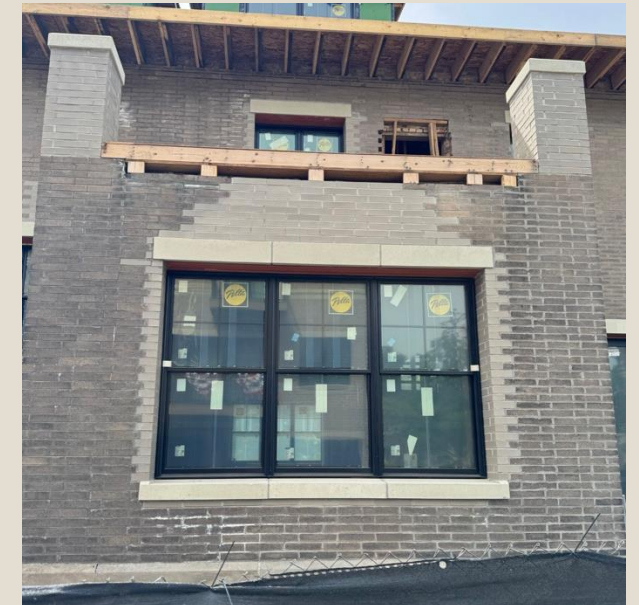
Black windows

Color: Install Black window frames on all exterior windows

Brand: Pella Aluminum Clad Lifestyle series

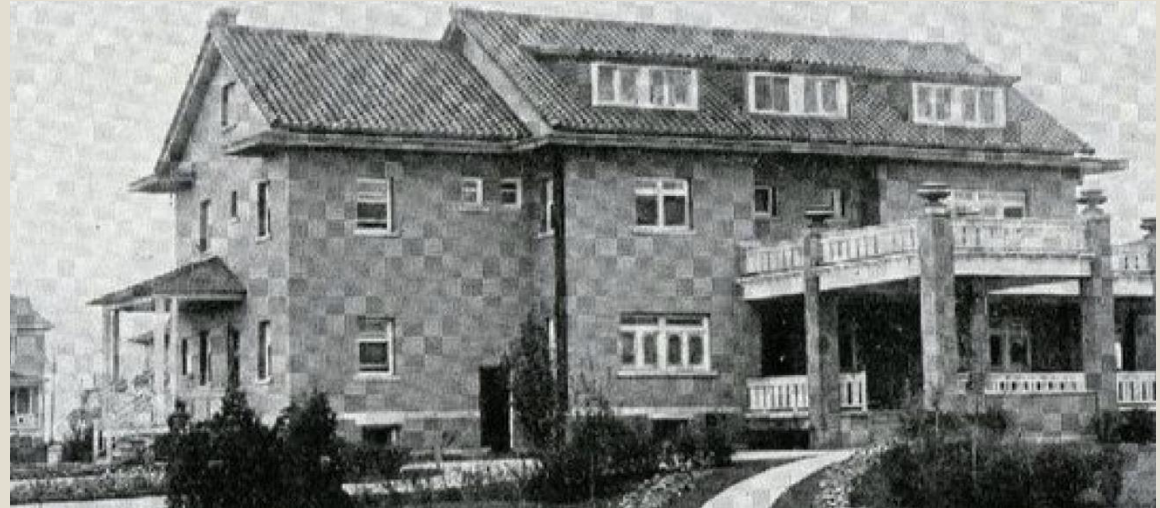
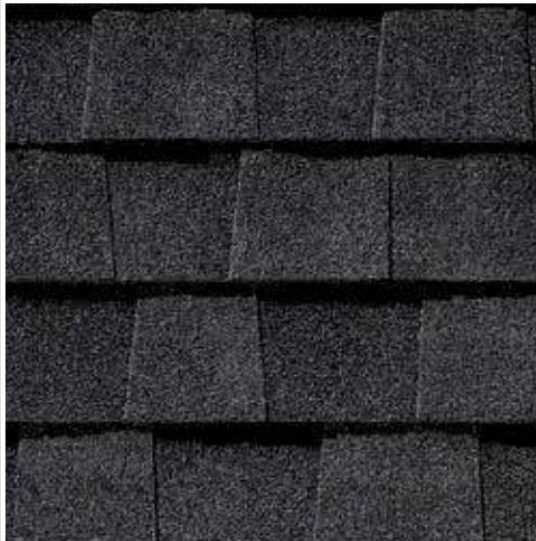
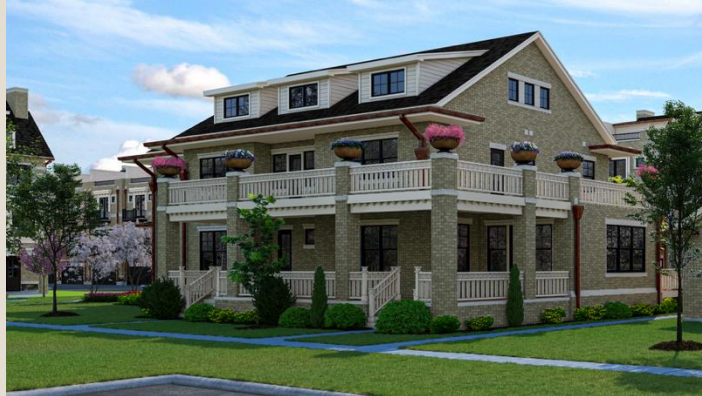
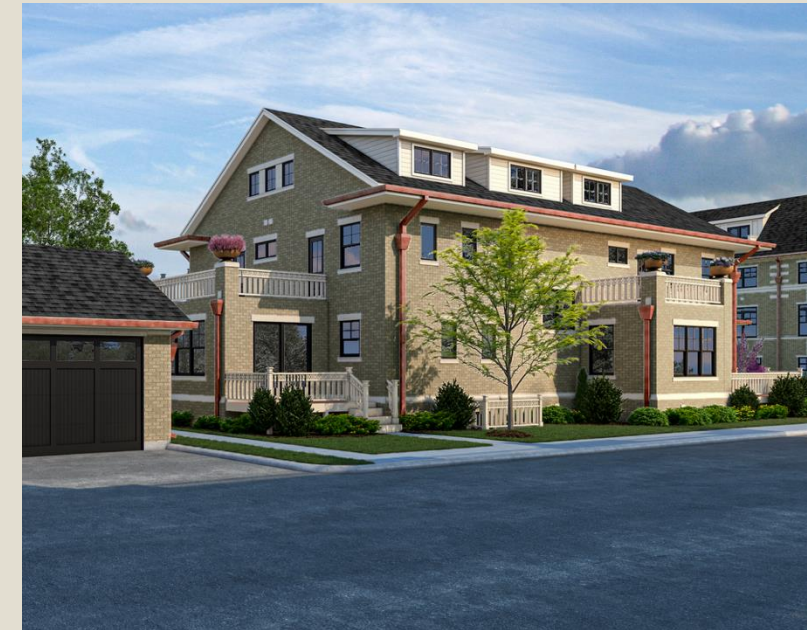
Moiré Black

Replace shingles with new shingles that would be Architectural grade Certainteed consistent with other townhomes in Heritage Place

Original shingles appear to be red / orange clay tiles

Shingle color: Certainteed Moire Black consistent with the other Townhomes in Heritage Place

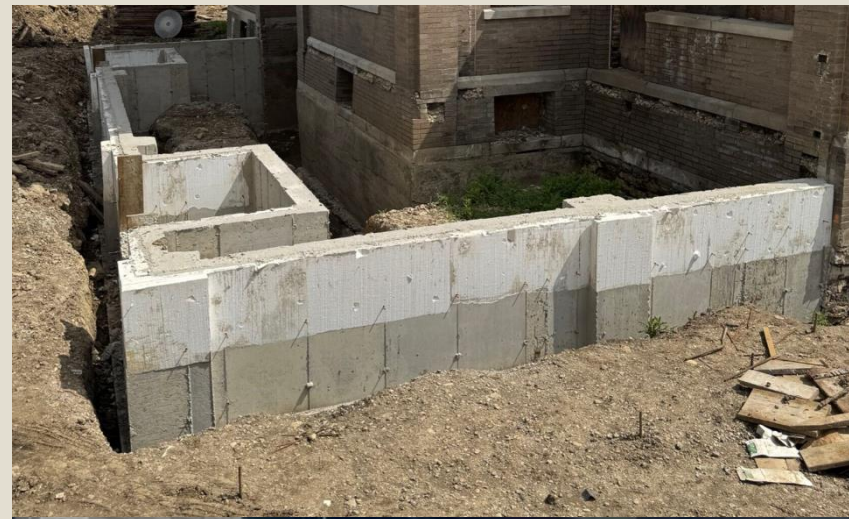
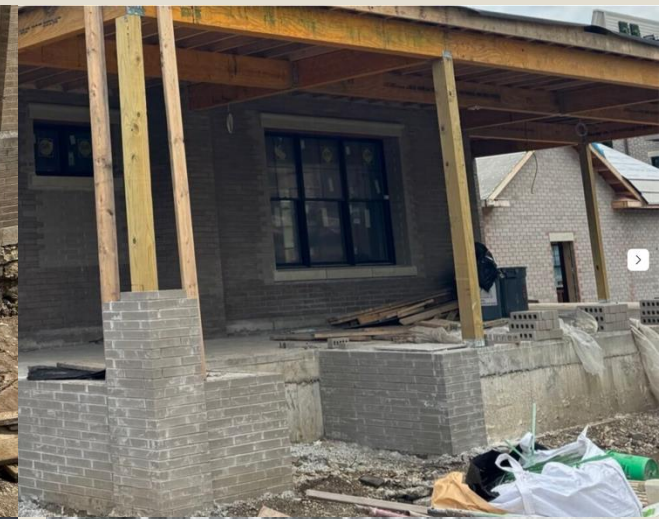
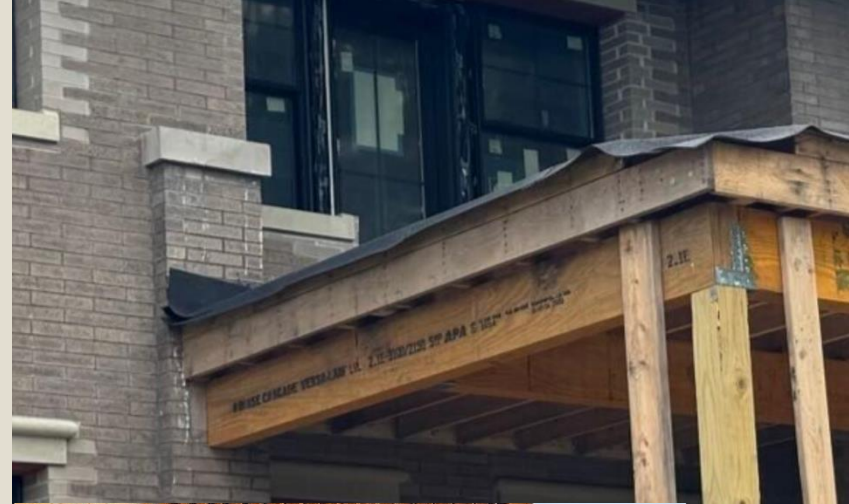
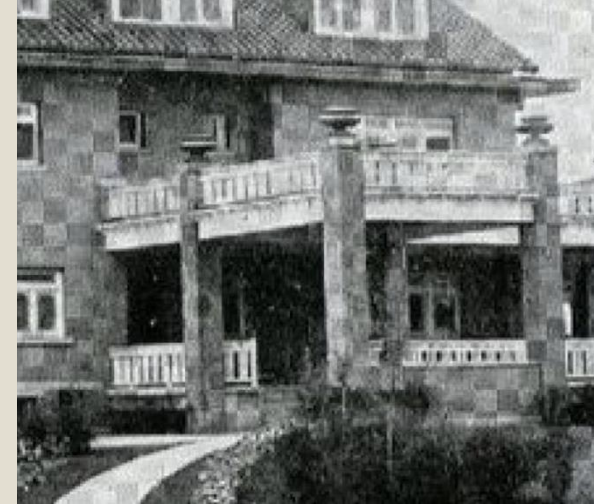
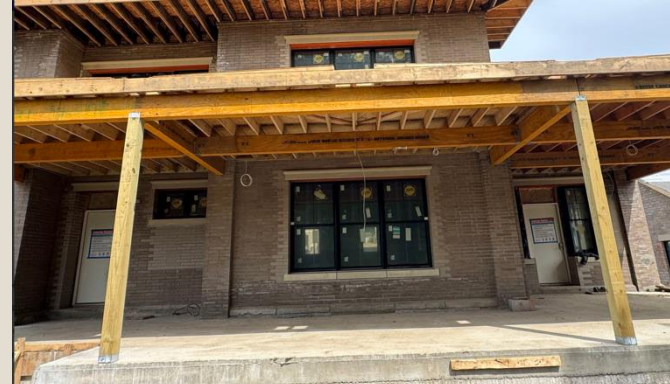
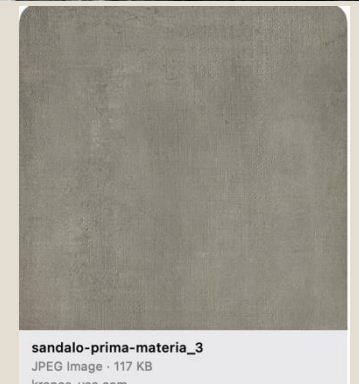
Removed entire porch

Installed New Foundation system

Structural Framing at same size and height as original with proper structure to meet current required loads as seen in picture

Poured Concrete porch surface in preparation for covered concrete look porcelain tile surface as seen in picture

Brick base and columns using new brick similar in size to the original brick as seen in picture

Extend the new brick columns to same height as originally above the main roof system as seen in picture

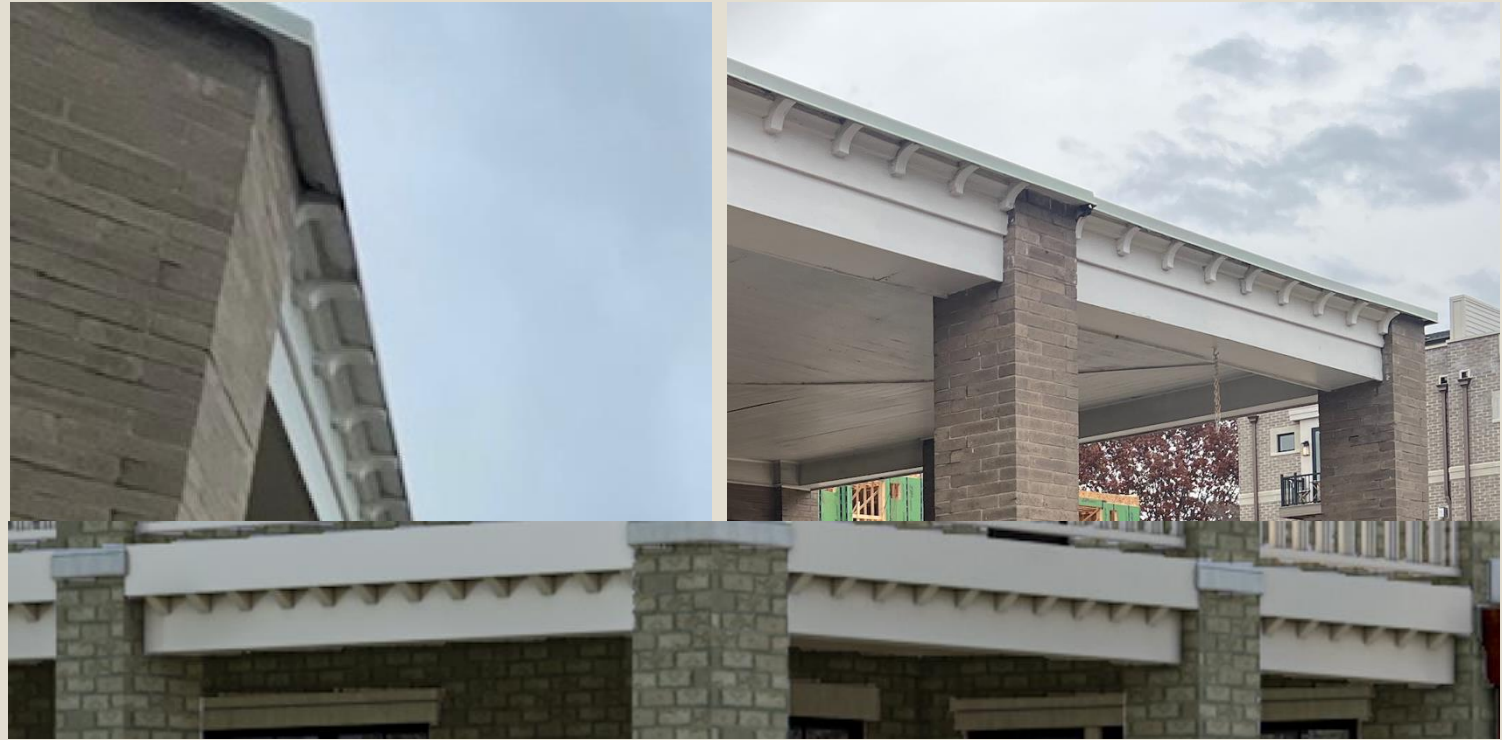
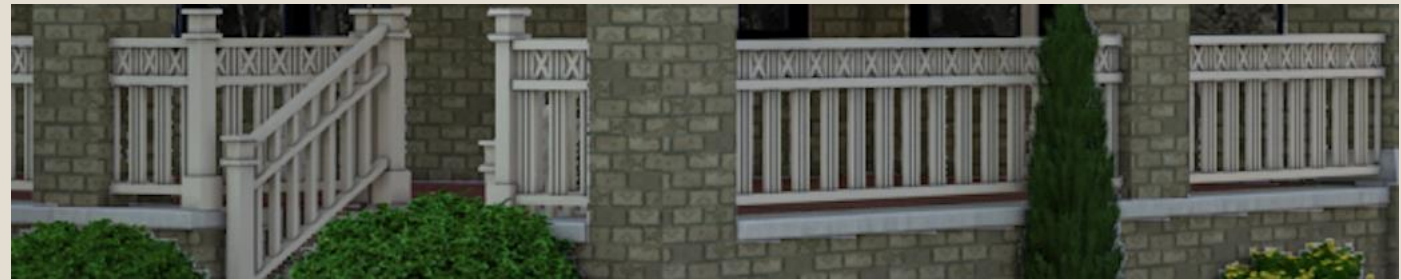
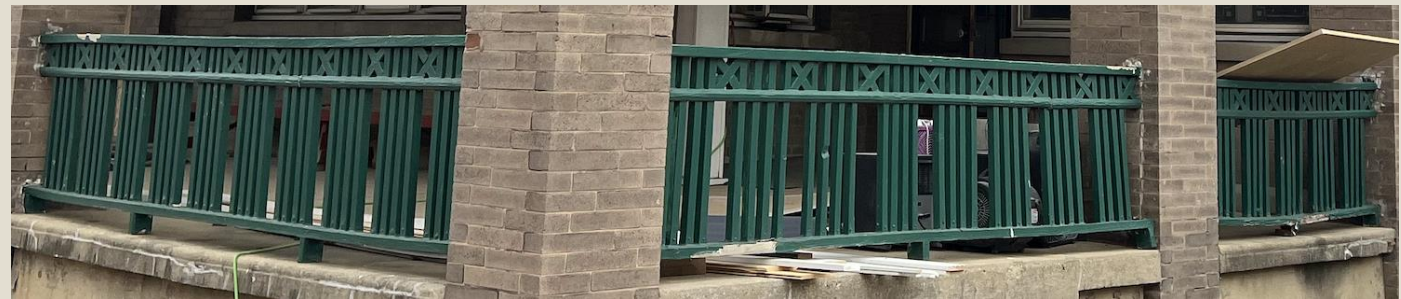
Similar Eave and Dentil system design as existed on original porch removed

Similar Railing system design as existed on original porch removed

Stair systems with railing to be similar to railing on balance of porch. In old pictures there does not appear to be a rail system on the original stairs but this would not work with existing codes

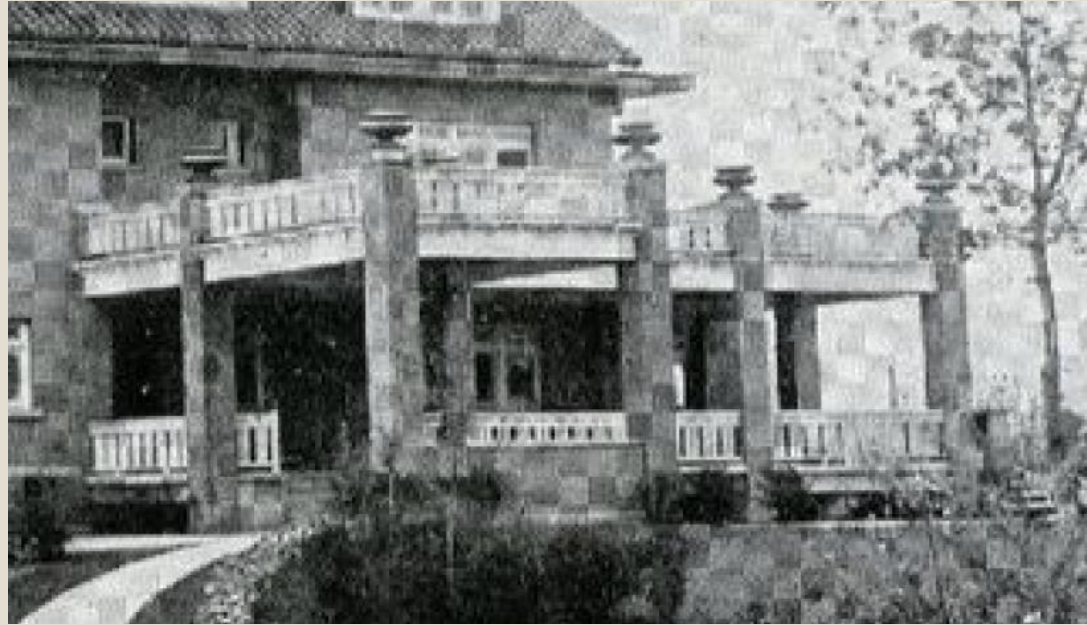
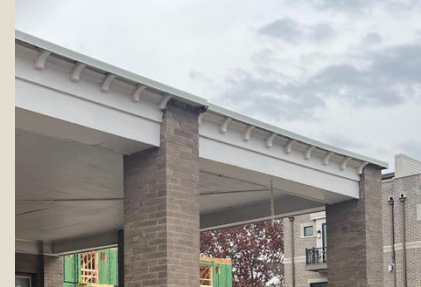
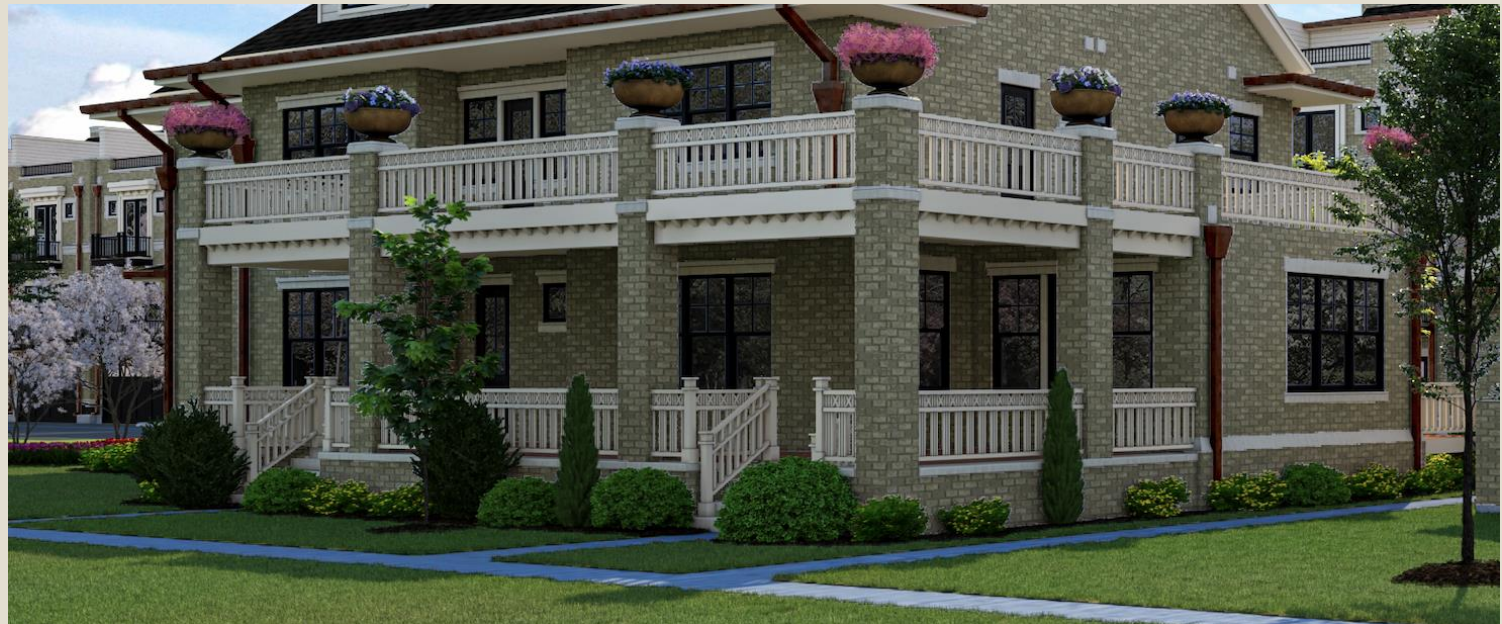
No upper railing existed when porch was removed

Installing new upper railing to bring back to original look as seen in old pictures

Upper Railing to be similar to new railing system on lower porch
