| <b>STREET #</b> | 6 |
| <b>STREET</b> | WRIGHT |
| <b>PIN</b> | 0818312004 |

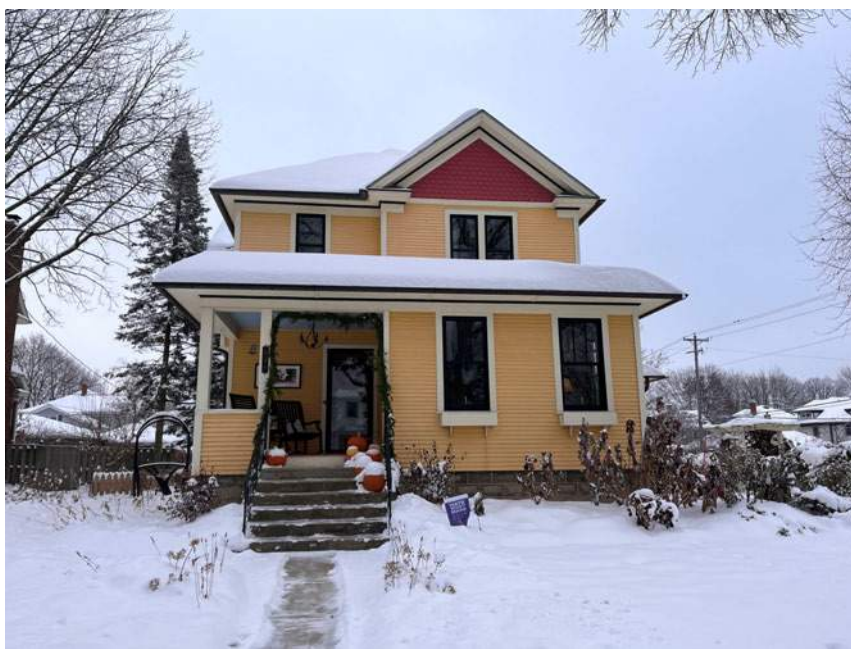
| <b>ARCHITECTURAL CLASSIFICATION</b> | Queen Anne - Free Classic | <b>PLAN</b> | rectangular |

| <b>SIGNIFICANT FEATURES</b> | Hipped roof with front gable; two story north bay with first story cutaway corners; two-story gabled south bay; 1st story south side window bay |

| <b>ALTERATIONS</b> | Replacement front porch, partially enclosed (historic); replacement siding (appropriate). Post-2007 -- windows throughout appear to be Aluminum replacement windows (configurations match previous windows); non-historic 2-story rear addition replaced with new 2-story rear addition with south side sun porch; new detached garage facing Benton Avenue. |

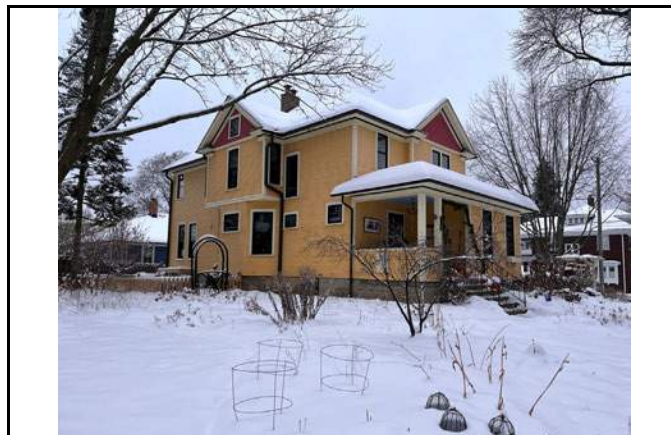
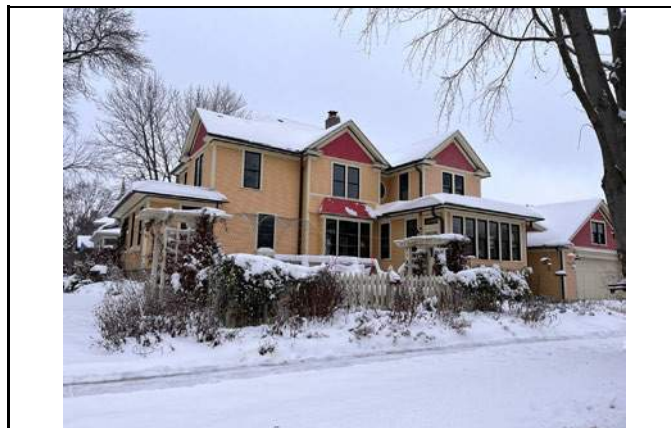
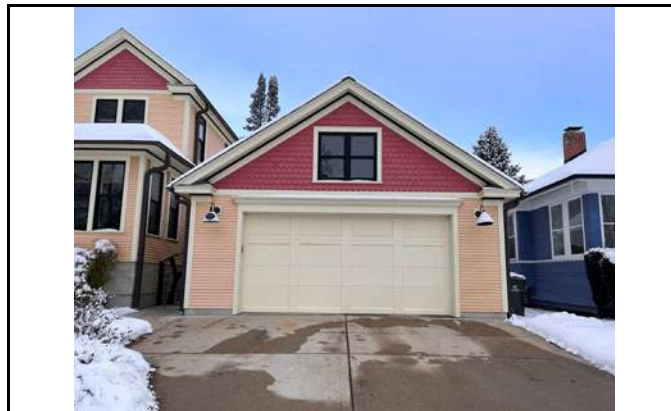
Aluminum replacement windows throughout.

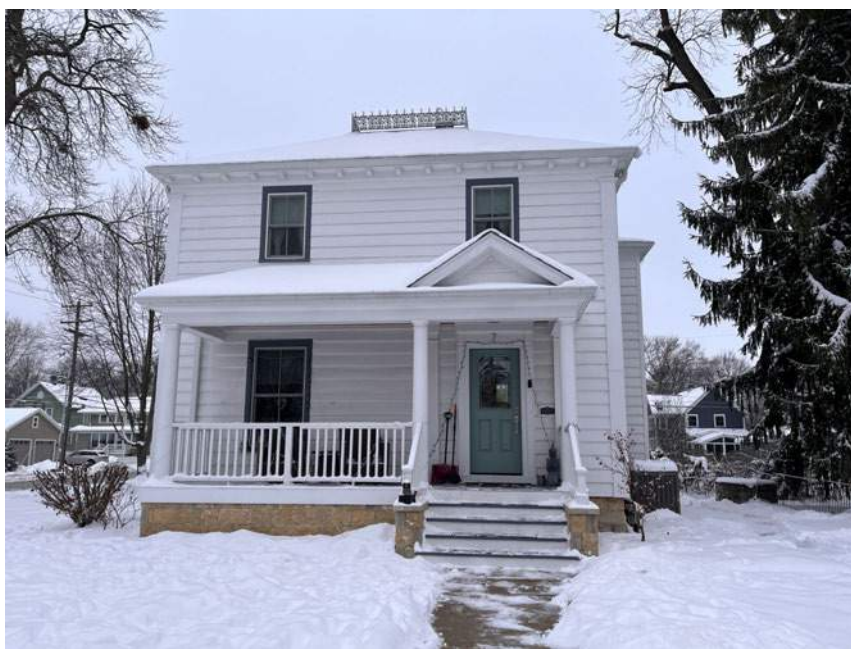
| ALTERATIONS | Wood siding (historic), and fixed shutters added; 2nd story north addition (not historic). Post-2007 -- early 20th-century entry porch replaced with new hipped roof porch with classical columns, painted wood railing, and triangular pediment; 2nd-story rear addition; historic wood windows (2/2, 4/4, 6/6, 1/1) replaced with 2/2 aluminum windows throughout |

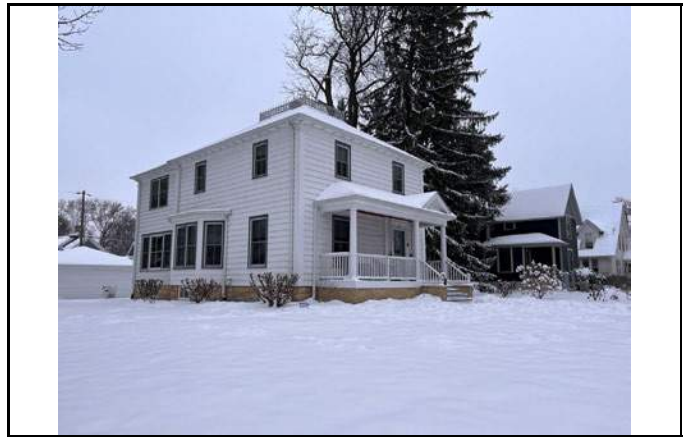
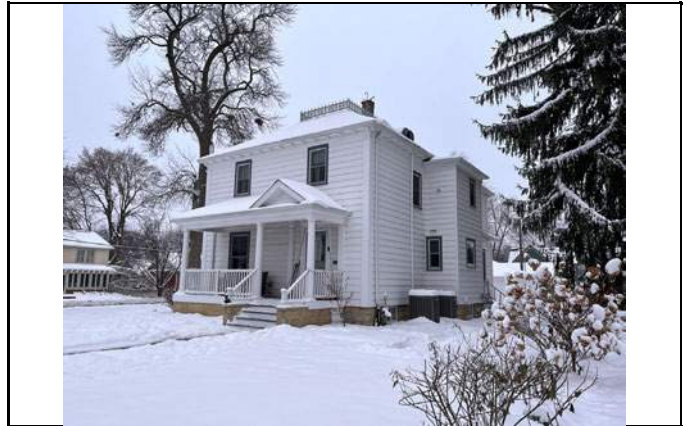
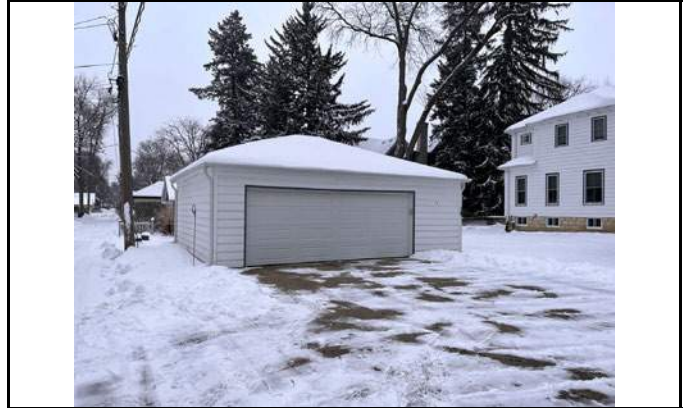
historic wood windows (2/2, 4/4, 6/6, 1/1) replaced with 2/2 aluminum windows throughout

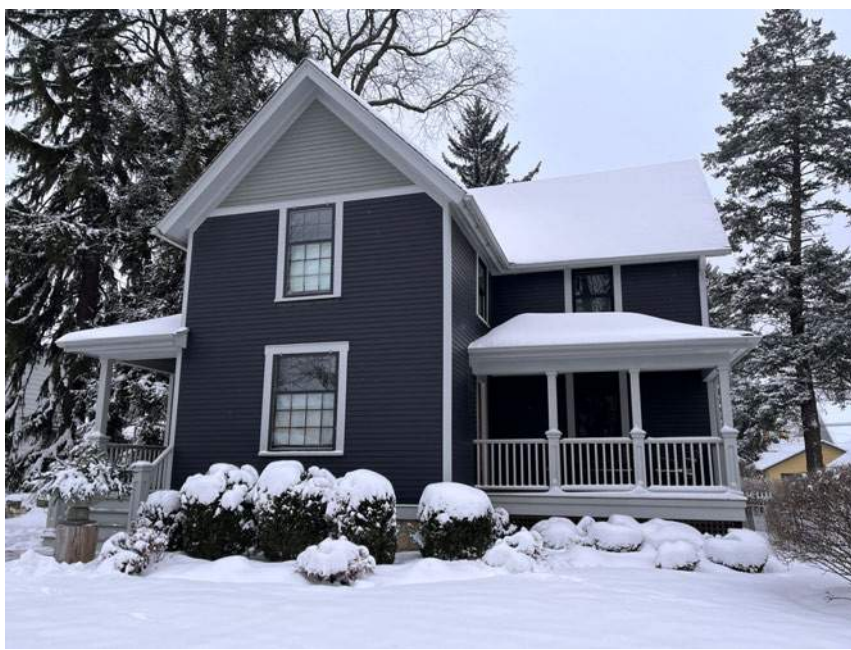
| ALTERATIONS | 2 story north side addition (historic -- c. 1915). Post-2007 -- sloped south extension of historic front gable bay, south entrance, and oriel bay on south elevation removed; new one-story entry bay with porch constructed south of front-gable bay; new hipped roof porch constructed along east elevation of c. 1915 north addition, with new entrance on north wall of original front bay opening onto new porch; 1/1 replacement windows on sections of north, front, and south elevations; replacement siding |

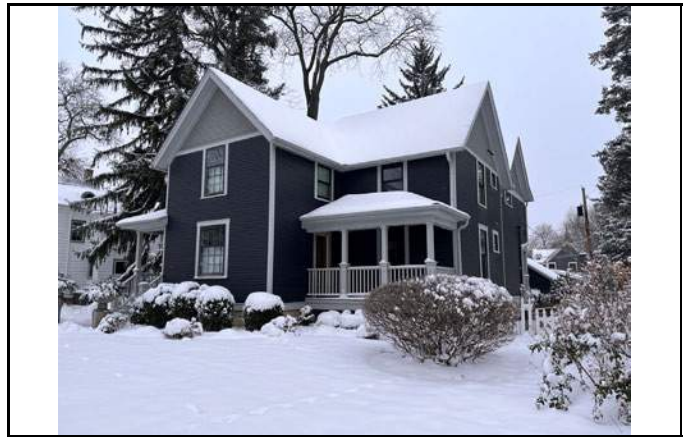
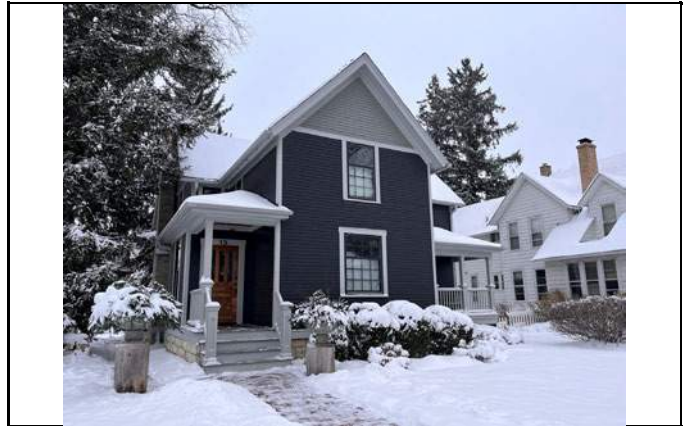
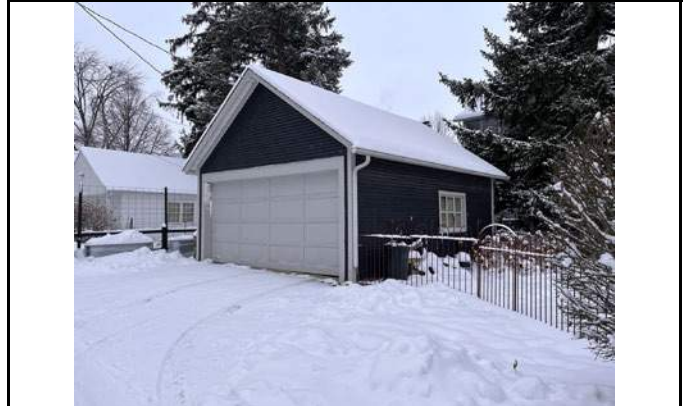
| <b>NOTES ON WORK:</b> | Some windows on front and side elevations appear to be newer replacement windows. |

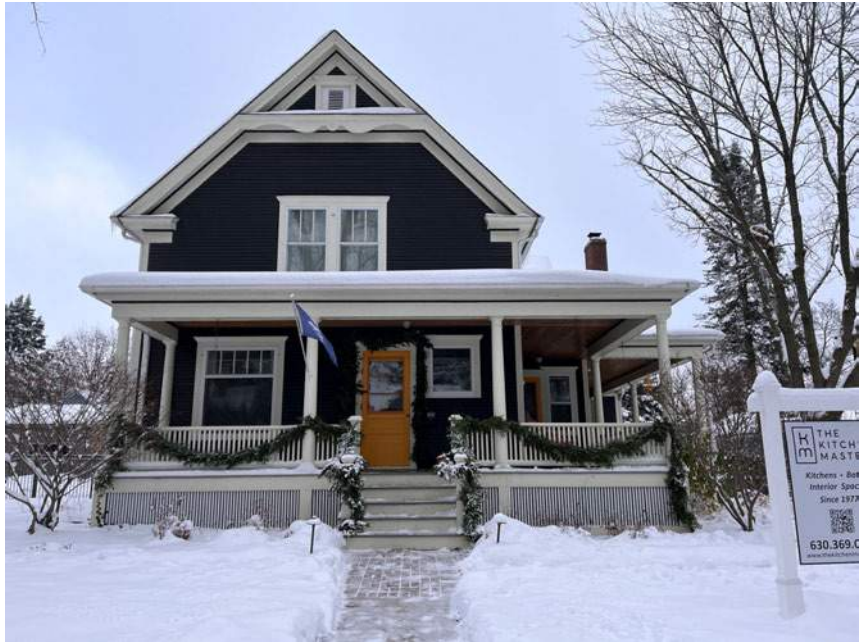
| ALTERATIONS | Replacement siding & verge board (not historic); wraparound front porch w/ 1 story entry add. on S. side (not historic); large 2-story rear (south) addition (not historic); replacement windows in original openings on original house (may be historic). Post-2007 -- no changes (exterior wood cladding painted). |

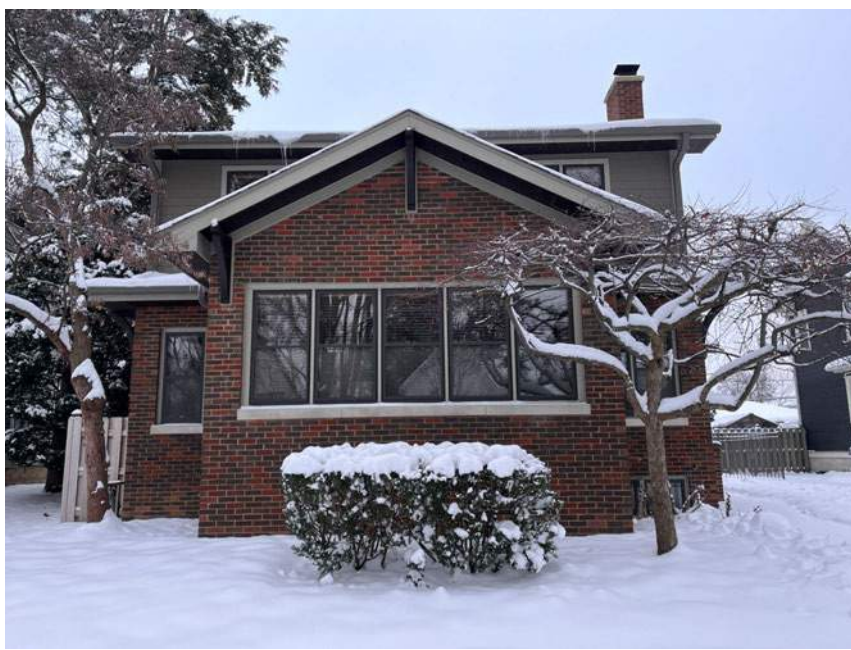
| ALTERATIONS | Original house obscured by alterations and additions--replacement windows in altered openings on north side, original openings on rest of house; 2nd story addition (not historic); aluminum under eaves. Post-2007 -- fiber cement board siding installed on second story. |

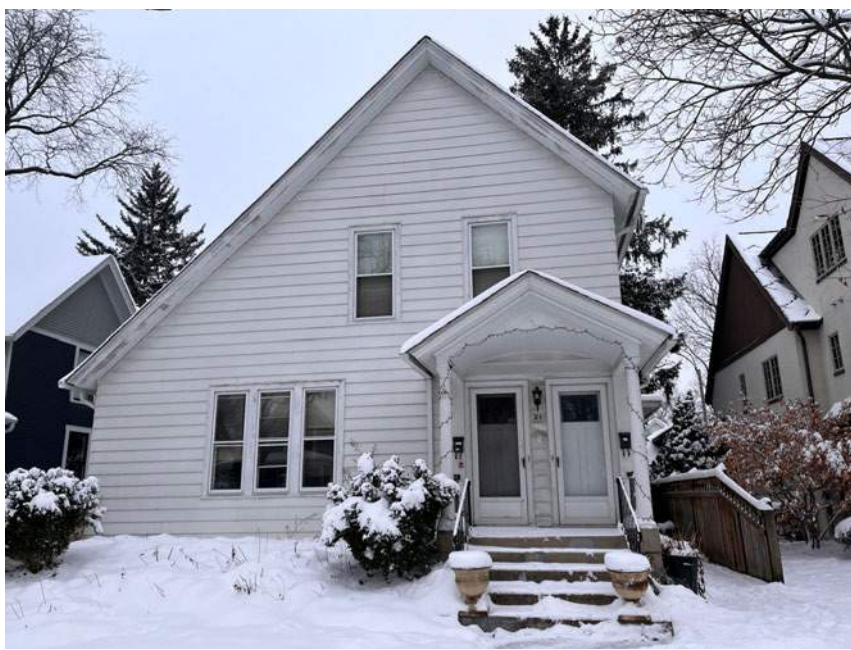
| ALTERATIONS | Aluminum siding; front gable extended to south (c. 1955-60); new front entry porch with 2 entry doors (conversion to multi-family post-1954); 2 story rear addition; 1 story north addition; windows appear to be wood replacement windows. Post-2007 -- in-kind asphalt shingle roofing replacement. | | |

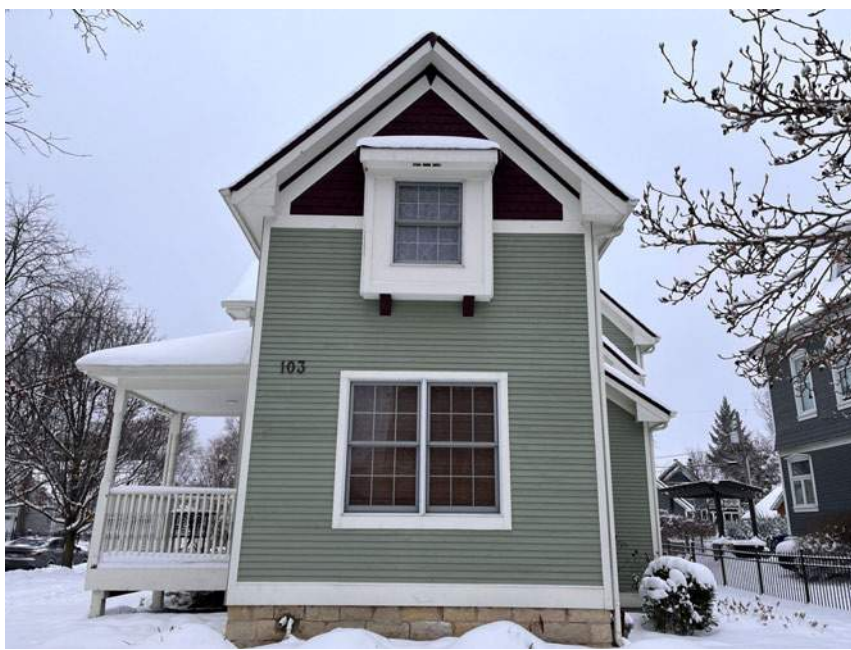
ARCHITECTURAL CLASSIFICATION Gabled Ell (altered) PLAN irregular  
 DETAILS Queen Anne NO OF STORIES 2  
 BEGINYEAR c. 1885 ROOF TYPE Multi-gable  
 OTHER YEAR c. 2005 ROOF MATERIAL Asphalt - shingle  
 DATESOURCE Surveyor FOUNDATION Stone/concrete  
 WALL MATERIAL (current) Wood PORCH Front entry  
 WALL MATERIAL 2 (current) Wood - shingle WINDOW MATERIAL Vinyl  
 WALL MATERIAL (original) Wood WINDOW MATERIAL  
 WALL MATERIAL 2 (original) WINDOW TYPE double hung  
 WINDOW CONFIG 6/6

House has been recently renovated---replacement front porch & door; large 2 story rear/south add.; 2 story north add.; 1 story extension of original south side bay; replacement siding; replacement windows; 2nd story bay window on front gable. Post-2007 -- no changes.

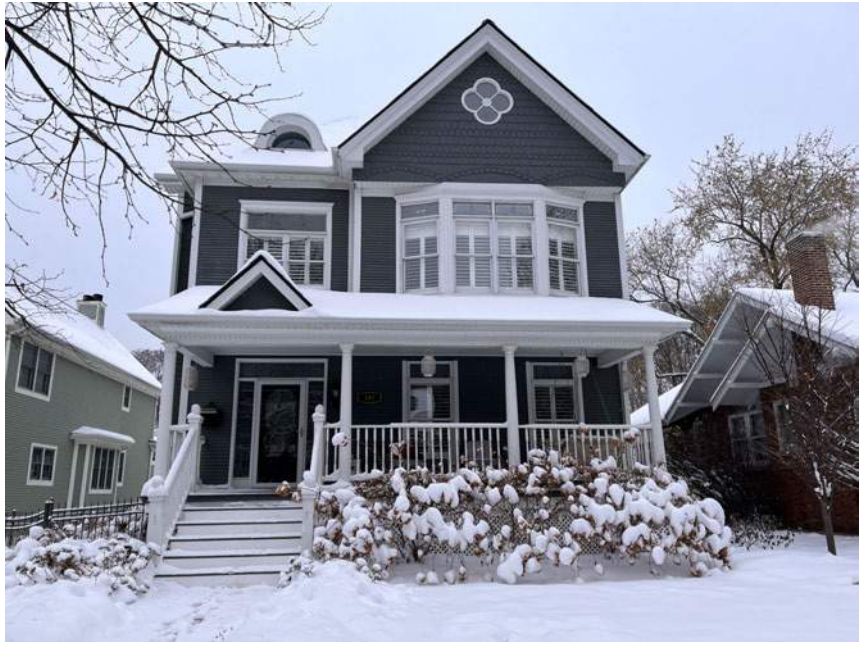
Original 1.5 story Gable Front Cottage completely obscured by extensive alterations and massive 2nd story addition. See COA application for photographs of original house. Post-2007 -- porch steps and decking replaced with composite material.

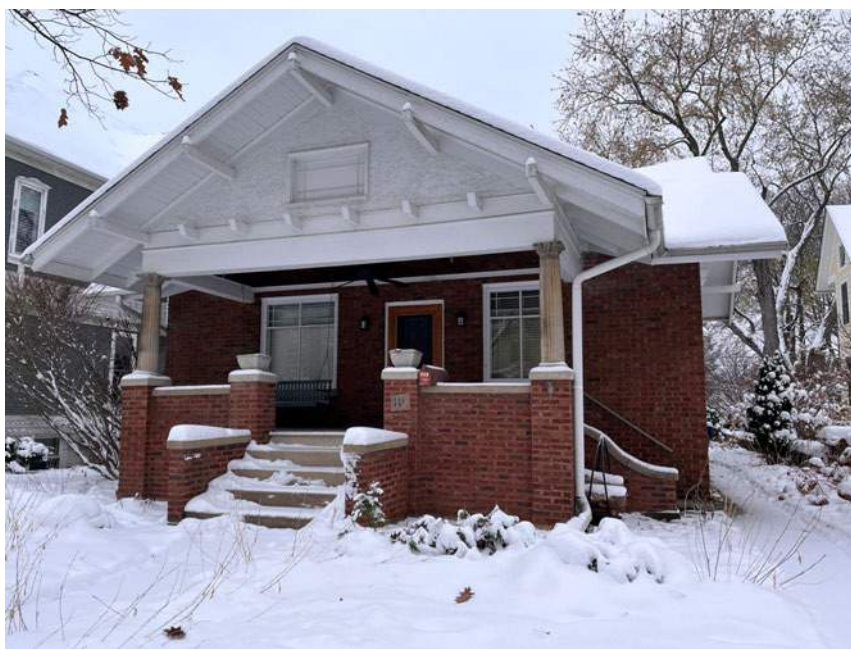
| <b>CONDITION</b> | good | <b>REASON for SIGNIFICANCE</b> | Excellent example of 1920s Craftsman Bungalow with many original features, including projecting front gable porch. |

| <b>ALTERATIONS</b> | front window under porch gable painted. Post-2007 -- in-kind roof replacement. | | |

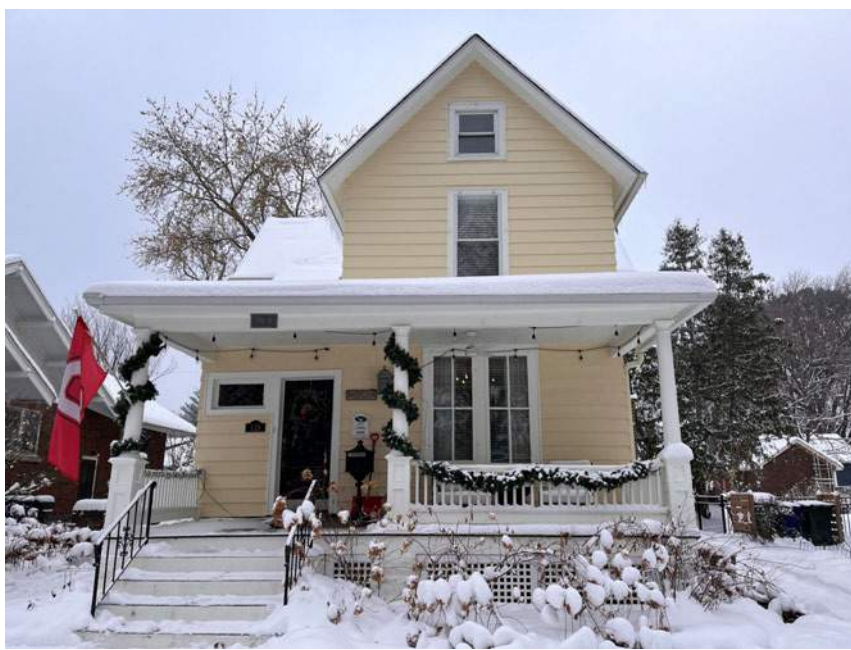
| ALTERATIONS | S. side addition between bays with interior stair & new entry (may be historic); replacement front porch (historic -- railings are later replacements); 2 story rear addition (c. 2000); replacement windows on south gable and on 3rd floor under front gable (not historic); aluminum siding on 1st story and on rear addition (not historic); fixed shutters (not historic). Post-2007 -- non-historic fixed shutters removed; replacement front door; in-kind asphalt shingle replacement roofing. |

| <b>COA COMPLIANCE NOTES:</b> | Siding and trim appear to have not been replaced (COA #19-3629). |

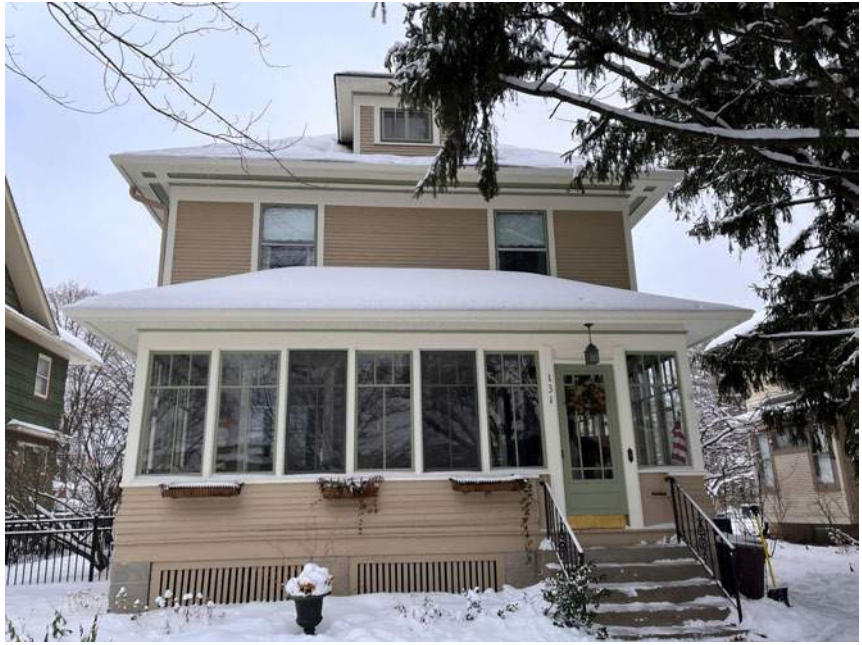
| ALTERATIONS | Porch enclosed with 5-light storm windows (historic alteration); roof of porch appears to have been raised (not historic); replacement front door behind porch; wrought iron railing and concrete steps. Post-2007 -- no changes to principal structure. New detached garage. | | |

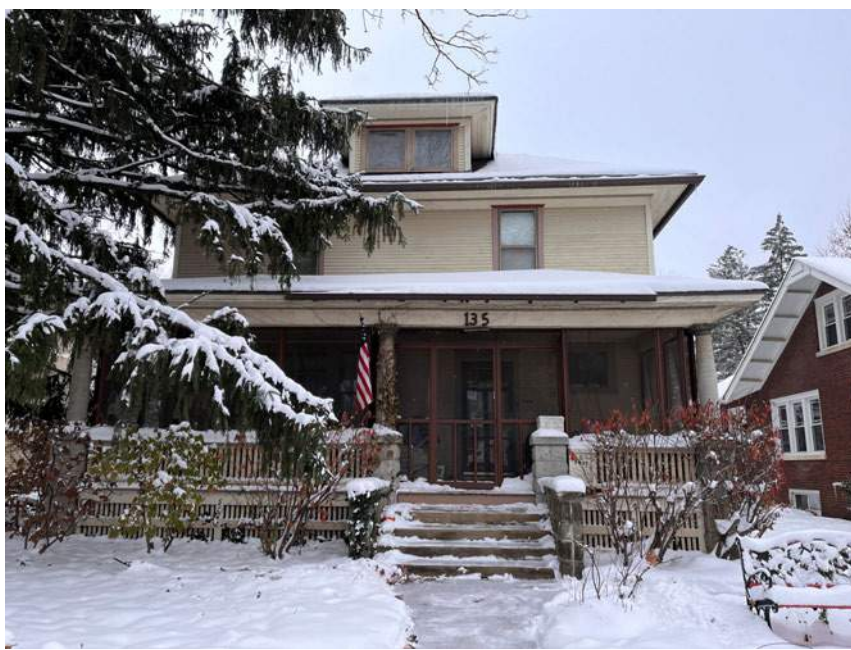
| ALTERATIONS | Porch screened in (not historic); replacement windows in dormer (enlarge openings, not historic); north exterior stair addition (not historic); one story rear addition. Post-2007 -- no changes. | | |

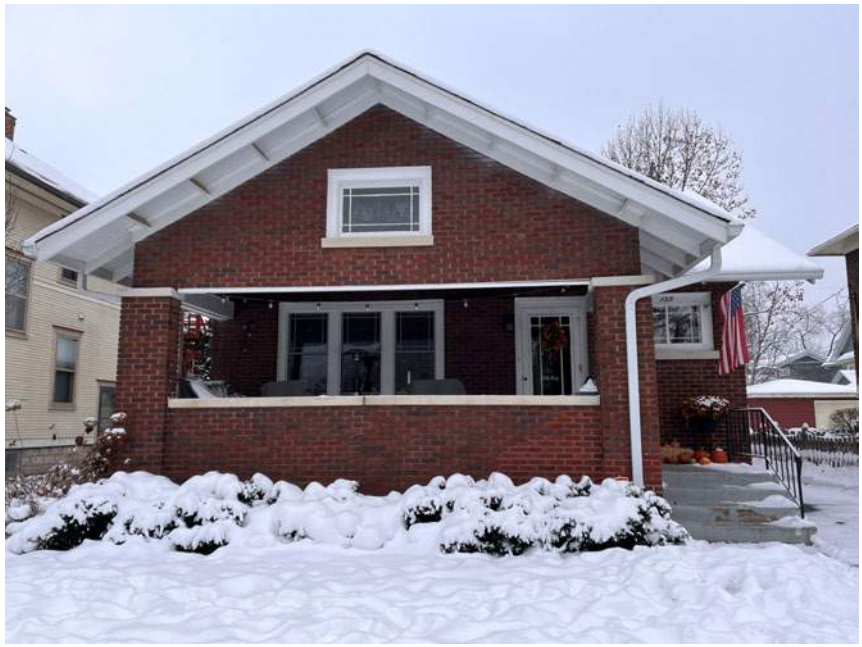
| ALTERATIONS | North side window filled with glass block (not historic); framing for door at porch entry (not historic); replacement porch steps and railing. Post-2007 -- vinyl replacement windows on side elevations and in three-part window under porch (matches historic configurations). | | |

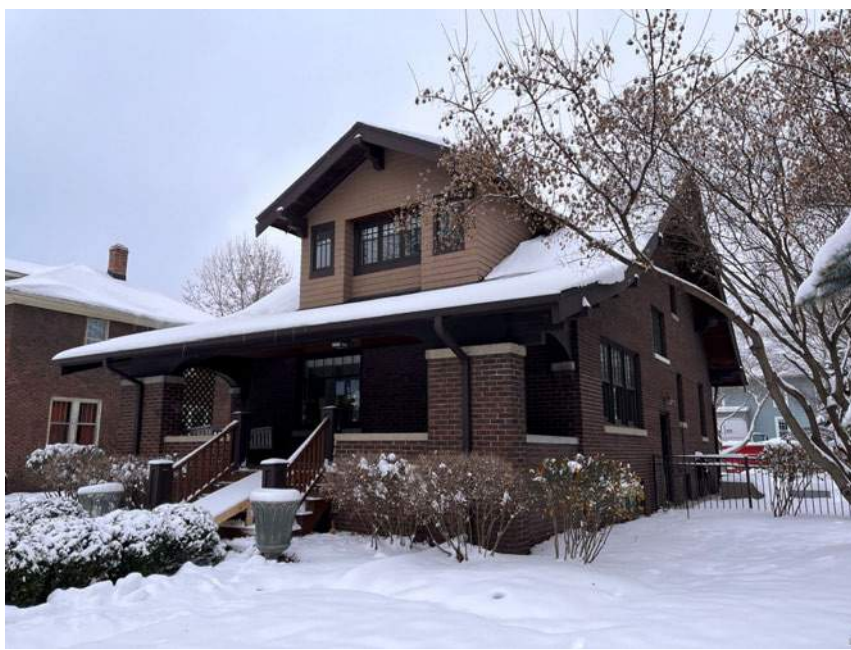
| <b>CONDITION</b> | good | <b>REASON for SIGNIFICANCE</b> | Pristine Craftsman Bungalow, with broad side gable roof that sweeps down to include a full-width front porch. |

| <b>ALTERATIONS</b> | Post-2007 -- work currently underway to replace most existing first-story windows and select second story and basement windows, install windows in new/altered openings at east ends of north and south elevations at first story, and replace front and rear doors. | | |

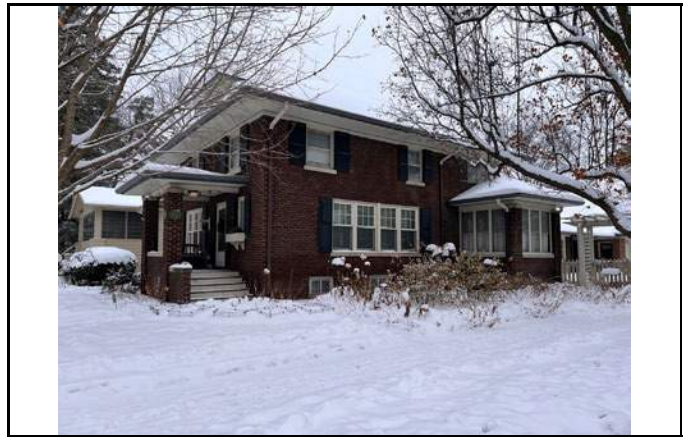
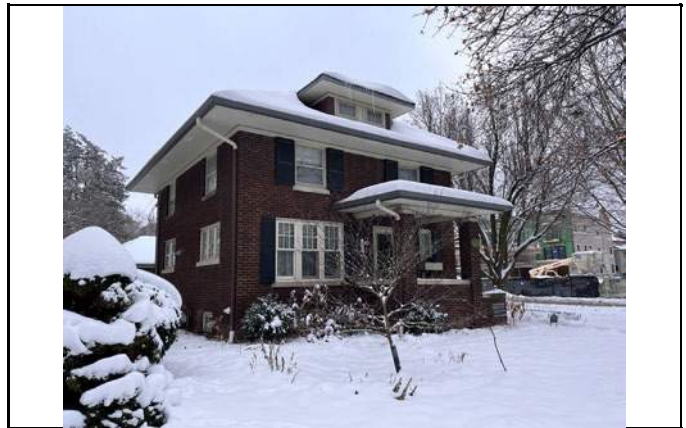
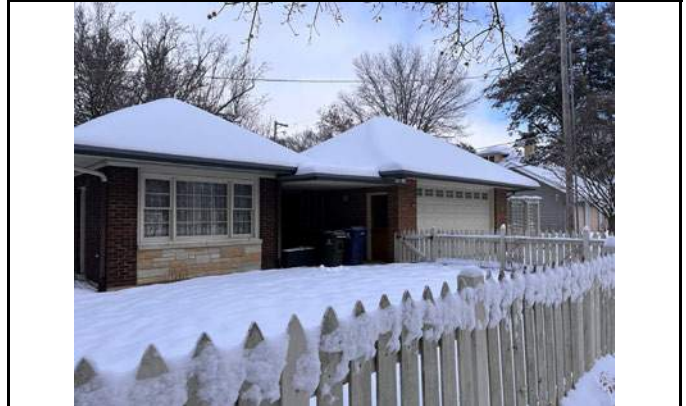
**NOTES ON WORK:** Historically compatible replacement windows in some existing window openings on front façade and south elevation.

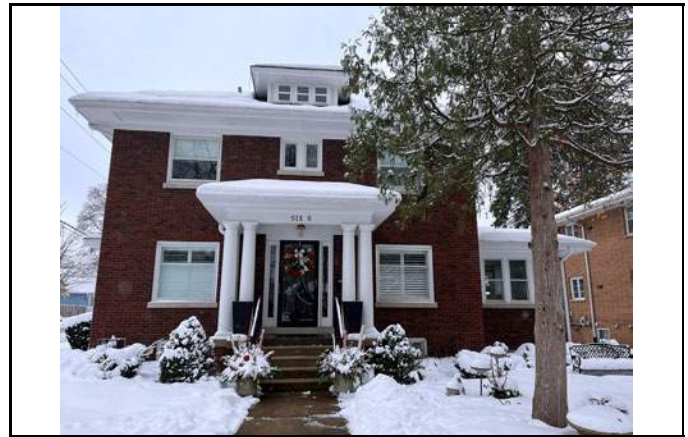
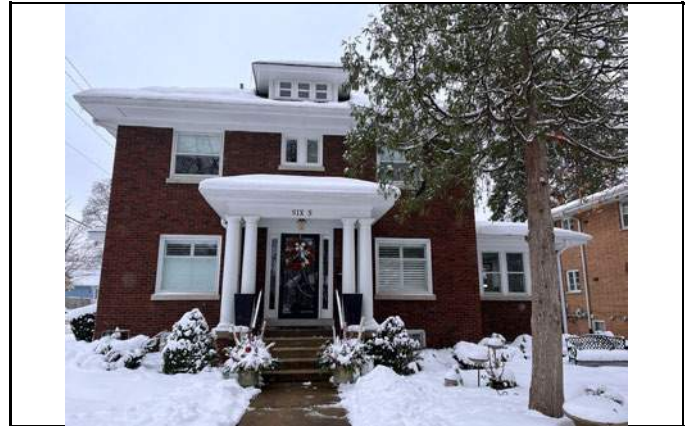
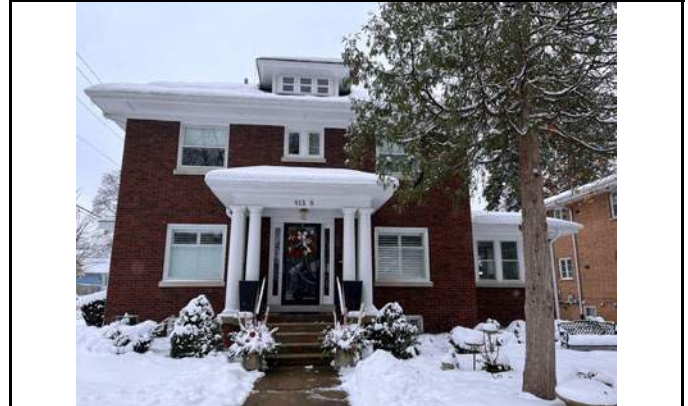
some replacement windows on front and north elevations; replacement windows in front and north dormers.

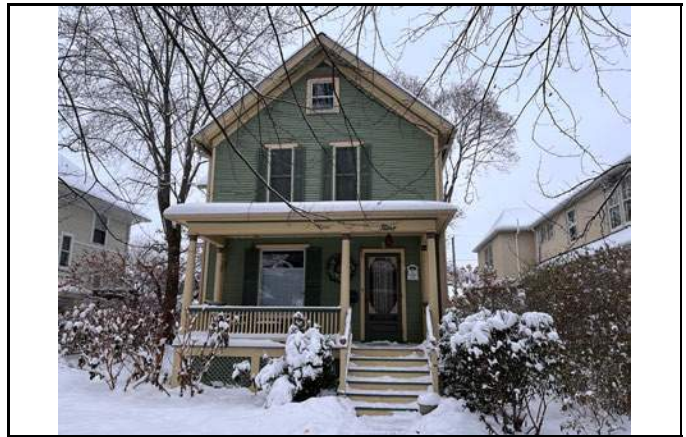
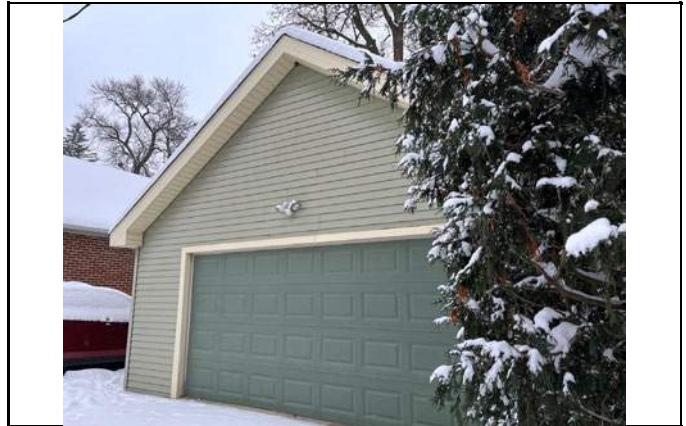
| <b>ALTERATIONS</b> | Fixed shutters (not historic); possible 2nd story rear addition; replacement front steps and railings (not historic). Post-2007 -- windows at 2nd story of front façade and at side elevations appear to be replacements. New detached garage. | | |

1/1 windows on 2nd story of front elevation and at side elevations appear to be replacement.

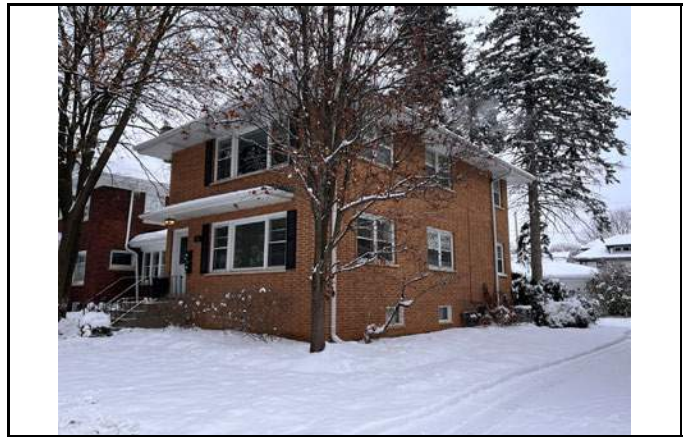
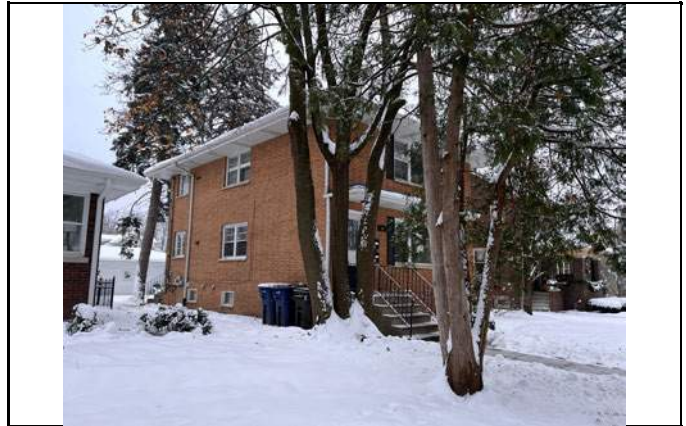
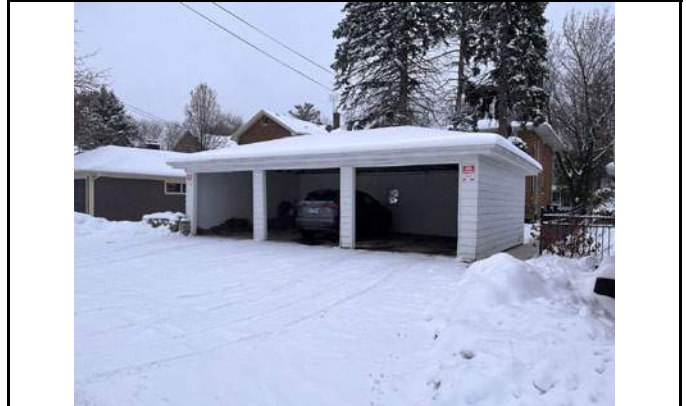
| ALTERATIONS | Aluminum siding under eaves. Post-2007 -- replacement front door. | | |

Replacement front door.

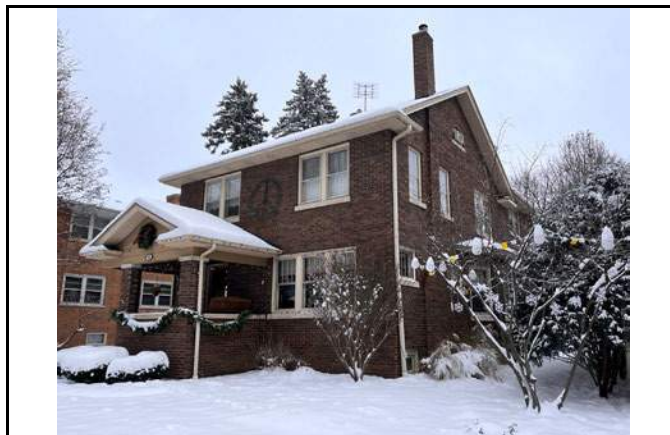
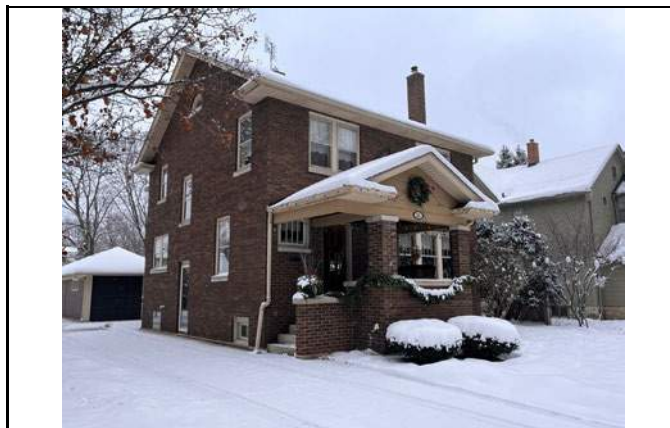
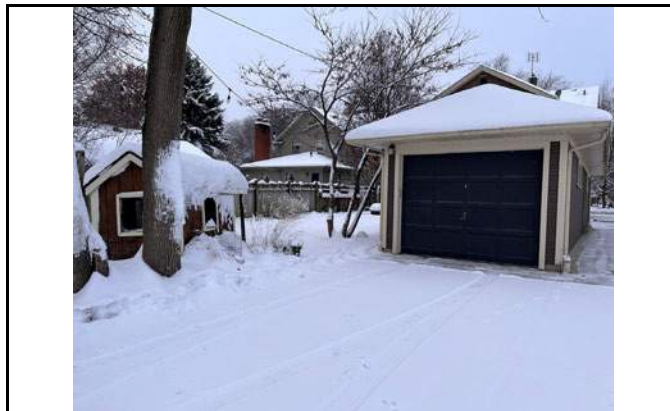
| ALTERATIONS | Front porch extended; new porch steps, wrought iron supports and porch railing; 2nd entry added under porch; 2 story rear addition. Post-2007 -- wrought iron supports and railing at porch extension removed and new steps with solid brick knee wall installed; second entry door north of original entrance replaced with historically appropriate window; new front door in original entrance opening under front porch and at secondary entrance on north elevation. | | |

Changes to front porch; replacement doors in main entrance under porch and secondary entrance on north elevation.

| COA DECISION | COA #08-02 -- 4/1 aluminum/vinyl clad windows in existing openings; replacement of door at north end of front façade with four-pane aluminum-clad window; removal of off-center gable roof, wrought iron railing, and concrete steps from front porch; installation of wood roof structure, concrete porch stairs, and brick knee wall at north end of existing front porch (approved 7/13/2009) -- modifications to porch plans (HSC 09-01-89) and wood | | |

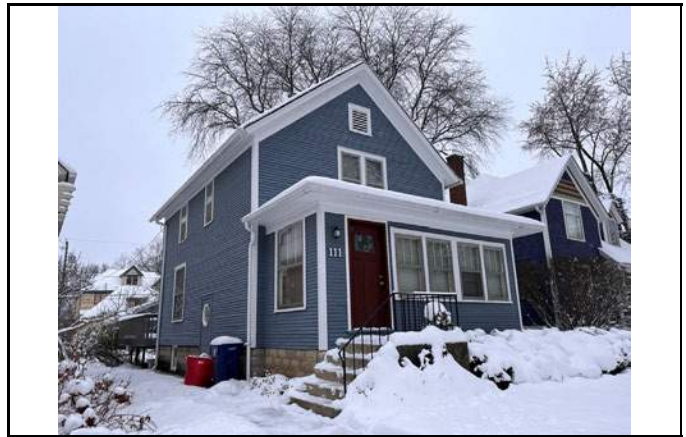
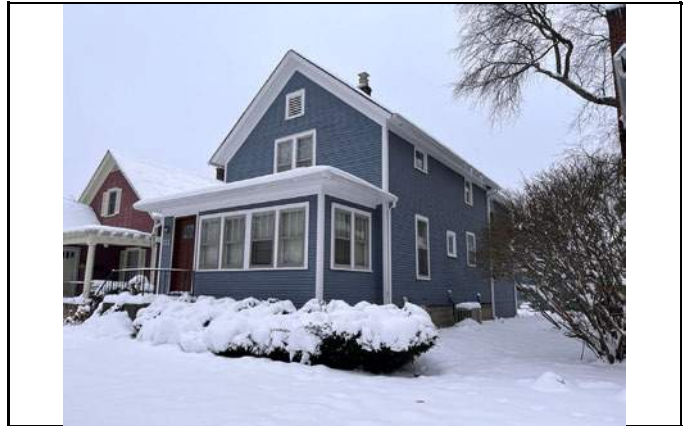
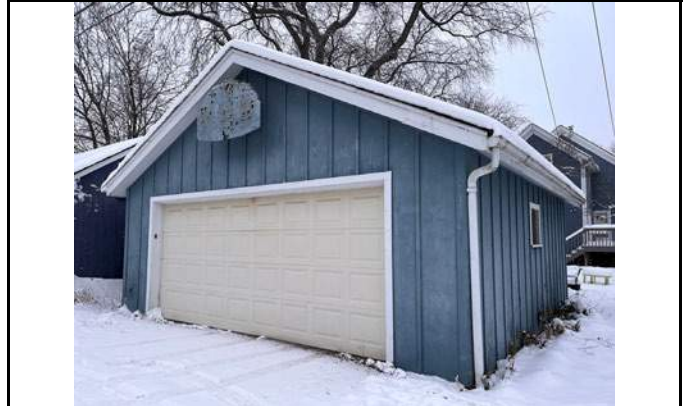
| ALTERATIONS | Front porch enclosed (c. 1920); two story rear addition; at-grade secondary entry opening filled in; rear deck addition. Post-2007 -- replacement door to enclosed porch. | | |

Replacement door to enclosed porch.

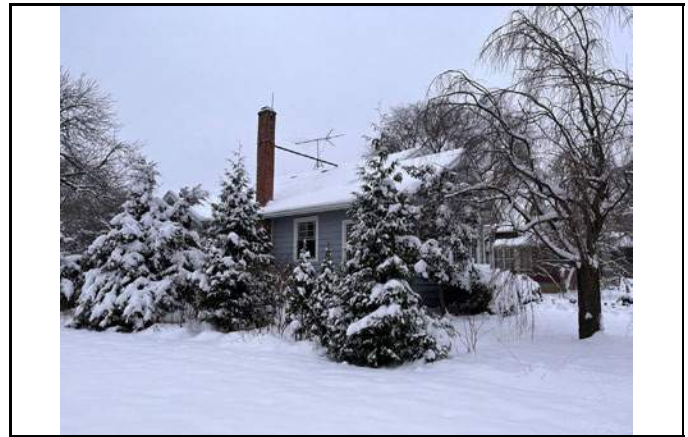
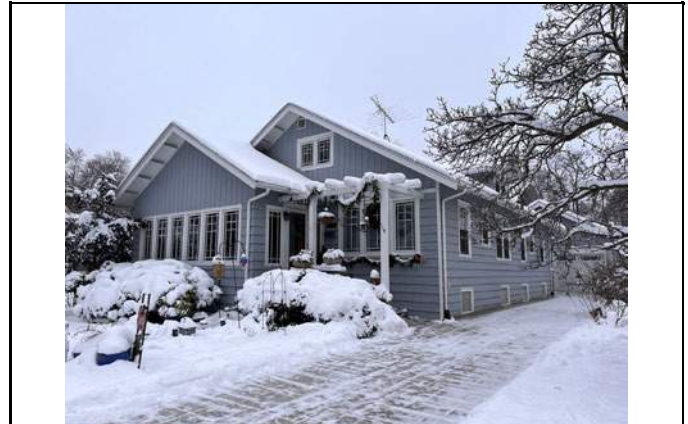
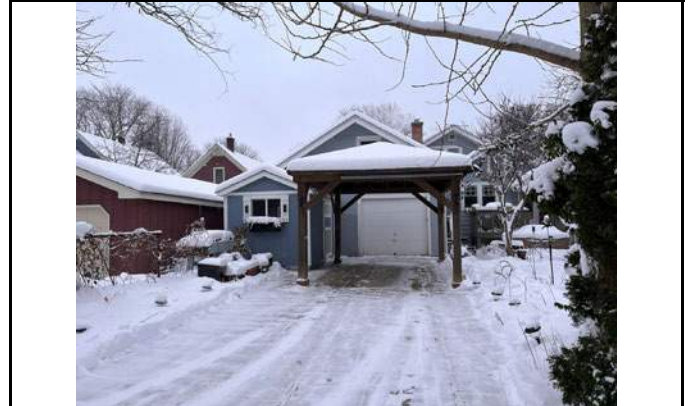
| ALTERATIONS | Replacement siding (1960s--current owners indicate house was originally stuccoed); replacement windows on front façade (not historic); front trellis (not historic); glass block basement windows; rear deck addition (1990s). Post-2007 -- historic 3/1, 2/1, and 4/1 wood windows on side elevations and 3/1 windows flanking front entrance replaced with aluminum windows (geometric-light casement windows or geometric/1 double-hung windows) |

Replacement windows flanking entry and at north and south elevations.

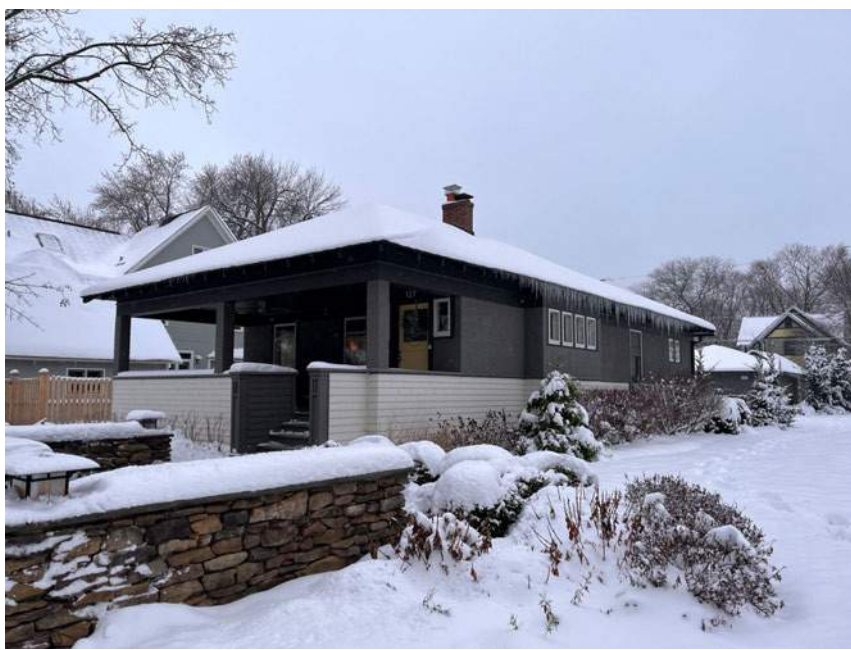
CATEGORY building HISTORIC FUNCTION Domestic - single dwelling  
 CONDITION good REASON for SIGNIFICANCE This ground-hugging Craftsman Bungalow includes fine detailing such as exposed rafter tails and leaded glass windows.  
 INTEGRITY addition(s)  
 SECONDARY STRUCTURE Detached garage

ARCHITECTURAL CLASSIFICATION Craftsman Bungalow PLAN L  
 DETAILS NO OF STORIES 1  
 BEGINYEAR c. 1920 ROOF TYPE Hipped  
 OTHER YEAR ROOF MATERIAL Asphalt shingle  
 DATESOURCE Surveyor FOUNDATION Concrete - poured  
 WALL MATERIAL (current) Stucco PORCH Full front  
 WALL MATERIAL 2 (current) Wood - shingle WINDOW MATERIAL Wood/Leaded glass  
 WALL MATERIAL (original) Stucco WINDOW MATERIAL Vinyl  
 WALL MATERIAL 2 (original) WINDOW TYPE Casement/fixe  
 WINDOW CONFIG 1-light; multi-light

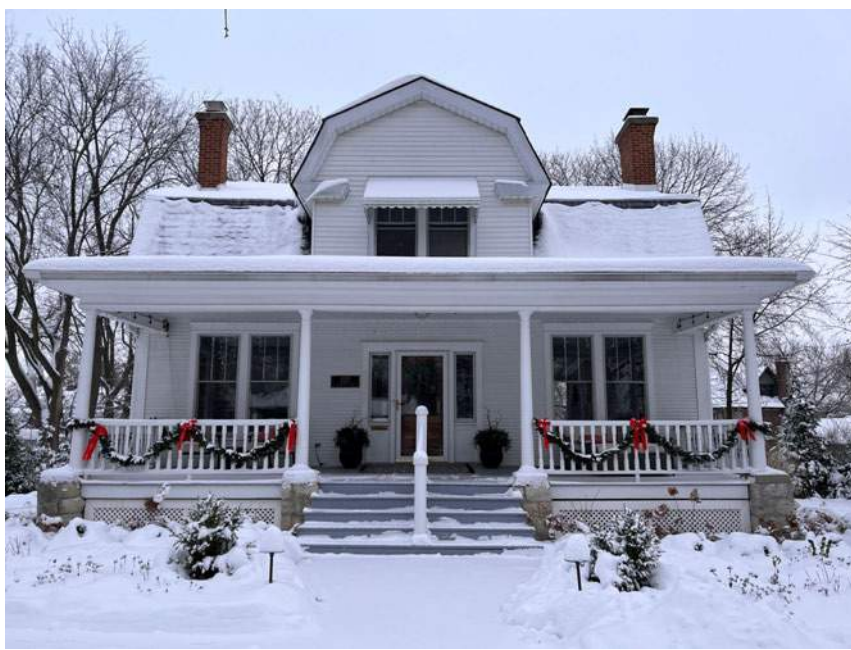
| <b>CONDITION</b> | excellent | <b>REASON for SIGNIFICANCE</b> | Unusual, early example of Dutch Colonial Revival architecture, with broad side-gambrel roof and classical front porch. |

| <b>ALTERATIONS</b> | Replacement 3/1 wood windows in original openings (historic--1920s); replacement front porch (historic); Aluminum awning on front 2nd story window (not historic). Post-2007 -- no changes. | | |
