| <b>STREET #</b> | 105 |
| <b>STREET</b> | ELLSWORTH |

| <b>PREPARER</b> | Lara Ramsey | <b>SURVEYDATE</b> |
| <b>PREPARER ORGANIZATION</b> | RAMSEY HISTORIC CONSULTANTS | <b>SURVEYAREA</b> |

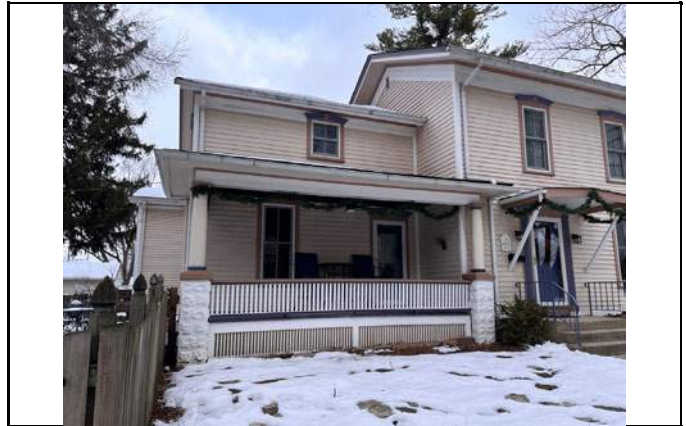
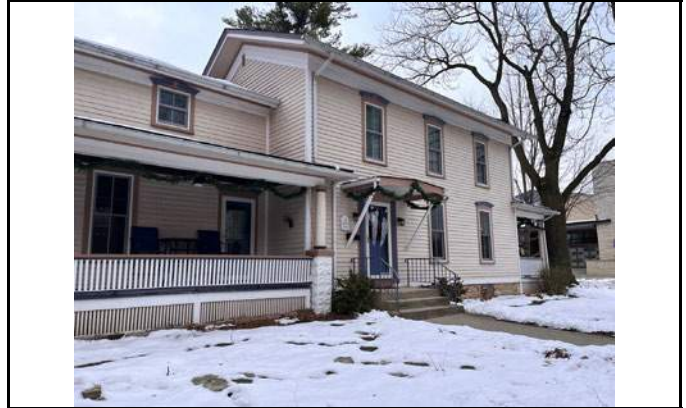
2/2 double-hung Aluminum replacement windows throughout

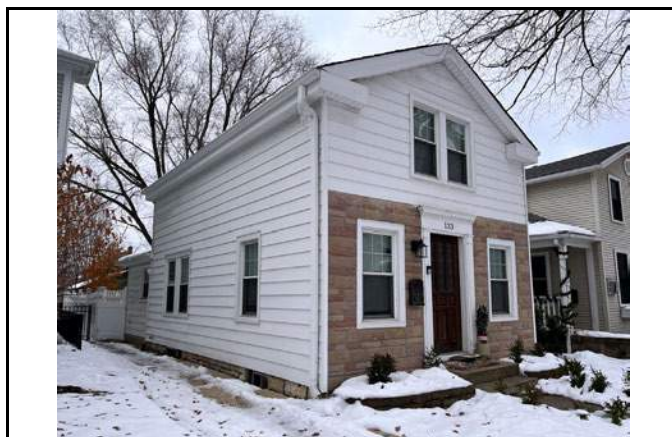
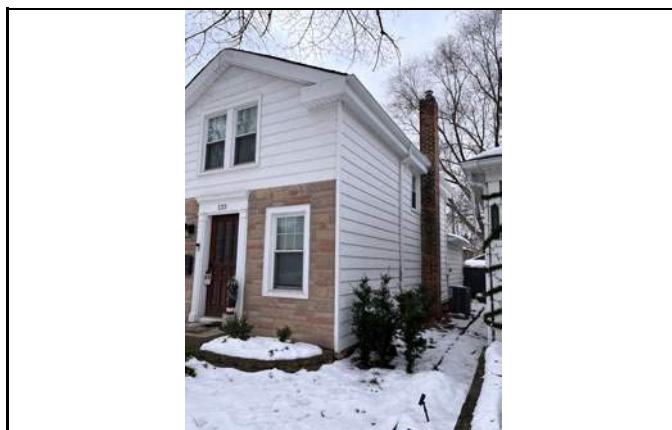
| ALTERATIONS | Aluminum siding (not historic); stone veneer on 1st story façade (not historic); 1 story rear addition. Post-2007 -- 6/1 vinyl replacement windows in existing openings; replacement front door; aluminum siding around first story windows at west end of south elevation replaced. | | |

6/1 vinyl replacement windows in existing openings; replacement front door; aluminum siding around first story windows at west end of south elevation replaced.

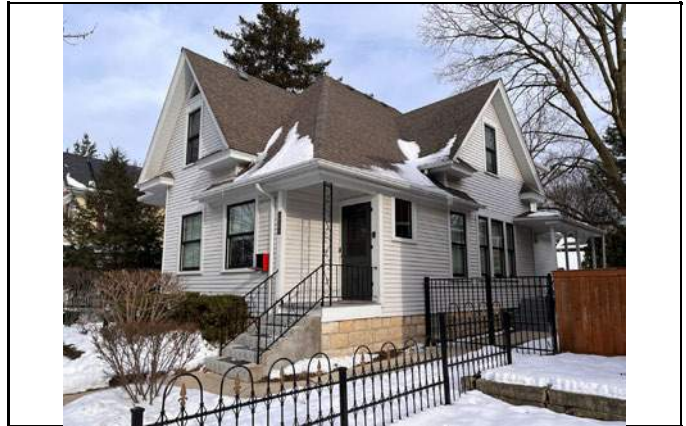
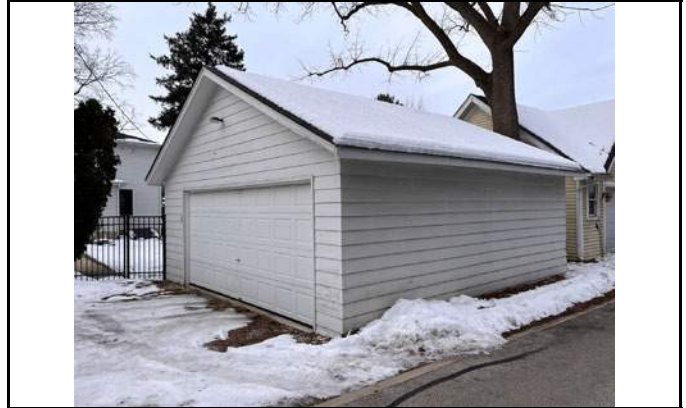
**COA DECISION** COA #18-2732 - In-kind replacement of windows (approved 7/17/2018)

**COA COMPLIANCE NOTES:** 2007 survey photos show 1/1 double-hung windows on front and side elevations -- replacement windows are 2/2.

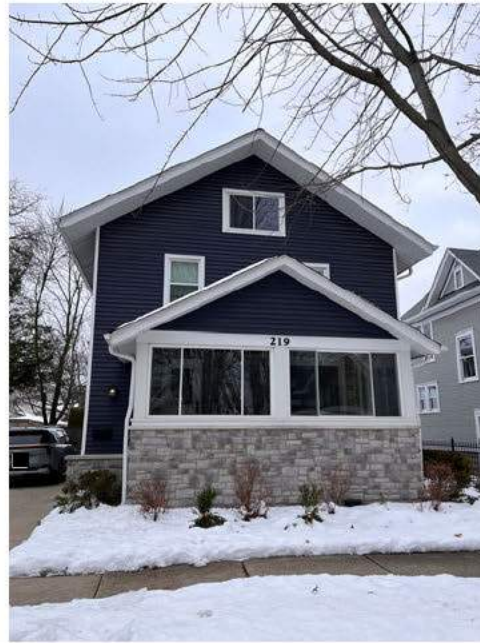
| CONDITION | good | REASON for SIGNIFICANCE | |

| ALTERATIONS | Aluminum siding; rear/south entry and porch addition; 2 story rear addition. Post-2007 – Aluminum siding repainted or replaced; 4-light geometric wood windows in enclosed porch relaced with single-light Aluminum windows; door to enclosed porch replaced; 1/1 Aluminum replacement windows in existing openings on front and side elevations; south-side entry porch removed; replacement door in south-side ground-level entry; cast stone covering base of front porch and foundation. |

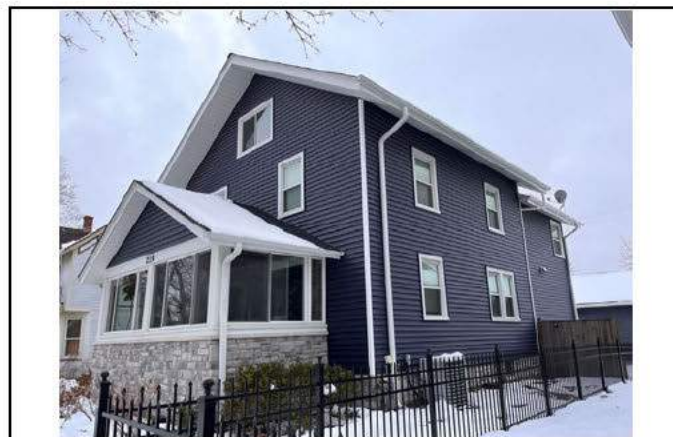
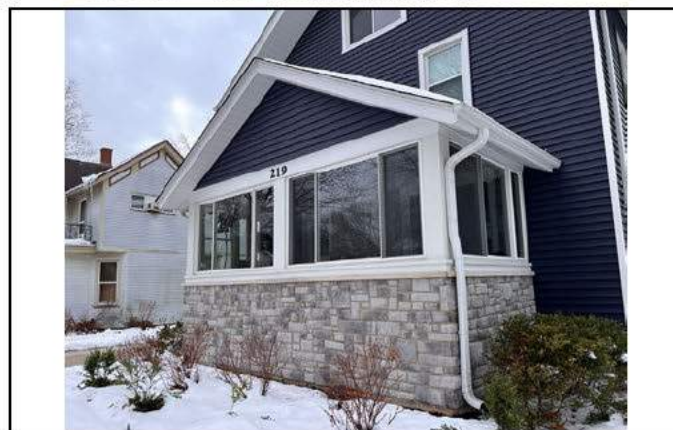
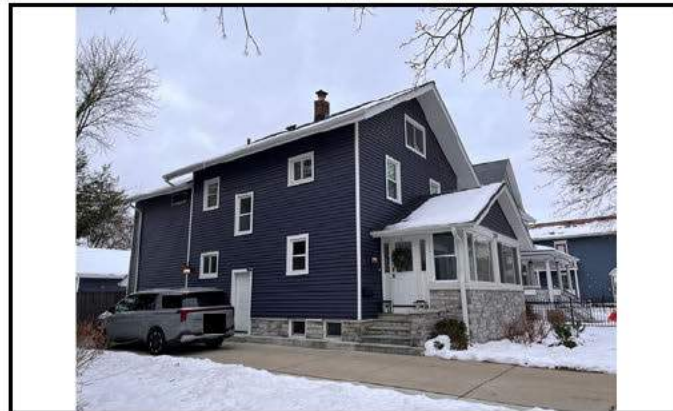
Replacement windows throughout; south side entry porch removed; replacement door in ground-level south-side entry.

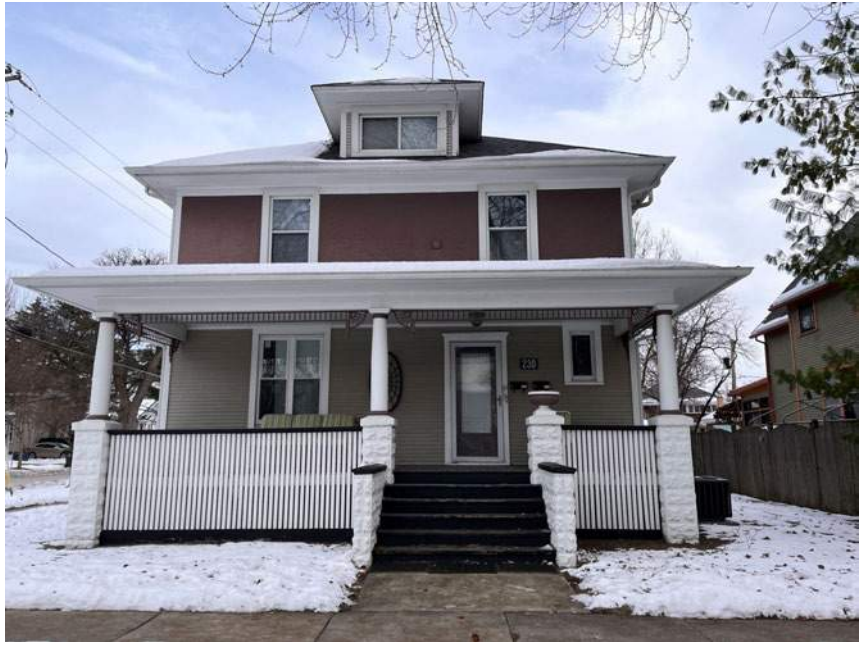
| CONDITION | excellent | REASON for SIGNIFICANCE | |

| ALTERATIONS | 1/1 replacement windows in original openings (not historic); replacement railing and added frieze on porch. Post-2007 -- single window at north end of front façade under porch replaced with paired Aluminum/vinyl 1/1 double-hung windows; replacement asphalt shingle roofing. | | |

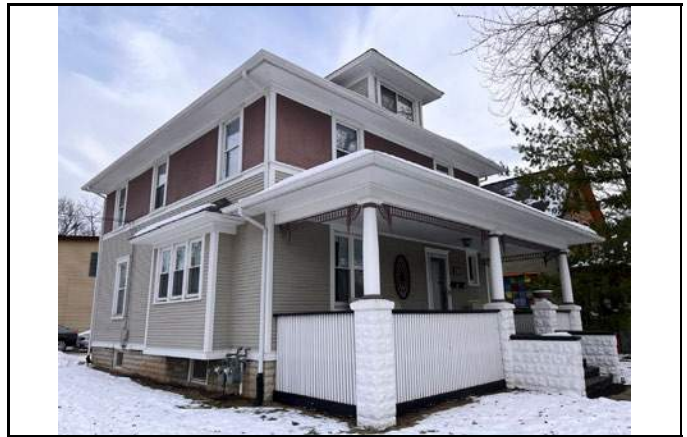
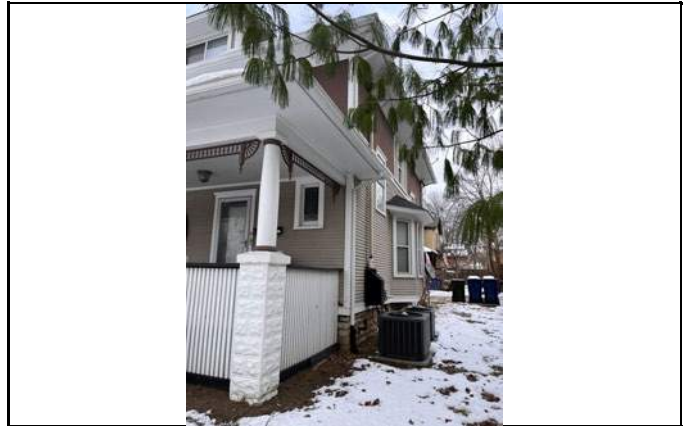
single window at north end of front façade under porch replaced with paired Aluminum/vinyl 1/1 double-hung windows.

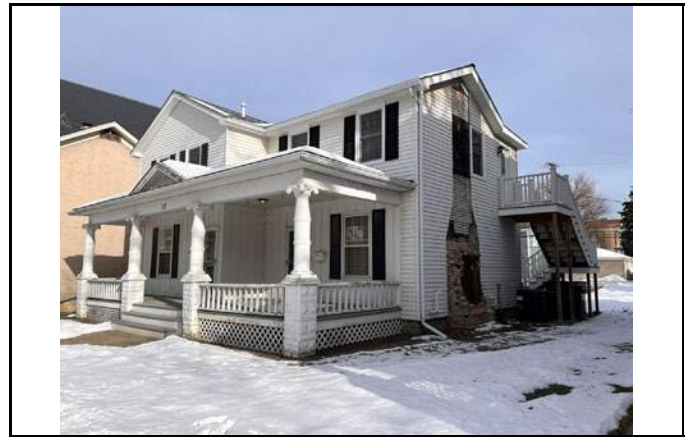
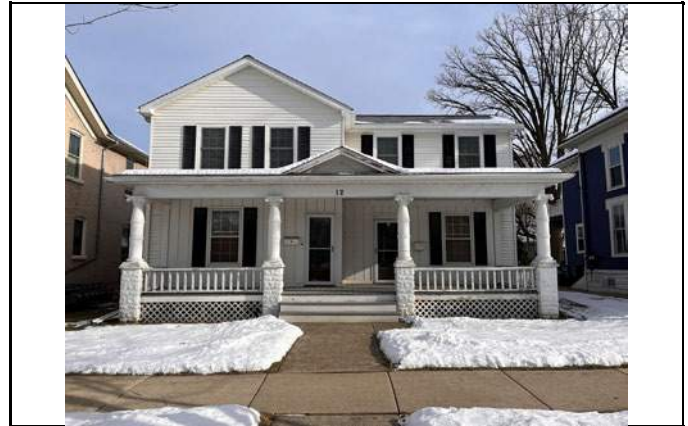
Aluminum/vinyl replacement windows on 2nd story; chimney on south elevation demolished.

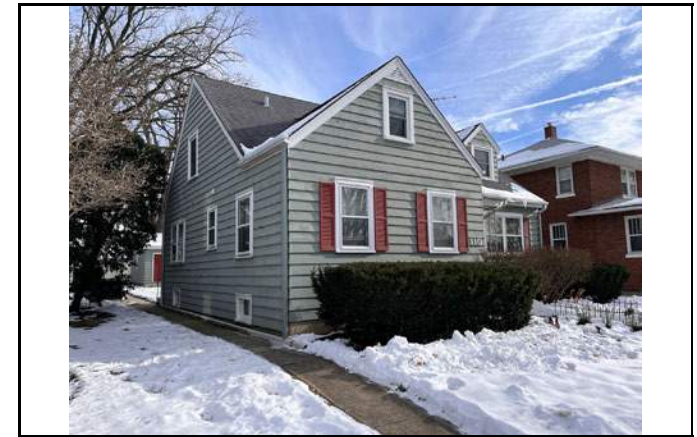
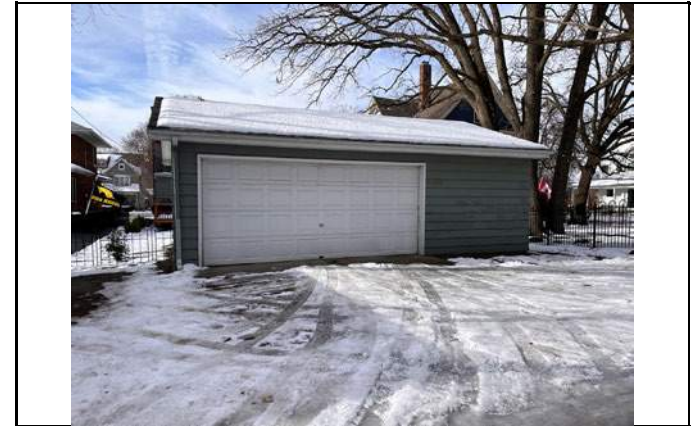
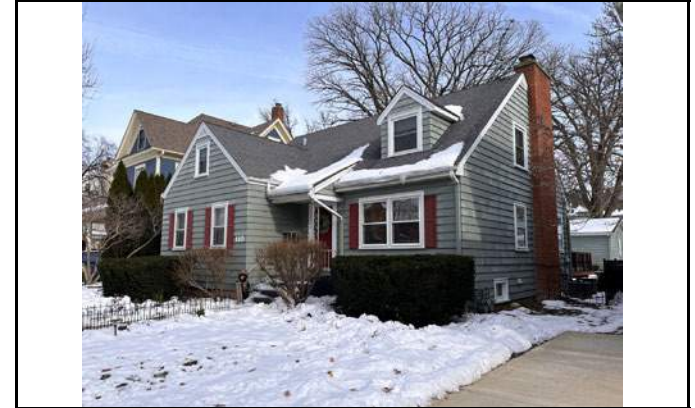
1/1 replacement windows on attic level and in front dormer.
